Betsy Pettit, FAIA

A18 Deep Energy Retrofits for Existing Single Family Homes Case Studies

Residential Design and Construction 2010

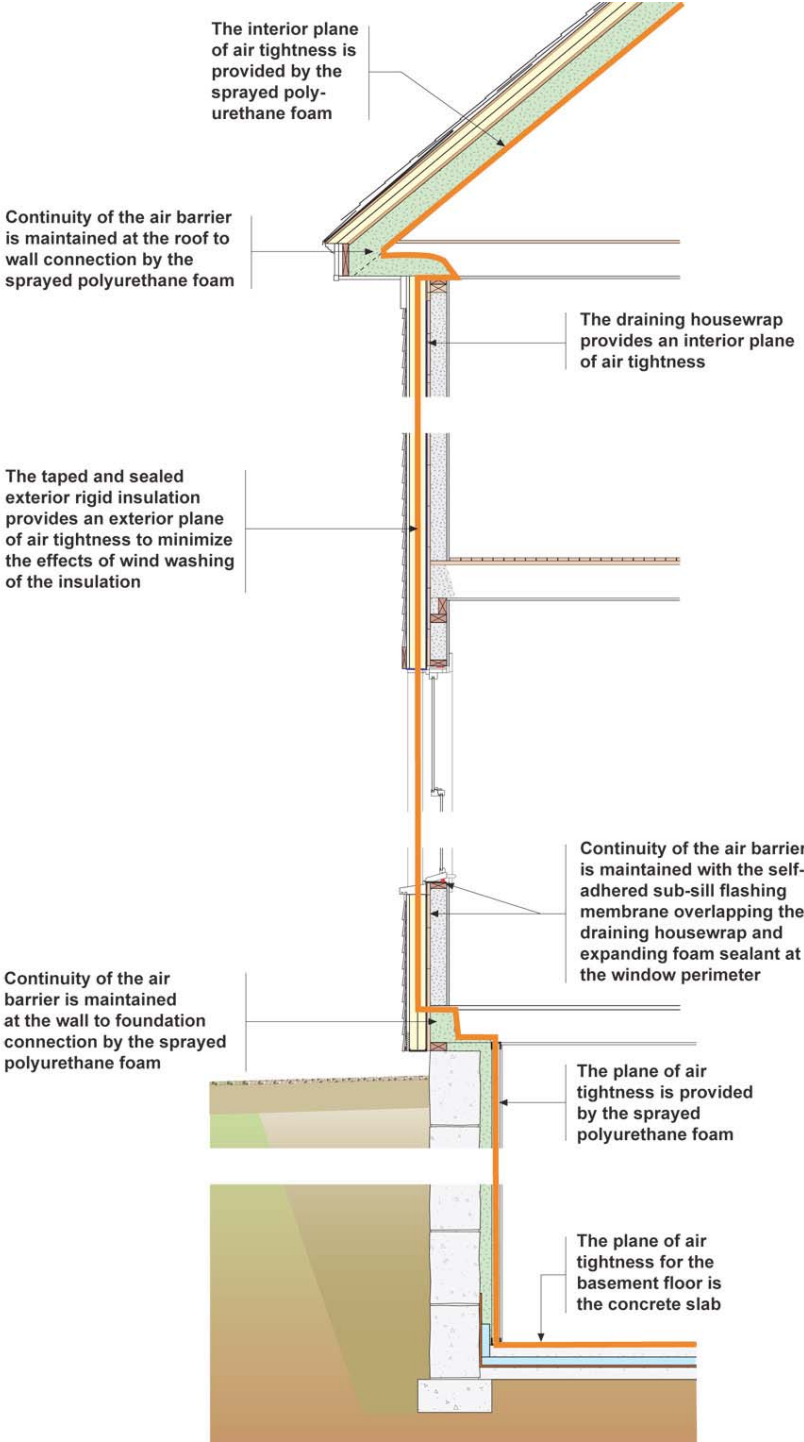
The interior plane of air tightness is provided by the sprayed polyurethane foam

Continuity of the air barrier is maintained at the roof to wall connection by the sprayed polyurethane foam

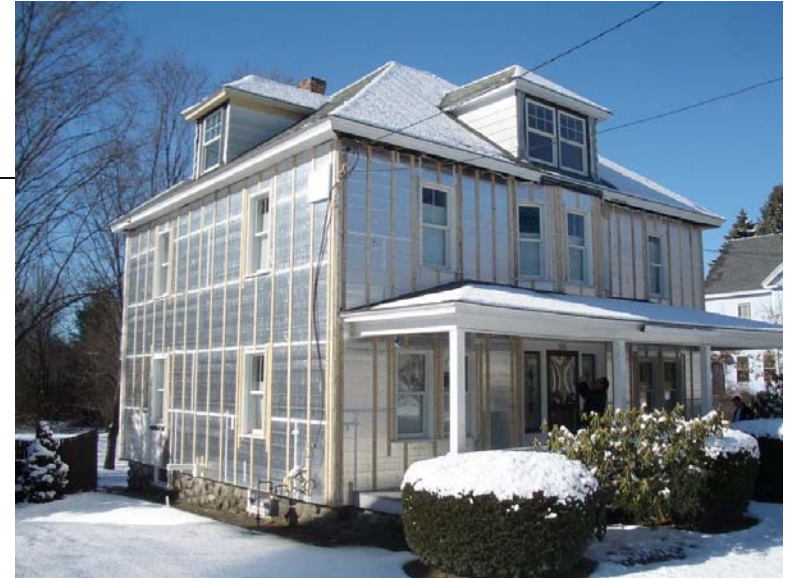
Air Barrier Continuity

The taped and sealed exterior rigid insulation provides an exterior plane of air tightness to minimize the effects of wind washing of the insulation

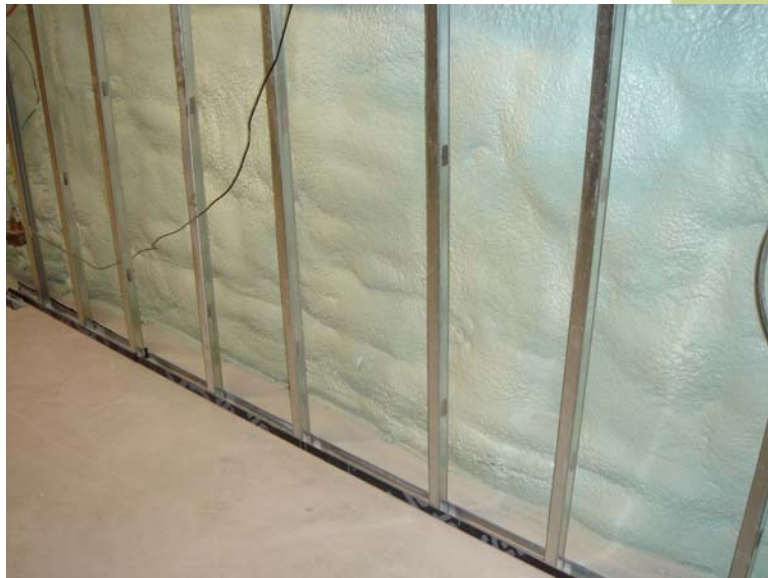
Continuity of the air barrier is maintained at the wall to foundation connection by the sprayed polyurethane foam

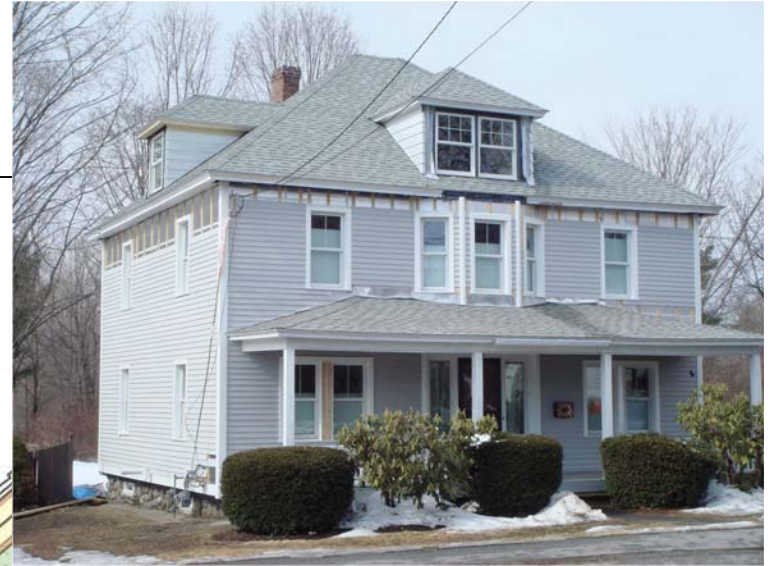
Rain water drains off roof and away from the foundation

Overhangs protect wall and window assemblies from direct rain water

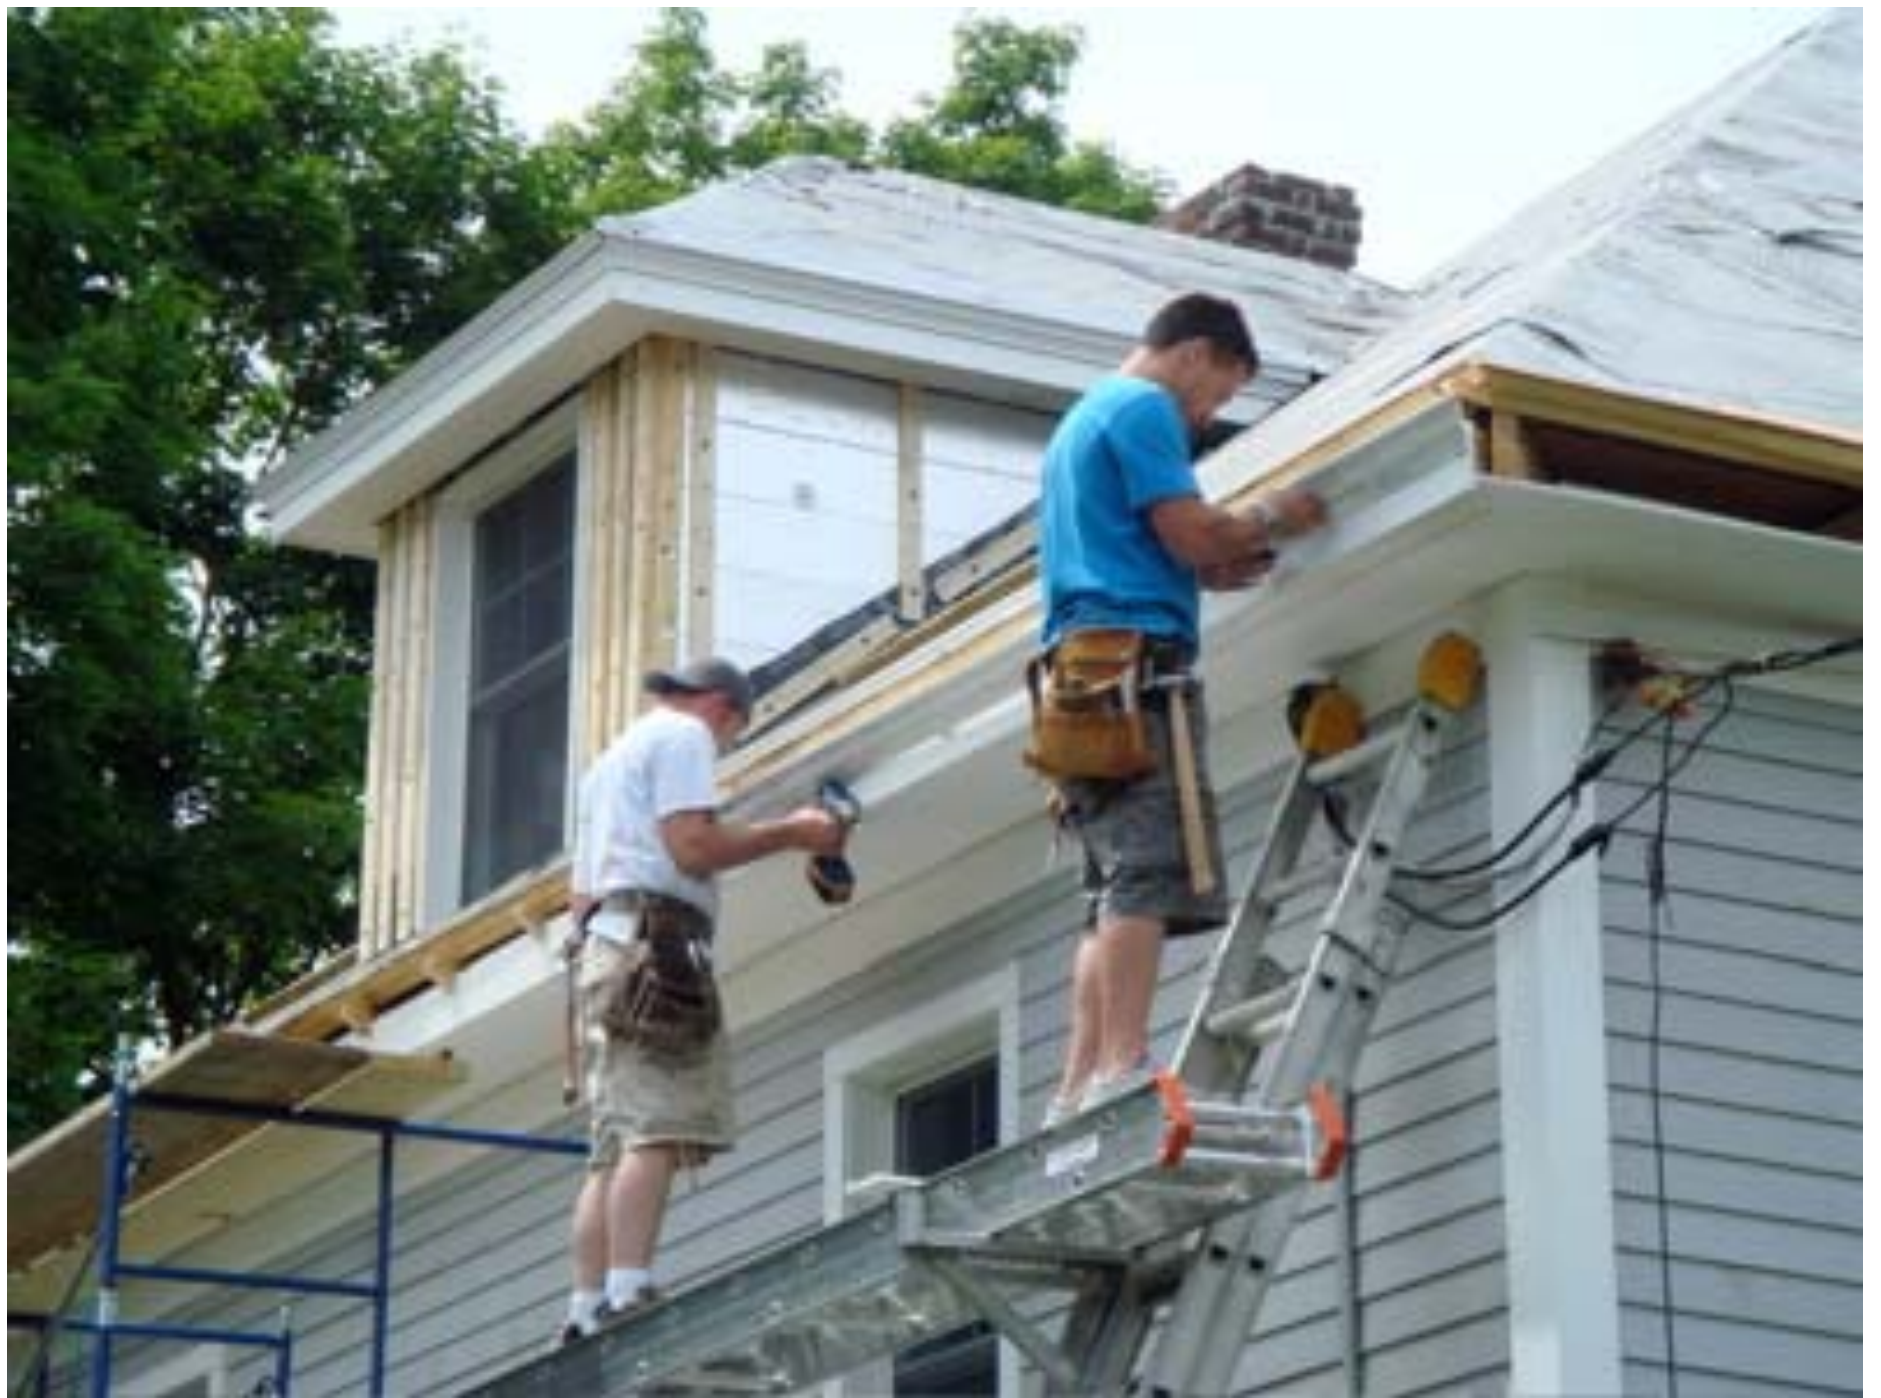
Drainage Plane Continuity

Rain water drains down over the shingle-lapped siding. Small amounts of water that penetrate past the cladding are drained on the insulating sheathing. Water that penetrates the insulating sheathing is carried down the wall on the draining housewrap.

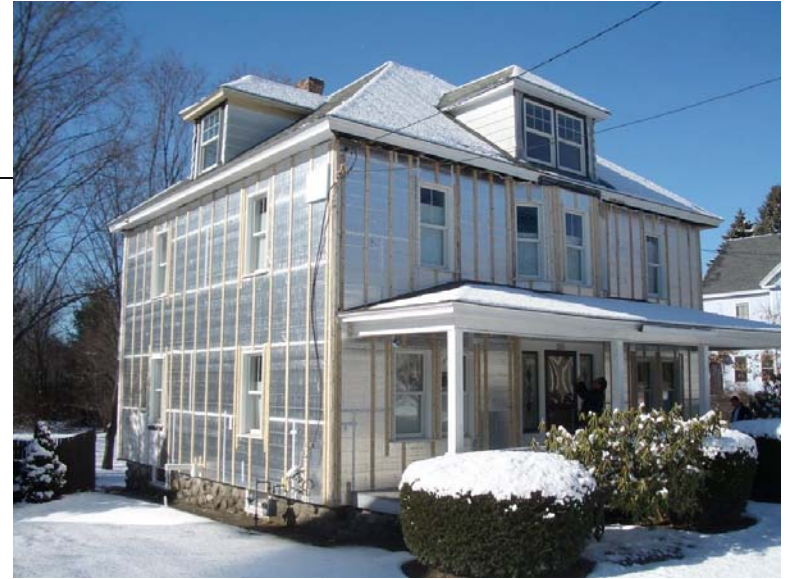
Thermal Continuity

The thermal resistance of the wall assembly is made up of the blown cellulose cavity insulation and the two layers of 2-inch rigid polyisocyanurate insulating sheathing

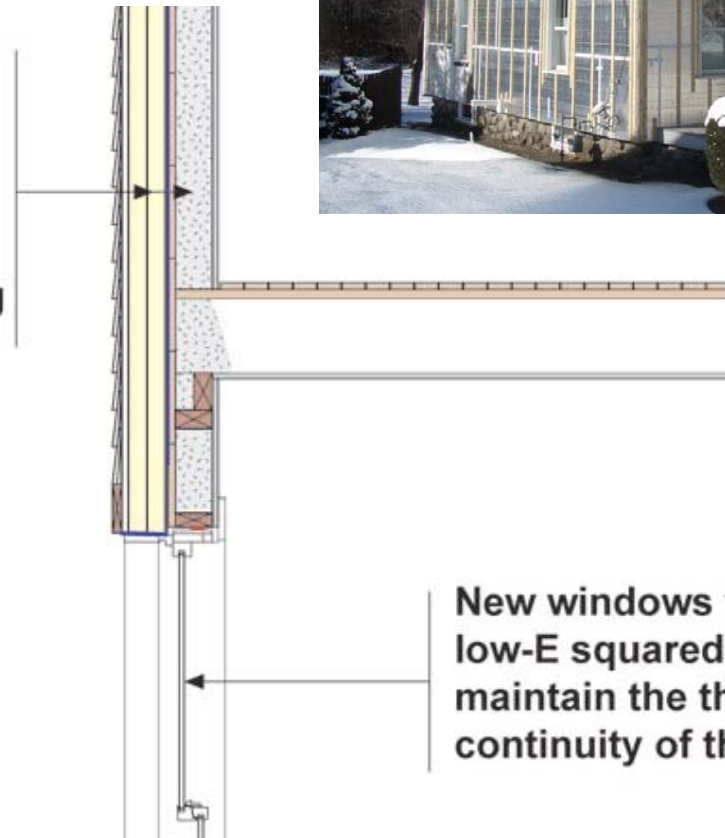
New windows with low-E squared glazing maintain the thermal continuity of the wall

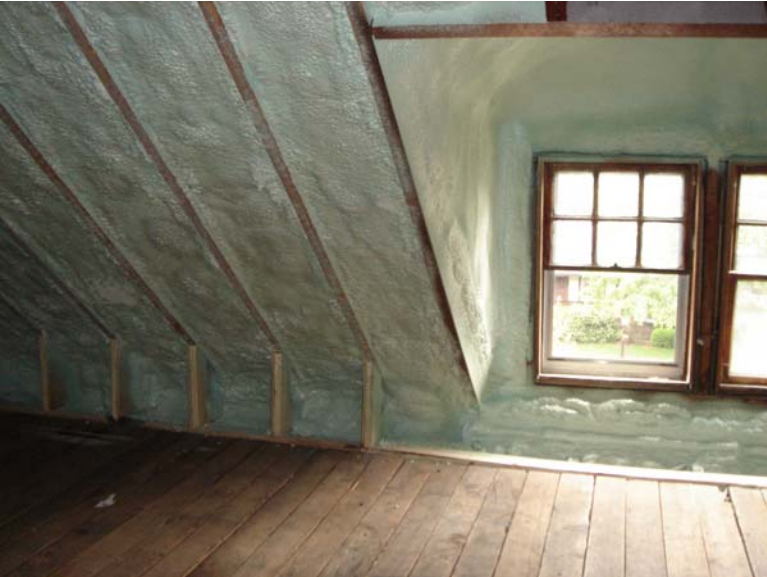
Vapor Barrier Continuity

Polyisocyanurate limits moisture flow from the interior during winter

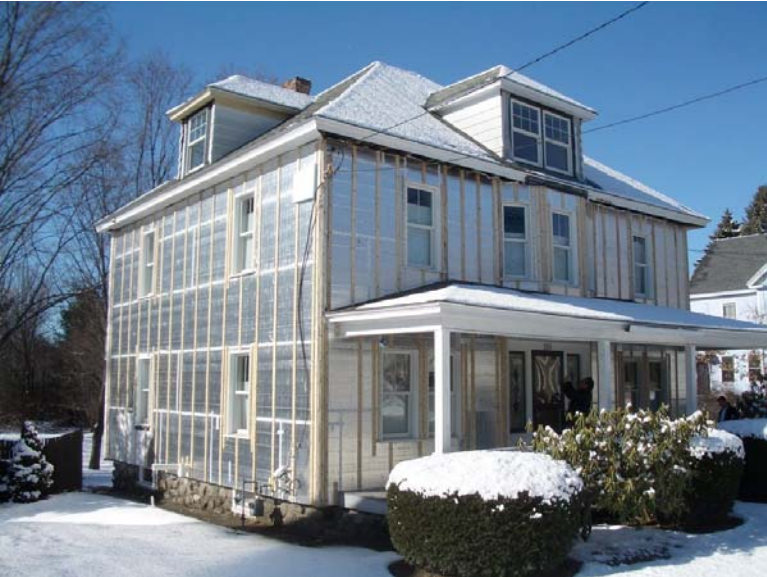
Vapor Barrier Continuity

Polyisocyanurate elevates the surface temperature of the exterior sheathing during the winter to reduce the condensation potential

Semi-permeable interior latex paint finish on gypsum board reduces moisture flow from interior during winter yet still allows drying to the interior during summer

Cellulose insulation acts as a hygric buffer by safely storing moisture until it can dry to either the interior or exterior

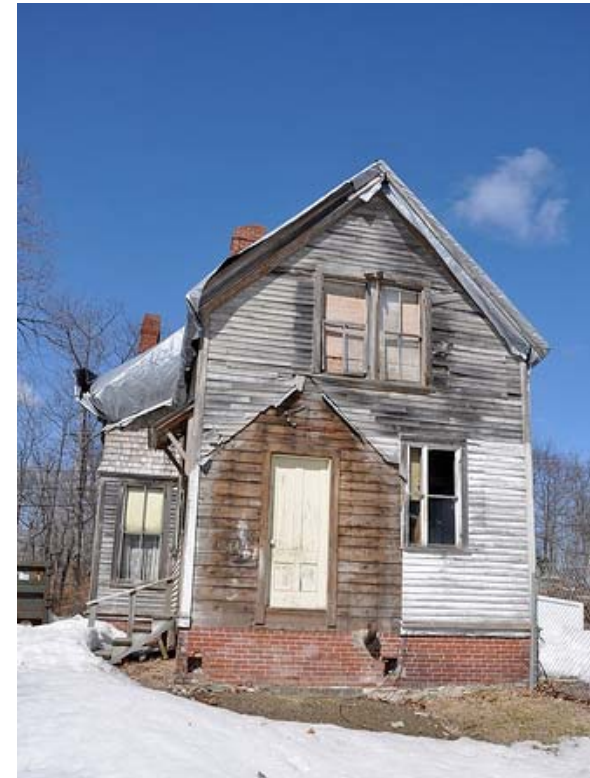
- Project Overview
 - Builder: Warren Construction Group
 - Location: Freeport, ME
 - Climate: Cold (6A)
 - Type: Single Family
 - Stories: 2
 - Bedrooms: 3
 - Baths: 1.5
 - Floor Area: 1,600 sq.ft.
 - Basement Area: 886 sq.ft.

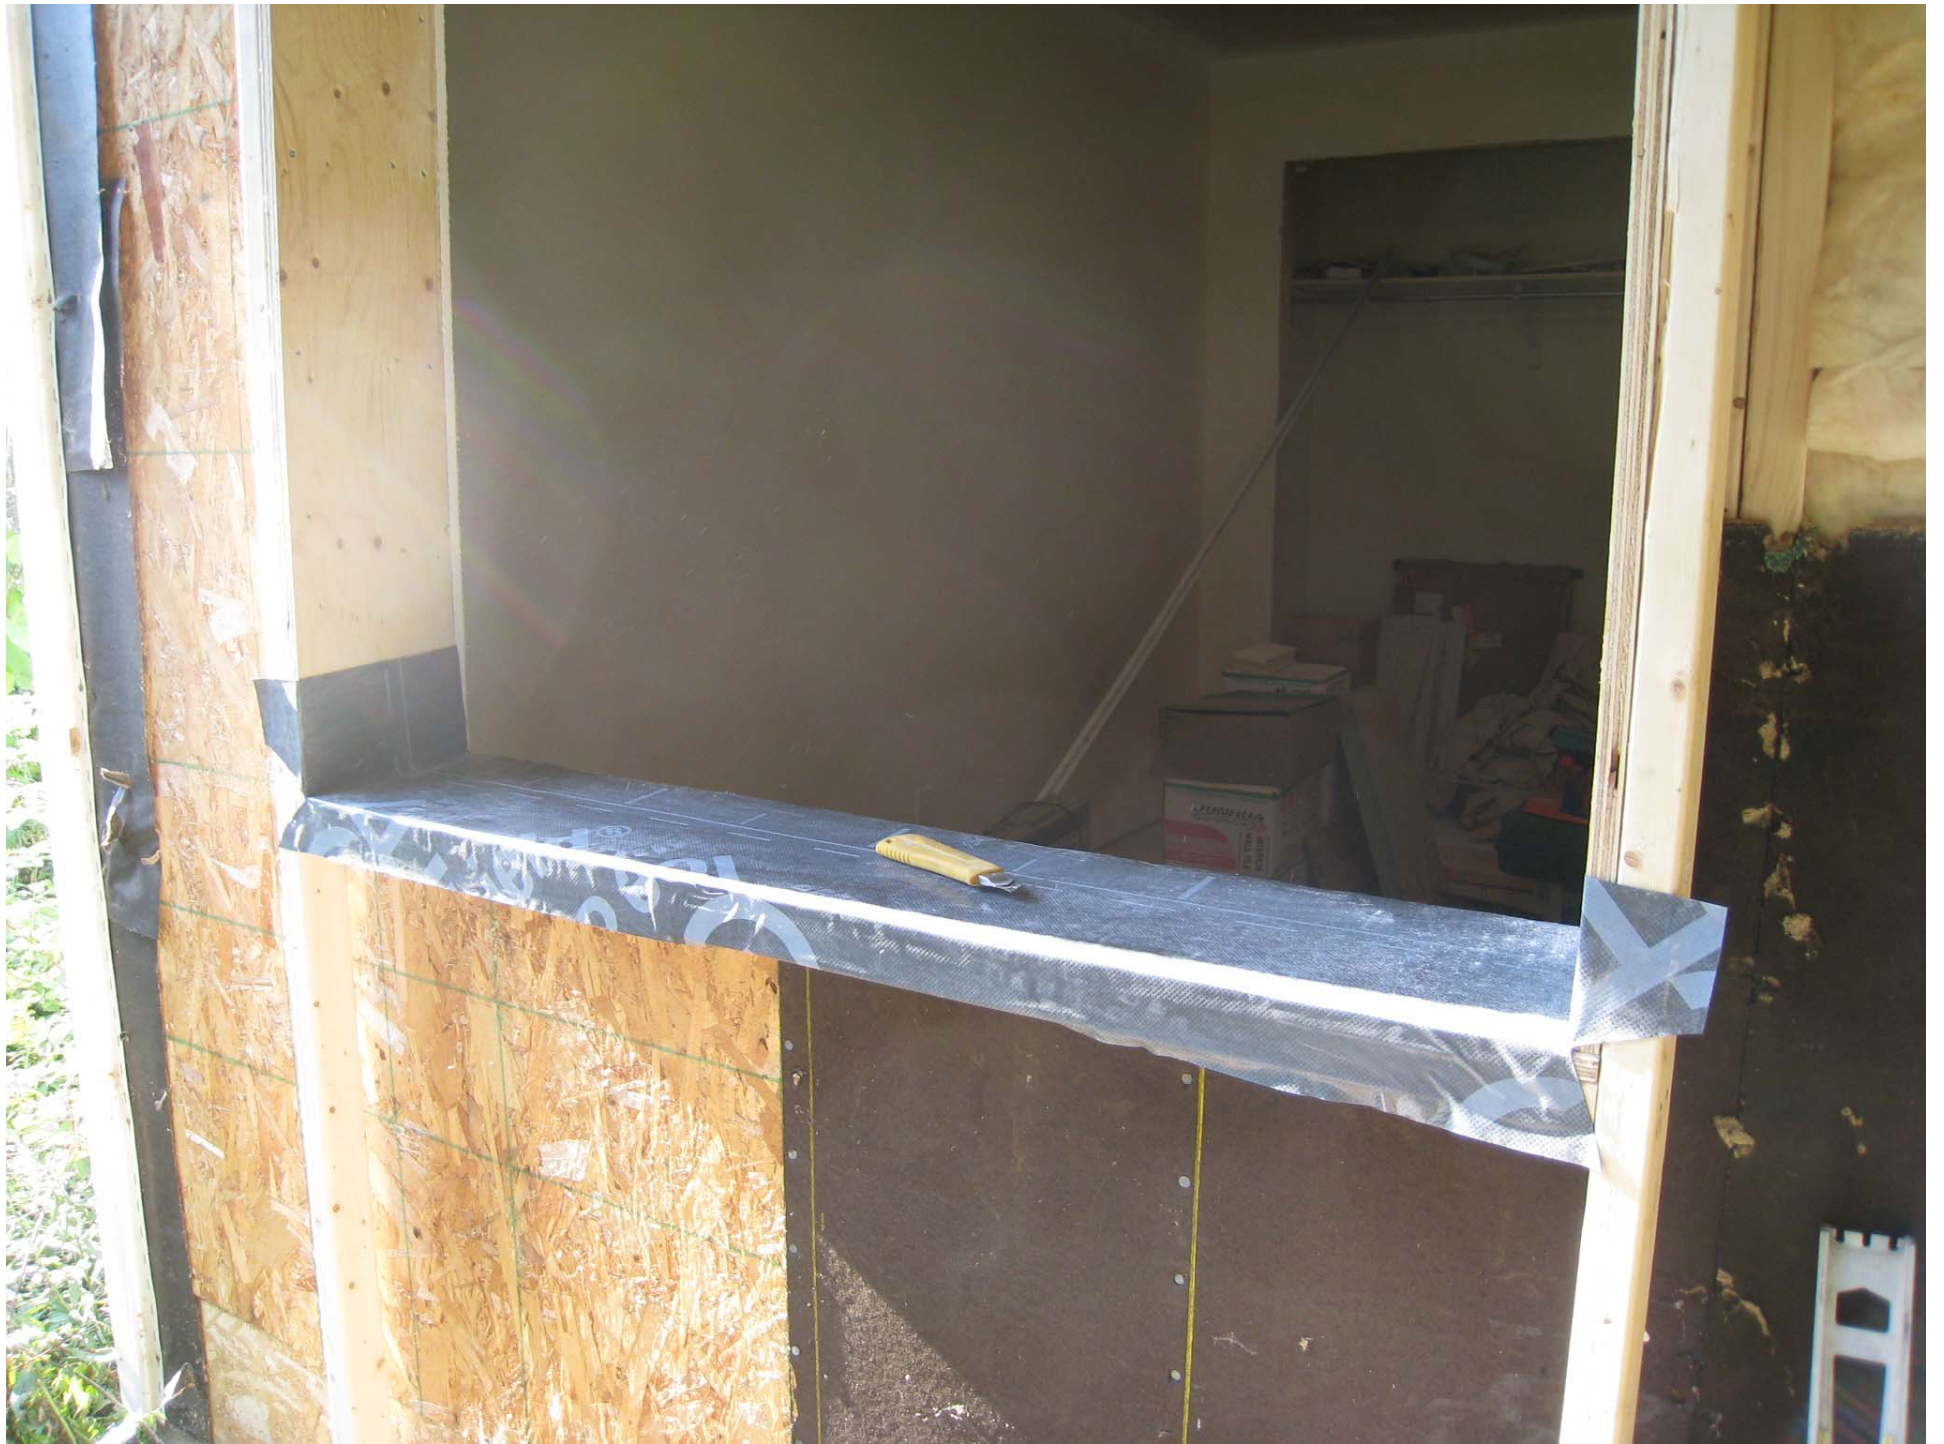
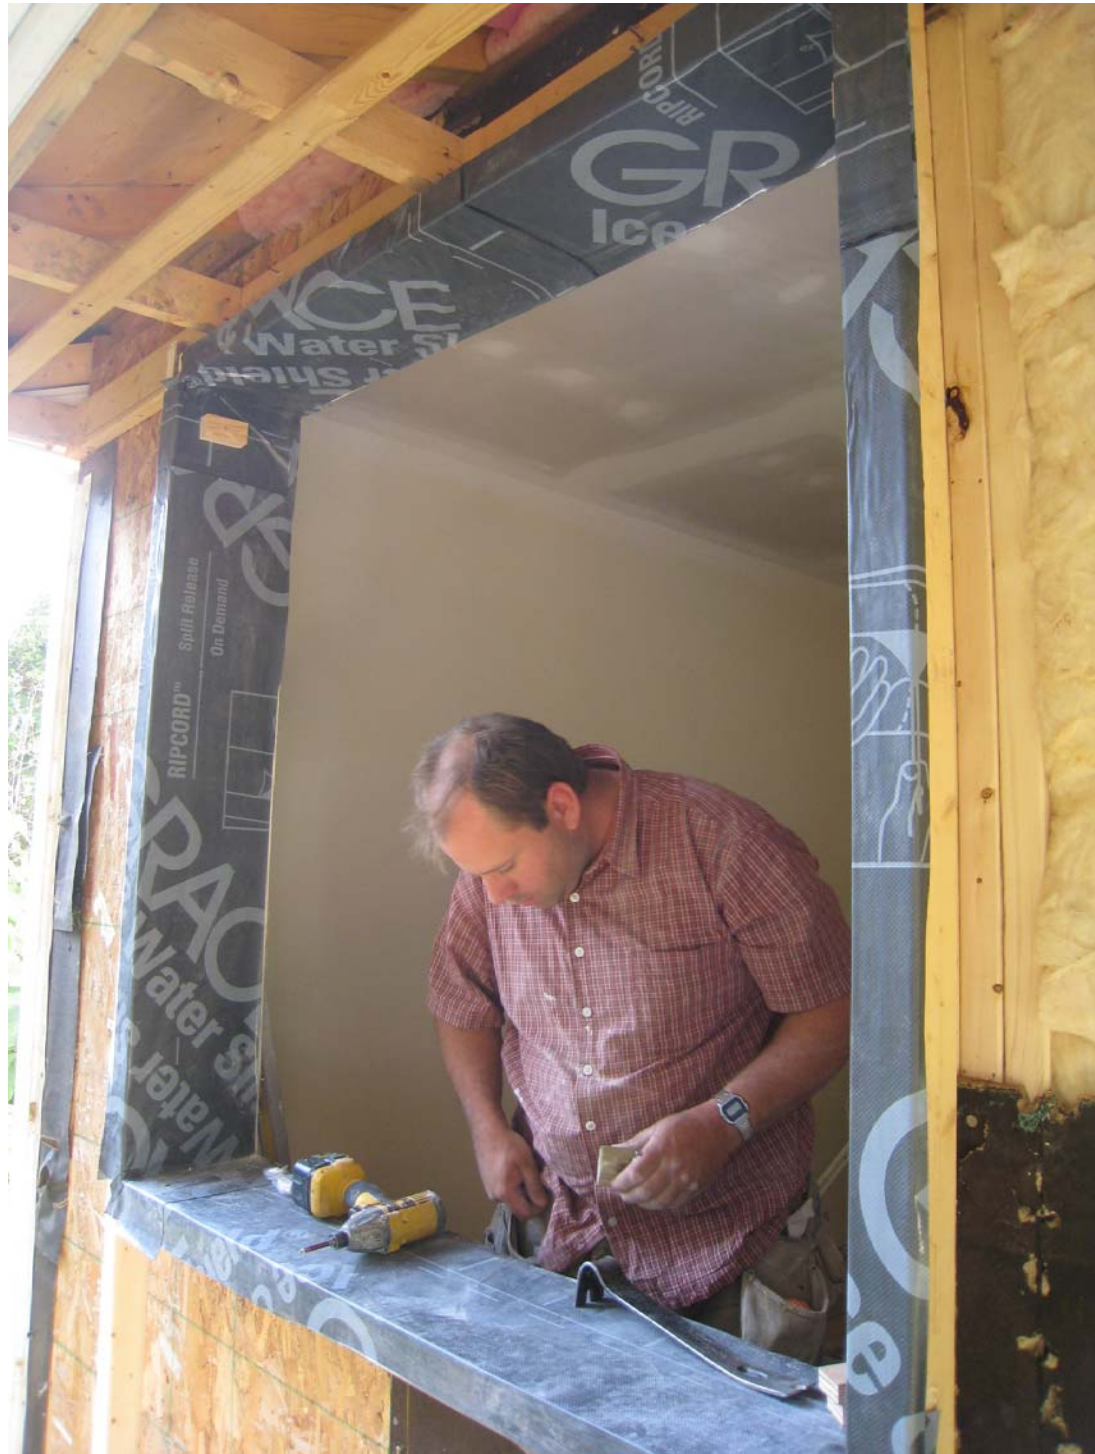
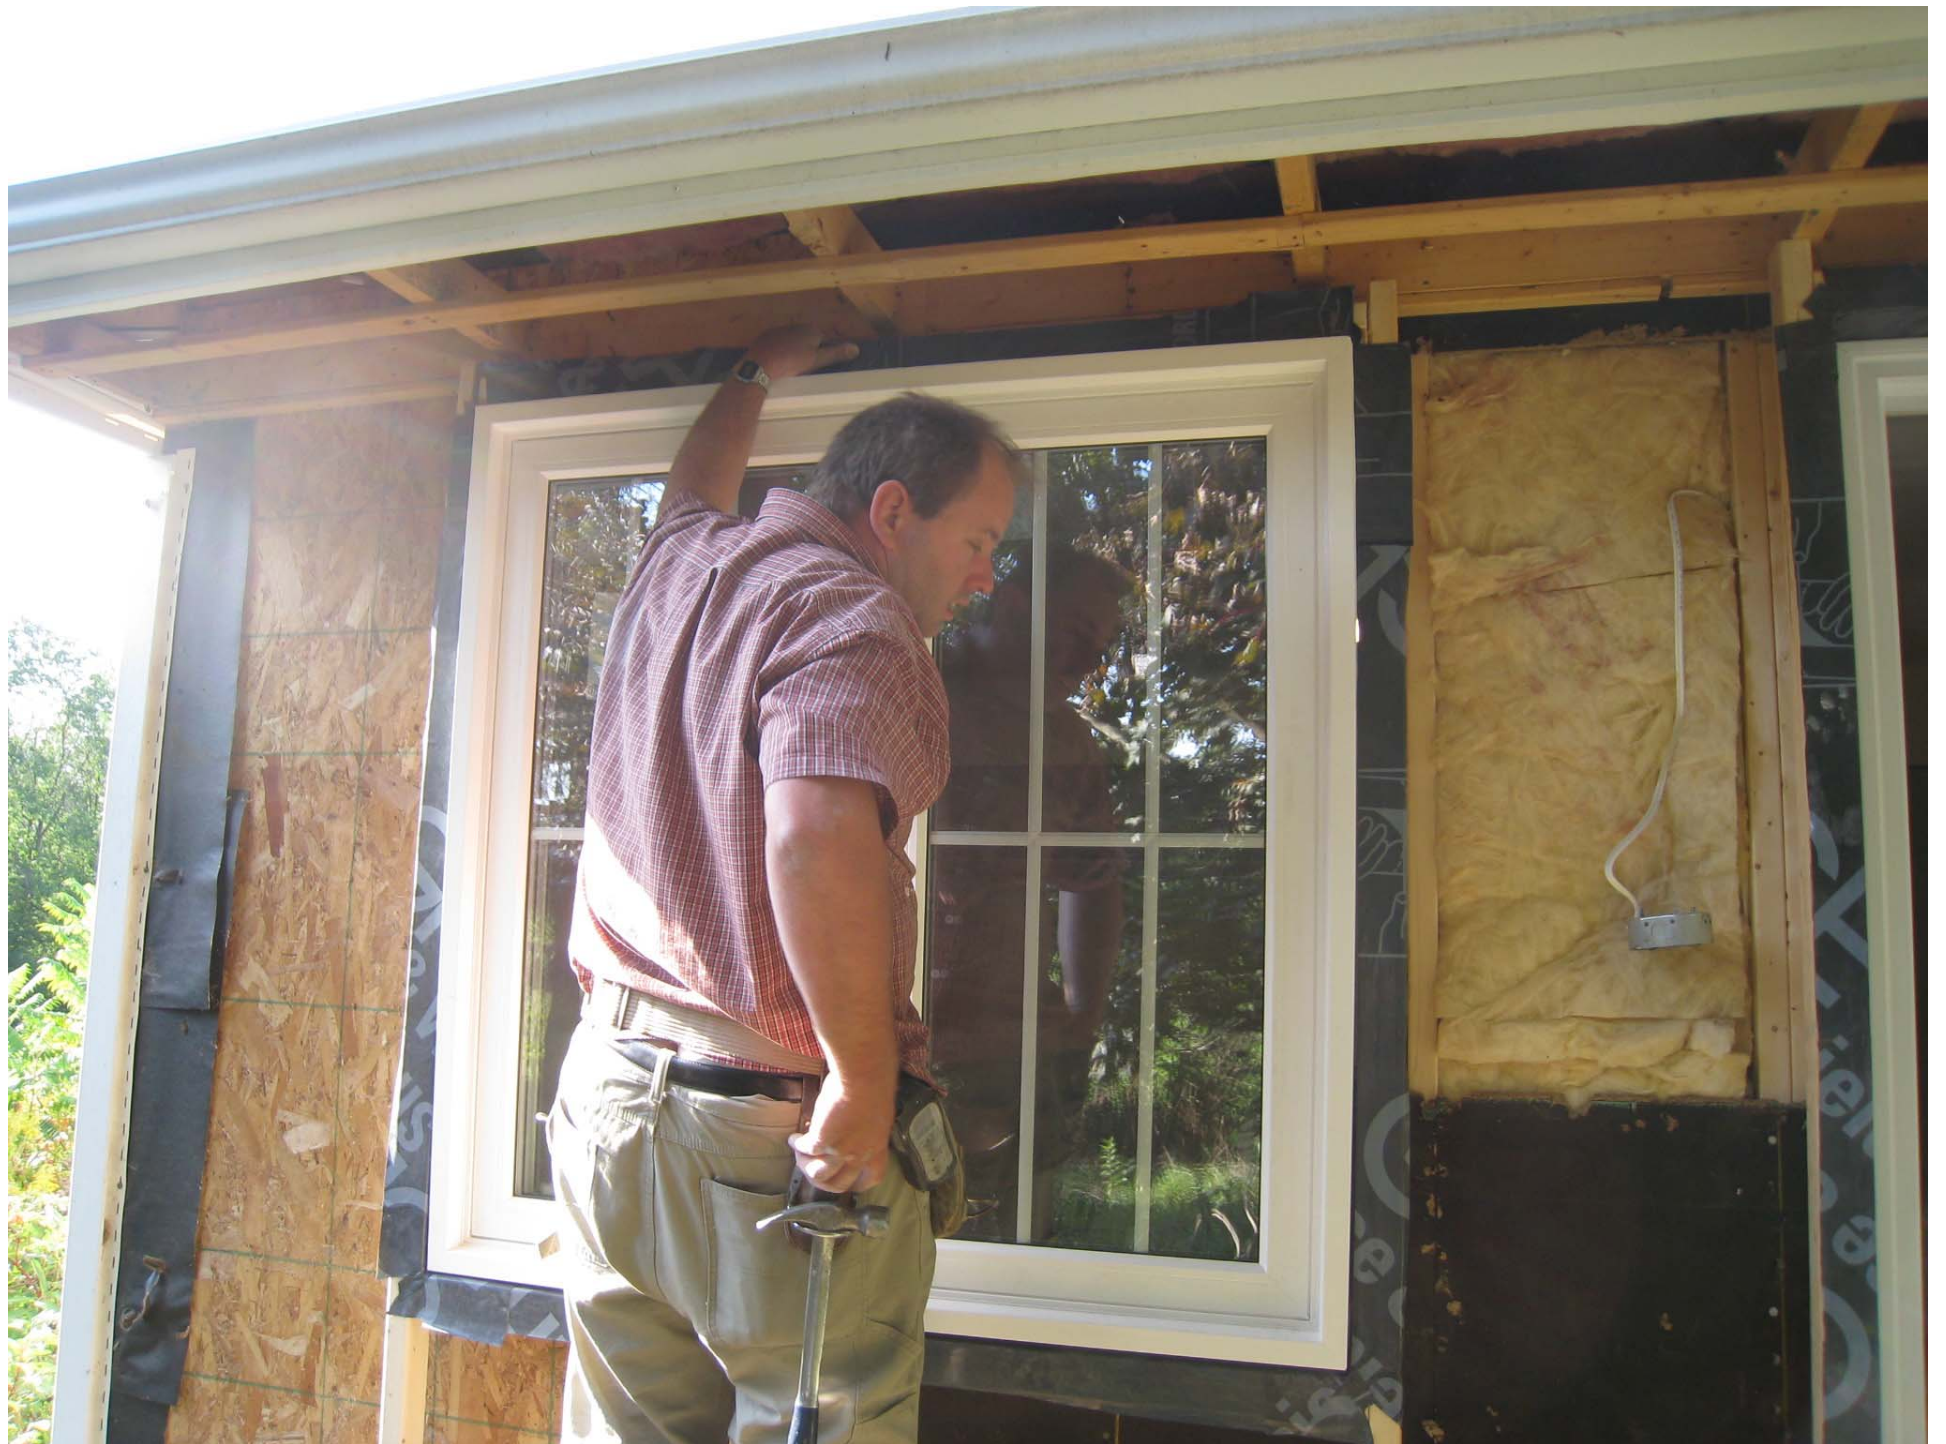
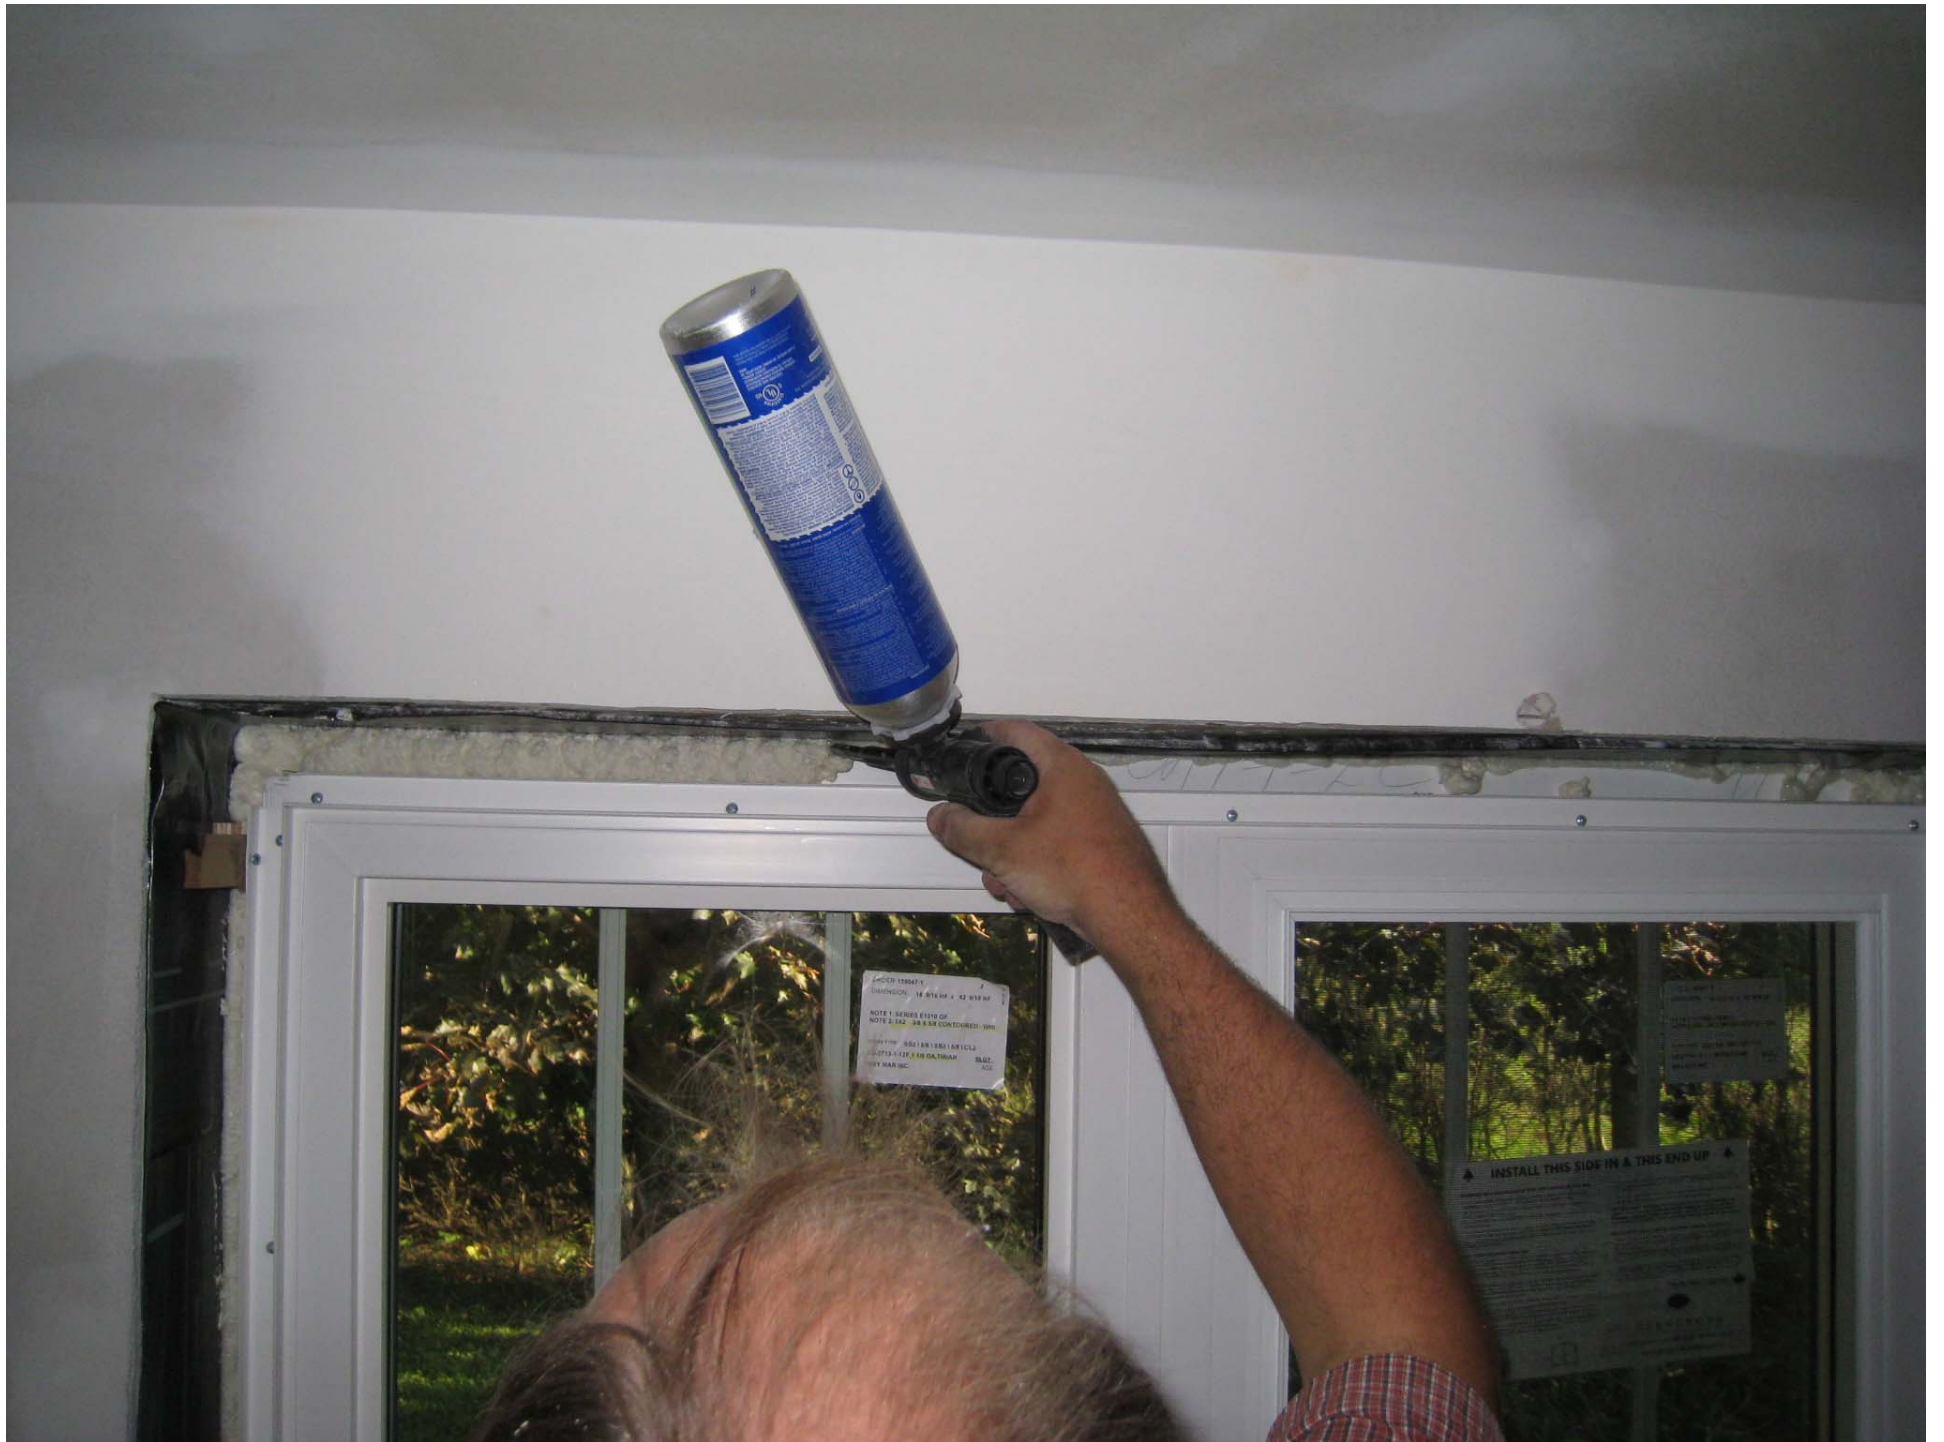
Windows

- Important choice!
- Need better rain control
- Improved R-value of course
