Betsy Pettit, FAIA

A18 Deep Energy Retrofits for Existing Single Family Homes Case Studies

Residential Design and Construction 2010

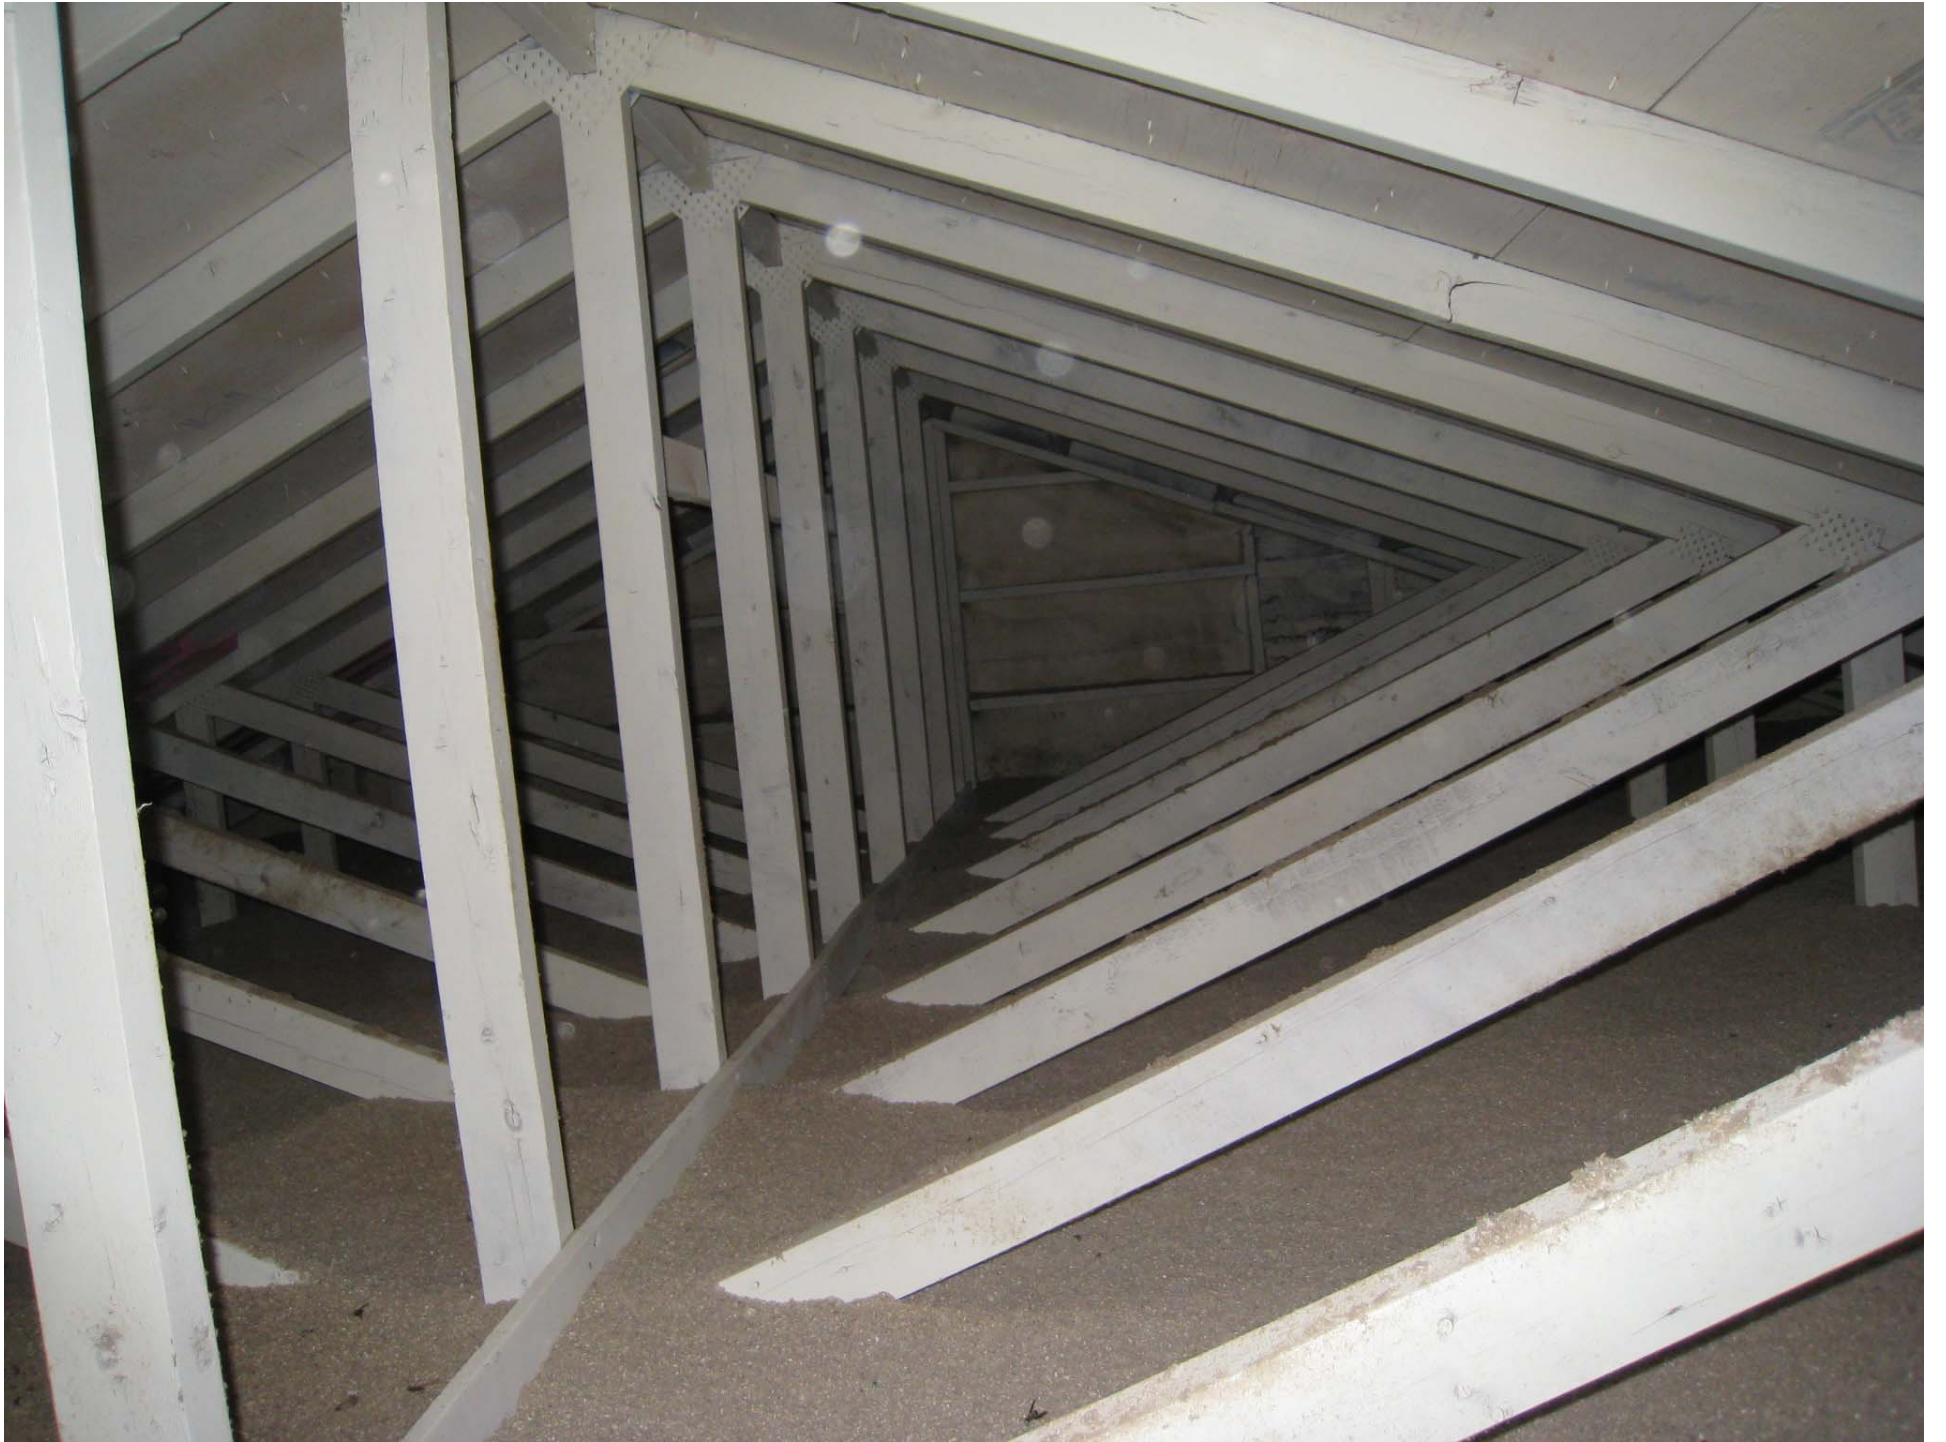
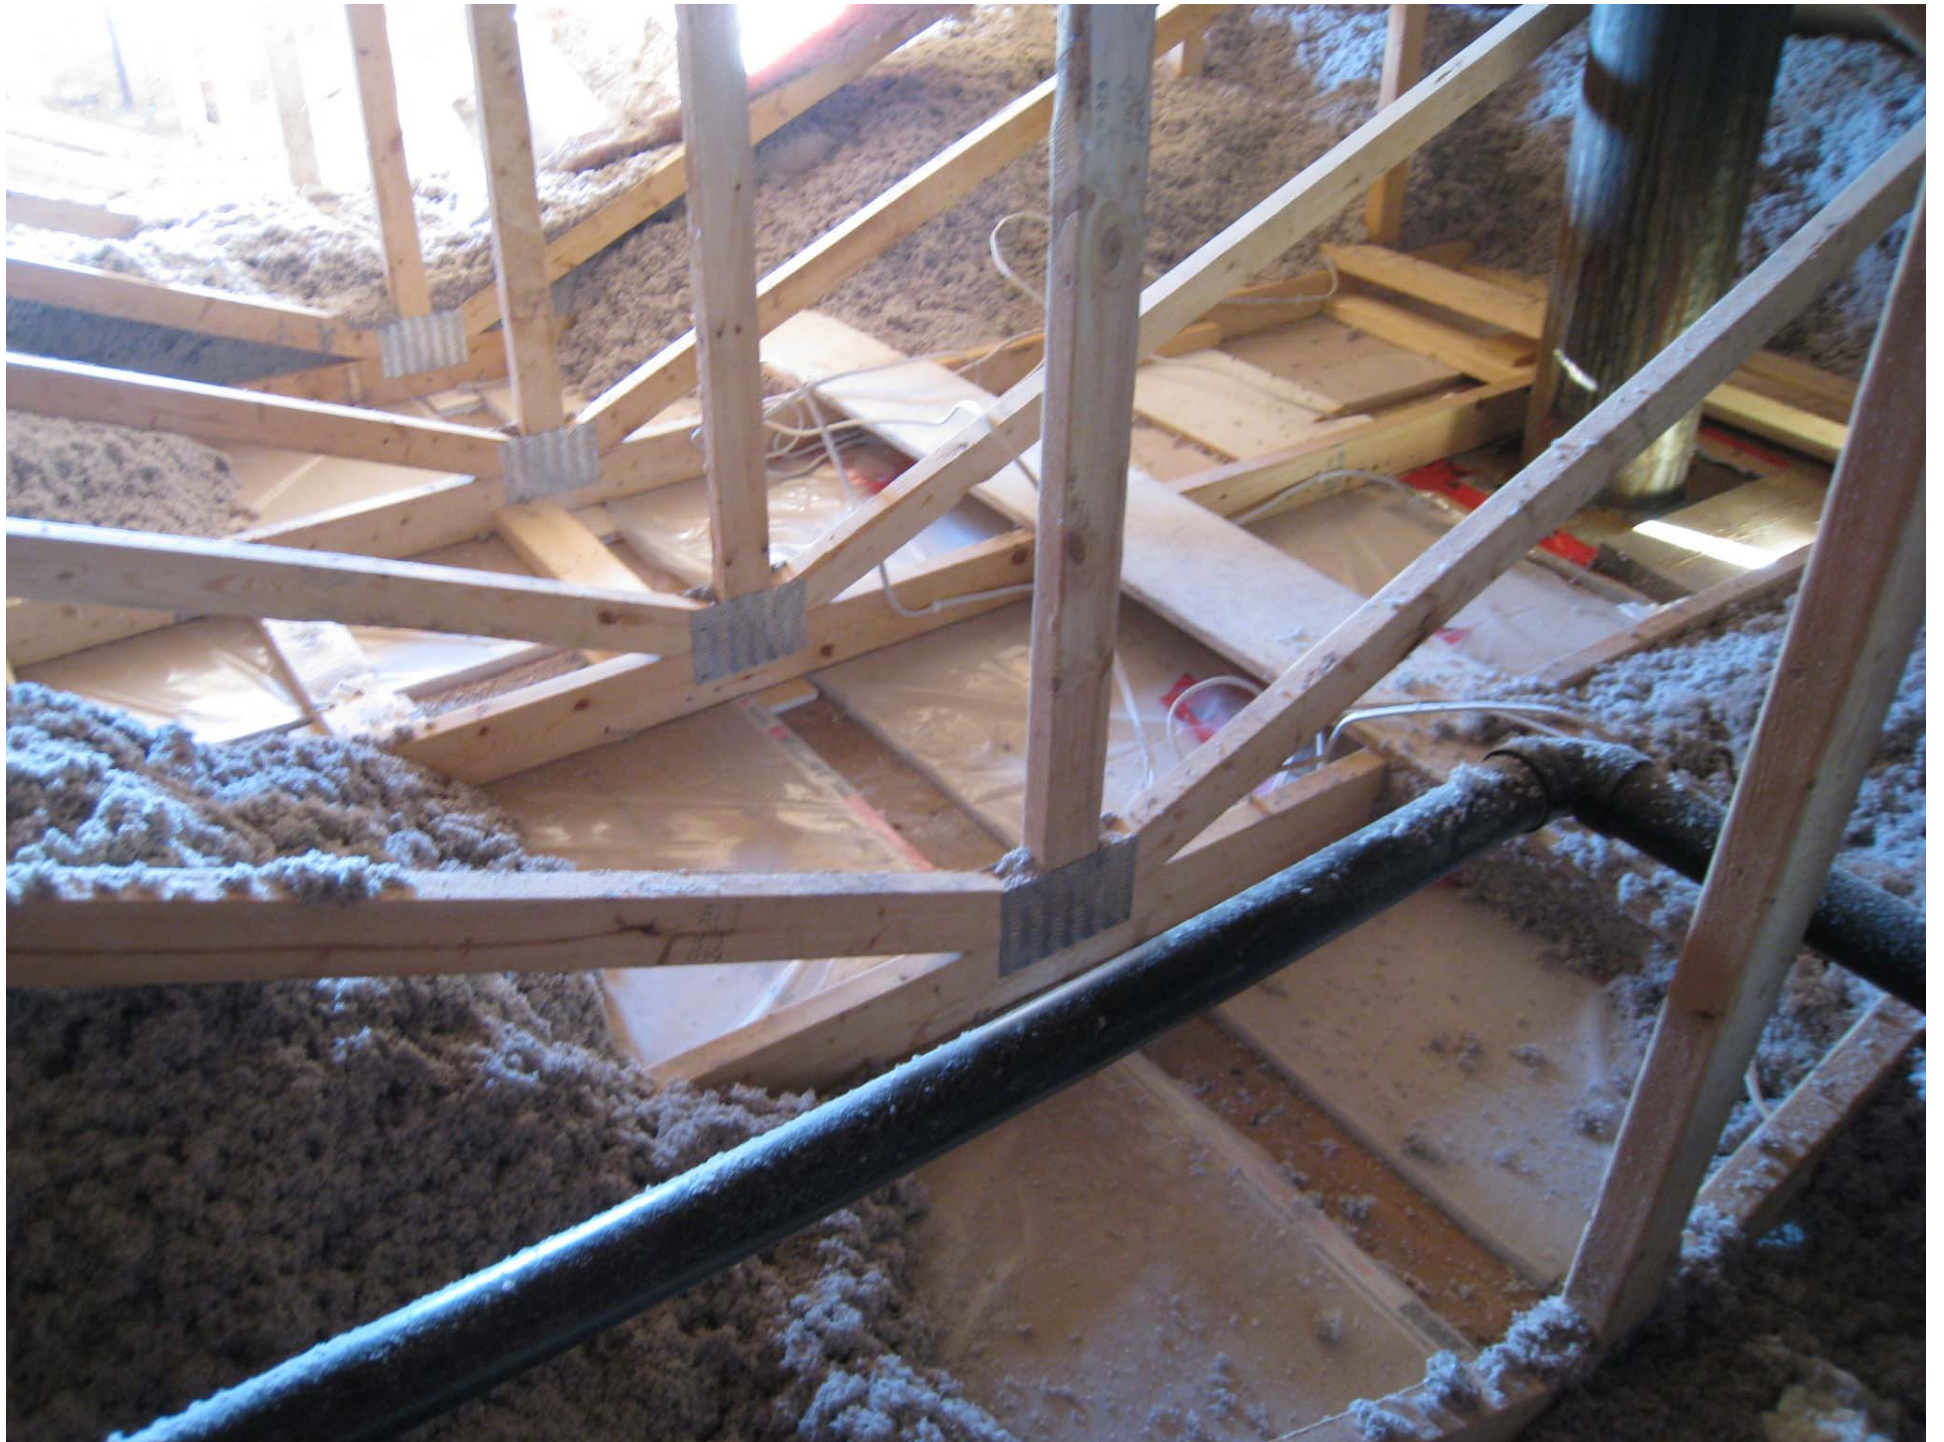
Fully Vented Attics

- Can re-roof whenever, with whatever
- Deal with moisture, then add insulation
 - Rain leaks, air leaks
- If possible, keep ventilated attic
 - Inspect ceiling plane, plug all holes with caulking and foam
 - Consider 1" of spray foam air barrier
 - Blow in minimum R60 cellulose, R75-R100 sensible
