Forensic Assignments

15th ANNUAL WESTFORD SYMPOSIUM ON BUILDING SCIENCE

The Vintage Club Clubhouse

Northridge Meadows Apartments
Northridge, California

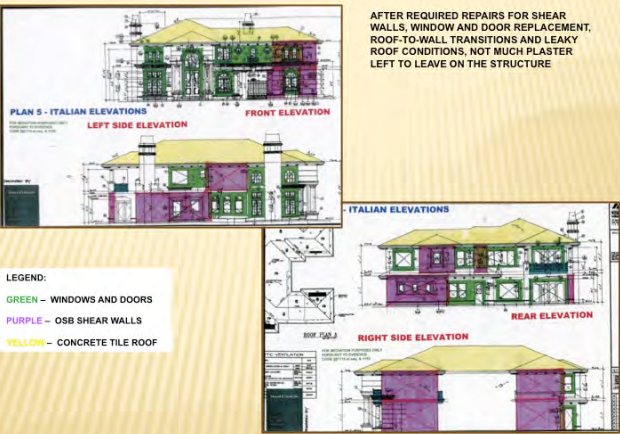
PLAN 5 - ITALIAN ELEVATIONS
LEFT SIDE ELEVATION FRONT ELEVATION

RIGHT SIDE ELEVATION REAR ELEVATION

AFTER REQUIRED REPAIRS FOR SHEAR WALLS, WINDOW AND DOOR REPLACEMENT, ROOF-TO-WALL TRANSITIONS AND LEAKY ROOF CONDITIONS, NOT MUCH PLASTER LEFT TO LEAVE ON THE STRUCTURE

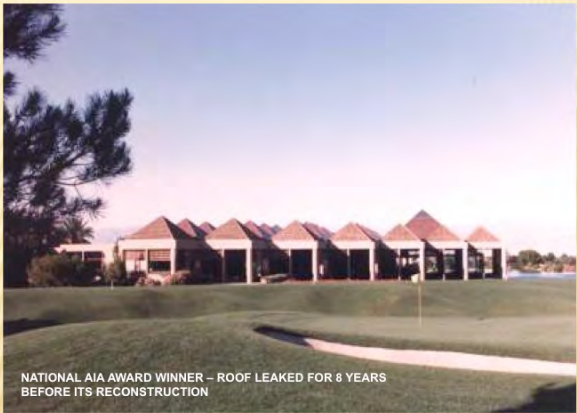
NATIONAL AIA AWARD WINNER - ROOF LEAKED FOR 8 YEARS BEFORE ITS RECONSTRUCTION

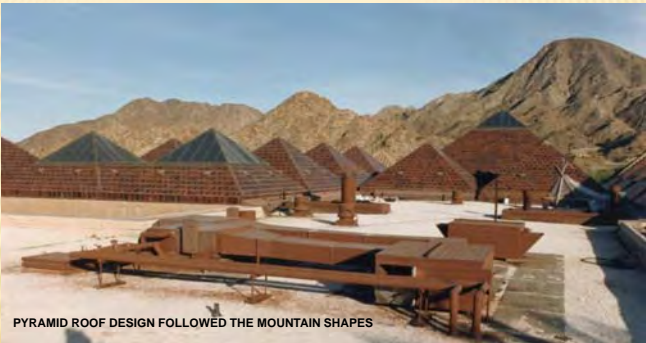
PYRAMID ROOF DESIGN FOLLOWED THE MOUNTAIN SHAPES

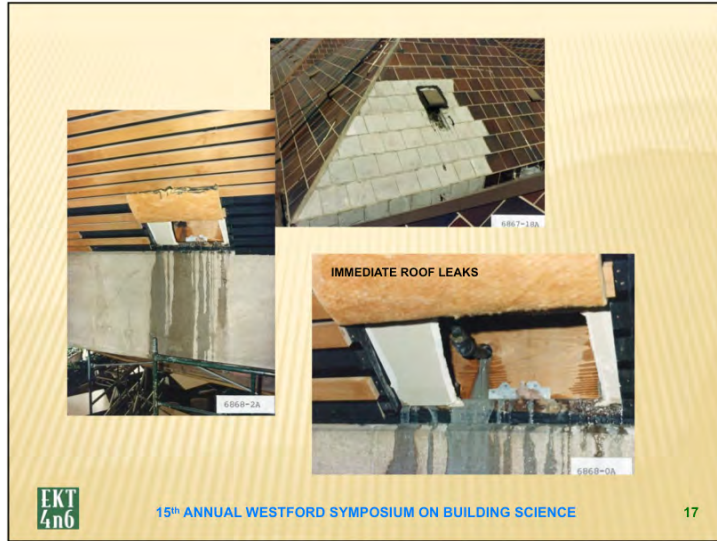
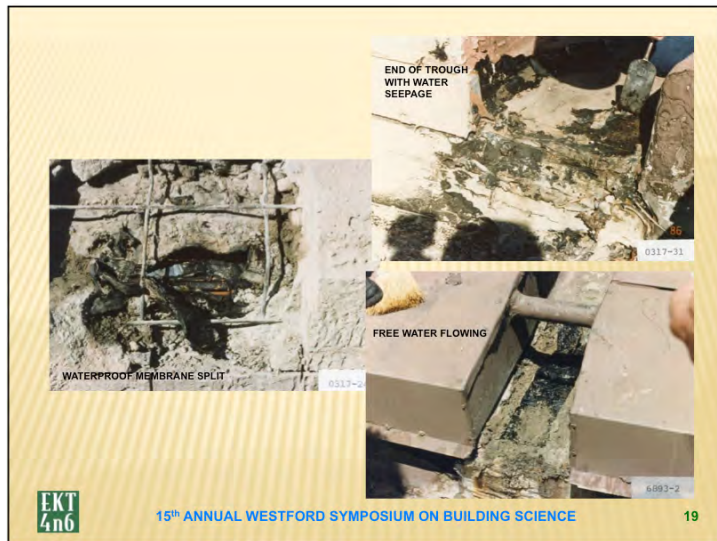
VINTAGE CLUB CLUBHOUSE ROOF PLAN

18 - 24' SQUARE WOOD TRELLISES
 4 - 24' SQUARE FLAT WOOD TRELLISES
 2 - 24' X 12' WOOD TRELLISES
 28 - 24' SQUARE PYRAMIDS
 4 - 24' SQUARE PYRAMIDS WITH SKYLIGHTS
 1 - 48' SQUARE PYRAMID
 2 - 48' SQUARE PYRAMIDS WITH SKYLIGHTS

PROPOSED SKY HORSE CRANE LOCATION

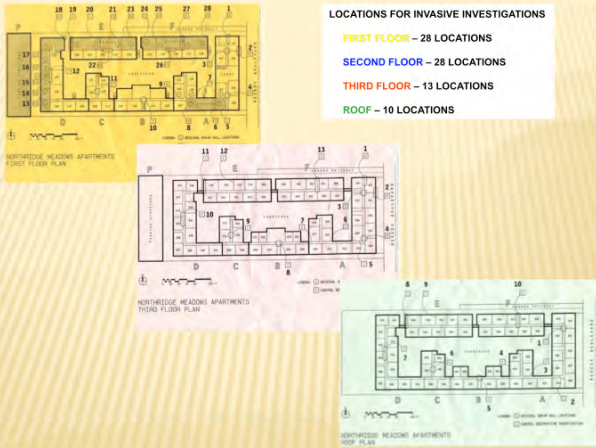
LOCATIONS FOR INVASIVE INVESTIGATIONS
FIRST FLOOR – 28 LOCATIONS
SECOND FLOOR – 28 LOCATIONS
THIRD FLOOR – 13 LOCATIONS
ROOF – 10 LOCATIONS
