# Insight Complex Three Dimensional Airflow Networks

By Joseph W. Lstiburek, Ph.D., P.Eng., Fellow ASHRAE

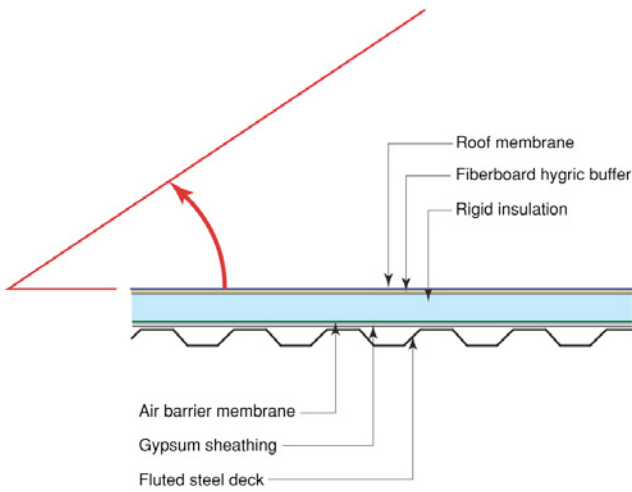
**Figure 1: Slope an Unvented Compact Roof**—This should be easy.

It's pretty simple to build a compact unvented cathedral ceiling. Take a flat unvented compact roof and slope it (**Figure 1**). No big deal, right? Not quite. Sloping roofs can get you convection cells – and worse. It turns out to be important to have multiple layers of rigid insulation with the joints offset horizontally and vertically (staggered) and to have an air barrier directly on the structural deck (**Figure 2**). Ask me how I know?<sup>1</sup>

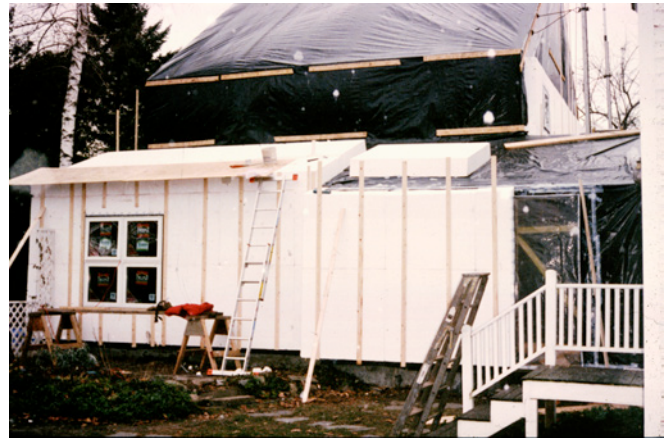
**Photograph 1: World’s Largest Canadian Beer Cooler Located in Westford, MA**—Barn retrofit with 8 inches of rigid foam on the exterior walls and 10 inches of rigid foam in one layer on the roof. The key thing to note is that the rigid foam on the roof is in one layer. Because it is in one layer it leads to convection.

Check out what this crazy person did – 8 inches of rigid foam on the exterior walls and 10 inches of rigid foam in one layer on the roof (**Photograph 1**).<sup>2</sup> The key thing to note is that the rigid foam on the roof is in one layer.

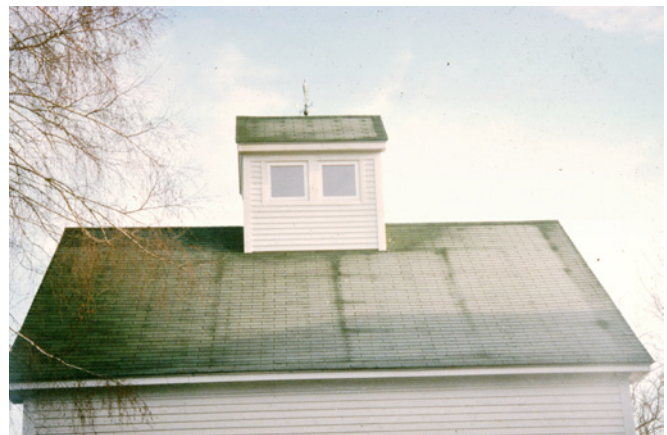
**Photograph 2: Professional Embarrassment**—Convective cells evident in frost melt pattern on shingles.

Because it is in one layer it leads to convection (**Photograph 2**).<sup>3</sup>

The convection loop in this example is not catastrophic because it is not coupled to the interior space – note the air barrier sheet membrane under the rigid insulation. Had the air barrier not been present the convection cells would have been coupled to the interior and there could have been moisture transport from the interior into the roof assembly. With moisture transport from the interior the roof would have likely been doomed as it is located in a cold climate. As it is, the convection only lead to professional embarrassment and an energy penalty. It turned out that the professional embarrassment was much worse than the energy penalty.

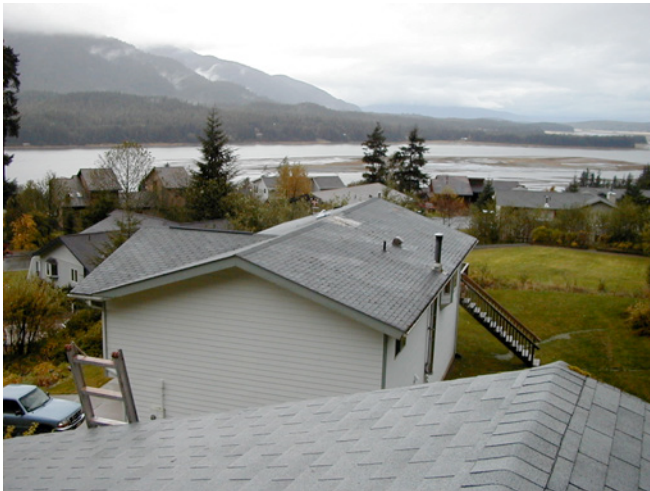
**Photograph 3: SIP Roofs**—Juneau, Alaska where rainfall is measured in feet not inches.

Let's now add a bit more complexity and enjoy the outcome. Structural insulated panels (SIP's) are a pretty elegant enclosure system – a foam core with exterior and interior linings of oriented strand board (OSB). The panels slip together to make walls and roofs – sometimes even floors and foundations. Easy, fast, no thermal bridges, it can't get better than that. Let's go to Juneau, Alaska and check a bunch of SIP roof assemblies (**Photograph 3**). The first sign that something was amiss were mushrooms growing out of the shingles – I call that the Wolfgang Puck effect (**Photograph 4**). Looking a little deeper (pun intended) we find moisture damage along the panel joints and the ridgeline (**Photograph 5**).

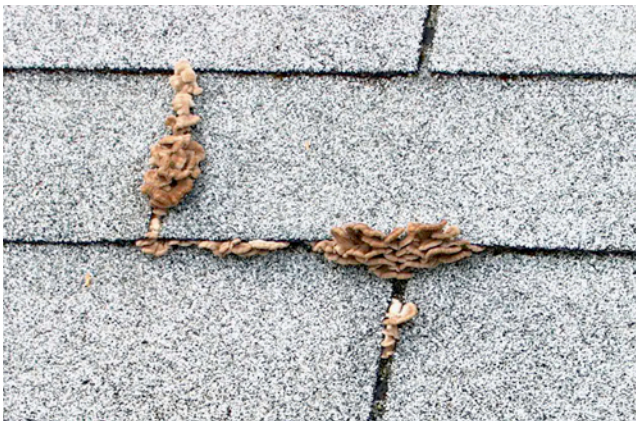
**Photograph 4: Mushrooms Growing Out of Roof**—The “Wolfgang Puck” effect.

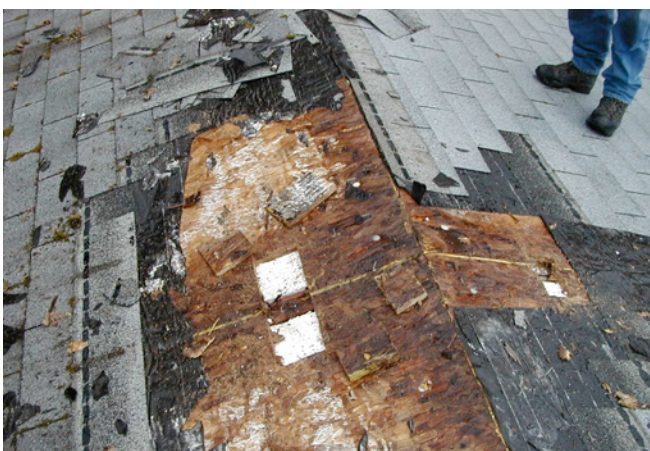
**Photograph 5: Moisture Damage**—Rot at panel joints and ridge.

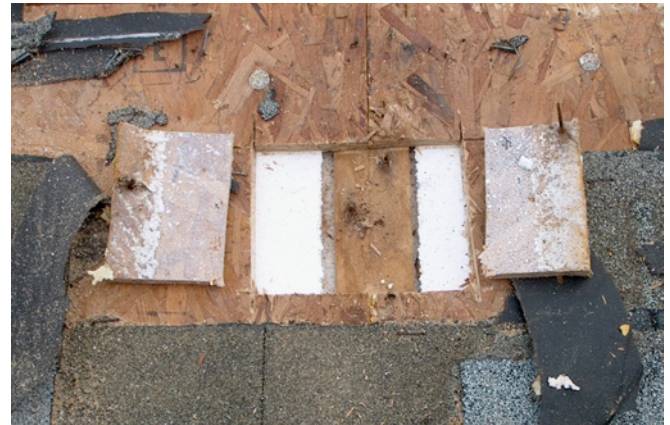
**Photograph 6: Micro Air Ducts**—Note the air gap on each side of the SIP joint spline creating parallel micro air ducts. The upper pair of air ducts are typically connected to the lower pair of air ducts at panel joints.

The upper and lower horizontal SIP splines have air gaps along their edges creating parallel “micro-ducts” (**Photograph 6**). The upper and lower pairs of micro ducts are connected at the panel joints (**Figure 4**). If the panel joints are not airtight at their interior surfaces

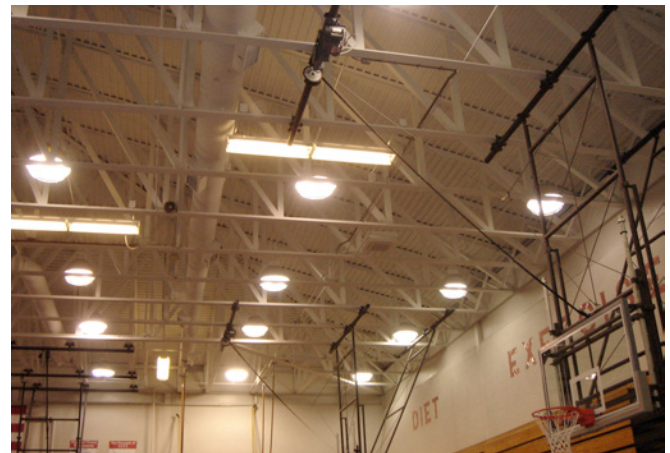
**Photograph 7: Sloping Fluted Metal Roof Deck**—Condensed water from exfiltrating interior moisture laden air in the winter and infiltrating exterior moisture laden air in the summer leads to moisture damage.

The roof assembly is a sloping fluted metal deck (**Photograph 7**) constructed with vented foam panels with an OSB nail base (**Photograph 8**). The vented foam panels are installed directly over the top of the fluted metal deck. No air barrier is present in the roof assembly and airflow can easily be detected using an evaporative thermal biometric airflow sensing device (**Photograph 9**). Rust stains are obvious at the top surface of the fluted metal deck at panel joints (**Photograph 10**).

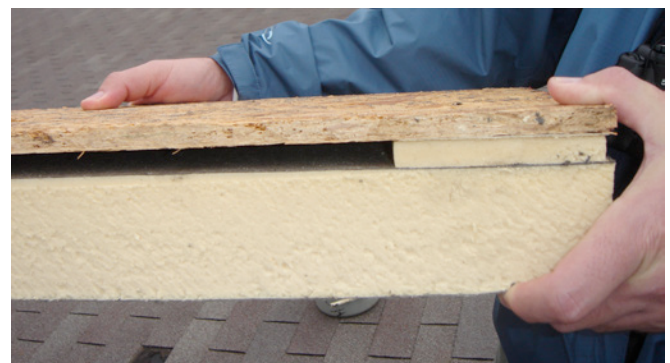
**Photograph 8: Vented Foam Panel**—The upper panel surface is OSB that acts as a nail base for shingle and other roofing systems.

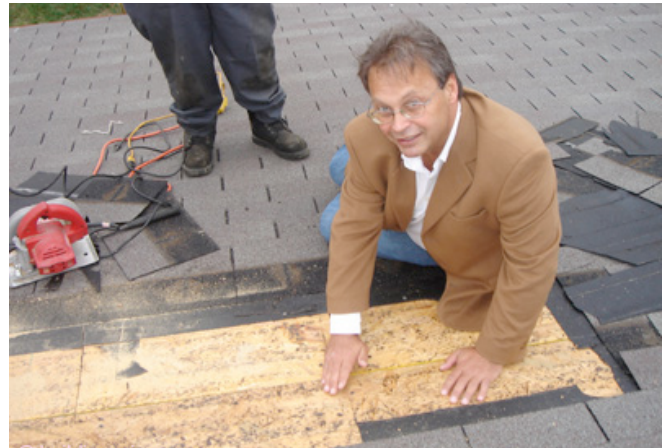
**Photograph 9: Evaporative Thermal Biometric Airflow Sensing Device**—A licked hand is very sensitive to small airflows. This building scientist is obviously having way too much fun, must be the bourbon.

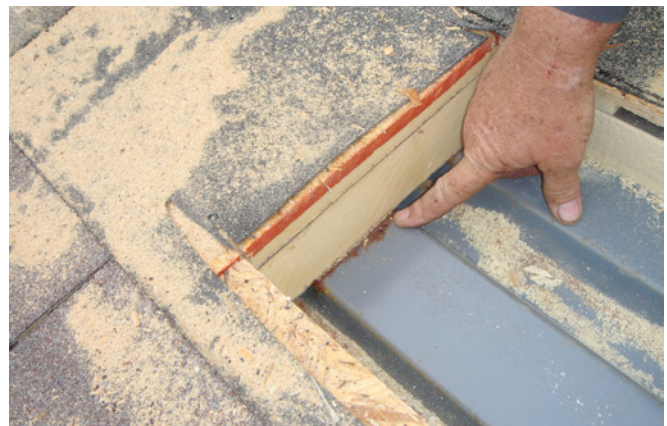
**Photograph 10: Rust Stains**—Note the evidence of moisture at the panel joints on the top surface of the fluted metal roof deck.

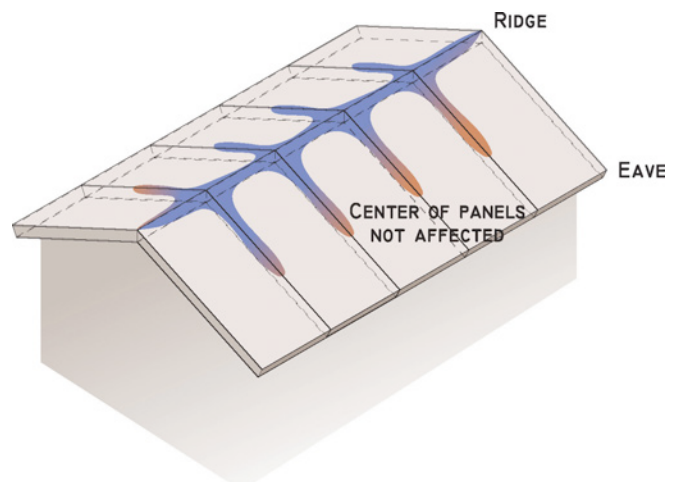
**Figure 3: SIP Ridge Rot**—Distinctive pattern of moisture damage at roof ridge and at upper panel joint locations.

The pattern of damage is distinctive and can be found in many cold climate SIP roof failures. It is called “ridge rot” (**Figure 3**) and can easily be avoided by dealing with panel joints. It is a classic case of three-dimensional airflow networks and convection cells.

Note that the damage is all along the upper part of the roof – at the ridge – and at the upper portions of the panel joints near the ridge. The damage at the upper portions of the roof assembly is due to both thermal buoyancy and moisture buoyancy. The thermal buoyancy should be obvious – we sometimes refer to it as the stack effect. However, moisture buoyancy is not always obvious. Yes, moisture-laden air is less dense than dry air and tends to rise. It is one of those counter-intuitive but true things that amaze people in bars late at night.

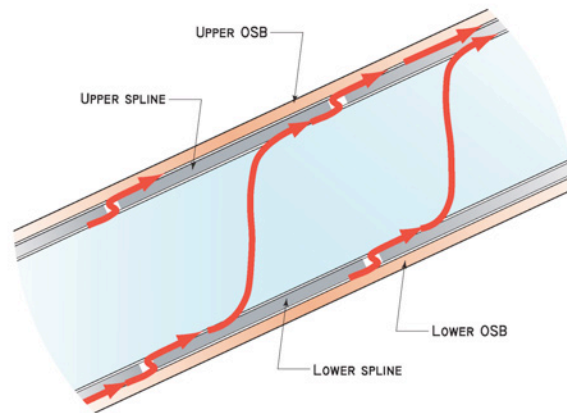
**Figure 4: Airflow at Joints**—Upper and lower splines are discontinuous, have gaps along their edges and are connected at panel joints.

interior moisture laden air can migrate into the interstitial joint cavities leading to the pattern of damage observed.

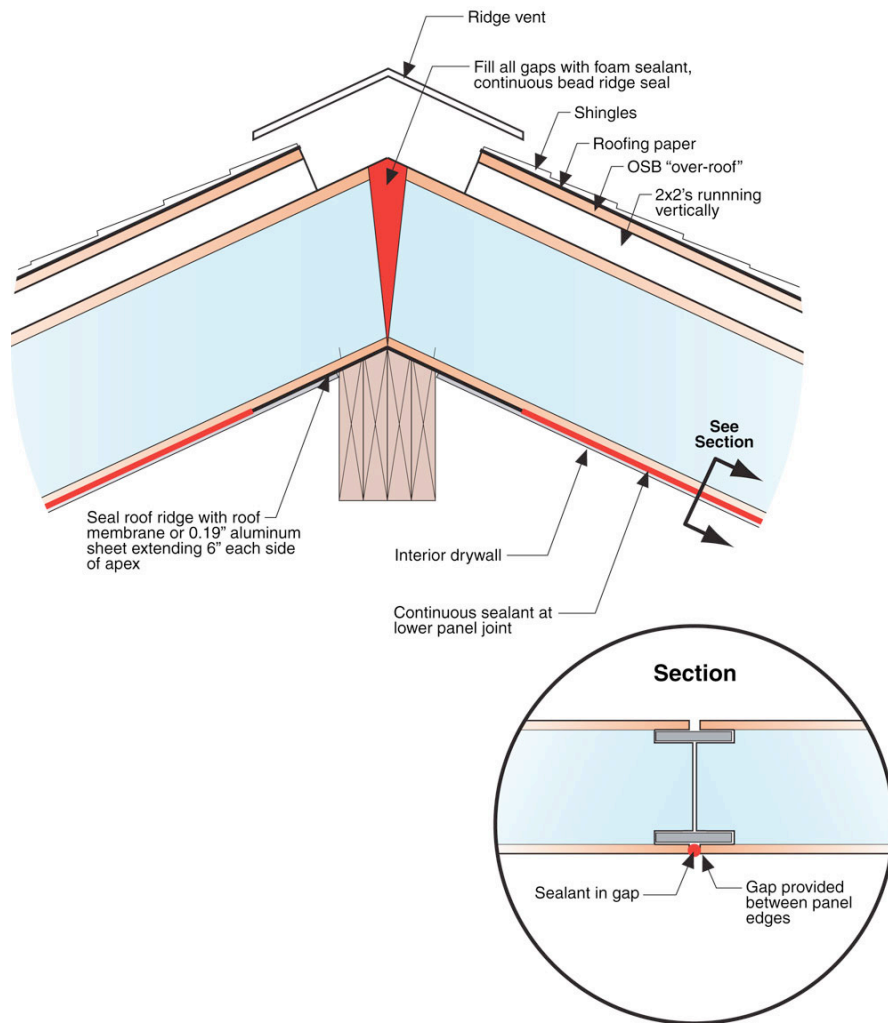
**Figure 5: Avoiding SIP Roof Problems**—Make the panel joints airtight especially over structural supports such as beams and purlins and provide a mechanism for moisture removal such as a vented over-roof.

How to avoid the problem of SIP ridge rot? Make the panel joints airtight – especially over structural supports such as beams and purlins – and provide a mechanism for moisture removal such as a vented over-roof (**Figure 5**). Easy once you know that it is important. Well, we now know that it is important and SIP’s can rock on in cold climates.

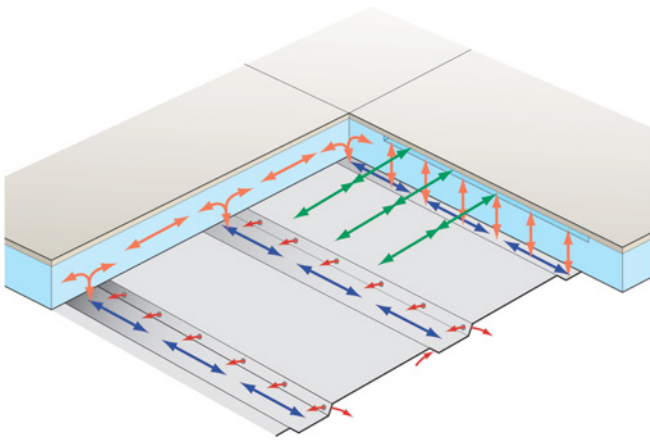
**Figure 6: Complex 3D Airflow Network**—Upper airflow paths are connected to lower airflow paths at panel joints. Inside is connected to outside.

Once again, a complex three-dimensional airflow network has rudely interrupted the successful performance of a sloping compact roof (**Figure 6**). The situation is made worse because the fluted metal roof deck is an “acoustical” deck with perforations. When you are going to screw up an assembly you may as well go all out.

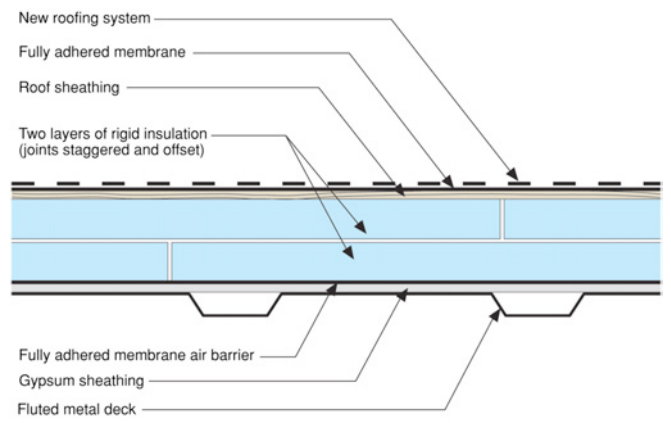
**Figure 7: Making the Problem Go Away**—Air barrier system and staggered layers of rigid insulation.

The solution to this problem is obvious – the roof assembly is in need of an air barrier. There is no way that the “nail-base panel” joints could have been made airtight at the bottom edges of the panel perimeters immediately on the top of the perforated fluted metal deck. Panels could have been used, but only if they had been installed over the top of an air barrier located on the top of the perforated fluted metal deck. Paperless gypsum roof sheathing supporting a fully adhered membrane air barrier should have been installed over the top of the perforated fluted metal deck. An even better solution would have been to use staggered layers of insulation over the top of the air barrier (**Figure 7**).
