# Insight

## The Pressure Is On

By Joseph W. Lstiburek, Ph.D., P.Eng., Fellow ASHRAE

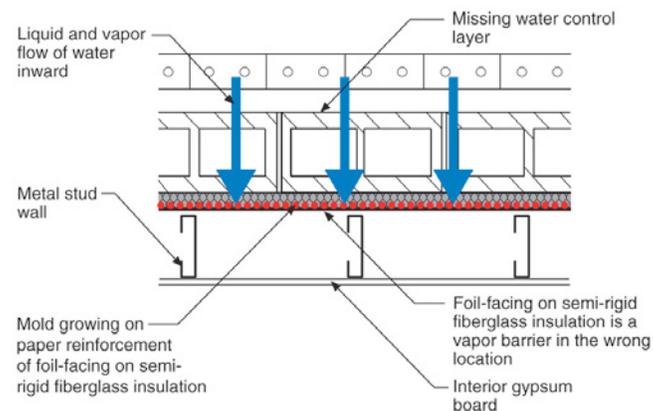
**Figure 1: Hospital Wall**—Classic reservoir-cladding-solar-driven-moisture-vapor-barrier-on-the-wrong-side-of-the-assembly problem.

It was a classic reservoir-cladding-solar-driven-moisture-vapor-barrier-on-the-wrong-side-of-the-assembly problem. But, it had a twist that changed my career direction. Check out **Figure 1**. The hospital building enclosure was a brick veneer with a masonry block backup wall. Mistake one: no water control layer on the exterior of the block backup wall (see *BSD-105: Understanding Drainage Planes*). The masonry block backup wall was insulated on the interior with semi-rigid fiberglass insulation. Mistake two: a foil-faced vapor barrier installed on the interior of the semi-rigid fiberglass insulation. Mold grew on the paper reinforcing of the foil vapor barrier. Guess what type of mold? Yes, *aspergillus fumigatus*. There it was: the mold reservoir and amplification site. But, how did the mold get from there and inside the patient?

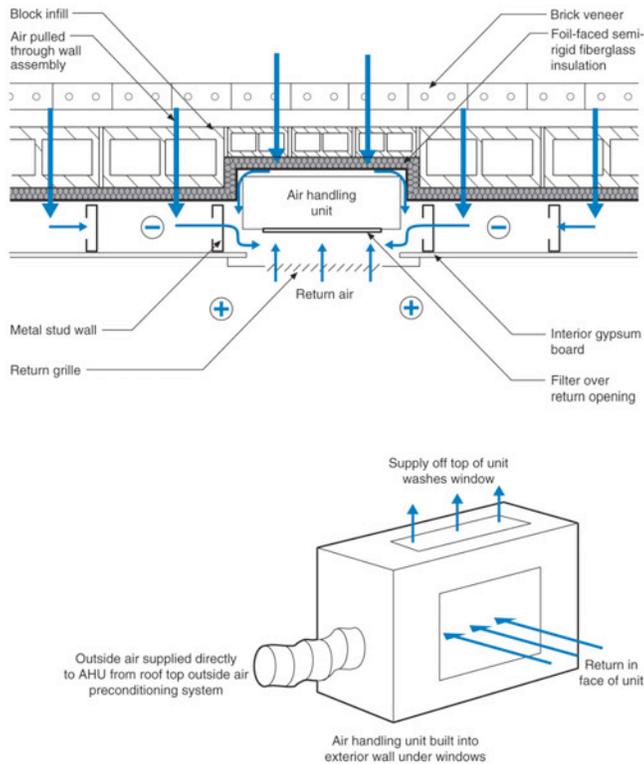
**Figure 2: Air-Handling Unit (AHU) Depressurizing Wall—**The AHU pulls air from both the room and the wall cavity. The air in the wall cavity was contaminated.

The patient rooms were positively pressurized relative to both the outside and the corridors. It was a beautiful system: continuous preconditioned air from rooftop units injected directly into each room. Wow. The pressure control was perfect, and continuously monitored. There was no way the mold in the interstitial cavity could have gotten into the room. Or, so I thought. Check out **Figure 2**. The room was pressurized relative to the outside but the exterior wall was negative due to the configuration of the room air-handling unit. The room air-handling unit extracted air from both the room and the exterior wall cavity, mixed this air with the outside direct ducted air and injected it back into the room. Unfortunately, the air in the exterior wall cavity was contaminated with *aspergillus*.

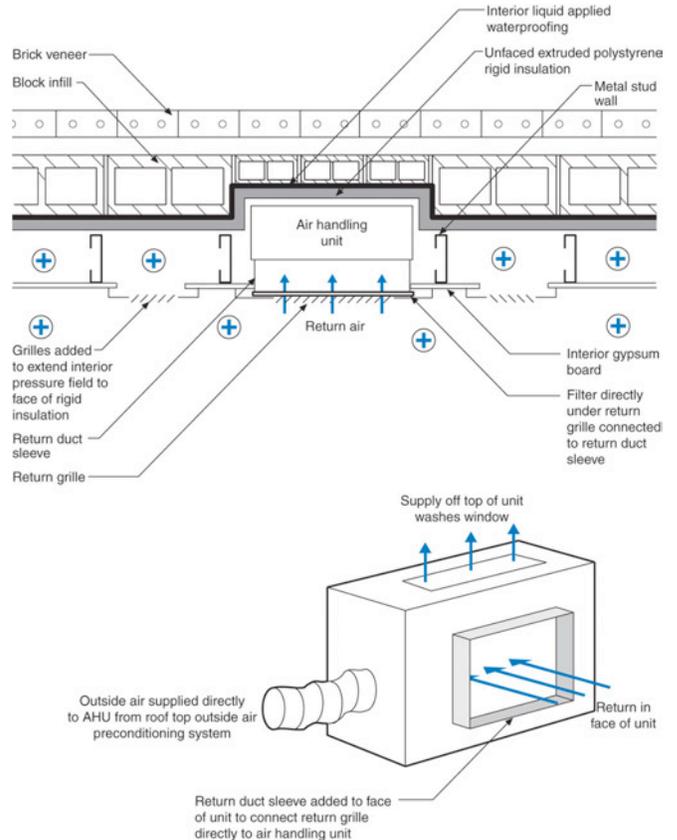
**Figure 3: Uncouple the AHU—**Sleeve added to the AHU to connect the return grille directly to the unit. Note the interior air pressure field extension into the wall cavity. Also, note the use of unfaced or unskinned extruded polystyrene rigid insulation—a semi-vapor permeable non-water sensitive material.

This was the first time “I got it.” Walls could suck while rooms could blow<sup>1</sup> (see *BSI-002: The Hollow Building*). The air-handling unit was depressurizing the interstitial cavity sucking the mold out the exterior wall and injecting it into the breathing zone of the occupied space. This was mistake three. The solution was pretty straightforward—disconnect or uncouple the air-handling unit from the exterior wall cavity, get rid of the interior vapor barrier, add some water and vapor control to the assembly and extend the interior positive pressure field into the wall cavity (**Figure 3**). Oh yeah, one more minor thing, clean up the rooms without killing anyone else. This was the first time I deliberately pressurized a wall cavity. It was not the last time, as we shall see.

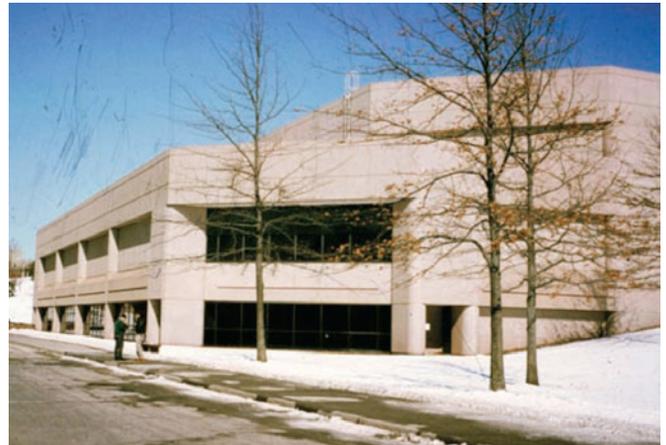
**Photograph 1:** Data processing center in Connecticut.

The next chance I got to do something with pressurizing cavities came along within a year: a data processing center in Connecticut (**Photographs 1 and 2**). It was a classic over-humidified-and-over-pressurized-building-in-a-cold-climate problem. You know what is coming. It was a precast building. It cried for help—literally. Condensed water leaked out at the joints and the tops of windows in cold weather (**Photograph 3**), or damaged interior finishes (**Photograph 4**).

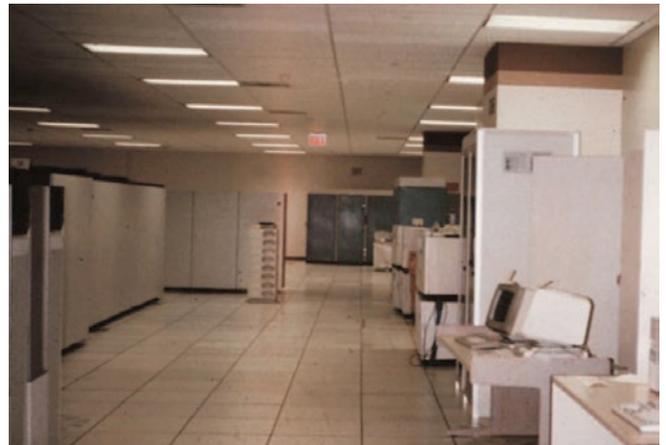
**Photograph 2:** Humidified and pressurized conditioned space.

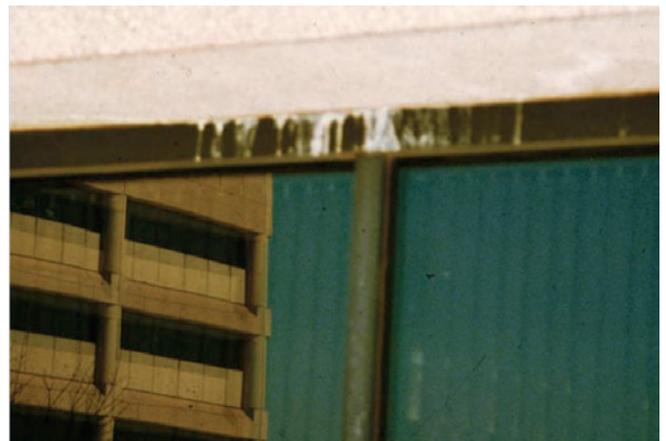
**Photograph 3:** Condensed water leaking out at window heads.

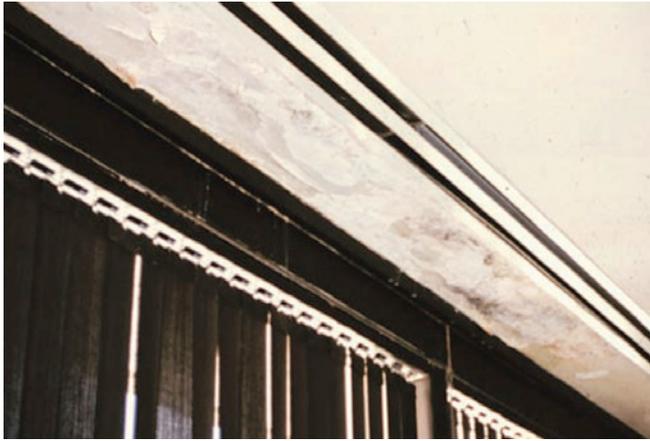
**Photograph 4:** Water damaged interior finishes at exterior walls.

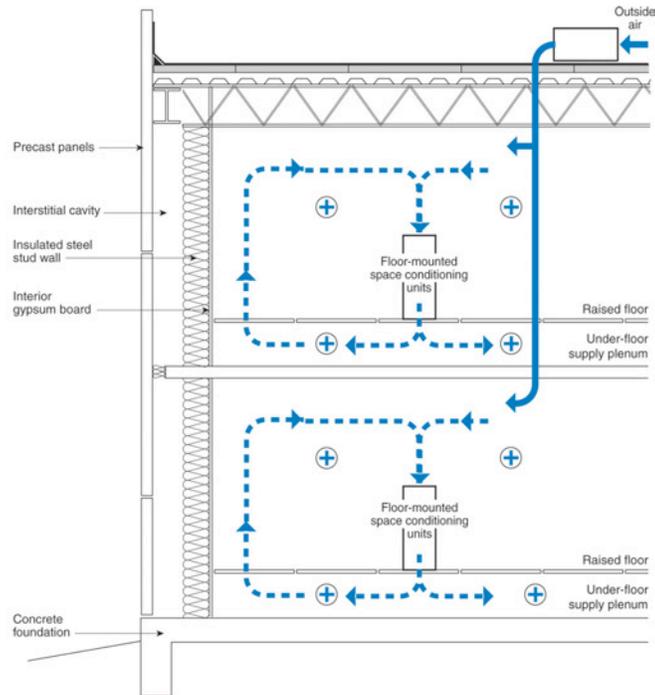
**Figure 4:** Classic Data Processing HVAC System—Raised floor supply plenum with continuous preconditioned outside air.

The HVAC system was a classic data processing center approach (**Figure 4**). A raised floor supply plenum with continuous preconditioned outside air. It was a beautiful system. Too bad the building enclosure was not matched to it (we still see these problems in modern underfloor air-distribution systems). The building enclosure was precast panels insulated internally with an insulated steel stud wall. The external concrete precast units were much

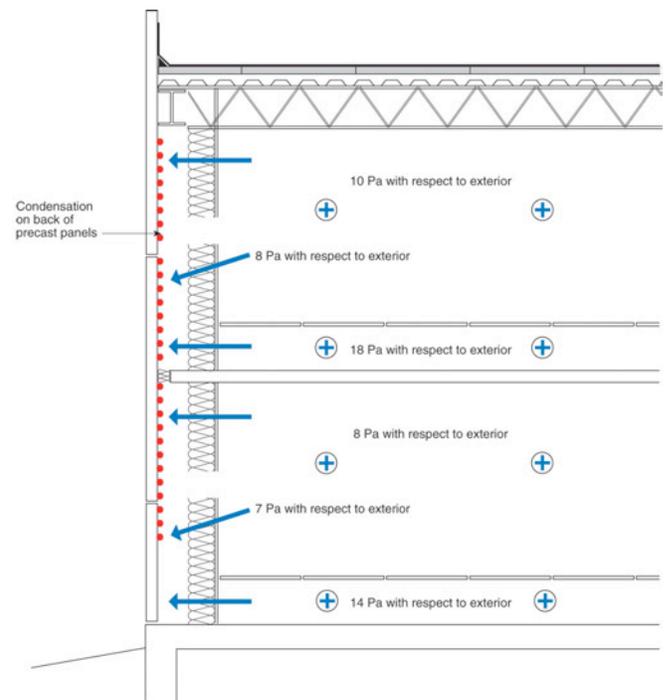
**Figure 5:** Precast Dehumidification System—The cold precast panels were the primary air barrier. This led to condensation on the back side of the precast.

more airtight than the interior gypsum board lining—by a significant margin. Interior humidified air exfiltrated into the cavity between the precast and the steel stud framing condensing on the backside of the precast (Figure 5).

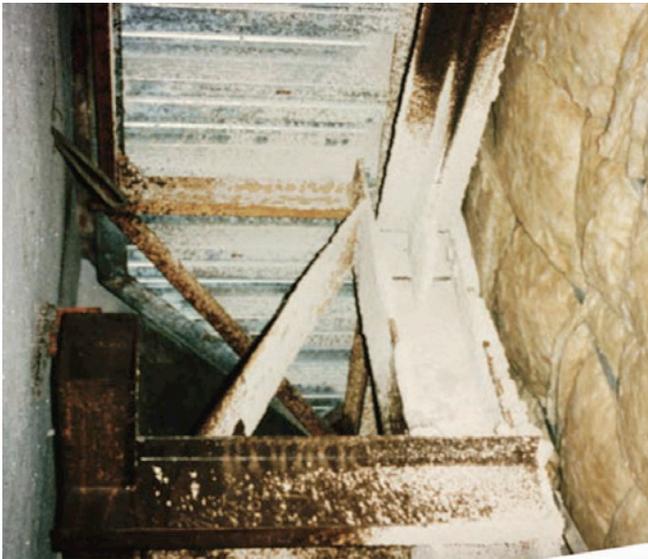
**Photograph 5: Gift from the Engineering Gods—A continuous perimeter air gap between the precast panels and the interior insulated steel stud wall framing.**

necessary cost and effort to turn this enclosure into the “perfect wall” was not going to happen. However, there was an air gap between the precast panels and the interior steel stud wall framing that varied between 2 in. and 18 in. (51 mm and 457 mm). (The reasons for this gap I still do not understand to this day. It was an architectural thing obviously beyond my humble engineering mind’s ability to grasp.) See **Photograph 5**. This air gap turned out to be a gift from the engineering gods. The solution was to pressurize the gap relative to the interior with outside air when outside temperatures dropped below the dew-point temperature of the interior air (Figure 6 and Photograph 6). No recladding. No major expense. And fast to fix. I still get thank you cards from the client to this day.

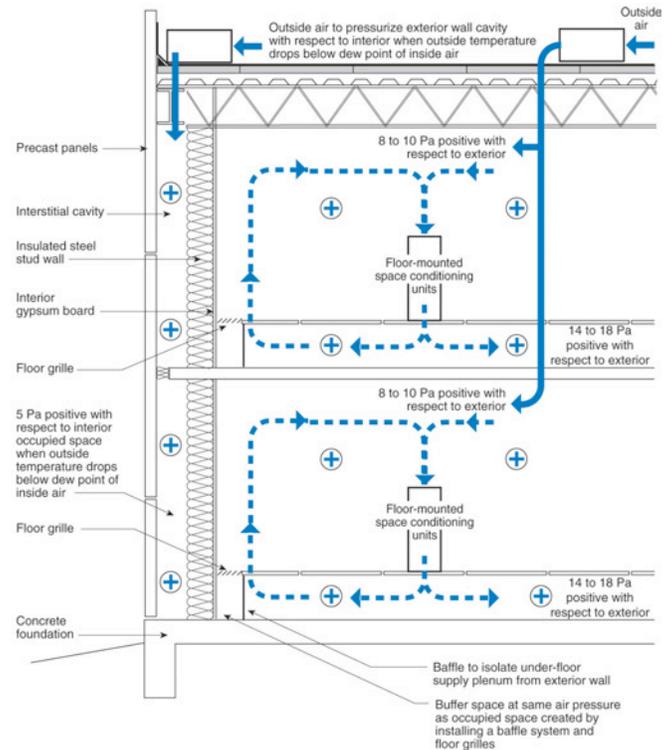
**Figure 6: Pressurization of Exterior Wall Cavity—Note the baffle and floor grilles that prevent the extension of the positive pressure field of the supply plenum from extending to the exterior wall assembly.**

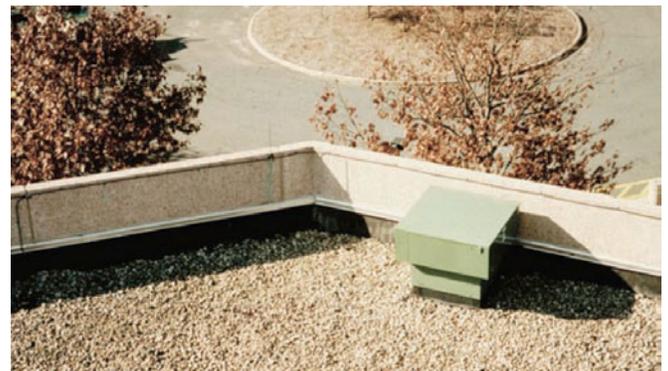
**Photograph 6: Rooftop interstitial cavity pressurization system.**

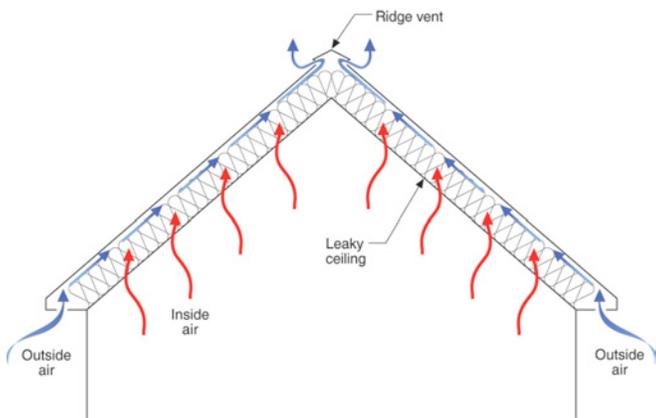
**Figure 7:** Ceiling Condensation Problem. Venting does not save you, it often makes it worse.

**Figure 7** describes the problem. Even though the roof was ventilated the ventilation provision actually drew inside air into the roof cavity due to the leakage of the ceiling. The flow path resistance of interior air migrating into the roof assembly was less than the flow path resistance of the outside air being introduced at the soffits.

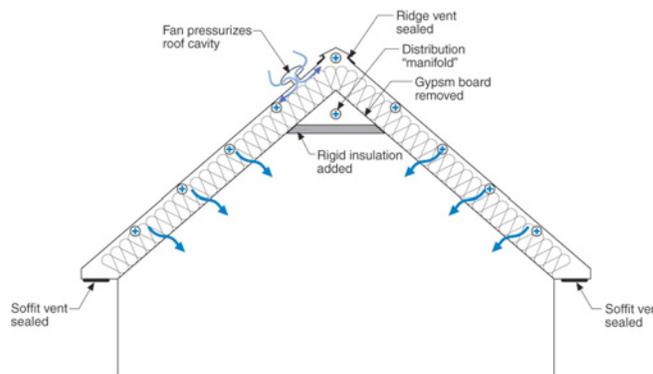
**Figure 8:** Non-Classic Cathedral Ceiling Condensation Solution. The key is not to over pressurize.

**Figure 8** describes the solution. I sealed the ridge vents and soffit vents and added a fan (**Photograph 7**) to pressurize the roof assembly. Thank you, Dick Solvason and Gus Handegord. I also stripped a little bit of gypsum board at the interior of the ridge to create a manifold to distribute the air. The key was not to ventilate the roof with outside air, but just to pressurize it slightly. I did not want to chill down the interior gypsum board finish, as it could lead to potential condensation or mold. What pressure did I select? I guessed. 1 Pa (0.004 in. w.c.) was probably too small and too difficult to control to, and 5 Pa (0.02 in. w.c.) was probably more than I needed. So, I picked a range between 2 to 3 Pa (0.008 to 0.012 in. w.c.)

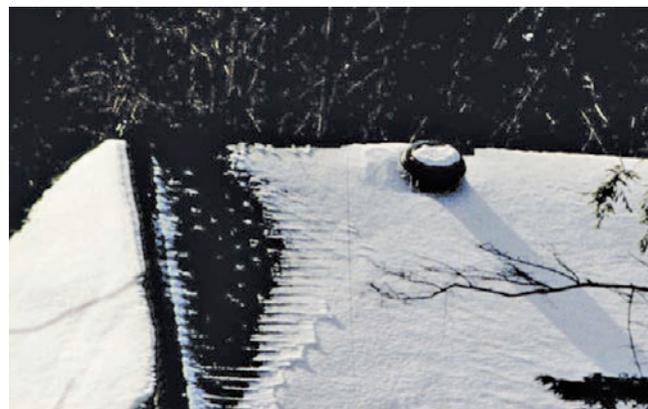
**Photograph 7:** Attic supply fan pressurizing roof cavity.

and it worked. The fan was controlled by an outside thermostat. Whenever the outside temperature dropped below 40°F (4°C), the fan would turn on.<sup>3</sup> Today, we

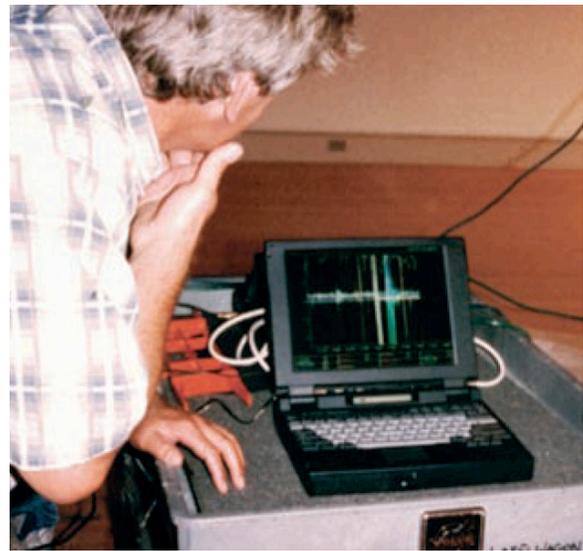
**Photograph 10:** Multichannel digital manometer.

The first thing that we did was to install some pressure taps in the roof assembly and wall assembly and parapet assembly (**Photograph 9**), and connect everything to a multichannel digital manometer (**Photograph 10**). Then,

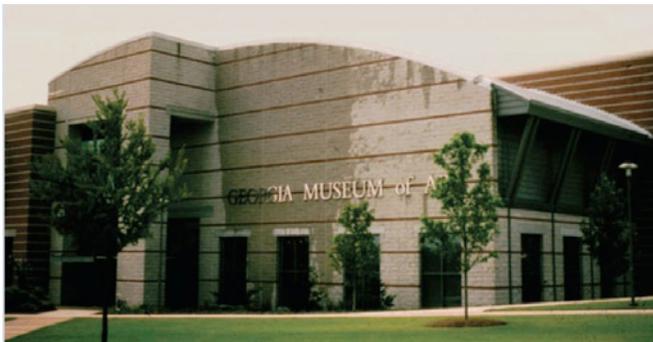
**Photograph 8:** Fire hose wetted reservoir cladding.

It wasn't the roof that was the problem. It was the wall that was the problem. The wall was a reservoir cladding that got wet when it rained. When the sun beat down on the wall to dry it the evaporated moisture got into the roof assembly and condensed and dripped out. The wall was in essence vented into the roof. How to prove it? Easy. Wet the wall with a fire hose (**Photograph 8**), and hope that it does not rain for a couple of days, and that it is sunny. Sure enough, we got the roof to "leak" when it didn't rain by wetting the wall and waiting a day. Awesome. Now what? We did not have time or money to rip apart the parapet (the roof-to-wall connection) and install a physical barrier (air barrier) that would prevent air from the wall from getting into the roof. But, we had toys.

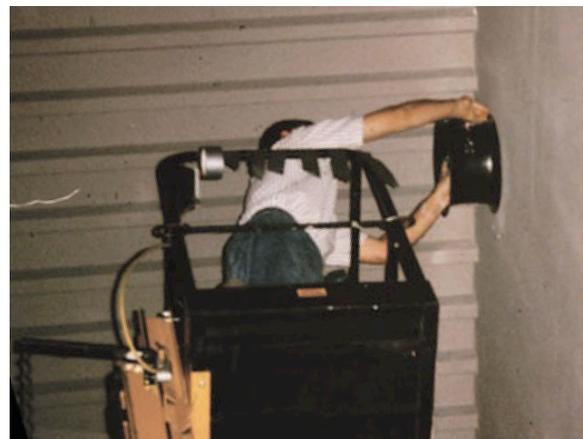
**Photograph 11:** Duct Blaster® pressurization of parapet assembly.

we cut a couple of holes in the interior walls up near the top at the underside of the roof, and used duct tape to hold a Duct Blaster® in place and figure out how much air needed to be added to pressurize the parapet to prevent air from migrating from the wall assembly into the roof assembly (**Photograph 11**). How much of a pressure difference did we need? You guessed it: 3 Pa (0.012 in. w.c.). Where did that come from? Experience. Final solution? Get ready for it... just leave the Duct Blasters® in place, and call it a day (**Photograph 12**). It was cheap, fast, and it worked. The collection came and went.

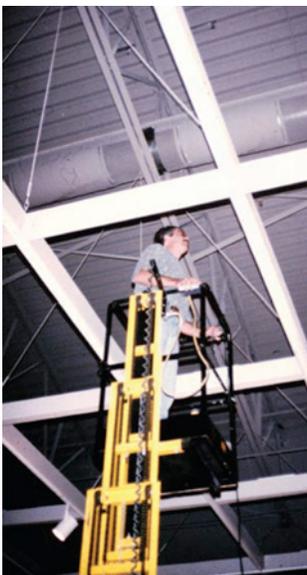
**Photograph 9:** Installing pressure taps.

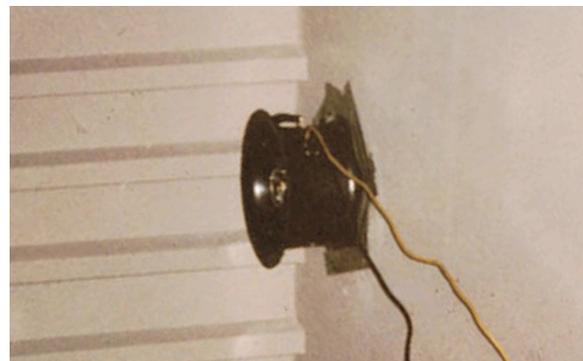
**Photograph 12:** Final Solution—Duct tape and a fan.
