Insight Leiningen Versus The Ants¹ Redux

By Joseph W. Lstiburek, Ph.D., P.Eng., Fellow ASHRAE

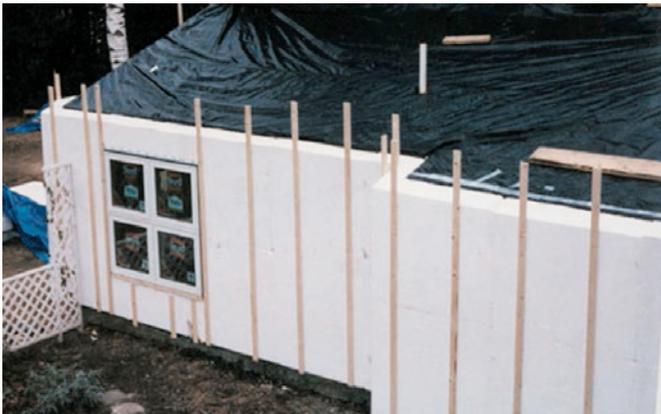
Photograph 1 (left): Perfect Wall—Water control layer, air control layer and vapor control layer outside of structure. EPS rigid insulation thermal control layer held in place with 1x4 wood furring strips over the top of everything else. The world's largest Canadian Beer Cooler built in Boston 15 years ago. Back-ventilated siding yet to be installed on wood furring strips. **Photograph 2 (right): Rigid Roof Insulation**—Note the billowing polyethylene air barrier/vapor barrier. I should have known then.

I had seemingly done the perfect barn renovation 15 years ago. I installed a continuous water control layer, a continuous air control layer, a continuous vapor control layer and a continuous thermal control layer. I back ventilated my cladding system. It was all perfect (**Photographs 1, 2 and 3**). It looked great. I gave myself an award.²

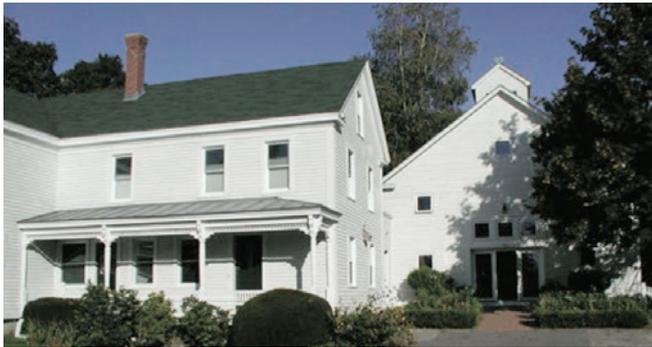
Photograph 3 (top left): Good Looking Barn—In this case the beauty is only skin deep

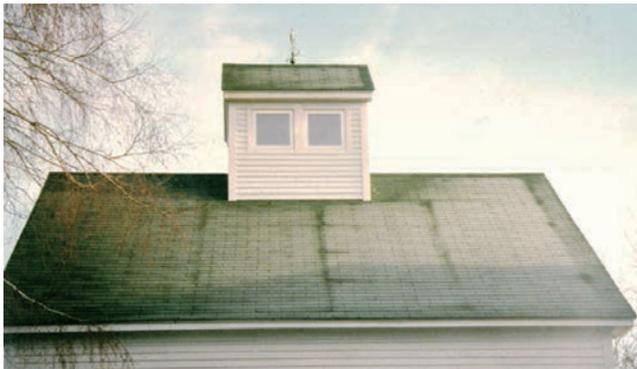
Photograph 4 (above): The Embarrassment Starts—Can anyone say 3-D airflow network?

It was so obvious it was embarrassing. I had already had enough embarrassment with the barn renovation. I learned about three-dimensional airflow networks the first year after the renovation—the first winter in fact (**Photograph 4**). I should have never installed the roof

foam in one layer. It should have been done in several layers with the joints off-set horizontally and vertically.⁴ This was nothing that some old roof guy couldn't have figured out or prevented. Ouch. But I already knew about this. Dumb, yes. But dumb that I knew about already. I needed to find new dumb. It didn't take long.

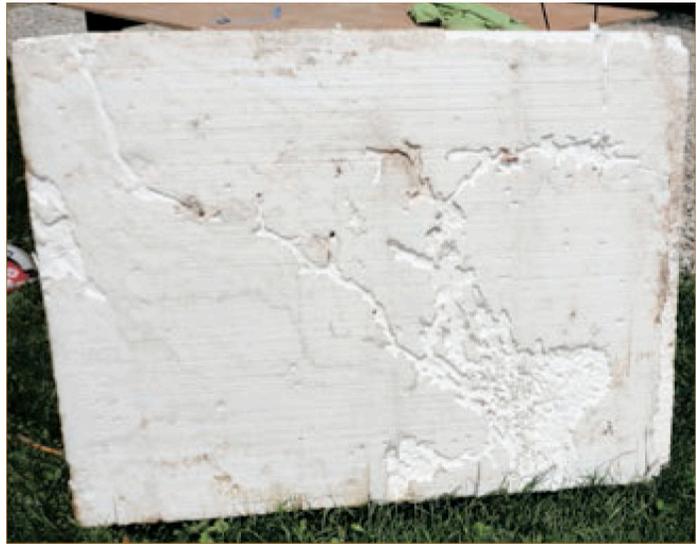
Photograph 5 (right): Ant Gallery—The ants don't eat the foam, they live in it. But they like and need water. Good thing I made sure they had some. This is a 4 ft x 6 ft (1.2 m x 1.8 m) ant gallery. There was one other like it. That was it for the entire structure: two of these bad boys. But the gallery went through the 10 in. (245 mm) thickness. Lots of space for lots of ants and lots of aggravation.

I found the ants. Tracked them layer by layer. Yes, they loved my foam. They made themselves a fabulous ant condominium—a fabulous ant “gallery” (**Photograph 5**)—in two spots. But I was ecstatic. Huh? The crew thought I was nuts. I was jumping around all happy about ants in my foam. Why so happy? The ants were only in two spots in the whole damn building. They were in the only two “wet spots” in the whole damn building. The ants only loved my “wet foam.” Where there was dry foam there were no ants. Duh. And it gets even better.

The message here is obvious: keep things dry and you will not have ants. By the way, keep things dry and you won't have a lot of other bad things as well. The dry/wet thing with ants is pretty much proving to be the case in all the ant foam infestation cases I (and others) have looked at over the years.

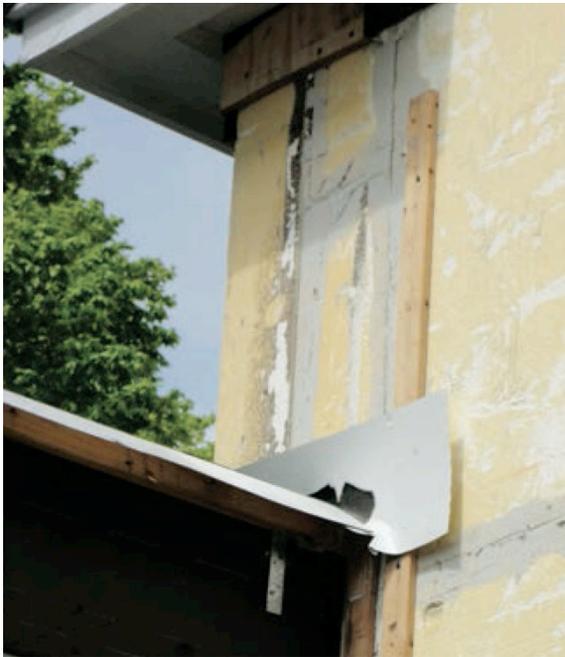
The wet spots were due to something really obvious—something unbelievably embarrassing—reverse flashing. Reverse flashing in two critical areas lead to a whole bunch of water getting into my roof insulation and wetting it. But not enough water leaked in to get past my water control layer. So my roof leaked because of two dumb mistakes—but my roof didn't leak “inside” for me to see it. A bush league mistake—reverse flashing of all things (**Photograph 6**). And in two spots. In the entire building two flashing mistakes, two wet spots and two ant galleries. How long have I been talking about flashing issues? The shoemaker's children are, in fact, barefoot.

Photograph 6: Reverse Flashing—This image makes me ill just looking at it. The sheet metal should have been tucked under the furring strips and sealed—and even better there should have been a membrane that extended under the 8 in. (203 mm) of foam on the wall and tied into the wall water control layer behind the EPS foam. This happened twice. Guess where the ants were? You absolutely know that when this puppy was rebuilt, this did not happen again. Check out **Figure 2** if you want to see the way it should have been built originally, and the way we rebuilt it.

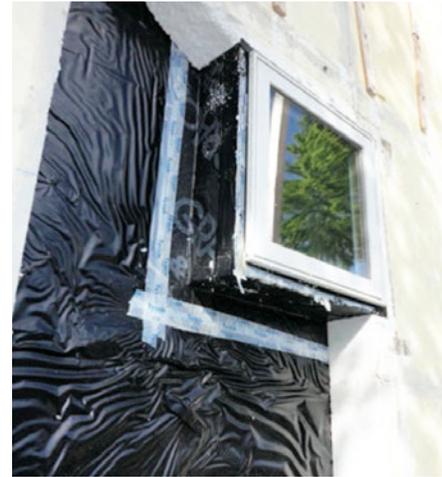
Photograph 7: Poly Air/Vapor Barrier—The sheathing tape worked well. The polyethylene had trouble withstanding the construction process. The membrane wrap around the window boxes held up well, except where it was reverse lapped and fishmouthed. Easy to prevent now that we know about the problem. Yes, I know, face-sealed window. I know better now. They didn't leak, but I should have known better.

What else did I learn? Some neat stuff. Obvious, but neat nevertheless. Polyethylene sheets make a lousy air barrier, even when supported on both sides. It is just too difficult

to get it done right with something so “flimsy.” There were lots of gaps, rips and tears. Original construction defects for sure. Stuff that I missed 15 years ago that I shouldn’t have missed. But, even so, it is not a very “robust” approach. I should have known better. Dumb again.

Having said that, the tape used to seal the polyethylene was fabulous (**Photograph 7**). In fact the same tape was used to seal sheets of XPS together on the main house and performed fabulously there as well. I opened up a bunch of spots on the main house to check adhesion and

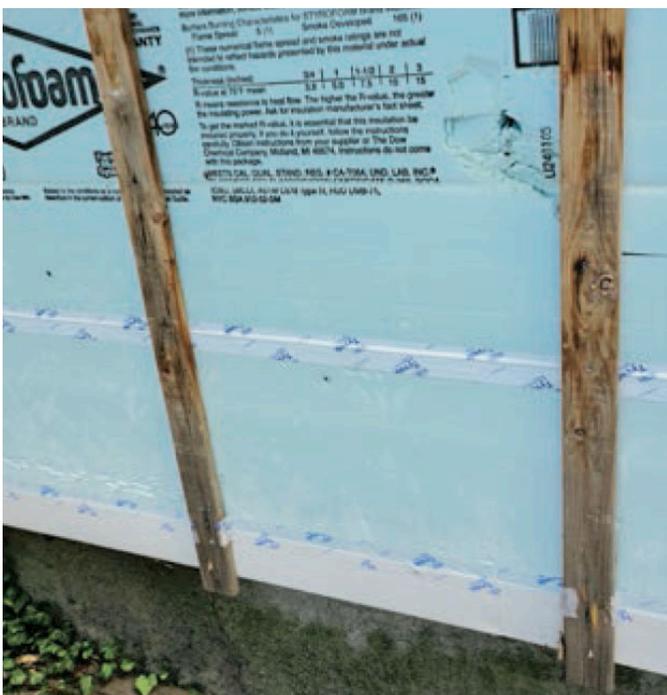
Photograph 8 (left): Sheathing Tape Works—Look at how good this looks after 15 years. That is not new tape; that is 15-year old tape. Awesome. Note the aluminum C-section at the bottom of the blue XPS capping the bottom protecting it from critters. Note how good the untreated wood furring looks.

after 15 years the sheathing tape was like new (**Photograph 8**). There was nothing wrong with the main house; I just needed to know. I really, really needed to know. I have been finding this to be the case pretty consistently in other projects that I have opened up, as have others. Sheathing tapes are proving to work over the long term in terms of sealing XPS joints, foil-faced isocyanurate board joints and joints in housewraps/buildingwraps.

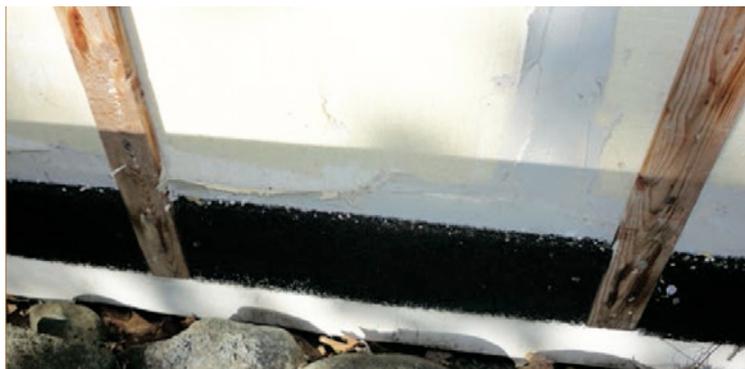
Photograph 9 (bottom): Insect Mesh—Polypropylene mesh acting as an insect barrier is installed between the furring strips at the bottom of the wall. This particular mesh typically is used in attic ridge vents to keep bugs out of roofs.

not been finding that to be the case. Here is the caveat: don’t leave the air gap completely open at the bottom or at the top. Check out **Photograph 9**. I used a polypropylene mesh at the bottom of the assembly to allow airflow and drainage but to block insects. I also used an aluminum “C-Section” to seal the bottom cantilevered portion of my exterior foam insulation to keep squirrels and chipmunks and other animals from getting into the foam. No insect damage (except for the ants discussed earlier), and no critter damage have occurred after 15 years.

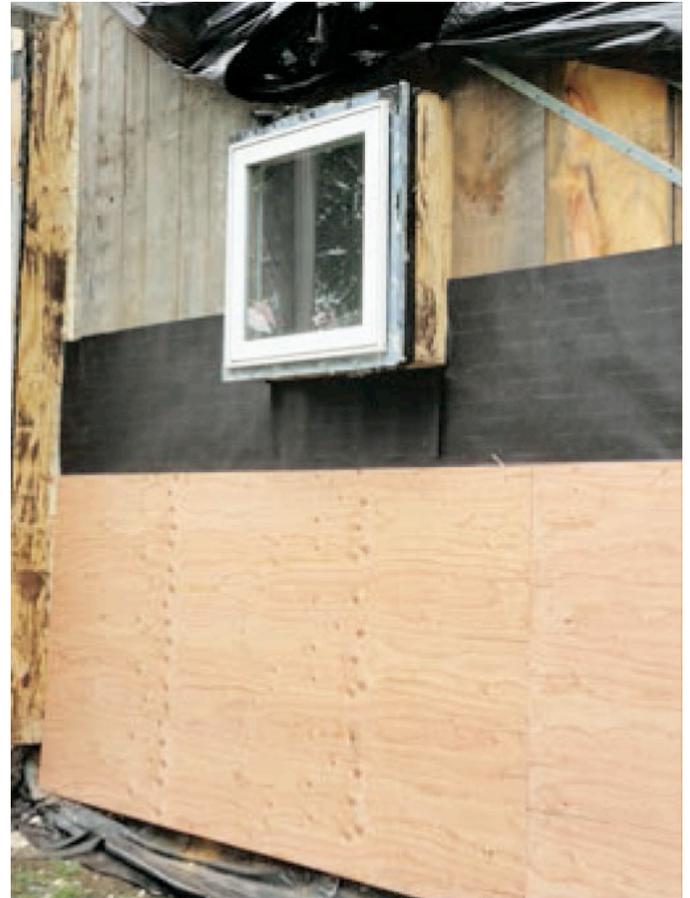
Photograph 10: New Wall—Note the “new” tar paper on the old barn boards under the new plywood structural sheathing.

something to fill the gaps. Then the entire building was sheathed with plywood for shear reasons (**Photograph 10** and **Photograph 11**).

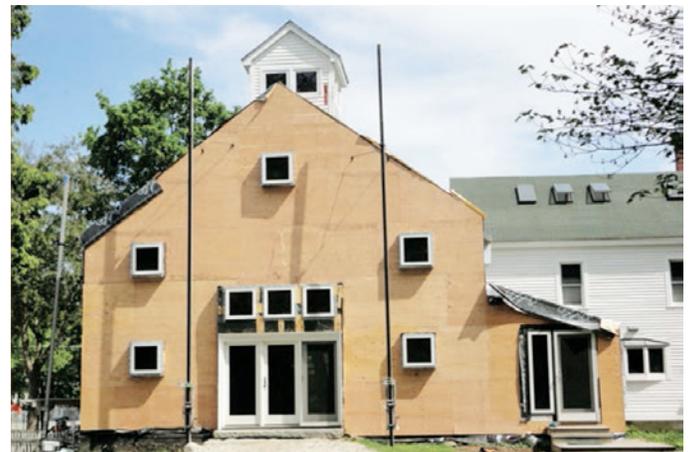
Photograph 11: Shear Control—A beautiful sight: plywood structural sheathing wrapping the walls and roof of a hundred-year board-sheathed timber frame. Bring on the nor'easters.

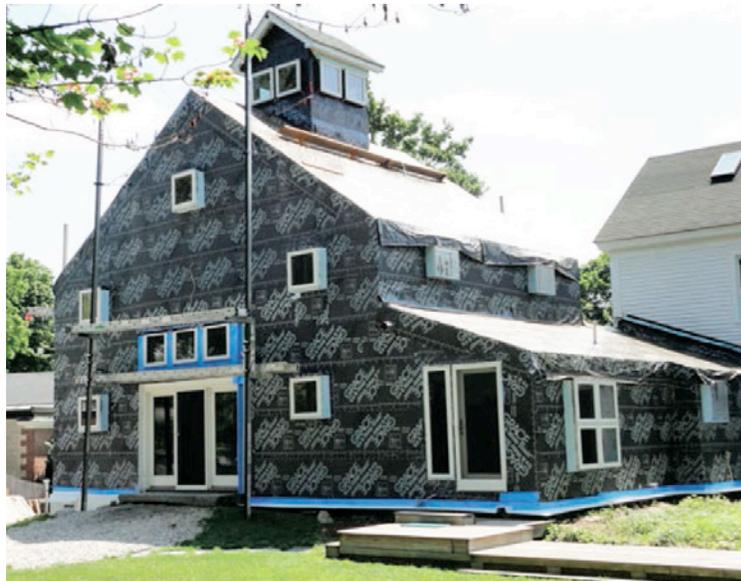
Photograph 12: Control Layers—An even more beautiful sight: a fully adhered membrane acting as a water control layer, air control layer and a vapor control layer. Reverse laps are taped with sheathing tape. No more poly for me.

The plywood sheathing was then wrapped with a fully adhered peel and stick membrane (**Photograph 12**). This layer acts as a water control layer, an air control layer and a vapor control layer. Note the control layer continuity between the roof assembly and the wall assembly. Reverse laps in the membrane were taped with sheathing tape.

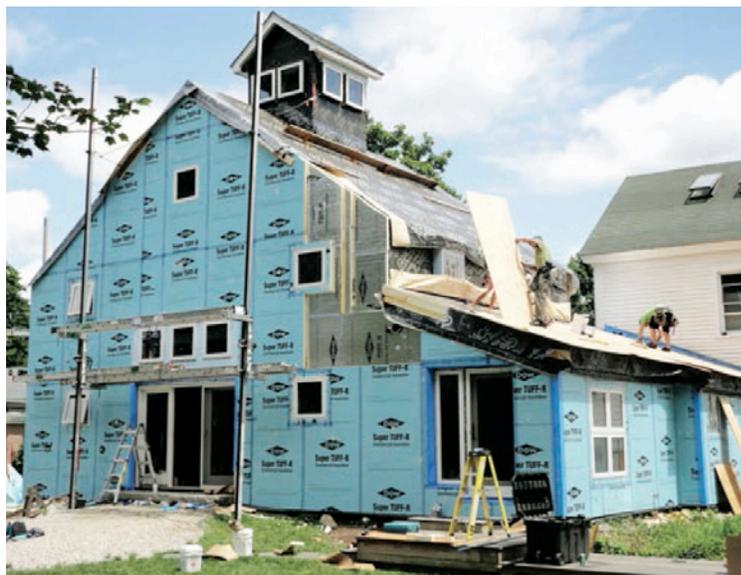
Photograph 13: Thermal Control Layer—Note the four layers of rigid insulation on the walls and the five layers of rigid insulation on the roof. You had better believe that each layer was offset horizontally and vertically and that each layer was sealed. I watched every sheet go in this time. None of this “faith-based” stuff anymore.

The thermal control layer for the walls and roof went on next: 8 in. (203 mm) of isocyanurate for the walls (four layers: each layer 2 in. (51 mm) thick with joints offset and each layer taped); 10 in. (254 mm) of isocyanurate for the roof (five layers: each layer 2 in. (51 mm) thick with joints offset and each layer taped). Check out **Photograph 13**.

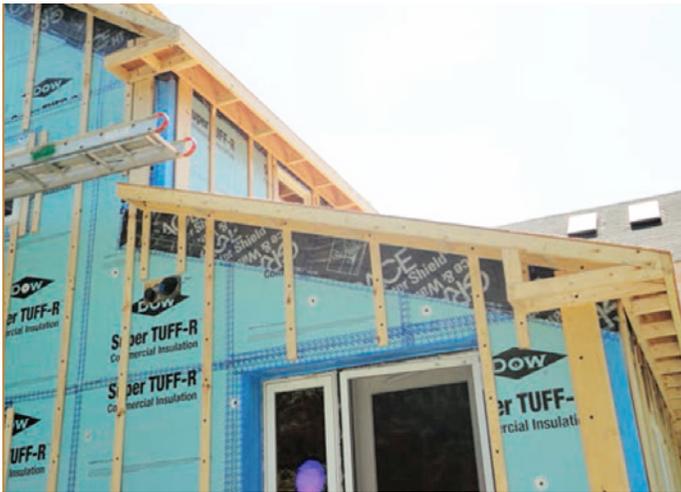
Photograph 14 (top left): Floating Roof—This takes a little bit of thinking to see what is going on. Check out **Figure 1** and **Figure 2** and then come back to this photograph. The overhangs are structurally sound, they just don't look that way until you understand how box beams work and that the rigid foam is not going to slide down the slope.

Wood furring (untreated) was then installed with long epoxy-coated steel screws through the rigid insulation into the structural sheathing and original board sheathing. Roof overhangs float on the top of the rigid insulation and tie into the wood furring on the walls (**Photograph 14**, **Figure 1** and **Figure 2**).

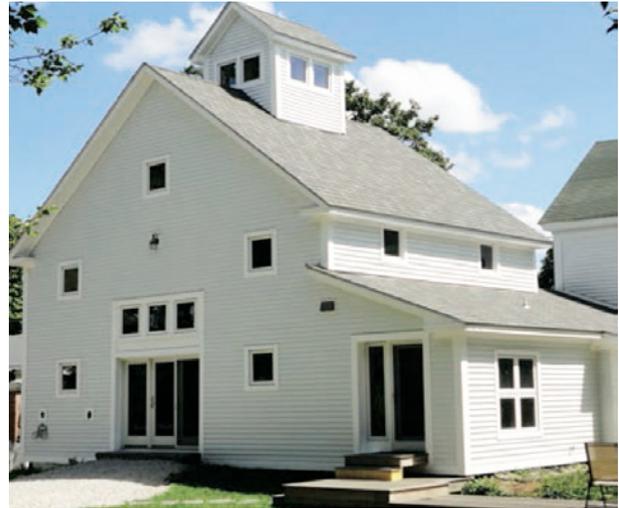
Photograph 15 (top right): Done—Looks almost normal. R-65 roof and an R-52 wall more or less. And tight. How tight? Pick an outrageous phrase. The actual numbers are for another column. Check out the two round holes where the heat recovery ventilator (HRV) intake and exhaust goes. The extreme tightness leads to some interesting problems with exhaust fans and extreme pressures that require some nifty solutions. Later babe.

How did it turn out when all was said and done? Check out **Photograph 15**. New shingles. Lots of new insulation. Lots of shear.⁷ No three-dimensional airflow networks. Not quite the plantation house of Charlton Heston and Eleanor Parker—but it will do—the Marabunta be damned.
