## Insight Parthenon, Eh?

## By Joseph W. Lstiburek, Ph.D., P.Eng., Fellow ASHRAE

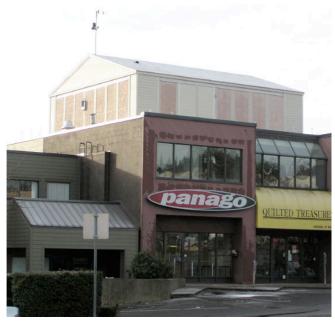
**Photograph 2: Temple to Hutcheon** – Constructed around 2005 overlooking Vancouver by the contractor Gauvin the Younger to honor the God of Building Science.

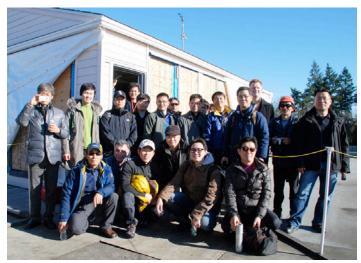
**Photograph 3: Building Science Pilgrims** – Faithful from Korea viewing wetted icons.

those who design and construct other temples. In the interim, Faithful from all over the world are making pilgrimages to the temple (**Photograph 3**) as it is on the

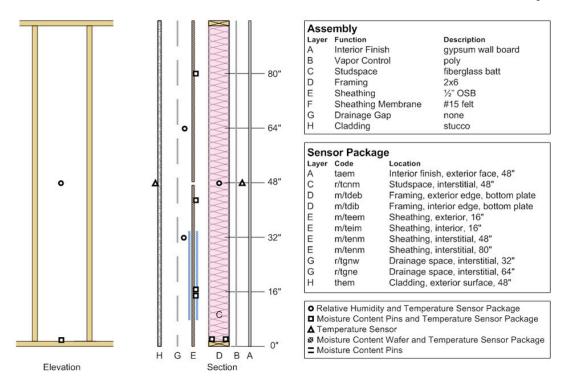
**Figure 1: Test Panel Instrumentation** – Note the location, number and type of sensors for each of the 28 test panels.

Twenty-eight test panels (4 ft. by 8 ft./1m by 2m) run through 12-month cycles over 6 years? Thousands of data points (**Photograph 4** and **Photograph 5**)–argh! Only crazy people do this kind of stuff. Guess what? Taking the darn things apart every year turned out to be the most insightful. Nothing beats looking at everything– every layer, every side of every layer. You get the idea. It's the only way to keep the data honest. Are you really measuring what you think you are measuring? The instrumentation was impressive (**Figure 1**). The entire approach is worth a discussion–but for some other time.

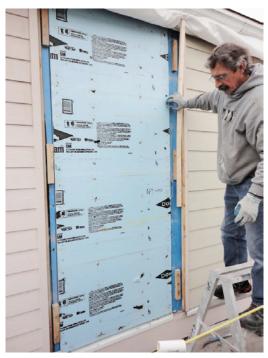
Photograph 7: Stucco over XPS Wall – North elevation deconstruction

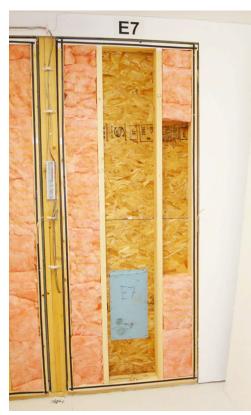
**Photograph 8: Interior Wetting Apparatus** – Note blue capillary active mat used to distribute water injected into assembly over interior surface of exterior OSB sheathing.

The walls were wetted both internally (**Photograph 8**) and externally (**Photograph 9**). The external wetting was done behind the "water control layer" – directly into the OSB sheathing to be representative of a flaw or a true leak or construction error or defect. The internal wetting was done in a similar fashion. Water was injected directly against the cavity side of the exterior sheathing–again to be representative of a flaw or construction error or defect.

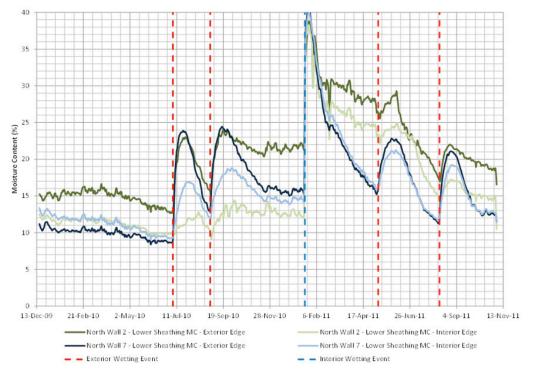
Figure 2: North Elevation OSB Sheathing Moisture Content – Note the wetting events and the drying rates.

The results are presented in **Figure 2** for the north elevation and **Figure 3** for the south elevation. Drying turns out to be faster on both the east and west elevations than the north elevation and fastest on the south elevation. No surprise. The OSB moisture

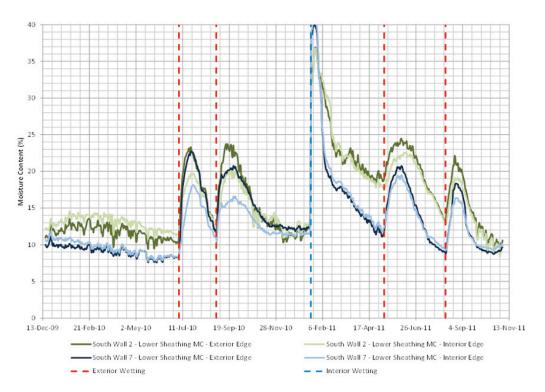
Figure 3: South Elevation OSB Sheathing Moisture Content – Note the wetting events and the drying rates.

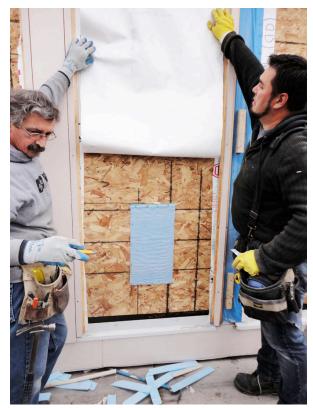
**Photograph 9: Exterior Wetting Apparatus** – Note that the capillary active mat used to distribute water injected behind cladding is located behind the water control layer directly over the exterior surface of the OSB sheathing.

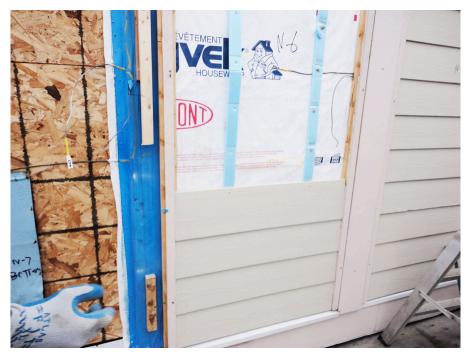
**Photograph 10: Fiber cement siding** - If you install a polyethylene vapor barrier on the inside of your wall and you sheath it with OSB you had better back ventilate your external cladding. It makes a big difference. Note the "blue" spacer strips that create a  $^{3}$ /<sub>8</sub>-inch ventilation and drainage gap between the siding and the water control layer.

(<sup>3</sup>/<sub>8</sub>-inch or 10 mm) between the stucco and the OSB. Again, this should be no surprise, for stucco. But it turned out to be as important for other cladding systems such as fiber cement siding installed over OSB (**Photograph 10**). If you install a polyethylene vapor barrier on the inside of your wall and you sheath it with

OSB you had better back ventilate your external cladding. It makes a big difference.
