Insight Great Fire of London

“Rain Screens, Claddings and Continuous Insulation”

By Joseph W. Lstiburek, Ph.D., P.Eng., Fellow ASHRAE

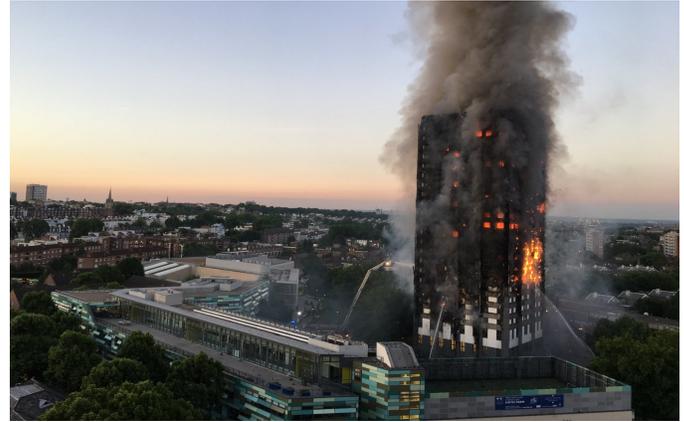
Photograph 1: Grenfell Tower Fire – June 14, 2017 (Source: [https://en.wikipedia.org/wiki/Grenfell_Tower_fire#/media/File:Grenfell_Tower_fire_\(wider_view\).jpg](https://en.wikipedia.org/wiki/Grenfell_Tower_fire#/media/File:Grenfell_Tower_fire_(wider_view).jpg))

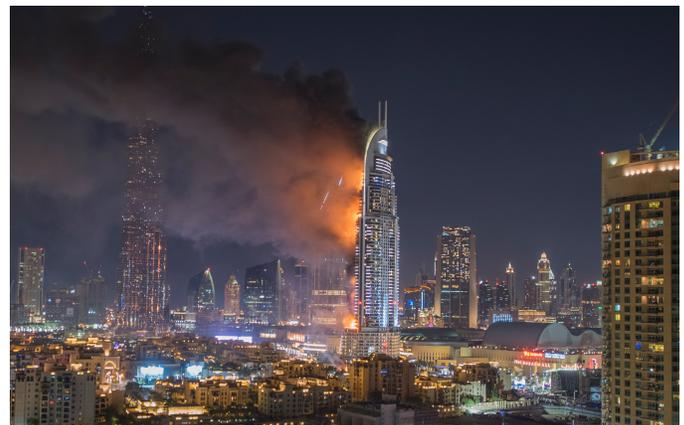
Photograph 2: Address Downtown Dubai - New Year’s Eve, 2015 (Source: <http://www.istockphoto.com/photo/dubai-burj-khalifa-new-year-fireworks-2016-gm503071274-82315509>)

We had warnings. The 18 story Mermoz Tower cladding fire in Roubaix, France, May 2012. The high rise fire in Dubai. The 63 story Address Downtown Dubai lit up the sky on New Year’s Eve, 2015 (**Photograph 2**). The combustible cladding was the culprit. The fire in Melbourne, Australia in November 2014, the 23 story Lacrosse apartment building cladding fire.

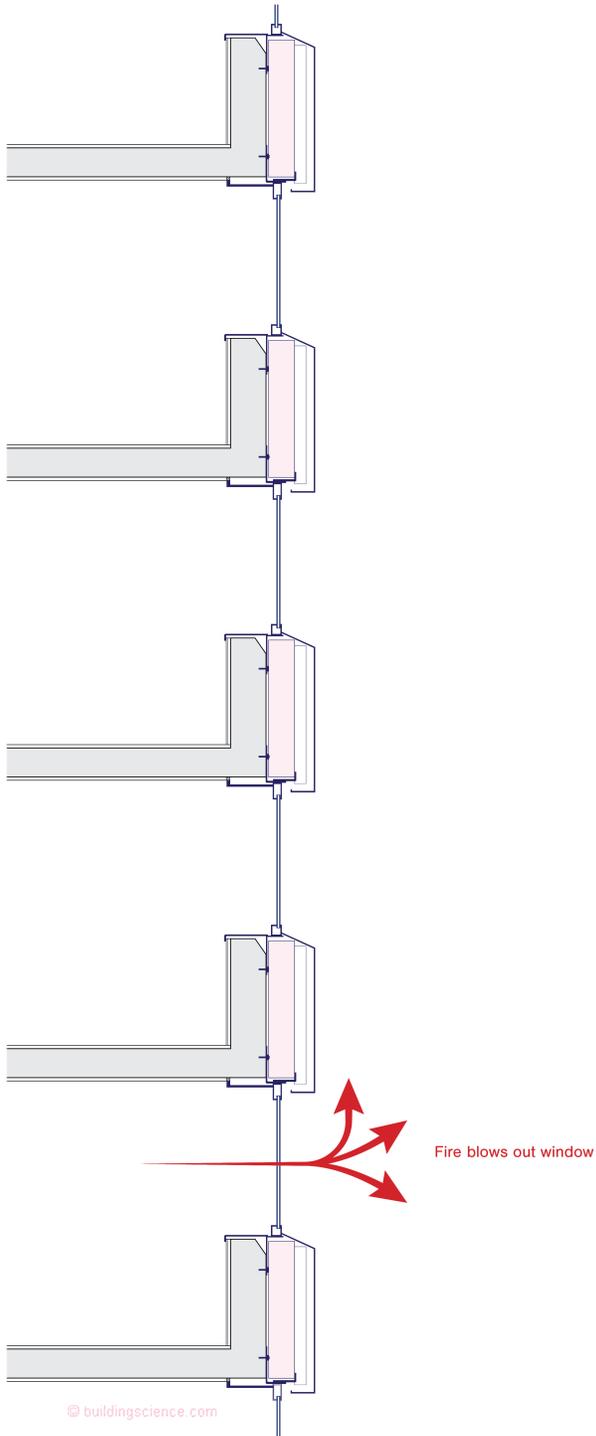
Figure 1: Fire Blows Out Window

In the Grenfell Tower, the fire began in an apartment – a “flat” – on the 4th floor. The fire in the apartment flashed over and blew out the window (**Figure 1**). Flames shot outside the window. The exterior cladding ignited (**Figure 2**) and the fire raced up the outside of the building (**Figure 3**). It got to the top of the building...the 24th floor in less than 15 minutes. On the way up it punched inward through the windows to the inside of the “flats” (**Figure 4**). Everything burned (**Photograph 1**). There were no sprinklers. There was no working fire alarm. There was one stairwell out. The instructions to the tenants was to shelter in place. This should not have happened. We knew better. This was not a proud moment for those of us who design, construct, operate, maintain and rehabilitate buildings.

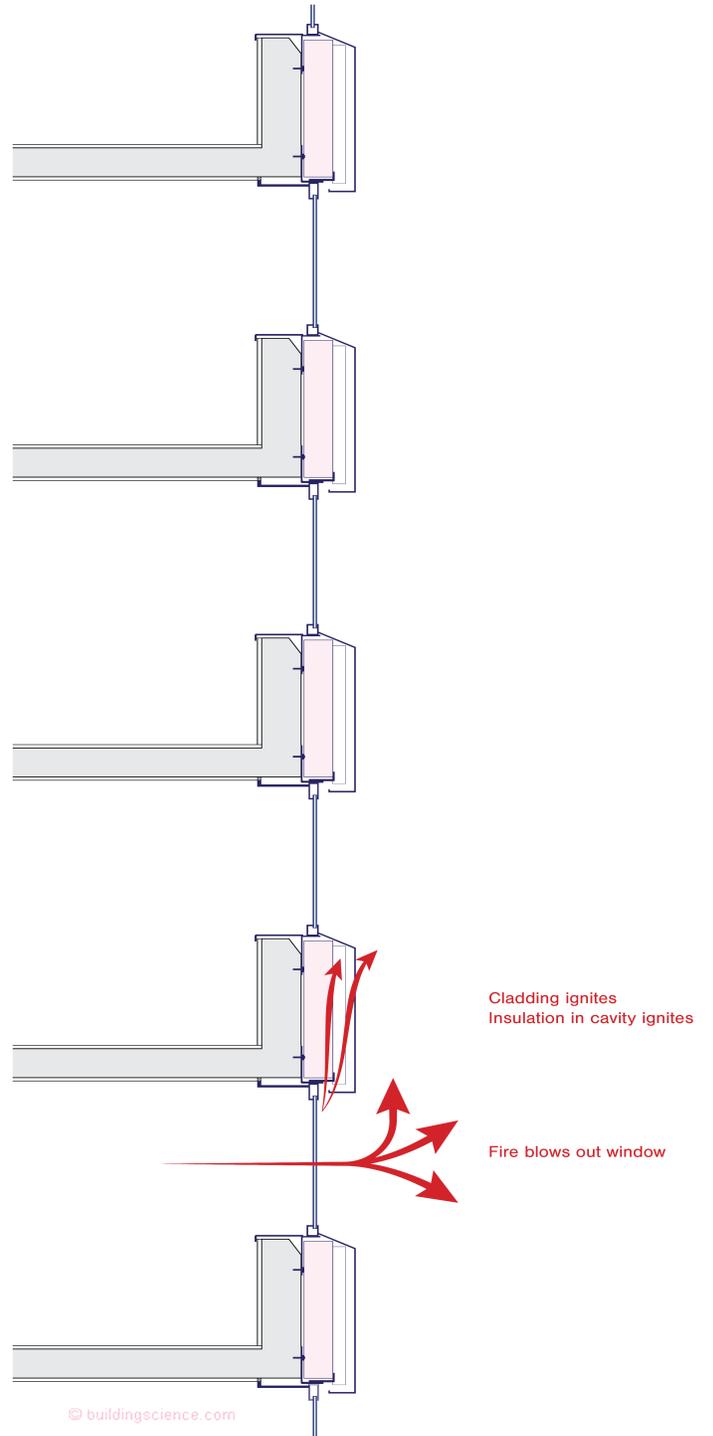
Figure 2: Cladding Ignites – Insulation In Cavity Ignites

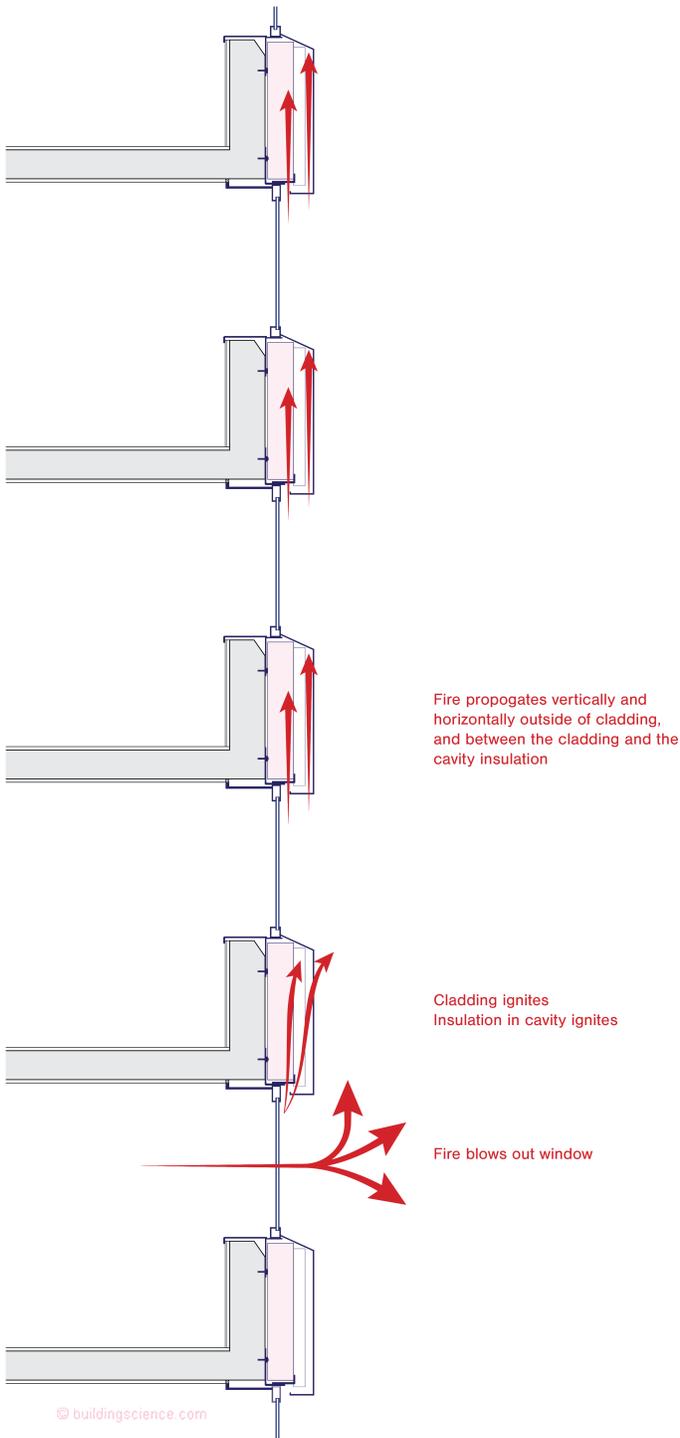
Figure 3: Fire Propagates Vertically and Horizontally

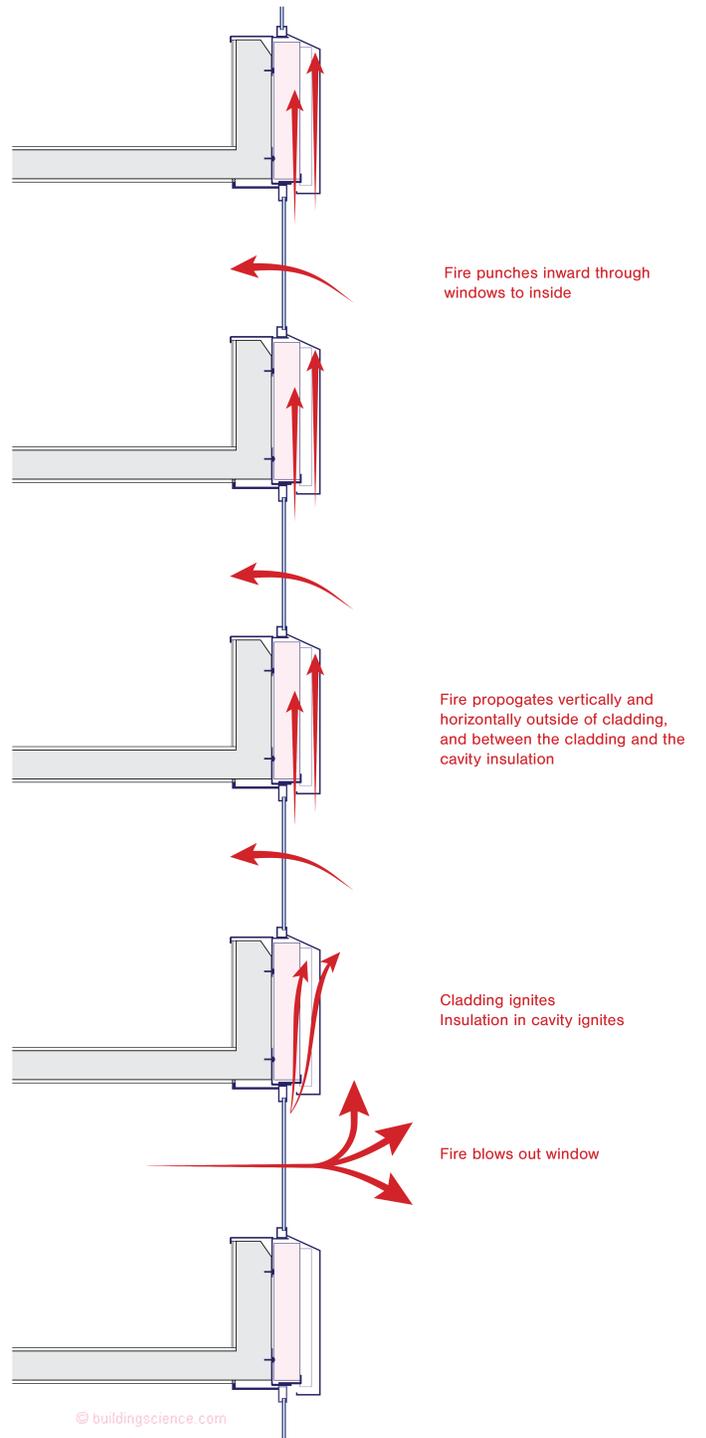
Figure 4: Fire Punches Inward Through Windows To Inside

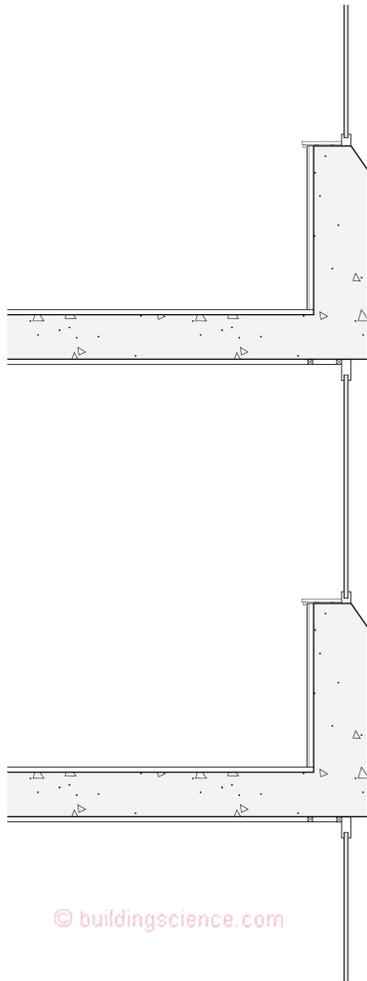
Figure 5: Grenfell Tower – Pre-Retrofit Assembly – Window aligned with concrete structure.

There is no way the Grenfell Tower assembly would pass an NFPA 285 test. **Figure 5** shows the Grenfell Tower wall assembly pre-retrofit. **Figure 6** shows the Grenfell Tower assembly post-retrofit. The retrofit cladding was an aluminum composite panel with a polyethylene core – highly combustible – installed over a 2-inch vented airspace. The “continuous insulation” behind the vented airspace was 6 inches of foil-faced isocyanurate – fire resistant, but not fireproof. Note the location of the retrofit window – it is outboard of the structure lining up with the thermal layer of the wall assembly. Good for thermal performance. Not so good for fire.

For the assembly in **Figure 5** to be able to pass the NFPA 285 test the cladding and the rest of the assembly (note that it is an assembly test) would have to limit its firespread vertically and horizontally to no more than a few feet during the duration of the test. Only a non-combustible cladding will do that...when coupled with an appropriate assembly. Additionally, fire propagation behind the

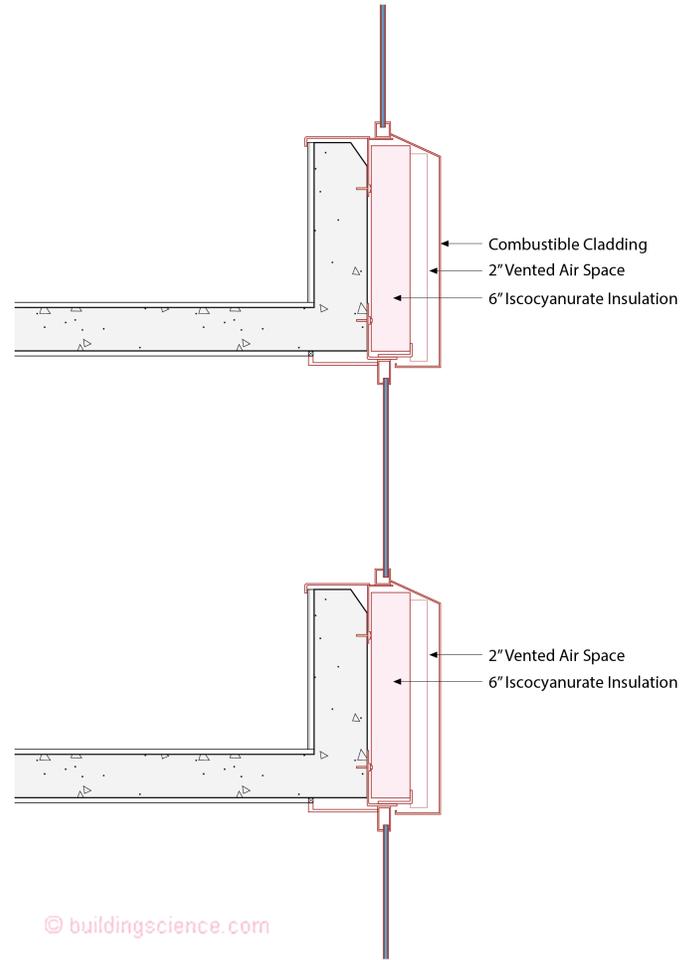
Figure 6: Grenfell Tower – Post-Retrofit Assembly - The retrofit cladding was an aluminum composite panel with a polyethylene core – highly combustible – installed over a 2-inch vented airspace. The “continuous insulation” behind the vented airspace was 6 inches of foil-faced isocyanurate – fire resistant, but not fireproof. Note the location of the retrofit window – it is outboard of the structure lining up with the thermal layer of the wall assembly. Good for thermal performance. Not so good for fire.

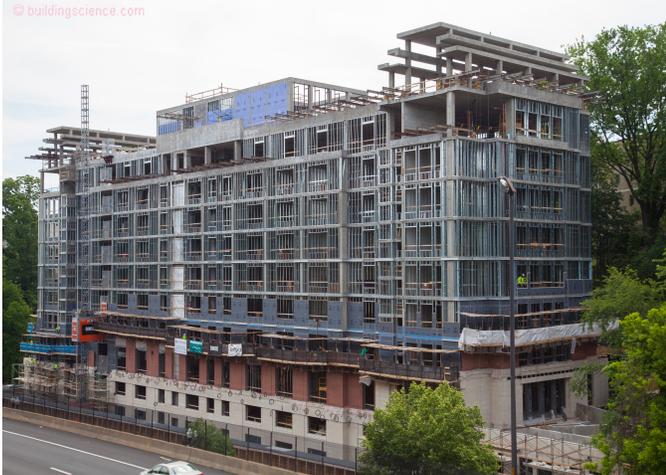
Photograph 4: Multi-Story Concrete Frame Building - Steel-stud back-up walls with a non-combustible brick veneer cladding installed over a 1-inch air space. The sheathing is a direct applied (“to the steel studs”) foil-faced isocyanurate continuous insulation with sealed joints. This assembly has passed the NFPA 285 test. Replace the brick veneer with stucco, terracotta, cultured stone and metal panels and we would have similar results.

Photograph 4 is a multi-story concrete frame building with steel-stud back-up walls. The cladding is a non-combustible brick veneer installed over a 1-inch air space. The sheathing is a direct applied (“to the steel studs”) foil-faced isocyanurate continuous insulation with sealed joints. This assembly has passed the NFPA 285 test. Replace the brick veneer with stucco, terracotta, cultured stone and metal panels and we would have similar results.

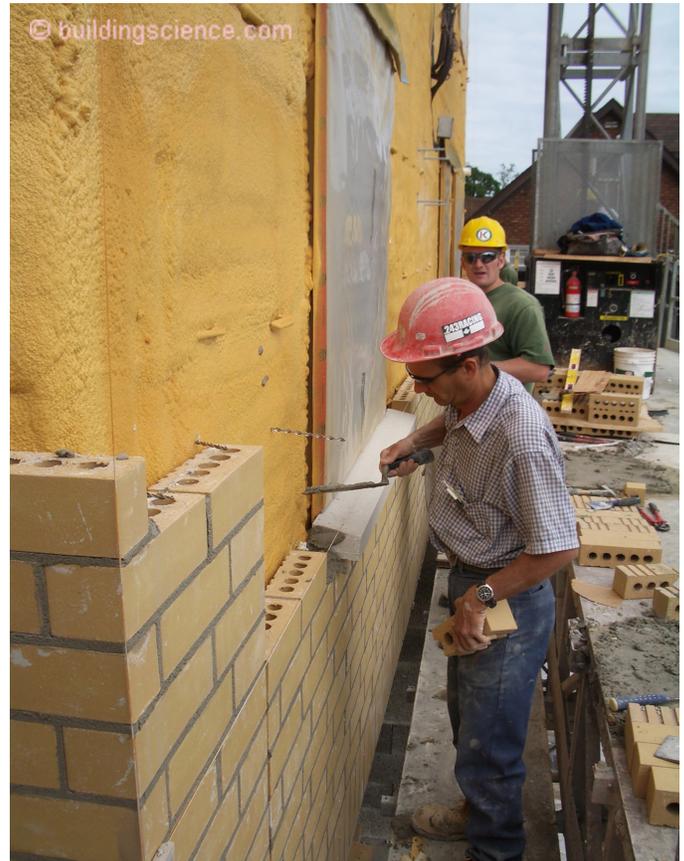
Photograph 5: Mid-Rise Concrete Frame Building – Masonry back up wall with a 3-inch layer of 2 lb/ft³ density spray polyurethane foam (SPF). The SPF is the continuous insulation layer – and is fire resistant but still combustible. The cladding is a non-combustible brick veneer over a ½ inch air space. This assembly has passed the NFPA 285 test.

Photograph 5 is a mid-rise concrete frame building with a masonry back up wall. A 3-inch layer of 2 lb/ft³ density spray polyurethane foam (SPF) has been applied over the masonry back up wall. The SPF is the continuous insulation layer – and is fire resistant. The cladding is a non-combustible brick veneer over a ½ inch air space. This assembly has passed the NFPA 285 test.

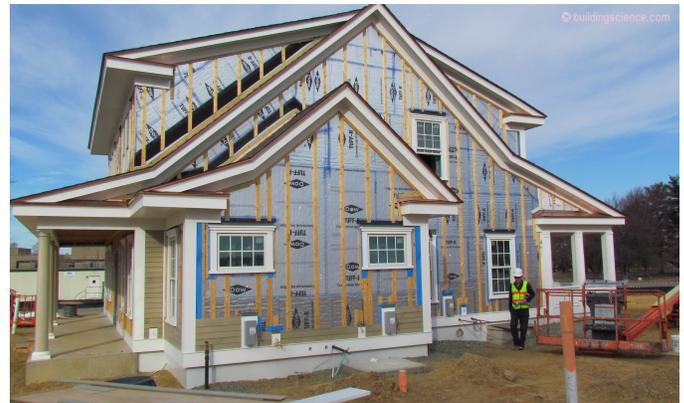
Photograph 6: Low-Rise Wood Frame Building – This is the NIST Net Zero Energy Test House. The continuous insulation layer is 4 inches of foil-faced isocyanurate. The cladding is non-combustible fiber cement siding installed over 1x4 wood furring (¾-inch air space). This assembly is not required to pass the NFPA 285 test and would easily outperform the Grenfell Tower in a fire because of the fiber cement cladding and the small “rain screen” airspace (¾ inch)."

Photograph 6 is a low-rise wood frame building. It is the NIST Net Zero Energy Test House. The continuous insulation layer is 4 inches of foil-faced isocyanurate. The cladding is non-combustible fiber cement siding installed over 1x4 wood furring (¾-inch air space). This assembly is not required to pass the NFPA 285 test.

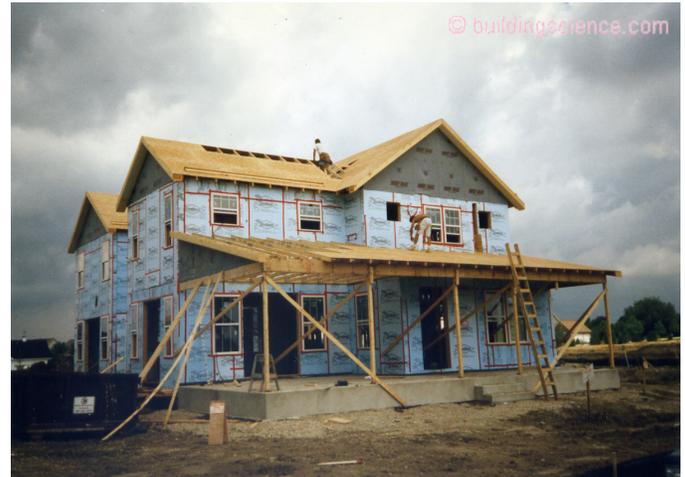
Photograph 7: Low-Rise Wood Frame Building - The continuous insulation layer is 1-inch extruded polystyrene insulation with sealed joints. The cladding (not installed) is direct applied vinyl siding. This assembly is not required to pass the NFPA 285 test.

Photograph 7 is a low-rise wood frame building. The continuous insulation layer is 1-inch extruded polystyrene insulation with sealed joints. The cladding (not installed) is direct applied vinyl siding. This assembly is not required to pass the NFPA 285 test.

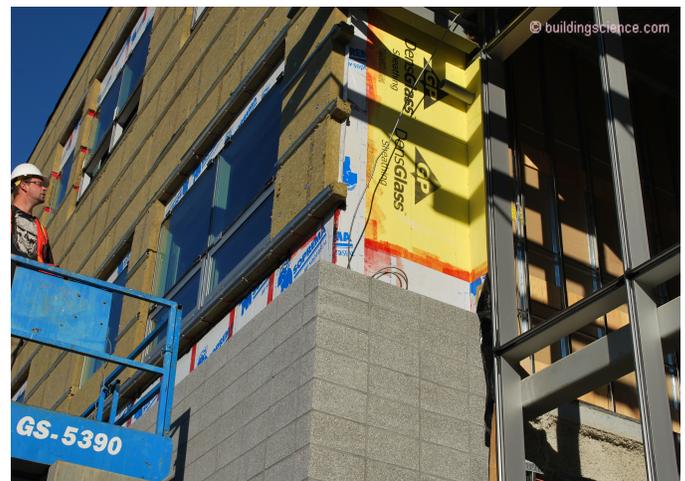
Photograph 8: Mid-Rise Concrete Frame Building – The wall assembly is a gypsum board sheathed steel-stud back-up wall. The continuous insulation is a 4-inch layer of non-combustible stone wool. The cladding layer is non-combustible masonry block. This assembly has passed the NFPA 285 test. Note that even though the continuous insulation is non-combustible and the cladding is non-combustible the water resistive barrier (WRB) and sheathing are required to meet NFPA 285. There are butyl and asphalt based WRB's that affect the fire performance of assemblies.

Photograph 8 is a mid-rise concrete frame building with a gypsum board sheathed steel-stud back-up wall. The continuous insulation is a 4-inch layer of non-combustible stone wool. The cladding layer is non-combustible masonry block. This assembly has passed the NFPA 285 test. Note that even though the continuous insulation is non-combustible and the cladding is non-combustible the water resistive barrier (WRB) is required to meet NFPA 285. There are butyl and asphalt based WRB's that affect the fire performance of assemblies.
