Insight The Coming Stucco- Pocalypse¹

By Joseph W. Lstiburek, Ph.D., P.Eng., Fellow ASHRAE

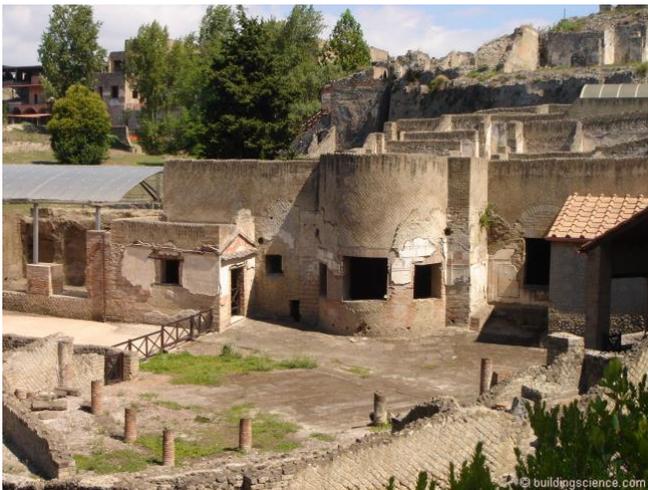
Photograph 1: Pompeii – Stucco applied over Roman brick. Minor issue with Mount Vesuvius in 79 A.D.

How can you take a system with thousands of years of history and screw it up? Easy. Keep improving it until it does not work. Babylonians used it. Egyptians used it. Greeks used it. Romans used it (**Photograph 1**). Everyone used it...and everyone uses it. But it sure has changed and what we put it over sure has changed.

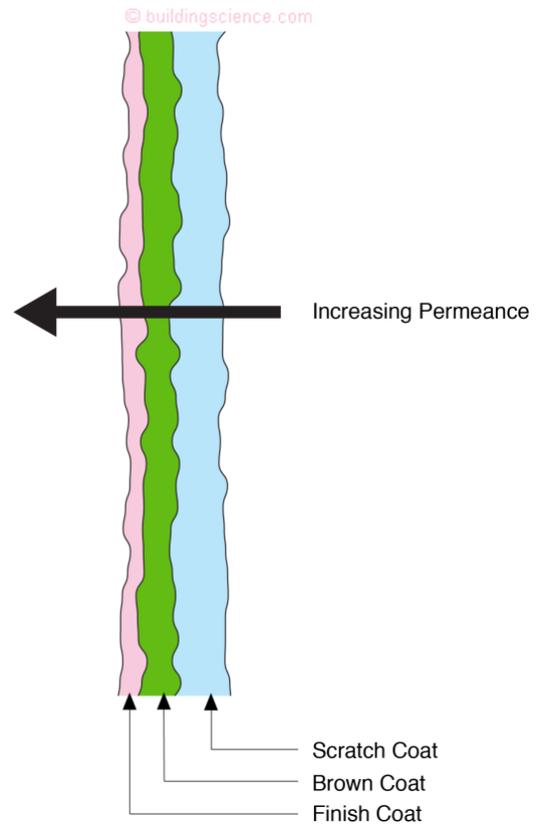
Figure 1: Traditional Stucco - Each successive layer to the exterior was more vapor open than the layer it covered. Yup. Old timers had it dialed in. Today? Not so much. Stucco historically had good compressive strength but not very good tensile strength. As we have manipulated the stucco “recipe” over the years, compressive strength has gotten better. And over the years so has tensile strength. To that end we have added cow dung, egg whites, pigs blood and finally polymers to the recipe. The “key” to the recipe is to create a strong “tinkertoy”³ (**Figure 2**). The older stucco tinker-toys had larger “voids” than newer tinkertoys. Water molecules could move through the older stucco tinkertoys more easily than the newer tinkertoys. But all of the tinkertoys could be pulled apart pretty easily. So what to do? Ah, add another tinkertoy inside the voids of the original tinkertoy (**Figure 3**). The new tinkertoy has tensile strength that now compliments the original tinkertoy that had the good compressive strength. Good news. Except now the voids are much smaller because of this new tinkertoy taking up much of the space in the voids of the original tinkertoy. The water molecules don’t move so easily any more. Welcome to polymer modification.⁴

Traditional lime based stucco was three layers: scratch coat, brown coat and finish coat (**Figure 1**). Each successive layer to the exterior was more vapor open than the layer it covered. Yup. Old timers had it dialed in. Today? Not so much.

The new recipe does not always follow the old rules laid out in **Figure 1**. Sometimes the finish coat and brown coat are less permeable than the scratch coat depending on what is added and how much. Oops.⁵

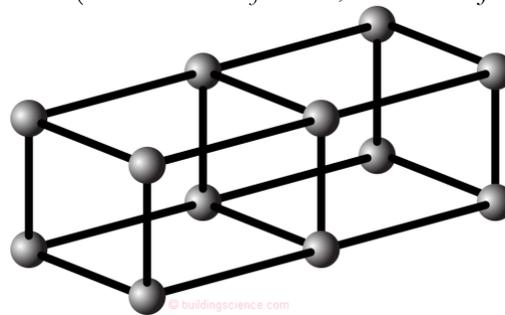
Figure 2: Stucco Tinkertoy - The older stucco tinker-toys had larger “voids” than newer tinkertoys. Water molecules could move through the older stucco tinkertoys more easily than the newer tinkertoys.

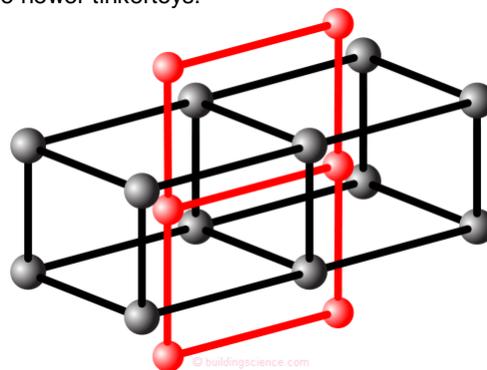
Figure 3: Polymer Modified Tinkertoy - Another tinkertoy inside the voids of original tinkertoy. This new tinkertoy has tensile strength that now compliments the original tinkertoy that had the good compressive strength. Good news. Except now the voids are much smaller because of this new tinkertoy taking up much of the space in the voids of the original tinkertoy.

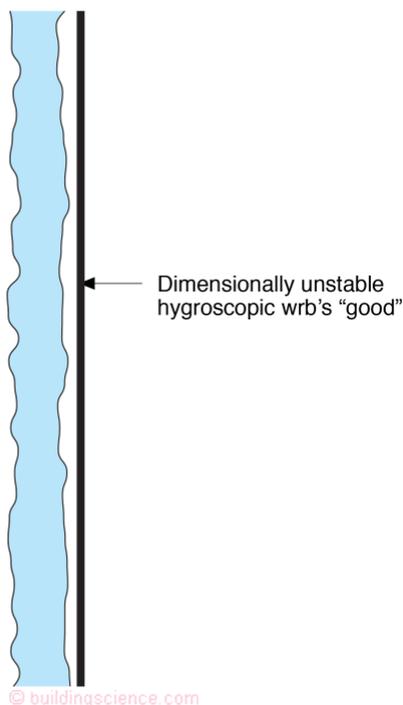
Figure 4: Dimensionally Unstable Building Paper - When building papers (aka “water resistive barriers” wrb’s) were

hygroscopic they expanded and contracted and stucco did not bond effectively to them.

Could we make it worse? Yes, of course. We can improve building papers. We could make them dimensionally stable. When building papers (aka “water resistive barriers” wrb’s) were hygroscopic they expanded and contracted and stucco did not bond effectively to them (**Figure 4**). Manufacturers of building papers began to make them more hydrophobic and dimensionally stable. How could this be bad? We began to get the stucco bonding to building paper. When stucco bonds to building paper the building paper loses water repellency and its ability to drain (**Photograph 2**). Could we make it worse? Yes, of course. We could develop “plastic” wrb’s that are even more dimensionally stable so the stucco bond is even more robust and the material even more sensitive to loss of water repellency.

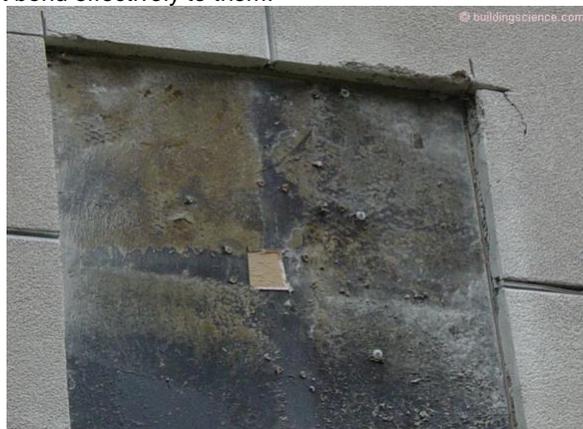
Photograph 2: Stucco Bonded to Building Paper - When stucco bonds to building paper the building paper loses water repellency and its' ability to drain.

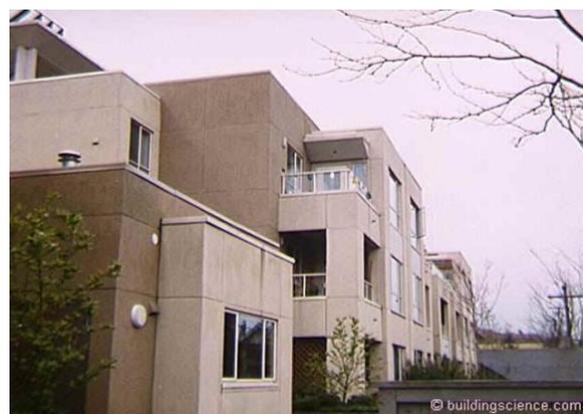
Photograph 3: Vancouver Condo – Classic building design. Folks tried to blame the lack of overhangs...

It all came together in Vancouver in the 1990’s and we almost rotted that great city to the ground. Low permeance stucco, high thermal resistance wall assemblies, OSB sheathing and dimensionally stable wrb’s.⁷ You could tell you were in Vancouver based on the number of tarps and scaffolding covering the rotting buildings (**Photograph 3** and **Photograph 4**).

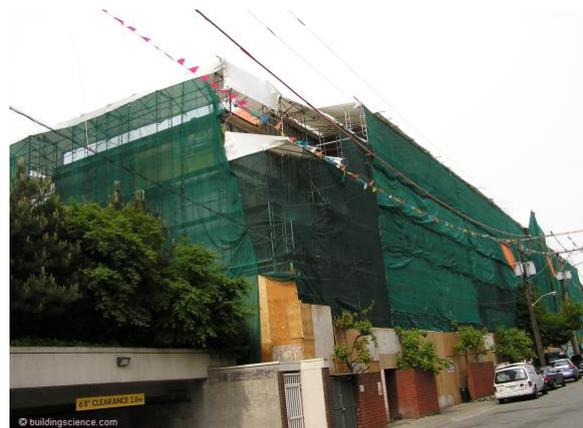
Photograph 4: Vancouver Tarp - You could tell you were in Vancouver based on the number tarps and scaffolding covering the rotting buildings. The images were dramatic....“crying” Vancouver stucco (**Photograph 5**)...stucco bonded to plastic wrb’s (**Photograph 6**)....and rotting OSB behind plastic wrb’s (**Photograph 7**). We should have paid attention. Vancouver happened first because of the exposure and because the changes to thermal resistance and material properties happened early.

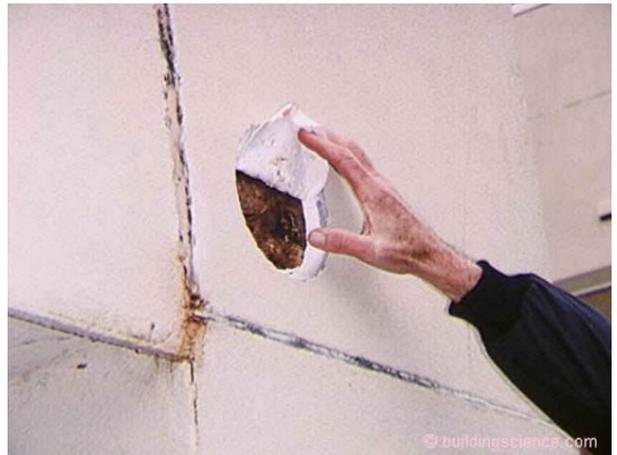
Photograph 7: Vancouver End Game – Rotting OSB behind plastic wrb.

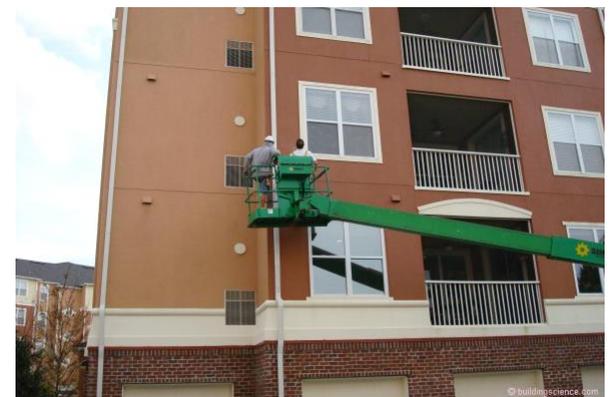
Photograph 8: Multistory Wood Frame - Things began to move south and east. First on the multistory wood frame buildings because the rain exposure increases with height.

Then things began to move south and east. First on the multistory wood frame buildings because the rain exposure increases with height (**Photograph 8**) then on regular wood frame low rise (**Photograph 9**).

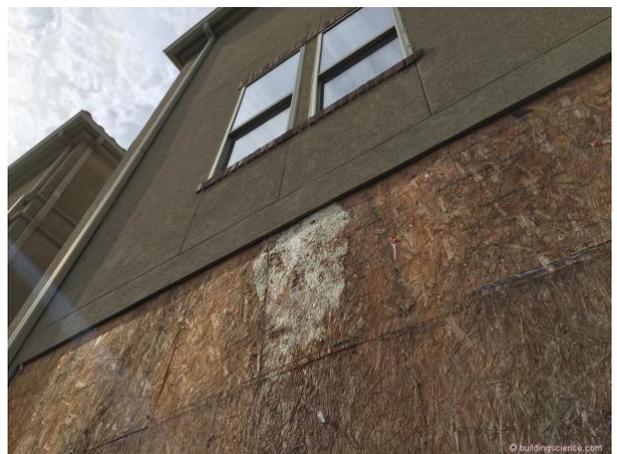
Photograph 5: More Vancouver – “Crying” stucco.

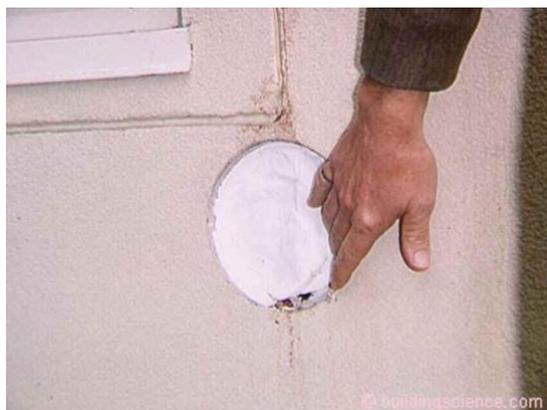
Photograph 9: Wood Frame Low Rise – Even though the exposure is less on low rise they are not immune.

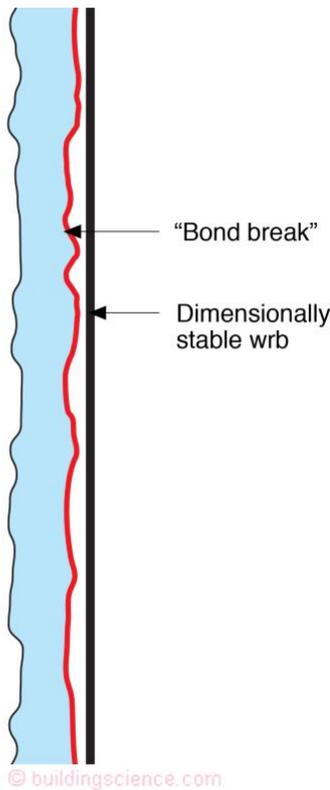
Figure 5: Bond Break - It became clear that there were issues with wrb’s and the first intervention was to use two layers – an outer layer that would act as a bond break and an inner layer that was the “true” wrb.

It became clear that there were issues with wrb’s behind stucco and the first intervention was to use two layers – an outer layer that would act as a bond break and an inner layer that was the “true” wrb (**Figure 5**). Unfortunately this was not enough.

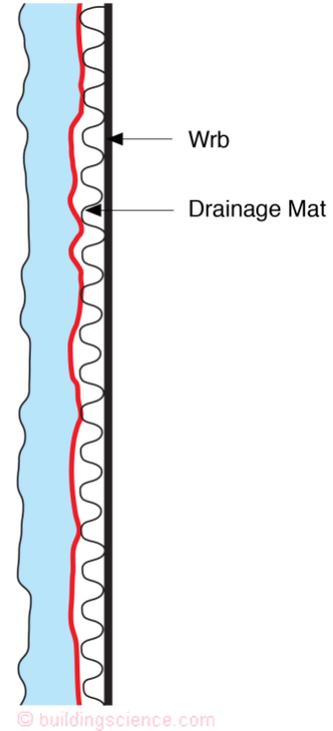
Figure 6: Drainage and Drying Gap - The assemblies needed enhanced drainage and enhanced drying. One of the more effective means of accomplishing both is to provide a drainage matt between the bond break and the wrb.

The assemblies needed enhanced drainage and enhanced drying. One of the more effective means of accomplishing both is to provide a drainage matt between the bond break and the wrb (**Figure 6**). We have learned this on the multistory wood frame buildings (**Photograph 10** and **Photograph 11**). We learned it on the multistory wood frame buildings first because they began to experience the problems first.

So what do we need to do? Easy. Provide a 3/8 inch air space behind stucco installed over OSB sheathing in regions where it rains more than 20 inches per year. That's it.

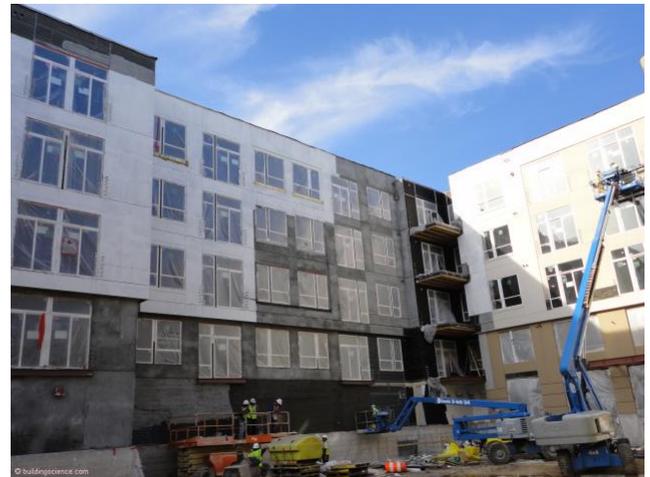
Photograph 10: Multistory Wood Frame Done Right - We learned to do it correctly on the multistory wood frame buildings first because they began to experience the problems first.

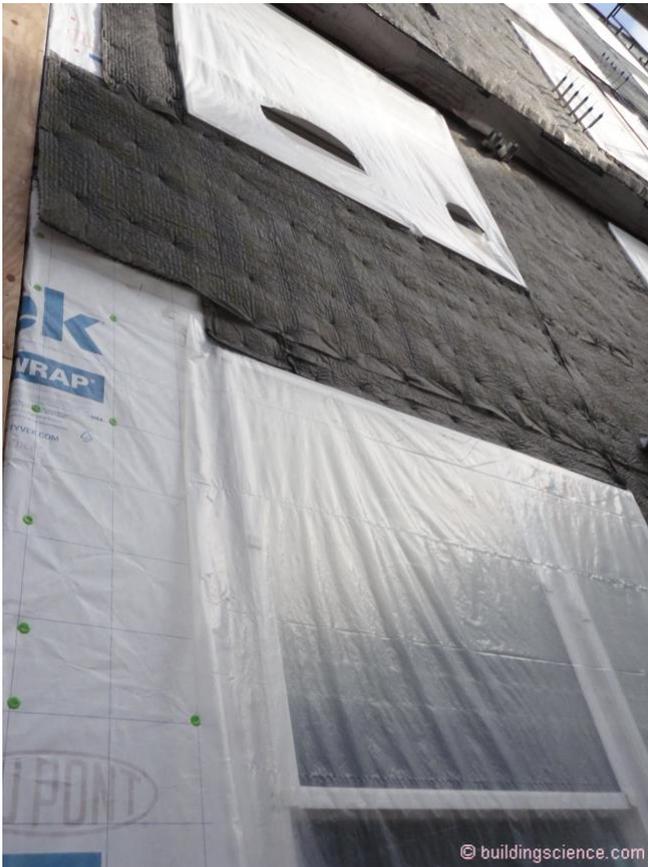
Photograph 11: Drainage and Drying Gap – Plastic wrap covered with a drainage mat with an integral bond break.
