Insight Stoned...

*Problems with thin stone and thin manufactured stone veneer...aka...
“lick and stick stone”...aka “lumpy stucco”...*

By Joseph W. Lstiburek, Ph.D., P.Eng., Fellow ASHRAE

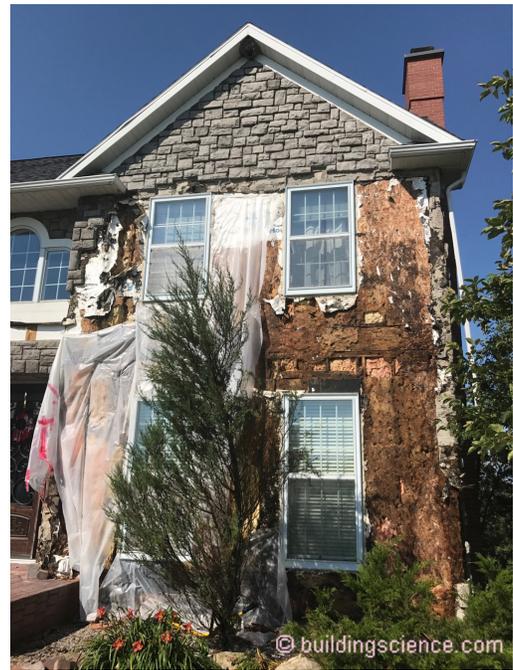
Photograph 1 – Lumpy Stucco Disaster: Stucco layer with adhered stone installed over a synthetic building paper over oriented strand board sheathing (OSB). Water held in nooks and crannies leads to a greater water load than traditional stucco. No drainage or capillary break or hygric redistribution.

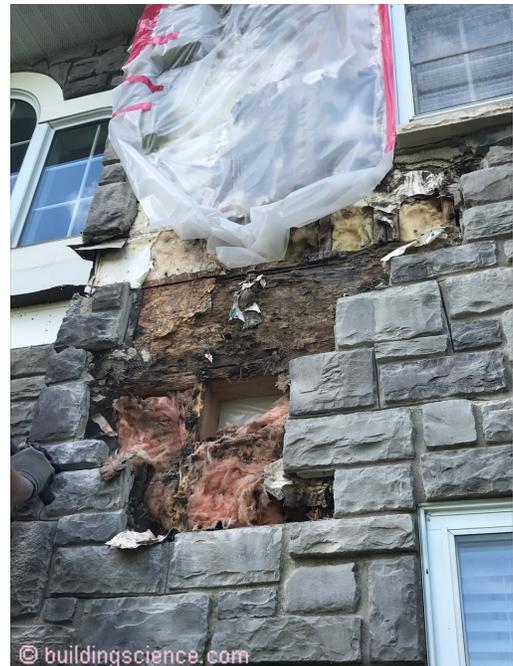
Photograph 2 – Disaster Made Worse: Interior plastic vapor barrier preventing inward drying coupled with a 2x6 insulated frame wall reducing energy flow thereby further reducing drying.

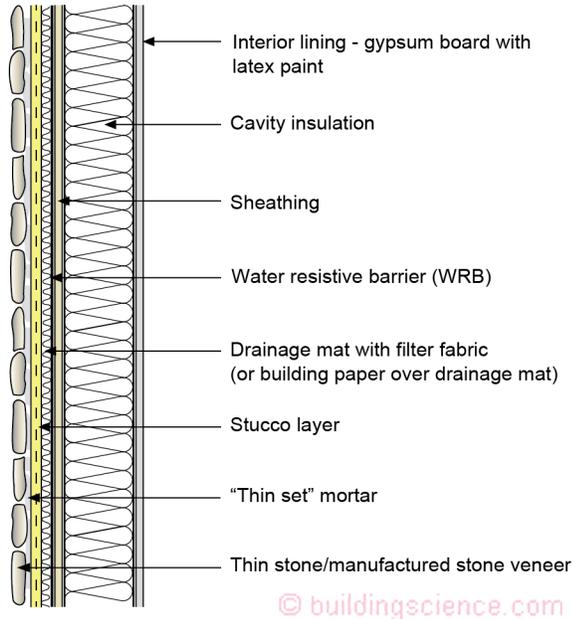
Figure 1 – Drainage Mat: The resulting gap provides drainage thereby addressing hydrostatic pressure concerns, provides a capillary break along with providing horizontal and vertical hygric redistribution – “aka” drying of the thin set mortar and stucco layer.

However, the problems are easy to avoid. Same approach as with stucco...provide a drainage layer behind the “lumpy stucco” (**Figure 1**). Drainage, drainage and drainage...and if the drainage gap is 3/16 inch or greater we get to address inward vapor drive and provide some hygric redistribution...aka “drying”.

This is becoming a huge issue....the solution.....easy.....a drained vented cavity behind the thin set mortar and stucco....sound familiar? Need to drain the rain baby....and dry the layers....Go back to **Figure 1**. The approach in **Figure 1** addresses both the rot problem and the thin stone adhesion problem. We get a two-for-one.

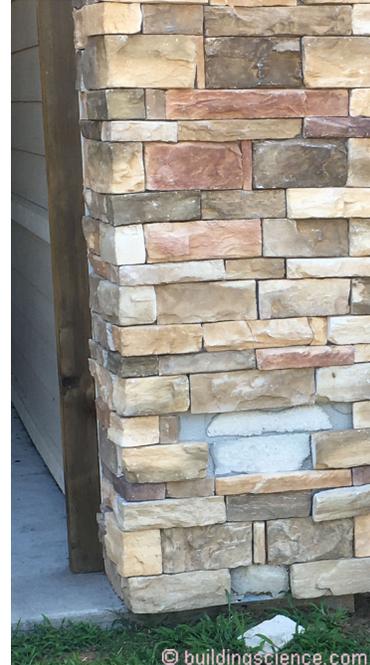
Photograph 3 – Adhesion Failure: High rainwater exposure.

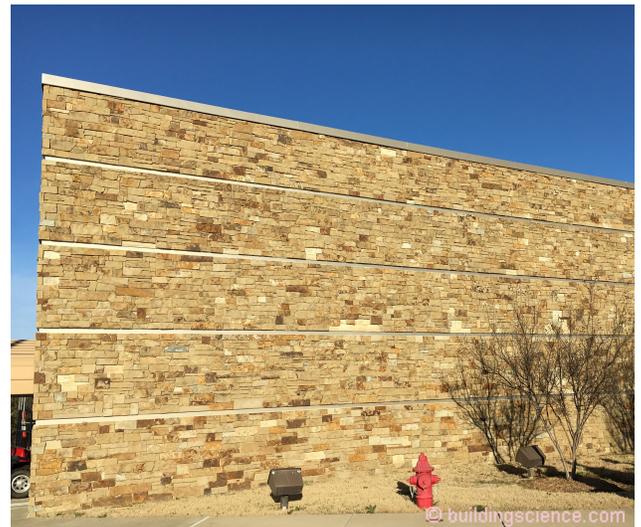
Photograph 4 – More Adhesion Failure: High rainwater exposure.

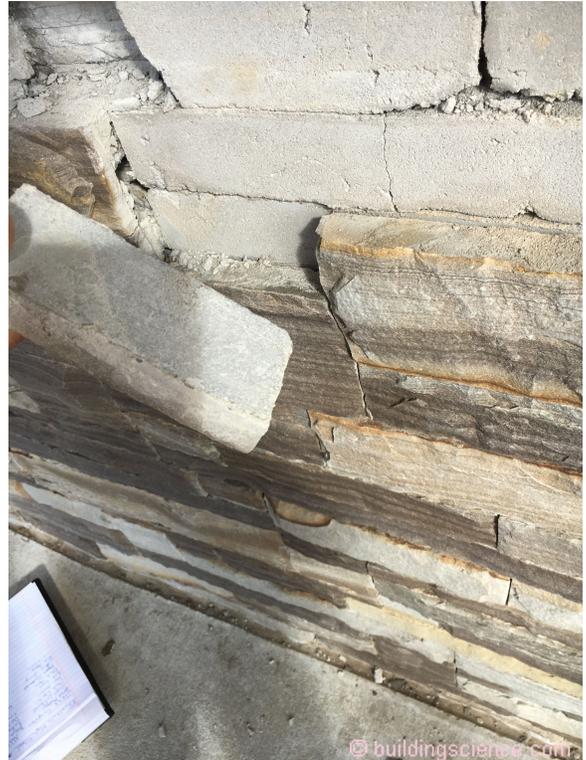
The patterns of failure are rainwater exposure related. The failures are predominantly concentrated where there is greater rain exposure. It gets better. The failures are almost always at the veneer-thin set interface (**Photograph 5** and **Photograph 6**). And it does not matter whether the veneer is real stone or manufactured.

Photograph 5 – Thin Stone Veneer Adhesion Failure: Bond failure is at the veneer-thin set interface.

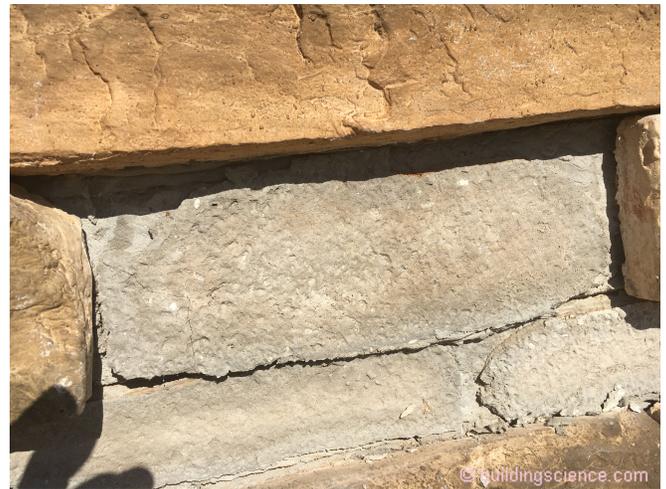
Photograph 6 - Manufactured Stone Veneer Adhesion Failure: Bond failure is at the veneer-thin set interface.

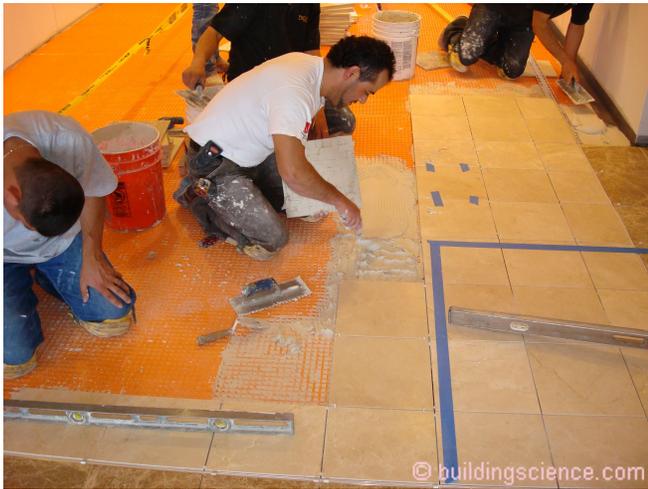
Photograph 7 – Floor Tile: Installation over an impermeable anti-fracture membrane must be done with unmodified thin set. Evaporation or drying cannot occur downwards into the concrete slab through the anti-fracture membrane. Since tiles are also waterproof and vapor closed evaporation or drying cannot occur upwards through the tile. No evaporation. Therefore, only unmodified thin set can be used. If a modified thin set is used a full bond does not occur.

So, if we have an anti-fracture membrane over a concrete slab we can’t use a polymer modified thin set to adhere tile to it as the anti-fracture membrane is typically waterproof and vapor closed. Evaporation or drying cannot occur downwards into the concrete slab through the anti-fracture membrane. Since tiles are also waterproof and vapor closed evaporation or drying cannot occur upwards through the tile. No evaporation. Therefore, only unmodified thin set can be used. If a modified thin set is used a full bond does not occur.

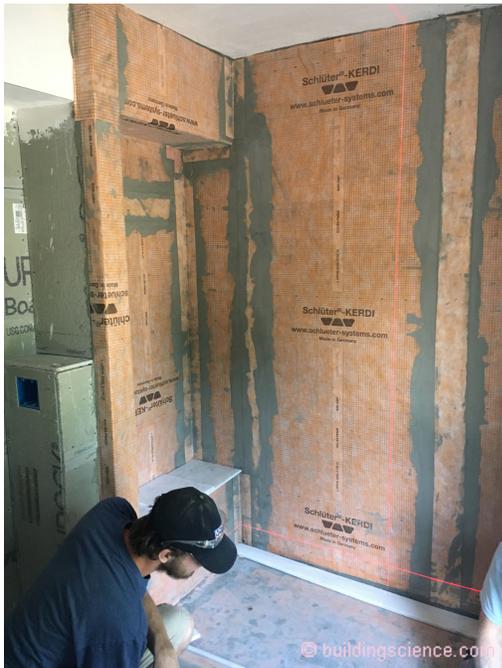
Photograph 8 – Tile in Shower: Installation of tile over an impermeable waterproof membrane must be done with unmodified mortar. Evaporation cannot occur through the waterproof membrane into the tile backer board and evaporation cannot occur outwards through the shower tile into the shower area. Therefore, only unmodified thin set can be used. If a modified thin set is used a full bond does not occur.

If we install a waterproof membrane in a shower we can’t use modified thin set to adhere the tile for similar reasons. Evaporation cannot occur through the waterproof membrane into the tile backer board and evaporation cannot occur outwards through the shower tile into the shower area. Therefore, only unmodified thin set can be used. If a modified thin set is used a full bond does not occur.

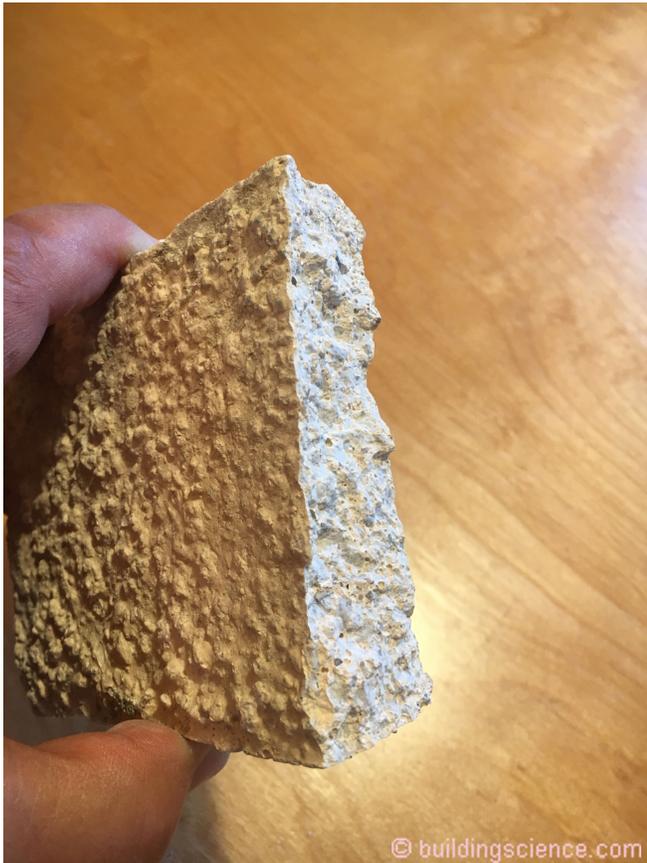
The water cannot dry or redistribute itself into the “real” stone because the stone is relatively impermeable. The water cannot dry or redistribute itself into the “manufactured” stone veneer because the manufactured stone is back-coated (“sealed”) to prevent excessive water absorption out of the thin set. The issue is desiccation of the polymer modified thin set mortar leading to not establishing a bond⁵. So a “porous” not real stone is made to behave like a non-porous real stone with the back-coating (**Photograph 9**).

Photograph 9 – Coating on Back of Manufactured Stone Veneer: Manufactured stone is back-coated (“sealed”) to prevent excessive water absorption out of the thin set. The issue is desiccation of the polymer modified thin set mortar leading to not establishing a bond. So a “porous” not real stone is made to behave like a non-porous real stone with the back-coating.

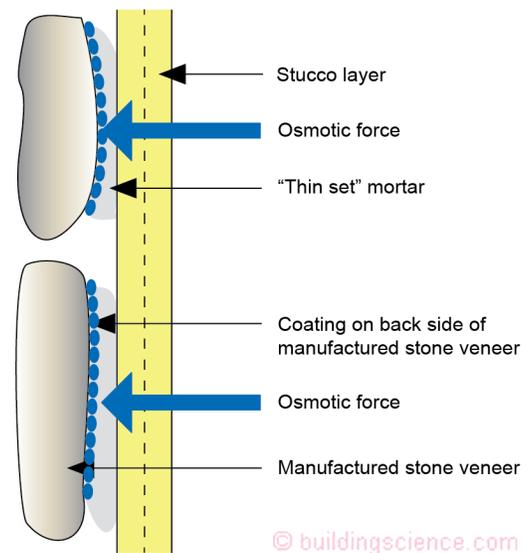
So we get a weak bond or a failed bond or we never got a bond at the thin set to veneer interface. But what “pushes” the stone off the wall? Osmosis (**Figure 2**). Yup. We get it in flooring failures. We get it in roofing failures and deck failures with cold fluid applied waterproofing installed over concrete decks and concrete roofs. We get it in coating failures. Now we are getting it with thin real stone and the thin manufactured stone veneer.

Figure 2 – Osmosis: There is salt in stone. You could argue that stone is really, really old salt. Second Law of Thermodynamics wants to get into the stone to dilute the concentration of salt that becomes a solute.

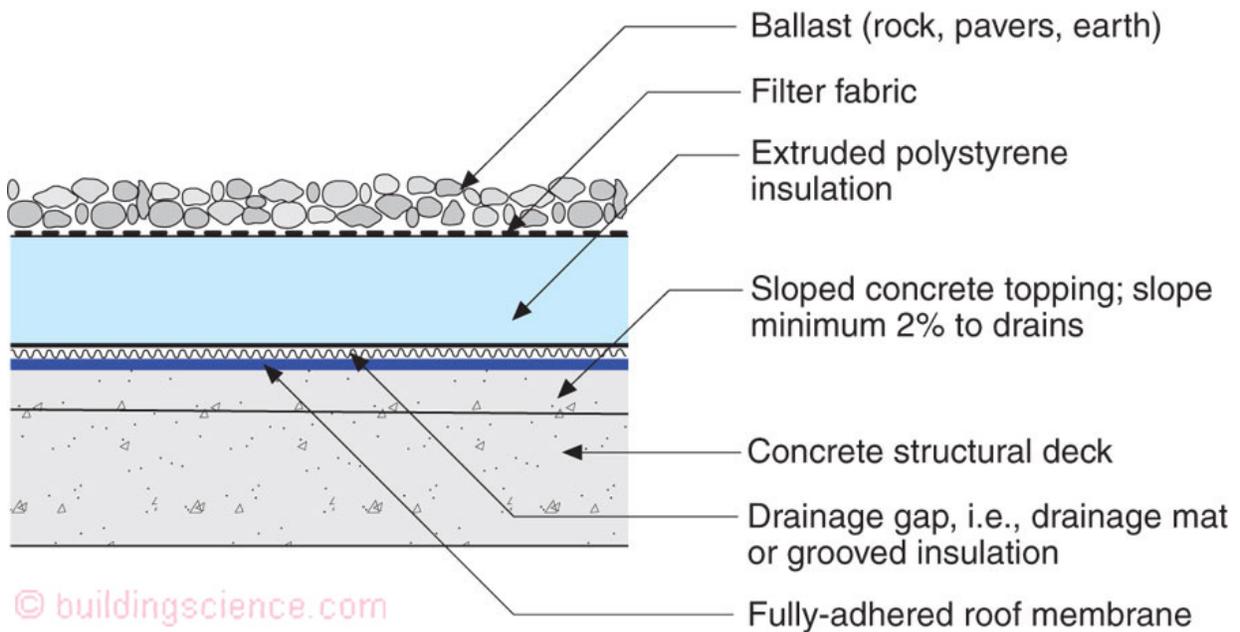
Figure 3 – Capillary Break Under Rigid Insulation: The gap under the rigid insulation prevents the rigid insulation from becoming saturated and promotes drying.

Think about the big picture...we need gaps behind claddings...we need gaps behind rigid insulation...we need gaps under protected membrane roof insulation and green roofs (**Figure 3**)...we need gaps under slabs (“capillary breaks”)...we need gaps almost everywhere⁶. Did not used to be this way. We changed materials, energy flow and moisture flow. To compensate we need to give back some energy. There is no such thing as a free thermodynamic lunch.
