# Insight

## Mind the Drip

Surface tension, rainwater, freeze-thaw and energy...

By Joseph W. Lstiburek, Ph.D., P.Eng.,  
Fellow ASHRAE

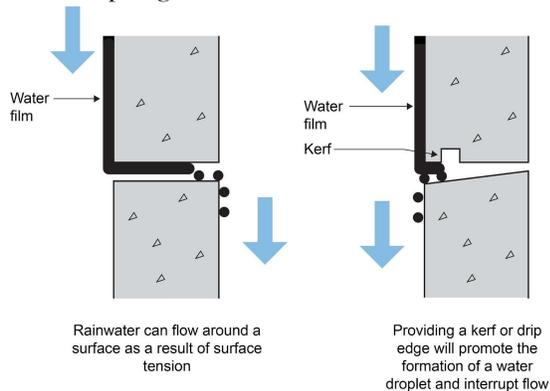
**Figure 1:** Surface Tension - Rainwater can flow around a surface as a result of surface tension. The traditional way of dealing with surface tension is to “break” the surface tension with a “kerf” and create a “drip”.

Surface tension can cause all kinds of problems in buildings. Rainwater can flow around a surface as a result of surface tension (**Figure 1**). The traditional way of dealing with surface tension is to “break” the surface tension with a “kerf” and create a “drip” or to provide...yes you guessed it...a “drip edge”.

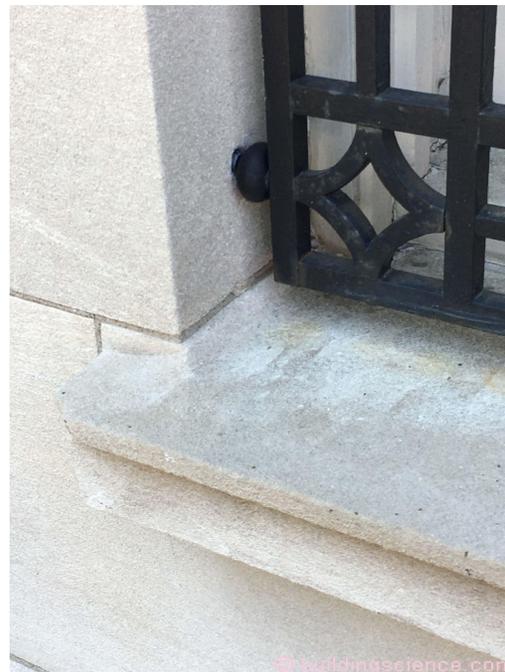
**Photograph 1:** Stone Sill - Beautiful sloping stone sill...sloping from the back...and from the ends...and look at the front edge drip.

**Photograph 1** is a spectacular image of doing it right. Look at the beautiful sloping stone sill...sloping from the back...and from the ends...and look at the front edge. It gets even better...look at the kerf under the sill (**Photograph 2**). This is in Washington, DC. Yup, we knew how to do things a hundred years ago.

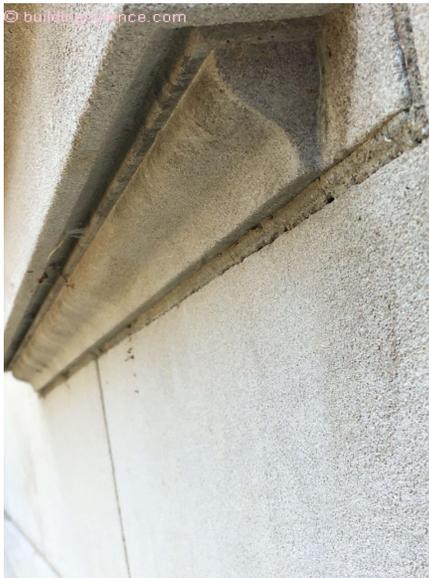
**Photograph 2:** Kerf - Kerf cut into the underside of the stone sill in Washington, DC a hundred years ago.

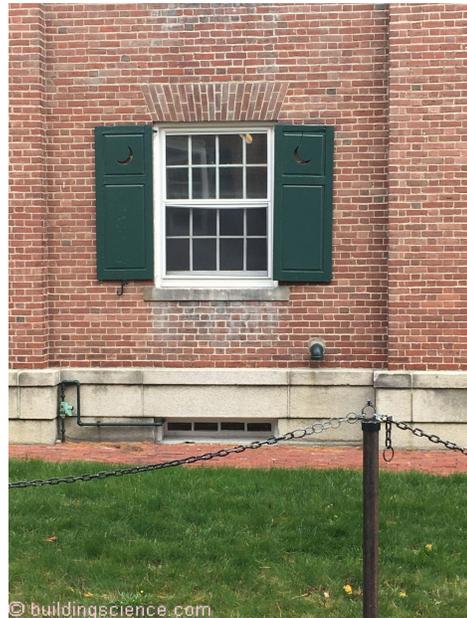
**Photograph 4:** Surface Tension Rainwater Stains - no kerf...no drip...

And then a decade or two goes by...and we forget (**Photograph 3 and Photograph 4**)....no kerf...no drip... The good news is that it can get fixed easily...and was with a Skilsaw and a diamond blade (**Photograph 5**)...kerf added...yeah! Even better, the kerf is invisible. Historic folks can take a deep breath<sup>2</sup>...

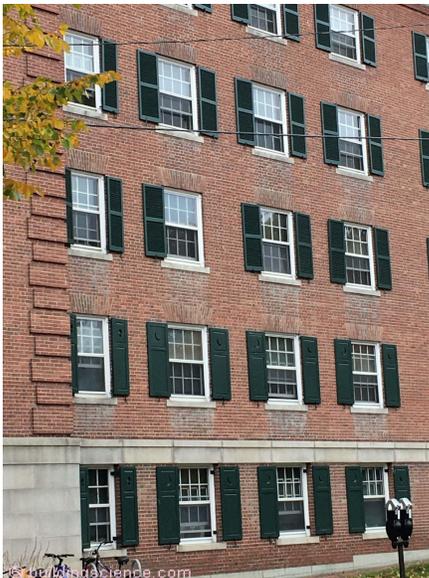
**Photograph 3:** Surface Tension Rainwater Stains - no kerf...no drip...

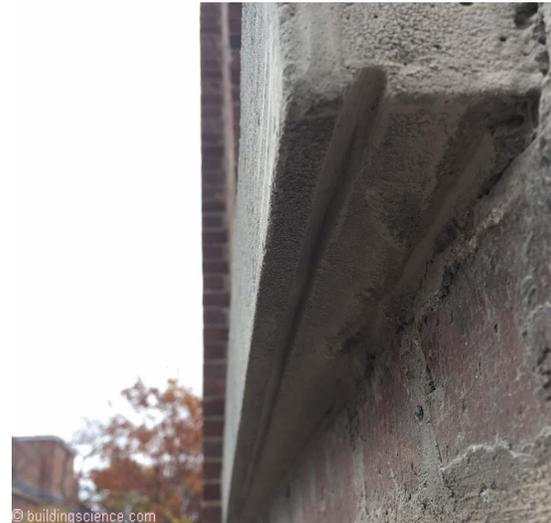
**Photograph 5:** Retrofitted Kerf – A kerf can easily be retrofitted with a Skilsaw and a diamond blade. Even better, the kerf is invisible.

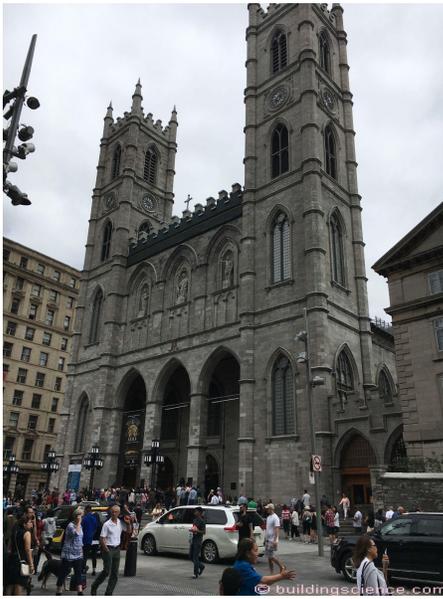
**Photograph 6:** Notre-Dame Basilica in Montreal - Look closely at the horizontal “bands”....they were supposed to act as “drip edges”...

Let’s go back 200 years....the Notre-Dame Basilica in Montreal (**Photograph 6**). Look closely at the horizontal “bands”....they were supposed to act as “drip edges”...but didn’t the first time out...so they got retrofitted with lead coated copper drips (**Photograph 7**).

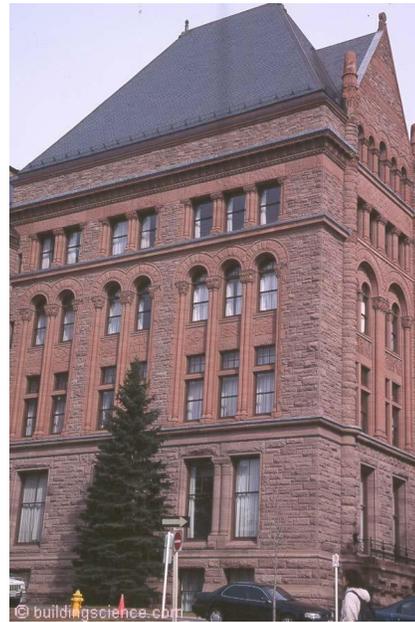
**Photograph 8:** Ontario Legislature Assembly - We got it wrong in Toronto on our Legislature Assembly a hundred years later and had to add drip edges.

Don't want to irritate the Quebecois too much...we Anglos got it wrong in Toronto in our Legislature Assembly a hundred years later and had to add drip edges (**Photograph 8**). Pretty sure a Quebecois sorted it out. We messed up the Canada Life Building in Toronto during the depression years...but fixed as well with retrofitted drip edges (**Photograph 9**).

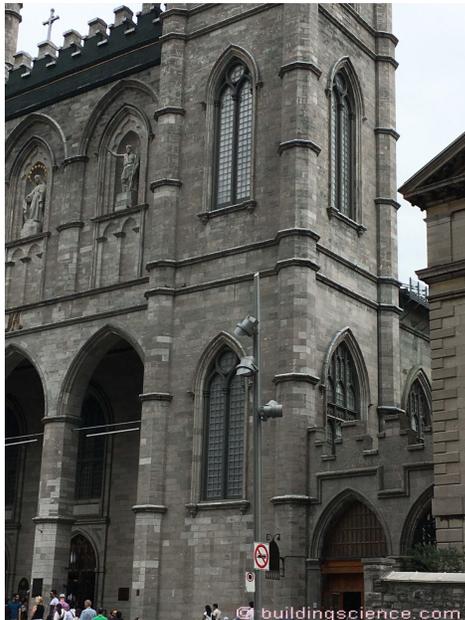
**Photograph 7:** Notre-Dame Basilica in Montreal – Deuxième partie – Original “drip edges” did not work...they got retrofitted with lead coated copper drips.

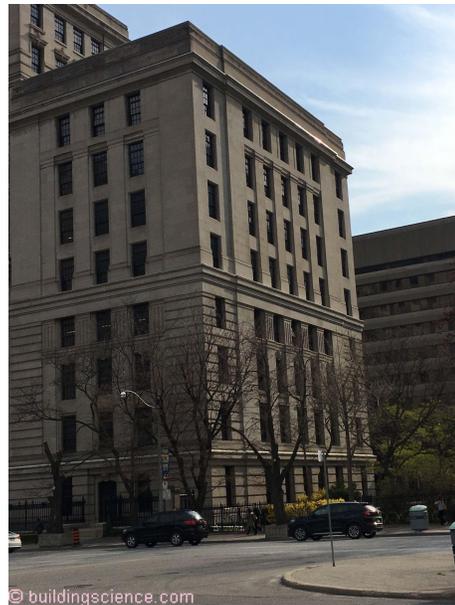
**Photograph 9:** Canada Life Building in Toronto - We messed up the building during the depression years...but fixed it with retrofitted drip edges.

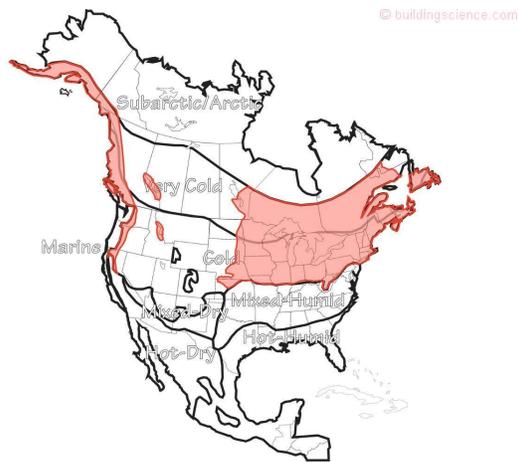
**Figure 2:** Map of Freeze-Thaw Risk – Freeze-thaw damage needs water and freezing temperatures. The greatest risk are regions with more than 20 inches of annual rainfall coupled with cold and very cold climates. The shaded area of the map combines rainfall with cold and very cold climates.

When we start retrofitting old wonderful mass buildings on the interior with insulation we significantly reduce energy flow and increase the risk of freeze-thaw damage in cold climates with lots of rain....more than 20 inches of annual rainfall (**Figure 2**).

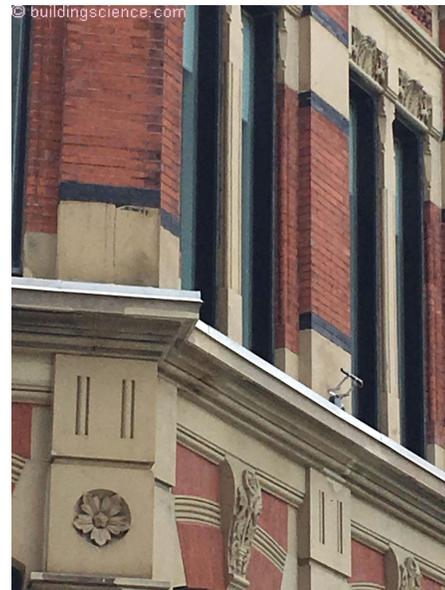
**Photograph 10:** Montreal Retrofits - Look at the retrofitted drip edges that are going hand-in-hand with the energy efficient window replacement and interior insulation.

Yes, if the rainwater is not concentrated and drips away...yeah!!! As much as I want to pick on folks from Montreal because the Habs keep beating my Leafs they have got it “sorted”<sup>3</sup>. Look at the retrofitted drip edges that are going hand-in-hand with the energy efficient window replacement and interior insulation (**Photograph 10**). And guess what? It has caught on in New Zealand (**Photograph 11**) and in Czechia (**Photograph 12**).

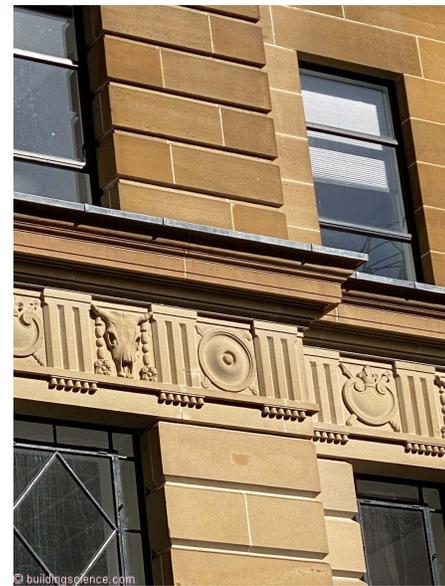
**Photograph 11:** New Zealand Retrofit Drip Edges – Wellington, New Zealand...they drive on the wrong side of the road...but they do know buildings...

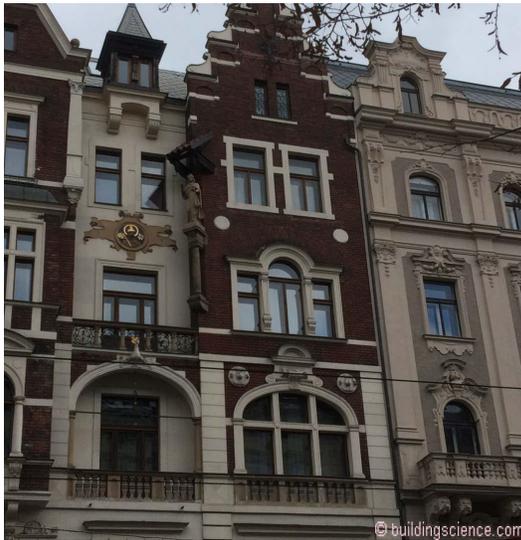
**Photograph 12:** Czech Republic – Lots of drip edges...no risk of freeze-thaw...

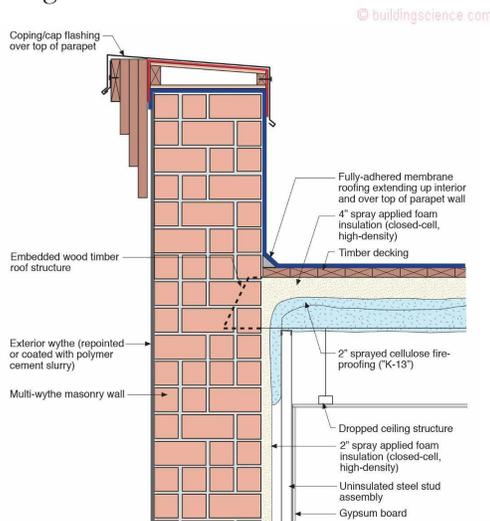
**Figure 3:** Parapet Coping Cap - Retrofitted “reversible” parapet coping cap with drip edges. Reversible means you can take it off and restore the “original” detail...even if it makes no sense to do so...except to make a historic statement...

Roof edges are a big deal. We have been retrofitting “reversible” parapet coping drips (**Figure 3 and Photograph 13**). Historic folks like the term “reversible” because they can “undo” whatever is done later. Of course, they shouldn’t because the “intervention” saves the building. The discussion often gets quite animated...we will leave it for later...with the understanding that “saving the building” is more important than “preserving a dumb detail”...

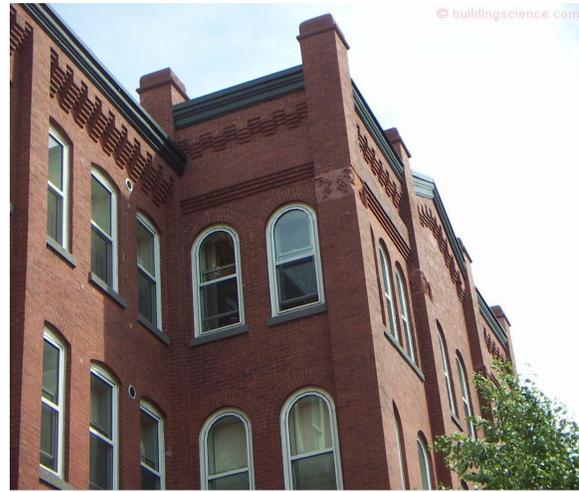
**Photograph 13:** Parapet Drip Edge - Retrofitted “reversible” parapet coping drips.

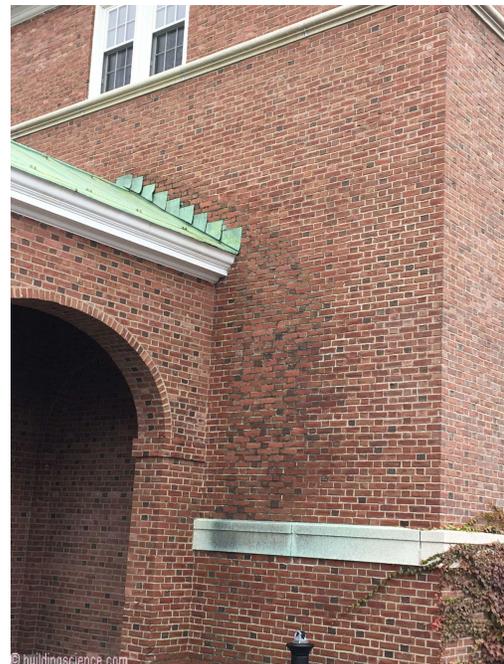
**Photograph 14:** Bad Detail - Dumping the roof rainwater runoff right on the wall is a bad idea.

Speaking of dumb details check out **Photograph 14**. Wow, dumping the roof rainwater runoff right on the wall. Ouch. Good news...got fixed...elegant fix that is pretty much invisible. A “minor” “kick out” with a “major” impact...a short diagonal metal roofing “ridge” directing water away from the roof/wall interface (**Photograph 15**).

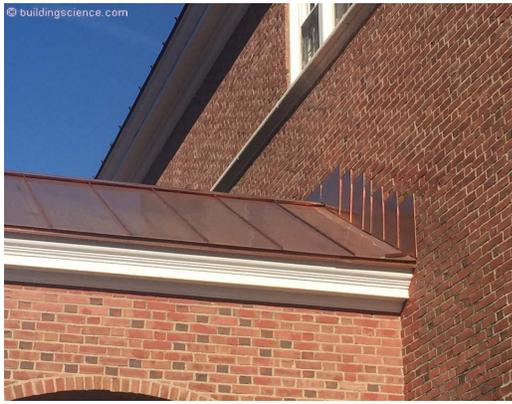
**Photograph 15:** Bad Detail Repaired - Elegant fix that is pretty much invisible. A “minor” “kick out” with a “major” impact...a short diagonal metal roofing “ridge” directing water away from the roof/wall interface.
