# National Grid Deep Energy Retrofit Pilot Program

## 1960s Garrison Colonial Comprehensive Retrofit

Milton, Massachusetts

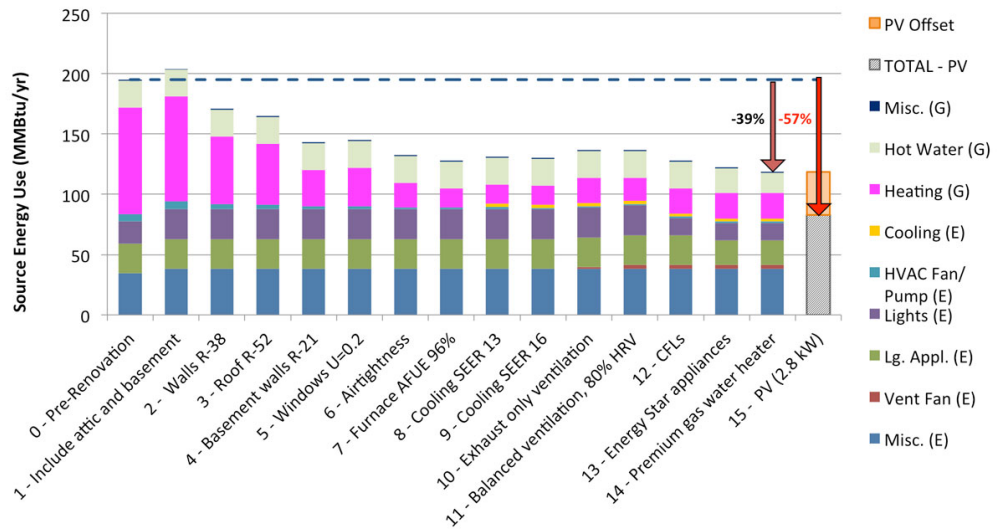
### PARAMETRIC STUDY

The design for this extensive renovation included super-insulation of the thermal enclosure and reconfiguration of the spaces within the thermal enclosure.

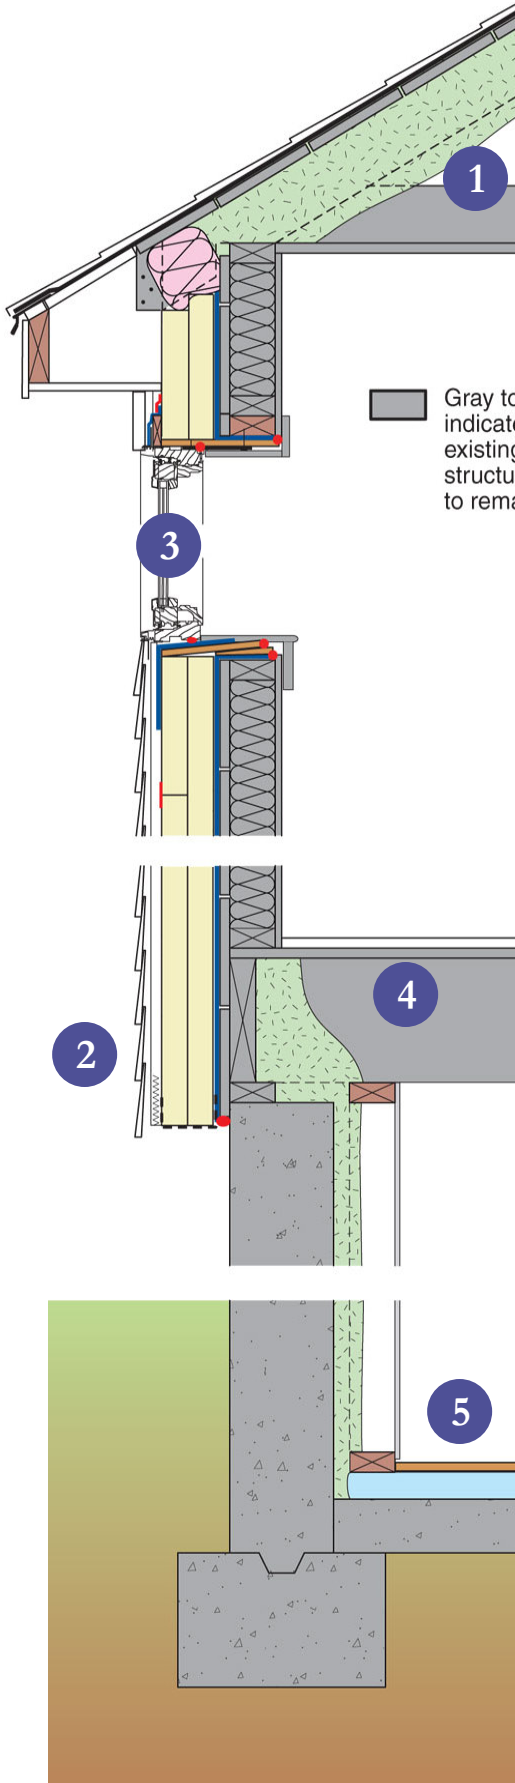
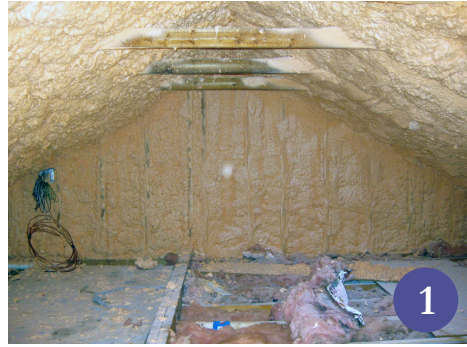
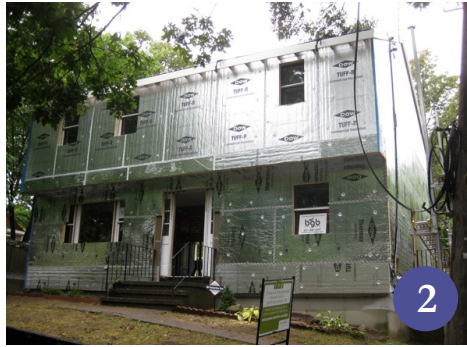
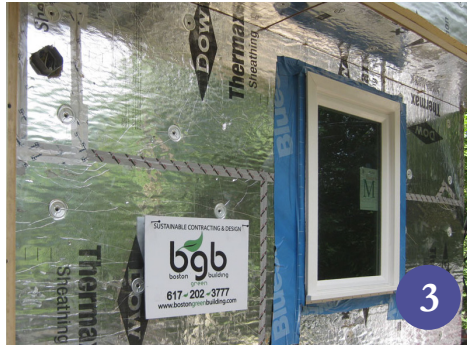
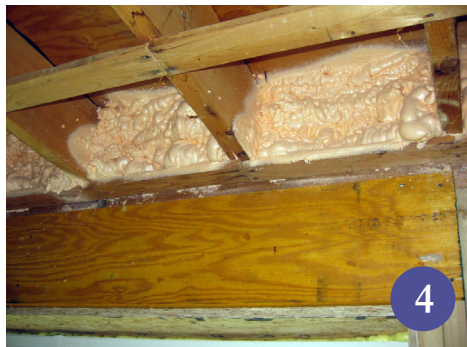
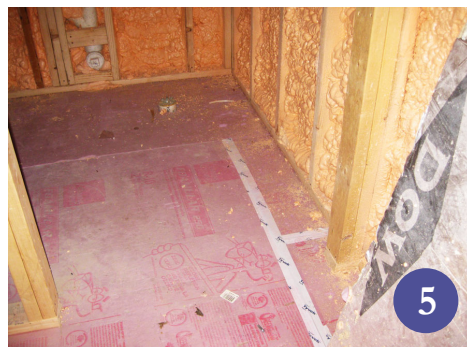
## ENCLOSURE DESIGN

**1 Roof Assembly:** R-56 (nominal) unvented roof: New asphalt shingle roof and underlayment over existing roof sheathing; rolled fiberglass batt as eave backstop for 8" of closed-cell spray foam between and over the existing 2x6 rafters.

**2 Wall Assembly:** R-38 (nominal): Fiber cement cladding installed over 1x3 wood furring strips; two layers of 2" polyisocyanurate exterior insulating sheathing; joints of foil-faced outer layer offset and taped; housewrap with joints lapped and seams taped applied over existing wall sheathing; existing 2x4 wall cavities with cellulose or existing fiberglass insulation.

**3 Window Specifications:** New EcoShield triple pane, low-E, argon fill, vinyl framed casement windows; U=0.21, SHGC=0.18; window installed proud of drainage plane on strapping.

**4 Infiltration:** Housewrap with joints lapped and seams taped under the taped outer layer of insulating sheathing on the wall is the air control layer for the field of the walls; closed-cell spray foam provides the air control layer for the foundation wall; the transition from the exterior wall air control to the foundation wall air control is through the top of the foundation wall and mudsill relying on a tight joint between the exterior sheathing and the mudsill and then the spray foam over the foundation wall extending up over the mudsill.

**5 Foundation Assembly:** Conditioned basement with closed-cell spray foam applied to existing foundation walls and partially embedding repositioned wood frame wall; 2" XPS rigid insulation with joints taped and perimeter embedded in wall spray foam over existing slab under floating floor; new sump pit added.

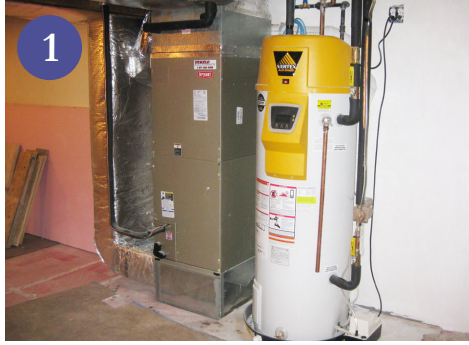
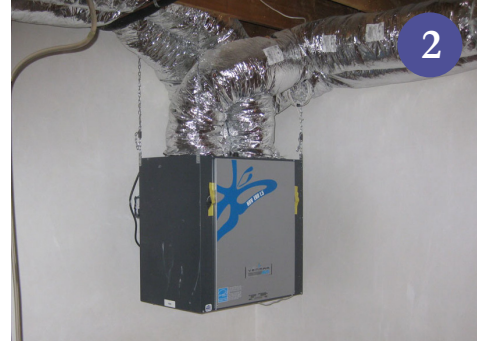
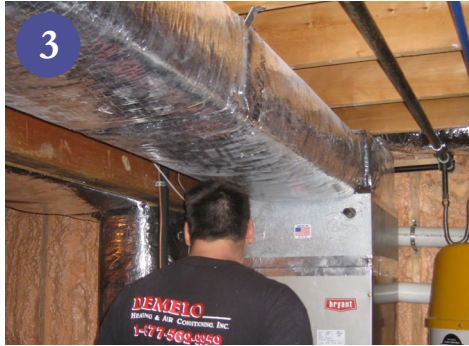
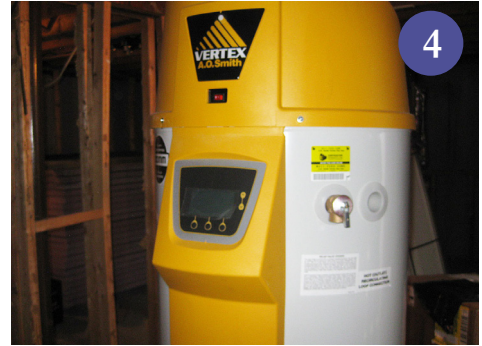
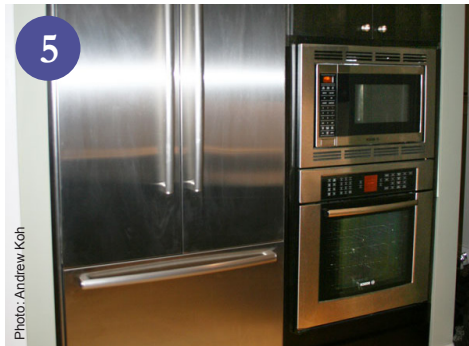
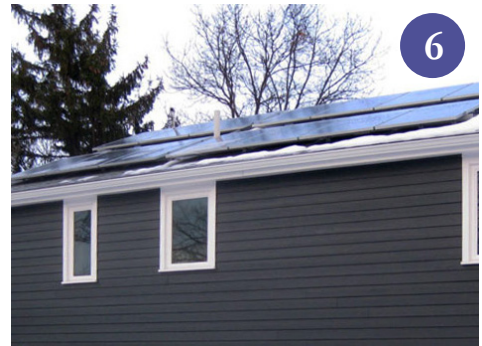
## MECHANICAL DESIGN

**1 Heating and Cooling:** Hydro-air heating with heating supplied by A.O. Smith Vertex™ high efficiency direct-fired storage water heater; central cooling with with 16 SEER/13.1 EER 2.5 ton AC

**2 Ventilation:** Venmar EKO 1.5 HRV system ducted to heating/cooling distribution system.

**3 Space Conditioning Distribution:** Entire distribution system within thermal enclosure.

**4 DHW:** A.O. Smith Vertex™ high efficiency direct-fired storage water heater.

**5 Appliances:** ENERGY STAR® dishwasher, refrigerator and clothes washer.

**6 Site Generated Power:** 2.8 kW PV array

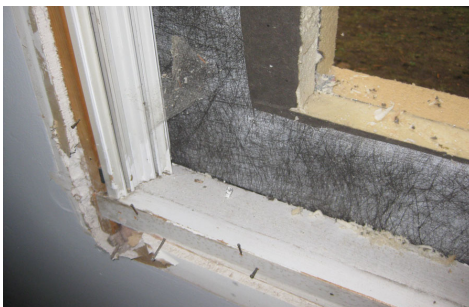
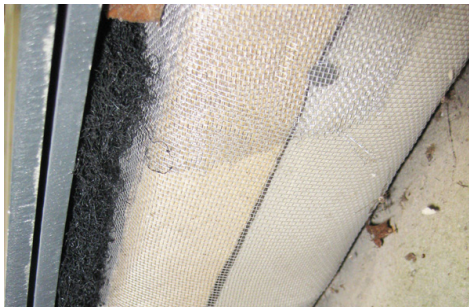
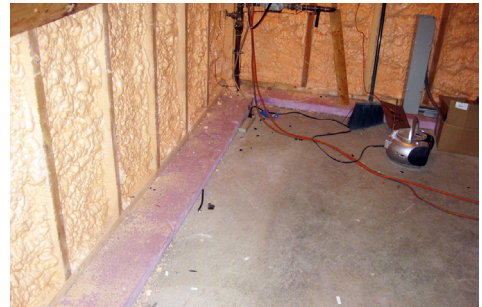
The builder installed the house wrap and exterior wall insulation before installing

the new windows in the existing openings. This sequence complicates the transition of the house wrap airflow control at the window. In this project, the exterior face of insulating sheathing was also detailed as an airflow control layer and may have had a more dominant airflow control role.

To protect the basement slab insulation from construction abuse, the builder installed just a 1' wide strip of insulation around the perimeter before re-installation

of the wood stud wall and application of spray foam at the foundation wall. This allowed for a continuous thermal and capillary break beneath the wood framing. The sequence also allowed the spray foam contractor to embed the floor insulation perimeter in spray foam for transition of airflow control. When the rest of the basement slab insulation was installed, it was a simple matter to seal it to the perimeter starter strip.

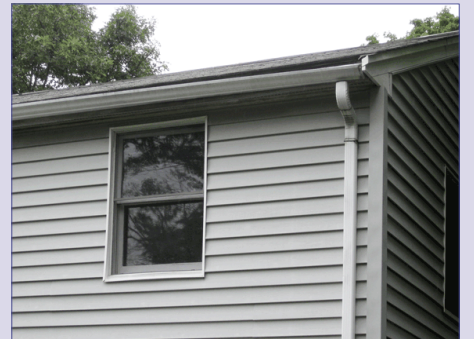
As is shown in the photograph of pre-retrofit conditions, the second floor window heads were already very close to the eave soffit (and the gable end overhangs were weak). Extending the eave overhang along the slope of the existing roof meant that the window heads actually had to be lowered to allow for some window trim above the second floor windows.

In retrospect, the design decision not to insulate over the roof represents a missed opportunity: exterior insulation and overclad in combination with a "chainsaw" approach would allow the soffit to stay at same height as existing or even go higher. An exterior insulation and overclad approach would also have allowed more insulation over the top plate of the wall and a more robust air flow control transition than is possible with the approach implemented.

For various reasons, the builder included a vented roof with air sealing and insulation at the attic floor in the DER design. To accommodate the additional wall thickness of 4" exterior foam and furring strips, the roof eaves were extended. Then, the roof was re-shingled.

Later in the project, when the homeowner decided to pursue an unvented roof with the attic inside the conditioned space, the only practical option was closed-cell spray foam installed to the underside of the roof deck.
