National Grid Deep Energy Retrofit Pilot Program

Comprehensive DER of Three-Family Triple Decker

Jamaica Plain, Massachusetts

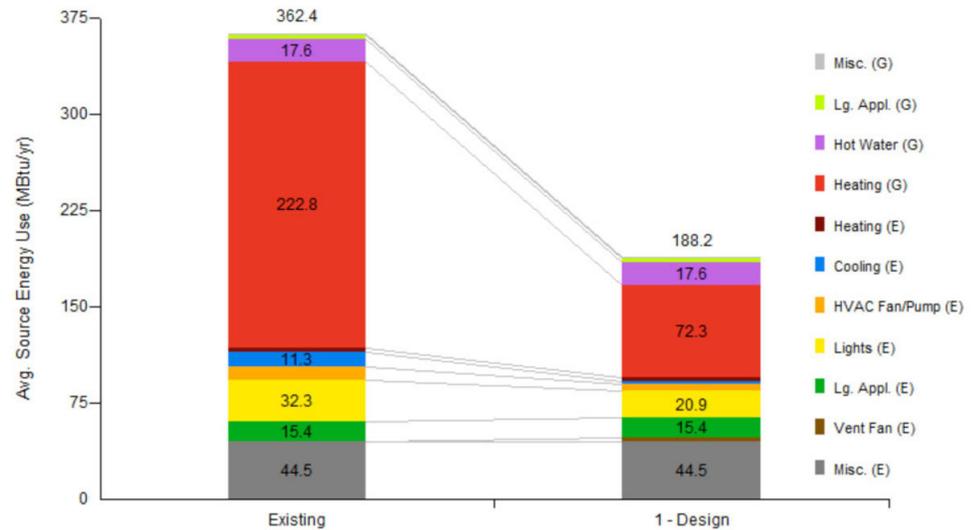
MODELED SOURCE ENERGY SAVINGS

Image from BSC generated by NREL's BEOpt 1.1 for retrofits

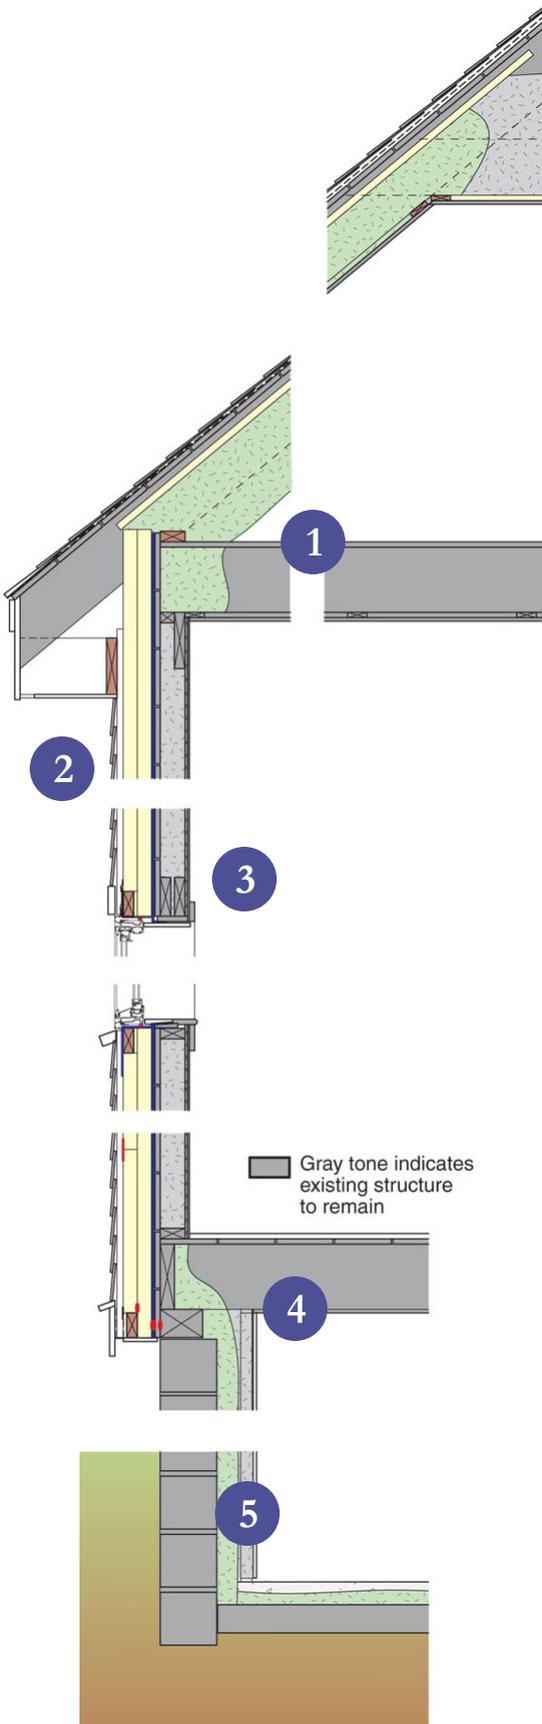
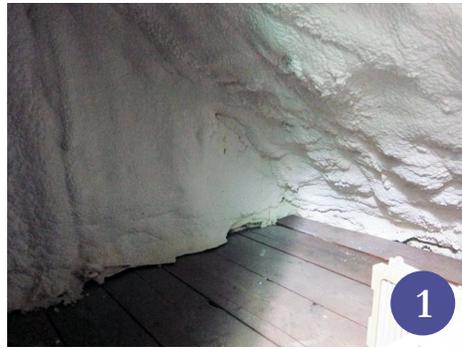
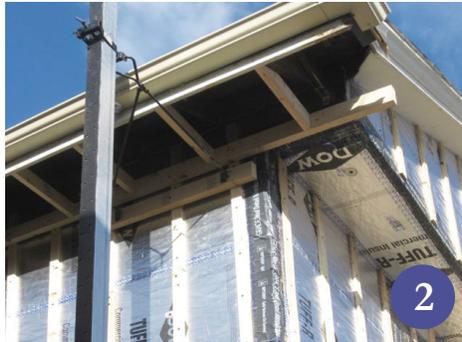
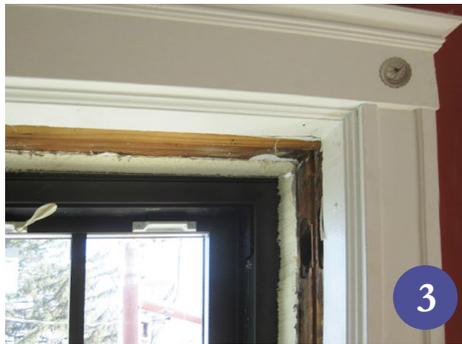
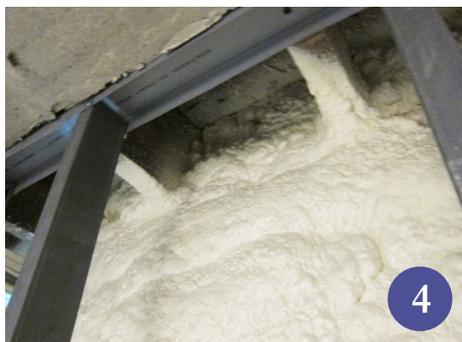
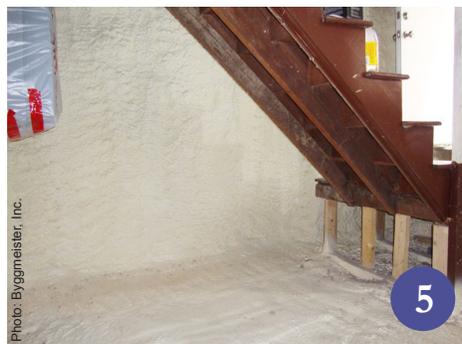
ENCLOSURE DESIGN

1 Roof Assembly: R-60 (nominal) vented attic: existing slate shingles, underlayment, and board sheathing; in knee wall and at sloped ceilings, 1" layer of polyisocyanurate rigid insulation between rafters, held away at least 1" from board sheathing, covered with closed-cell spray foam; attic above flat ceiling has deep layer of cellulose.

2 Wall Assembly: R-40 (nominal): Fiber cement cladding installed over 1x4 vertical furring strips; two 2" layers of foil-faced polyisocyanurate insulating sheathing; housewrap applied over existing board sheathing; existing wall cavities filled with blown-in cellulose where needed.

3 Window Specifications: New construction windows—525 series fiberglass Serious Windows: U=0.22, SHGC=0.20; installed in alignment with surface of outer layer of insulating sheathing.

4 Infiltration: Air barrier system is as follows: spray foam on basement floor, interior side of foundation walls, and interior side of rim joist; taped outer layer of insulating sheathing on exterior framed walls; spray foam under roof deck at knee wall and sloped ceiling; flat plaster ceiling in third floor unit; transitions between components made using spray foam and sealant.

5 Foundation Assembly: Conditioned basement with 2" closed-cell spray foam applied directly to stone foundation walls and finished with a metal stud framed perimeter wall; 2" closed-cell spray foam applied directly over existing concrete slab and covered with new 1 1/2" concrete slab.*

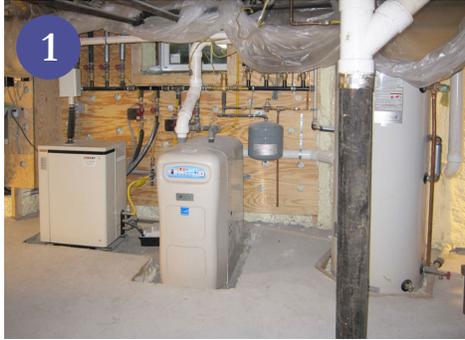
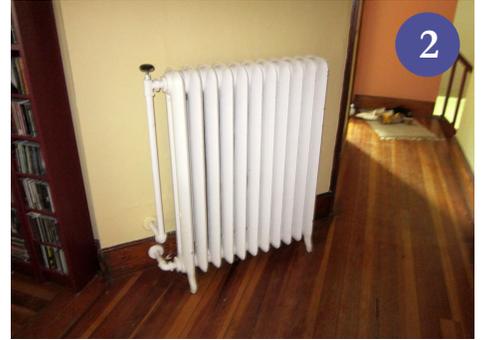
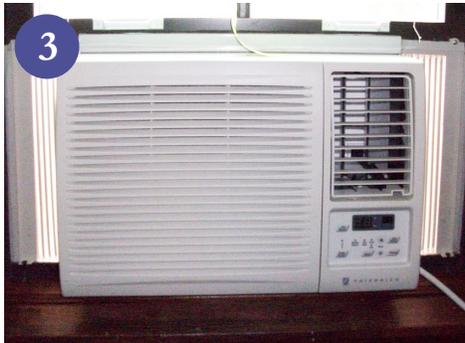
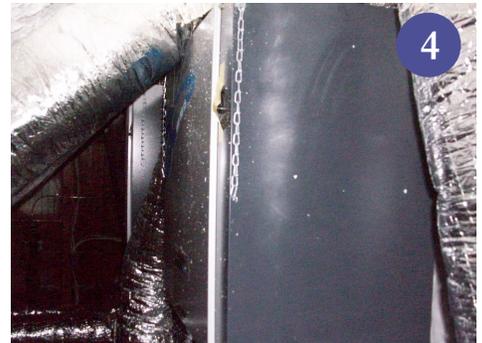
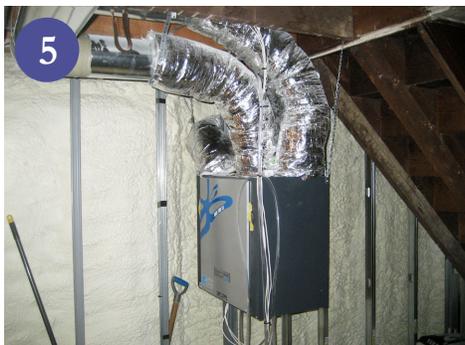
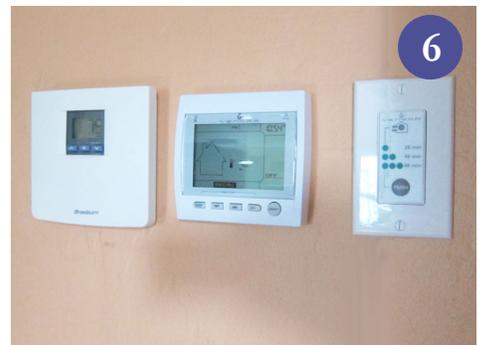
MECHANICAL DESIGN

1 2 Combined Heating and Power (CHP): Retained existing FreeWatt hydronic system that includes a CHP power module that provides electricity for two of the units, a natural gas closed combustion boiler that provides heating for all three units; this uses a pre-existing radiator distribution.

3 Cooling: New window air conditioners were provided with system of gaskets for sealing and easy installation/removal.

4 5 6 Ventilation: For each unit, a Venmar EKO 1.5 HRV (ECM motor and 80% recovery efficiency); outside supply ducted to common space; inside exhaust taken from bathroom; units for upper two floors installed in 3rd floor kneewall space; unit for 1st floor installed in basement.

1 DHW: The existing FreeWatt hydronic system includes an indirect hot water tank that provides hot water for all three units.

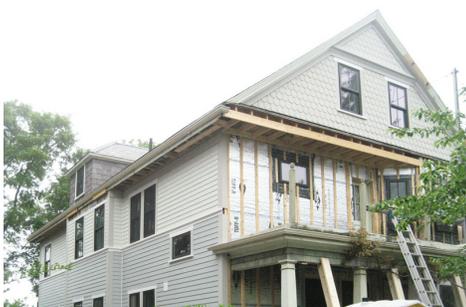
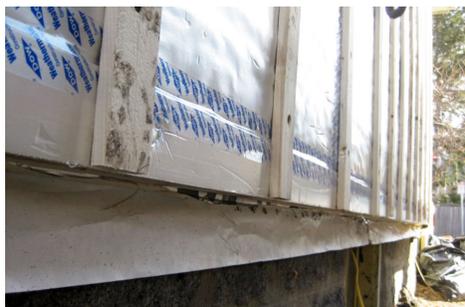
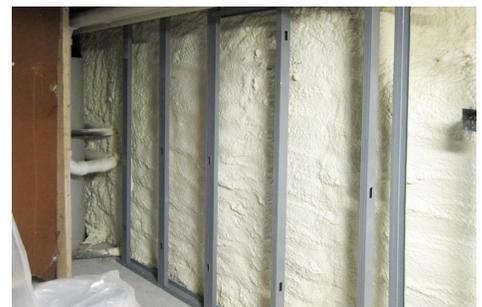
CONSTRUCTION

The construction process for the above grade walls of the house was fairly straightforward since the contractor was experienced with the installation of exterior insulating sheathing and the detailing required for the outer layer to be a drainage plane and part of the air barrier. Although the roof and overhangs were not modified in this retrofit, there were places where special handling was

required because the existing overhang was barely sufficient to cover the extra thickness of the retrofitted exterior wall.

To condition the basement, the contractor used a “bathtub” of spray foam created within the existing basement by applying the spray foam directly onto the existing walls and slab. The “bathtub” provides the thermal, air, water and vapor control layers for the basement. BSC recommended that XPS be used as the

underslab insulation instead of spray foam and that a water management system be incorporated by placing a drainage mat under the insulation. However, given that the contractor had previous success using the “bathtub” approach, could do this method at a lower cost, and noted that there was no history of water in the basement, the contractor chose to use the spray foam “bathtub” approach.

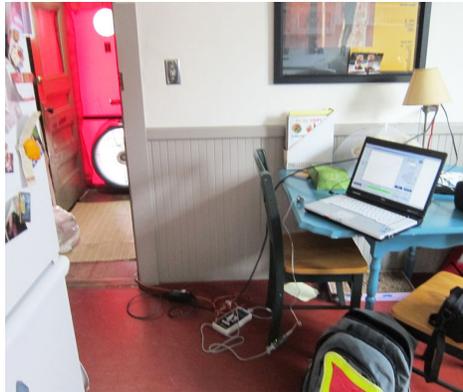
BSC performed blower door testing to determine the overall air tightness of the building before the retrofit started and after the retrofit was substantially complete. The test result was 7729 CFM50 for the entire enclosure (including the basement) before the retrofit. This corresponds to 11 ACH50. The post-retrofit result for the entire enclosure (including the basement and with window air conditioners installed)

was 1802 CFM50. This corresponds to 2.5 ACH50.

The National Grid DER goal for this project was 746 CFM50. To assess how much of the leakage was associated with the window air conditioners, another

test was run after sealing off the air conditioner units. This improved the results by only 114 CFM. Other places that are likely to be contributing to the air leakage include the transitions between air barrier components at attic, roof, and wall connections, especially where accessibility was an obstacle.

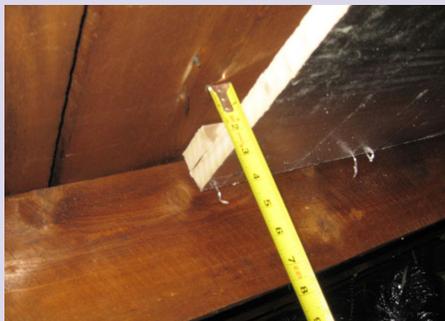
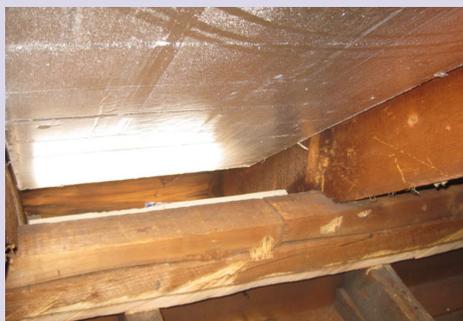
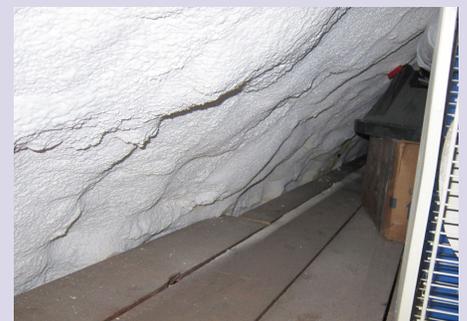
DESIGN CHALLENGE: DON'T TOUCH THAT SLATE ROOF!

One constraint for this project was that the slate roofing material was not to be removed. Since it could not be removed, this eliminated the option of adding insulation to the outside of the roof deck. It also meant that the water management layer under the roofing could not be inspected and, if necessary, improved.

Even a slate roof that is in good condition and has proper water management details is going to allow some water to get to the underlying board sheathing. This is not a problem provided the moisture can be absorbed into the board sheathing and redistributed enough to allow drying. For this project, in order to get an insulation value close to the National Grid DER goal of R-60 while insulating only from the inside, the rafter bays needed to be filled with closed-cell foam insulation in the knee wall and sloped ceiling spaces. However, closed-cell spray foam insulation applied directly to the underside of the board sheathing severely restricts the ability to dry because there is no air gap below the boards and the spray foam is vapor impermeable. For this reason, BSC does not recommend applying spray foam directly under the roof deck of an unvented roof where the water management system of the roof cannot be verified. A remedial measure was devised for the project by placing a 1" rigid polyisocyanurate board in each rafter bay held back from the board sheathing by at least 1". The air gap created under the sheathing supports redistribution and drying, provides a relatively high R-value, and served as the backer for the application of the closed-cell spray foam in the rafter bays.
