Vancouver Field Exposure Facility: Analysis and Comparison of HardiePlank Walls

Research Report - 1306

17 May 2013

Jonathan Smegal

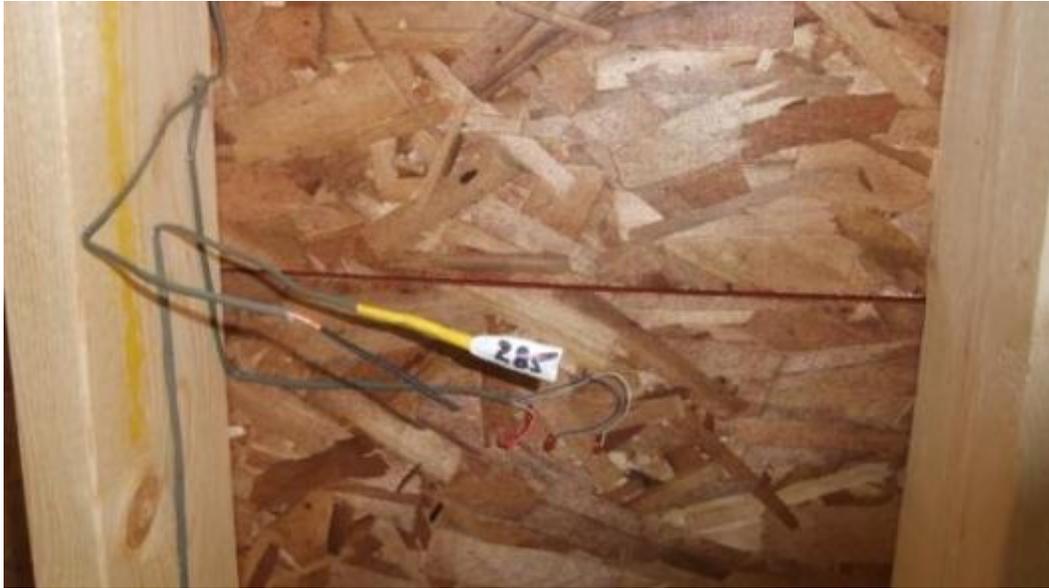
Figure 4 : Relative Humidity and temperature sensor installed in a stud bay (with moisture content pins installed below).

Relative humidity sensors were installed in the middle of each stud cavity, and in the drainage space of each wall. The relative humidity sensor was always installed in combination with a temperature sensor, both of which are protected by a vapor permeable, water resistant cover (see Figure 4). Relative humidity and temperature sensors were installed at the midpoint of the stud space, between the drywall and the sheathing, as well as some exterior drainage cavities.

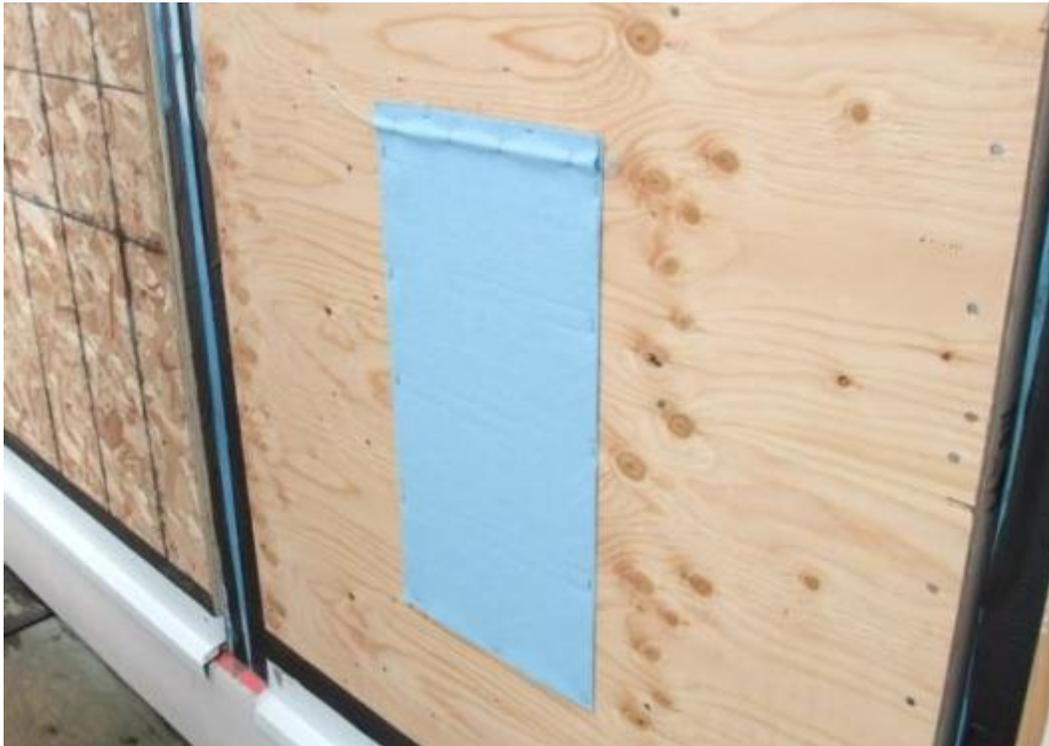
Figure 6 : Exterior wetting apparatus

A wetting apparatus was installed on both the interior and exterior of the sheathing of each of the test walls to allow a known amount of water to be injected at a controlled time and location. The wetting apparatus consisted of a storage media installed directly against the interior and exterior surface of the sheathing (Figure 6), with a perforated tube connecting each of the storage media to the interior of the test hut for access for water injections. This enables wetting to either the interior or exterior independently without opening and disturbing the wall system. The wetting system is designed to simulate a window leak, and can be used to help determine the drying potential of a wall system. A photograph of an exterior installed wetting apparatus is shown in Figure 6. On the analysis graphs the exterior wetting events are indicated by red vertical dashed lines, the interior wetting events are indicated by blue vertical dashed lines. When an intentional wetting event occurred repeatedly over multiple days, only one line is shown indicating the first wetting. There were five intentional wetting events as shown in Table 1. For each wetting event, 1.5 oz (45 mL) was injected twice a day for five days. This is a total of 15oz (~450mL) into the wetting apparatus directly against the sheathing. For the entire test period 60 oz (~1.8L) was injected against the exterior of the sheathing, and 15oz (~450mL) was injected against the interior surface of the sheathing.

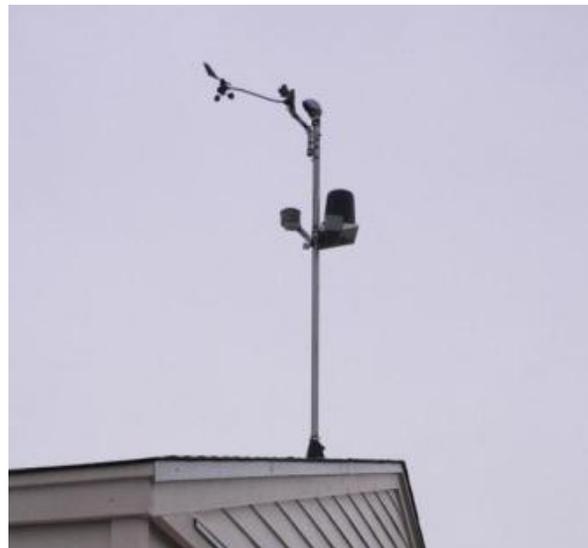
Figure 7 : Weather station on the roof of the Coquitlam Test Hut

To monitor the exterior weather conditions, a steel mast on the roof of the test facility supports a weather station at a height of 22 ft above the roof of the office building and 50 ft above ground level. The monitoring system continuously collects weather data including: temperature, relative humidity, wind speed and direction, rainfall, and solar energy. A photograph of the installed weather station is shown in Figure 7. It is important to have on-site weather information for comparison and correlation purposes with the data.

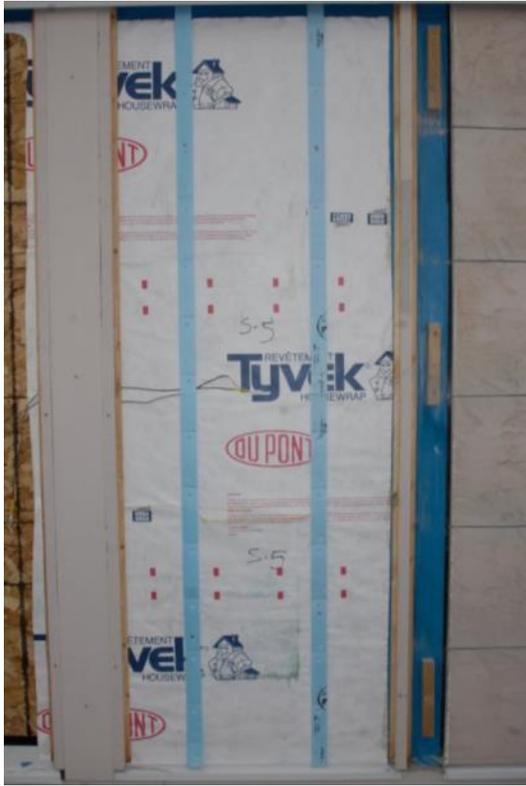
Figure 16 :3/8” XPS strips installed over sheathing membrane behind HardiePlank

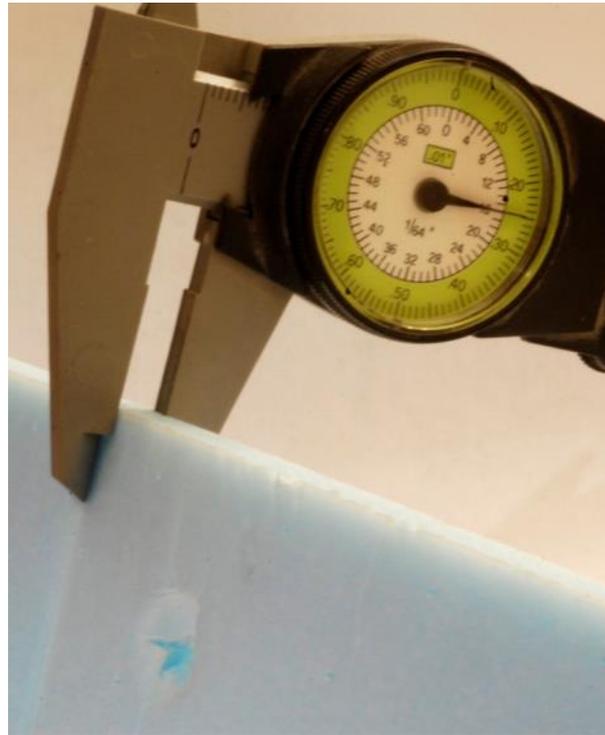
Figure 17 : Measured gap at permanently compressed portion of Dow HPU Layflat Insulation

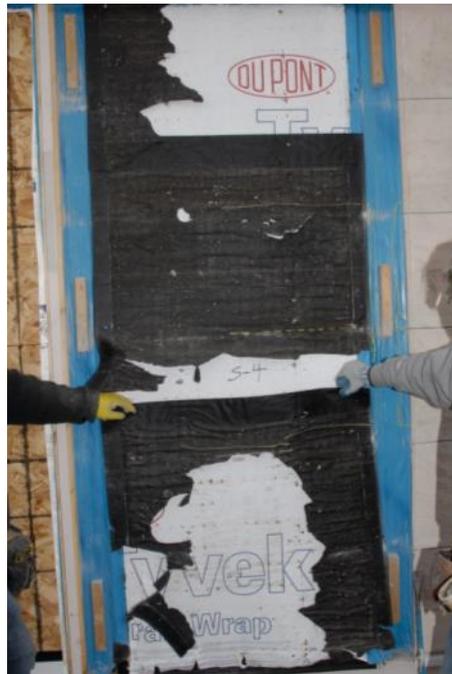
Figure 18 : Wall 4 - Deconstruction showing building paper over DrainWrap

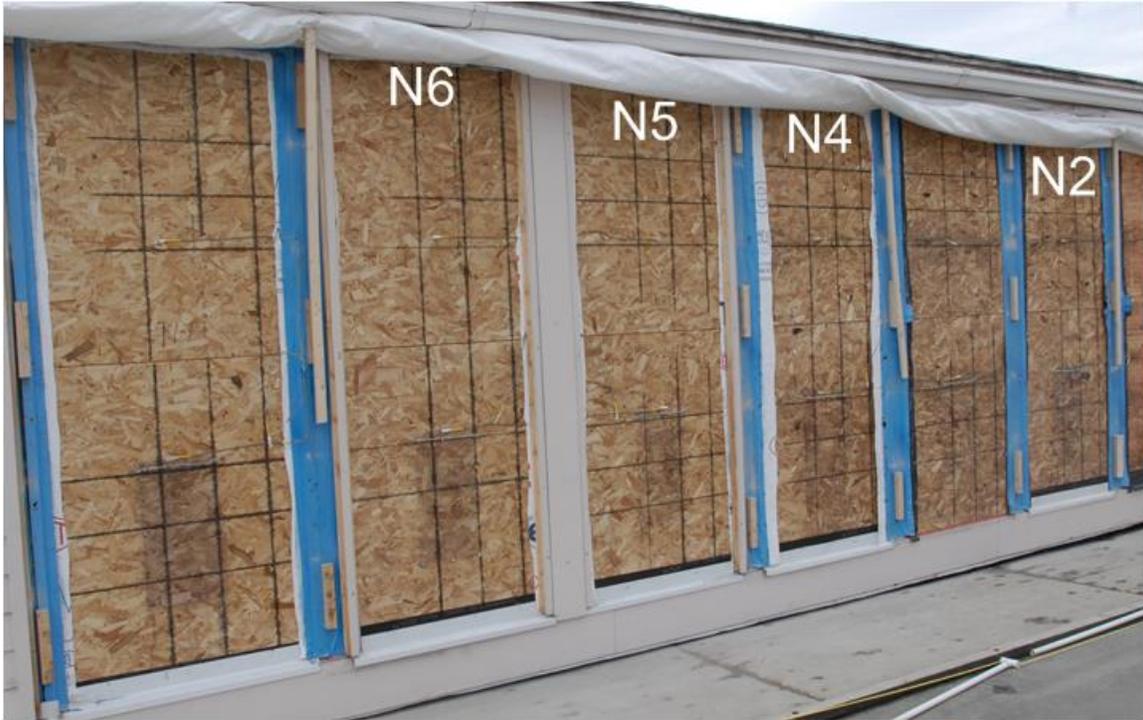
On the North orientation, the exterior of the OSB on Wall 2 was quite dark and stained, particularly in the vicinity of the wetting apparatus (Figure 35 and Figure 36). Wall 4 appeared marginally better and not quite as dark over the entire surface as expected. The sheathing of Wall 5 and Wall 6 was in very good condition when visually inspected. These walls had less staining around the wetting system, indicating faster drying rates, and water was not held in contact with the sheathing as long.

Figure 35 : Exterior OSB sheathing on the North orientation immediately following deconstruction

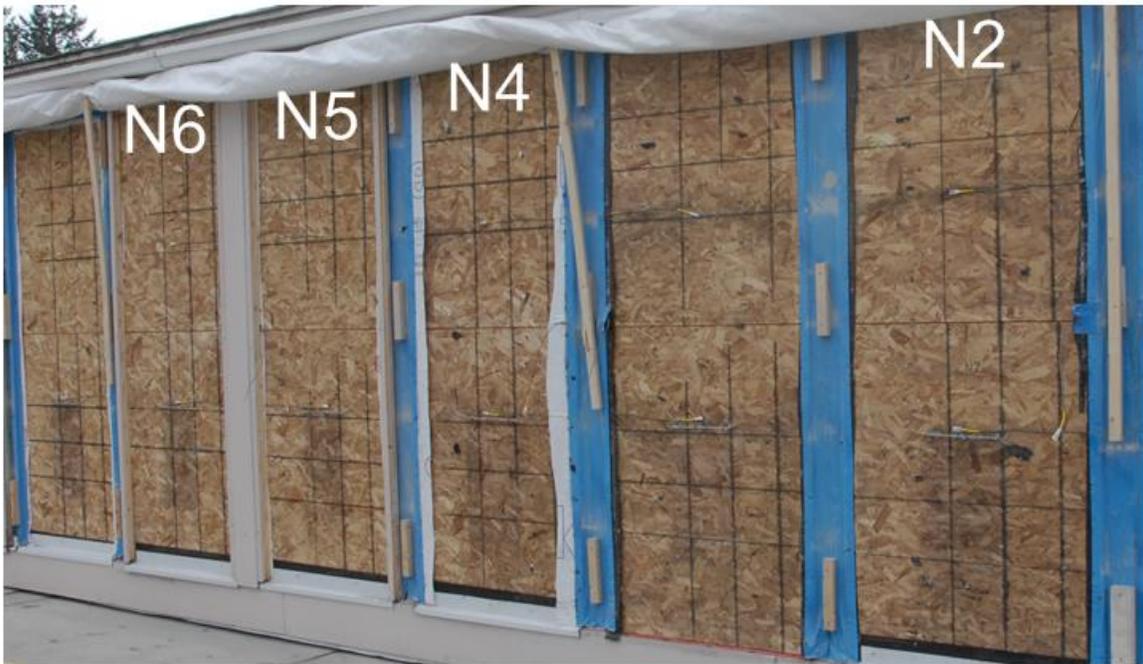
Figure 36 : Exterior OSB sheathing on the North orientation immediately following deconstruction (photo taken from the opposite direction of Figure 35)

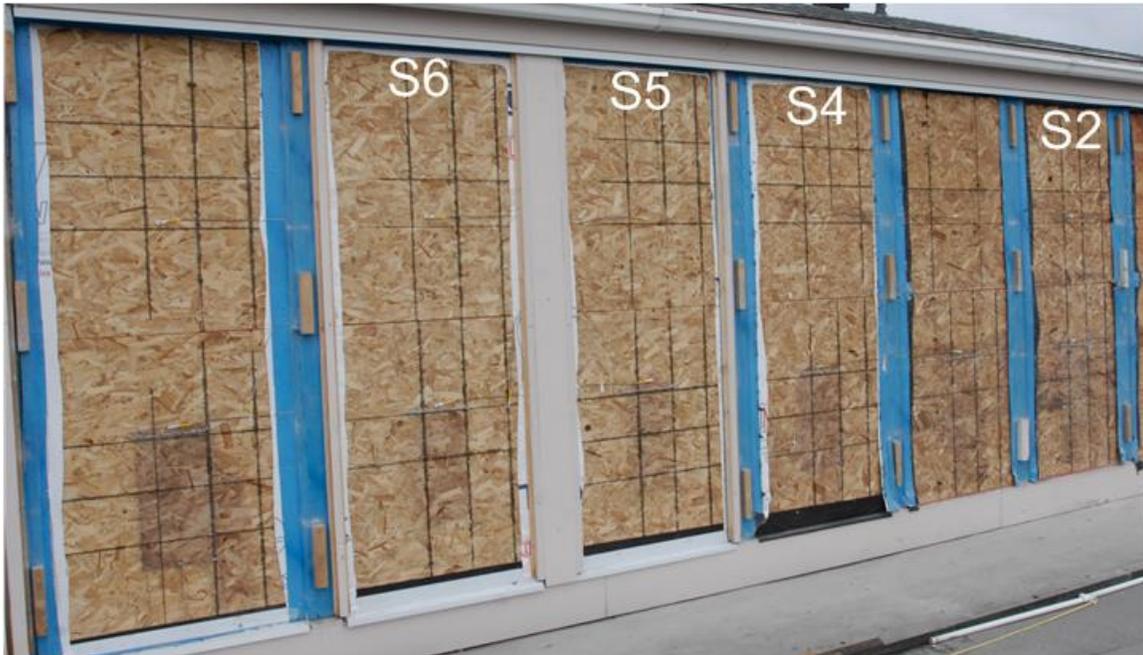
The exterior surface of the OSB on South Wall 2 with interior poly and a stucco cladding applied to only one layer of building paper is clearly the darkest and most stained of the three comparison walls (Figure 37). Wall 4 showed less moisture related staining on the South orientation than on the North orientation, but was still darker and more stained than both Walls 5 and 6.

There was some staining in the vicinity of the wetting apparatus on both Walls 5 and 6, but overall, the exterior surface of the sheathing showed no signs of moisture related damage, and looked as good as new OSB often looks on a construction site.

Figure 37 : Exterior OSB sheathing on the South orientation immediately following deconstruction
