Multifamily Ventilation Retrofit Strategies

Building America Report - 1209

K. Ueno, J. Lstiburek, and D. Bergey
Building Science Corporation

December 2012

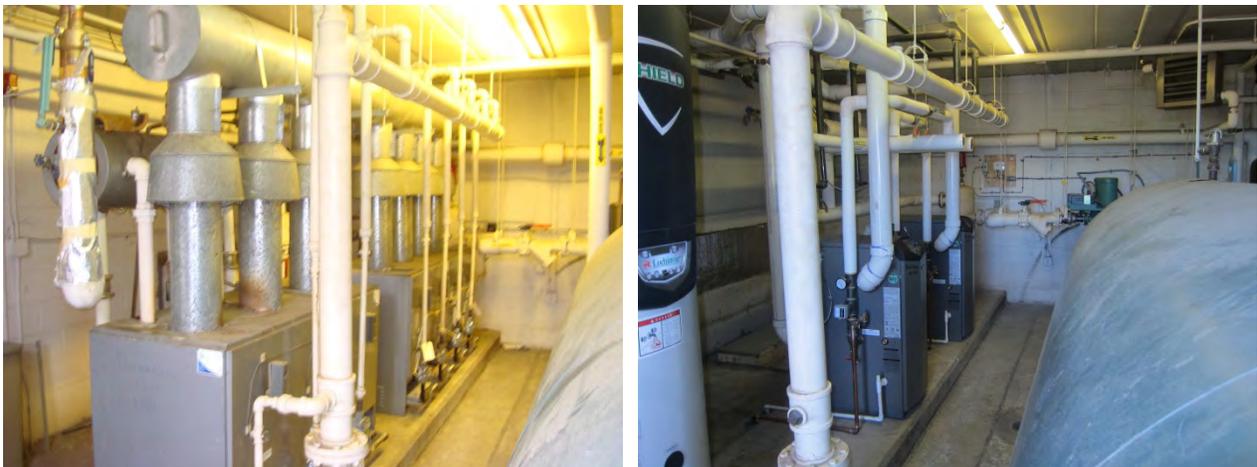
Figure 8. Replacement of atmospheric boilers (L) with condensing sealed-combustion boilers (R)

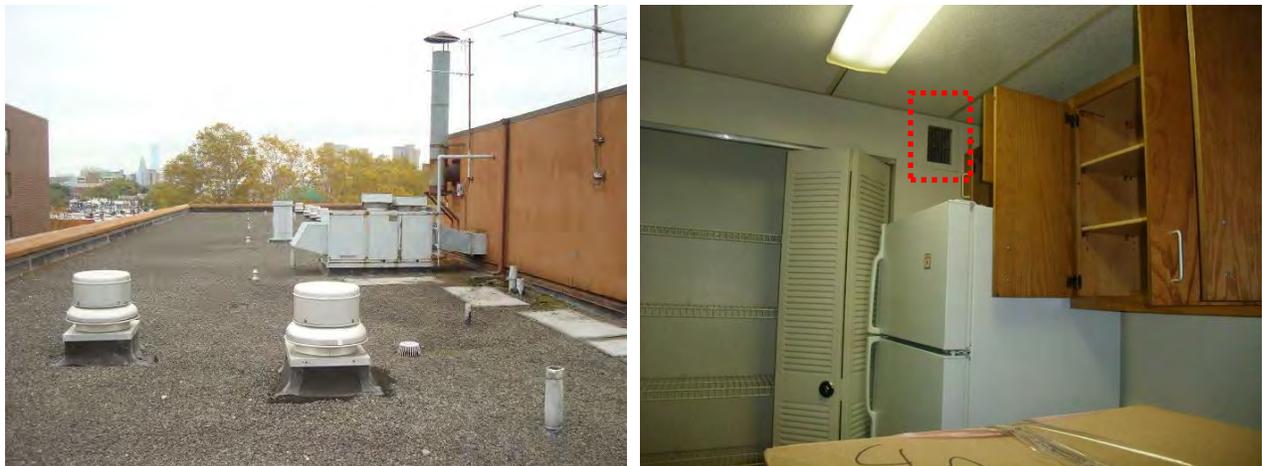
Figure 15. Rooftop ventilation system components (L) typical kitchen exhaust grille (R)

The kitchens are exhausted via a wall register (Figure 15); no separate range-top hood is installed (e.g., recirculating hood for grease capture).

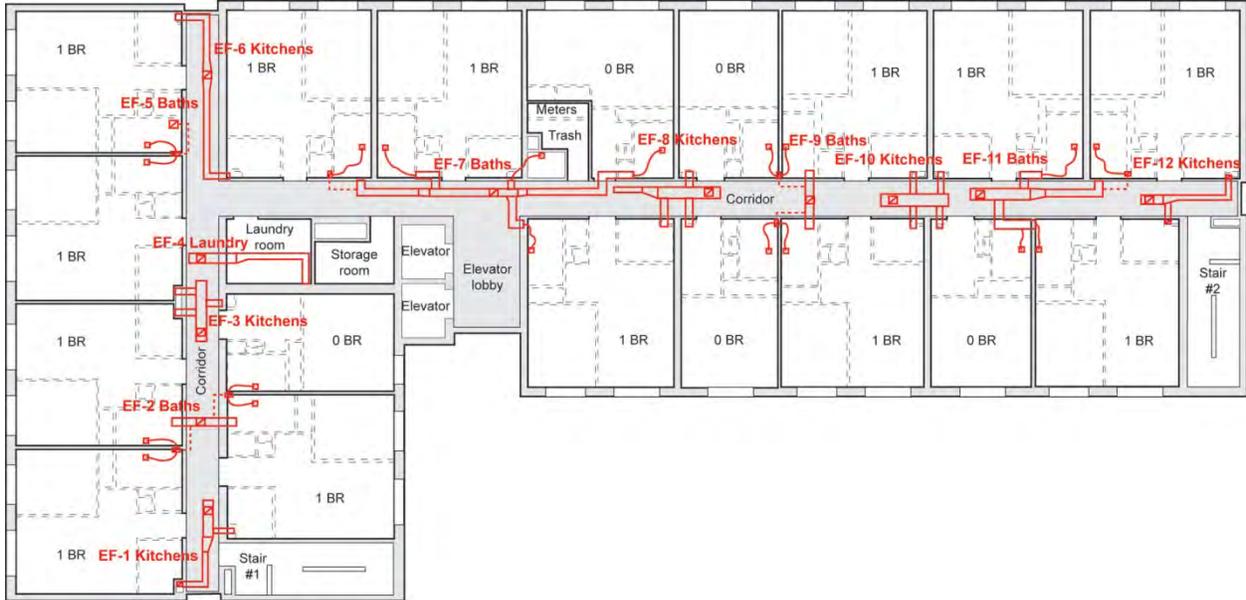
Figure 16. Typical floor plan, showing kitchen/bath exhaust systems and risers

A given shaft/fan handles only kitchen exhausts or bathroom exhausts; the two types of exhausts are not mixed in any shaft (see Figure 16).

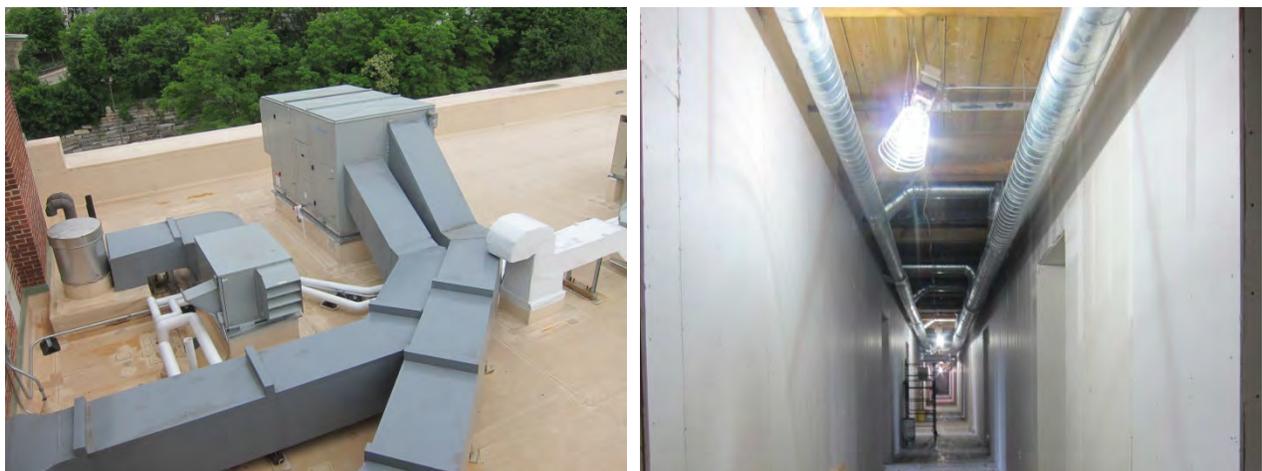
Figure 20. Rooftop HRV, with supply/exhaust ducts (L); supply and exhaust ductwork in corridor (R)

A central HRV system can deliver excellent performance (with some caveats); however, it requires a fully ducted supply and exhaust system that connects each apartment unit to the rooftop unit (see Figure 20). Retrofitting a second set of ductwork into an existing building is typically not feasible in terms of cost. The representative images of a central HRV system in Figure 20 are from a different project (not the current Innova work).

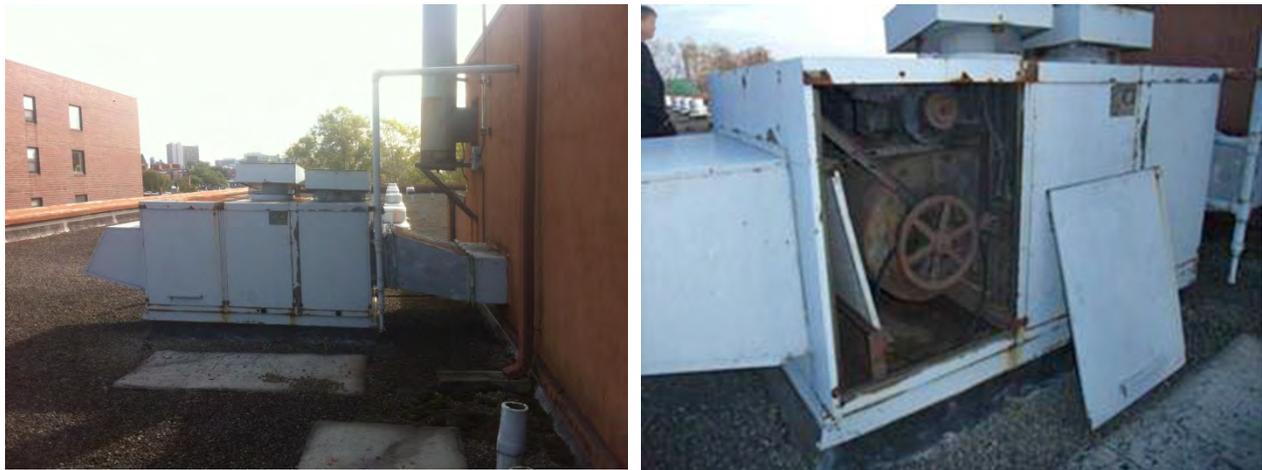
Figure 22. Nonoperational rooftop MAU

Existing rooftop make-up air unit has been disabled for approximately two years, resulting in poor indoor air quality and a fire safety hazard due to depressurization. (Innova 2011)

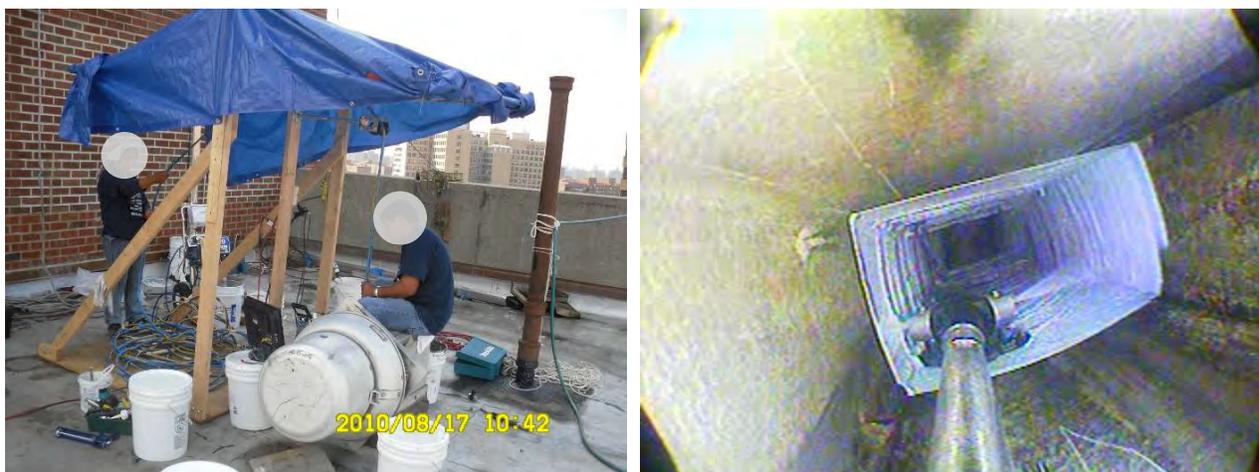
Figure 25. Remote shaft-sealing spray mastic system
(Photo from Consolidated Environmental, Inc.)

One option for air sealing is a remote shaft spray mastic system, developed by Consolidated Environmental, Inc., and shown in Figure 25. A segmented pole is lowered down through the rooftop fan opening; a remote camera allows inspection of the exhaust shaft for seams and penetrations. Targeted retrofit sealing is accomplished using spray-applied mastic, as shown in Figure 25 (right)

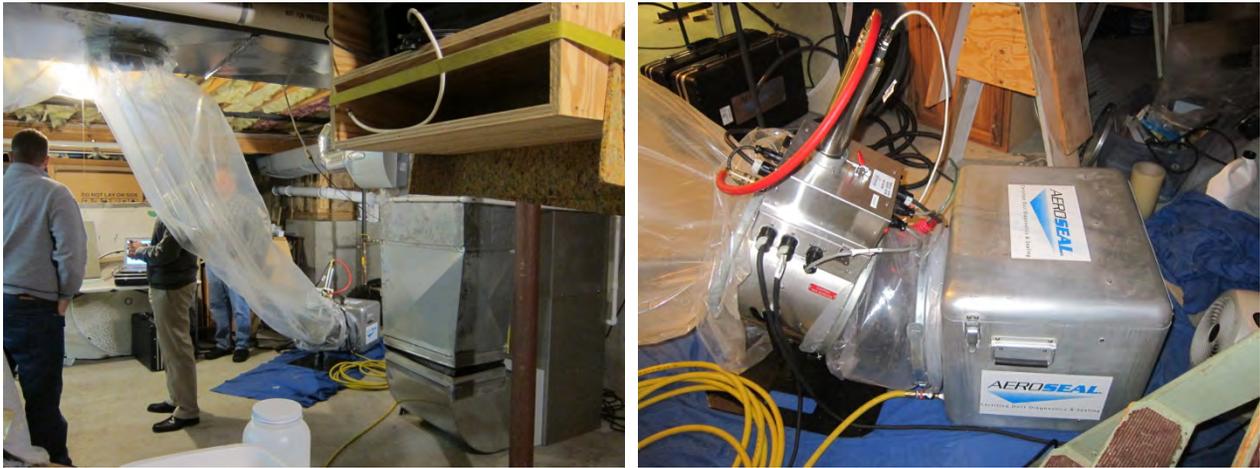
Figure 26. Aerosol duct sealing of residential HVAC system (L); with close-up of equipment (R)

An alternate duct sealing solution is the use of a commercially available aerosol-based duct sealing system, as described by Modera et al. (1996). This technique involves the injection of a fine aerosol spray of a vinyl-acetate (water-based) polymer that preferentially deposits on leakage locations (see Figure 26). The manufacturer furnishes studies showing significant reductions in exhaust shaft leakage (from 326 cfm 25 to 12 cfm 25 in a Boston-area study). Zuluaga and Fitzgerald (2010) present results showing a reduction from 220 cfm 25 to 19 cfm 25 in one building, and from 1,606 cfm 25 to 30 cfm 25 in another building. These results essentially tighten the ducts enough that leakage is close to insignificant.

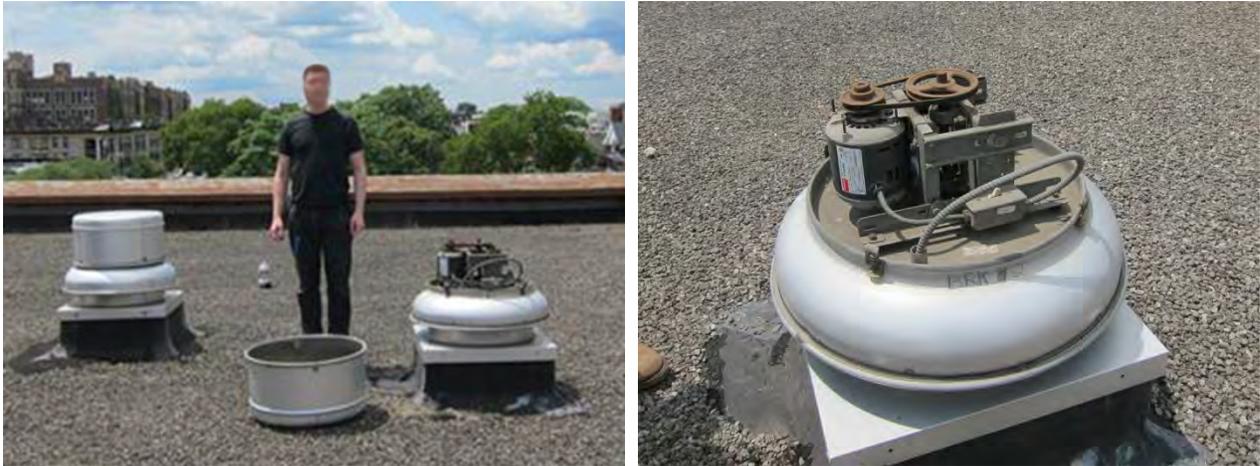
Figure 27. Typical rooftop exhaust units (L); cover removed from exhaust fan (R)

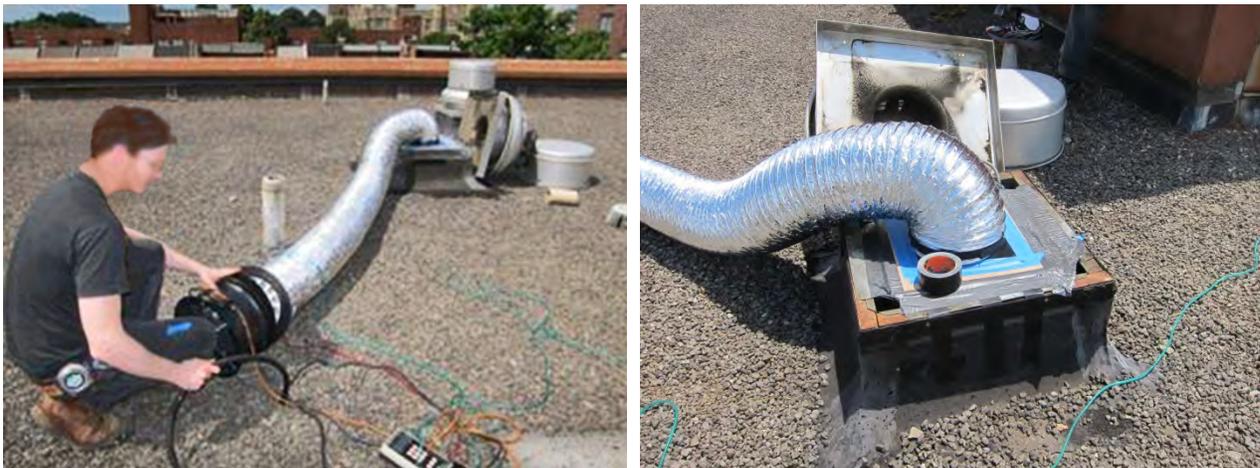
Figure 28. Air leakage testing of exhaust fan (EF) shaft 5 (EF-5)

The exhaust shafts were then tested for air leakage, using fan depressurization and pressurization testing from the roof curb (Figure 28).

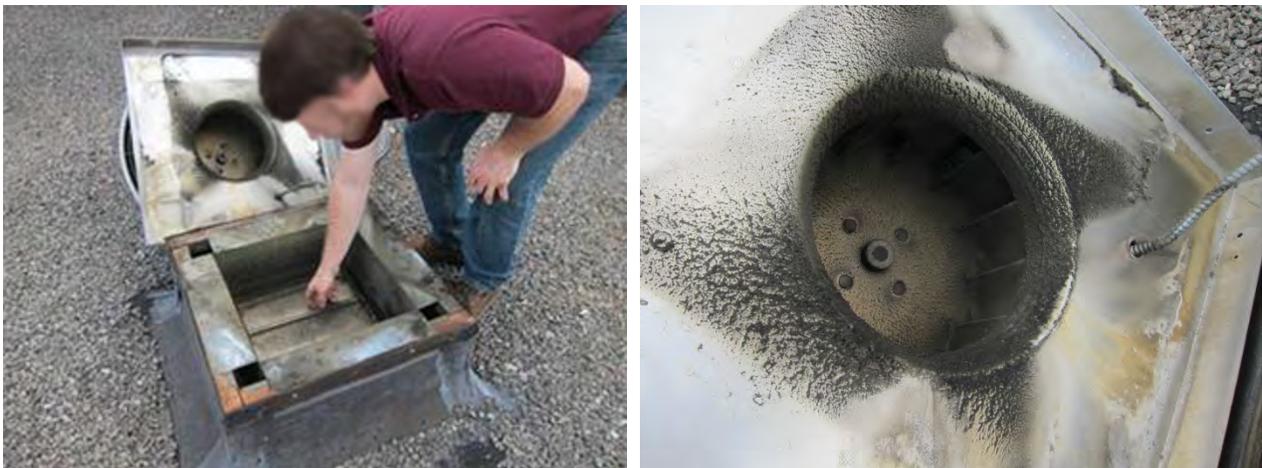
Figure 29. Open corners at exhaust shaft rooftop curb (L), with dust marking patterns (R)

One shortcoming of the testing of EF-1 was that the installation of the connection plate (corrugated cardboard) covered the void spaces between the roof curb and the sheet metal duct; these voids or open corners are shown in Figure 29. As the dust marking patterns show, airflow from these corners influences airflow into the fan, reflecting the fact that leakage occurs in operation. Therefore, the measurement at EF-1 must account for this additional duct leakage. Given that the relative flexible cardboard was pulled flat against the open corners in depressurization testing, though, this leakage may be smaller than the physical size of these holes would suggest. EF-5 was tested with the connection solely to the metal duct (Figure 28).

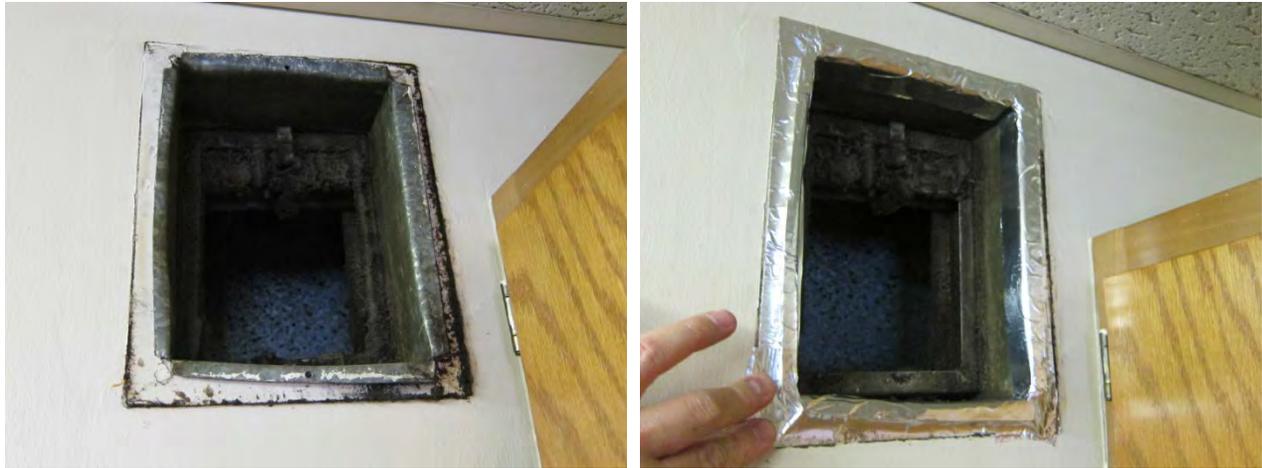
Figure 30. Kitchen exhaust boot-to-drywall as found (L) and retrofit seal (R) state

Significant leakage was noted around the duct boot attachment through gypsum board (similar to observations by Zuluaga and Fitzgerald [2010]); air leakage is evidenced by the dust deposition under the sheet metal register outline (see Figure 30, left). The junction from the sheet metal to drywall was sealed with foil tape (see Figure 30, right), and the shafts were retested.

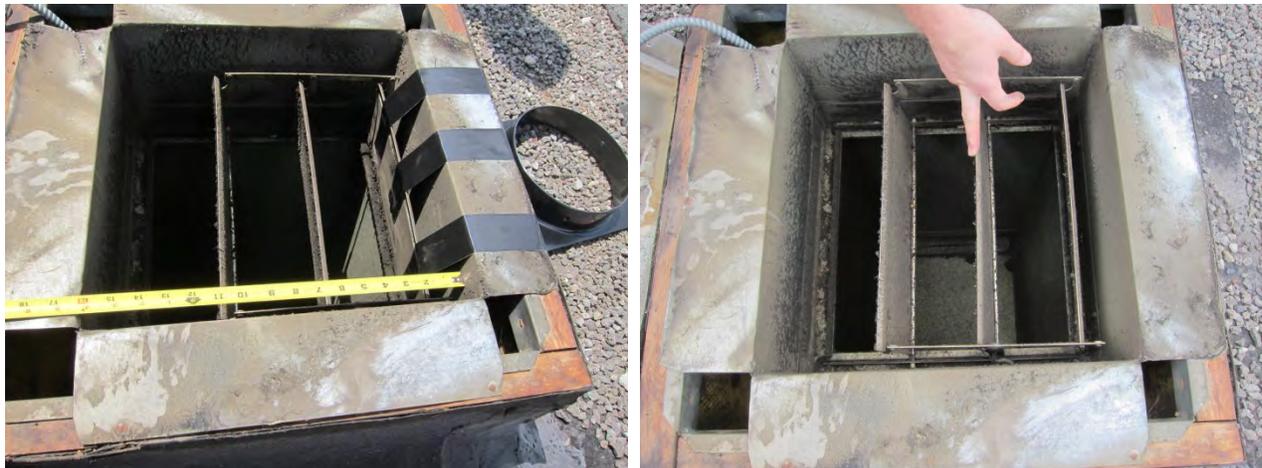
Figure 31. Spring-loaded louvers on exhaust fan rooftop curb blocked open at EF-1 testing

The flow versus depressurization curve obtained at EF-5 demonstrated that the louvers were closing incrementally as the multipoint fan depressurization dropped from 60 Pa to 25 Pa. As a result, multipoint testing from this shaft was ignored and only the highest pressure was used, assuming that the louvers were at their most open position at this test point.

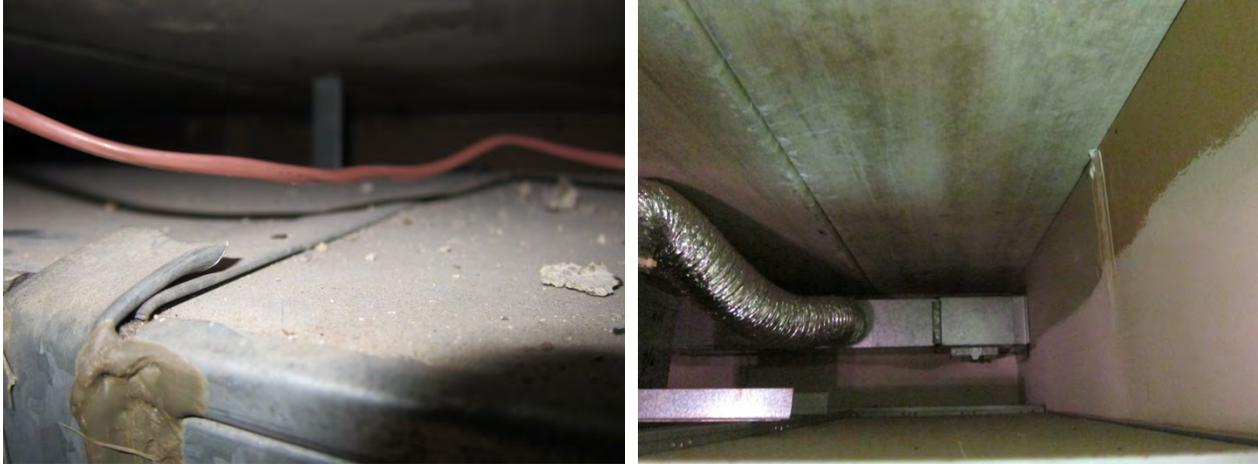
Figure 33. Limited mastic sealing at sheet metal joints (L); connection to flex runouts (R)

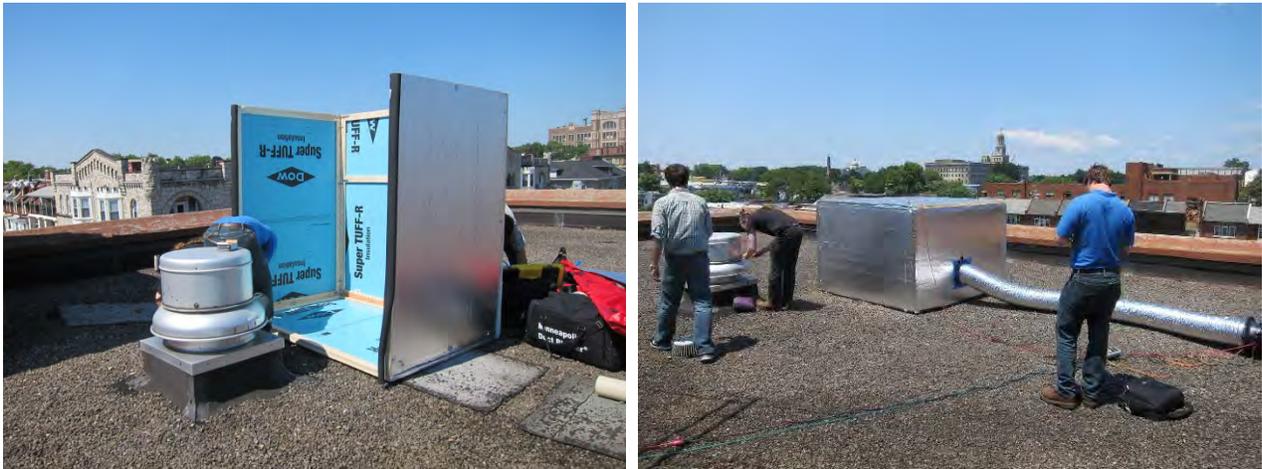
Figure 34. Powered flow capture enclosure for rooftop exhaust fans showing construction

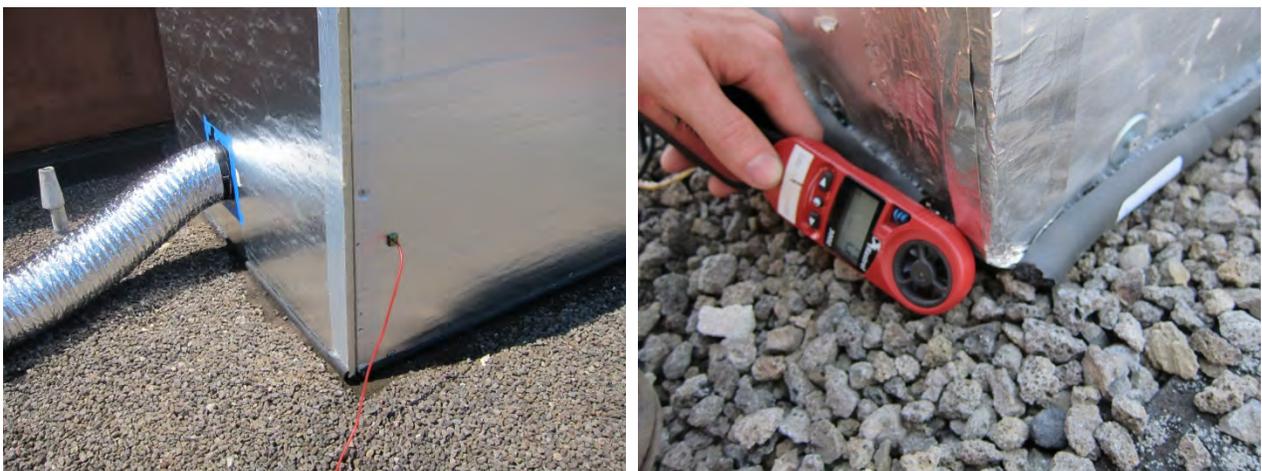
Figure 35. Static pressure probe in enclosure (L); measurement of bypass leakage (R)

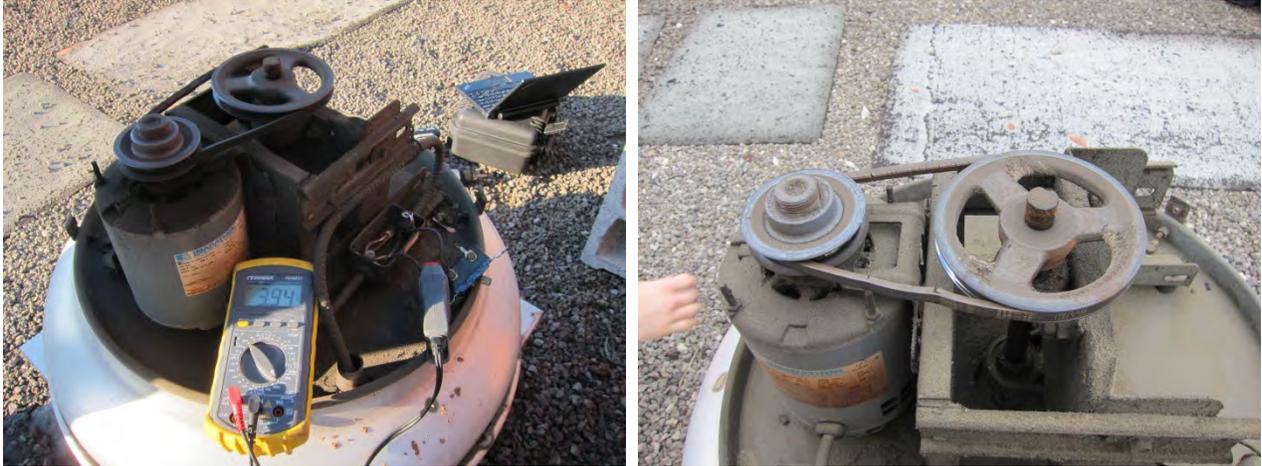
Figure 36. Measurement of amperage draw (L); loose fan belt at EF-2 (R)

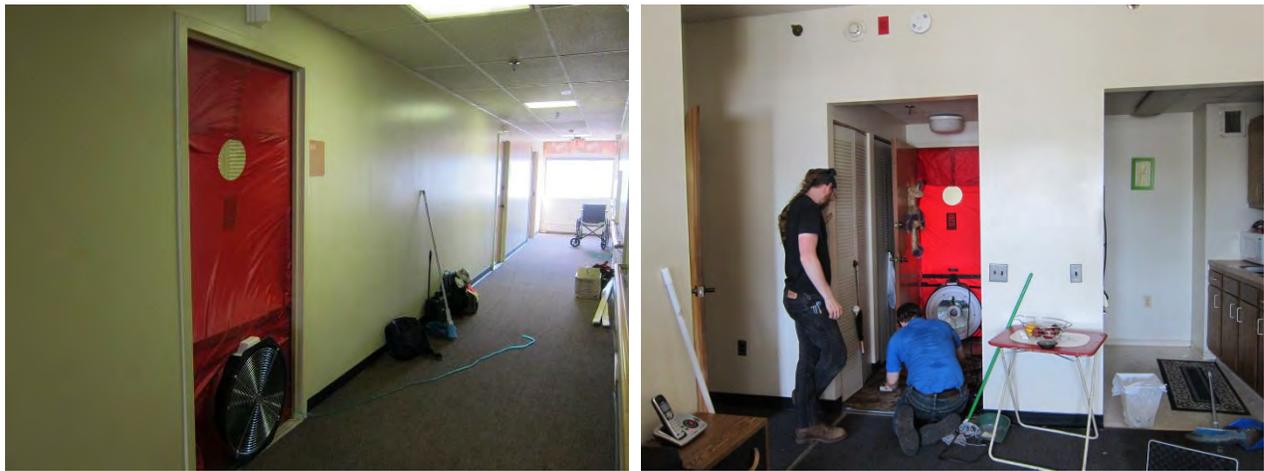
Figure 43. Air leakage testing of units from hallway (L) and interior of unit (R)

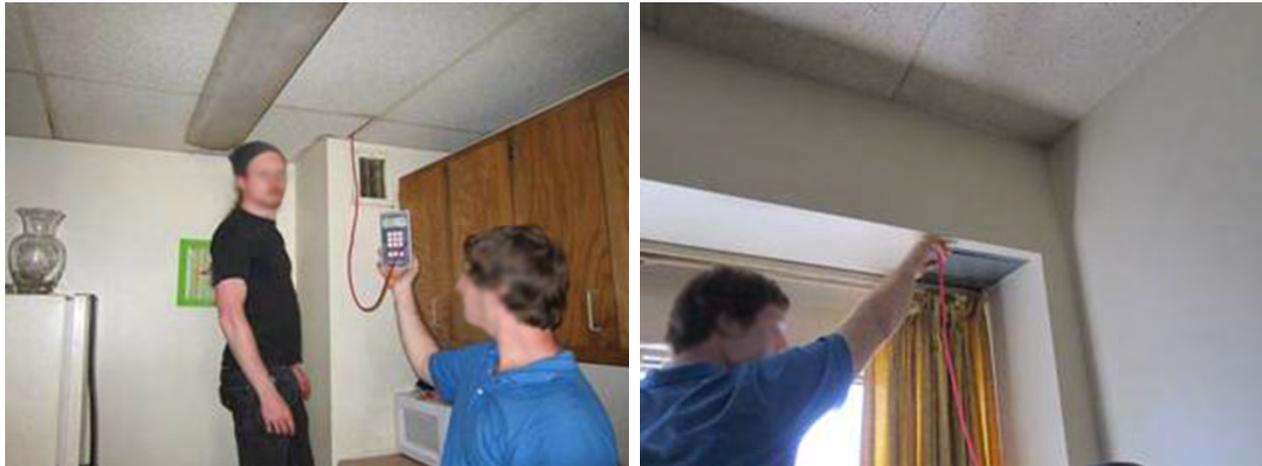
Figure 45. Interzonal pressure measurements (suspended ceiling, L; mechanical access, R)

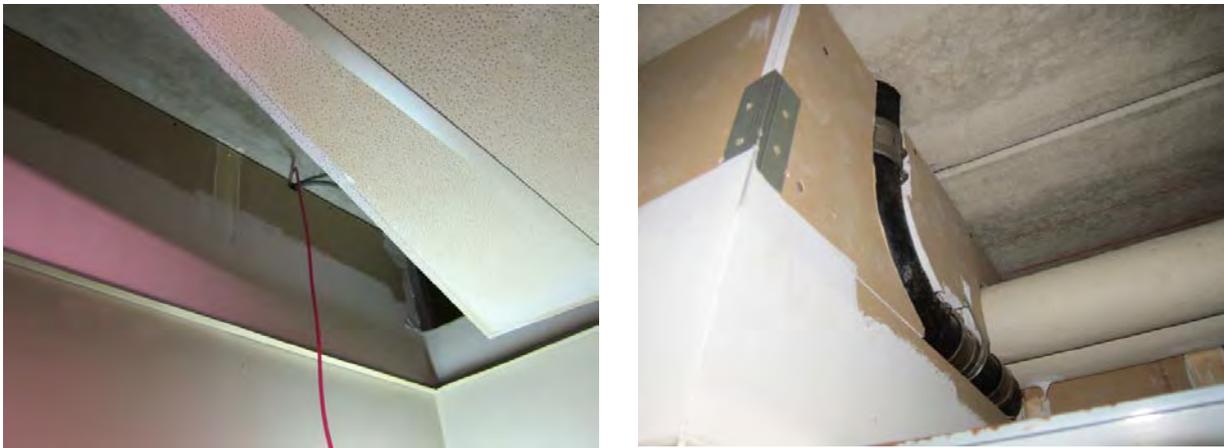
Figure 47. Lack of air sealing at demising wall to concrete plank (L) and pipe penetration (R)

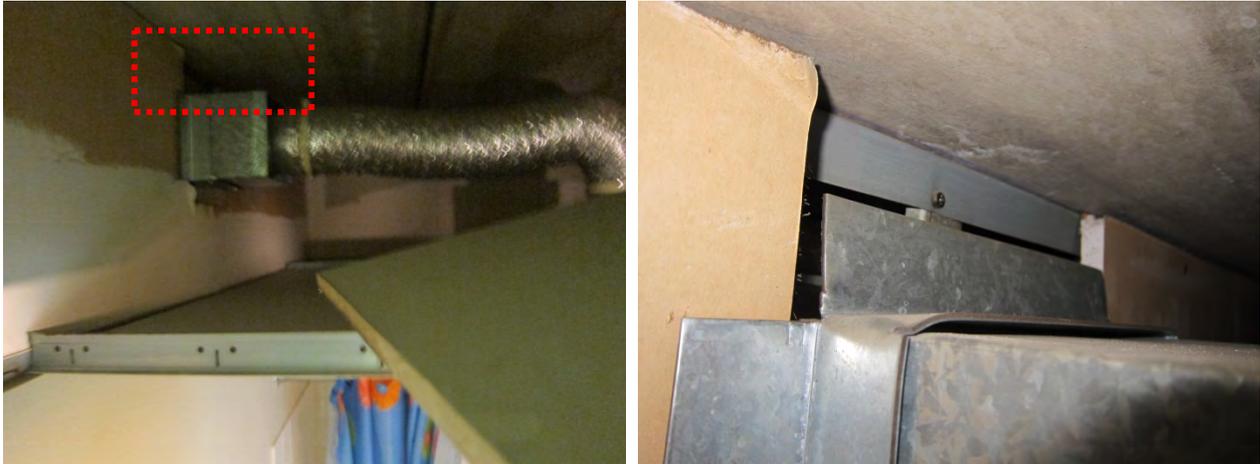
Figure 48. Exhaust duct penetration at demising wall, showing lack of air barrier continuity

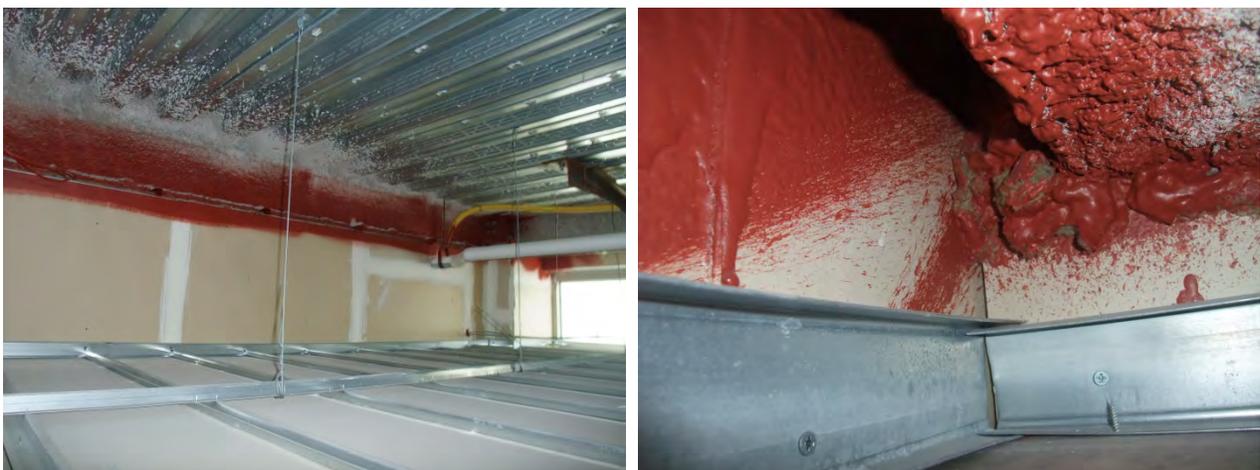
Figure 49. Liquid spray-applied fire-rated sealant

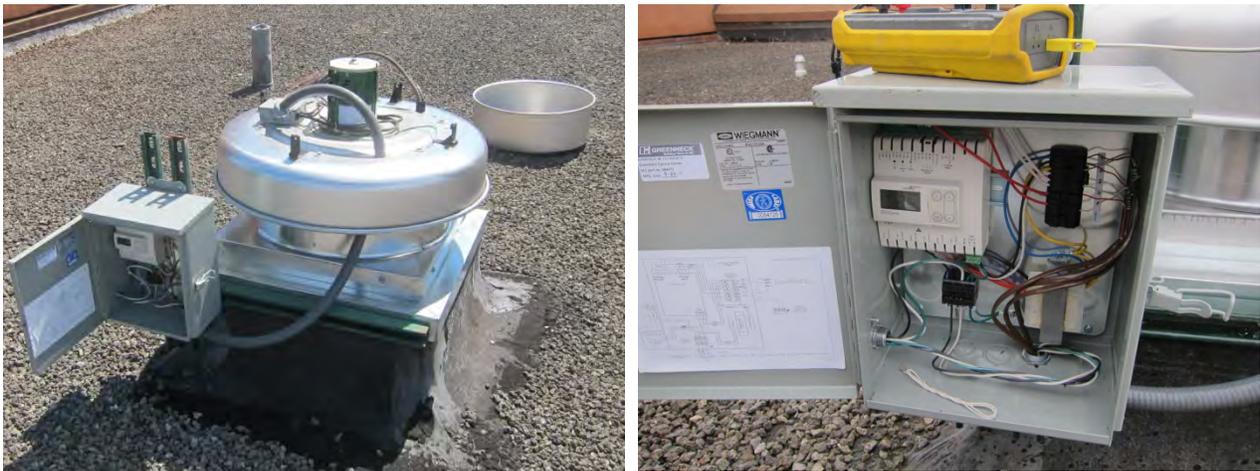
Figure 50. Variable-speed exhaust fan with cover removed (L), with controller box (R)

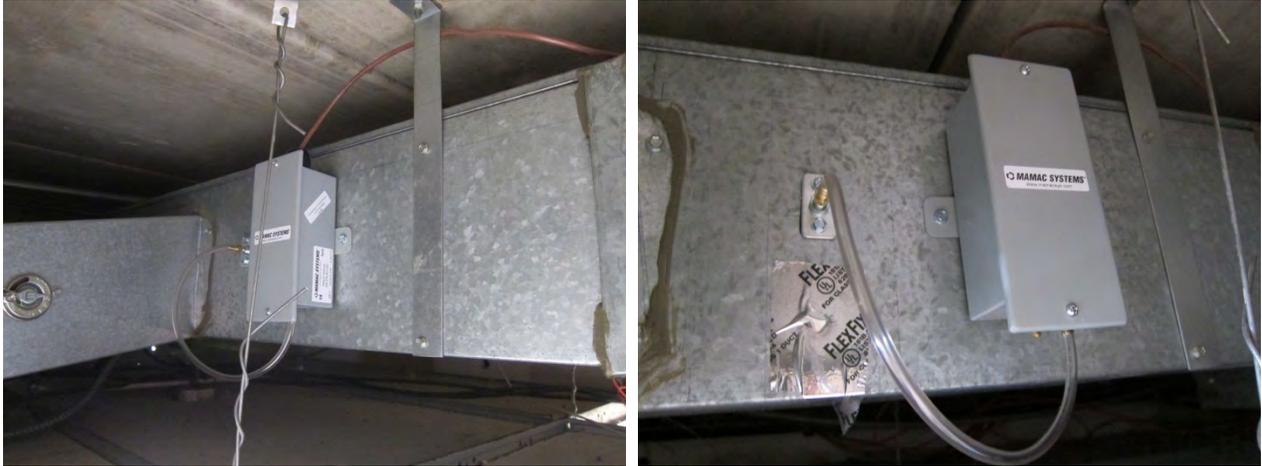
Figure 51. Duct pressure transducer and static pressure probe on top floor trunk duct

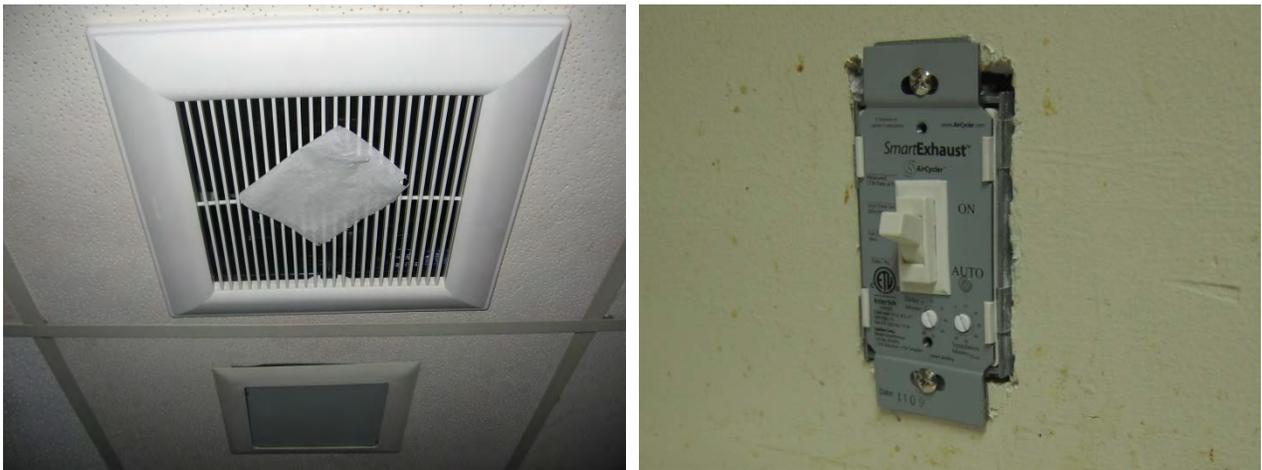
Figure 52. Bathroom dwelling unit exhaust fan (L) and controller timer switch (R)

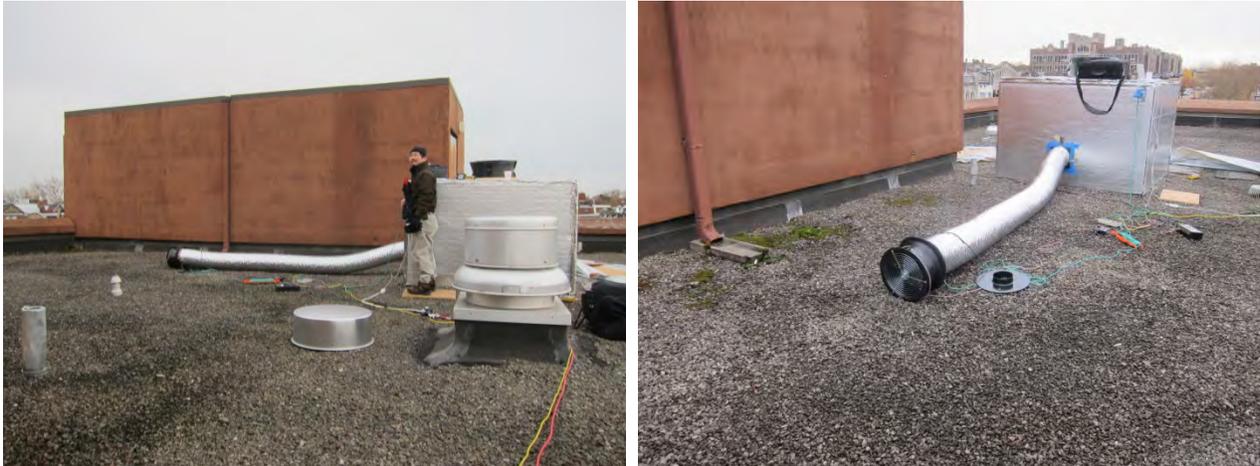
Figure 53. Powered flow capture hood, showing duct testing fan

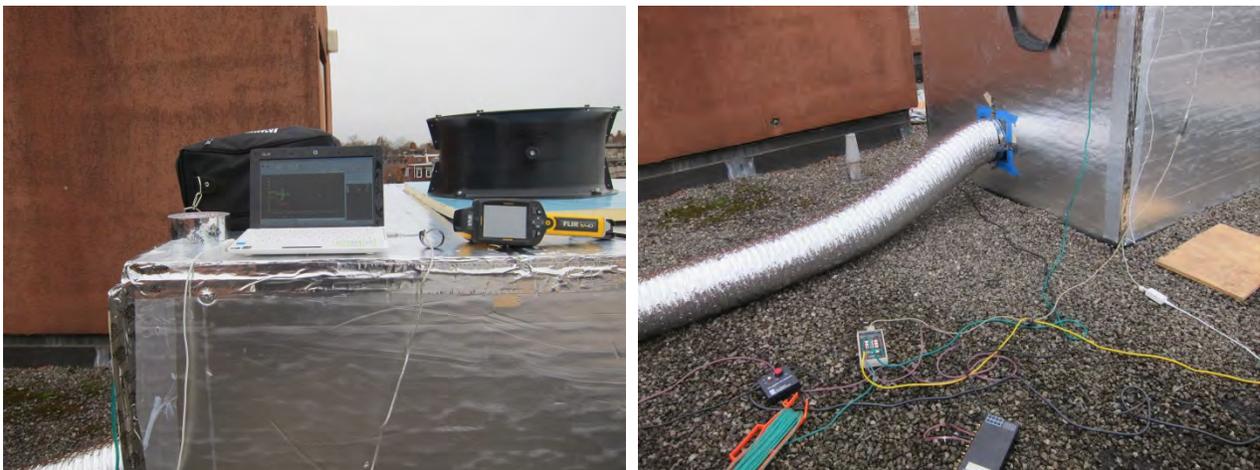
Figure 54. Computerized flow capture hood testing (L), showing manometer (R)

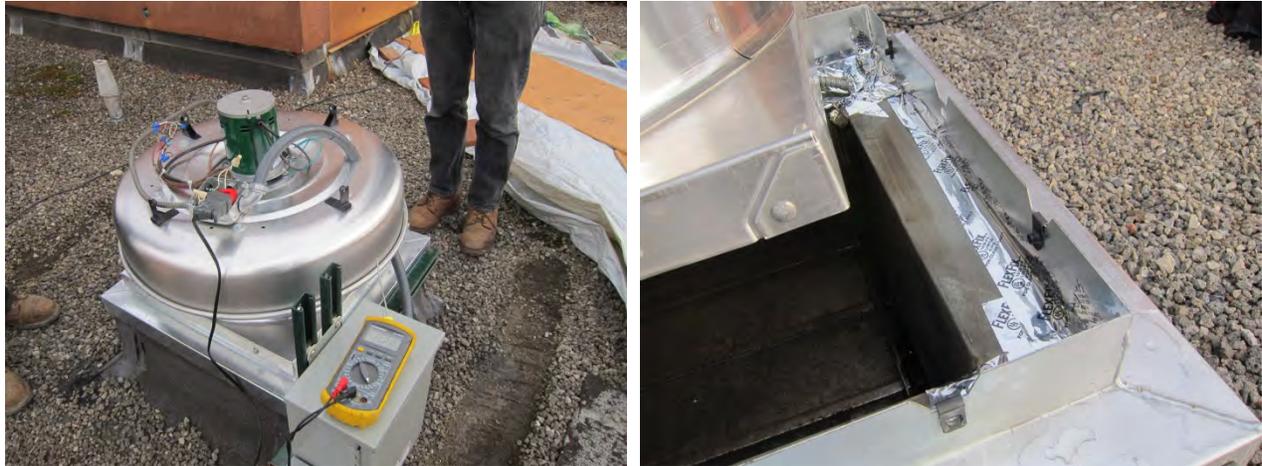
Figure 61. Amperage measurements at rooftop exhaust fan (L); temporary seal of roof curb (R)

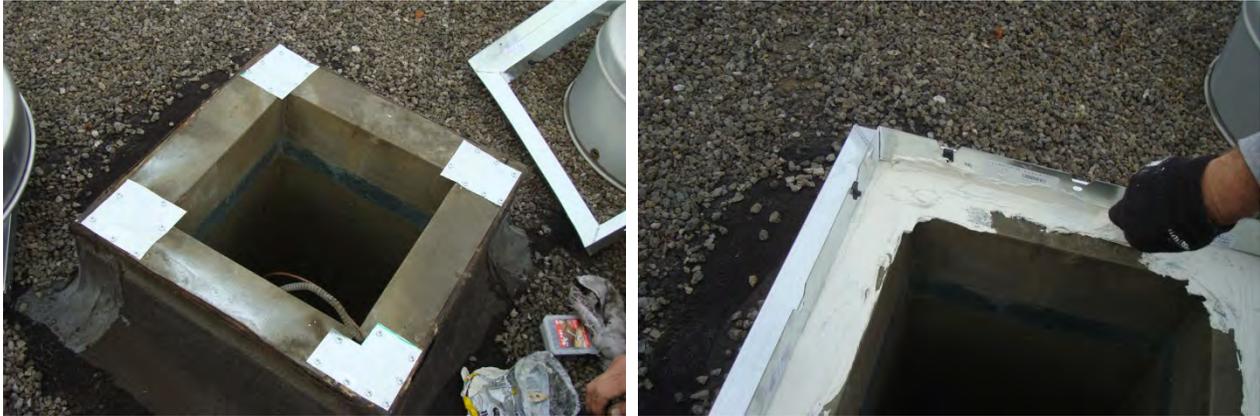
Figure 71. Mastic and sheet metal retrofit air sealing of exhaust shaft roof curb

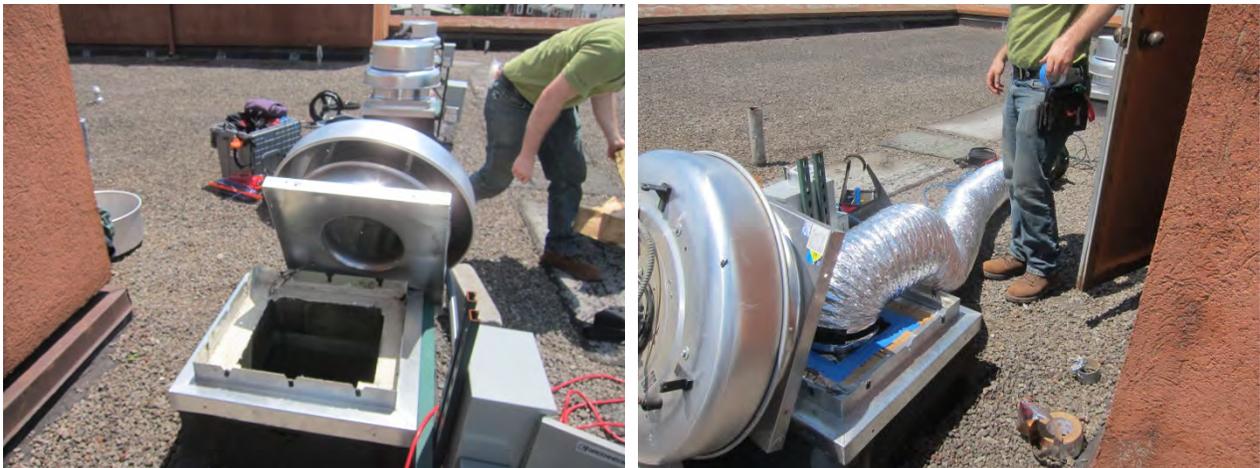
Figure 72. Duct leakage testing of EF-3 (post-retrofit)

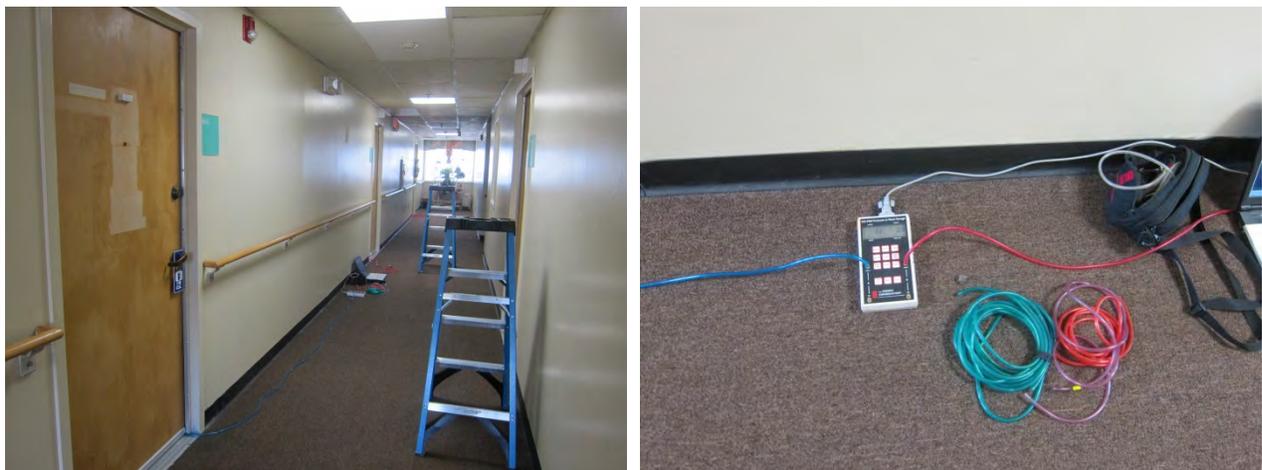
Figure 74. Interunit pressure difference measurement

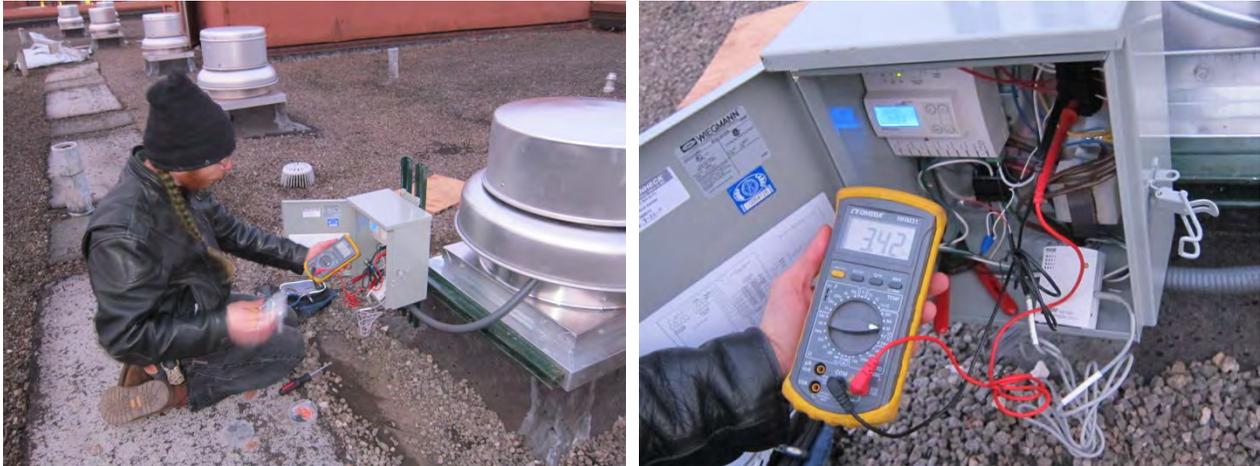
Figure 77. Installation of voltage data logging equipment on variable speed fans

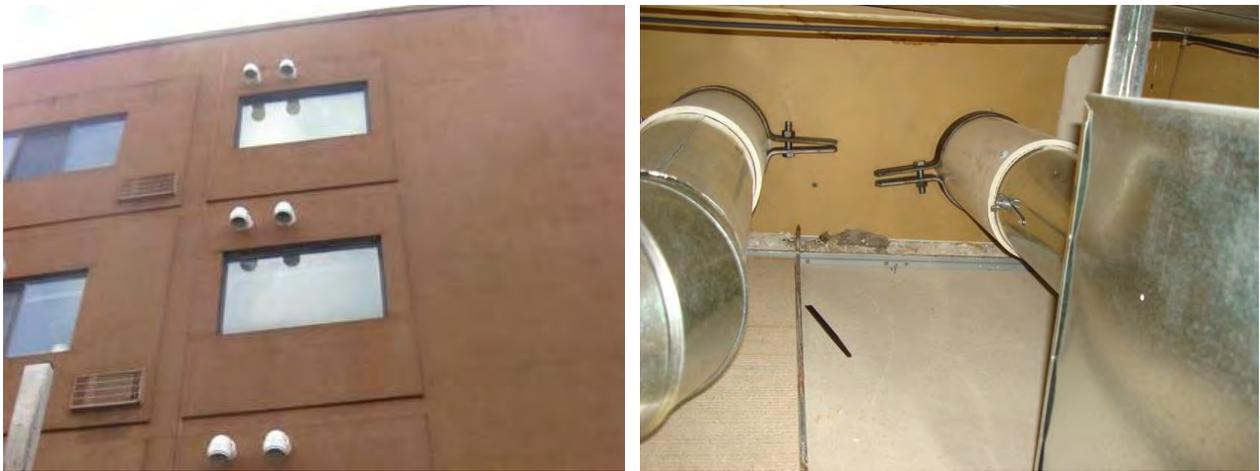
Figure 87. Corridor ventilation exterior view (L) and connections above suspended ceiling (R)

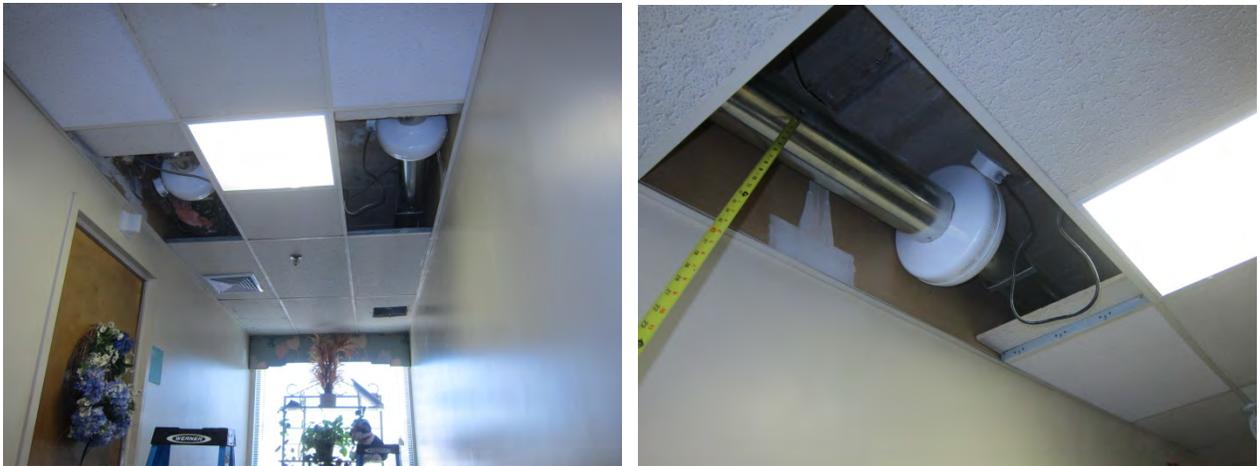
Figure 88. Inline fans and registers in suspended ceiling
