Betsy Pettit, FAIA

A18 Deep Energy Retrofits for Existing Single Family Homes Details

Residential Design and Construction 2010 14 April 2010

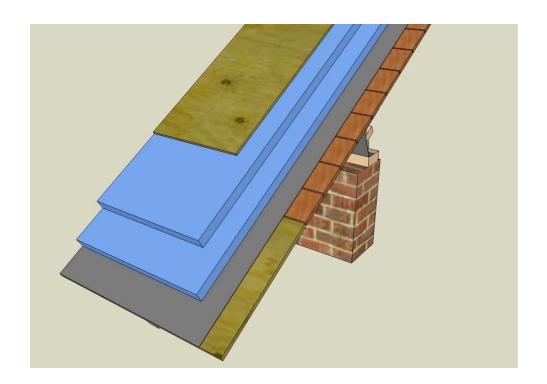
Roof

Insulating sheathing above existing roof board sheathing

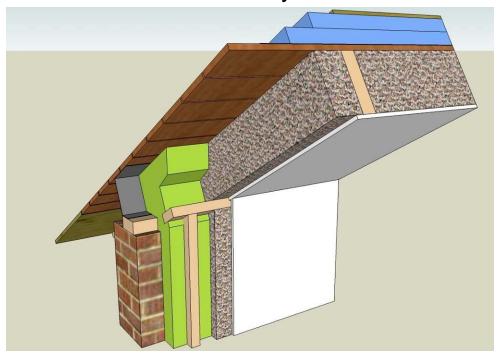
Roof

Insulating sheathing above existing roof board sheathing and spray foam and cellulose in rafter bay

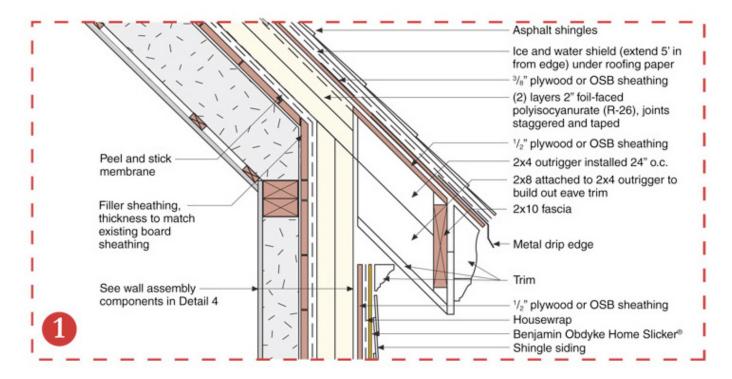
Roof

Insulating sheathing above existing roof board sheathing and cellulose in rafter bay

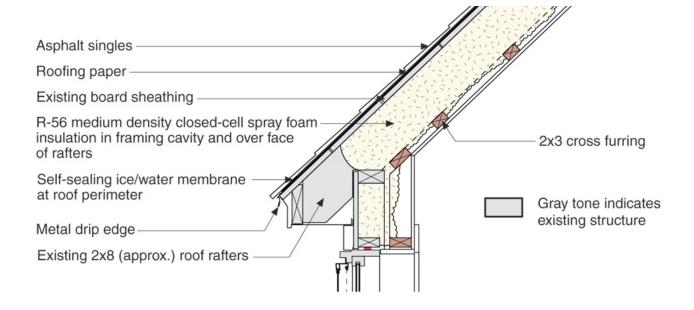
Roof

Spray foam in existing rafter bays

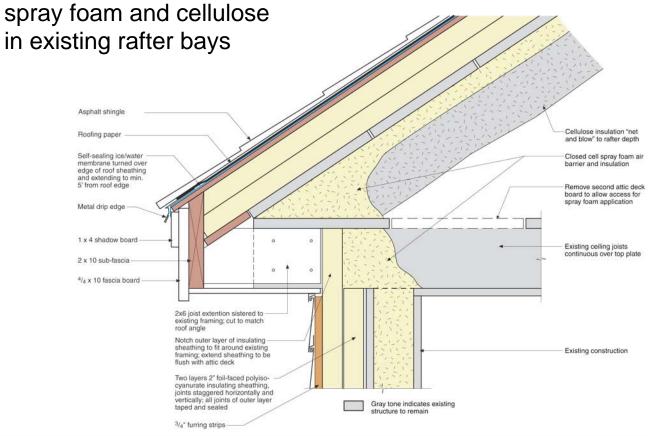
Roof

Insulating sheathing above existing roof board sheathing and

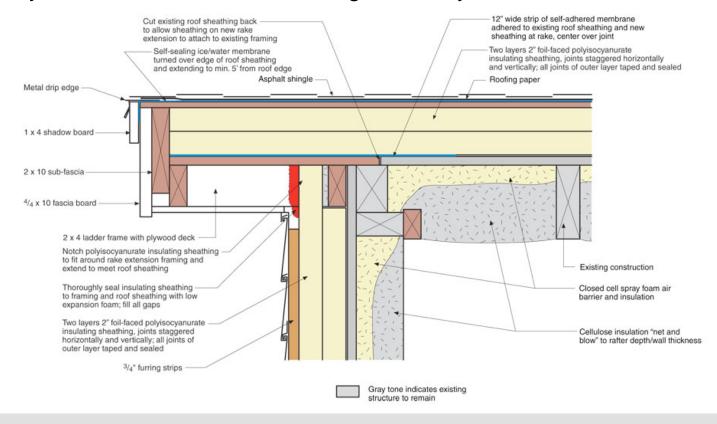
Roof

Insulating sheathing above existing roof board sheathing and spray foam and cellulose in existing rafter bays

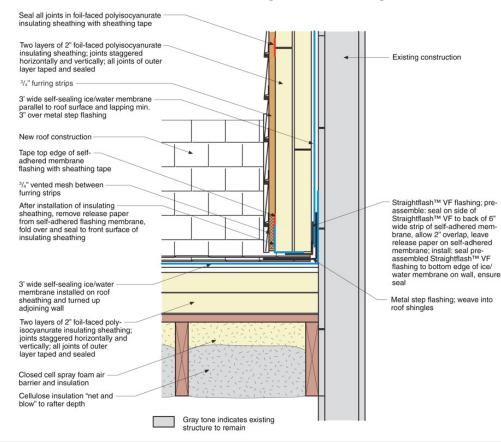
Roof to wall transition – 4" insulating sheathing

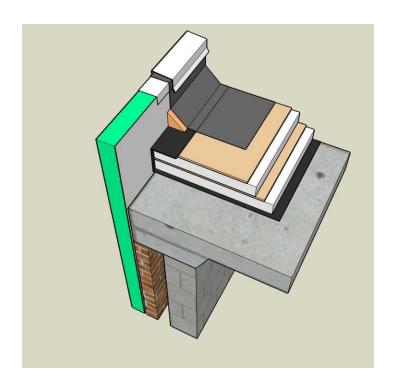
- Roof
 - Metal panel parapet

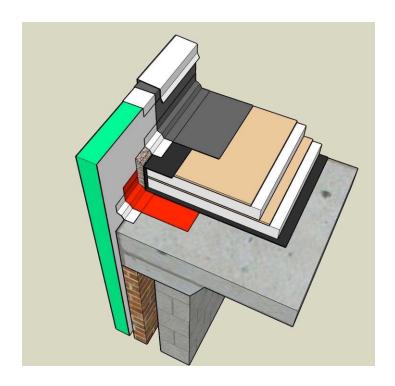
- Roof
 - Metal panel parapet

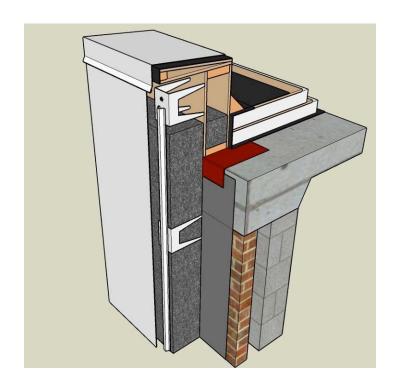
- Roof
 - Metal panel and framed parapet

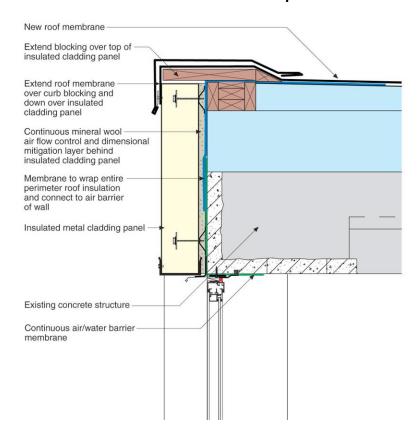
- Roof
 - Roof to wall transition insulated metal panel

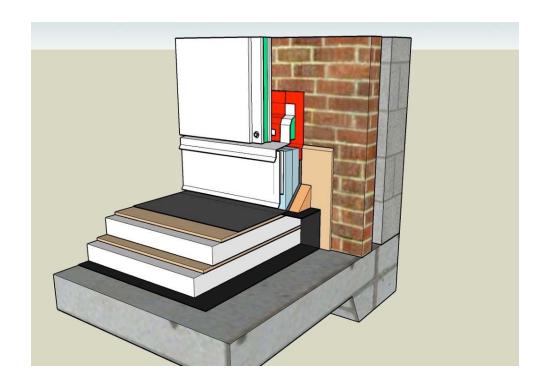
- Roof
 - Roof to wall transition insulated metal panel

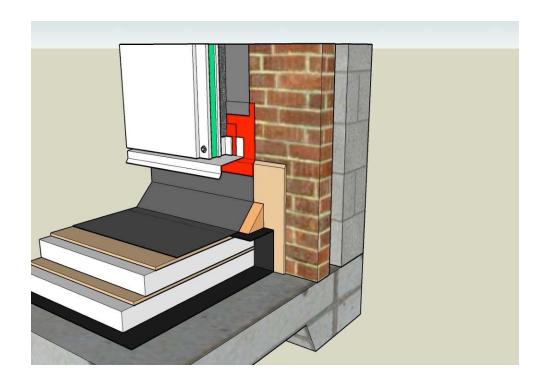
- Roof
 - Roof to wall transition insulated metal panel

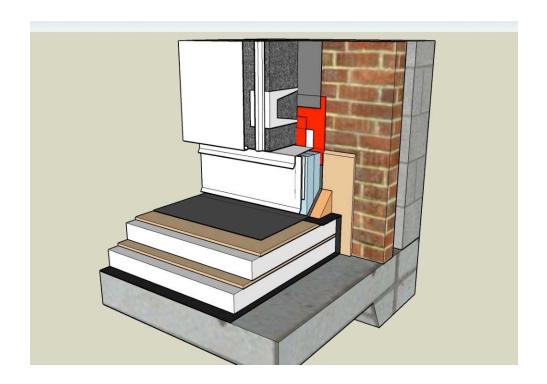
- Roof
 - Roof to wall transition insulated metal panel

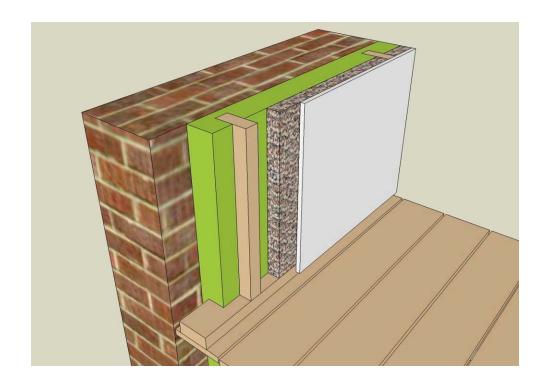
- Wall
 - Spray foam and cellulose to interior of brick wall

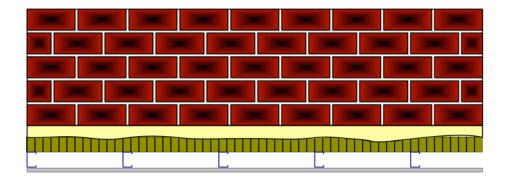
- Wall
 - Spray foam and mineral wool to interior of brick wall

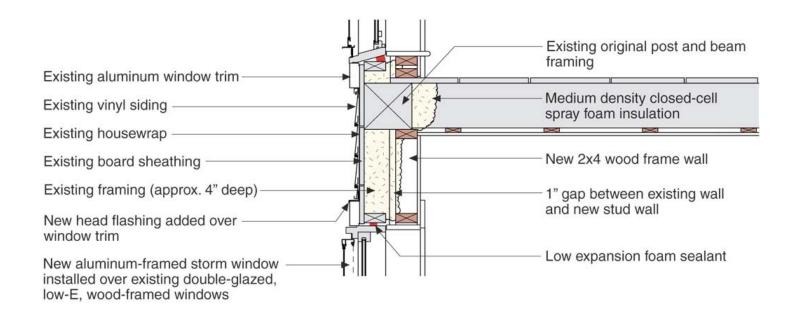
Wall

Spray foam in existing stud bays

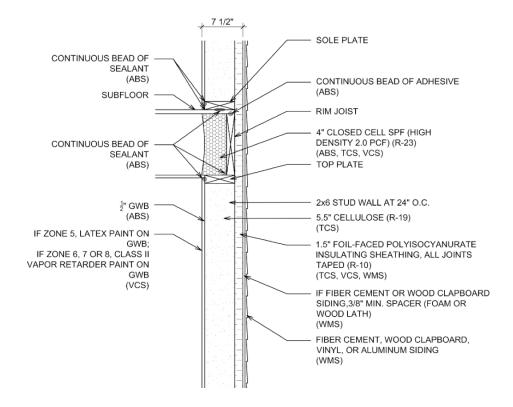
1.5" insulating sheathing
 (Note: Wall drawn as new construction but can apply to retrofits)

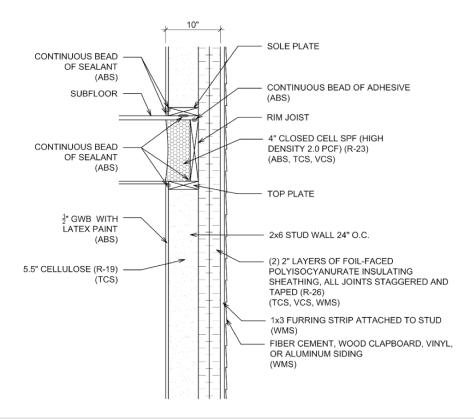
4" insulating sheathing
 (Note: Wall drawn as new construction but can apply to retrofits)

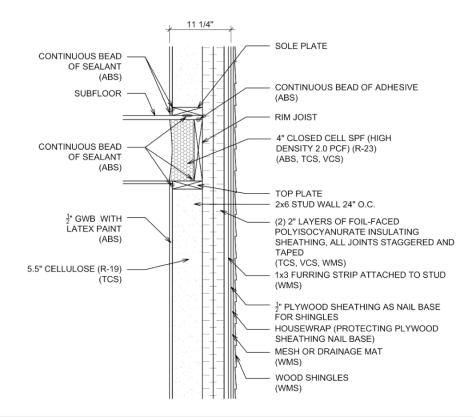
4" insulating sheathing with shingles
 (Note: Wall drawn as new construction but can apply to retrofits)

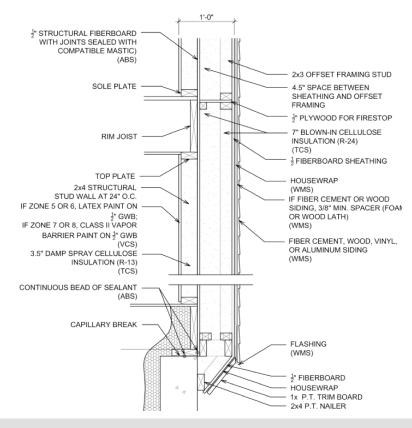
Double stud with interior load-bearing wall
 (Note: Wall drawn as new construction but can apply to retrofits)

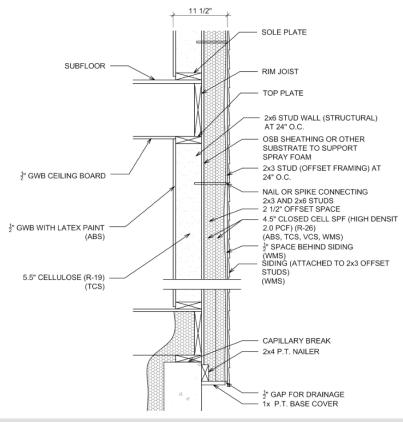
Offset framed wall
 (Note: Wall drawn as new construction but can apply to retrofits)

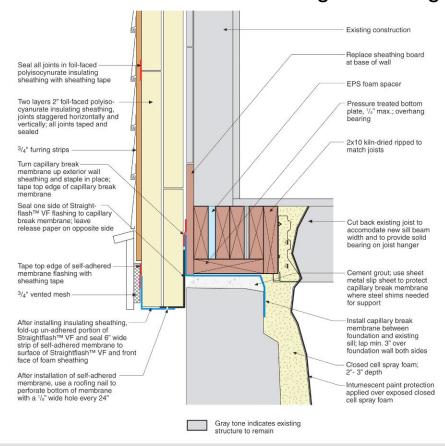
Foundation

Wall to foundation transition – 4" insulating sheathing

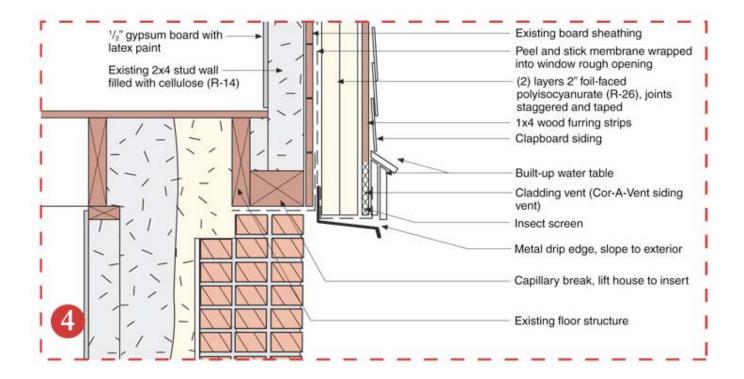
Foundation

Wall to foundation transition – 4" insulating sheathing

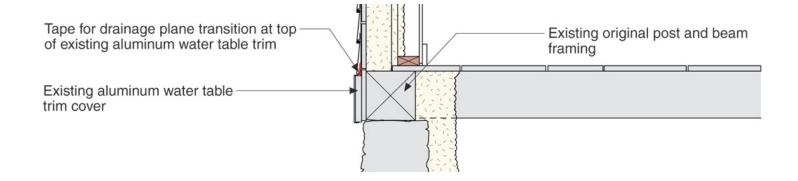
Foundation

Wall to foundation transition – spray foam

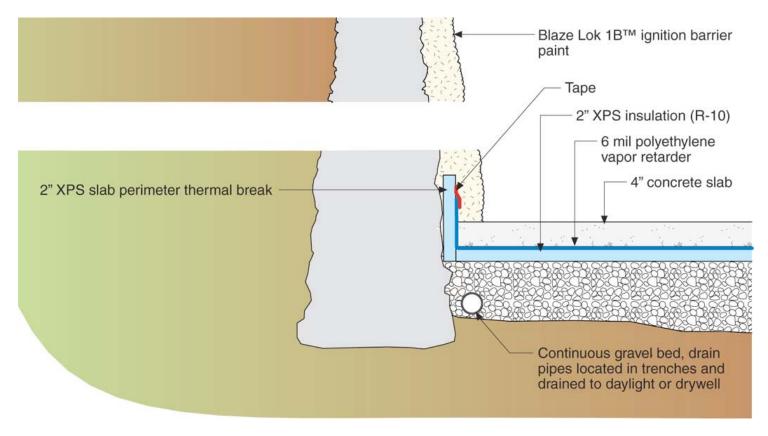
Foundation

Interior perimeter drain

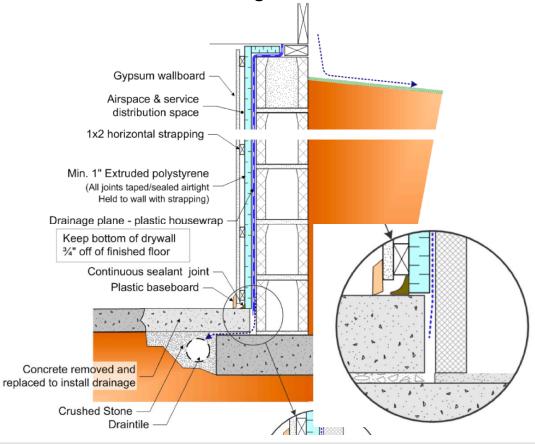
Foundation

Interior perimeter drain and existing concrete slab

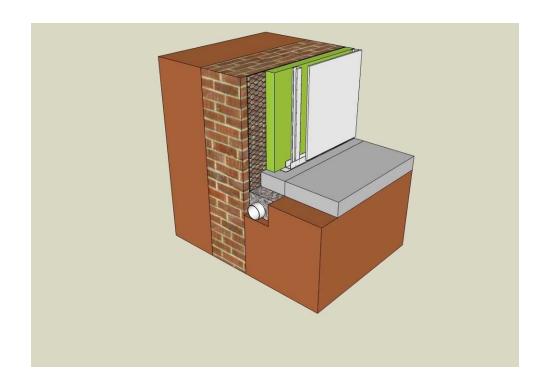
Foundation

Interior perimeter drain and existing concrete slab

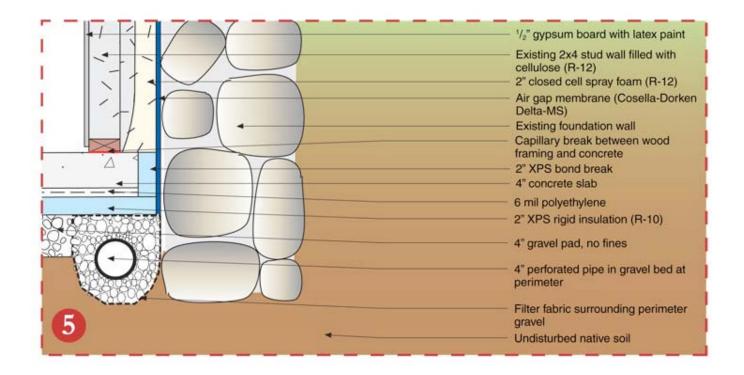
Foundation

Interior perimeter drain and new concrete slab

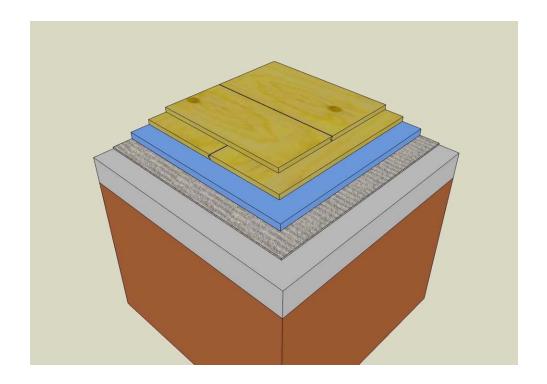
Foundation

Insulated floor above existing slab

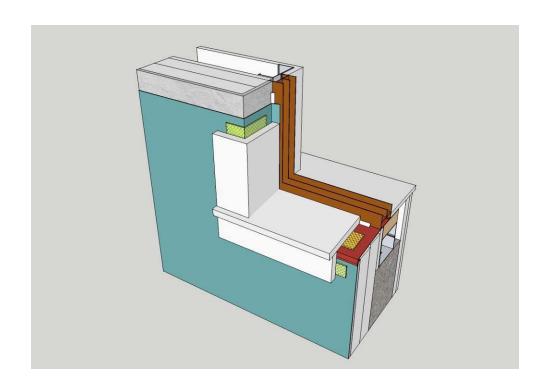
- Windows
 - Replacement in EIFS wall

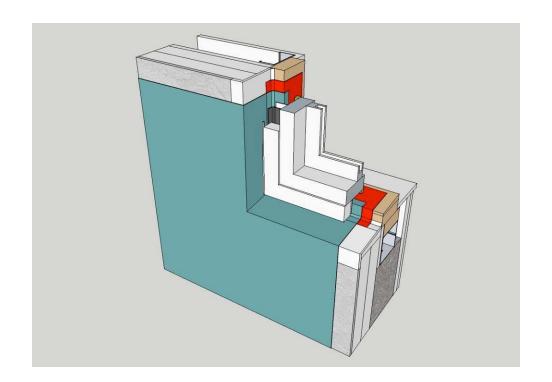
- Windows
 - Replacement in EIFS wall

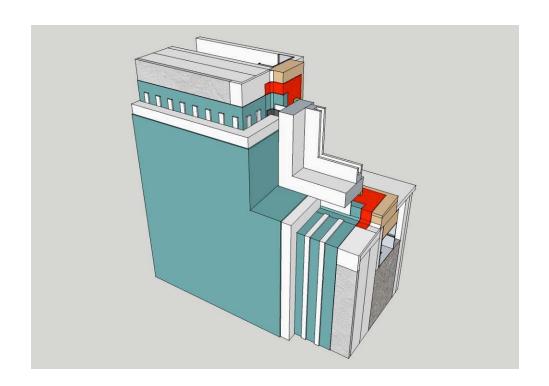
- Windows
 - Replacement in EIFS wall

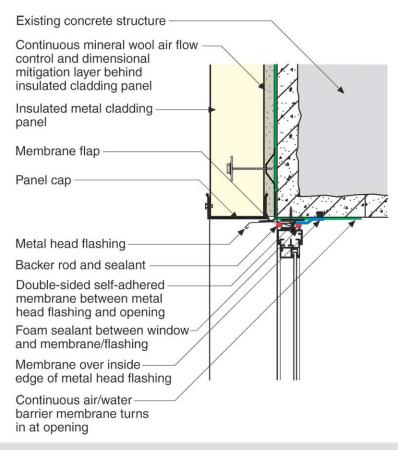
Windows

Replacement in concrete wall

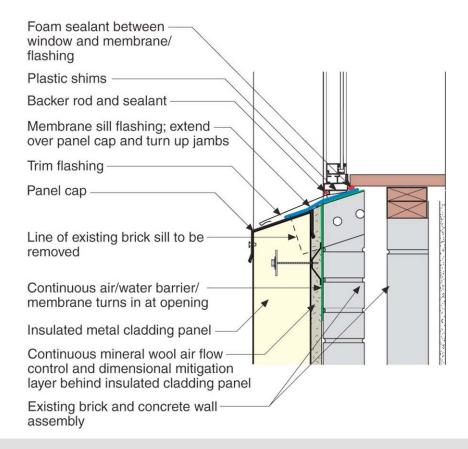
Windows

Replacement in brick and CMU wall

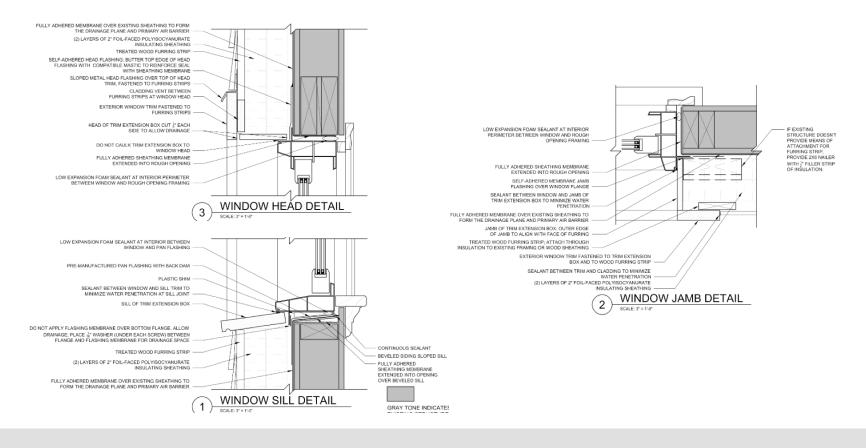
Windows

Replacement in wood framed wall – with flange – "innie"

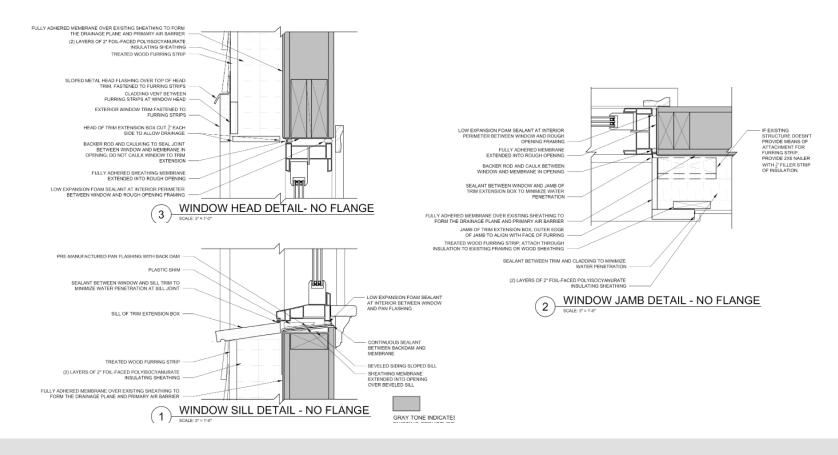
Windows

Replacement in wood framed wall – no flange – "innie"

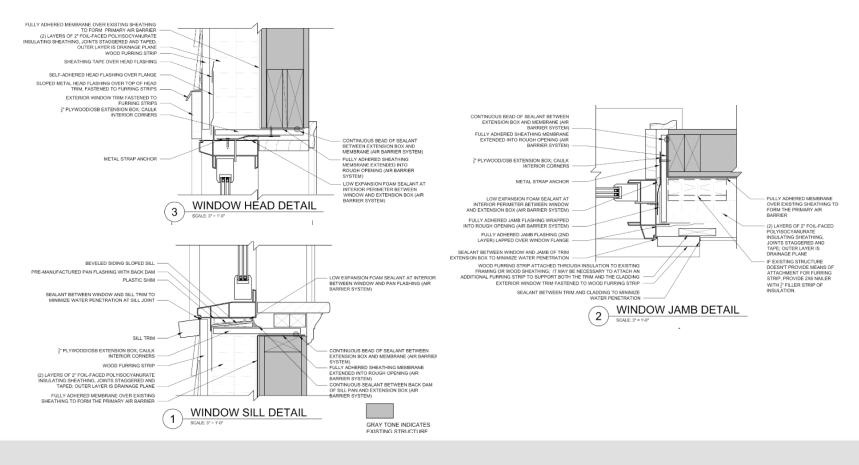
Windows

Replacement in wood framed wall – with flange – "outie"

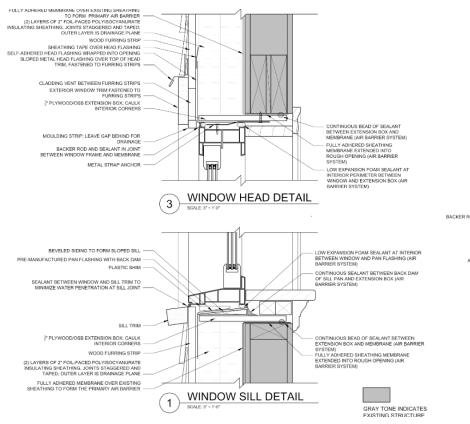
Windows

Replacement in wood framed wall – no flange – "outie"

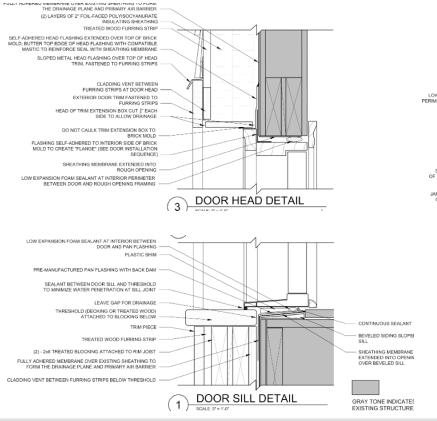
Doors

Replacement in wood framed wall

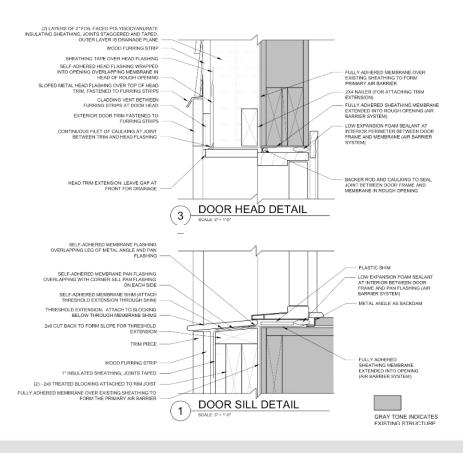
Doors

Replacement in wood framed wall
