Wyandotte Energy Summit
NSP2 Building America Construction
 June 28, 2012

Aaron Grin
 Building Science Corporation
 agrin@building science.com

WYANDOTTE NSP2 NEW CONSTRUCTION SPECIFICATION

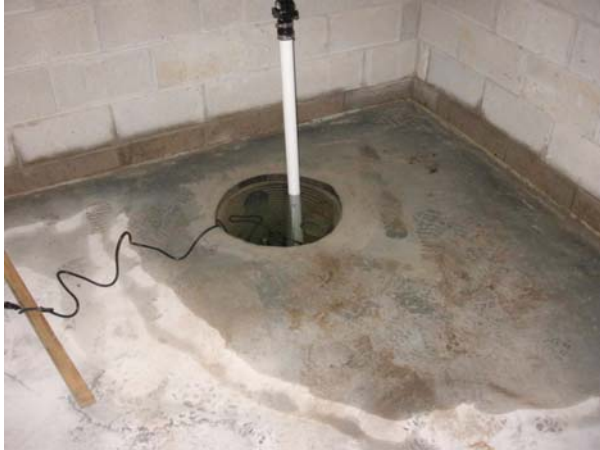
bsc Keeping Moisture Out!

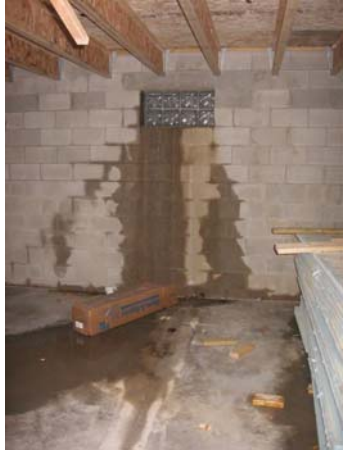
bsc Keeping Moisture Out!
