Glass Condos: Throw away or here to stay?

Dr John Straube, P.Eng.

Dept of Civil Engineering & School of
Architecture

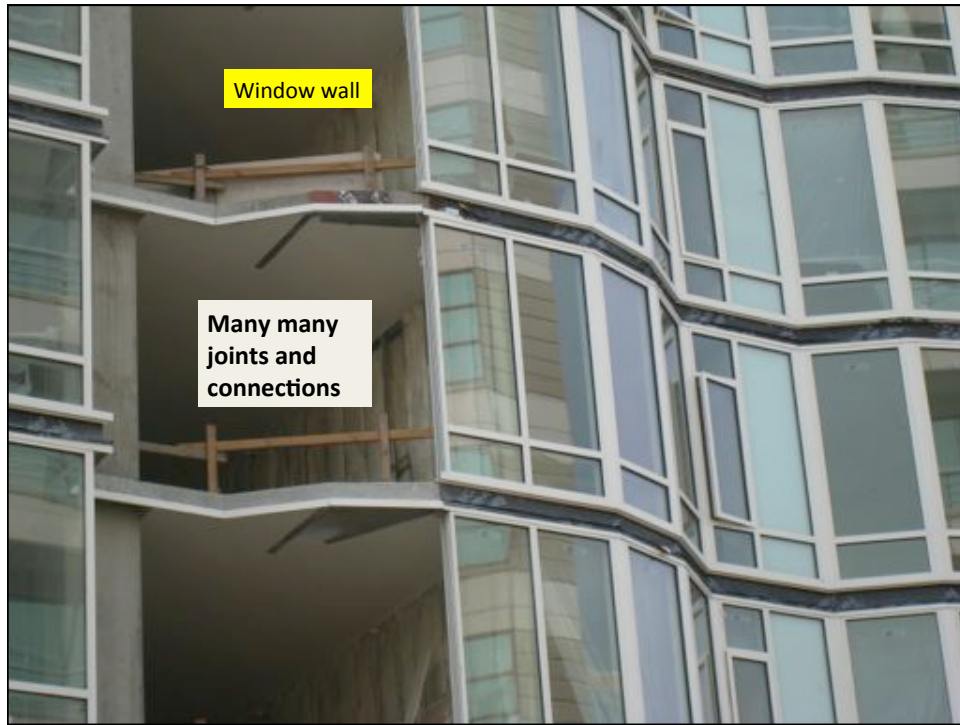
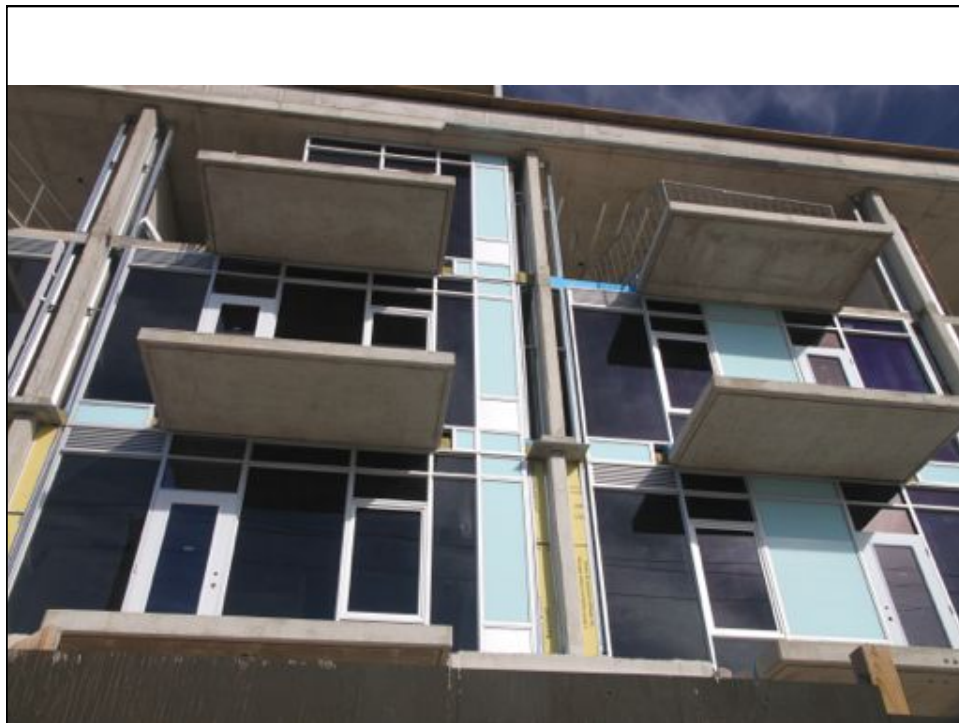
Sealants/Gaskets

- Exposed and hidden sealants are the key to most window-wall systems
 - Used to stop water and air leaks
- Essentially all materials are organic, and these break down with exposure to sun/ heat/cold
 - Polyurethane, neoprene, PVC
- Maintenance will be required
 - When? 5 yrs? 10 yrs? 20 yrs?

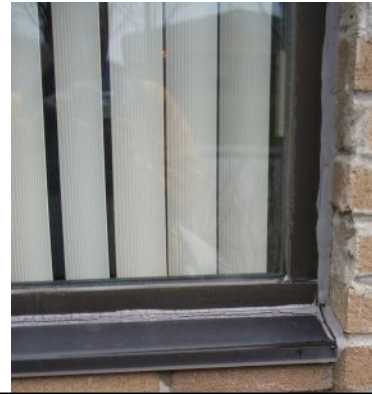
- Low-cost designs (e.g. most condos) rely on organic gaskets and sealants to stop air and water leakage
- Sealants / gaskets deteriorate over time
- Need repair/maintenance
- Access to high-rise is expensive

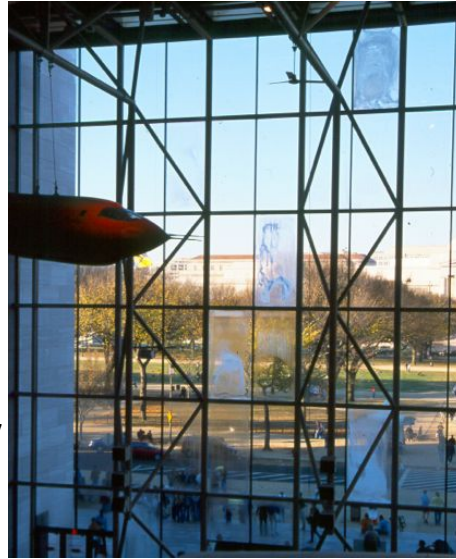
IGU “fogging”

- Condensation between panes of glass
- Caused by seal failure
- Expected to occur 20+ years after install
- Premature failure common due to rain leaks into glazing cavity

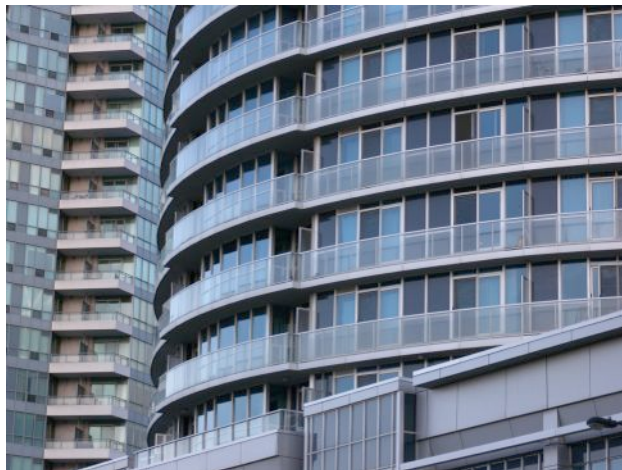
Thermal Resistance

- Transparent Glazing (R3 to R4)
- Aluminum Frames (R1)
- Balconies (R1)
- Spandrels (R5)
