SIPS Roof Shingle Ridging

New England
2016

Investigation:
Forensic Investigations

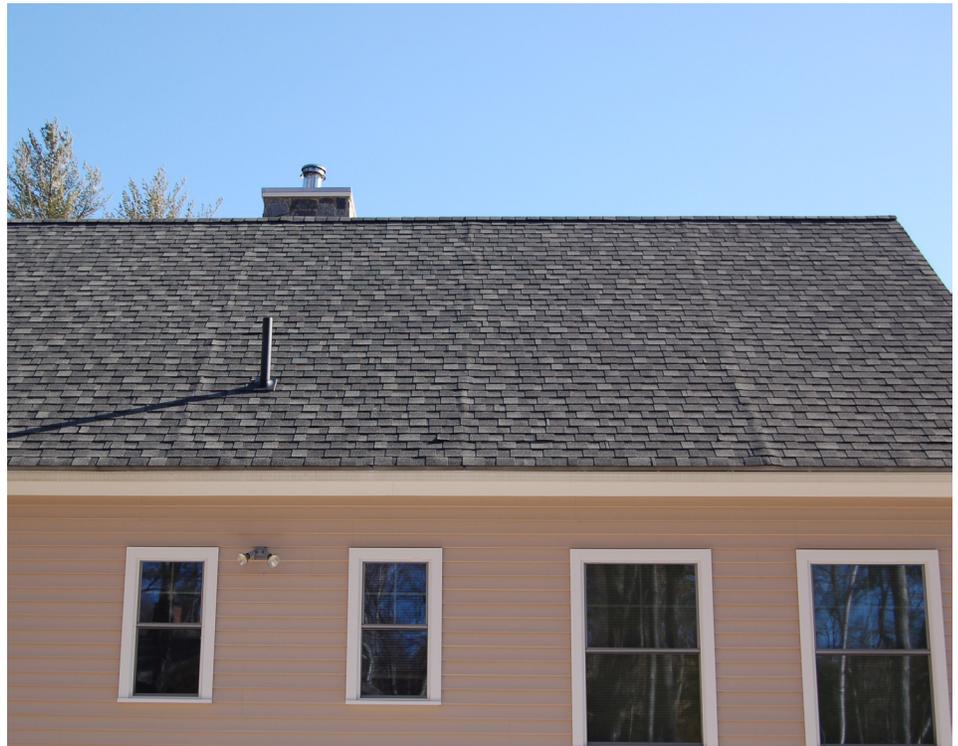
BSC was asked to examine a 7-year old structural insulated panel system (SIPS) residence that had exhibited seasonal asphalt shingle ridging and ant infestation issues. These shingle ridging problems were worst in winter, and on the north elevation. Investigation with blower door depressurization and infrared thermography revealed significant air leakage at panel seams; this air leakage appears as warm anomalies in this summertime investigation. Air leaks was pronounced at the attic ridge beam, where application of an interior tape seal would be difficult during construction. These air barrier deficiencies allow interior air leakage into the panel system, resulting in ridging due to moisture deposition and localized OSB skin expansion and contraction. A roof panel seam was disassembled from the exterior, to determine whether this air leakage caused any damage. Wood moisture contents were low, and the OSB was intact and dry, reflecting summertime conditions. The roof had been retrofitted with a ridge vent (allowing outward leakage of moist air) as a remediation to avoid moisture problems, but with negative energy consequences. Recommended solutions included retrofit air sealing from the interior with flashing tape, foam injection at the panel joints, and post-retrofit air leakage testing. Another issue was ant infestation and visible “crumbs” of foam at the interior of one room. This was found to be caused by a poorly detailed roof-wall flashing, including a vinyl siding J-channel directing water accumulation behind the cladding. This resulted in wetting of the SIPS skin, making it vulnerable to infestation. Retrofit of a kickout flashing was recommended at this detail.
