Application of Spray Foam Insulation Under Plywood and OSB Roof Sheathing

Building America Report - 1312
September 2013
Aaron Grin, Jonathan Smegal and Joseph Lstiburek

Application of Spray Foam Insulation Under Plywood and Oriented Strand Board Roof Sheathing

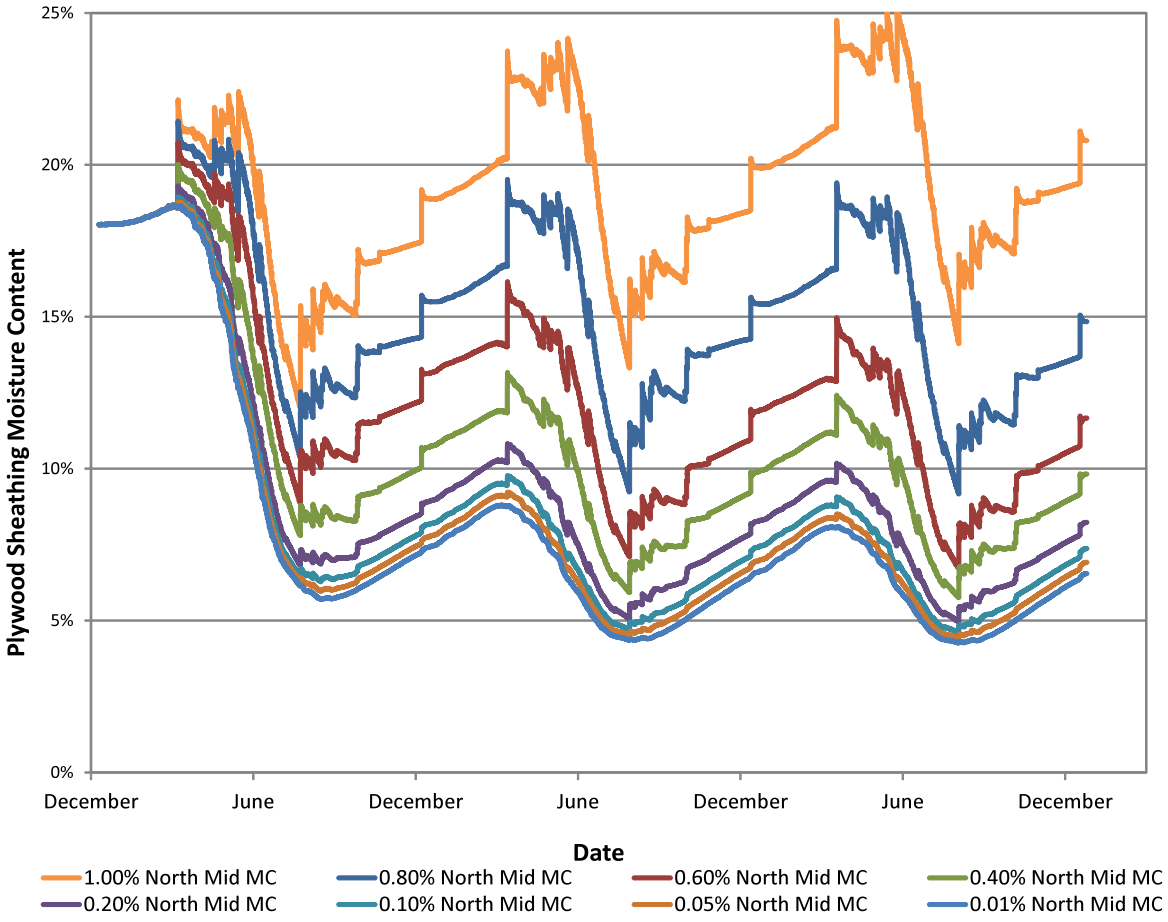
Figure 5. Minneapolis plywood sheathing MC of ccSPF unvented roof

plane. For the roof systems analyzed, fractions of the ASHRAE 1% rainfall (ranging from 0.01% to 1.00% of total rainfall) is able to pass the fully adhered membrane and come in contact with the wood-based sheathing. This is the amount of water that is modeled and has to dry through the roofing system or accumulate and possibly cause damage. Figure 5 shows the correlated plywood sheathing MCs for 0.01%–1.00% rainfall leaks for the roof system described with ccSPF and cellulose insulation. Over the three-year analysis period, all of the injection scenarios are within the safe range and are not maintained above 25% MC. For the 0.80% and 1.00% cases there appears to be an increasing trend long term, which could likely lead to damage; the rest of the assemblies demonstrated a decreasing trend in MC.

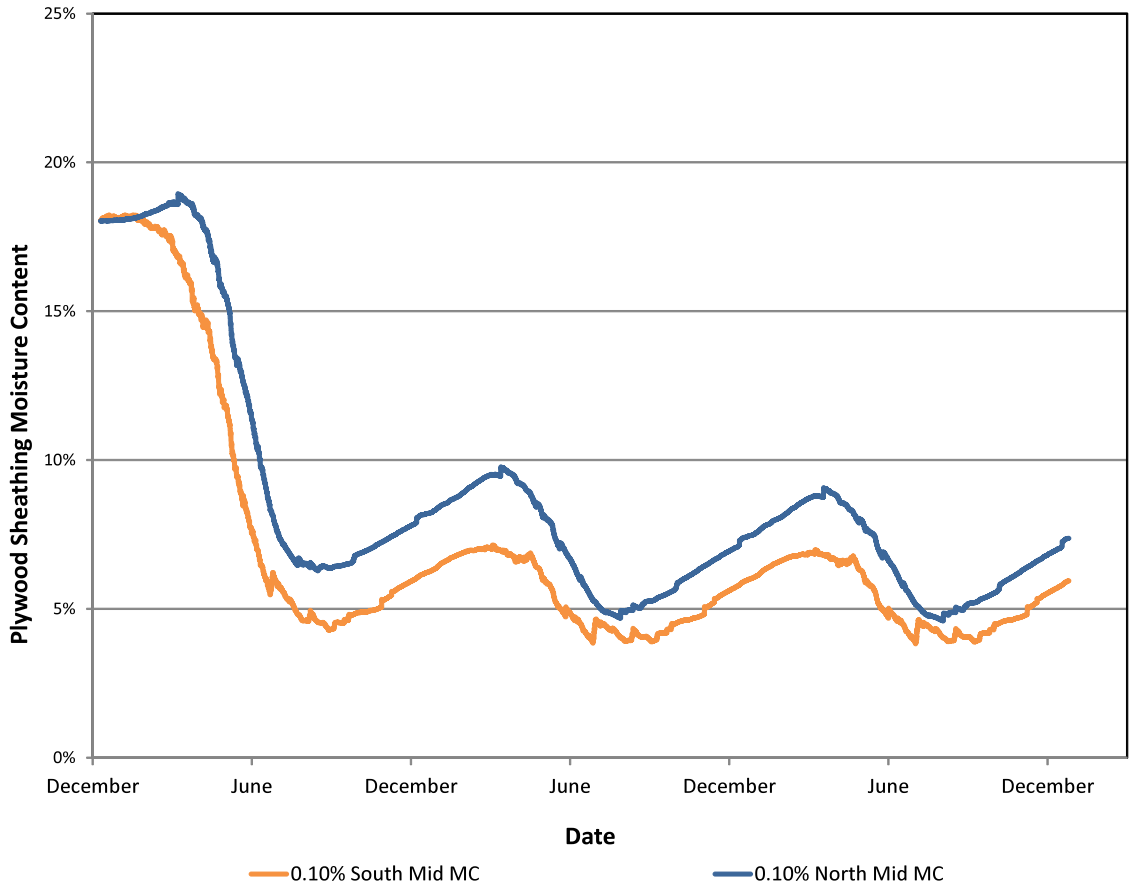
Figure 6. Minneapolis sheathing MC—north versus south

Table 7 shows plywood sheathing MCs at 0.10% rainfall contacting the plywood on a north orientation and a south orientation with ccSPF and cellulose insulation. The graph shows that the north orientation increases the peak MC of the sheathing by up to 3% but that the sheathing MCs all remain well below any level of risk.

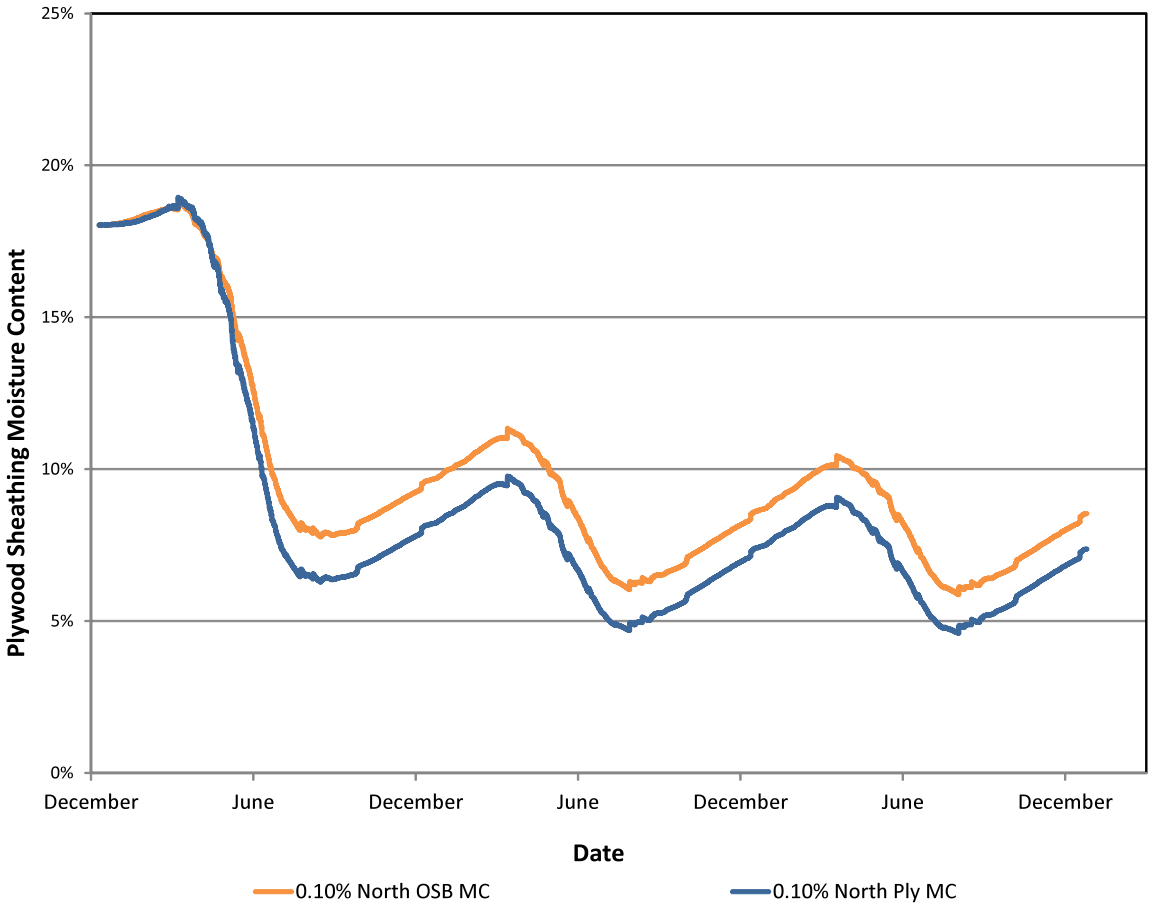
Figure 7. Minneapolis sheathing MC—OSB versus plywood

Figure 7 shows sheathing MCs at 0.10% rainfall contacting the sheathing considering OSB and plywood sheathing at ½-in. thick on the north orientation with ccSPF and cellulose insulation. The graph shows that OSB sheathing maintains 1%–1.5% higher MC than plywood, but also that the sheathing MCs all remain well below any level of risk.

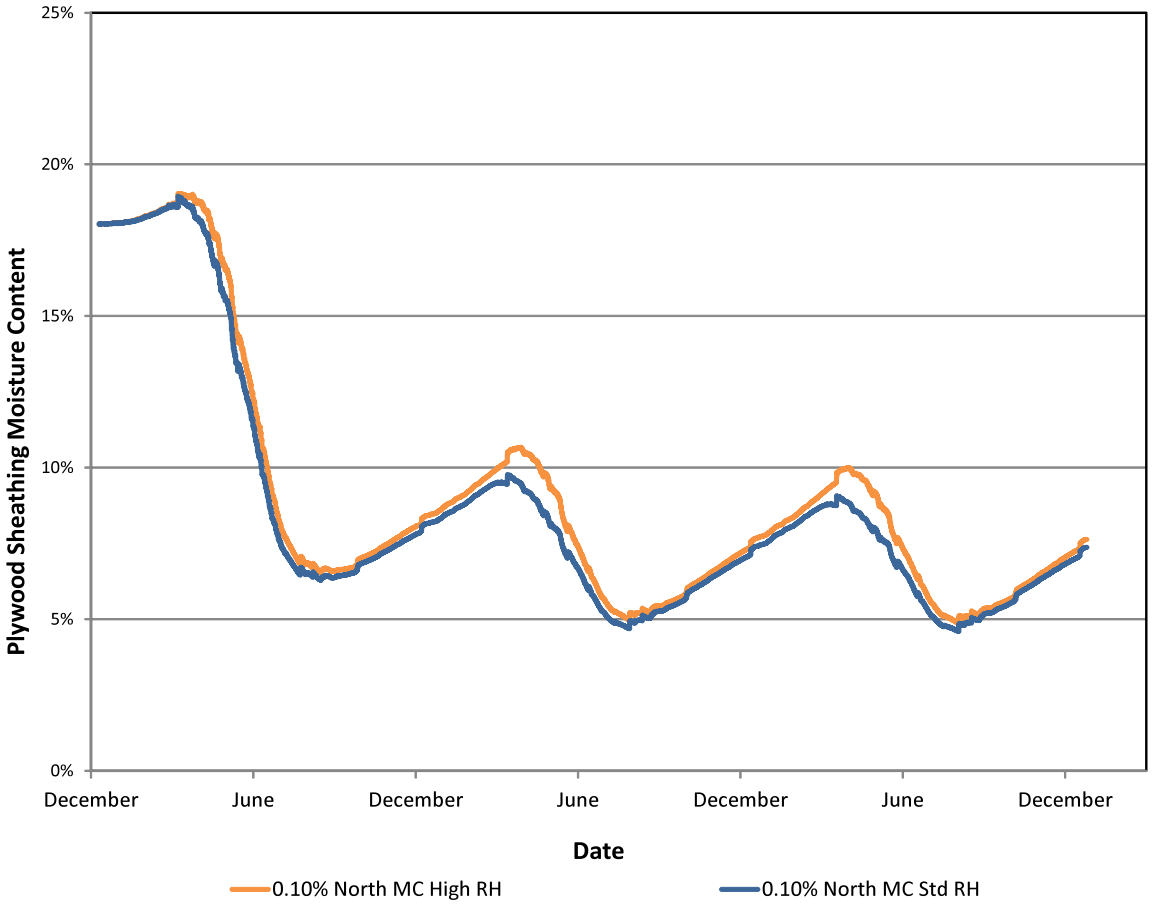
Figure 8. Minneapolis plywood sheathing MC based on standard and high interior RH

Peak plywood sheathing MC was affected by up to 1% when considering two interior RH scenarios (Figure 8). The first scenario allowed wintertime interior RH to fall to 30% while the second only fell to 40%. Both scenarios had summertime RH of 60%. In both scenarios the sheathing MCs all remain well below any level of risk.

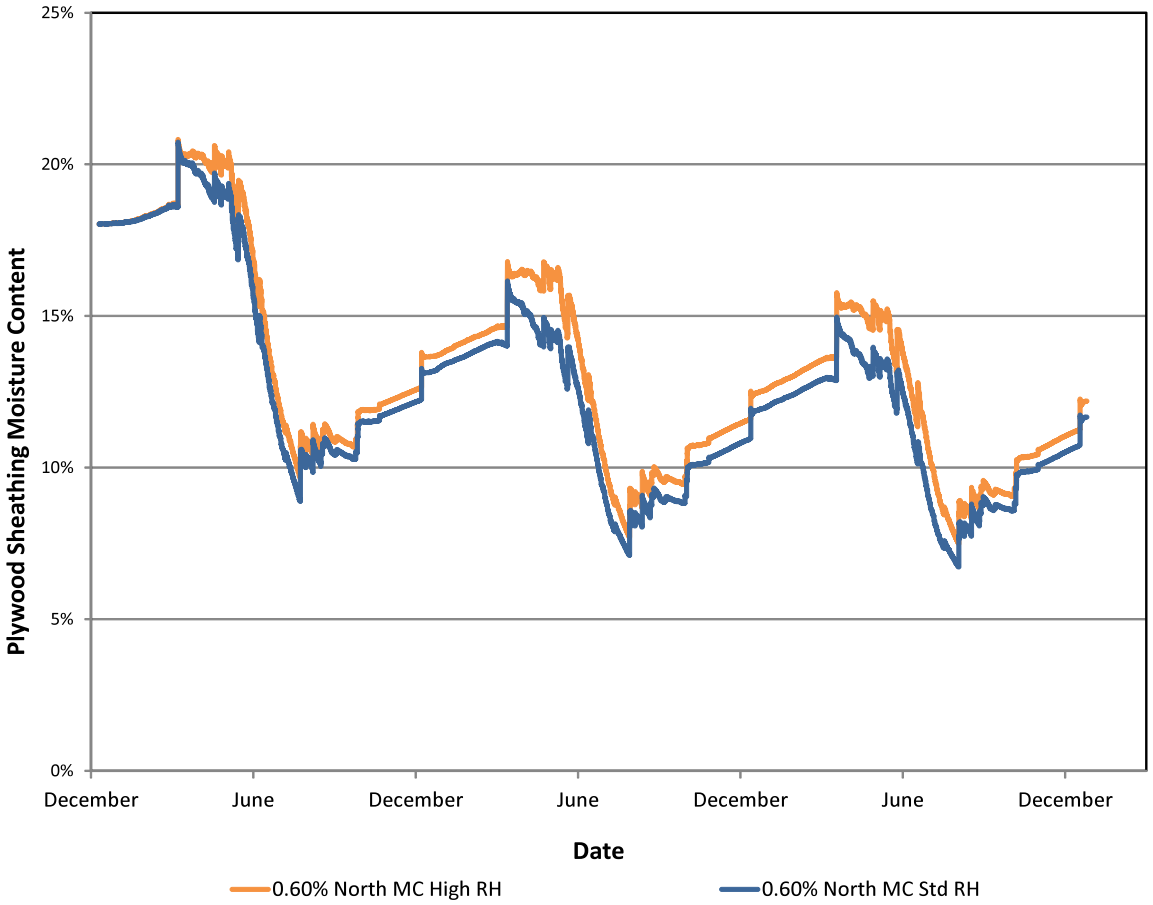
Figure 9. Minneapolis plywood sheathing MC based on interior RH—larger leak

To determine if the interior RH affects a larger leak in a different way, the 0.60% leak was analyzed at the standard and high RH scenarios. As shown in Figure 9, the MC of the sheathing is affected only slightly more by the change in interior RH. The sheathing MCs all remain well below any level of risk.

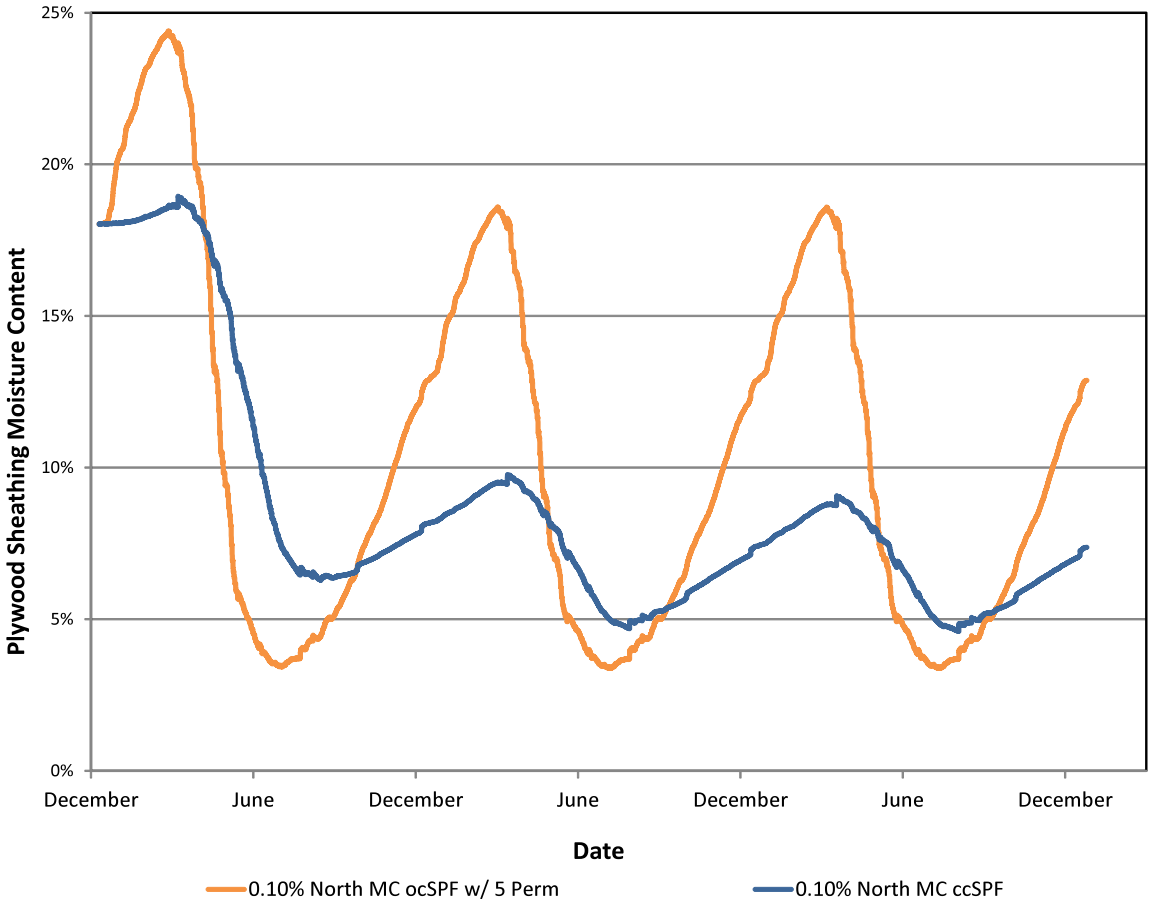
Figure 10. Minneapolis plywood sheathing with ccSPF and ocSPF

The type of SPF was analyzed in Figure 10. The ocSPF in this case requires a Class II vapor retarder installed on the interior face of the insulation. A 5 perm coating was modeled, as this represents the actual effective achieved perm value based on BSC experience with spray-applied Class II vapor retarder coatings. Figure 10 shows sheathing MCs at 0.10% rainfall contacting the plywood sheathing on the north orientation. The ocSPF MC varies significantly more than the ccSPF, but both remain within safe wood MCs. The ocSPF dries much faster than the ccSPF during warm weather, but also has the ability to pass more moisture from the interior to the exterior during cold weather and hence the MC of the plywood increases significantly more during those periods.

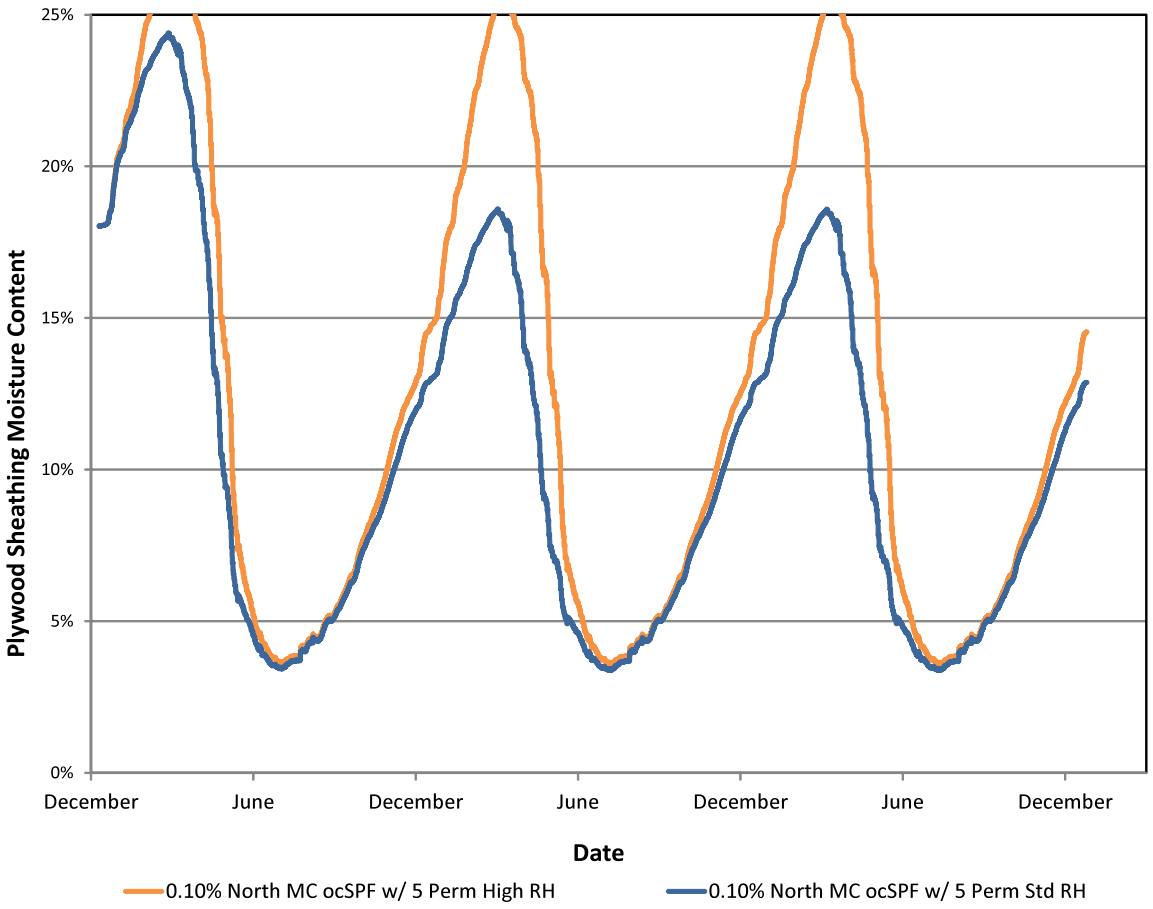
Figure 11. Minneapolis plywood sheathing MC ocSPF and high RH

Because the ocSPF more easily tracks interior RH, a comparison using only ocSPF was completed. Figure 11 shows the effect of increased RH on a system using ocSPF and a 5-perm coating with a 0.10% rainfall leak. With elevated interior wintertime RH of 40%, the plywood sheathing MCs rise above 25%, but are not sustained for a significant period of time. If interior RH is kept below 35% in this climate zone, this system can operate safely.

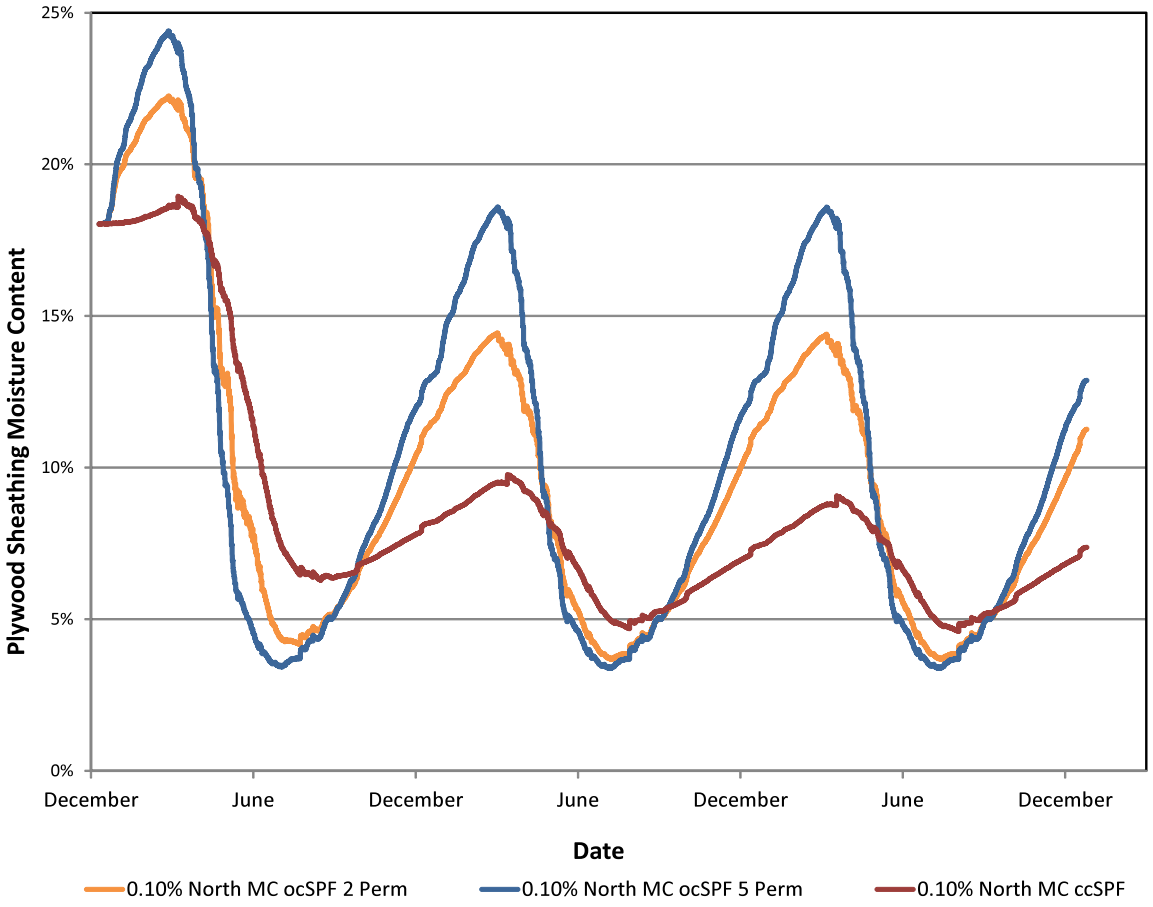
Figure 12. Minneapolis sheathing MC—ocSPF, 2 perm coating, and 5 perm coating

The coating on the interior of the ocSPF plays a significant role in the vapor transmission from the interior to the exterior in a cold climate. The ocSPF system in Figure 11 was altered to include an effective 2 perm coating instead of the 5 perm coating previously considered. This was modeled and compared to the ccSPF system. With a 0.10% rain leak, the MC of the sheathing is shown in Figure 12. The 2 perm coating with standard RHs reduces the sheathing MC by almost 5%, while using ccSPF decreases it another 5%. Both the 2 perm coating and 5 perm coating on ocSPF dry the sheathing faster than ccSPF, but both get the sheathing wetter during cold weather than ccSPF.

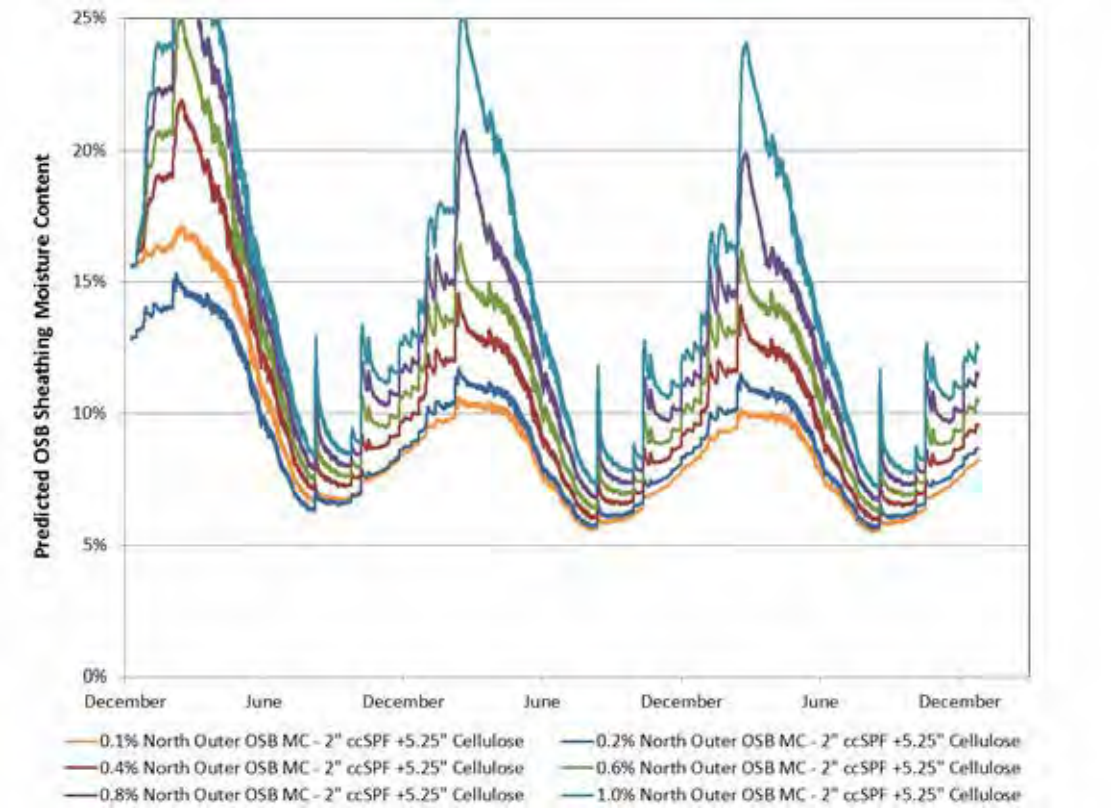
Figure 13. Seattle sheathing MC north 2 in. ccSPF + 5.25 in. cellulose

Similar to the data shown in Figure 5, 0.1%–1% of rainfall was injected into the sheathing and the resultant wood MCs were compared. The Seattle modeling shows that a roofing system using ccSPF insulation against the underside of the roof sheathing and cellulose insulation was able to

cycle 8%–24% MC with the influences of both indoor RH and up to the full 1% rainwater leak (Figure 13). The three-year analysis shows a drying trend of the system, although it is not recommended to allow MCs to regularly attain more than 25% for long durations, as occurs with the full 1% leakage. When the cellulose is replaced with fiberglass insulation (Figure 14) a very similar model is produced. In this system, cellulose and fiberglass perform nearly identically.

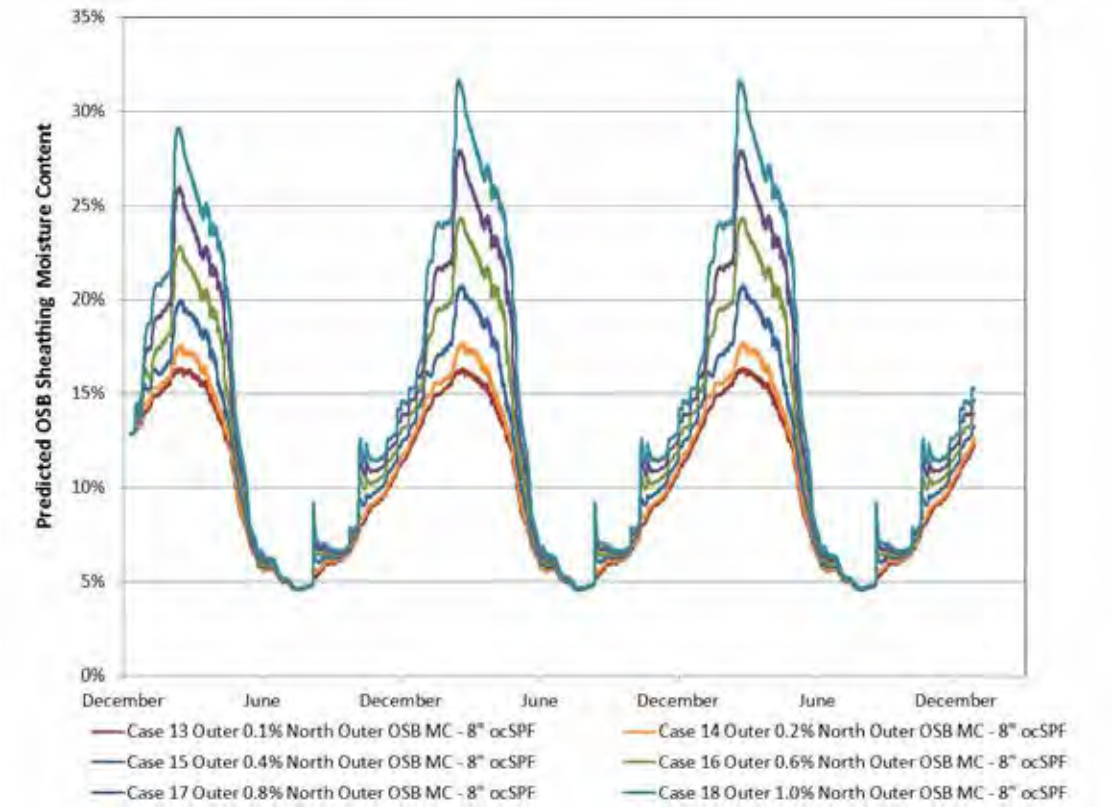
Figure 15. Seattle sheathing MC north 8 in. ocSPF

Climate zone 4 is a difficult climate in that there is relatively continuous rain-based wetting as well as inward and outward vapor drives due to the heating and cooling of the homes during the alternating seasons. Figure 15 shows the sheathing MC as modeled between 0.1% and 1% of the rainwater. The modeling shows an increasing trend to the sheathing MC if more than 0.6% of rainwater leaks into the assembly. This correlates with the data analyzed for Minneapolis. In the Seattle case, both rainwater leakage year round and outward vapor drive in cold weather caused increased MCs in the sheathing while drying abruptly occurred during warm weather with the relatively high vapor ocSPF.

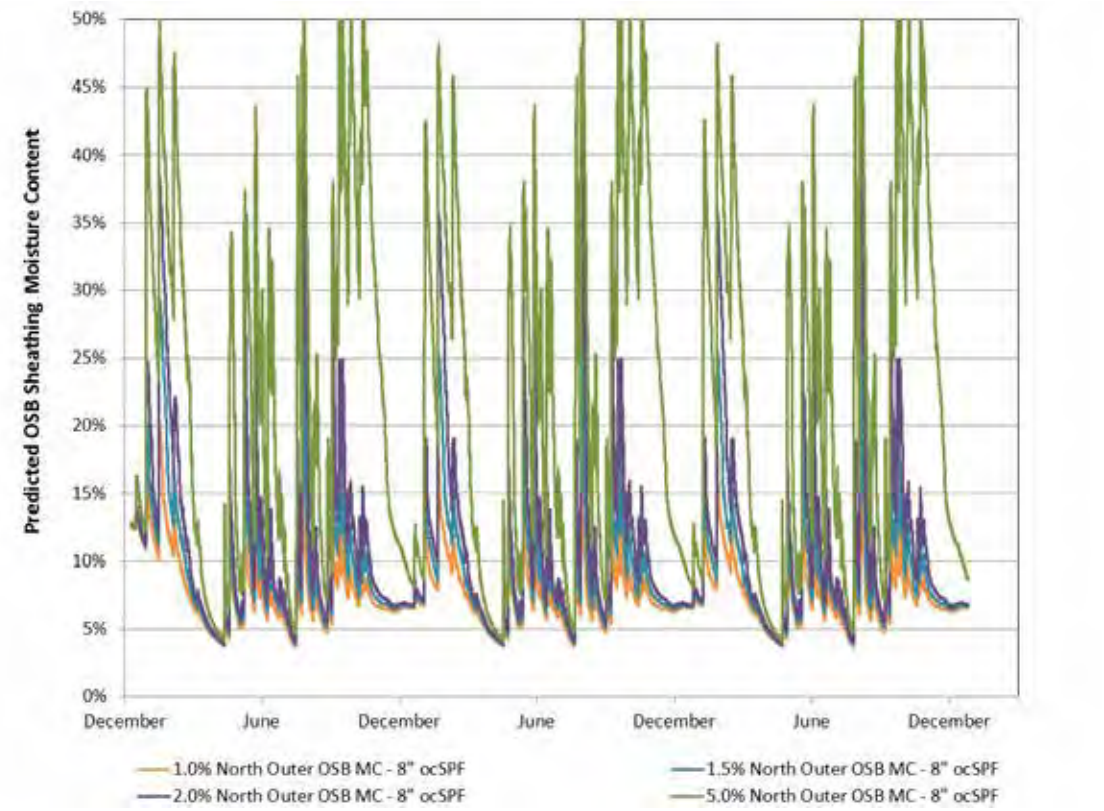
Figure 19. Miami sheathing MC north 8 in. ocSPF high stress

The Miami modeling was then further stressed to determine its upper limit of wetting. Using the ocSPF case, the rainwater percentage was increased from 1% to 1.5%, 2.0%, and then 5%. Figure 19 shows the sheathing MCs for the high leak rates in Miami using ocSPF. At the 2% step the roof began to have extended periods of time with the exterior layer of the sheathing experiencing MCs above 25% and as such the dryable limit was chosen as 1.5%.

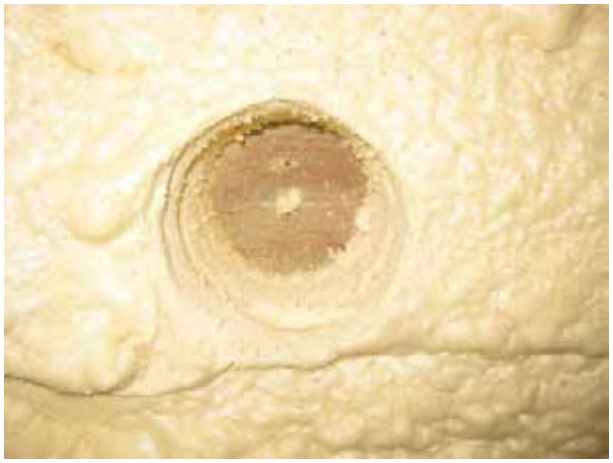
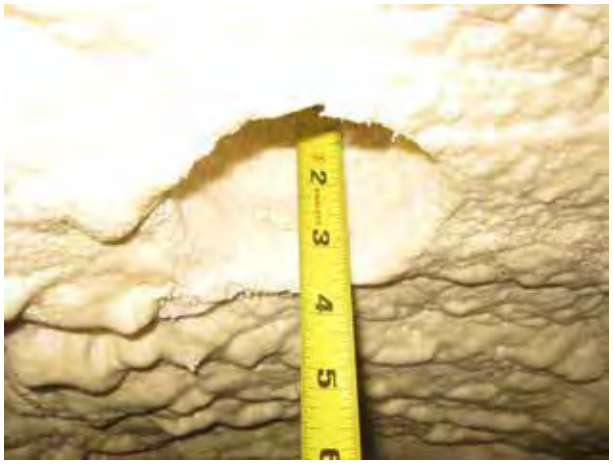
5.1 House 1: New Orleans, Climate Zone 2, June 2012

- Built 2009
- Cathedralized attic
- R-21—~3.5 in. ccSPF below OSB roof sheathing

- 6% moisture content reading
- No visible signs of moisture damage

- 7.5% MC reading
- No visible signs of moisture damage
