Byggmeister Test Home: Cold Climate Multifamily Masonry Building Condition Assessment and Retrofit Analysis

Building America Report - 1202

13 September 2012

Honorata Wytrykowska, Kohta Ueno and Randy Van Straaten

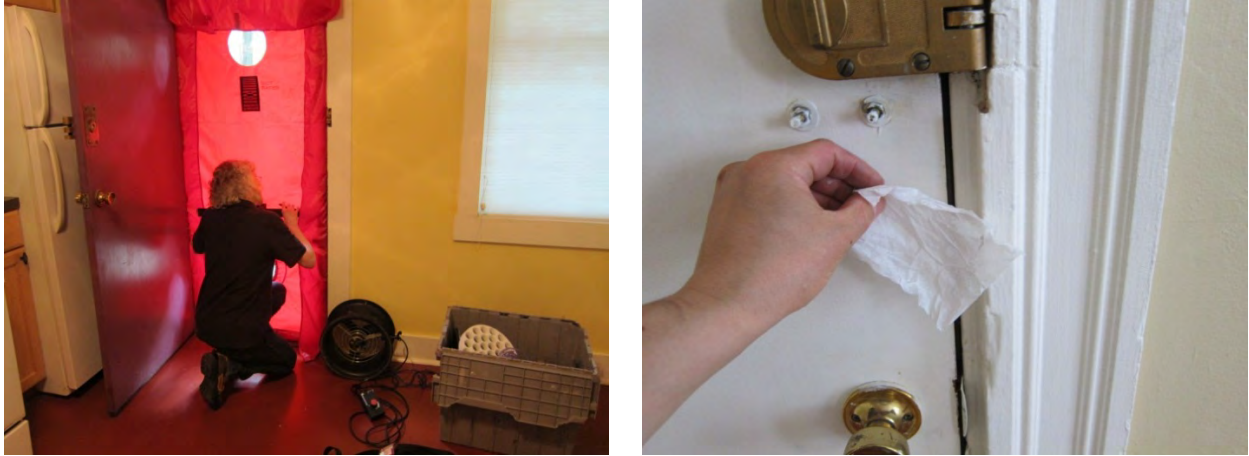
Figure 26. Airtightness testing; leakage at doors to hallway

Air leakage was evident at the hallway doors, which was expected given the lack of gaskets around the doors. In addition, air leakage was observed at electrical receptacles and from the ductwork grilles. This was not a guarded or nulled test, so results include leakage to the exterior and to other units.

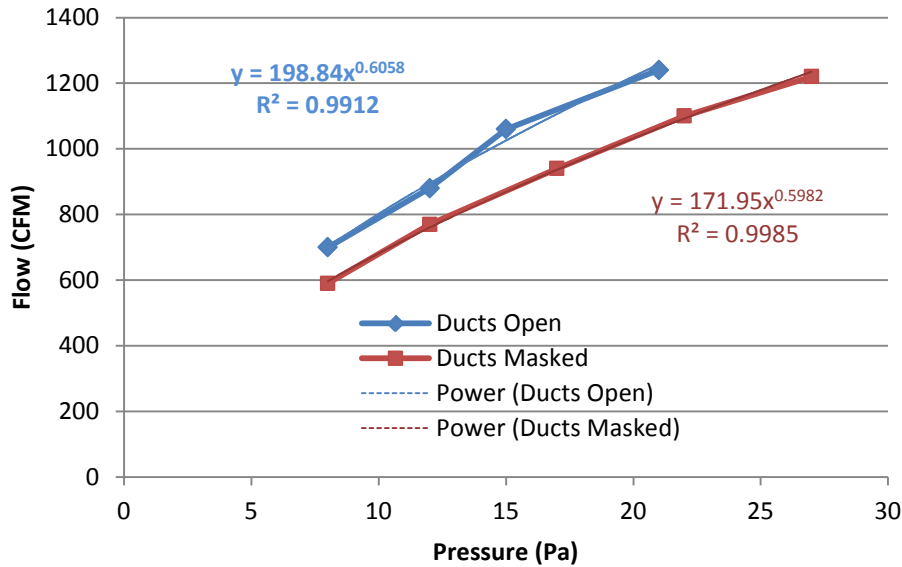
Figure 28. Multipoint air leakage testing of Unit 2

Therefore, multipoint air leakage testing was conducted with the grilles open and sealed with duct mask (i.e., subtraction method duct leakage test). The results are shown in Figure 28; note that the maximum pressure achieved was 27 Pa, so cubic feet per minute at 50 pascal test pressure (cfm50) results are extrapolated using the $Q = C \times \Delta P^n$ relationship.

Results indicate a large total enclosure air leakage; however, results do not indicate separate air leakage to the exterior (which would have impact on energy consumption). However, with conservative estimates of two-thirds of the total leakage to the exterior, this is still equivalent to 9 ACH at 50 pascal test pressure. In addition, 342 cfm50 is attributed to the ductwork system by the subtraction test. Assuming an exponent (n) value of 0.65 (in $Q = C \times \Delta P^n$), this leakage is equivalent to 218 cfm25. Note that leakage to the exterior via the ductwork system represents a large portion (16%) of total enclosure leakage. However, direct testing of the duct system leakage was not conducted due to time constraints; only a subtraction test was done.

Additional testing, such as guarded/nulled tests to separate interior and exterior leakage and whole-building (single zone) test to determine aggregate exterior air leakage, would be useful.

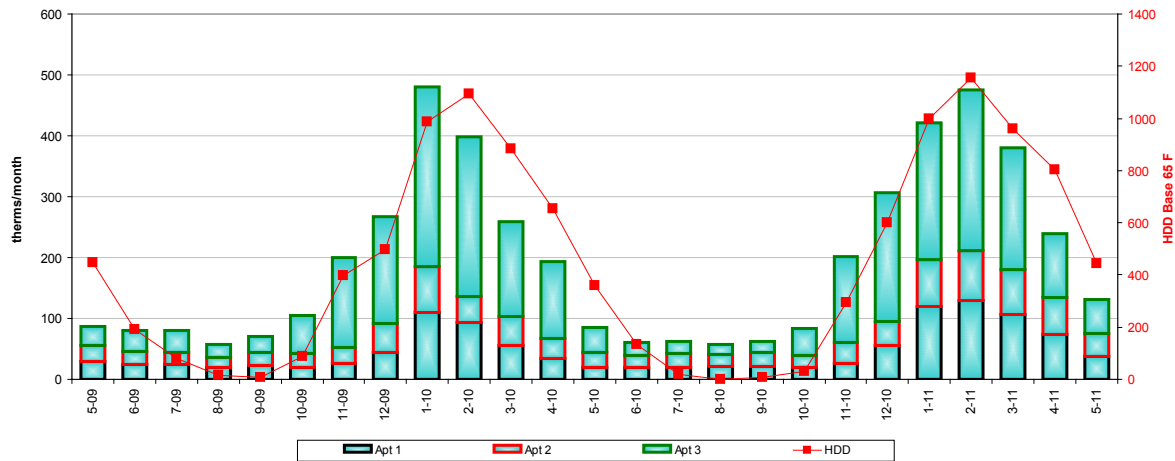
Figure 30. 25 months' gas usage and HDD base 65°F for all three apartments

Natural gas data, plotted in Figure 30, was available for 25 months for all apartments. The owner noted that the residents of Apartment 3 were from a warm climate and, hence, used an exceptionally high setpoint which resulted in the high gas usage for Apartment 3.

Comparing the data points for Apartment 3 in Figure 31 clearly shows the effect of occupant behavior on natural gas consumption. Except for the high-user in Apartment 3, all data follow similar patterns, with wintertime peaks in the 100–150 therms per month range and baseline (gas cooking plus DHW) use of approximately 20 to 25 therms per month. Given the potential effects of occupancy and setpoint, it is difficult to draw any conclusions on energy use due to exposure (i.e., Apartment 2 lower due to less exposed surface area).

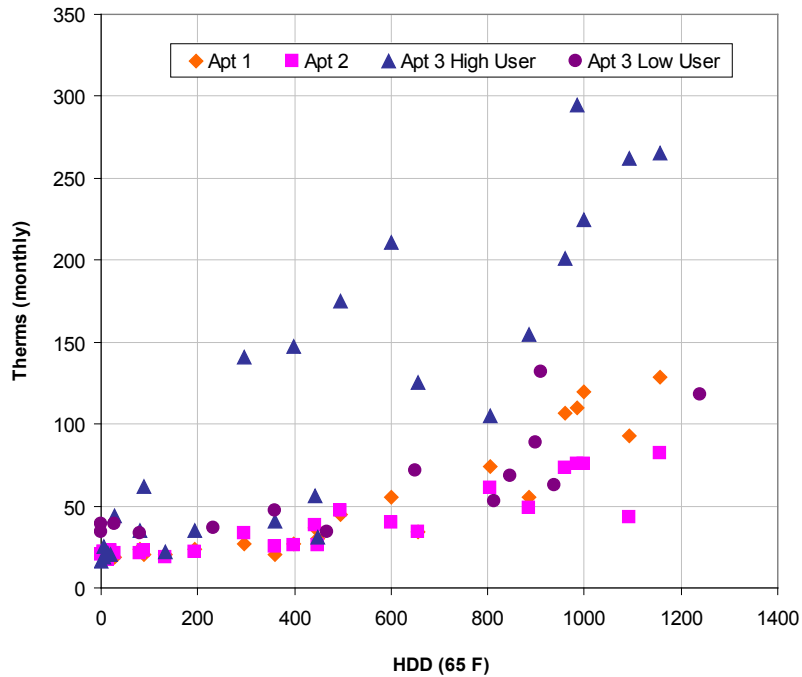
Figure 31. Monthly gas use (therms) versus heating degree days (HDD 65°F)

Because of the abnormally high usage for Apartment 3, the owner provided gas use data for Apartment 3 from 2008 when it was occupied by previous tenants. Instead of plotting this data separately, BSC generated an x-y plot of gas use (therms/month) against monthly heating degree days for all apartment data, as shown in Figure 31.

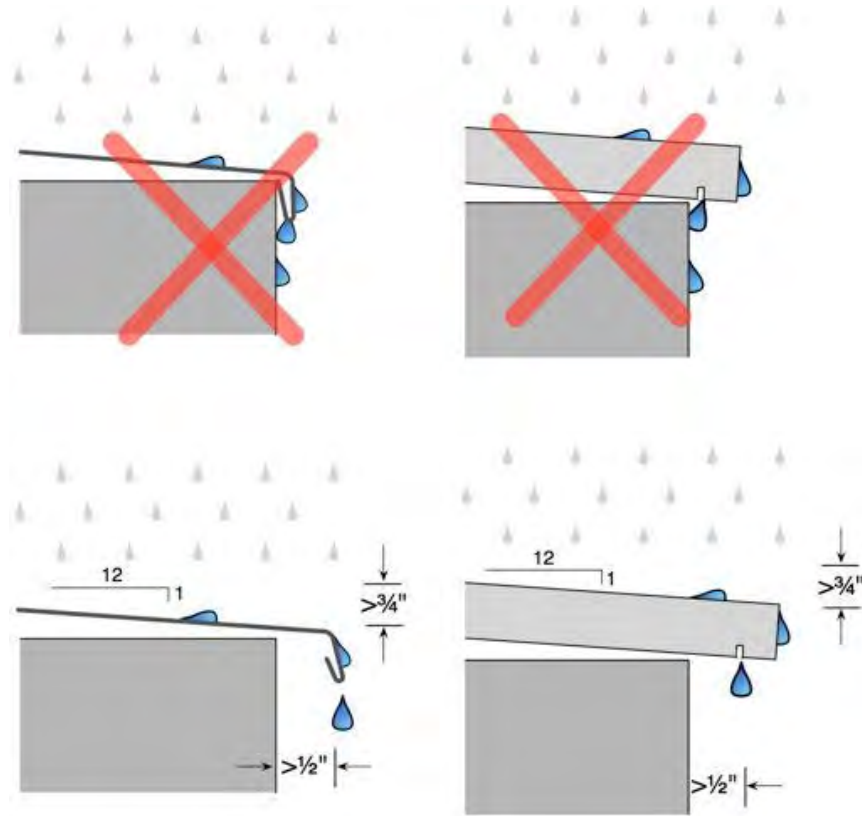
The exterior mass masonry shows signs of water accumulation under the windows due to the lack of a drip edge. As shown in Figure 35, a lacking or inadequate drip edge can cause bulk water to deposit onto the wall below a window (which is a water concentration detail due to the non-porous surface of the glass).

Figure 35. Drip edges and sloped window sills are critical deflection elements (Straube 2011)

Therefore, in conjunction with the interior wall insulation, drip edge detailing is required at the window sill stone bands. Due to the geometry, the retrofit of a "notch" drip edge is not possible; therefore, BSC recommends using a regletted metal drip edge (cut into the masonry).

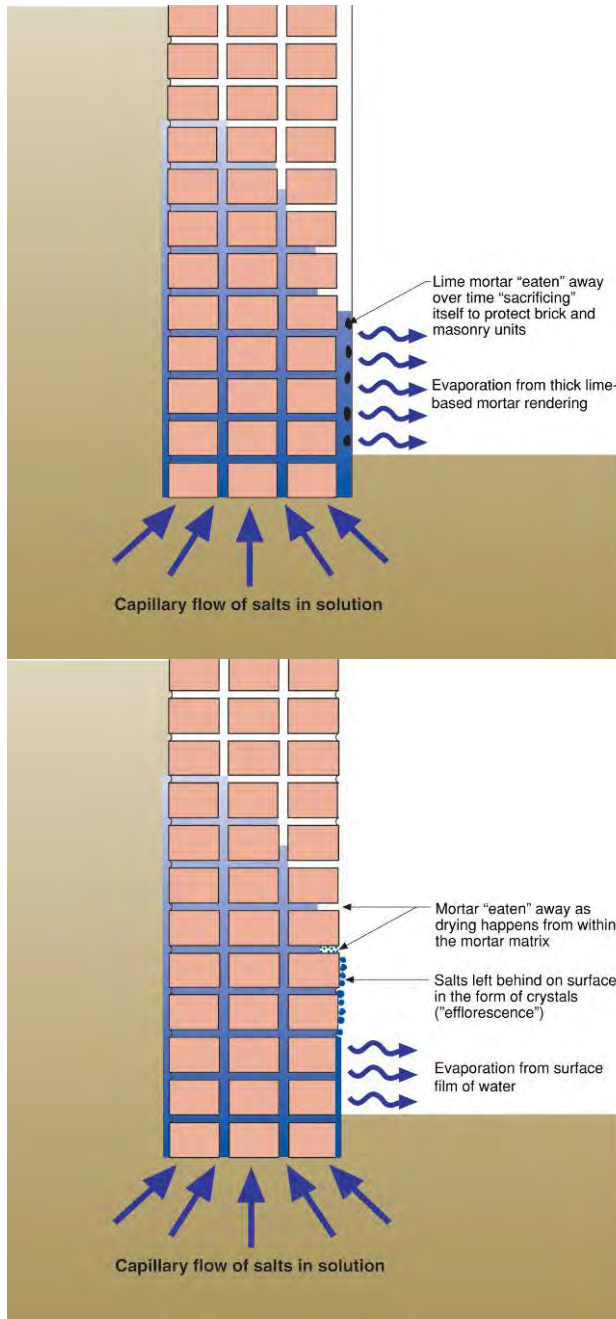
The foundation wall shows evidence of capillary rise (a.k.a. "rising damp") as moisture from the ground is drawn into the porous brick foundation. This rising moisture results in loss of the surface parging, erosion of mortar joints, and damage to exposed brick surfaces, as discussed by Lstiburek (2007b). This process is shown graphically in Figure 36.

Figure 36. Parging and mortar erosion due to capillarity (Lstiburek 2007b)

Adding interior insulation will reduce drying potential to the interior, which will reduce the rate of efflorescence, subfluorescence, and mortar erosion. However, it is unknown if this might result in subfluorescence damage to the brick. BSC will study this in a future project, Hybrid Foundation Insulation Retrofits.

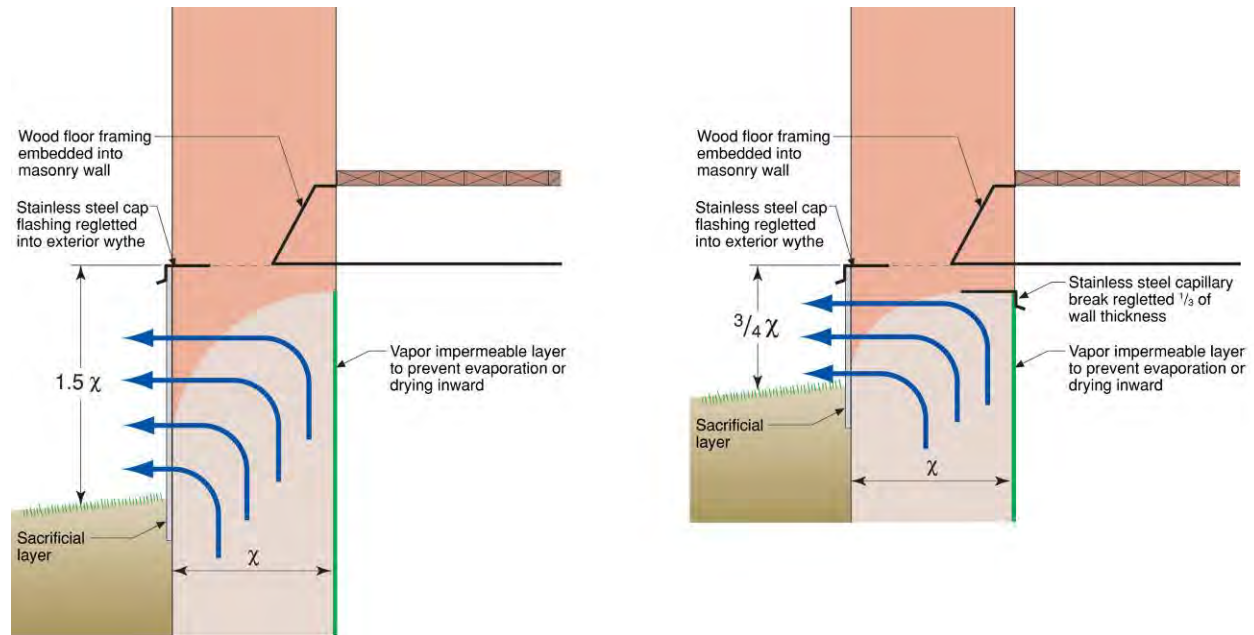
Figure 37. Reglet details to protect embedded beam ends (Lstiburek 2007)

Another potential risk of adding interior insulation is that moisture from the ground will no longer dry to the interior of the basement; it is possible that the moisture might continue to rise upward, resulting in moisture damage to the ends of the structural wood member embedded in the masonry. Regletted metal details to prevent capillary transport are shown in Figure 37. Note

Another potential solution is "injectable damp proofing courses" that appear to be commonly available in the United Kingdom and Europe. Their installation involves drilling a horizontal series of holes in the mortar joint, and injecting a silane/siloxane-based cream into the holes. The cream is reported by manufacturers to migrate laterally, resulting in reduced capillary uptake at this mortar joint as silanes and siloxanes change surface tension (and therefore capillary transport) in porous materials. The holes are then plugged for appearance.

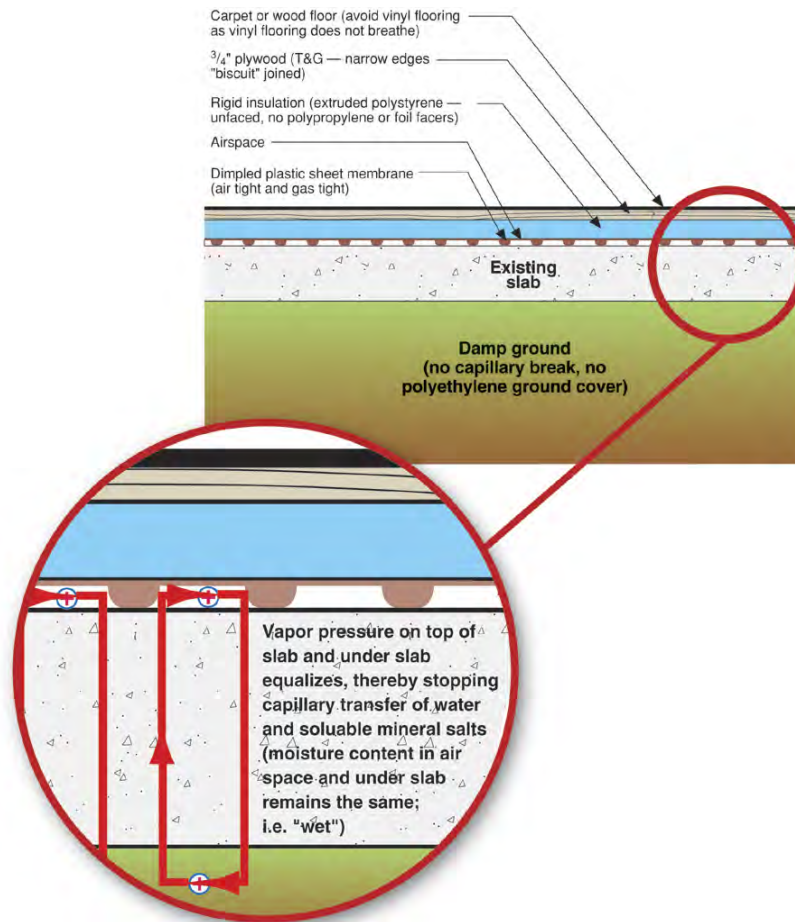
As noted above, there were no significant energy savings associated with insulation of the basement slab, but it is recommended for moisture control. If National Grid DER program requirements are not being followed, it may be permissible to omit the rigid foam insulation. This will likely increase the risk of storage of moisture-sensitive materials (e.g., boxes) on the surface. However, there is some minimal R-value associated with the air gap membrane, even though it is bridged by dimples (roughly R-1), thus providing some thermal break from the concrete slab.

Figure 39. Use of air gap membrane and insulation as a "wet slab" retrofit (Lstiburek 2008)

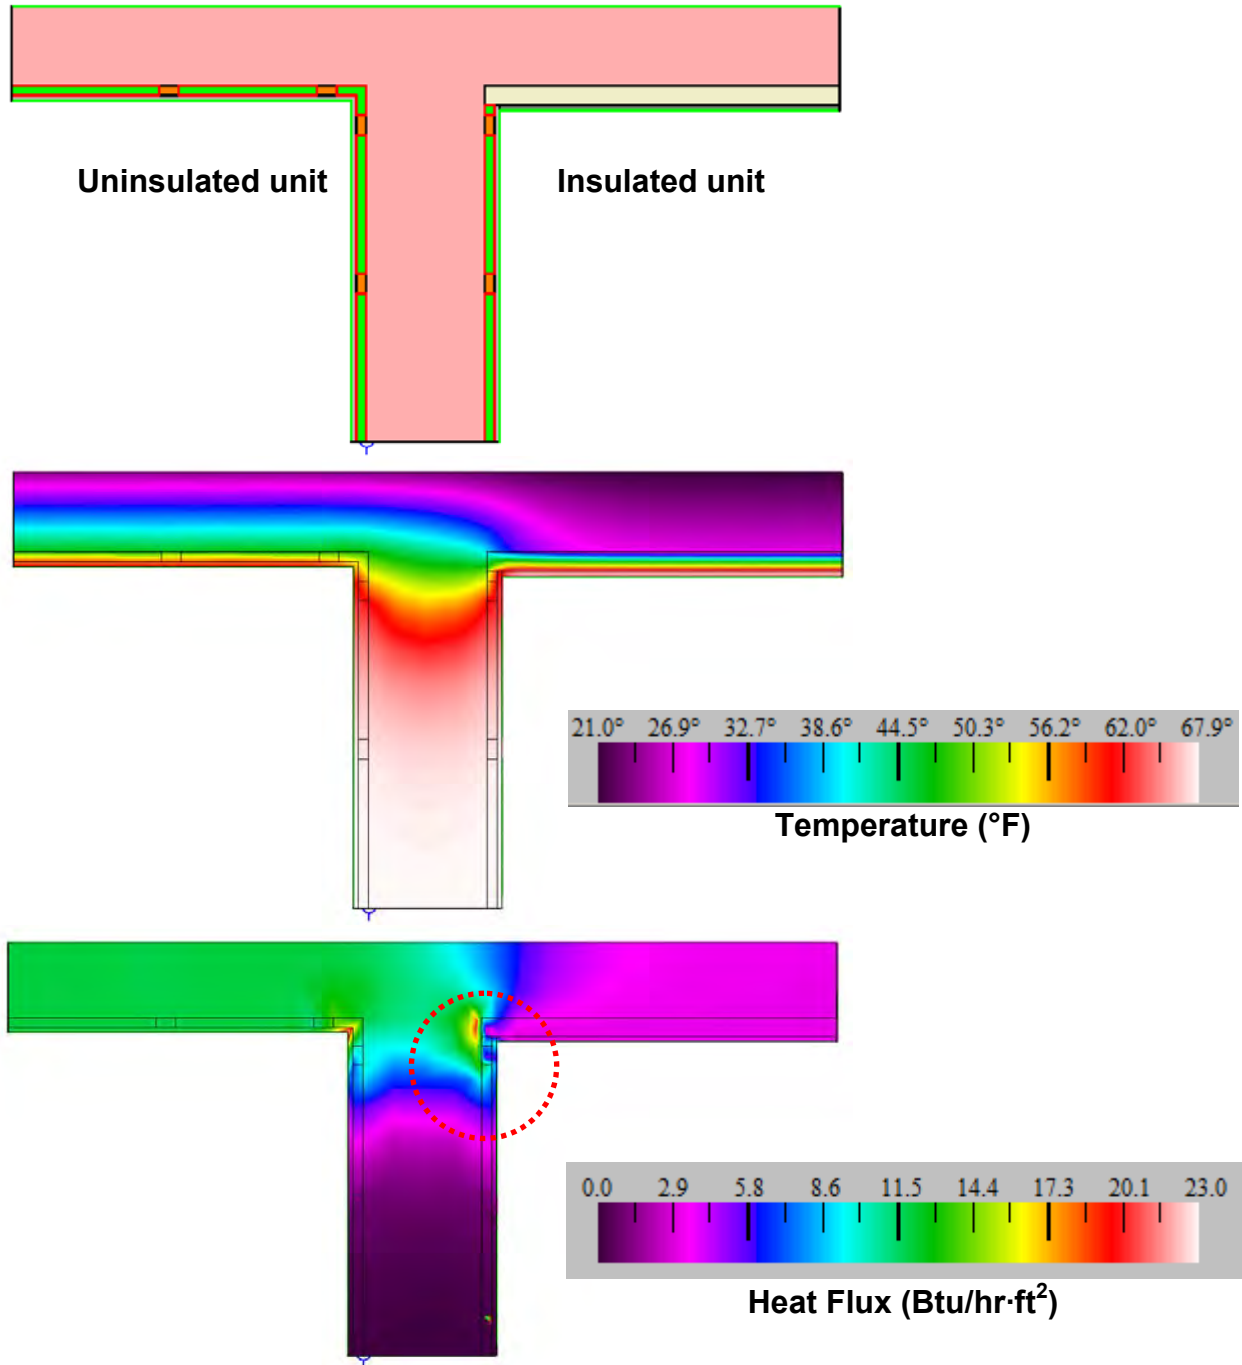
One common concern in interior retrofits has been the possibility of condensation on uninsulated interior surfaces adjacent to the insulation; it is likely that the surfaces will be colder than their original condition, increasing condensation risks. However, the temperature distribution on the tee wall seems to indicate that temperatures of exposed surfaces (at the corner) are roughly the same as they are in the uninsulated case, indicating no increased condensation risk.

Figure 43. Tee wall with 2-in. spray foam depicting materials, temperature, and heat flux

Heat flux measurements show that adding insulation greatly reduces heat flux through the insulated wall, as would be expected. The greatest heat flux occurs at the interior corners (area

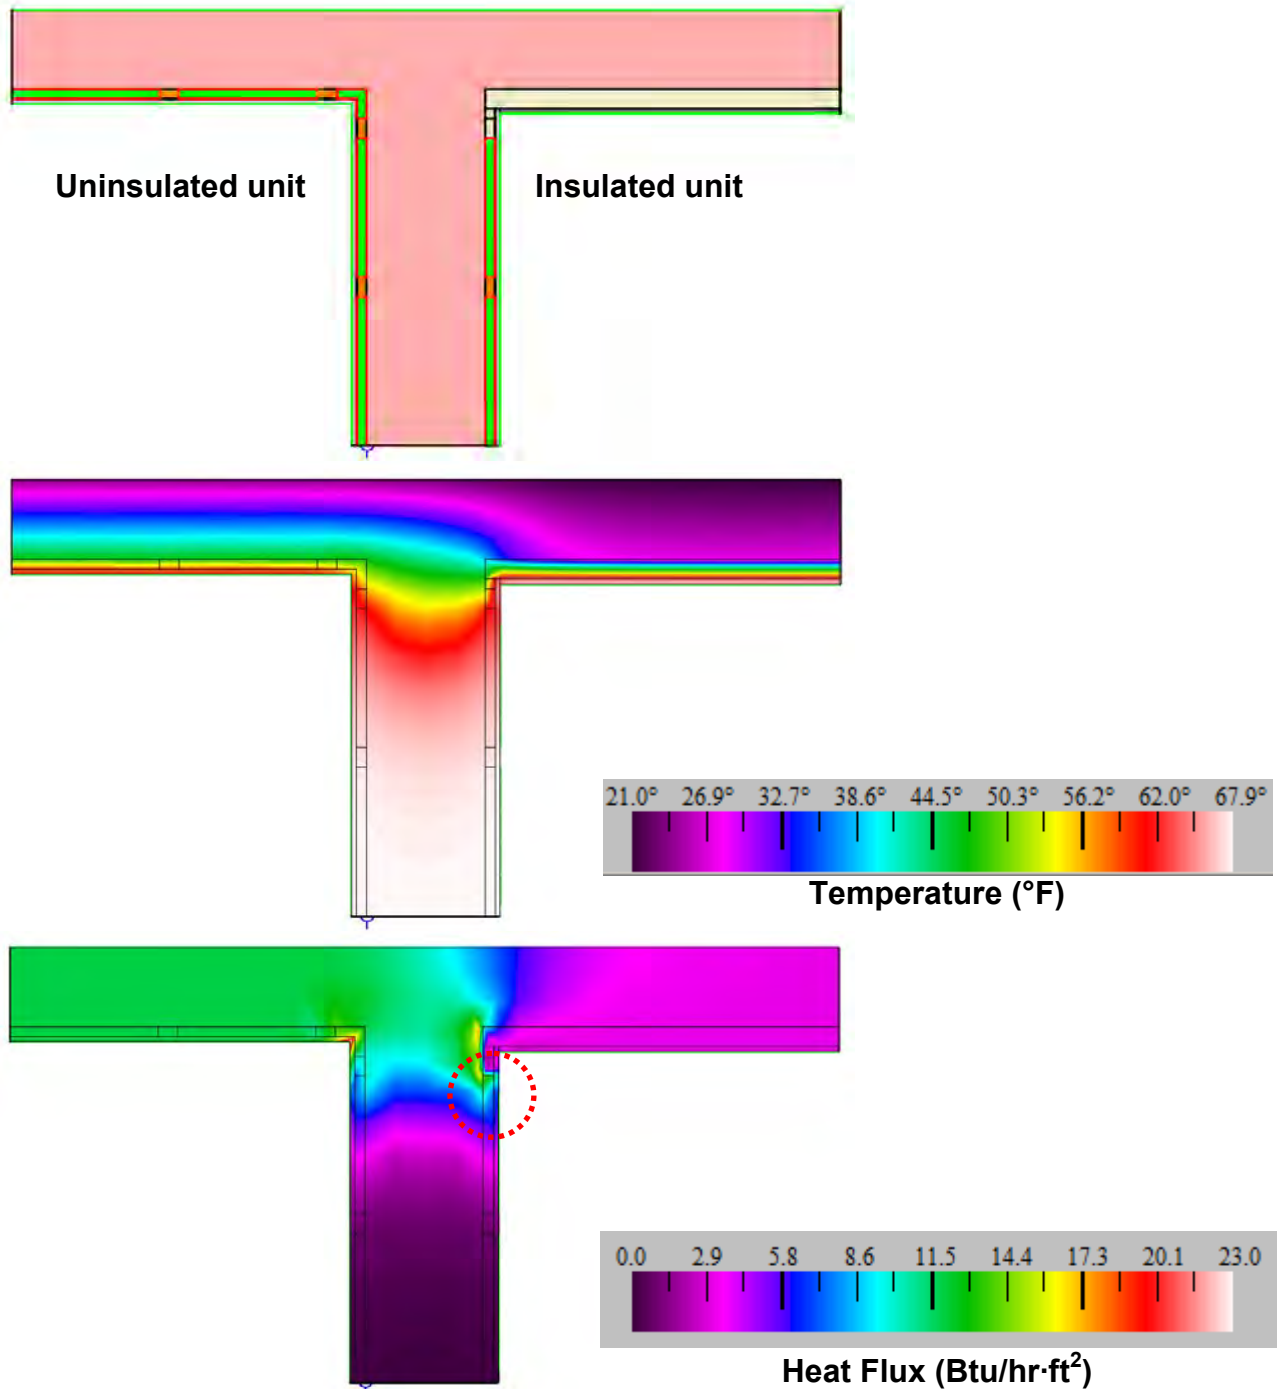
Figure 44. Tee wall with 2-in. spray foam and foam at corner depicting materials, temperature, and heat flux

In these simulations, the highest heat flux is reduced, and interstitial condensation risks are minimal—in fact, there is less risk than in the base, uninsulated case. However, there are still

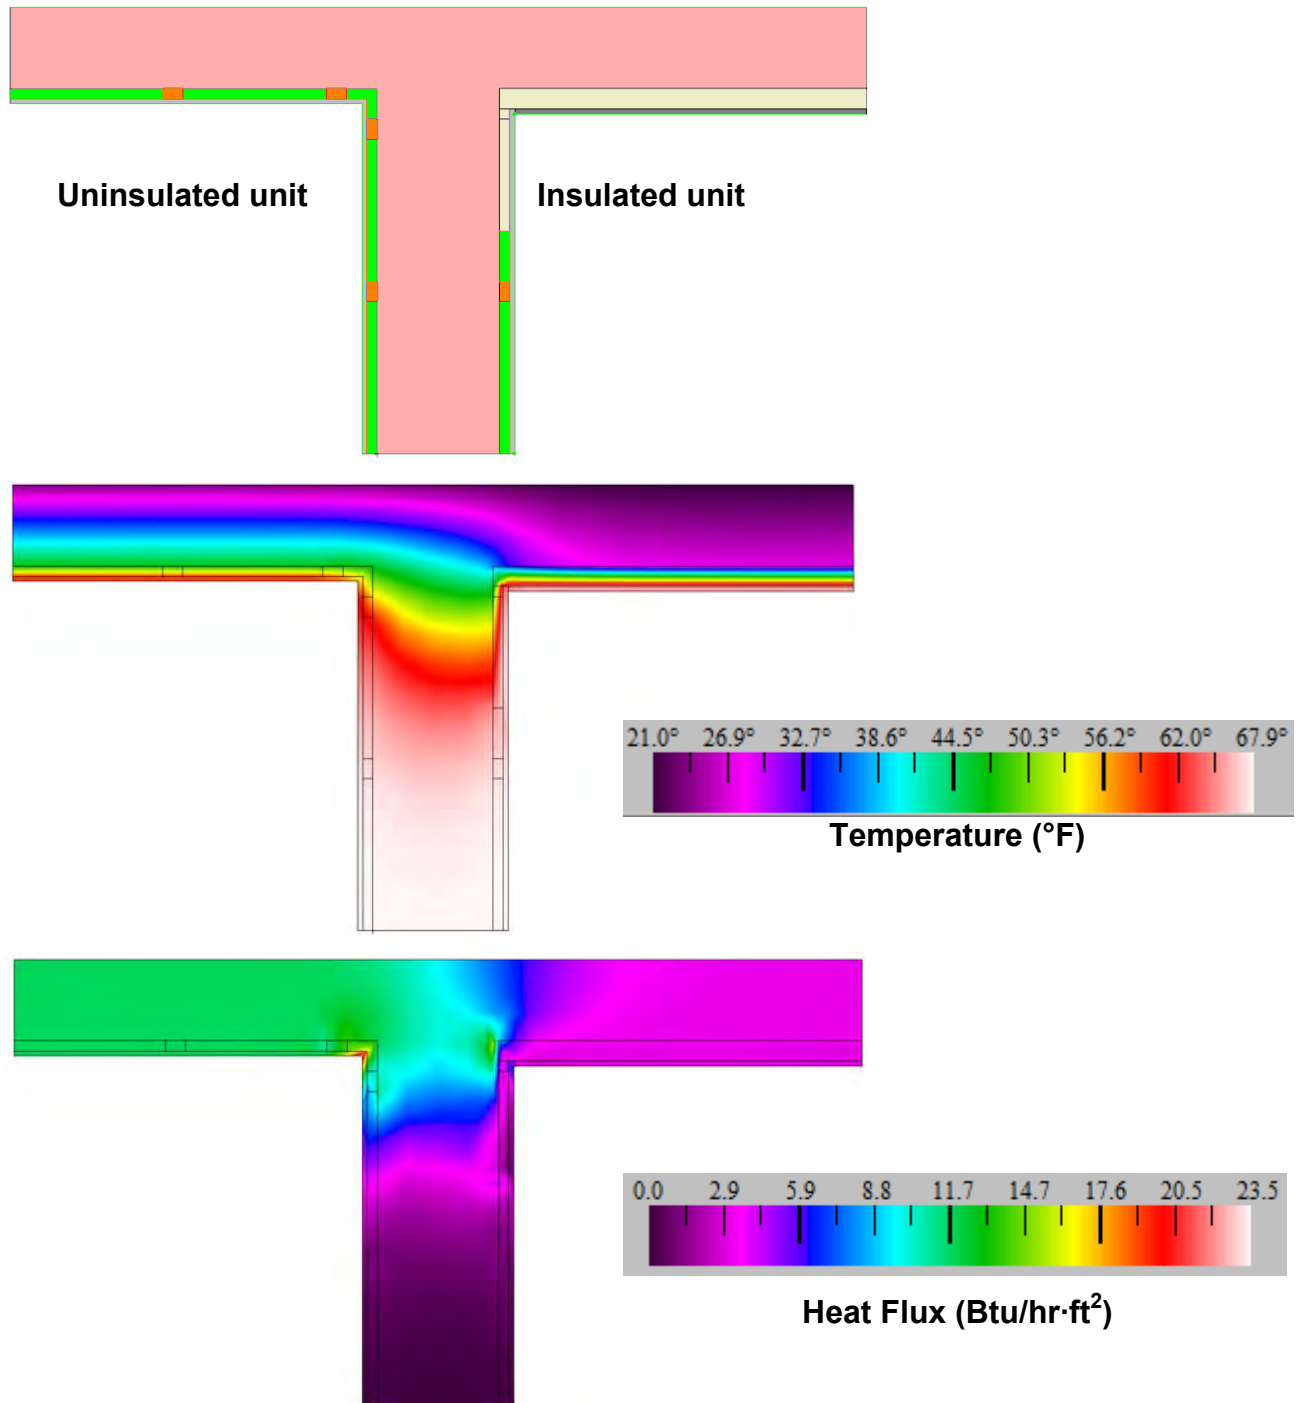
Figure 45. Tee wall with 2-in. spray foam and 1-ft. foam at corner depicting materials, temperature, and heat flux

These simulations show that the overall heat flux due to corner effects is strongly reduced by extending the tee wall insulation by a ft. However, it is vital to remember that these results are specific to the geometry of the building, and the relative thermal characteristics of the masonry

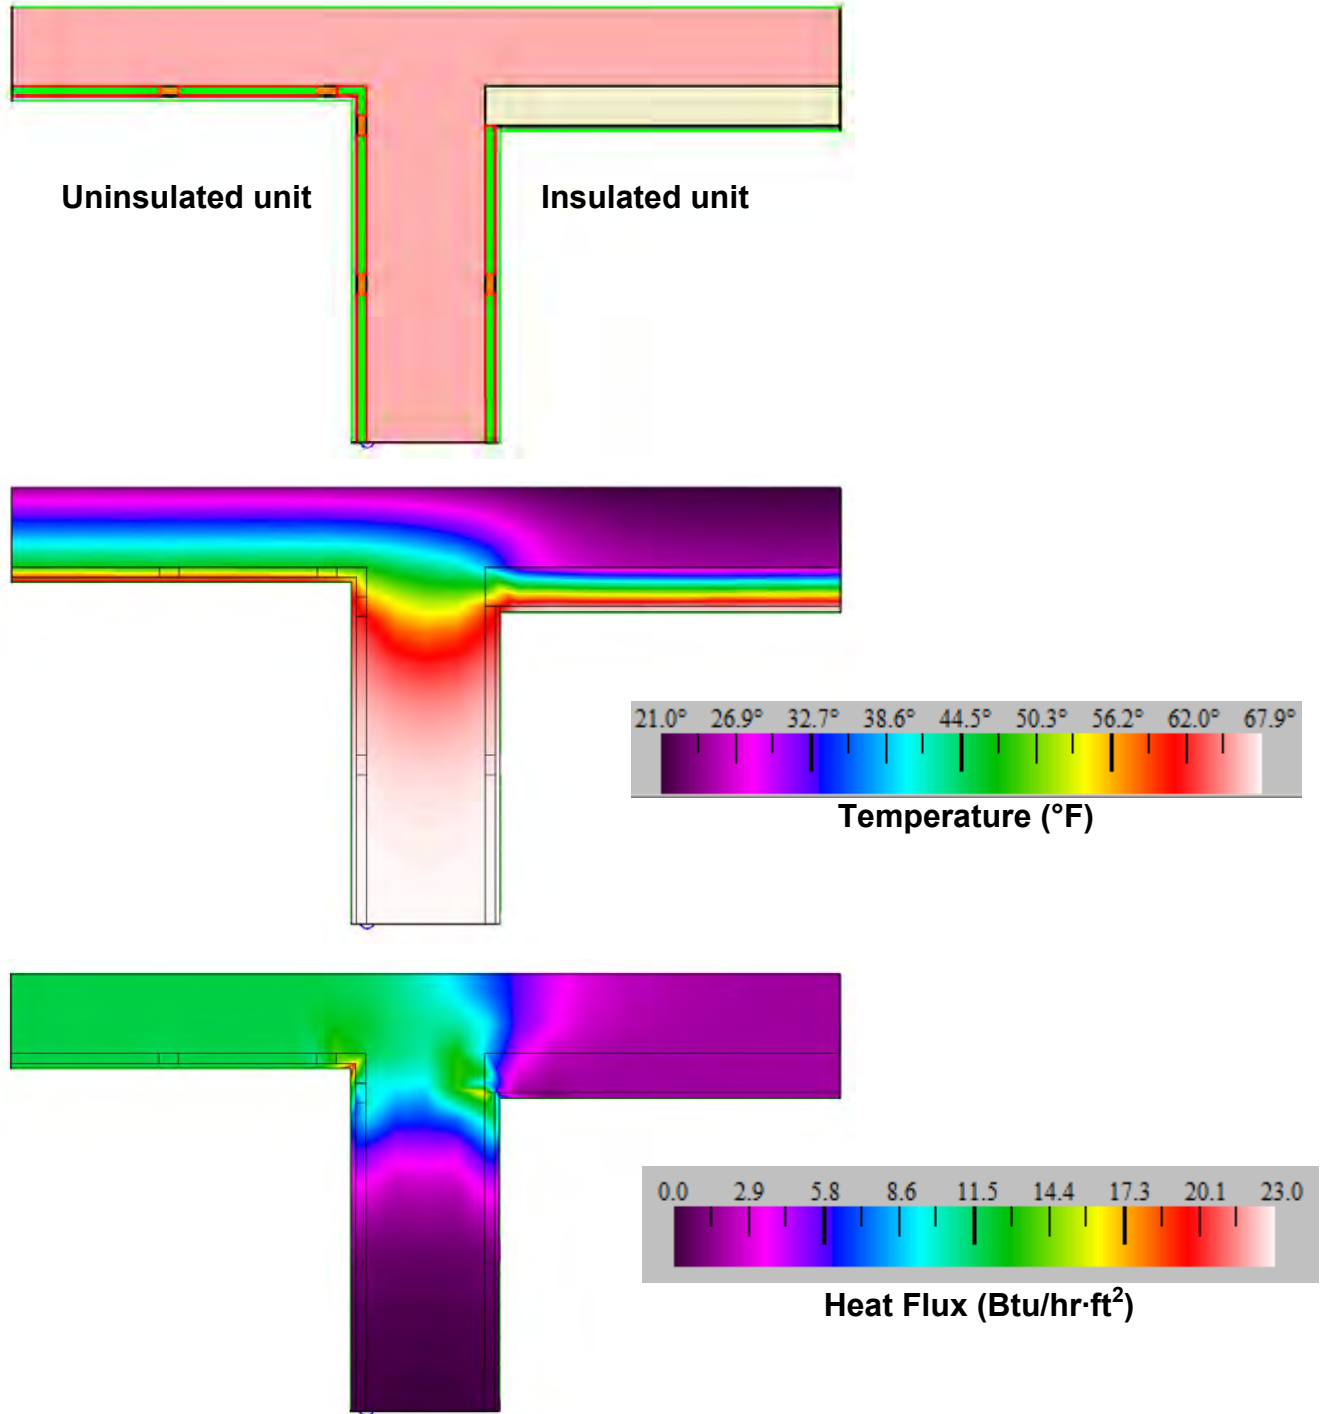
Figure 46. Tee wall with 4-in. spray foam depicting materials, temperature, and heat flux

Similar to previous cases, Figure 46 shows that heat flux through the party wall does occur. However, surface temperatures do not appear to pose a condensation risk in the postretrofit unit. Overall, if the deep energy retrofit insulation option is considered, extending this insulation onto the party wall is a reasonable step to limit heat flux.

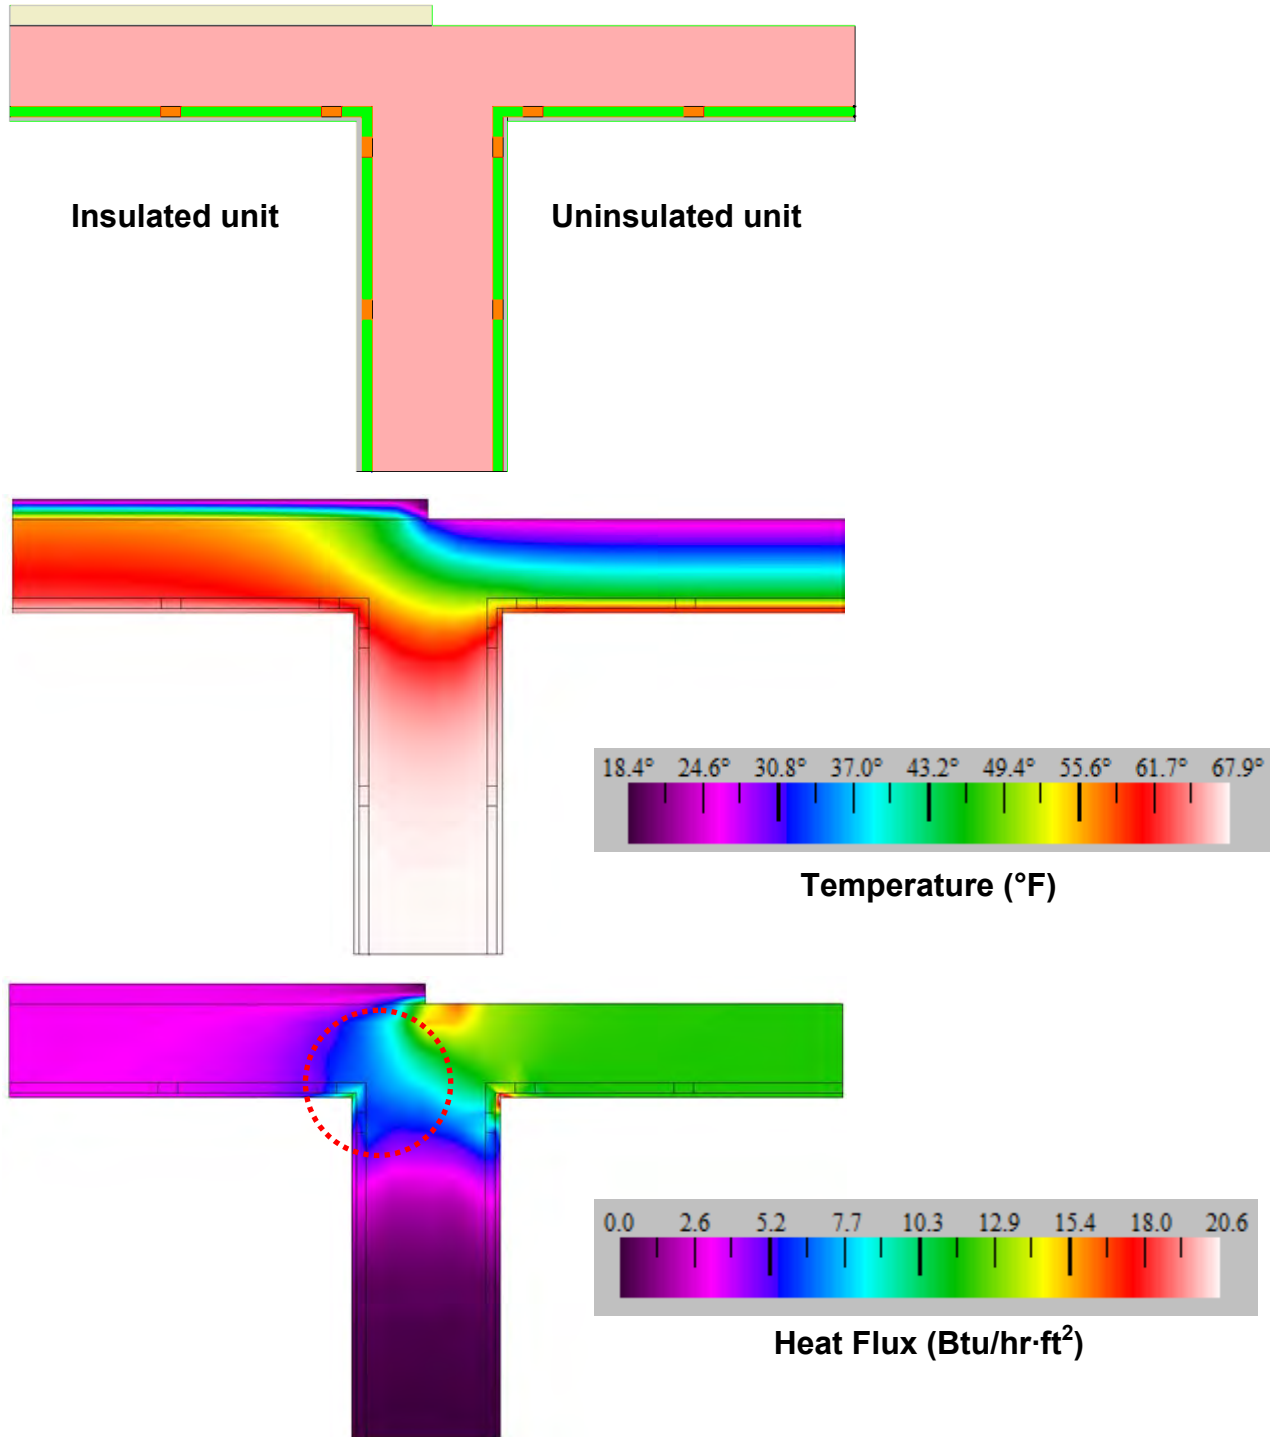
Figure 47. Tee wall with exterior insulation (base case) depicting materials, temperature, and heat flux

However, Figure 47 shows noticeable heat flux from thermal bridging through the masonry at the tee wall, even with exterior insulation. Therefore, simulations were run extending the exterior insulation past the midpoint of the party wall, to the far side of the masonry wall (Figure 48).

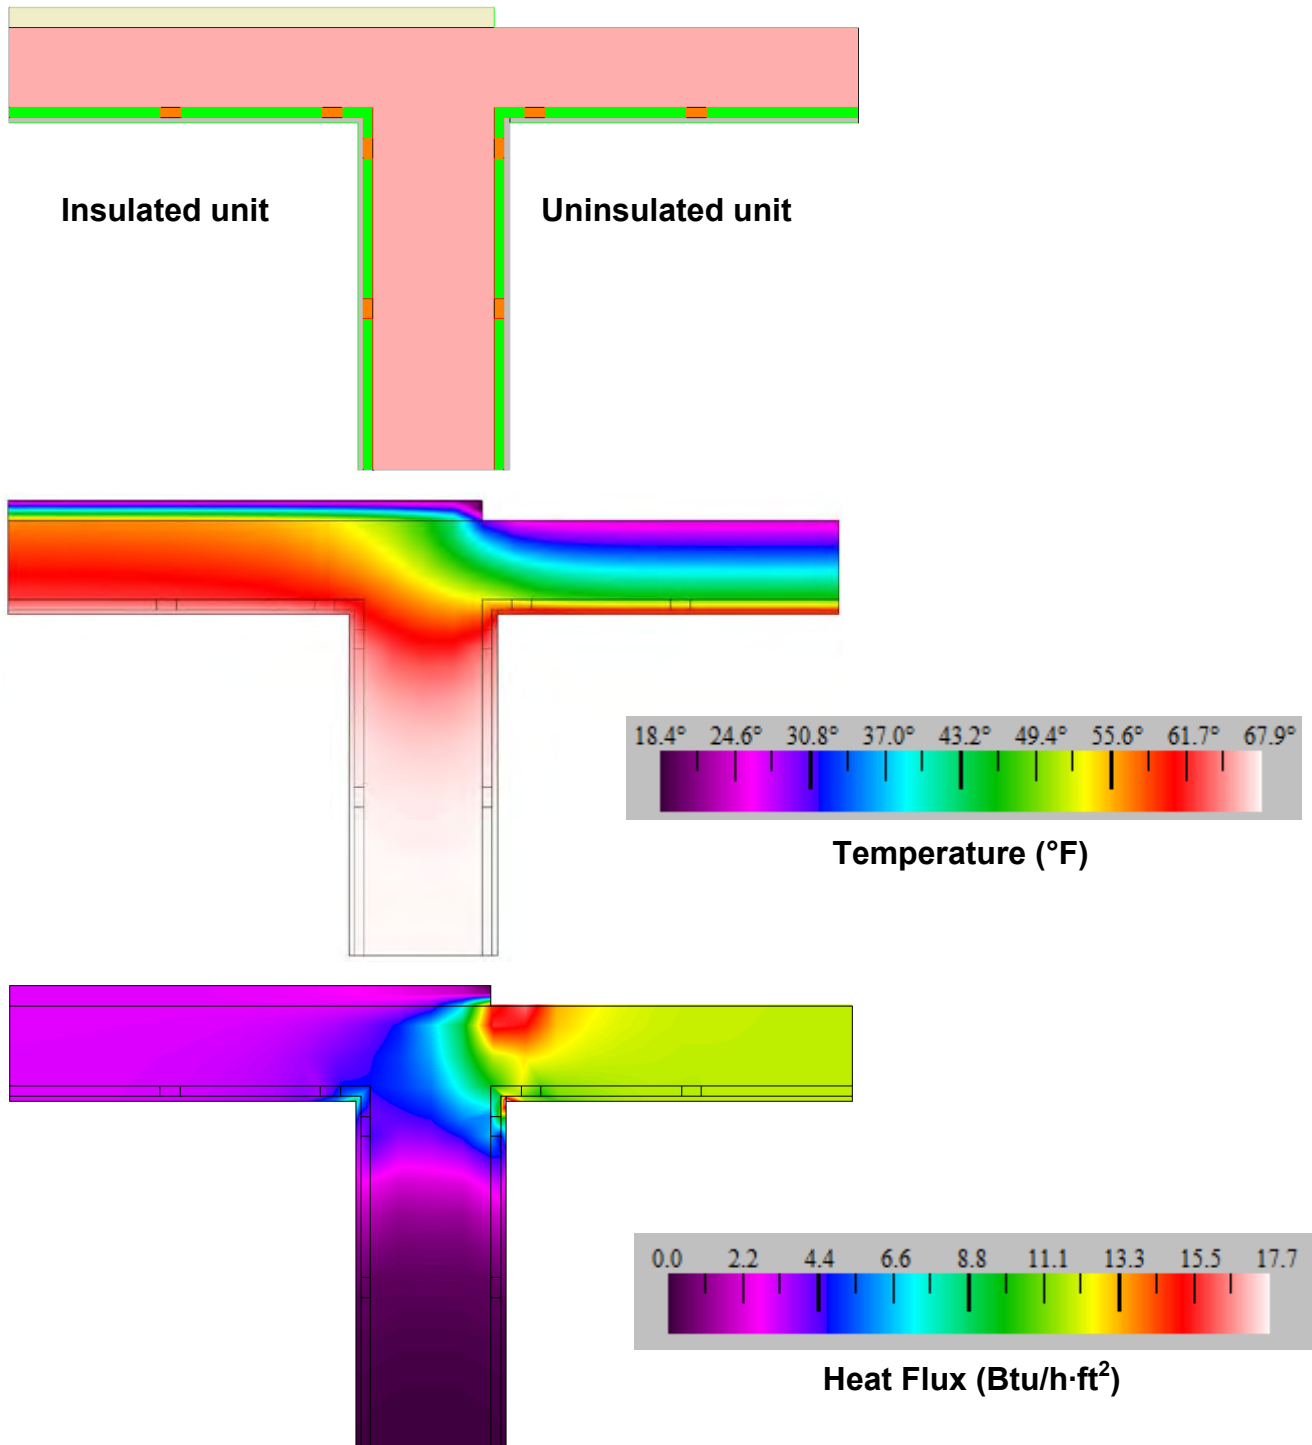
Figure 48. Tee wall with extended exterior insulation depicting materials, temperature, and heat flux

This change significantly reduces the heat flux from the insulated corner. Note that the color key in Figure 48 differs from previous runs, so the images should not be compared directly. Specifically, the heat flux in the corner is close to 7 Btu/h·ft^2, while in the previous case (non-extended insulation), it was closer to 9 Btu/h·ft^2 or higher. If this additional insulation is a

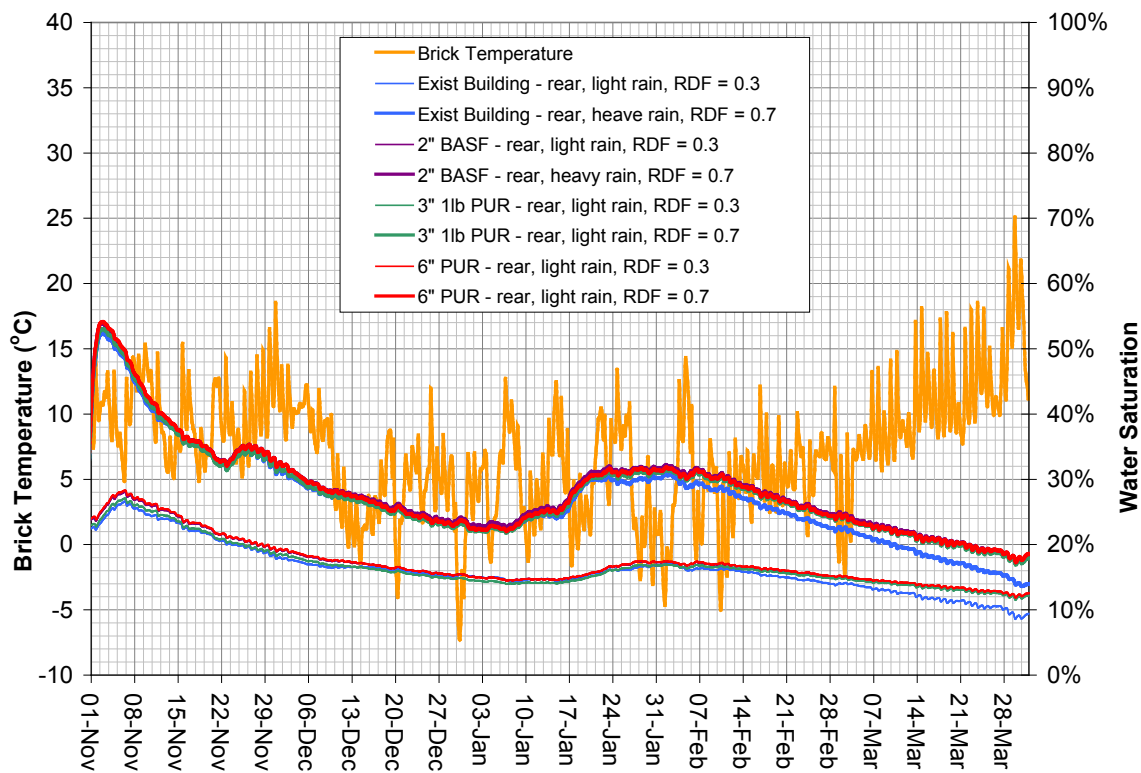
The east façade rain exposure was higher in the model, and the brick had a greater liquid water uptake rate. If the actual S_{crit} of the brick is close to 0.4, the model (see Figure 55) shows significant increases for FT degradation risk due to any of the retrofit strategies. If the actual S_{crit} of the brick is close to 0.7, the model shows that only the retrofit option of adding 3 in. of 1 lb/ft^3 spray foam results in a similarly low FT degradation risk where rainwater concentrations are avoided.

Figure 54. Predicted winter conditions at back of rear face brick

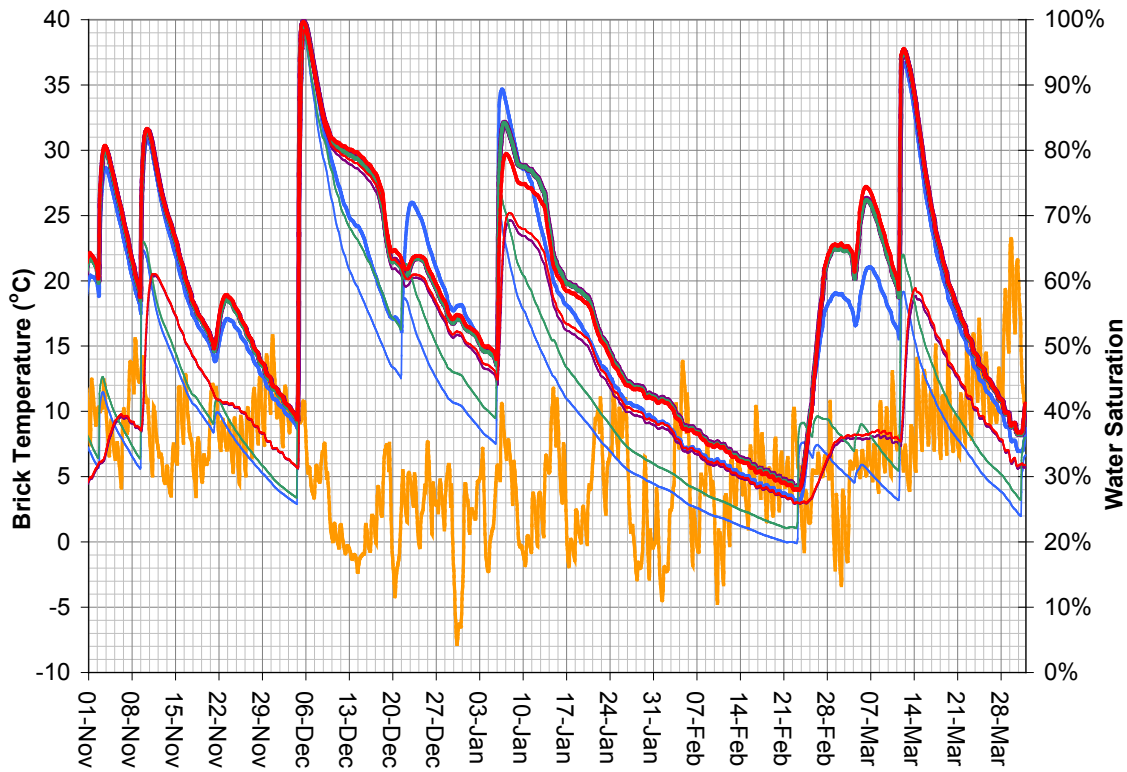
Figure 55. Predicted winter conditions at back of front face brick
