Forensic Engineering Practice Lessons

Case Study of a Multi Building Cladding Failure
in New Zealand

Brian Hubbs, P.Eng.
Principal, RDH Building Science Inc.
bch@rdh.com

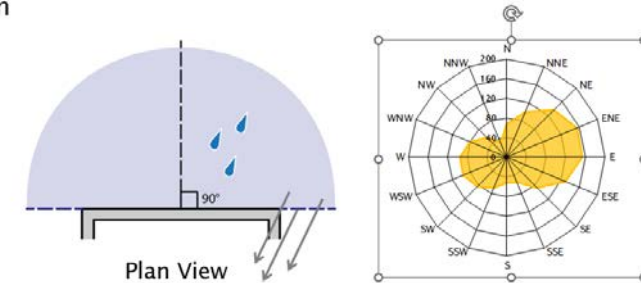
Additional NZ Exposure Risks: Driving Rain

→ Wind zones do not take into account prevailing wind direction for **Driving Rain**

→ Wind within 90° of the facing direction contributes to driving rain

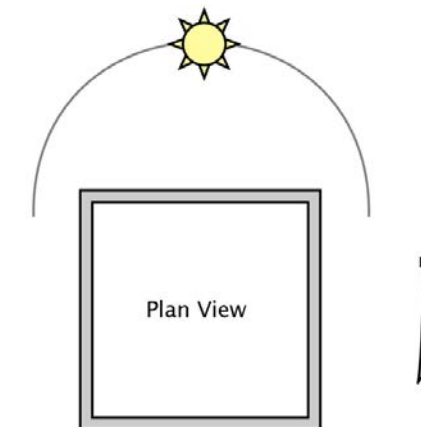
Additional NZ Exposure Risks: Solar Radiation

→ North-facing elevations shown to be at lower risk of moisture accumulation due to solar drying potential

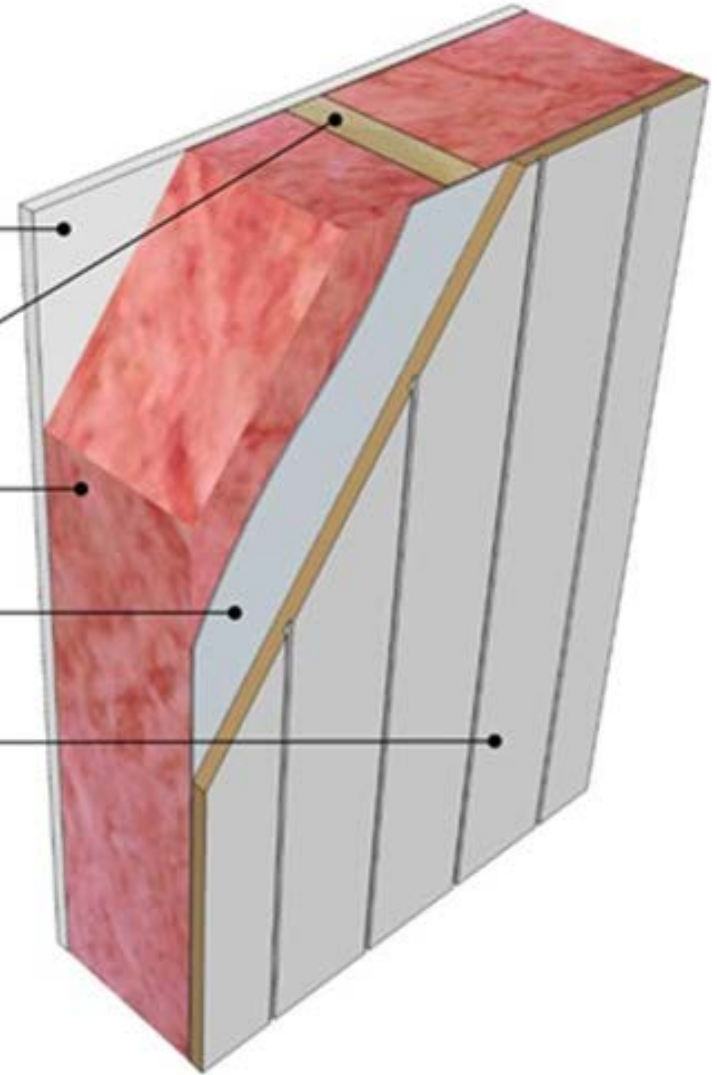
The Problematic Wall Assembly

Interior

Interior Finish

Wall Framing

Batt Insulation in Cavity

Building Paper

Plywood Cladding

Exterior

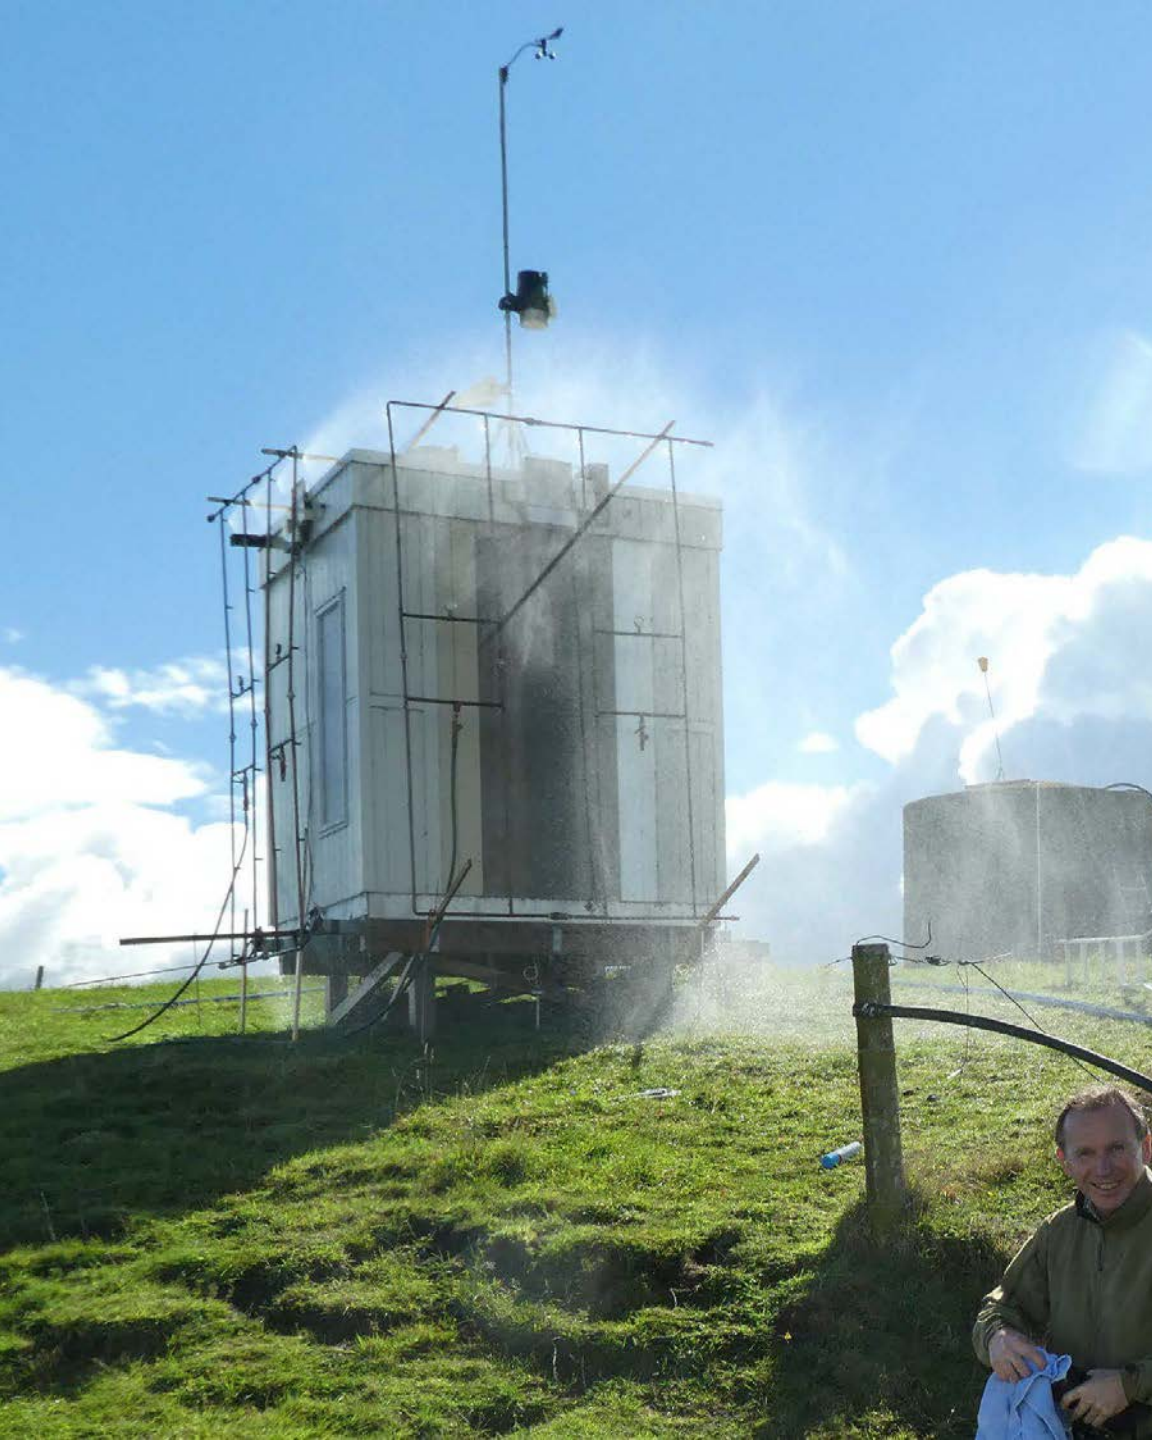
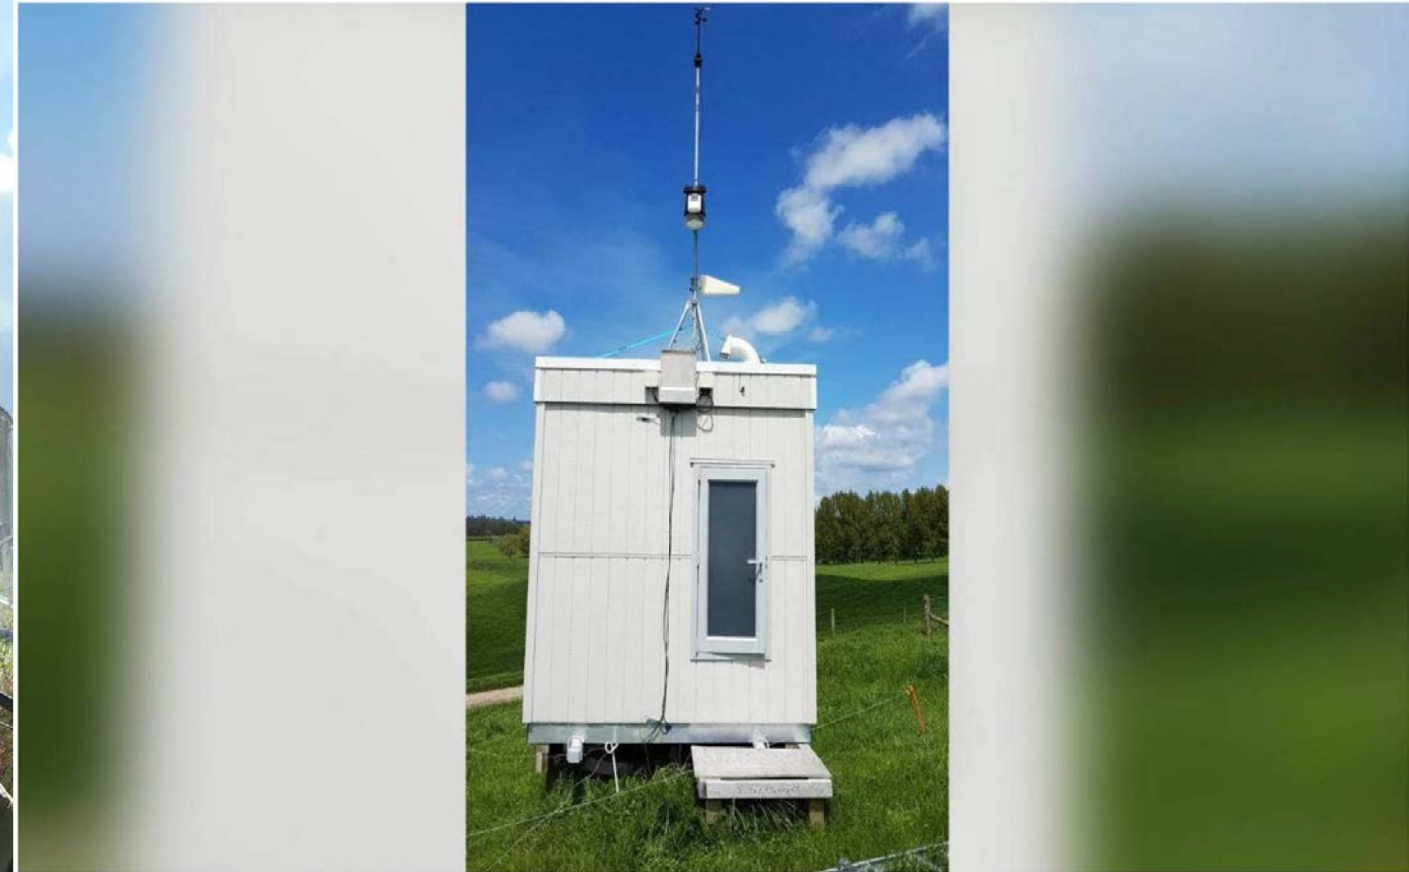
The hut that was built to leak

A small building, called a test hut, has been built specifically by the Ministry of Education to see whether it would leak in a bid to gather evidence for its leaky schools claim.

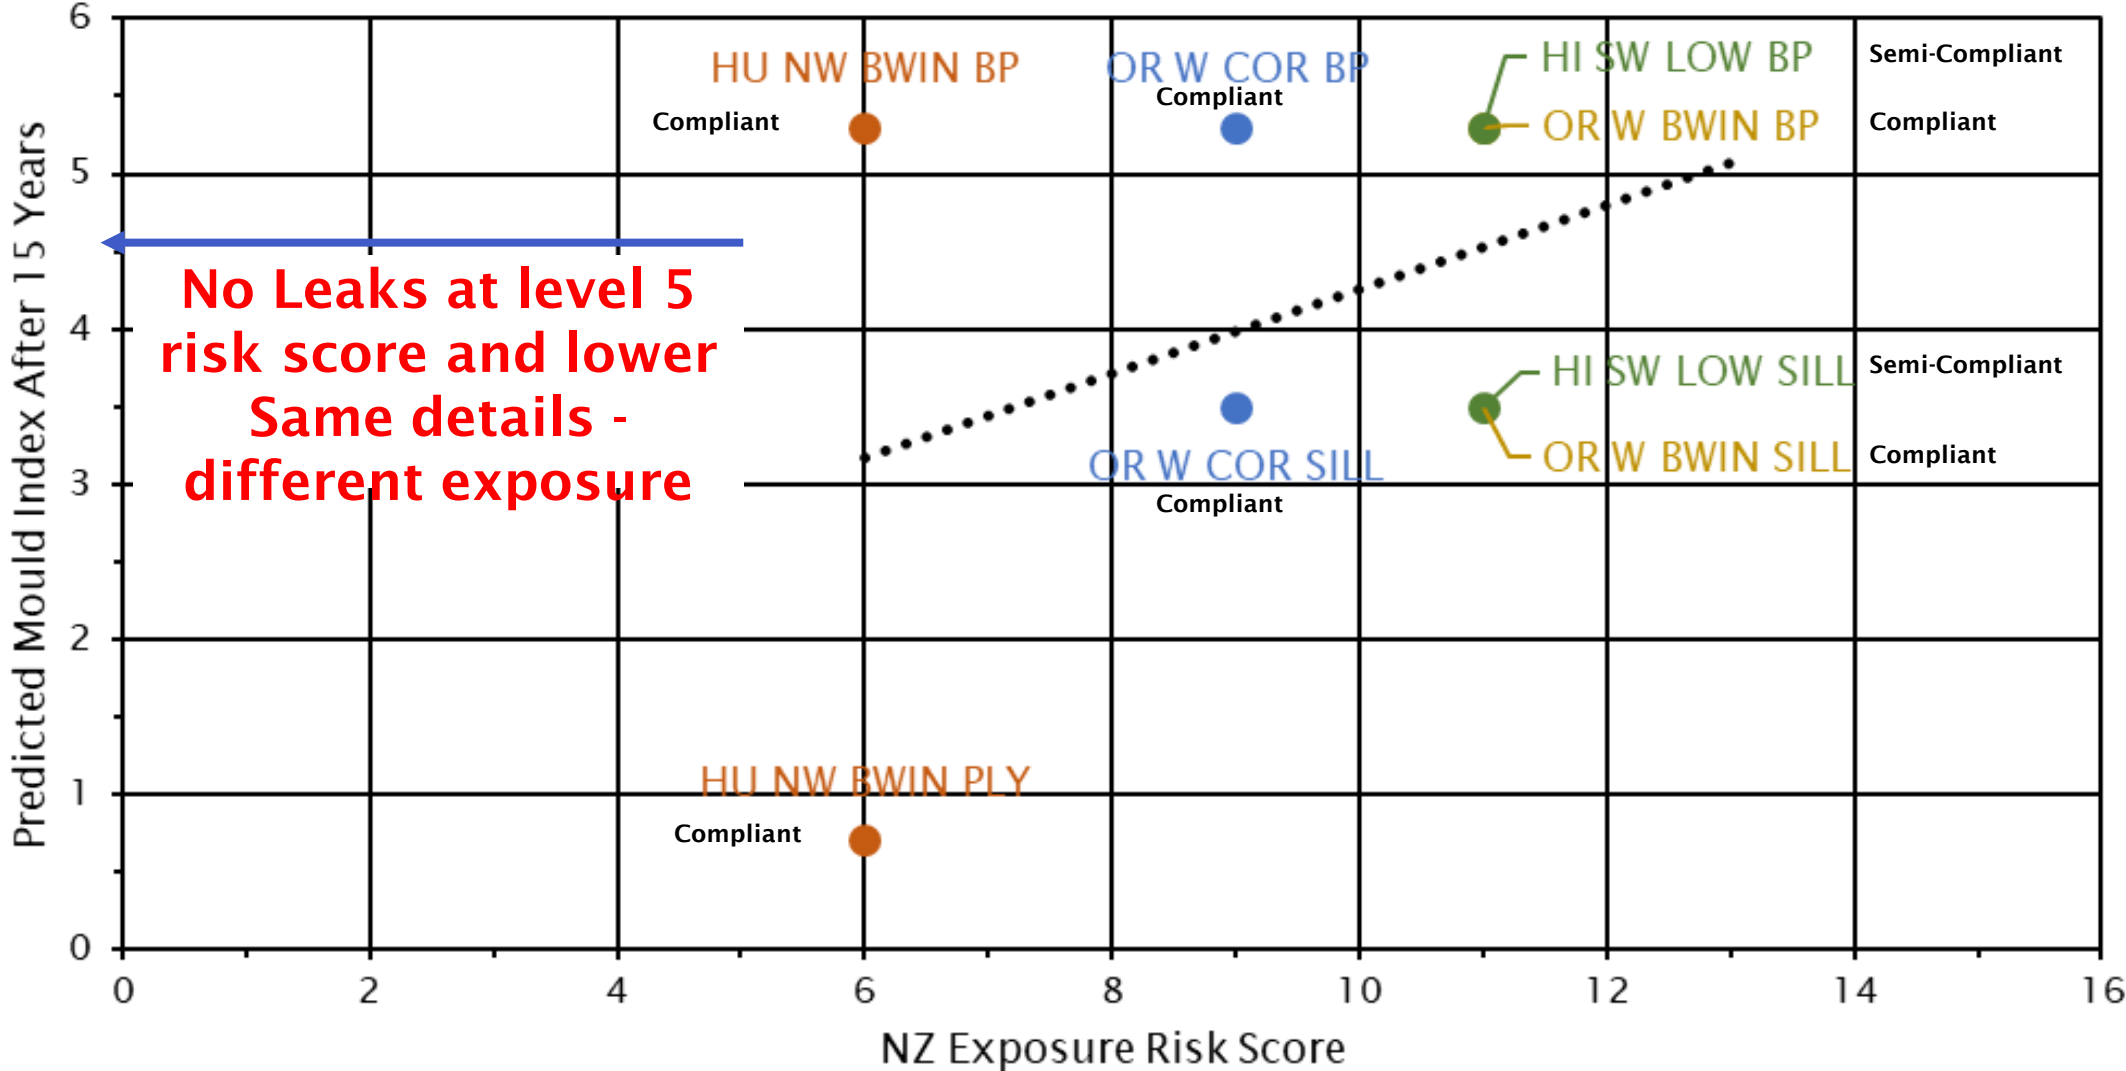
Risk Score & Mould Index - Leak Locations (compliant)

- Primary Failure Causal Factors in order of impact (Visible Mold):
1. Water leakage through “compliant” interface details
 2. Exposure to driving rain (overhangs, site, Location)
 3. Base-of-panel absorption
 4. Centre-of-wall wetting (in exposed areas only)

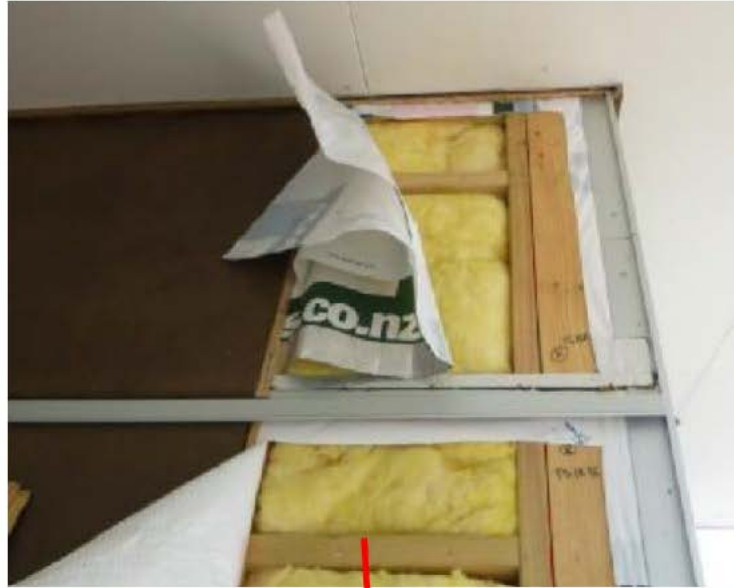
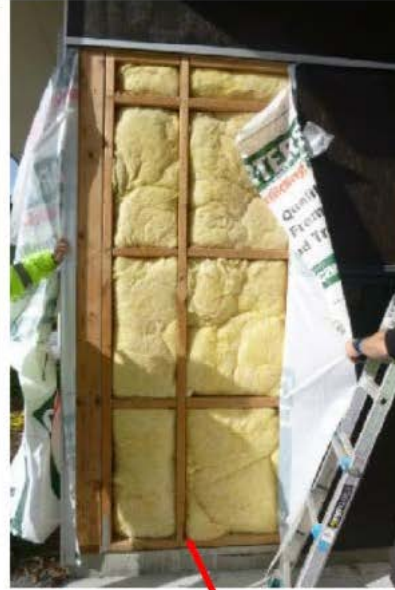
Defendants
Expert Report
confirming
excellent field
performance
when installed
correctly

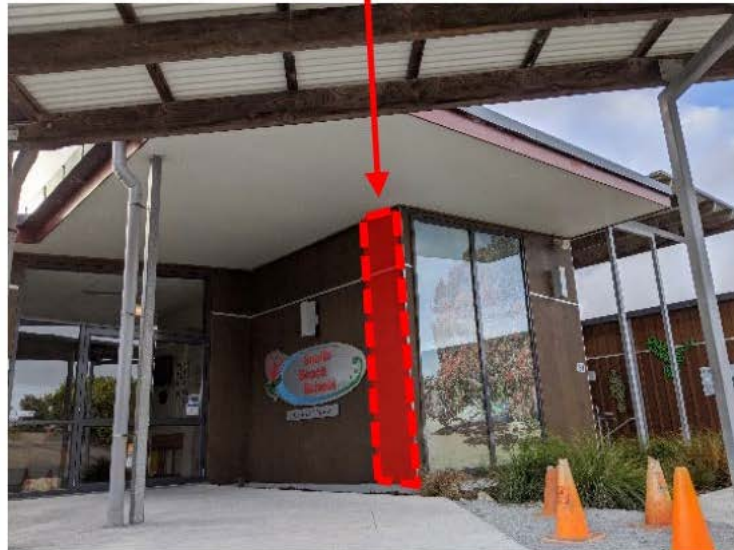
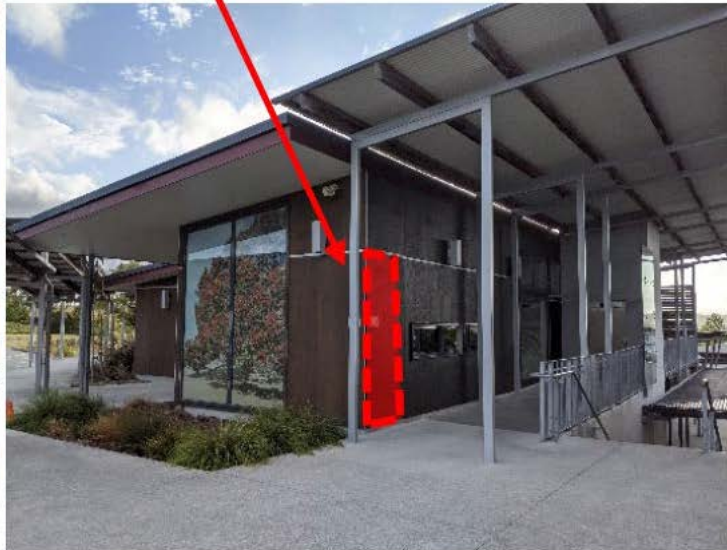
RDH Rebuttal
Report showing
locations of test
openings and
simulation
results
predicting this
performance

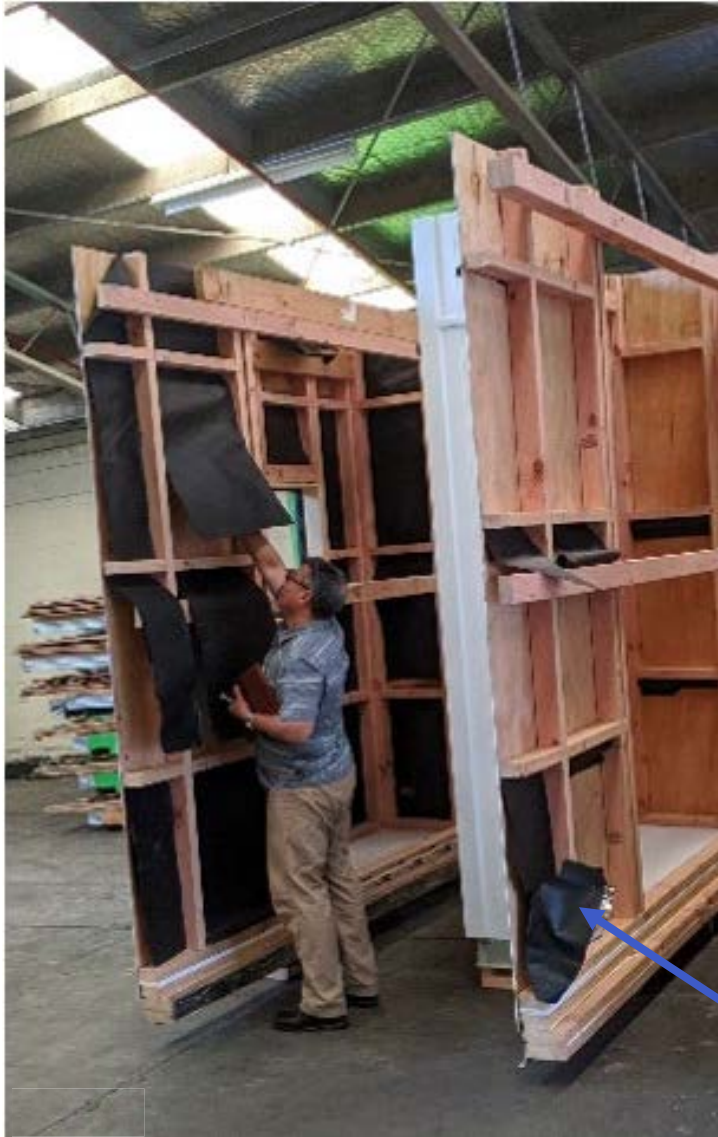
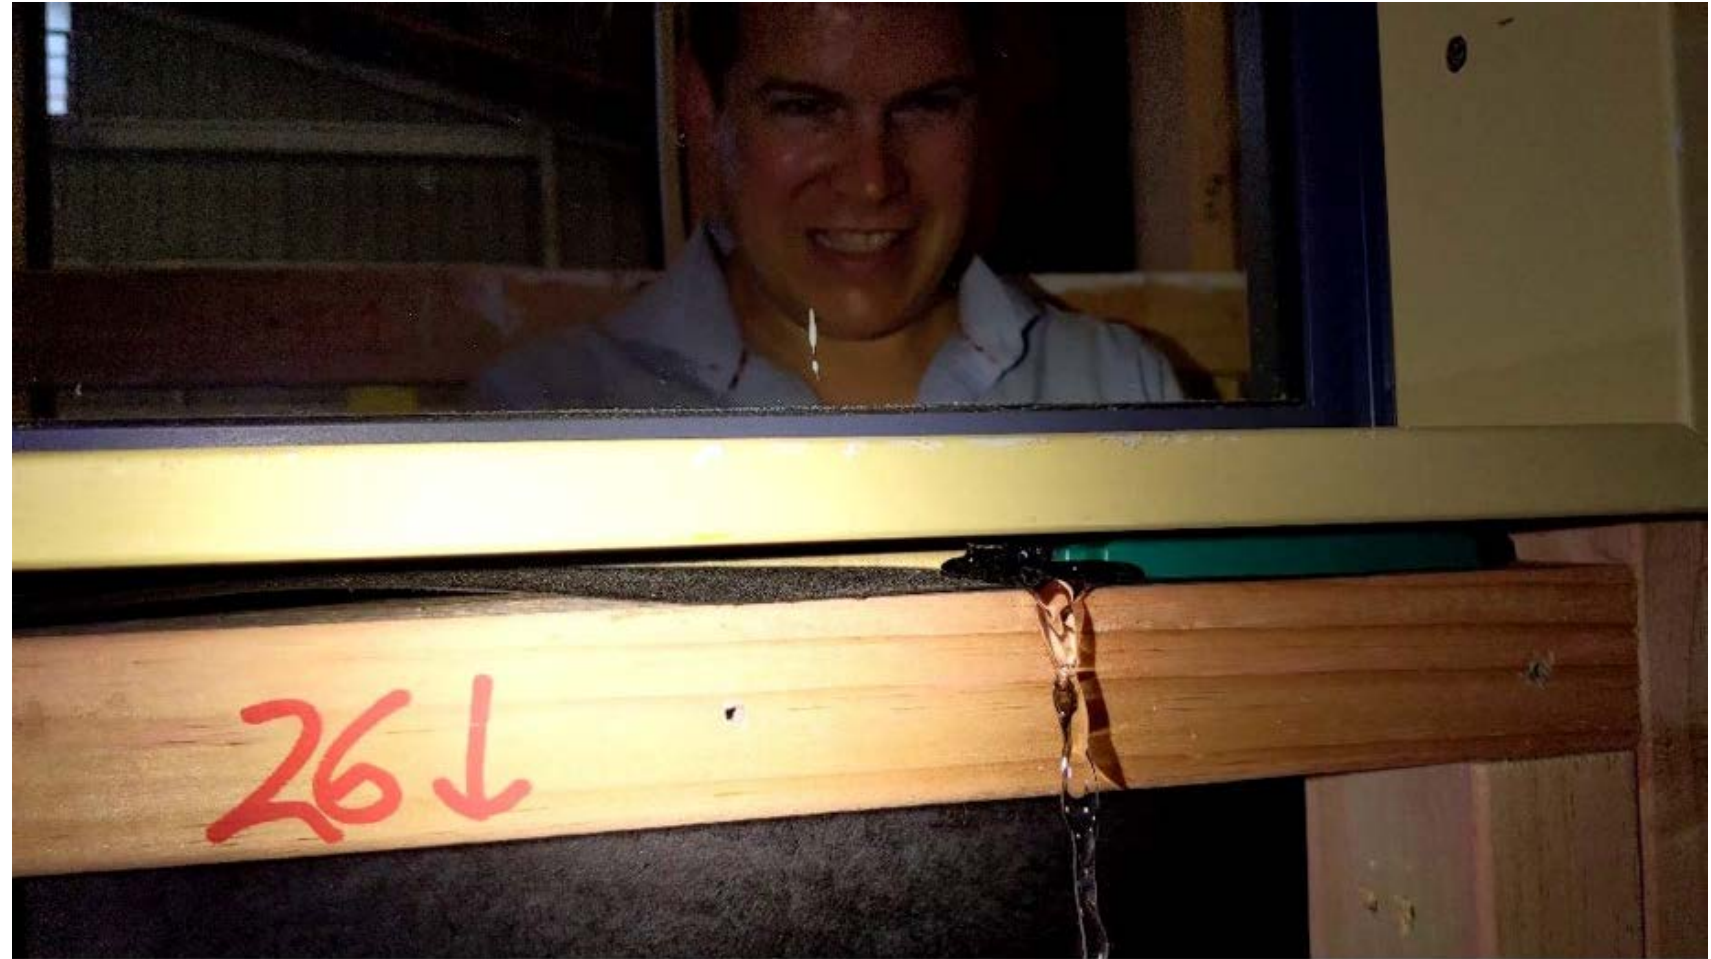
Roofing underlayment used NOT building paper or red "do not get wet" building paper

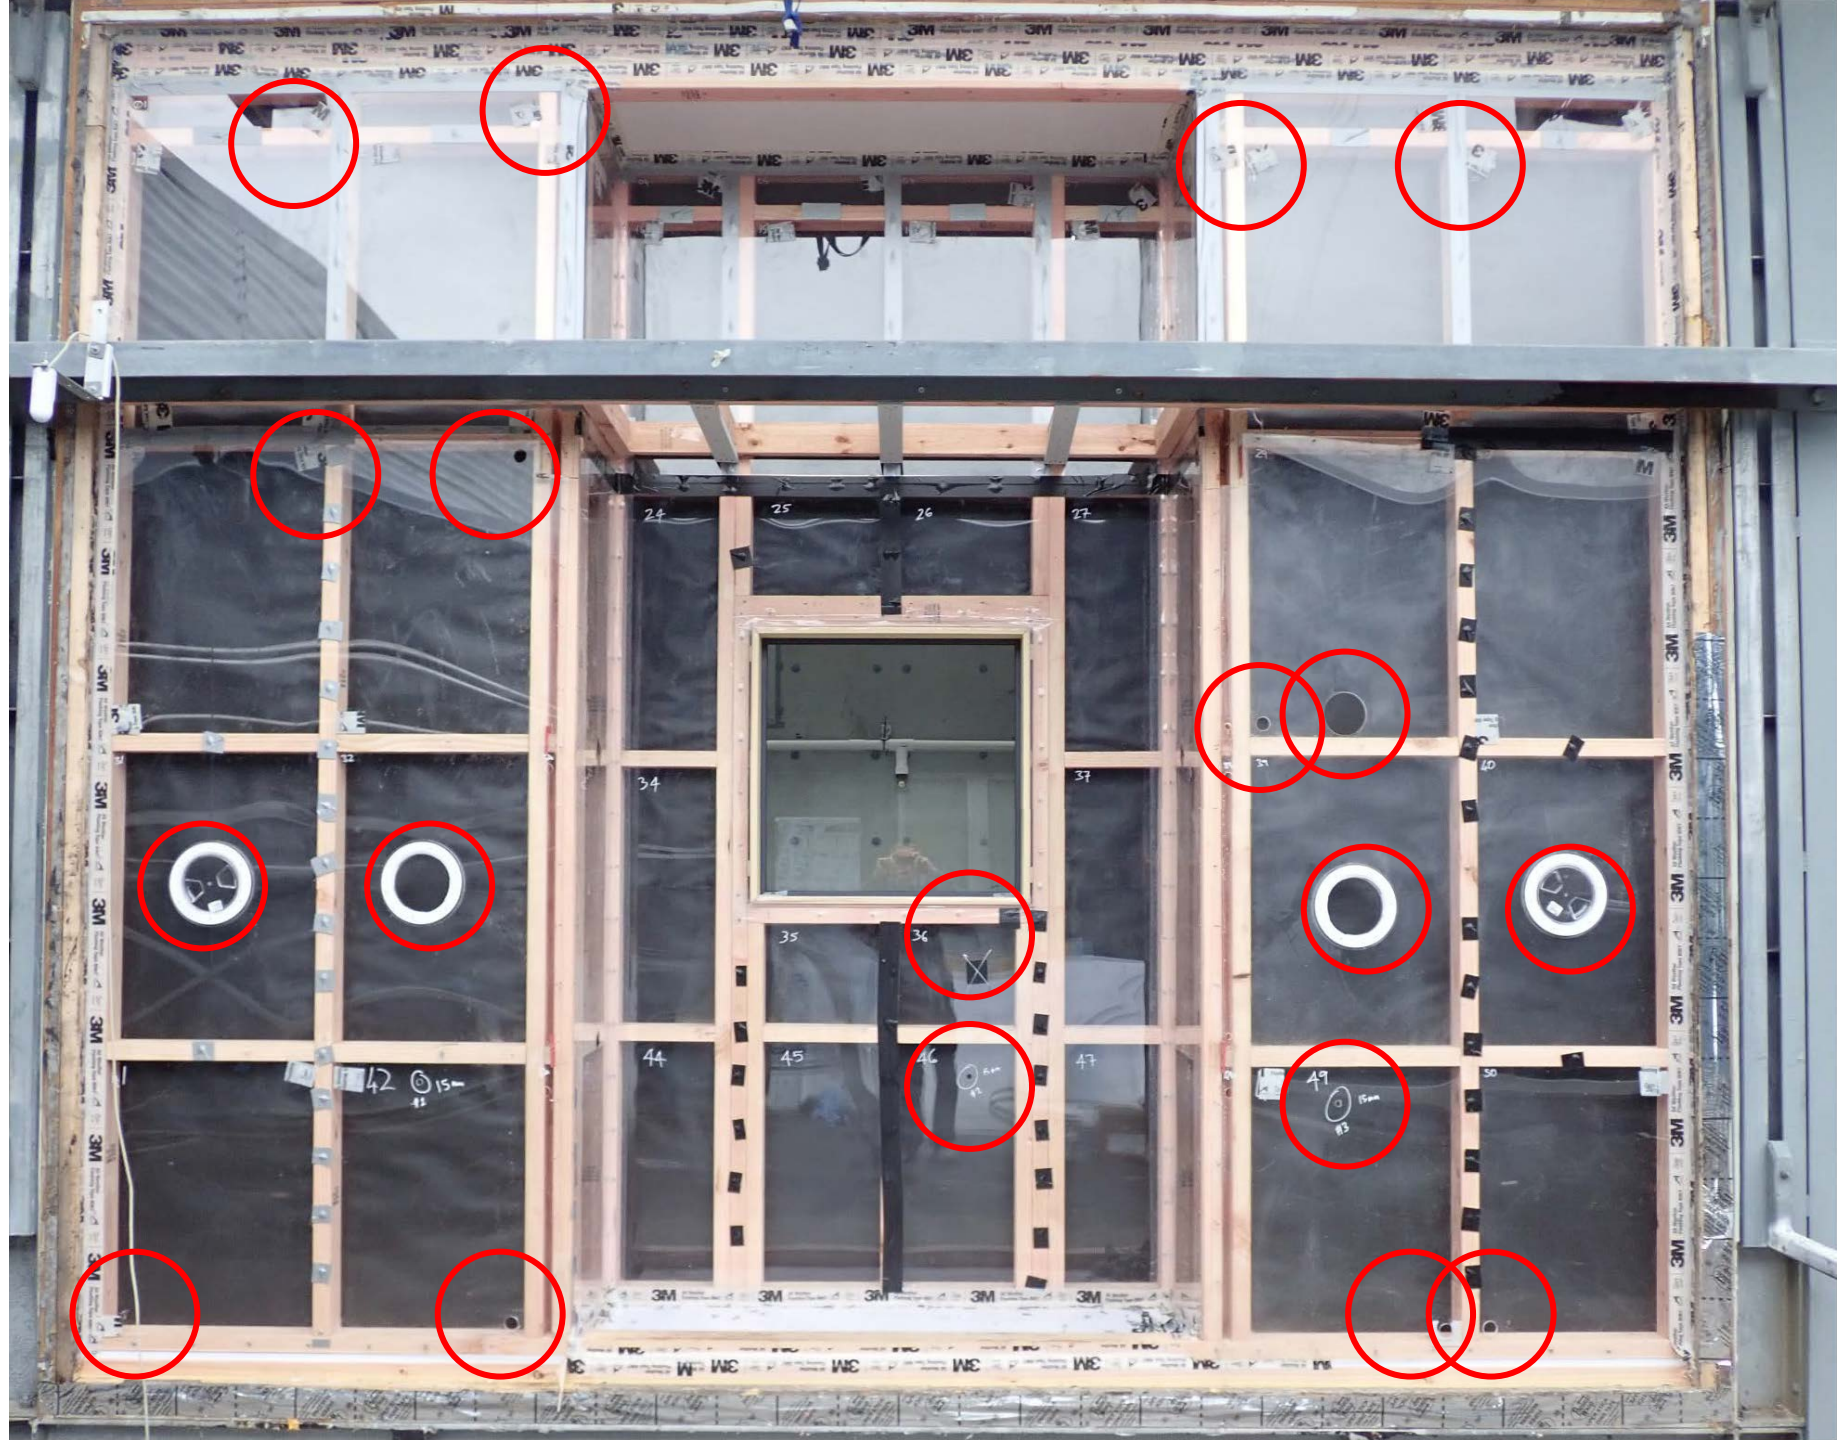
Defendants Report -Thermographic scan after water testing Sample 2

NOTE: Moisture in plywood panels 1 through 10, 14 through 17 and 27 are as a result of the water spray and test pressures applied during AS/NZS 4284 Testing.

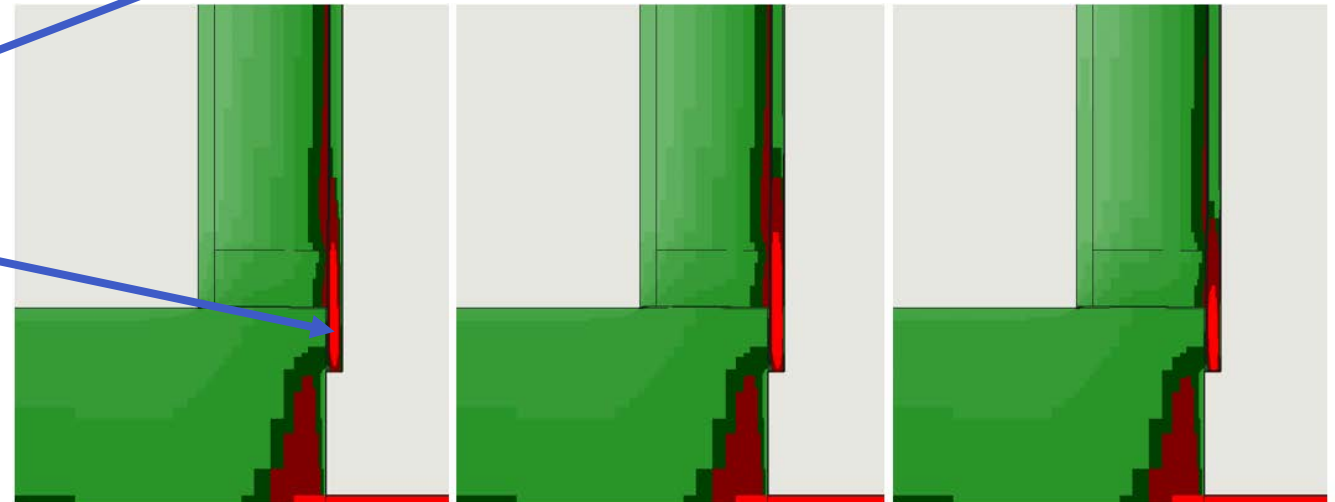
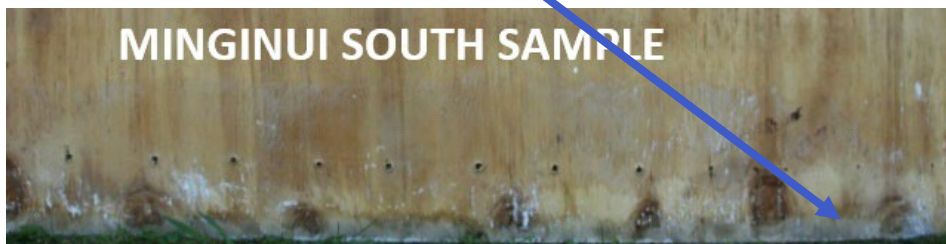
Defendants Expert Testing (Pass?)
 RDH Test Hut Monitoring Results
 RDH 2D WUFI Simulation (3 months)
 RDH Field Investigation

Figure 3.29 Test Hut Sheet "W" Unpainted face/edge (left), unpainted edge (centre) and painted edge (right) predicted RH distribution after the first 3-months of modelling from April to July.

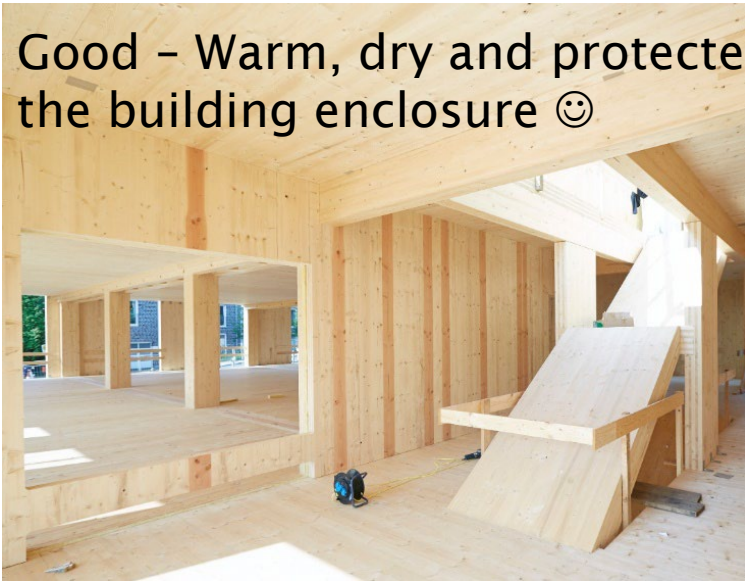
Good – Warm, dry and protected by the building enclosure 😊

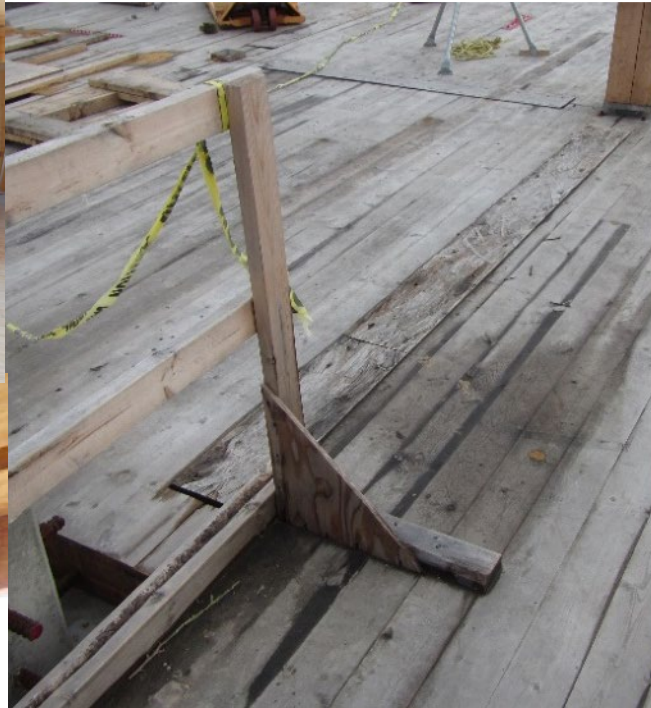
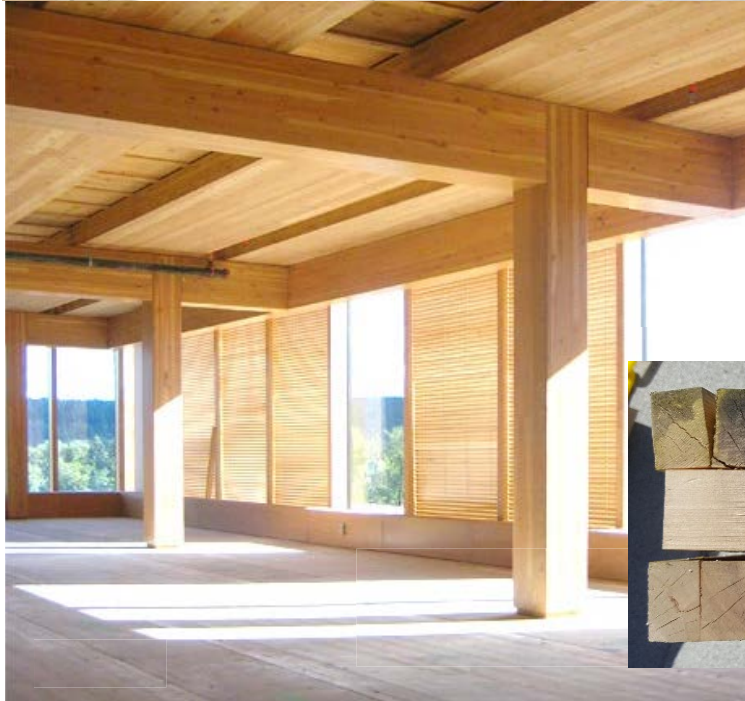
Bad – exposed to weathering ☹️
