# Field Testing of Compartmentalization Methods for Multifamily Construction

Building America Report - 1506

March 2015

Kohta Ueno and Joseph Lstiburek

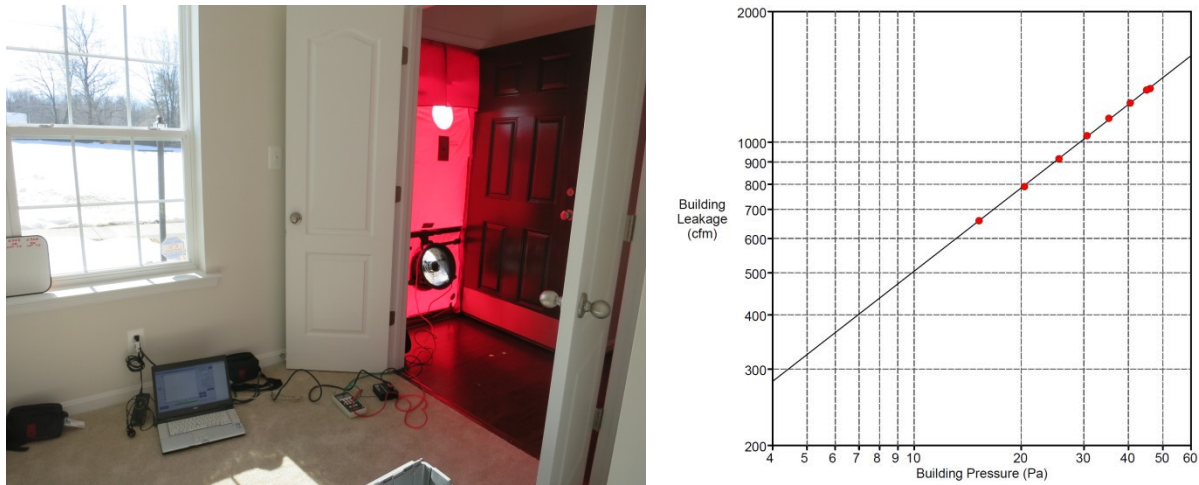
**Figure 18. Individual unit air leakage testing and multipoint test results**

- None of the units tested below 3 ACH50 (2012 IECC target).
- The end units (6700/6708) had lower air leakage than the middle units, both in terms of normalized metrics (ACH50 and CFM50/ft<sup>2</sup> enclosure), and in absolute terms (CFM50). For reference, the end units are larger (12% greater surface area, 18% greater volume).

- The end units are lower than 0.25 CFM50/ft<sup>2</sup> enclosure; the middle units are noticeably higher (~0.30 CFM50/ft<sup>2</sup> enclosure), which suggests that leakage might be ascribed to the area separation wall (two area separation walls for middle units, versus one for the end units).

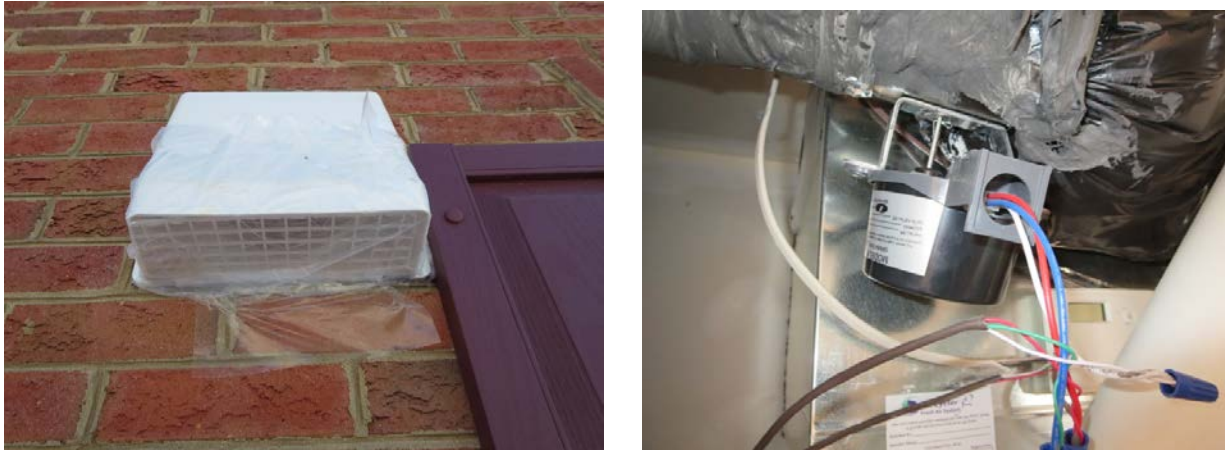
**Figure 21. Outside ventilation air intake; motorized damper at air handler**

During the Day 2 tests, all outside ventilation air intakes were taped off at the exterior hood (Figure 21). This was done because Day 1 testing revealed noticeable air leakage coming from some ductwork systems (especially at the returns). The likely explanation was a malfunctioning motorized damper on the outside air duct (Figure 21); however, the damper would have had to be disassembled to ascertain its position. Given that the focus of this research is enclosure leakage, the ventilation ducts were removed from the experiment with this sealing.

Various mechanical systems were also a source of air leakage. Air leakage was evident at the air handler returns, which was linked with incorrectly operating motorized dampers in the outside air supply ventilation duct (see Figure 21).

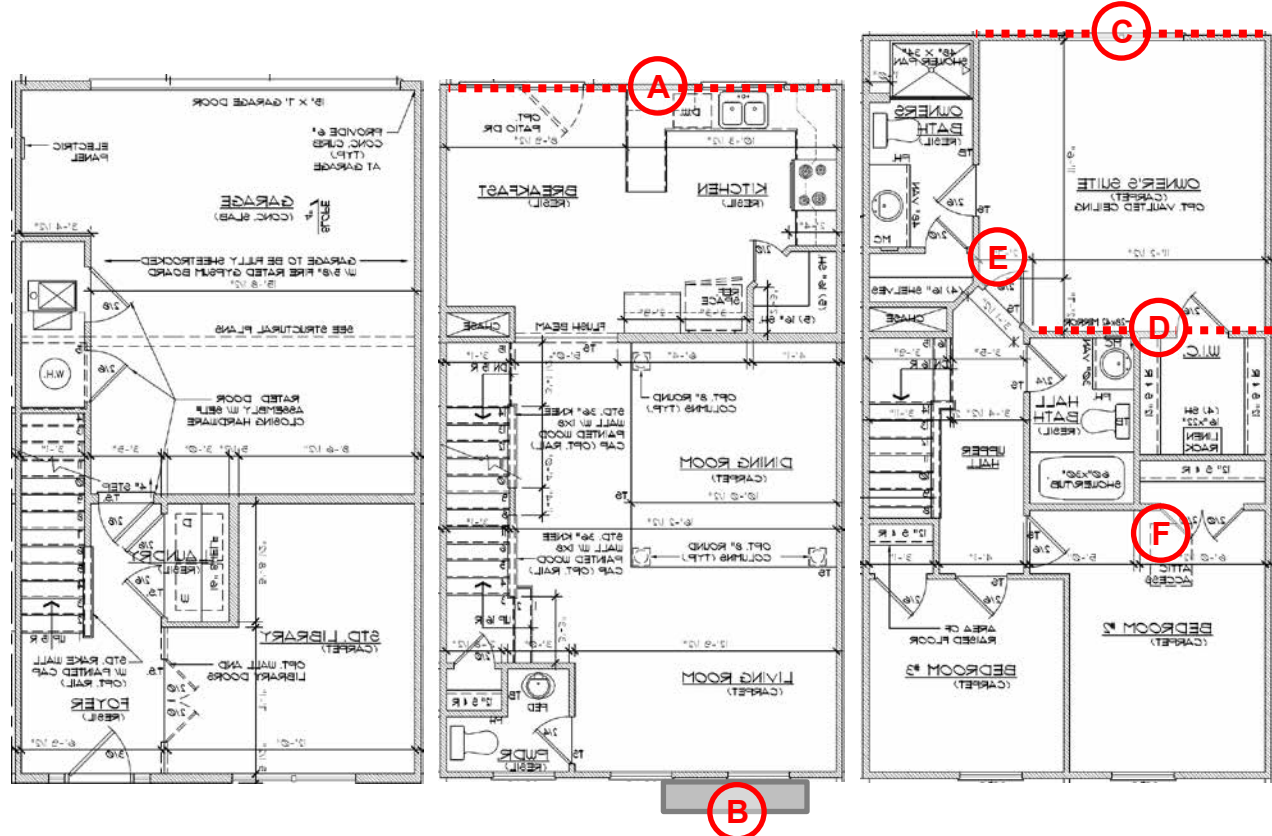
Figure 23. Air leakage location infrared image key, middle unit

Some of the air leakage issues described in this section are keyed to locations shown in Figure 23. The floor plan shows a middle unit, which captures most of the important locations.

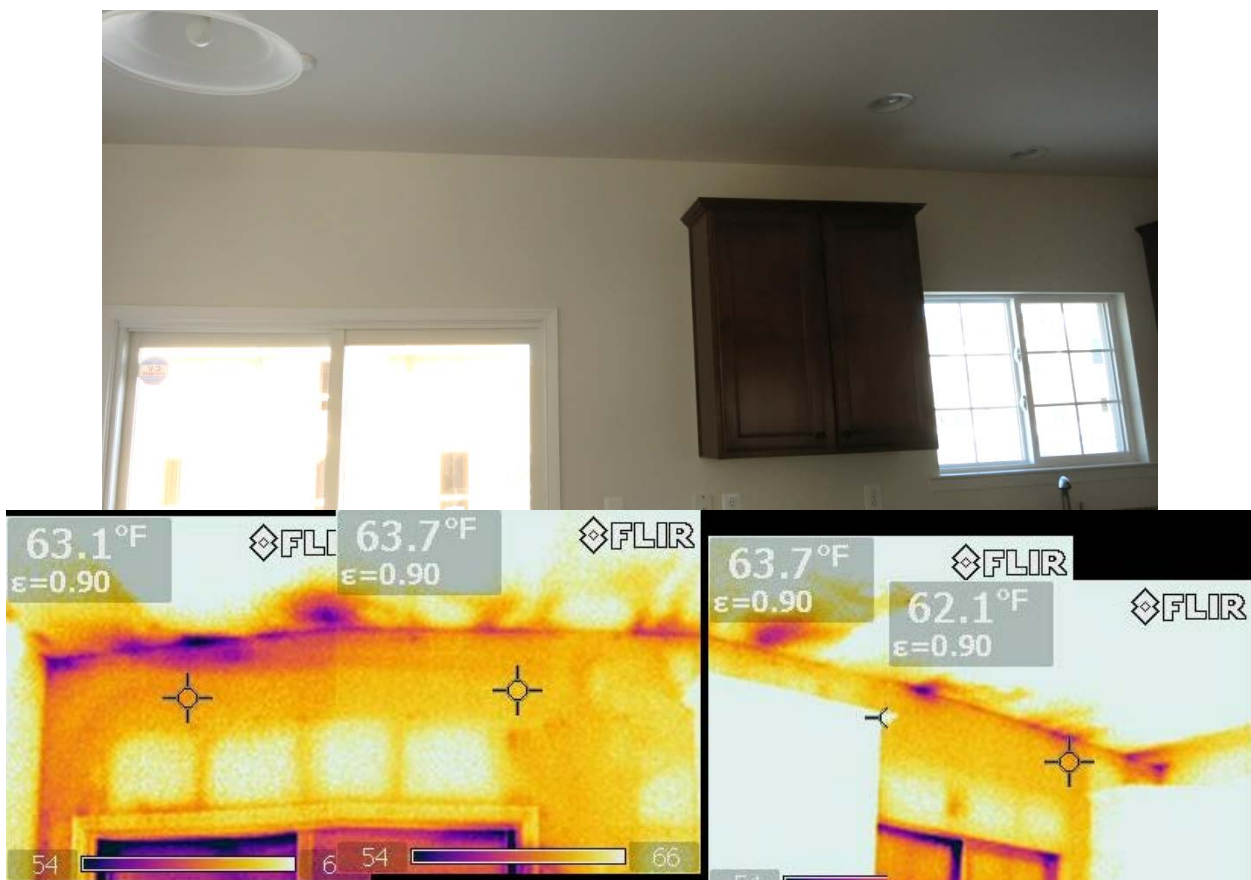
Figure 25. Rear second-floor kitchen/dining area, Unit 6704 (middle)

One consistent issue arose at the second- to third-floor ceiling/floor assembly (across several units); this is shown at a rear second-floor kitchen in Unit 6704 (conventional construction) in Figure 24 and Figure 25 (keyed to “A” in Figure 23). Air is entering the floor framing cavity from the exterior at the third-floor overhang detail.

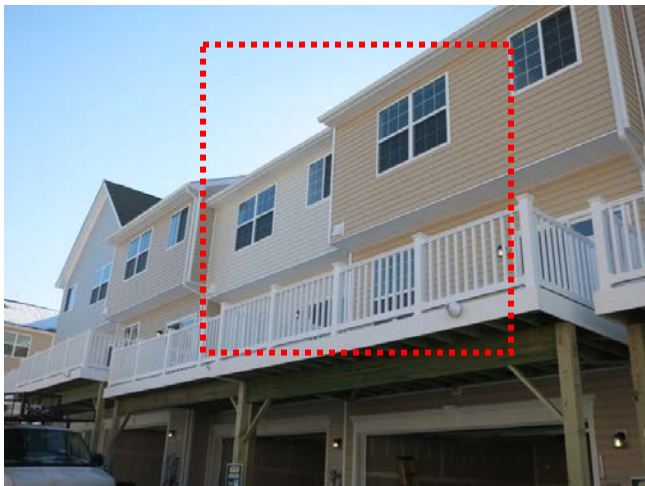
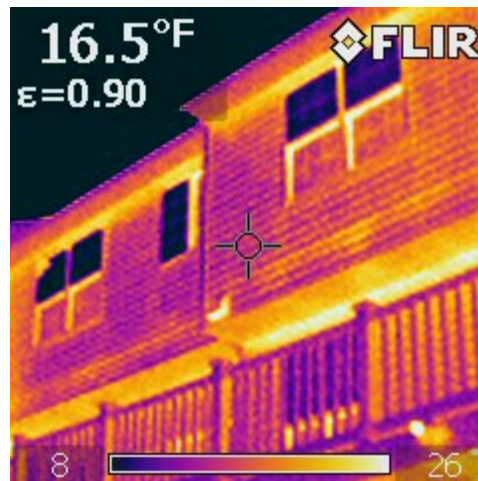
Figure 28. Rear overhang infrared image, units 6702 and 6704 (taped and conventional)

An exterior infrared image of the overhang (Figure 28) shows warmer surface temperatures (outdoor temperature 30°F and rising). This might be due to air leakage, but the overhang surface is shielded from night sky radiation, which might increase its temperature.

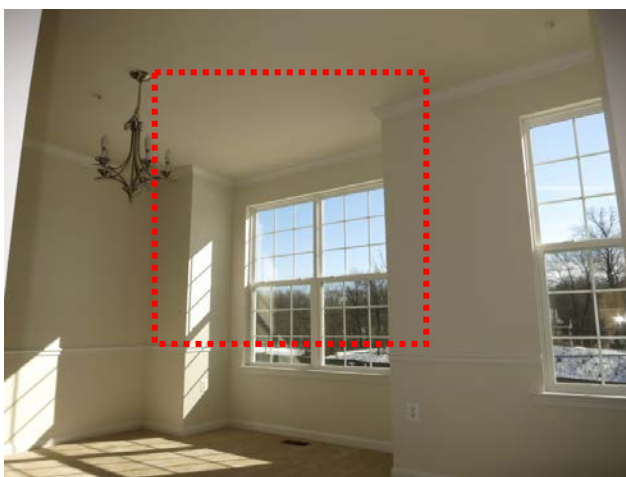
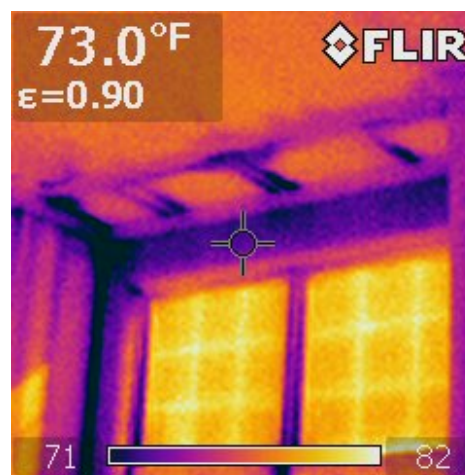
Figure 29. Front bump out bay detail at unit 6702

The projecting bay at the front of Unit 6702 (middle, improved, and taped) had significant air leakage at the ceiling, visible at the framing (Figure 29; keyed to “B” in Figure 23). An exterior view of the bay is seen in Figure 30. The metal roof of the bay does not appear to be vented; no further investigation or disassembly was done.

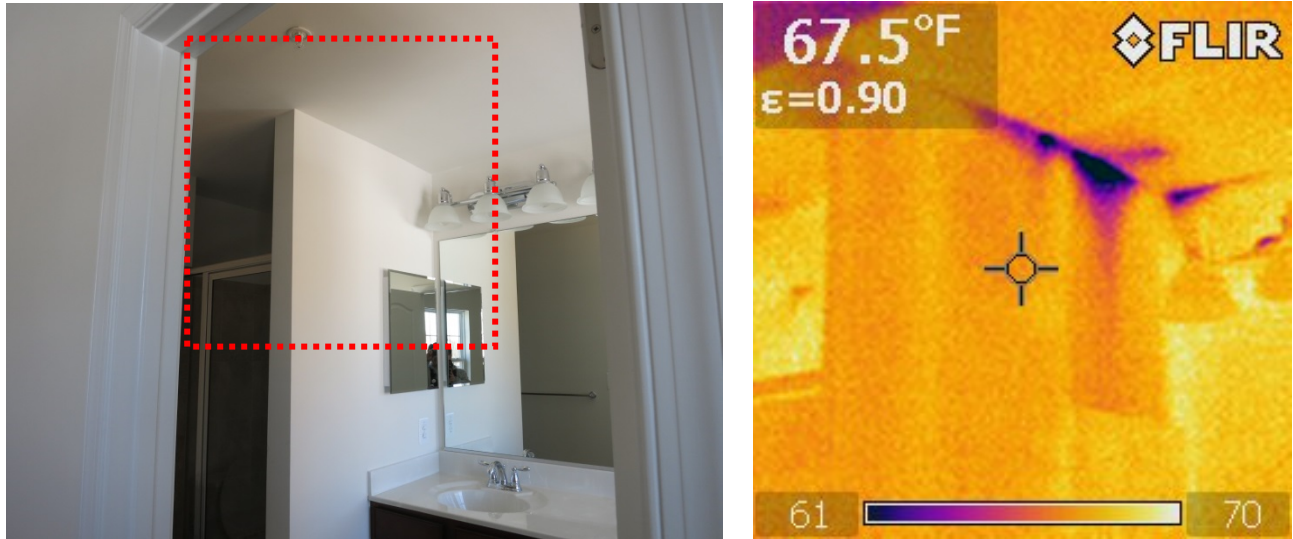
Figure 35. Interior wall under attic (third floor), Unit 6702

At several interior walls under the vented/unconditioned attic, noticeable air leakage was visible at the top plate (Figure 34 and Figure 35, keyed to “D” in Figure 23). Unfortunately, this indicates that the interior top plate detail (Figure 8) was not executed correctly or consistently.

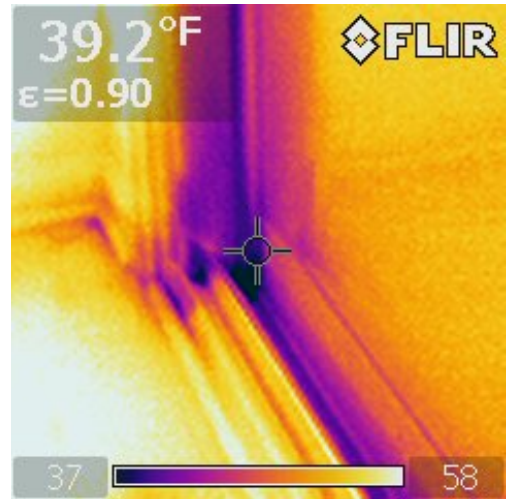
Figure 39. Sliding glass door air leakage at weep hole (door unit)

Windows and doors were noticeable sources of air leakage. Air leakage occurred in the window units at the sash to frame interface (often worst at the corners), as shown in Figure 38. At a sliding glass door, an interior weep hole at the sill track was a distinct air leakage point (Figure 39 and Figure 40), which is a flaw in the design of the unit.

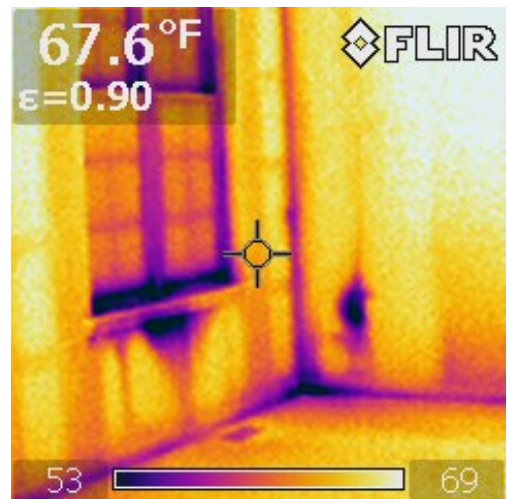
Figure 41. Window air leakage (window-to-wall connection at sill), Unit 6706

The window-to-wall connection was also a source of air leakage in some cases, as evidenced by the leakage plume coming from the stool casing below the window sill (Figure 41).

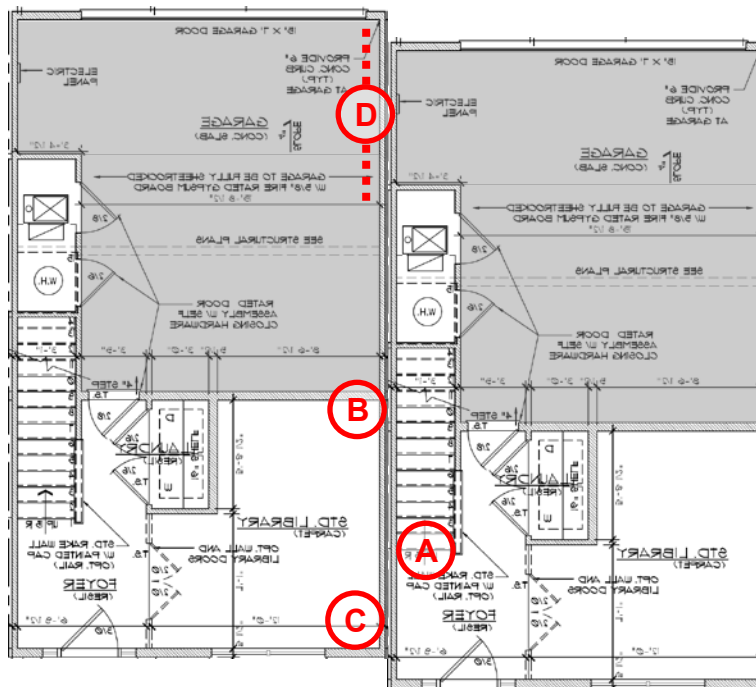
Figure 47. Plan of two adjacent middle units (first floor), with key locations highlighted

Several of the observed air leaks were associated with details at the area separation walls/demising walls. A plan of two adjacent middle units is shown in Figure 47, providing a map of some of the following observations. These area separation wall air leaks were found in multiple units; the plan in Figure 47 is meant to show typical connections between two middle units.

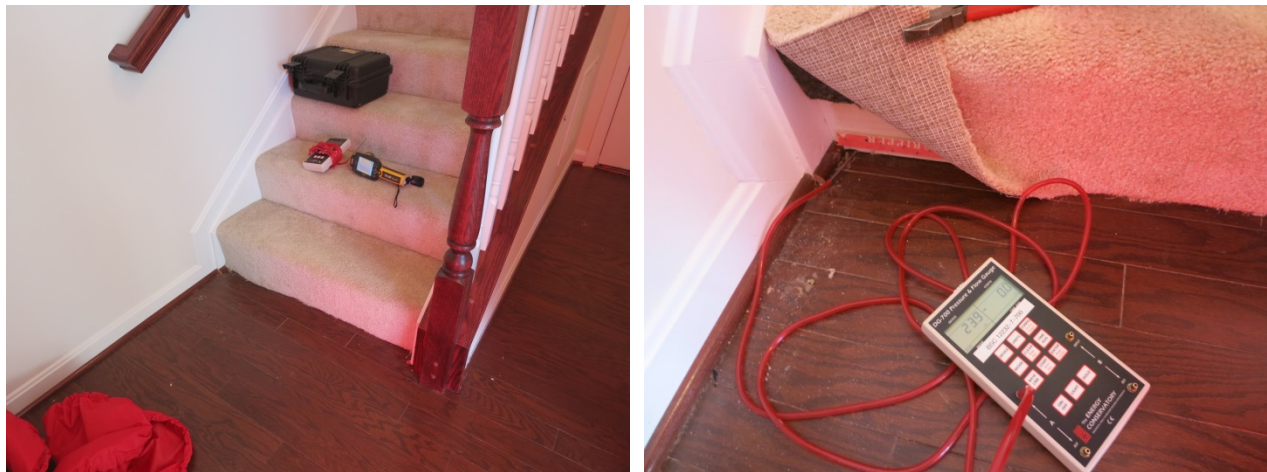
**Figure 49. Measurement of pressure difference under stairs, location A**

A pressure measurement was taken at the space under the stairs; when the unit was depressurized to 50 Pa, the stairs were at 24 Pa with respect to the interior. In other words, the area under the stairs is 50% interior and 50% exterior, indicating significant leakage to the exterior.

- The area under the stairs in Unit 6704 is still roughly half inside/half outside (24 Pa), despite the nulled test. This suggests that the leakage at the stairs is due to a connection to the mechanical room in the garage (rather than at the area separation wall alone).

The interior staircase effectively functions as a component of the air barrier, based on the air leakage patterns and interstitial pressure measurements (Figure 48 through Figure 50). Ideally, the triangular volume under the stairs would be contained entirely within conditioned space, and a vertical air seal detail per Figure 76 would be installed at the end wall of this space. The rough frame condition of a stairwell (albeit on an exterior wall) is shown in Figure 77.

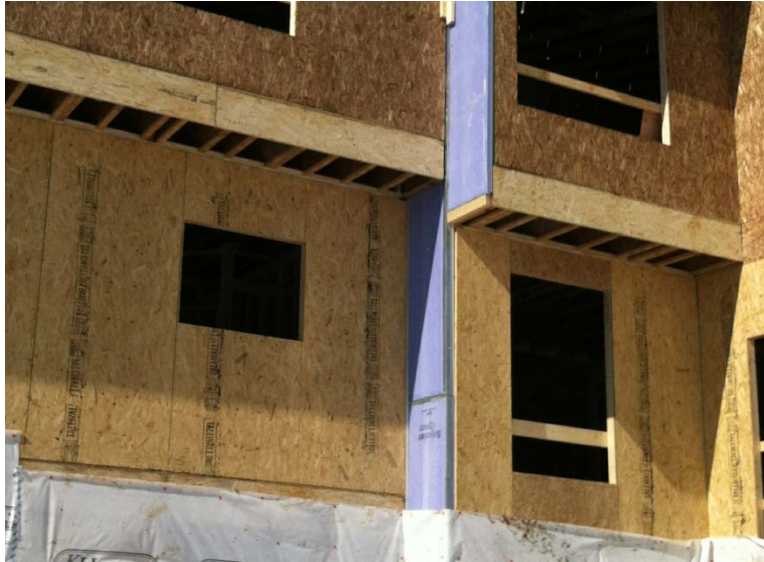
**Figure 60. Separation wall “jog” at second and third floors, frame building**

Mechanical penetrations through the area separation wall were often associated with air leakage from the outside. For instance, this was seen at an electrical receptacle in Unit 6706; there is a “stub” of interior-exterior wall here at the jog, as shown in Figure 60. The area separation wall stub was called out for having taped connection details, per Figure 13.

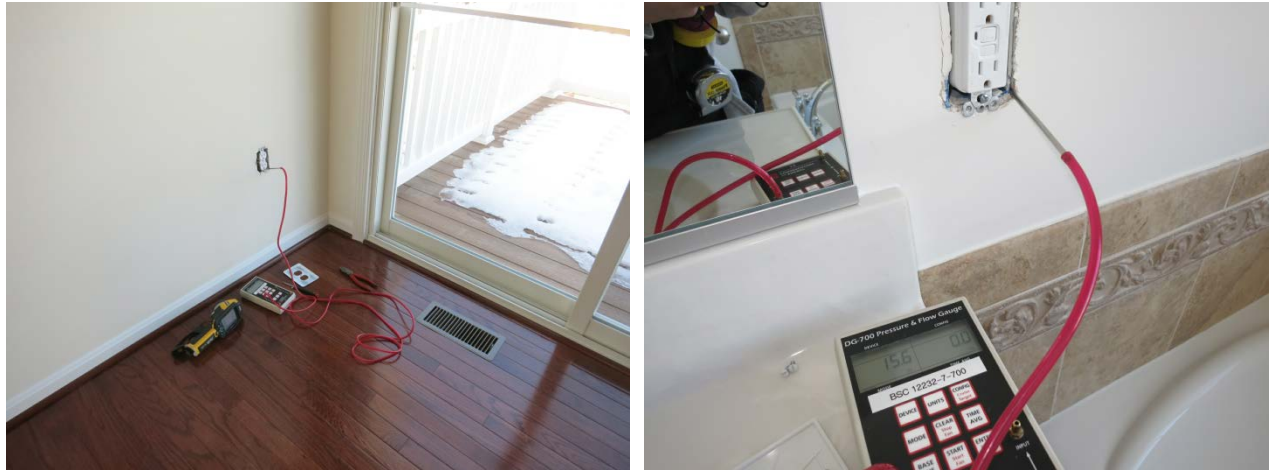
Figure 62. Pressure difference measurements at electrical box penetrations

Two adjacent middle units (6702 and 6704) were depressurized in parallel to  $-50$  Pa; this operation should nominally null or neutralize the pressure difference in the area separation wall between the two units. This wall was taped at the exterior gypsum or OSB sheathing (see Figure 7 and Figure 17). Pressures were measured at the openings around electrical receptacles (Figure 62). The resulting pressure measurements are shown in Figure 63 through Figure 65.

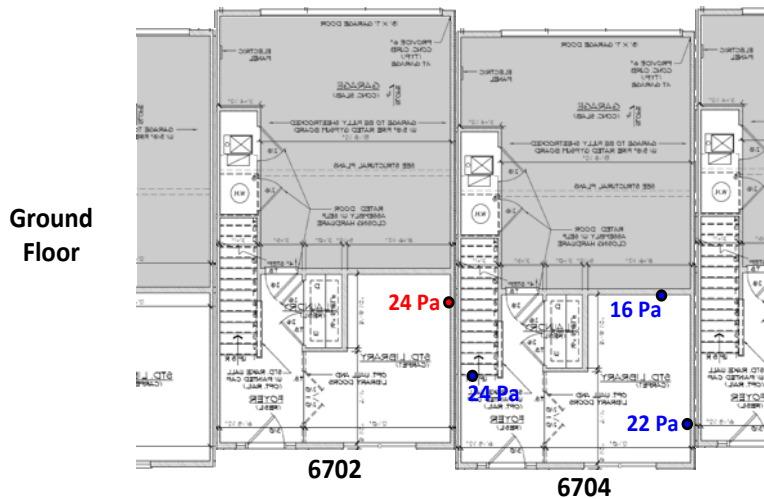
Figure 63. Pressure difference measurements, first floor (6702–6704)

- The area separation wall cavity near the garage in Unit 6702 has a large pressure drop (24 Pa), despite the wall being “nulled” by the two fans. This suggests substantial leakage to the garage from this cavity (per Figure 51).

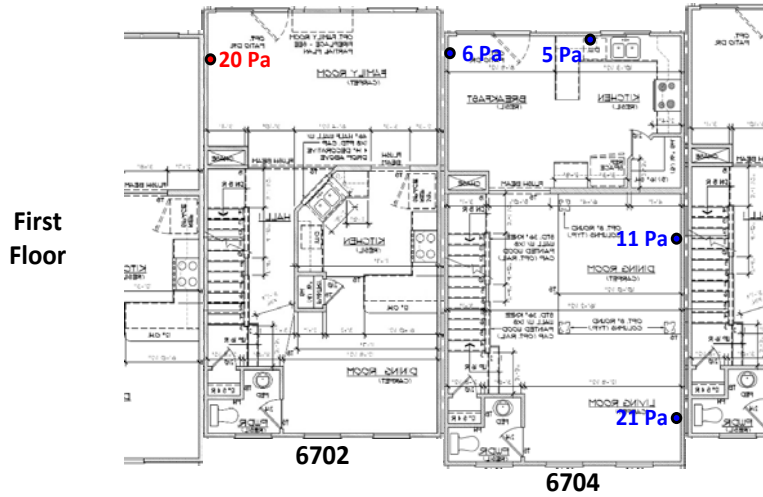
Figure 64. Pressure difference measurements, second floor (6702–6704)

- Pressure differences to the nulled area separation wall were as low as 4–6 Pa in some cases, suggesting that the depressurization field has reached those cavities. However, this is not a “perfect” result (i.e., 0 Pa difference), which shows that the nulling test is not a complete elimination of air leakage between units. Interstitial cavities between the two nulled units result in a gradient of pressures through the various air spaces.

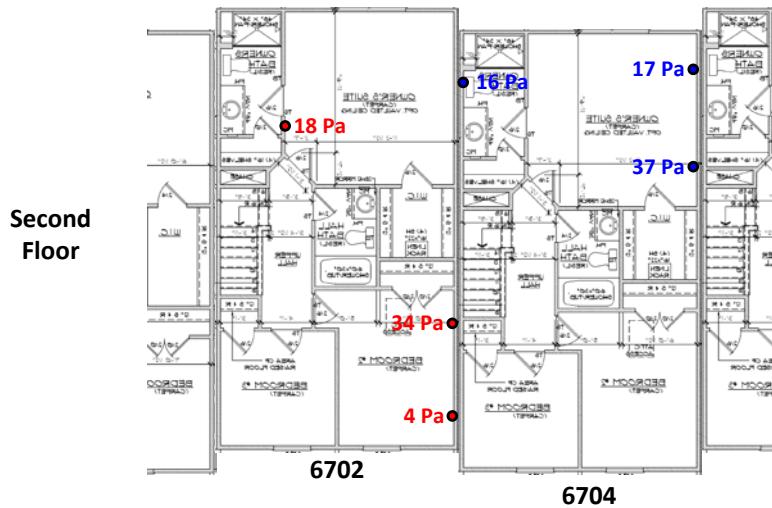
Figure 65. Pressure difference measurements, third floor (6702–6704)

- Other pressure differences into the nulled area separation wall were higher: the third floor bedroom was 34 Pa, suggesting substantial leakage to the attic from the area separation wall cavity.
- Pressure differences to the nonnulled area separation walls ranged from 10–37 Pa, with 20 Pa measurements typical. This suggests that—as discussed elsewhere—there is substantial leakage from the area separation wall cavity to exterior or other units.

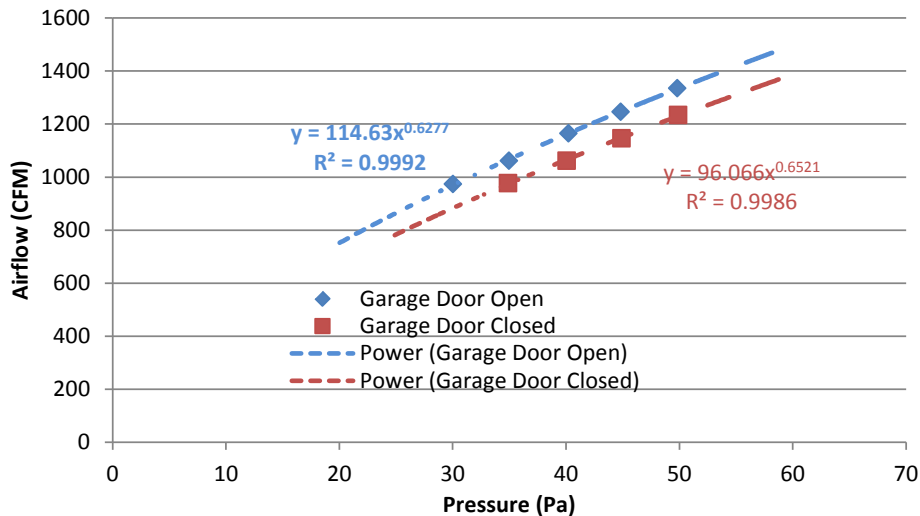
**Figure 66. Air leakage results with garage door open and closed, Unit 6706**

Previous measurements and observations suggest substantial air leakage to the garage. Multipoint blower door tests were run with the garage door open and closed in Unit 6706 (middle, “improved” details, no sheathing tape), as shown in Figure 66. The difference between the garage door open/door closed tests was 8% of the result (1336 versus 1232 CFM50).

During the “door closed” test, the pressure difference from the unit to the garage was measured: the garage was consistently connected 50% to the unit. This implies that leakage from the garage to the exterior (i.e., around a leaky garage rollup door) is equal to the leakage from the unit to the garage. This has negative consequences for energy and indoor air quality (contamination from garage pollutants).

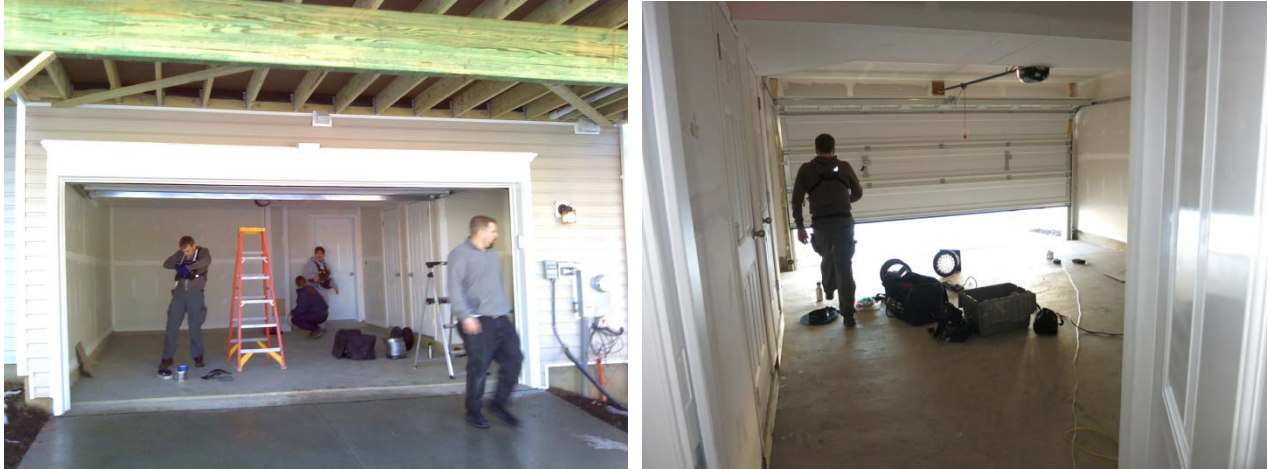
**Figure 67. Unit 6706 garage overview**

For instance, the overhead bulkheads required for ductwork running across floor framing (Figure 67) connect floor framing cavities across the width of the garage that are well-connected in turn to the interior. If draftstopping is omitted at the end of the bulkheads, they will be well connected to the area separation wall cavities (Figure 12).

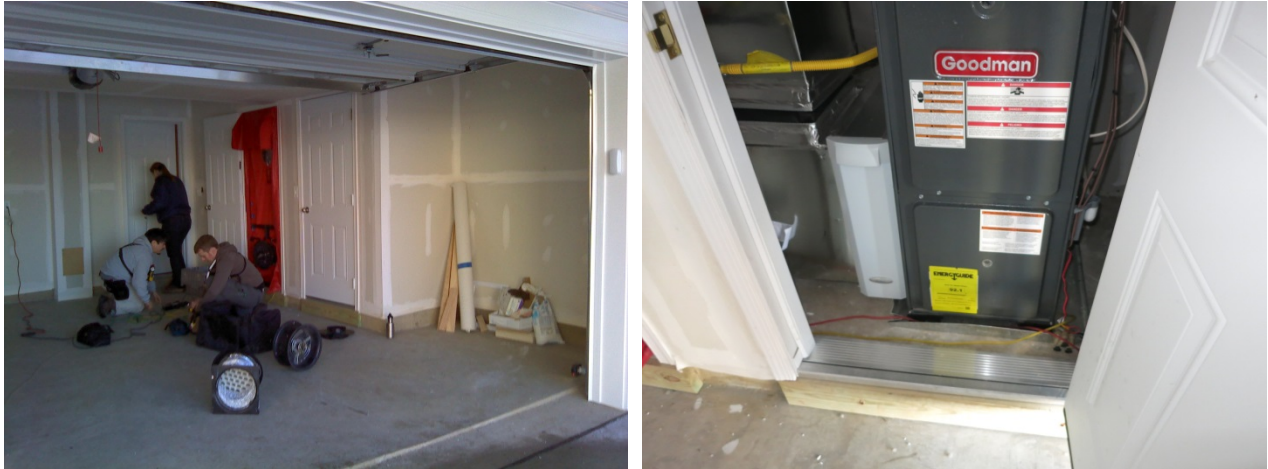
Figure 68. Mechanical room located in rear garage (Unit 6706)

Testing similar to the garage work was done in Unit 6707, measuring the pressure difference from the house to the mechanical room during a blower door test (with the garage door open). The mechanical room was consistently 42% exterior/58% interior.

A nulled test was performed using a TEC Minneapolis Duct Blaster installed in the mechanical room door (Figure 68), with the unit and mechanical room simultaneously depressurized. Hult and Sherman (2014) note that a two-fan “pressure balancing” test has lower uncertainty than most single-fan methods. However, the authors also noted that the two-fan Herrlin and Modera method has even lower uncertainty than pressure balancing; this method will be considered in future work.

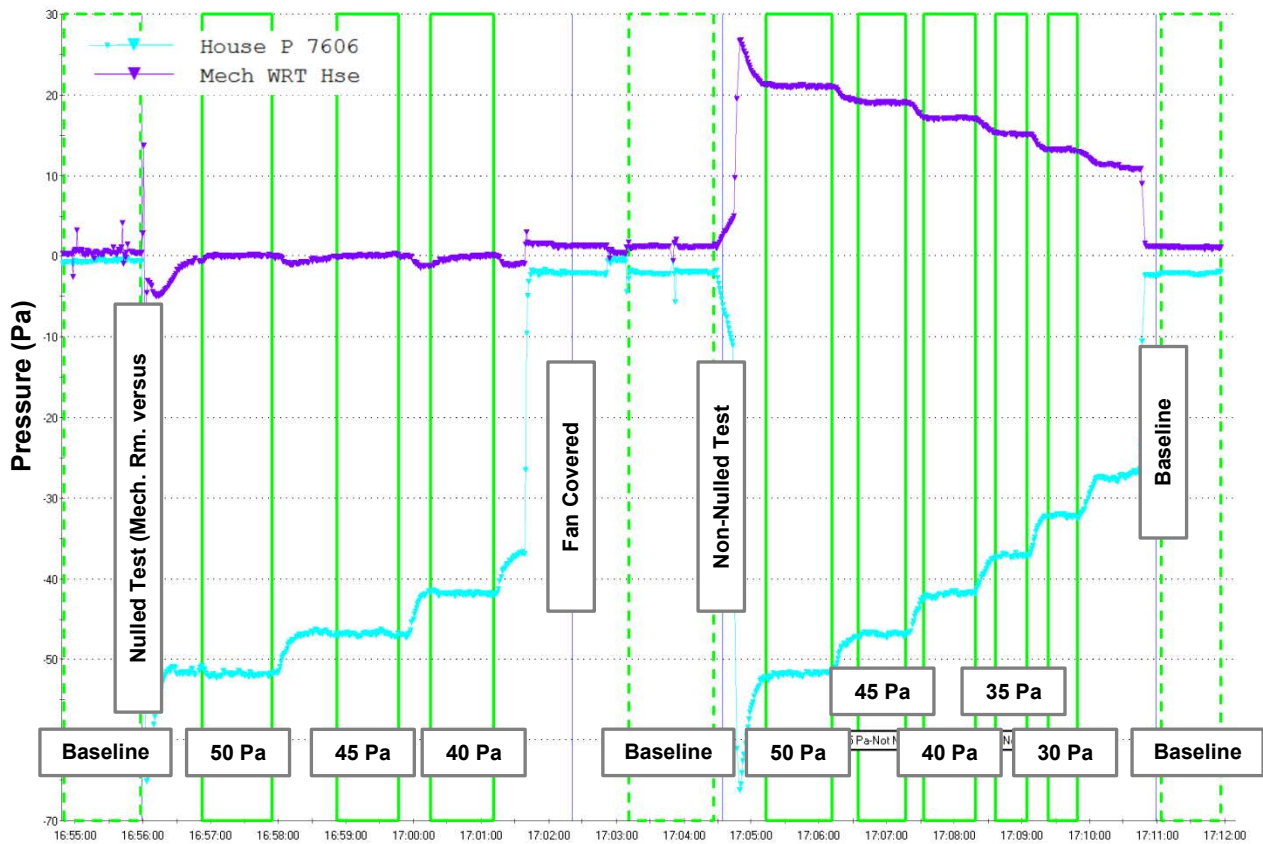
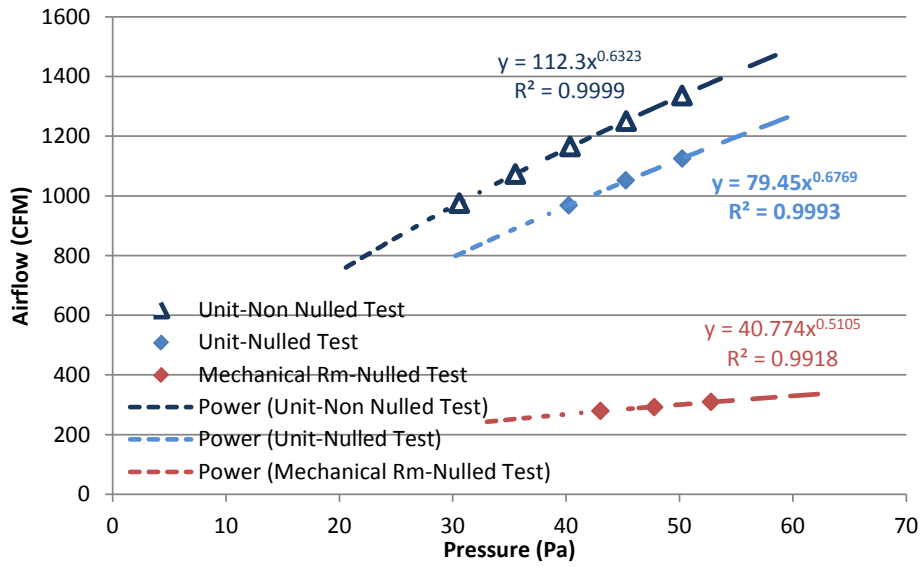
TECLOG3 output and calculated results are shown in Figure 69 and Figure 70 for the nulled and nonnulled tests.

Figure 69. Nulled and nonnulled testing of the garage mechanical room TECLOG3 output

**Figure 70. Garage mechanical room nulled and nonnulled tests, Unit 6706**

Results are summarized in Table 6, with the CFM50 (from the multipoint test), and calculated EqLA (in square inches). The sum of the two nulled tests (1122 + 300 = 1423 CFM50) is not equal to the nonnulled test (1332 CFM50), even though both tests nominally measure leakage of unit and mechanical room to the exterior. The explanation is that during the nonnulled test, the pressure field does not extend completely to the mechanical room (21 Pa in the mechanical room, when the unit was at 50 Pa test pressure), resulting in a lower measured flow. But the results indicate that roughly 20% of the unit’s total leakage originates at the mechanical room. These results also allow calculation of the connection of the mechanical room to the unit’s interior space (210 CFM50/22 in.<sup>2</sup> EqLA). EqLA is considered a reasonable representation of actual changes in air leakage open areas (TEC 2014).

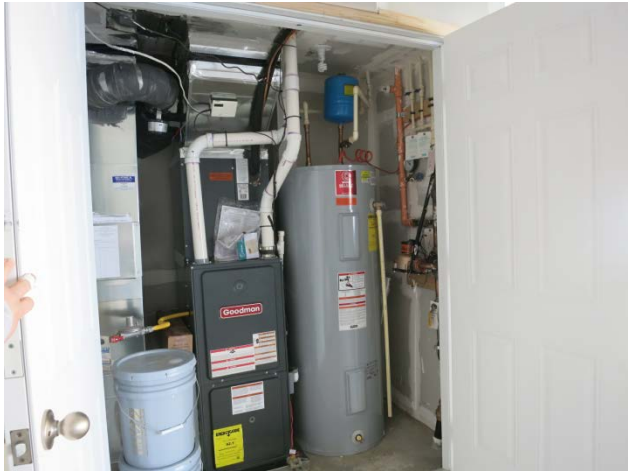
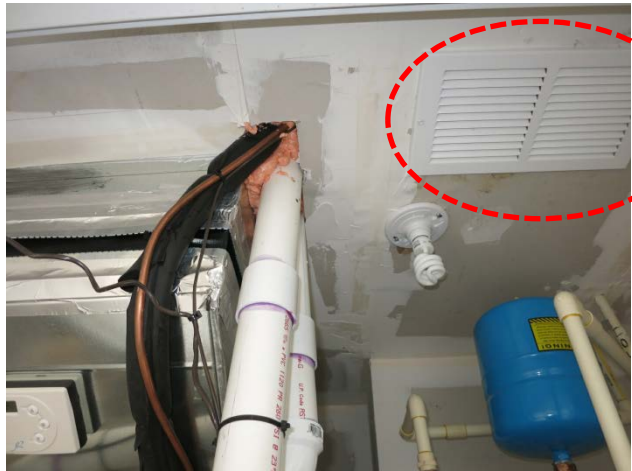
The mechanical room is well connected to the interior, as it is intentionally heated (see supply register in Figure 71 right). There are also many connections from the mechanical room to interstitial spaces (wall stud and floor joist cavities) from the variety of mechanical penetrations, including furnace supply/exhaust pipes (Figure 71, right), air conditioner refrigerant lines (Figure 72), supply and return duct penetrations, pipe penetrations (Figure 72), and other substantial openings (Figure 73 is a clear opening into the floor joist cavity). If the floor joist cavity is connected to the exterior or the garage, it is in turn connected to the interior. These penetrations are difficult to access and seal, given the congestion in the small mechanical room.

Figure 71. Furnace and water heater at mechanical room (Unit 6700); supply register

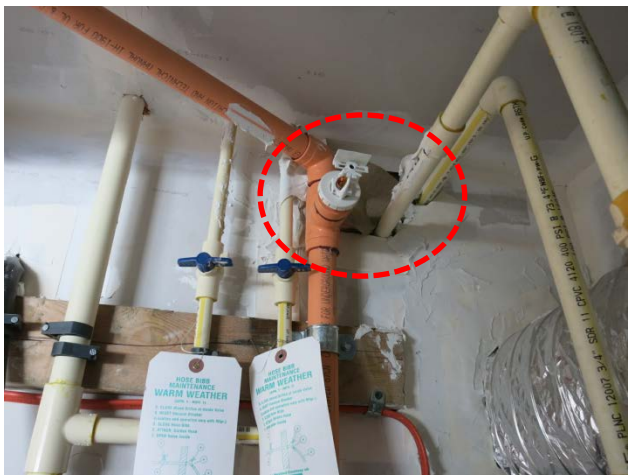
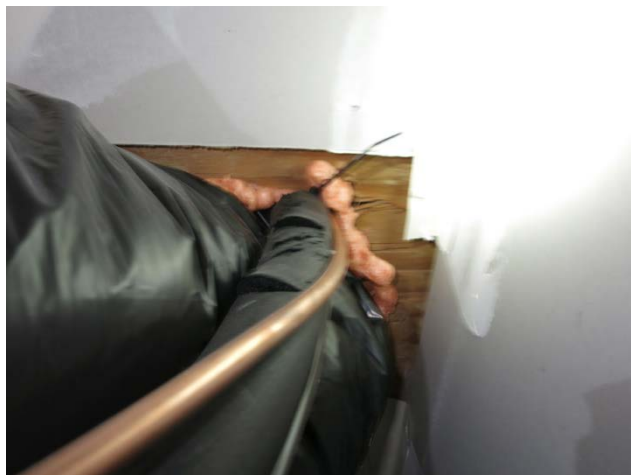
Figure 72. Ceiling and wall penetrations at mechanical room (Unit 6702)

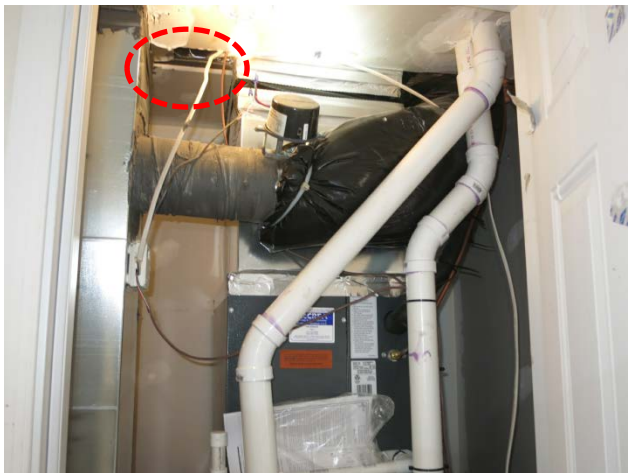
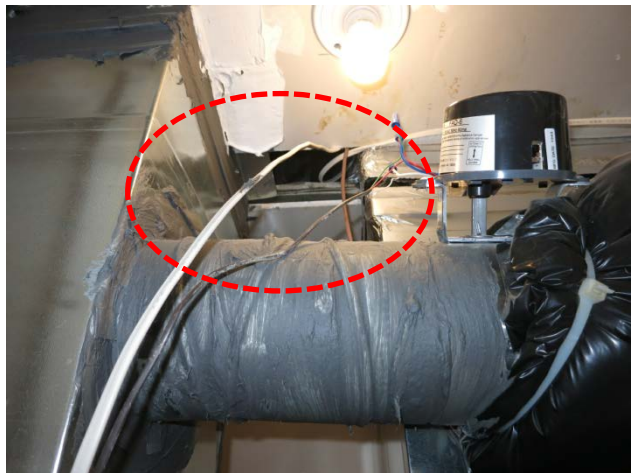
Figure 73. Ceiling penetrations at mechanical room (Unit 6702)
