Leveraging Limited Scope for Maximum Benefit in Occupied Renovation of Uninsulated Cold Climate Multifamily Housing

Building America Report - 1106

21 December 2011 (Rev. March 2012)

K. Neuhauser, D. Bergey, and R. Osser
Building Science Corporation

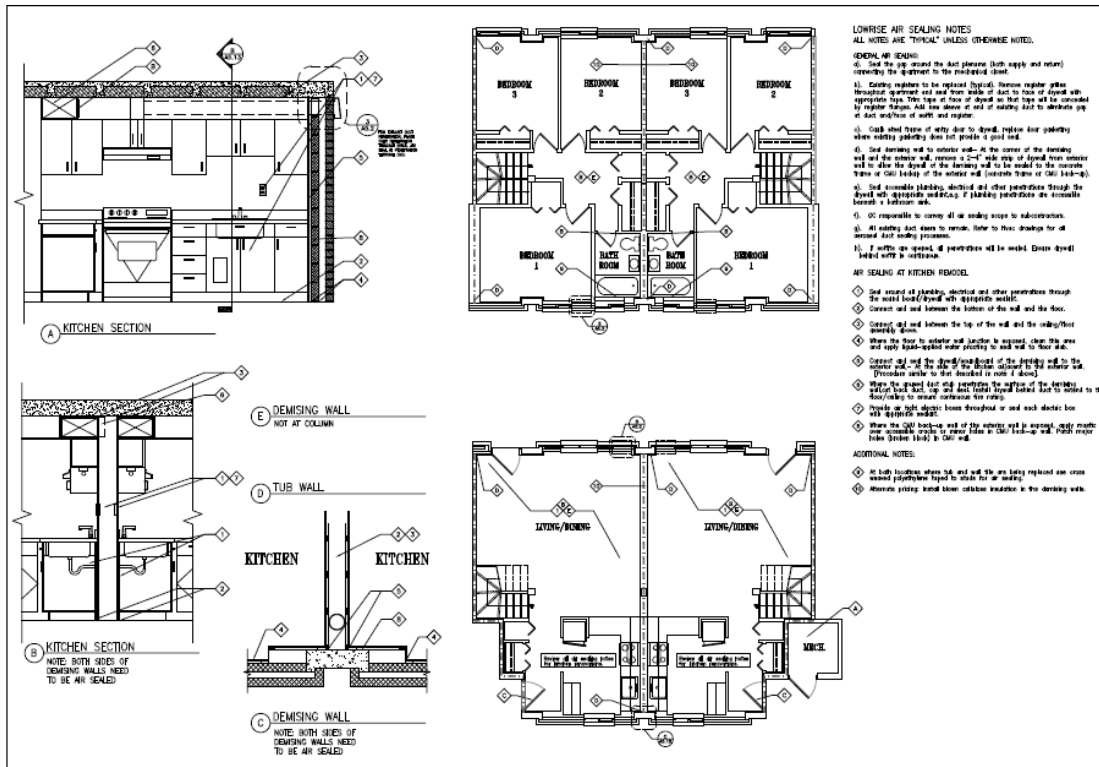
Figure 10. Air sealing scope in construction drawings.

The architect conveyed this air sealing scope in construction drawings reserved exclusively for air sealing details (see Figure 10). In addition to the explicit air sealing scope, other scopes of work impacted air leakage control. The window details in particular were developed to provide robust air leakage control. The air sealing objectives were also reinforced throughout the project specification. BSC and the architect wrote a performance testing quality assurance protocol that was written into the project specifications (see Appendix B). The owner's representative also

BSC observed the mock-up apartment after the contractor had performed initial demolition work. These observations confirmed many of the air sealing needs identified in previous investigations. The observations also highlighted the need for air sealing work to be resistant to rodents as on going rodent activity was evident in this apartment (see Figure 17). BSC conveyed a report (see Appendix E) to the architect conveying suggestions relative to the air sealing scope drawings excerpted in Figure 10.

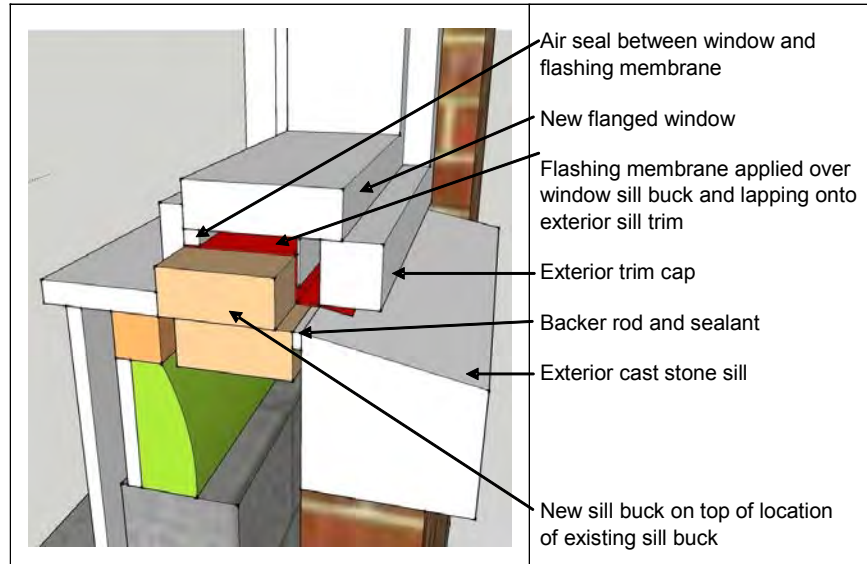
Figure 12. Early schematic detail for low-rise window replacement

The window replacement represents an important opportunity to address airflow control because of the large openings in the airflow control layer observed around the window openings. The windows had been installed to wood bucks. A large (but, as discovered later, variable) gap existed between the wood buck and the CMU opening. In Figure 11, the back of the brick veneer is clearly visible through the gap between the sill buck and the CMU. Because the CMU backup wall, with its dampproof coating on the interior side, was the primary infiltration control layer for the apartments, the window replacement details and installation sequence needed to provide a means to seal between the wood bucks and the CMU opening.

BSC provided comment and review of architectural details, including those for the window. As details evolved in the course of the design process, BSC provided technical guidance to ensure that critical control functions were evinced in the details.

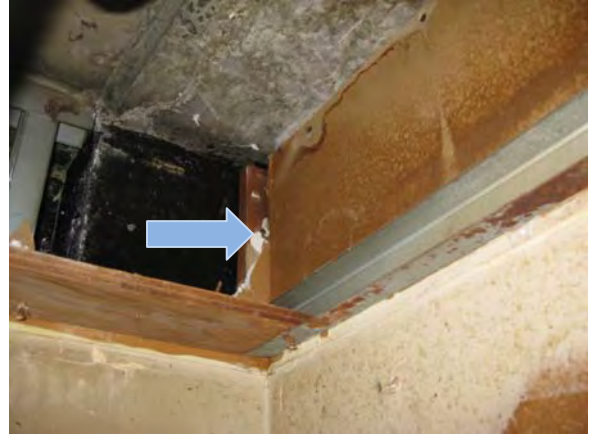
A gap at this intersection was evident in the kitchen soffit (see **Figure 4**). A piece of wood strapping is fastened to the wall at this location. Sealing the demising to the exterior wall will require 1) sealing the demising wall to the strapping and 2) sealing the strapping to the demising wall.

Figure 4: Intersection of demising wall and exterior wall structure in kitchen soffit

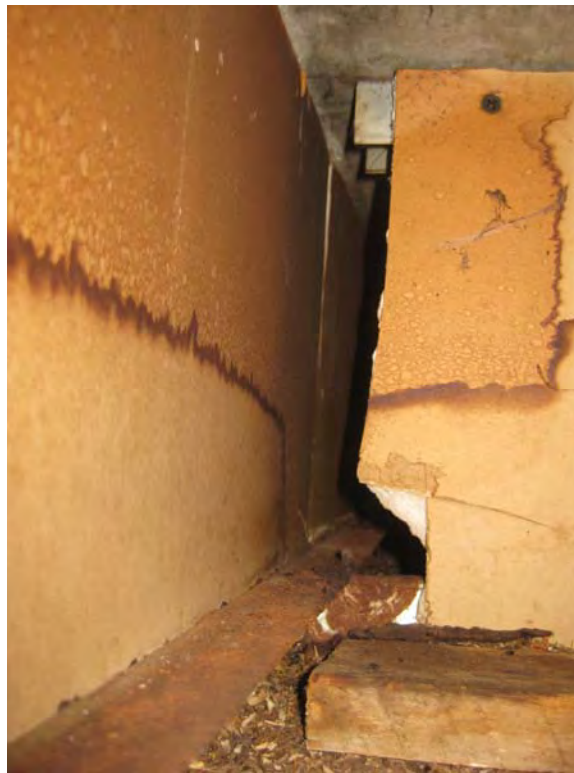
The duct soffit that runs perpendicular to the demising wall was not opened at the time of my visit. From the vantage point of the kitchen soffit, it was not apparent to me whether or not the duct stub penetrates the demising wall. Regardless of whether the duct penetrates the surface of the demising wall, it will be important to open this soffit to seal openings into the demising wall at this location.

Figure 5: View from kitchen soffit (demolished) into perpendicular soffit containing supply duct

Note 6 – Where the duct stub penetrates the surface of the demising wall, cut back duct, cap and seal air, smoke, and gas tight. Install drywall behind duct to extend to the floor/ceiling to ensure continuous fire rating.
