## 2. HABITAT FOR HUMANITY OF GREATER LOWELL, FARMHOUSE RENOVATION, BEDFORD, MA

#### Farmhouse Retrofit Prototype, Gate 3

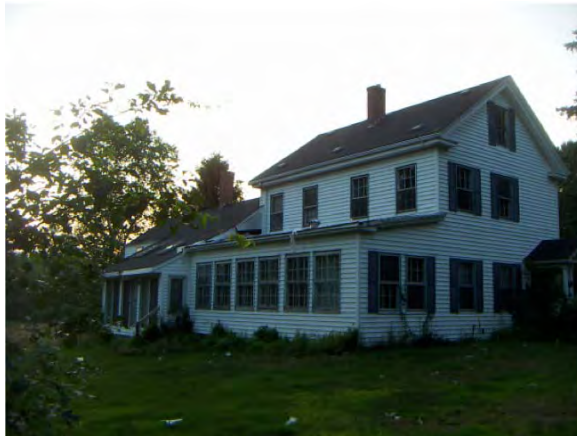
When HfHGL acquired the property, the farmhouse had already been altered and adapted many times to suit the changing needs and means of occupants. Some of the additions were poorly constructed (e.g., south-facing sunroom), and were demolished (see Figure 2.1 through Figure 2.2).

**Figure 2.1: South elevation showing added sunroom and rear addition demolished prior to retrofit**

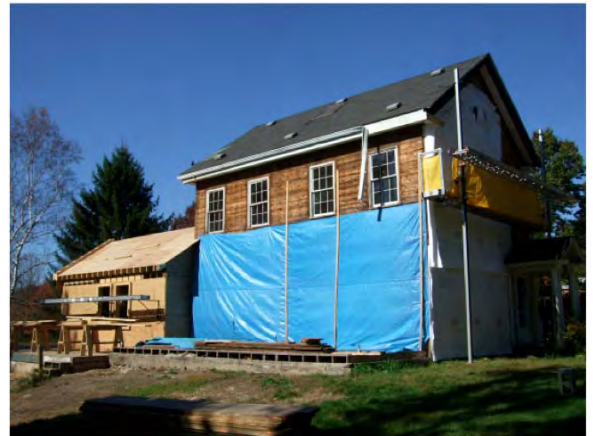
**Figure 2.2: South elevation showing demolition and new rear addition**

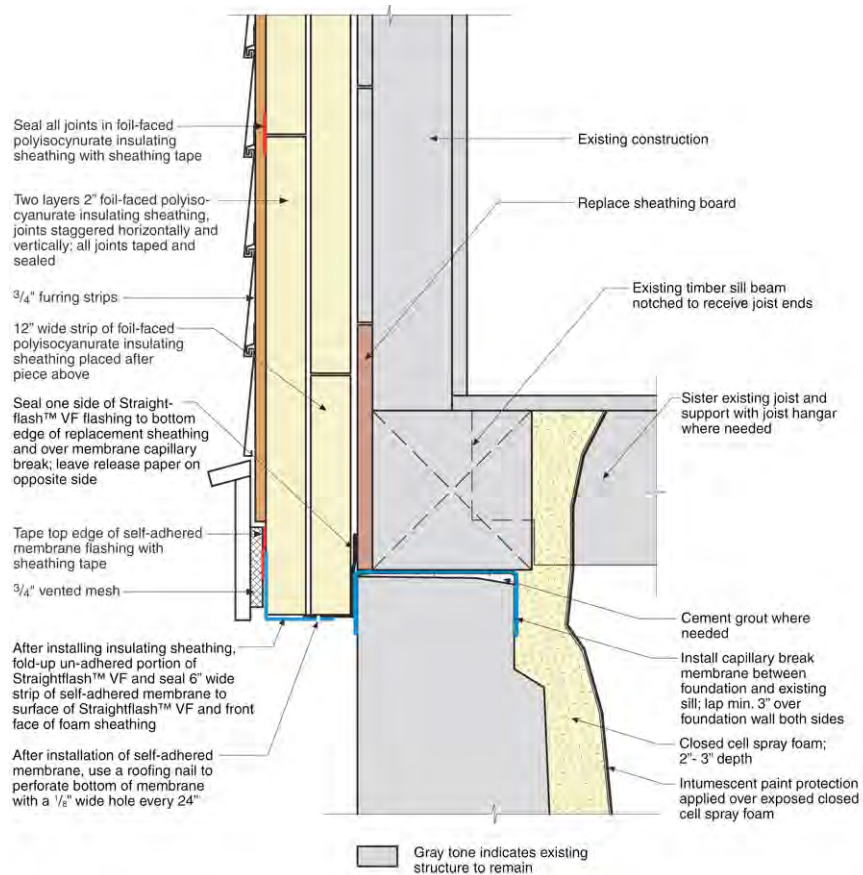
At this location, the air barrier of the foundation wall insulation system – 2-3” closed-cell spray foam – must be connected to the air barrier of the wall system, i.e. the outer face of the insulating sheathing. This must be accomplished without raising the possibility of exacerbating damage that might result from water leaking into the assembly (if—or perhaps when—this occurs).

**Figure 2.9: Air barrier and water management detail at sill**

A layer of self-sealing ice/water membrane placed beneath the sill (see section 2.3.2.4 “*Sill Beam Evaluation and Replacement*” below) serves as both a capillary break membrane and an air barrier transition membrane. It effectively transfers the air barrier from the inside

A membrane air barrier transition provides a more robust and durable air barrier and is compatible with the sequence of construction, including discrete inspection steps. In the solution developed, one side of a self-adhered flashing membrane (DuPont StraightFlash™ VF “Versatile Flange”) is sealed to the bottom of the wall sheathing and the capillary break membrane mentioned above. The proper installation of this membrane piece can then be verified. Then, after installation of the insulating sheathing, the free side of flashing membrane is folded up and sealed to the face of the insulating sheathing with another piece of flashing membrane. The seal can be verified when the top edge of the flashing membrane is then taped to the outer foil facing to ensure drainage plane continuity, and prevent low-angle shear de-adhesion issues common to vertical membrane flashings.

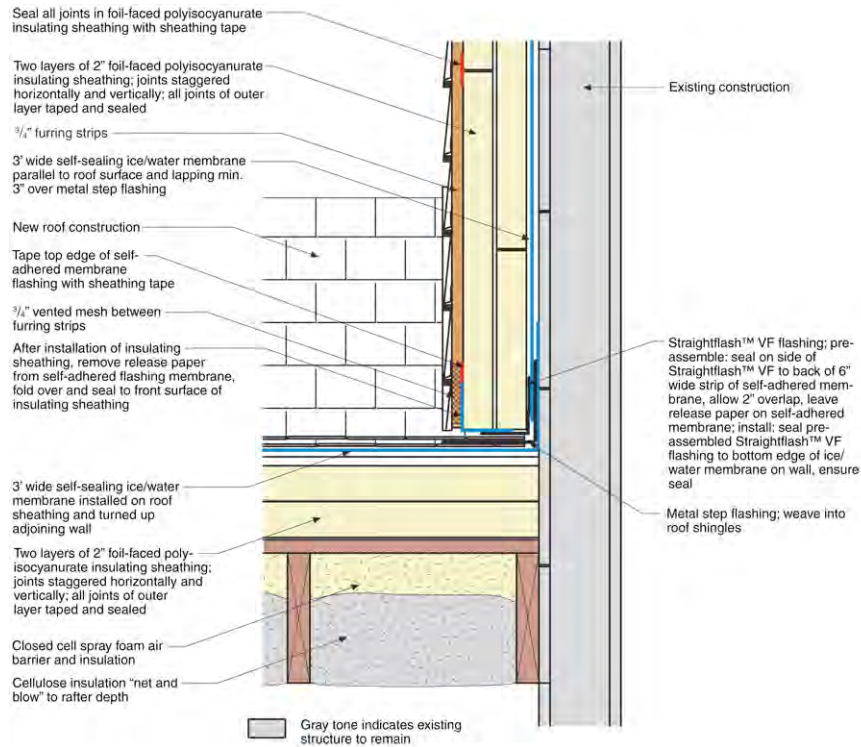
This transition is detailed in a manner similar to the base of the wall at the foundation. One important difference, however, is that there is no clearance underneath the wall insulating sheathing to manipulate the flashing membrane. This requires that the two piece flashing membrane air barrier transition be pre-assembled. It is then adhered to a 3' wide (roll width) piece of ice/water membrane that is adhered to the existing board sheathing of the wall. This ice/water membrane on the wall seals to the air barrier membrane of the roof (fully adhered ice/water membrane turned up the wall at the roof-wall interface) and provides ample protection against water that might penetrate the outer face of the foam sheathing and back up the wall due to, for example, snow accumulation against the wall.

**Figure 2.10: Air barrier and water management detail at wall-to-lower roof interface**

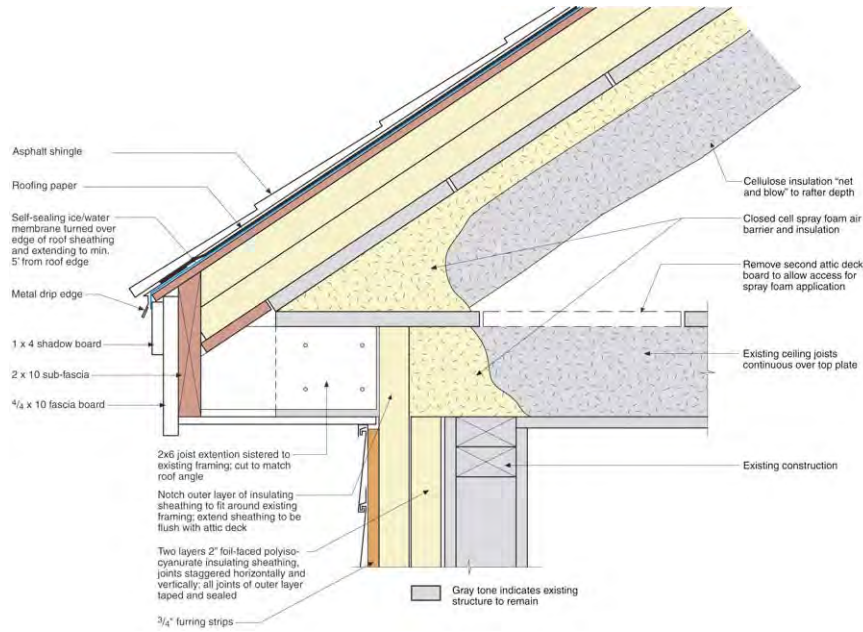
Except for the gable end of the single story addition, the air barrier continuity at this interface relies upon the application of spray foam to transfer the air barrier from the insulating sheathing to the air tight roof system. At the gable end of the single story addition (a portion of the building that represents new construction), the two sided adhesive flashing membrane (StraightFlash VF) is used to transfer the air barrier from the insulating sheathing to the structural sheathing from which it is then transferred to the roof system.

**Figure 2.11** Air barrier detail at top of wall, existing roof eave

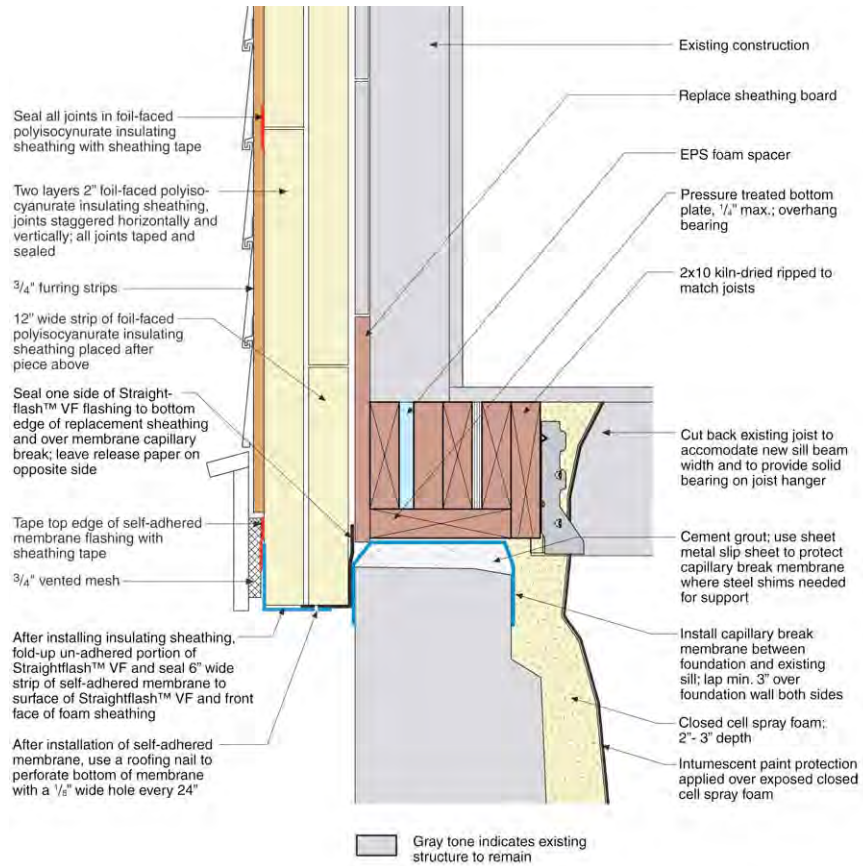
In light of the increase in moisture risks due to the retrofit of insulation described earlier, the condition of the sill beam was of particular interest. This framing member is exceptionally vulnerable, given its location. The moisture sources at play include the following:

- **Capillarity:** the wooden sill beam is in direct contact with the stone or masonry foundation. Liquid capillary water can rise in the foundation, potentially creating high relative humidity conditions at the wood-masonry interface, raising the risks of moisture damage.

- **Sorption isotherm behavior:** the stone foundation is highly thermally conductive; therefore, during wintertime, the sill-foundation interface will be very cold. At typical dewpoint conditions, the interface will be at a high relative humidity. The sorption isotherm (material response to relative humidity) shows that RH determines moisture content, so at these conditions, the moisture content will rise.

- **Bulk water/flashing:** similarly, at the base of the wall, incorrect flashing details can direct bulk rainwater into the foundation, similarly causing accelerated damage.

**Figure 2.21:**  
Replacement sill detail

The builder contracted an engineer to design the sill beam with these considerations. The resulting design is as depicted in Figure 2.21 below.

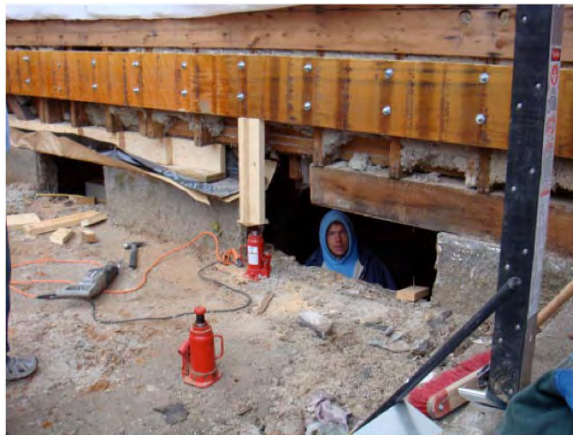
**Figure 2.22:** LVL used as lifting beam for sill replacement

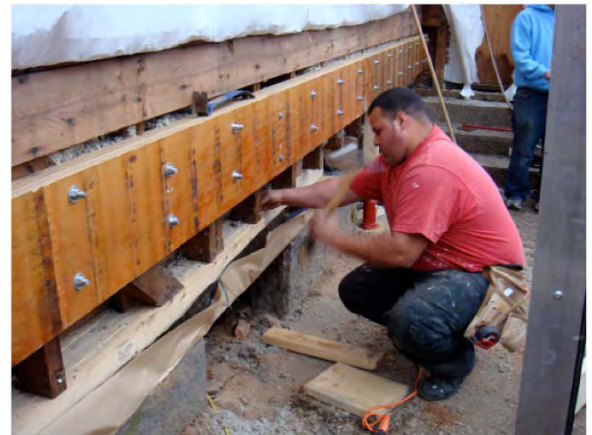
**Figure 2.23:** Toenailing of existing studs to replacement beam

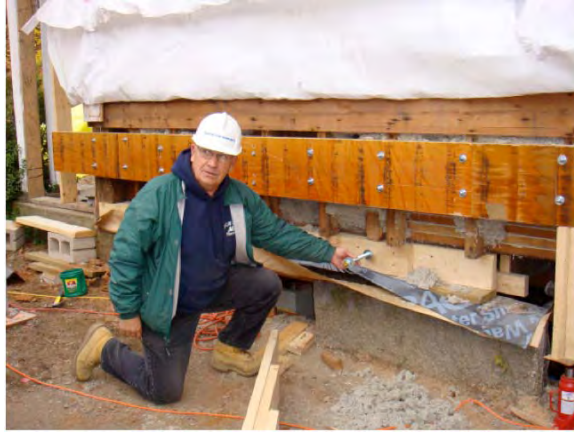
**Figure 2.24: Built-up sill assembly, showing capillary break under beam**

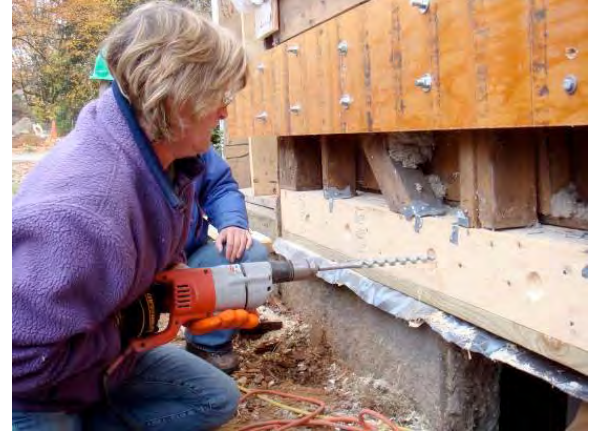
**Figure 2.25: Built up sill, showing metal connector plates from sill to stud**

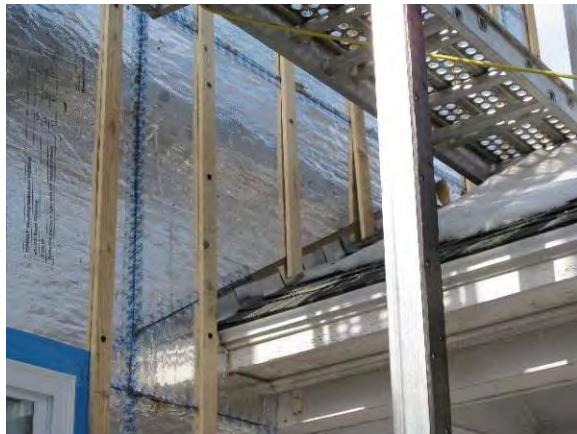
Figure 2.29: Corrected step flashing integrated with the drainage plane

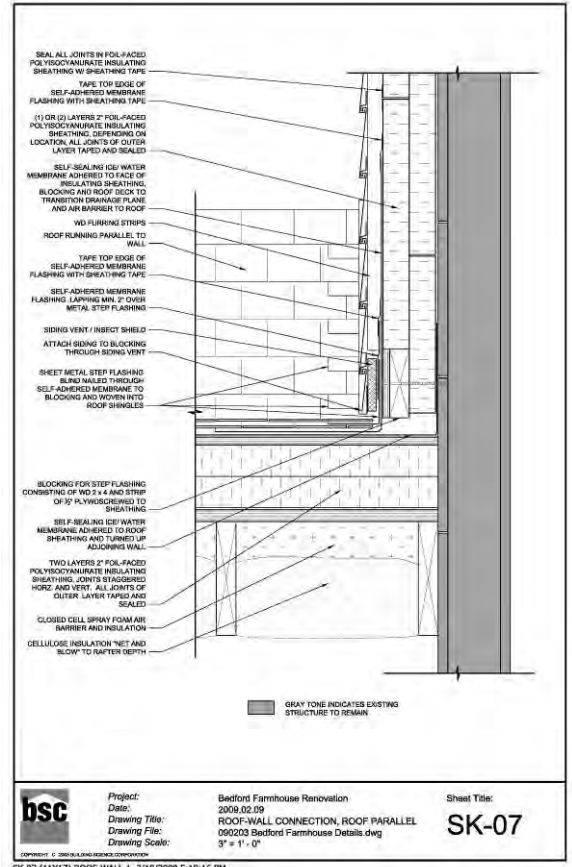
In many cases, construction proceeded ahead of design, or differently than the specific details of the design. In these cases the team consulted with the builder and revised details in order to preserve the performance objectives. The roof-wall interface detail in **Figure 2.30** shows an example of a detail created for one of these situations. **Figure 2.28** also shows a detail that was revised after construction followed a different direction than indicated on the project drawings. The revision was formulated and agreed to in a discussion with the site supervisor during a site visit. It was necessary to provide an alternative method of achieving air barrier continuity at this location, when the earlier solution was not implemented.

Figure 2.30: Roof-wall intersection detail drawn to guide correction of drainage plane and air barrier transition

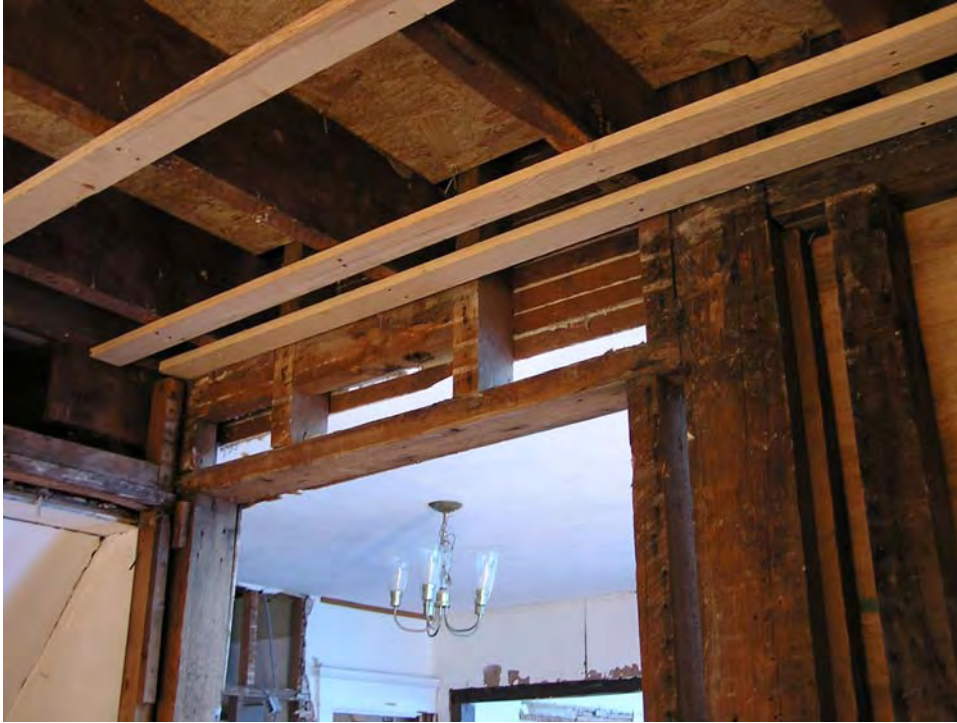
**Figure 1: Opening to addition\_1.JPG**

1. Opening to addition lacks a header. Existing vertical framing 35” apart with the vertical bearing members spaced wider at 41” apart.
2. Width of addition inside framing 14’-1 ½”. This is 1’-8 ½” narrower than shown on our plans.
3. Bath 1 is 8’-0” deep inside framing
4. Closet 1 is 38 ½” wide inside framing. This is ~1’-8” narrower than shown on our plans

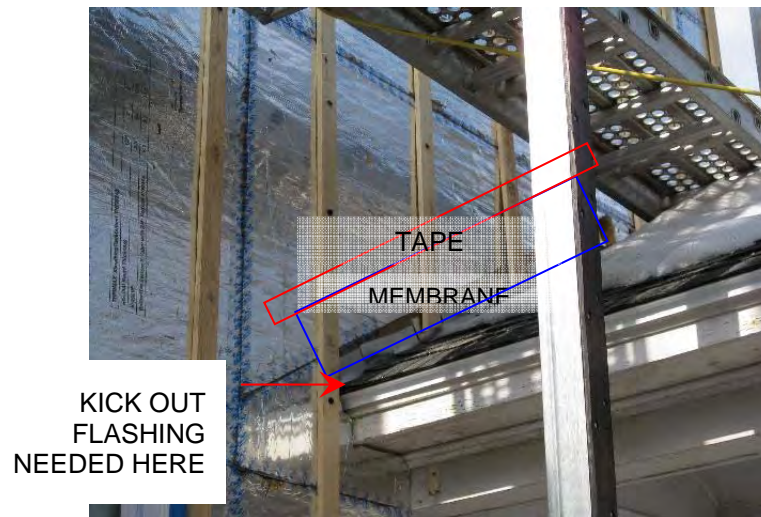
**Figure 1 - Roof over front entry**

A kick-out flashing is needed where the wall terminates in the field of the wall.

At the roof over the front entry, the drainage plane is not transferred to the roof. Where the ice and water membrane is currently installed, it could direct water into the wall assembly. To remedy this condition, membrane should be installed over the vertical leg of the step flashing, adhered to the wood blocking and continue up the foil facing. The top edge of the membrane is then taped.

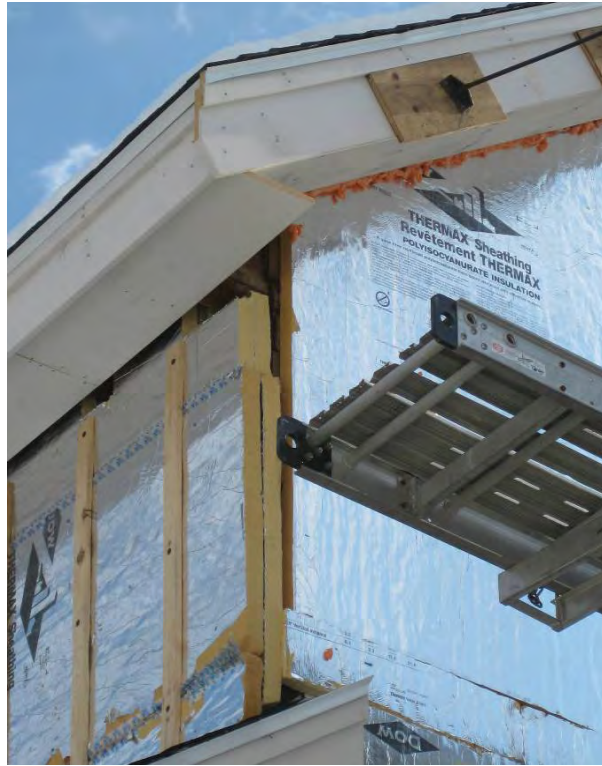
**Figure 3 - Foam Sheathing Corner**

In general, it appears that the air barrier concept has not caught on with the crews. There are several places with large gaps between sheets of foam. The foam corners are very loose with no membrane applied. In some cases, furring would need to be removed to apply membrane over the corners.

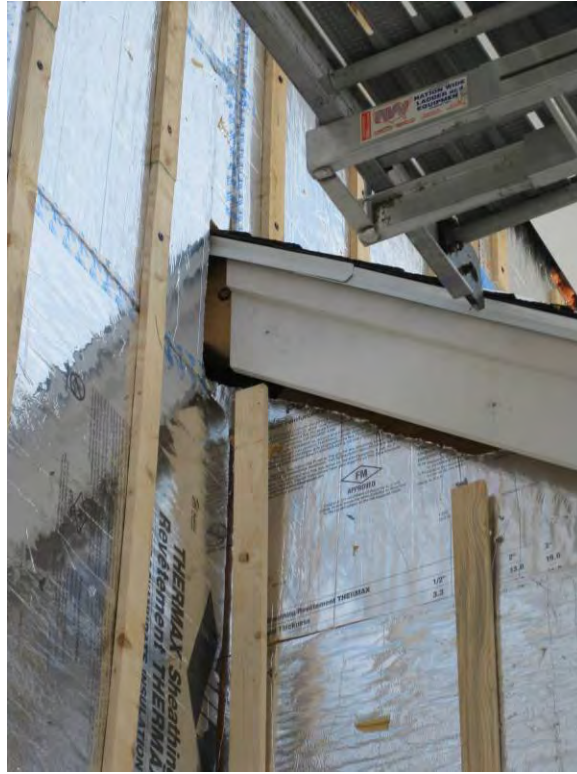
**Figure 4 - Wall to Roof Connection**

Other roof wall connections, such as that shown in Figure 4, show a lapse in the air barrier continuity. The air barrier foam sheathing should be air sealed to the underside of the roof sheathing where possible. Where this is not possible, the air barrier foam sheathing should be sealed to roof framing and these framing members then sealed to the roof sheathing.

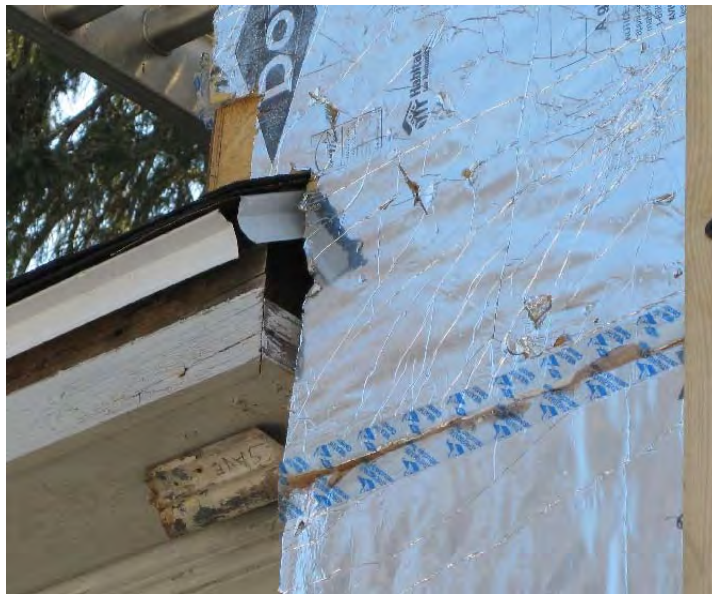
**Figure 2 - Front entry porch roof at corner**

Where the bottom of the porch roof meets the wall at the corner (Figure 2 below), it can be flashed similar to the rake of the kitchen roof:

1. Foam in the gaps between the fascia return and the foam sheathing.
2. Install a membrane flashing or metal corner flashing at the vertical inside corner where the rake meets the face of the foam. Cut the rake drip edge at the face of the foam sheathing to let in this inside corner flashing.
3. Tape the top edge of this flashing that extends up the face of the foam as well as the side edges of the membrane.

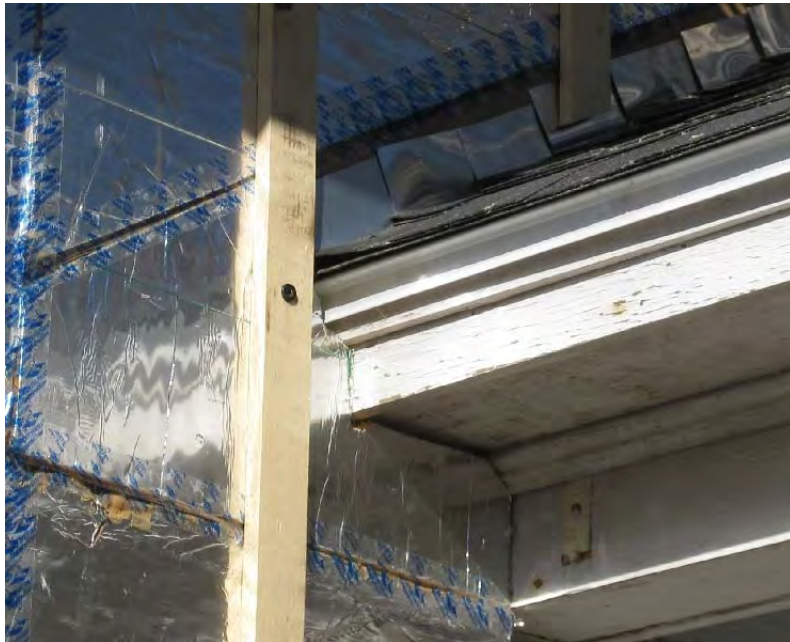
**Figure 3 – Roof over front entry at front wall**

Where the bottom of the roof over the front entry meets the front wall in the field of the wall (Figure 3 below), the existing wood work presents a challenge to implementation of the water management and siding. To address these challenges I offer the following (note that this interface is to be sheltered by a kick-out flashing):

1. Leave roof sheathing and fascia intact but cut away the drip edge and crown moulding beneath the drip edge at a point that is even with the face of the vinyl siding to be installed later.
2. Remove the drip edge and crown moulding to the wall side of the cut.
3. Paint the cut end of the crown moulding with wood primer or sealer.
4. Foam in the gap between the fascia board and the foam sheathing with canned foam to flush with the foam sheathing.
5. Install a membrane flashing or metal corner flashing at the vertical inside corner where the fascia board meets the face of the foam.
6. Tape the side edges of the inside corner flashing.

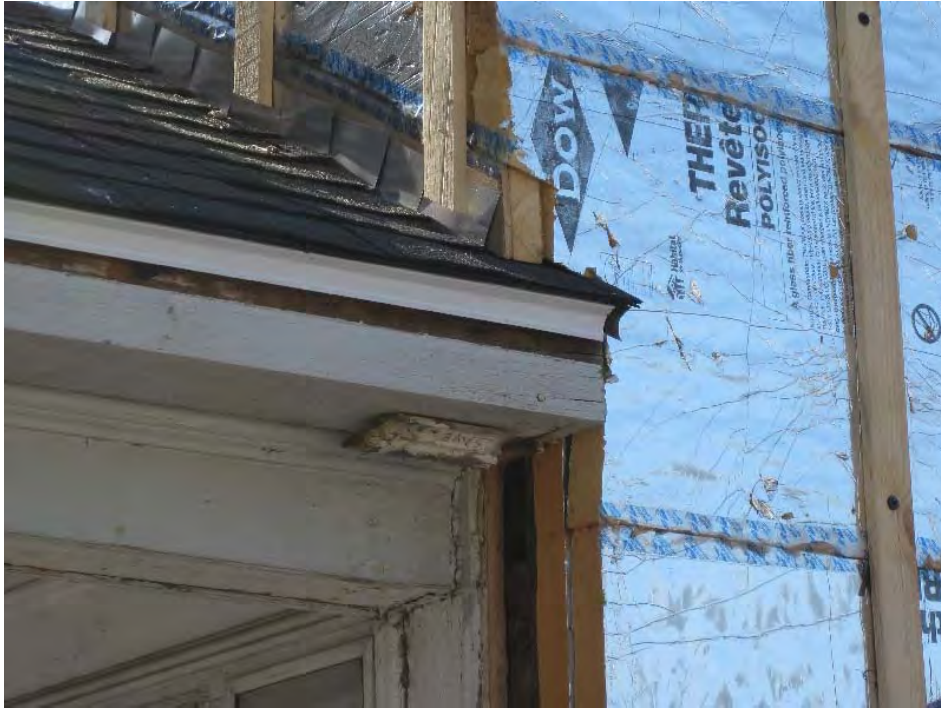
**Step 0 – Current, in-process, condition**

- **Foam held back to flush with front wall wood sheathing below roof soffit**
- **Wood trim below support beam left in place**

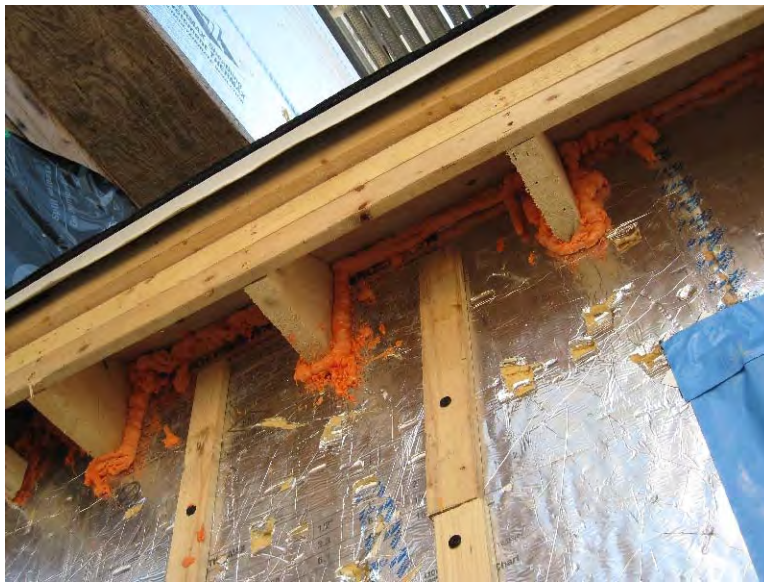
**Figure 1 - air sealing at addition roof eave**

One area we considered is the roof eaves. Upon visual inspection, these appear to be well sealed with foam sheathing extending between rafter framing to the roof sheathing and canned foam applied around the perimeter of the foam sheathing (refer to Figure 1 and Figure 2 below).

***Roof eaves at addition*** – Generally, the eaves appeared well sealed (see Figure 1 above). Some leaks were observed and sealed.

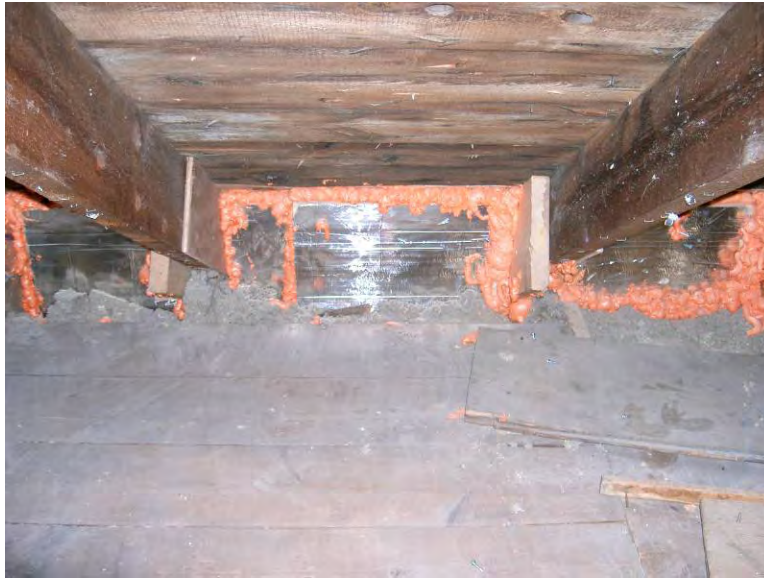
**Figure 2 - air sealing at existing roof eave**

**Roof eaves at existing roof** – with the greater depressurization, no air leakage was observed at a sample of locations along the existing roof eaves.

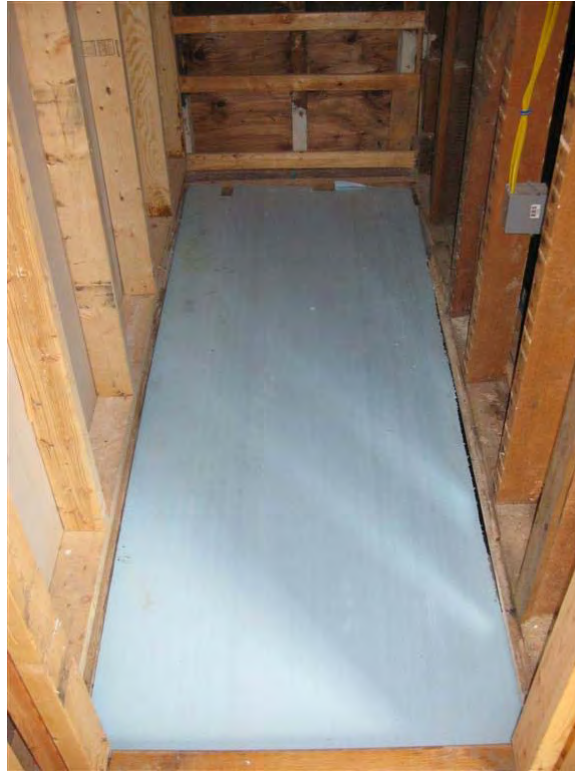
**Figure 3 - XPS blocking at stair opening**

Note: Blocking at stair opening shown before application of tape and before installation of a second blower door frame used to prevent the foam board from being lifted out of place.

The major connection between the basement and the rest of the building was a floor opening for the basement stairs. Other large connections were noted at plumbing penetrations. Openings in the floor assembly containing ductwork also represented holes to the basement. Systemic connections between the basement and the first floor include the sometimes-open joint between floor sheathing and the sill beam as well as the leakiness of the floor system itself. The stair opening was closed with a large piece of extruded polystyrene cut to fit in the opening, supported

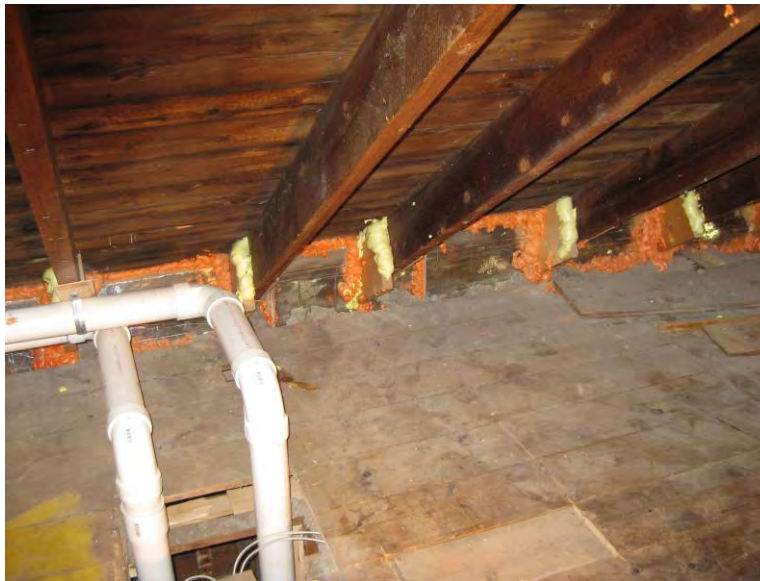
**Figure 9 - additional air sealing at existing roof eaves**

The first air sealing task of the volunteers was to seal any leakage felt or observable (by use of a smoke stick or movement of dust particles) at the main roof eaves. Volunteers Nitash and Sri accepted this task. Use of the blower door did not appear to offer a clear signal of air leakage at the eave due to the front door being frequently opened and consistently left open during this part of the operation. Nonetheless, the volunteers proceeded to apply canned foam to all joints of types where observations suggested the possibility of air leakage.

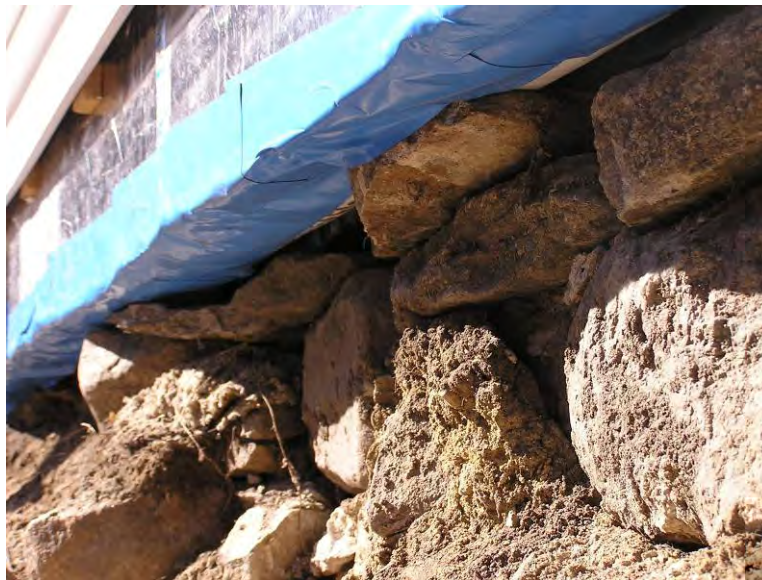
**Building Sill** – Significant design effort was devoted to air barrier transition at the building sill. In general, the designed appeared to be implemented successfully. At some locations, it was clear that one particular brand of membrane used in the design failed to adhere to the substrate. At a location on the Northeast corner, repair of the lower sheathing was carried out without using a new piece of the Straight Flash VF which had been adhered to the sheathing.

**Figure 14 - sill to wall air barrier transition from below**

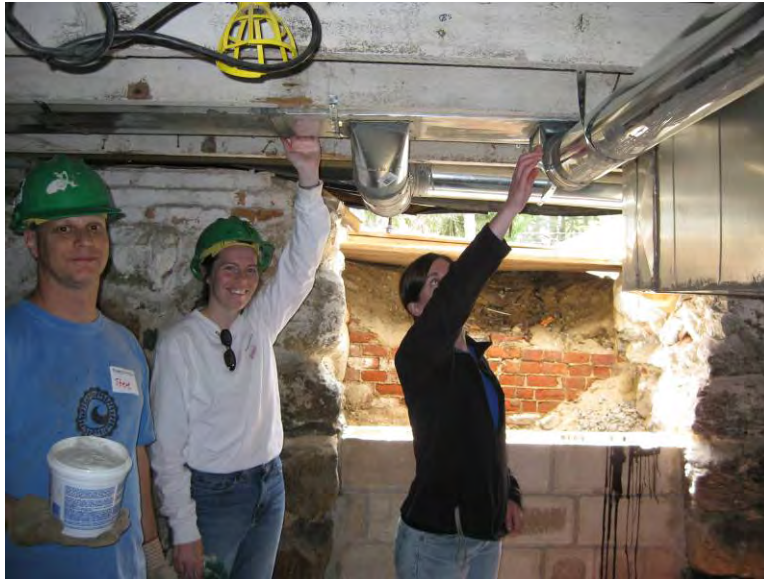
After an initial baseline depressurization test of the duct system, volunteers spent a considerable amount of time locating and applying mastic to duct leaks. During this operation, the duct system was pressurized.

**Figure 20 - Habitat volunteers and a BSC staffer locating duct leaks**

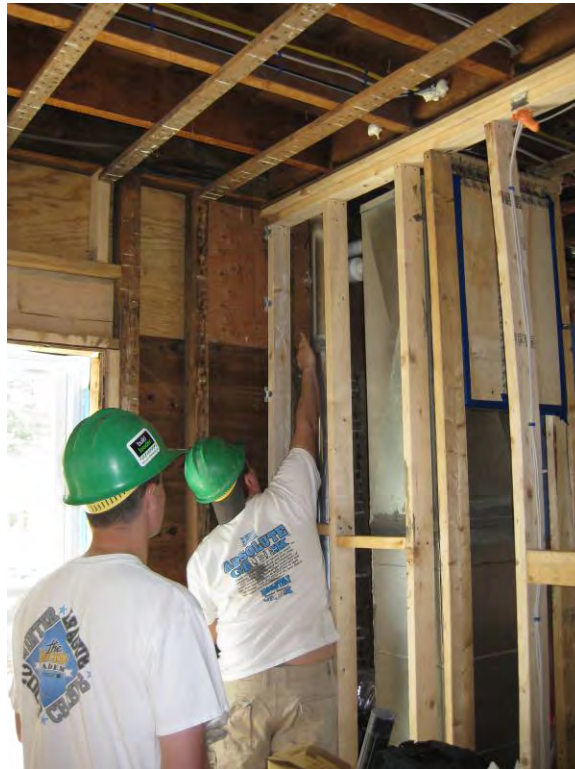
**Figure 21 - Habitat volunteers locating and sealing duct leaks**

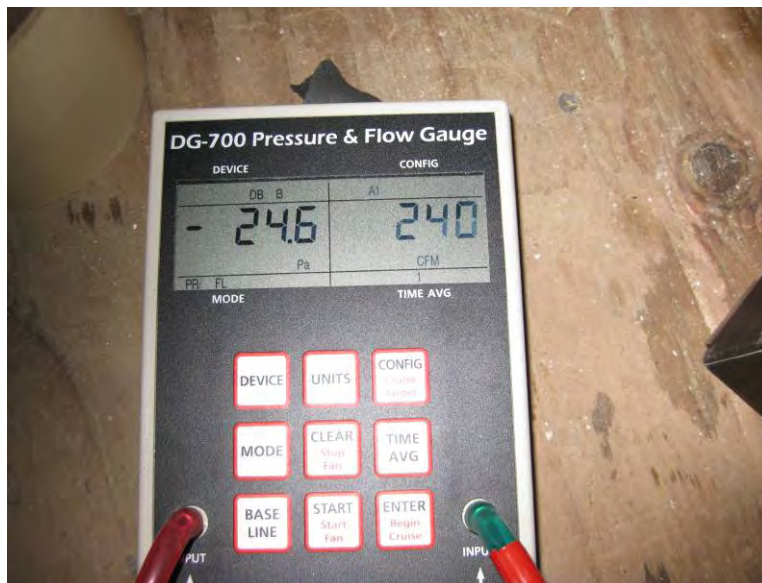
After the volunteers had completed this work in the basement, first floor, second floor and attic, a second test of the duct system was conducted. Puzzlingly, the additional duct sealing work resulted in a decrease in measured duct leakage of only about 5%. No registers were found to be un-masked during this follow-up test. The total duct leakage measured at 25 Pa seems large relative to the system capacity and nominal air flow. However, conferring with other BSC staff suggests that such total duct leakage is within the realm of expected performance for Building

America projects of this size. The total duct leakage at 25 Pa is less that 10% of the conditioned floor area.

**Figure 22 - duct leakage test results after duct sealing**
