Monitoring of Unvented Roofs with Fibrous Insulation, Diffusion Vents, and Interior Vapor Control in a Cold Climate

Building America Report - 2001

September 2020

K. Ueno and J.W. Lstiburek

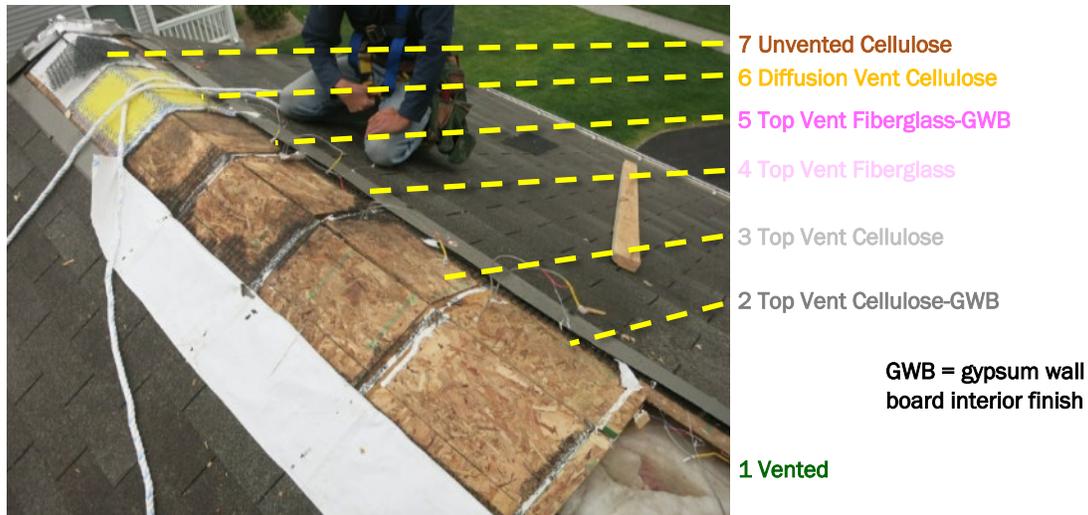
Figure 1. Disassembly of Chicago unvented roof assemblies at conclusion of experiment

Previous Building America-funded research monitored unvented roof assemblies in a cold climate (Chicago, climate zone 5A; Ueno and Lstiburek 2015). That work demonstrated that an unvented cellulose roof assembly has high moisture risks when subjected to high interior RHs (Figure 1). That work also demonstrated that a diffusion vent provides limited drying ability—insufficient to avoid failures. The project also showed that dense-pack cellulose had lower moisture risks than commodity fiberglass batt insulation. However, this work did not study the effect of interior vapor control beyond latex paint (Class III vapor retarder, ~10 perms). Lower interior permeance could control moisture entry into the cavity sufficiently to minimize risks.

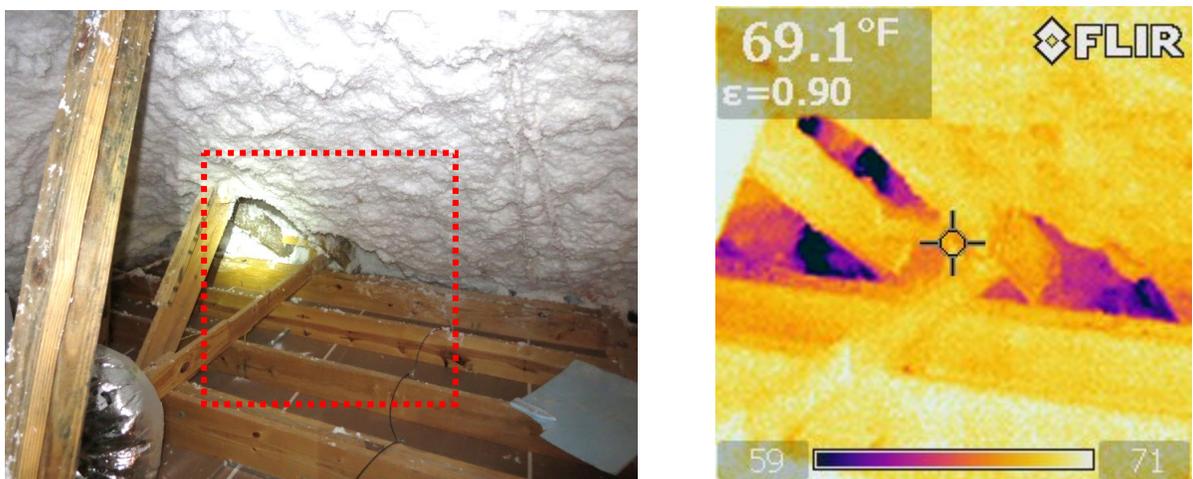
Figure 5. Air leakage at roof-to-wall details at dormer/intersecting roofs

One conclusion from the Houston and Orlando work (Ueno and Lstiburek 2016a, 2016b) is that when switching from spray foam to fibrous (air permeable) insulation, air barrier detailing—especially at roof-wall connections—is critical. Figure 5 shows an infrared image during depressurization air leakage testing with cold exterior conditions; complicated roof-wall interfaces were a common source of air leakage.

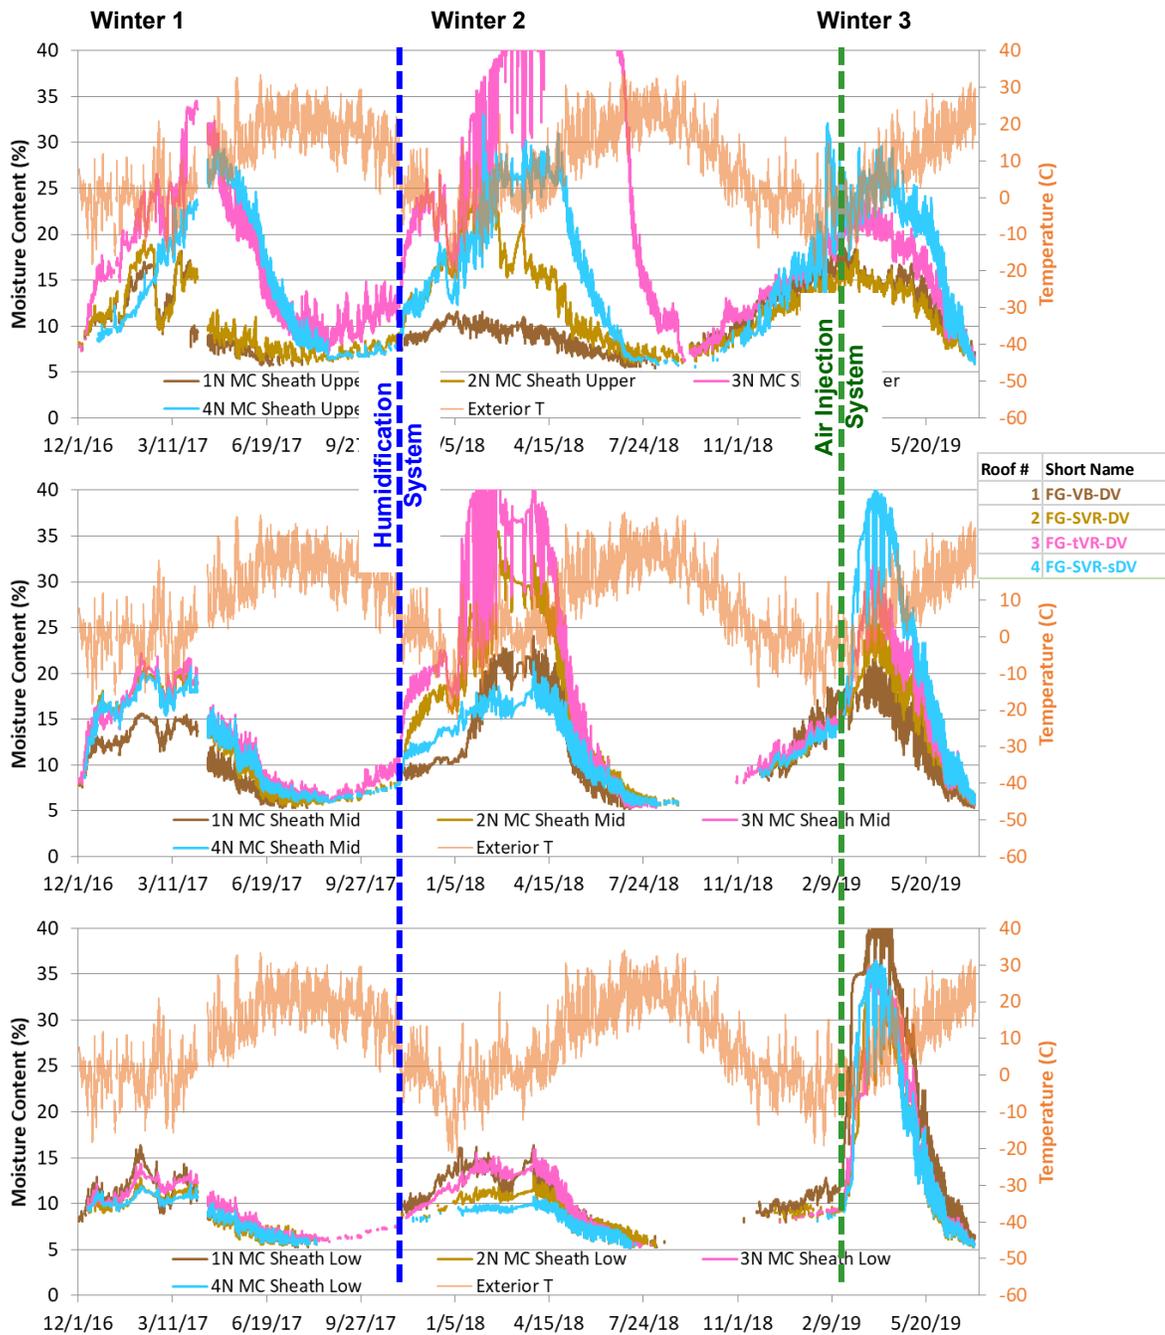
Figure 57. Fiberglass roofs' (1-4) sheathing MC north measurements

In Winter 1, on the north side (Figure 57), upper sheathing MCs in the diffusion vent roofs (Roof 1 and Roof 2) reach the 15%–20% range in mid-winter, but the non-diffusion-vent roofs (Roof 3 and Roof 4) have much higher peak MCs of 25%–35%, which is in the risk range for moisture-related damage. However, the middle and lower sheathing MCs are lower, with wintertime peaks slightly above 20% and 15% respectively, which is a safer range.

In Winter 3, before air injection (to the left of the GREEN vertical dotted line in Figure 57), all roof MCs were much lower than Winter 2, despite identical interior conditions. This is consistent

Then, after activation of the air injection system (late February 2019, to the right of the **GREEN** vertical dotted line in Figure 57), there was a sharp rise in sheathing MCs, especially at the low location (directly above the air injection port). Sheathing MCs rose to the 30%–40% MC range at the low location, and similar levels at the mid-height location. However, no discernable rise occurred at the high (near-ridge) location.

Air injection was ended in mid-April 2019; sheathing MCs then declined, falling to safe levels by the summer. The wettest was **Roof 1** (fixed-perm vapor retarder), but not by a significant margin; this is consistent with inhibited inward drying.

Overall, the Winter 3 north-side MC measurements indicate that a small (~0.5 CFM) air leak can result in significant wetting of the roof sheathing in these unvented roof assemblies.

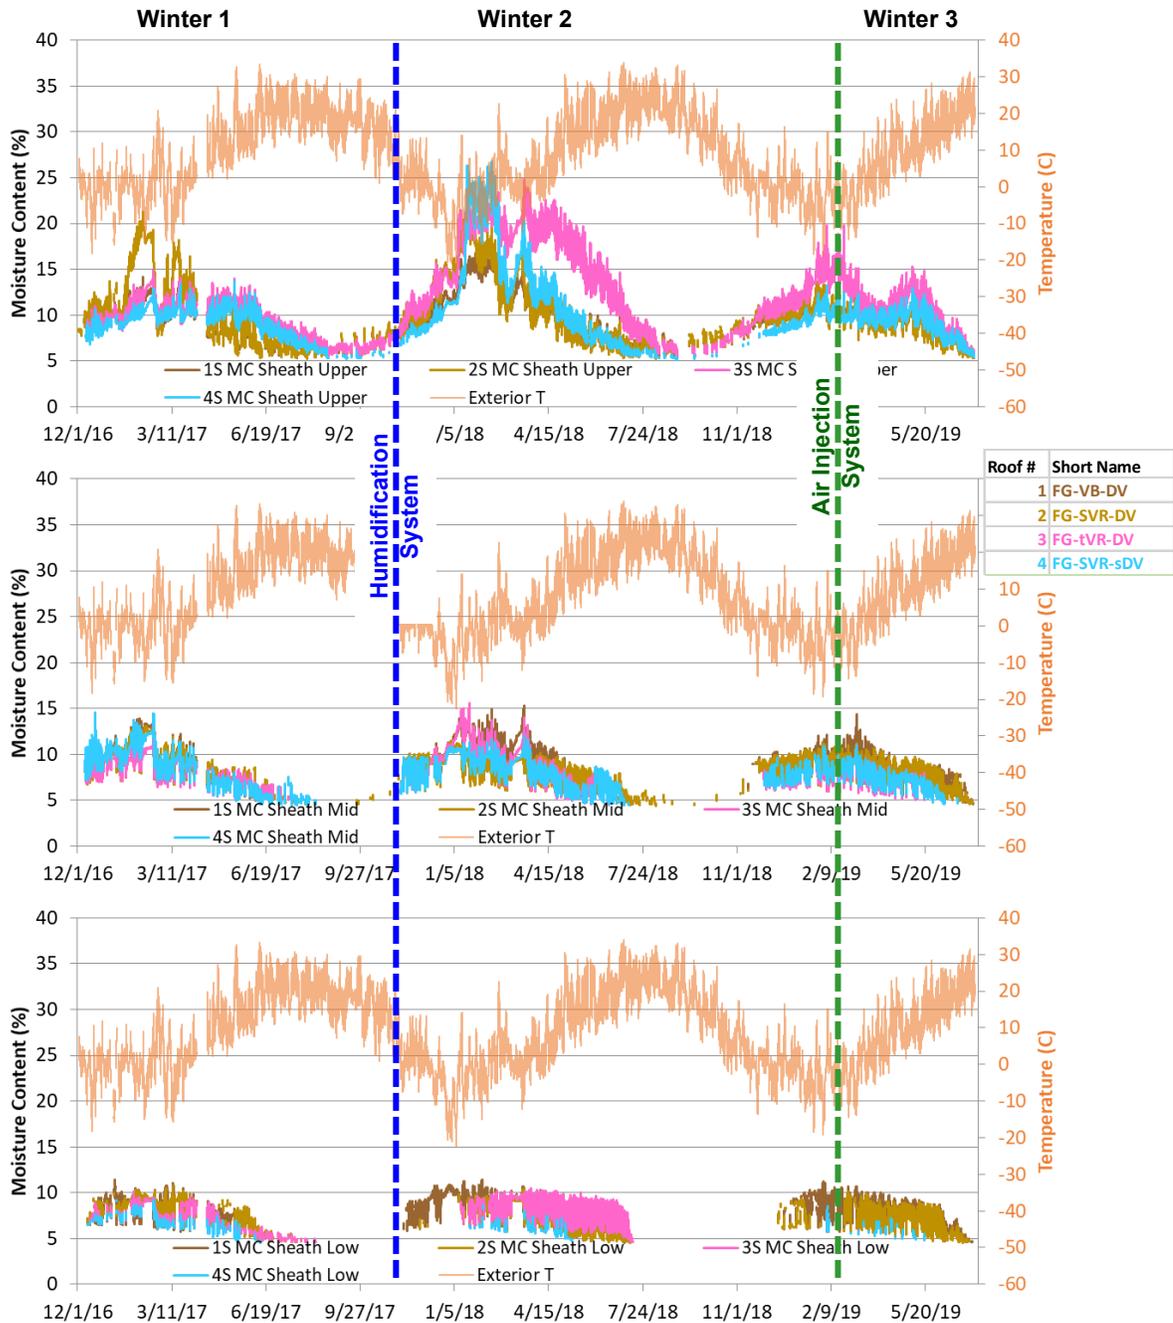
Figure 58. Fiberglass roofs' (1-4) sheathing MC south measurements

The sheathing MCs for the south fiberglass roofs are shown in Figure 58. This showed similar patterns of Winter 2 having higher MCs than Winter 1 (due to humidification). As expected, all south MCs are drier than the corresponding north measurements.

In Winter 2, operation of the humidification system increases MCs, which is particularly noticeable at the mid and lower heights. However, MCs remain within the safe range at those locations.

Winter 3 results are drier than Winter 2 (again consistent with repacking of insulation suppressing convective airflow). The air injection system was not designed to impact the south-facing roofs, so no response was expected.

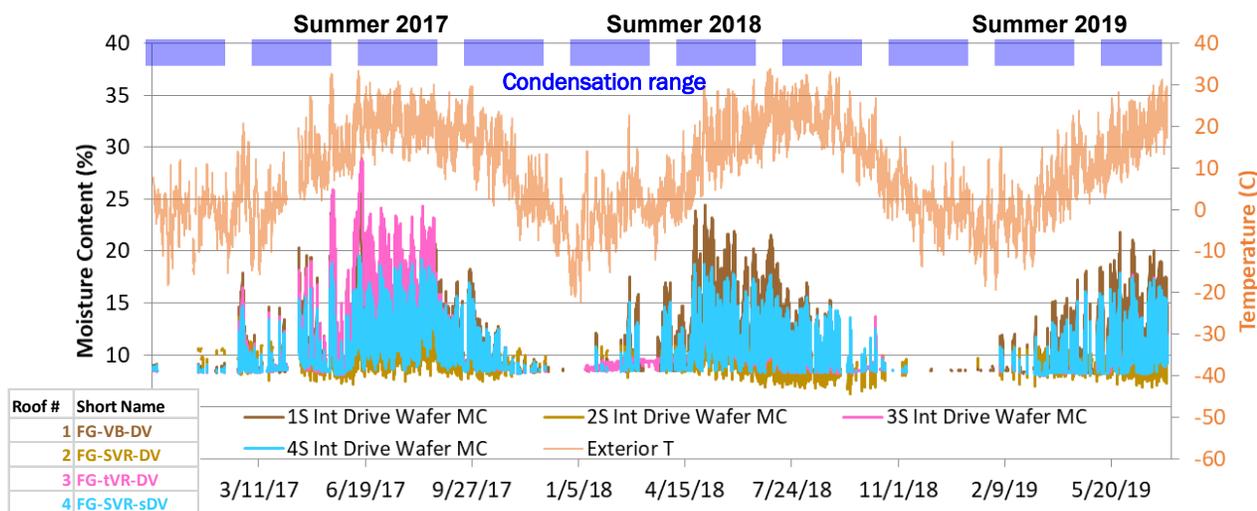
Figure 60. Fiberglass roofs' (1–4) inward drive wafer MC south measurements

In 2017, wafer peaks first occurred in February 2017, during unusually warm outdoor conditions. As exterior temperature warmed, moisture spikes occurred more frequently, and in proportion to outdoor temperatures. Moisture spikes remained well below the 40% MC range that indicates condensation. However, summertime spikes were above levels consistent with 100% RH.

The highest moisture spikes occurred in **Roof 1** and **Roof 3**, which both had fixed-perm (1 perm) interior vapor and air barriers. In contrast, **Roof 2** and **Roof 4** (variable-perm vapor retarders) had noticeably lower peaks and accumulation of moisture.

The presence of liquid water condensation was noted during roof disassembly work (vapor retarder replacement) in summer (August) 2017. Specifically, condensation was found on **Roof 3** (fixed-perm vapor retarder in Winter 1) within 3 ft of the ridge; this disassembly work is covered in Section 12.3: Inward Vapor Drive Condensation. The instrumentation at mid-height did not capture this extreme accumulation.

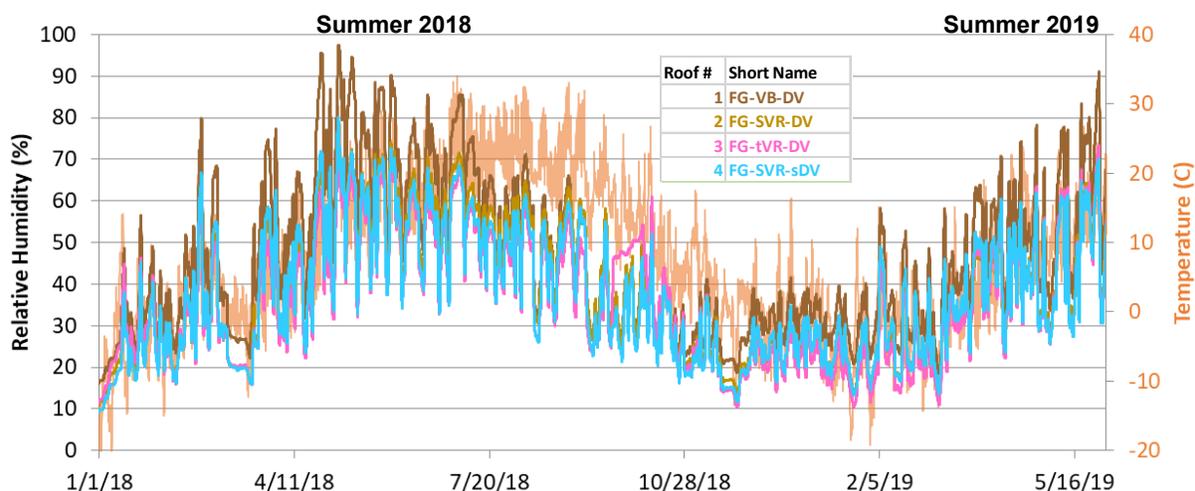
Figure 61. Fiberglass roofs’ inward drive 24-hour average RH, south measurements, 2018–2019

The south-facing inward drive RH sensors’ 24-hour moving average data are plotted in Figure 61, for summer 2018 and summer 2019. Averaging was used to make the data readable. Again, **Roof 1** (fixed-perm vapor barrier) is the consistent high outlier, although moisture levels remain in the safe range (mostly below 90% RH).

One observation when comparing Figure 61 (south RHs) and Figure 62 (north RHs) is that inward drive problems appear to be worse on the north side. This was surprising, given the greater solar gain on the south roof elevation. This is ascribed to greater wintertime moisture accumulation in the north-side assembly, which provides a greater reservoir of moisture.

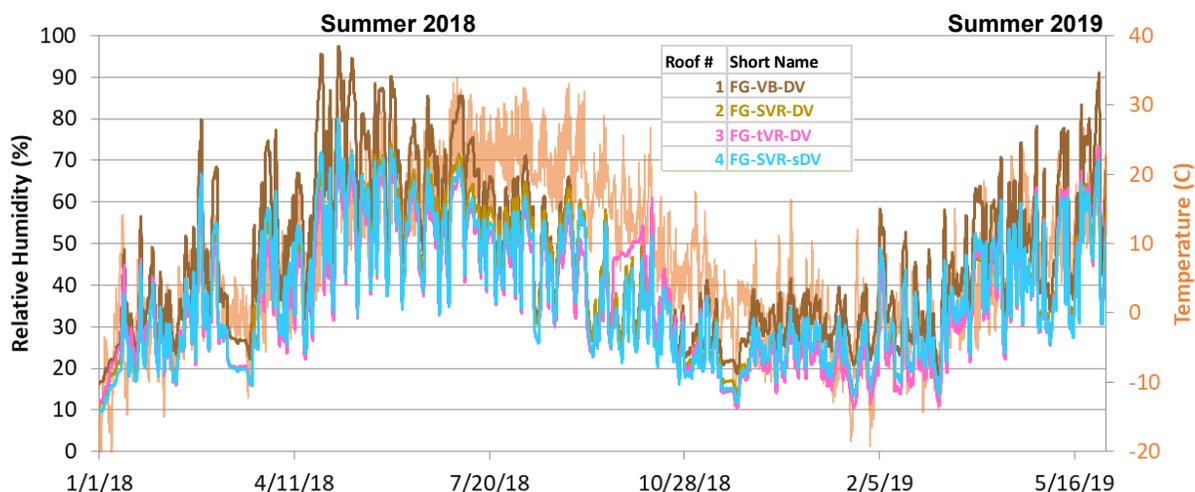
Figure 62. Fiberglass roofs' (1–4) inward drive 24-hour average RH, north measurements 2018–2019

Again, **Roof 1** (fixed-perm vapor barrier) is the high outlier, although other roofs operate in a similar range. Summertime peaks on the north side reach 100% RH.

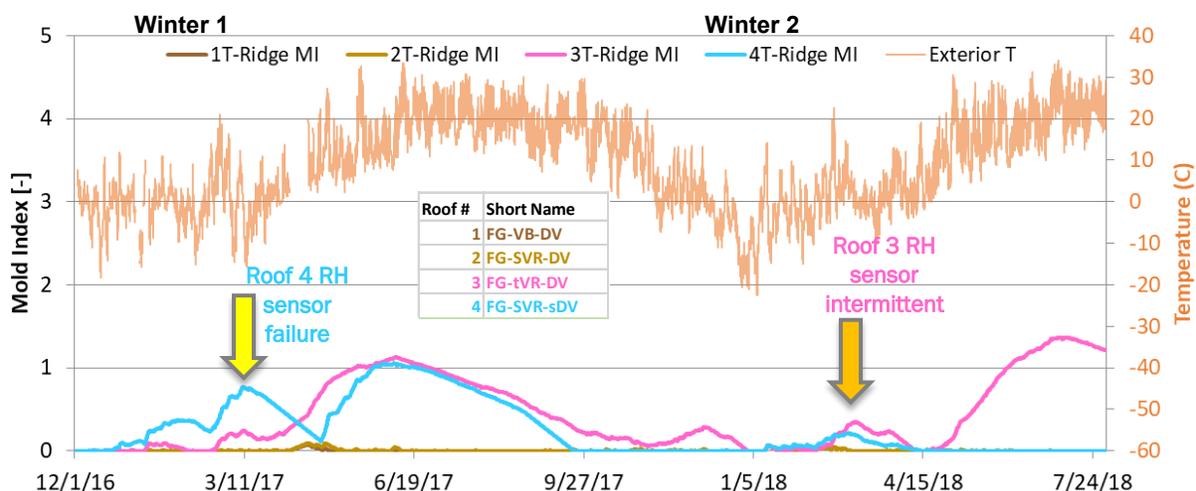
Figure 63. Fiberglass roofs' (1–4) ridge mold index calculations

In Winter 1, **Roof 3** and **Roof 4** (no diffusion vent) had extended winter periods at high RH (95%–100%) and indications of condensation. In contrast, **Roof 1** and **Roof 2** (diffusion vent) had much lower RH levels and no indication of condensation. The calculated mold index shows a rise slightly above 1.0 (microscopic mold growth levels) in **Roof 3** and **Roof 4** in the spring, as outdoor temperatures warmed while RH levels remained high. In contrast, **Roof 1** and **Roof 2** mold index values barely exceeded 0.

The decline seen in **Roof 4** (**YELLOW** arrow in Figure 63) is an artifact of sensor failure; the ridge RH sensor failed in March 2017, returning unrealistically low measurements and zeroes. **Roof 4** would likely have a higher mold index than **Roof 3** if the sensor returned valid data.

In Winter 2, all roofs had extended periods at 95%–100% RH (Figure 43). **Roof 3** (tight diffusion vent) showed indications of extensive wintertime ridge condensation (Figure 45); other fiberglass roofs remained below the condensation range. **Roof 3's** RH ridge sensor was intermittent during April 2018, also causing an artificial decline (**GOLD** arrow in Figure 63). However, the calculated mold index remained below 2.0, and well below the failure criterion of 3.0.

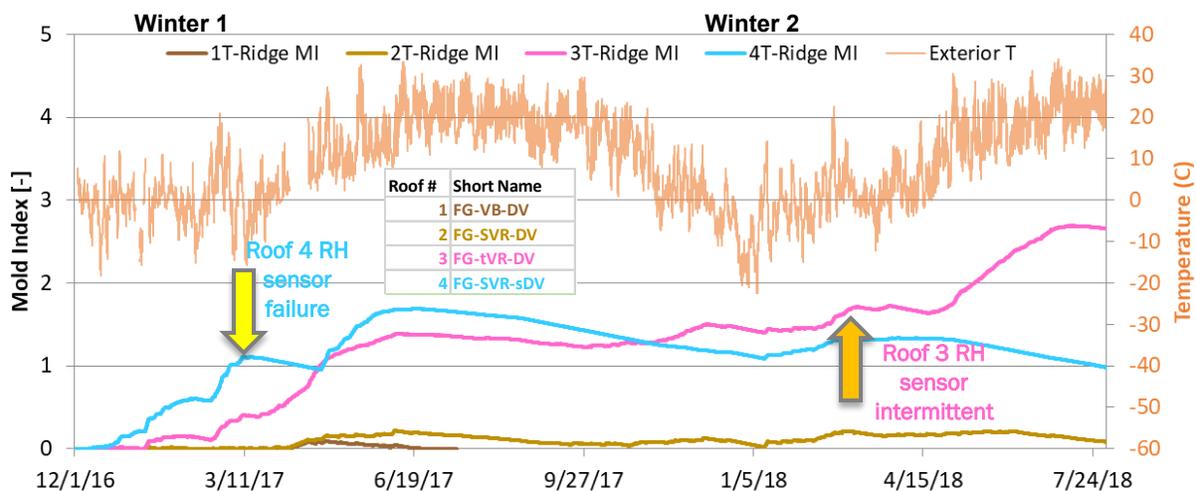
Figure 64. Fiberglass roofs' (1–4) ridge mold index calculations, with decline coefficient 0.25 (versus 1.0 default)

One variable to adjust in the mold index calculation is the decline coefficient. It was changed from 1.0 (default value) to 0.25 (“relatively low decline”), with results for the ridge T/RH sensor shown in Figure 64. For reference, a decline coefficient of 0.1 is “almost no decline.” These results can be compared between Figure 63 (1.0 value) and Figure 64 (0.25 value). The smaller decline coefficient results in higher peak mold indices; however, maximum values remain below 3.0.

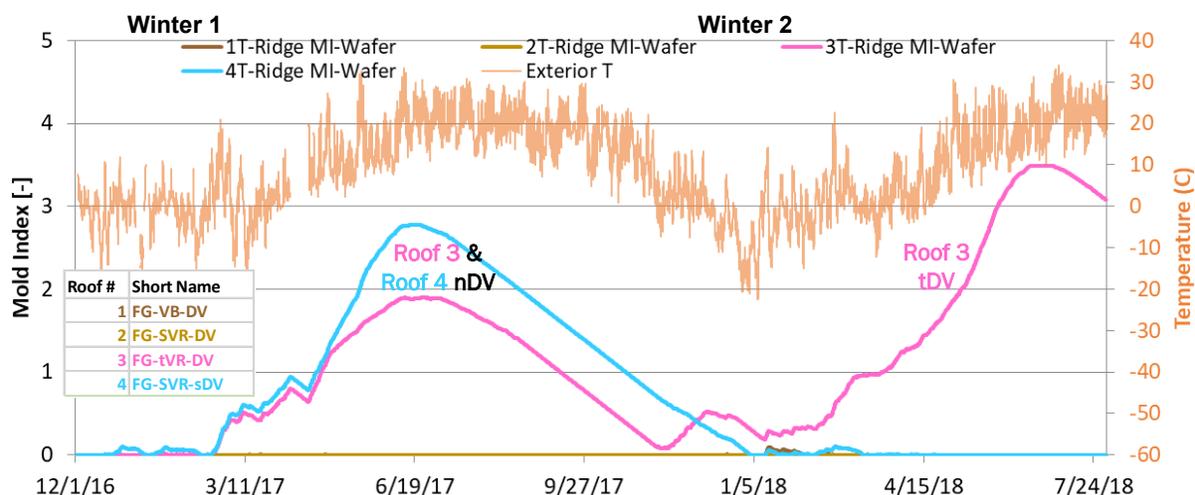
Figure 65. Fiberglass roofs' (1–4) ridge mold index calculations (derived from wafer MCs)

The mold index results are shown in Figure 65 for both Winter 1 and Winter 2. Winter 1 showed higher risks of **Roof 3** and **Roof 4** (no diffusion vent) but below the risk threshold of 3.0.

Winter 2 shows **Roof 3** (tight diffusion vent) with a mold index rising over 3.0 in late spring/early summer, which is consistent with the sustained high moisture levels measured at the ridge.

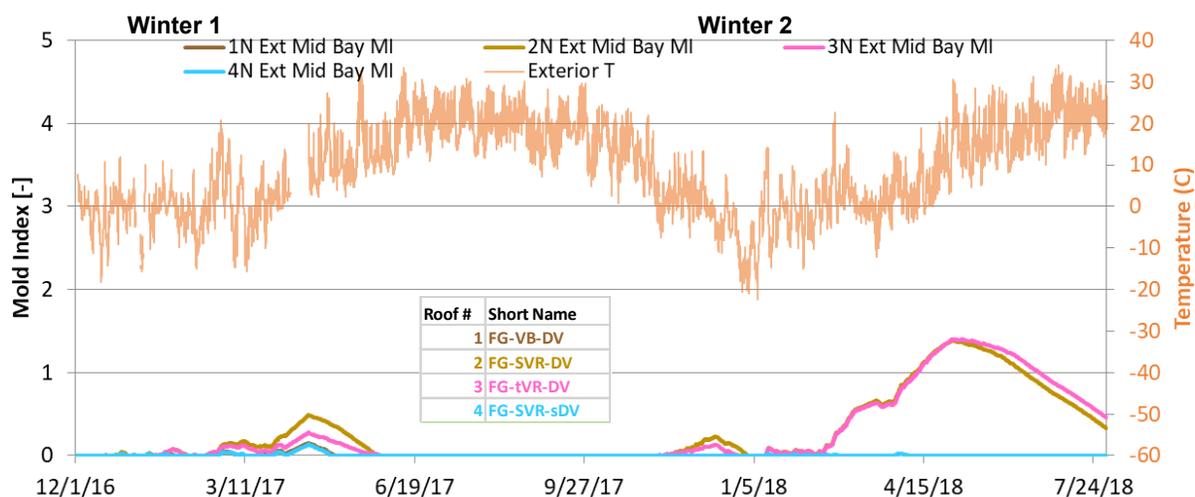
Figure 66. Fiberglass roofs' (1–4) north sheathing-insulation interface mold index calculations

Another high-risk location was the north-side sheathing-insulation interface. In Winter 2, this interface had extended periods at 95%–100% RH in all four roofs (Figure 48) and sheathing MCs over 25% in some roofs (Figure 57). The mold index calculation results are shown in Figure 66: peak values were well below 2.0 for Winter 2, indicating low risk. Roof 4 (small diffusion vent) had lower interface RHs, which was ascribed to a sensor anomaly, rather than an actual performance difference; the mold index for this roof remains near zero for the winter. Given these low risks, mold indices were not calculated for the drier south sheathing-insulation interface.

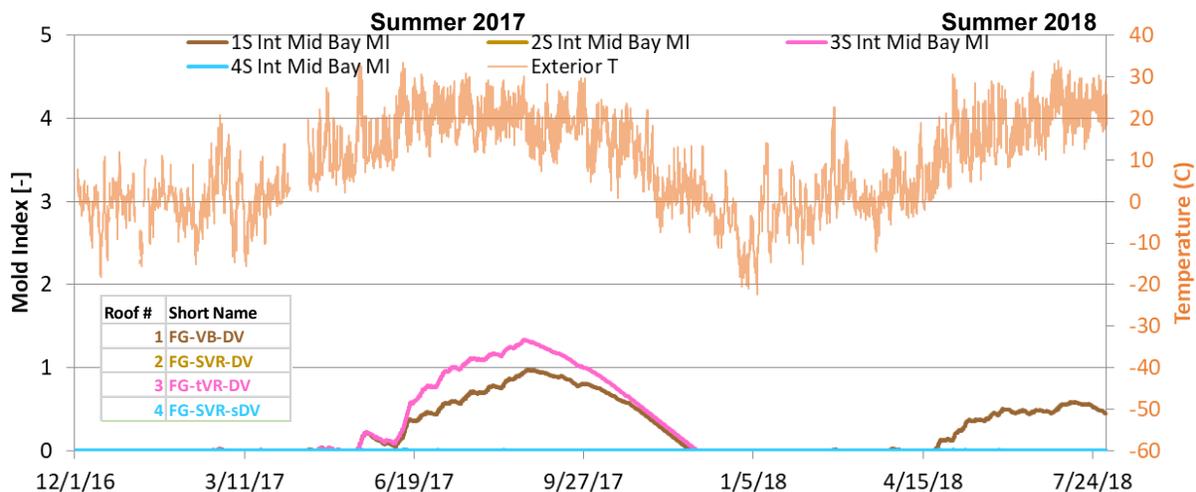
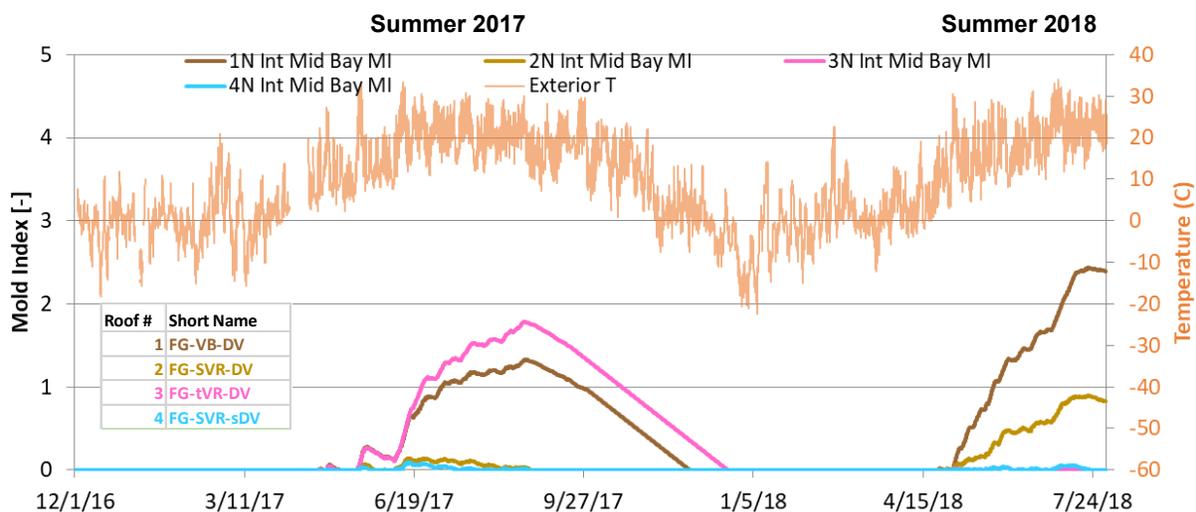
In summer 2017, consistent with RH and wafer measurements, **Roof 1** and **Roof 3** (fixed-perm vapor retarder) showed higher risk than **Roof 2** and **Roof 4** (variable-perm vapor retarder). Mold indices for the fixed-perm vapor retarder roofs rose slightly above 1, which is below the failure threshold, but greater than the ridge mold index maximum. In addition, the north side had higher maxima than the south side, which was ascribed to greater stored moisture from the winter in the north-facing roof.

In summer 2018, **Roof 1** (fixed-perm vapor barrier) was the higher outlier on both the north and south sides, consistent with a lack of inward drying, compared to SVRs used in **Roof 2**, **Roof 3**, and **Roof 4**. Note that summer 2018 follows Winter 2 (humidified condition) with substantial moisture accumulation in the rafter bays. However, mold index remained below 3.0 on both orientations. The north-side roofs showed higher mold indices than the south side, again consistent with inward drive of stored wintertime moisture.

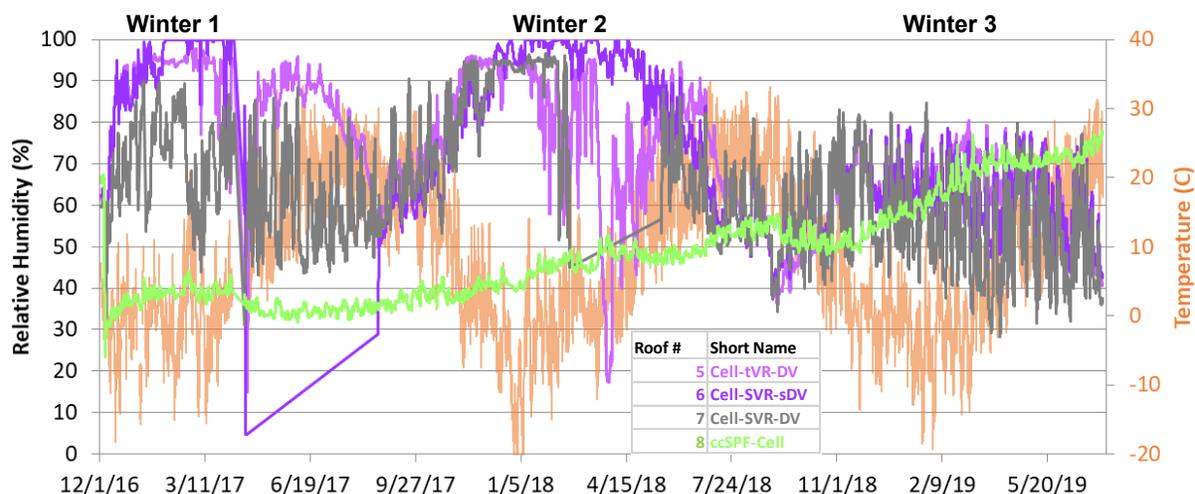
Figure 70. Cellulose roofs' (5–8) ridge RH conditions, 24-hour moving average

In Winter 1, **Roof 5** and **Roof 6**, (no diffusion vent) have similar behavior to the equivalent fiberglass roofs: RH levels rise to 95%–100% RH and remain there over the course of the winter. However, **Roof 7** (SVR and diffusion vent) has markedly drier behavior, with only brief excursions over 90% RH through the winter.

During spring drying, **Roof 5** (no diffusion vent) remained wetter than **Roof 7** (diffusion vent). The ridge RH sensor in **Roof 6** failed in April 2016, so spring drying data are not available; however, this sensor started to return data in fall 2017.

Lastly, **Roof 8** (ccSPF and cellulose) had consistently low RHs at the ridge, remaining in the 35%–45% range. This is consistent with the air- and vapor-impermeable ccSPF protecting the sheathing from interior moisture; the code-compliant roof has the driest conditions. These moisture levels continued through the spring dry-down.

In Winter 2, all ridge RHs were higher than Winter 1 due to interior humidification. For instance, **Roof 7** (full-sized diffusion vent) can be compared between Winters 1 and 2, as it is unchanged between those two periods. In Winter 1 (moderate interior RH), ridge RH seldom peaked above 90%, but in Winter 2 (humidification to 50% RH), RHs rose to ~95% and remained there until sensor failure. **Roof 5** also showed drops in RH consistent with sensor issues rather than actual drying.

Roof 8 (ccSPF-cellulose) shows a slow increase in RH over the three years. This trend does not match expected behavior or typical observed field conditions for this type of assembly. Ridge conditions at this roof were examined more closely with handheld instruments, as covered in Section 8.5: Ridge Sensors and Long-Term Moisture Accumulation. These measurements indicate that the upward trend is likely sensor drift.

The §R806.5 code-compliant hybrid ccSPF-cellulose roof (Roof 8) showed a concerning trend at one sensor over the three-year experiment: the ridge RH sensor showed a constantly increasing accumulation of moisture (Figure 70). It was unclear if this was due to sensor drift or an

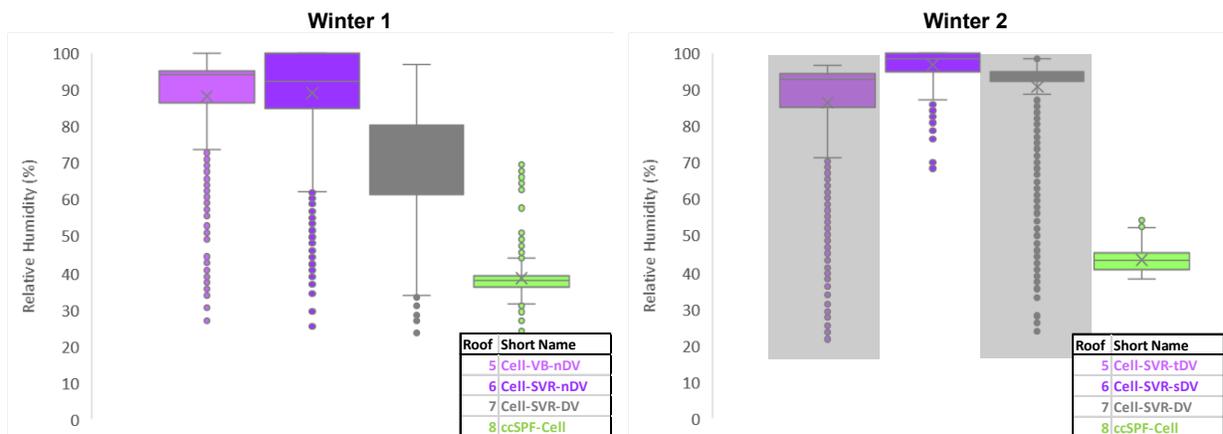
Figure 71. Cellulose roofs' (5–8) ridge RH box-whisker plots, Winter 1 vs. Winter 2

Box and whisker plots for the cellulose roof ridges in Winters 1 and 2 are shown in Figure 71. Winter 1 shows the superior performance of **Roof 7** (diffusion vent) and **Roof 8** (hybrid ccSPF-cellulose). But in Winter 2, interior humidification pushes all cellulose roofs into the 85%–95% RH range, including the best-performing **Roof 7**. The Winter 2 plot should be interpreted with caution: the RH sensor in **Roof 5** and **Roof 7** showed erratic data for much of the winter, as denoted by the gray shaded bars.

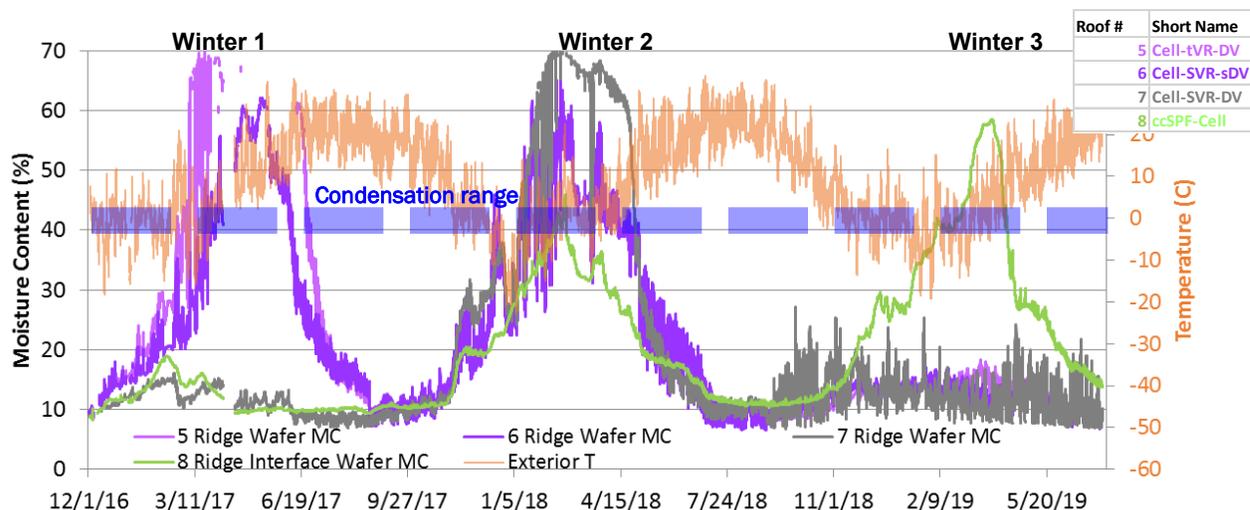
Figure 72. Cellulose roofs' (5–8) ridge wafer MC measurements

In Winter 1, wafer MC rose sharply in **Roof 5** and **Roof 6** (no diffusion vent). The MC measurements are well outside the realistic range, with maxima of 60%–70% MC. This is ascribed to migration of borate salts from the cellulose insulation into the wafer, which lowers electrical resistance, resulting in these false high readings. Migration of borate salts occurs at high moisture levels (in the presence of liquid water due to capillary salt transport); this is consistent with wafer measurements rising above 40%–45% MC (condensation range). These moisture levels remain high well into spring; this matches the **Roof 5** ridge RH measurements, but the absolute wafer MCs are suspect.

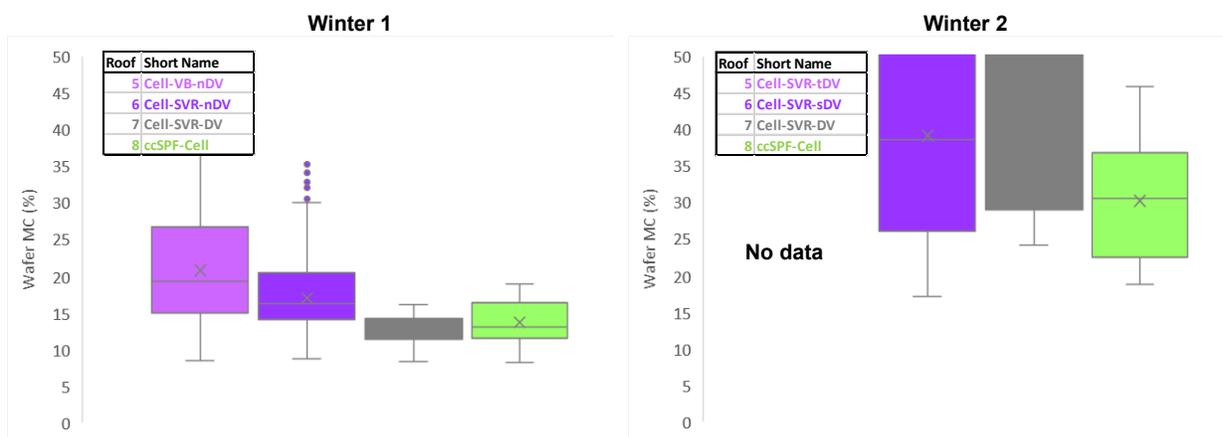
Figure 73. Cellulose roofs' (5–8) ridge wafer MC box-whisker plots, Winter 1 vs. Winter 2

The ridge wafer sensor plots are shown in Figure 73. They demonstrate the greater drying of Roof 7 (full-size diffusion vent) and safe behavior of Roof 8 (ccSPF-cellulose hybrid) in Winter 1.

In Winter 2, Roof 5 (tight diffusion vent, SVR) had no sensor and is not plotted. Roof 6 and Roof 7 had very high wafer MCs, ascribed to borate contamination.

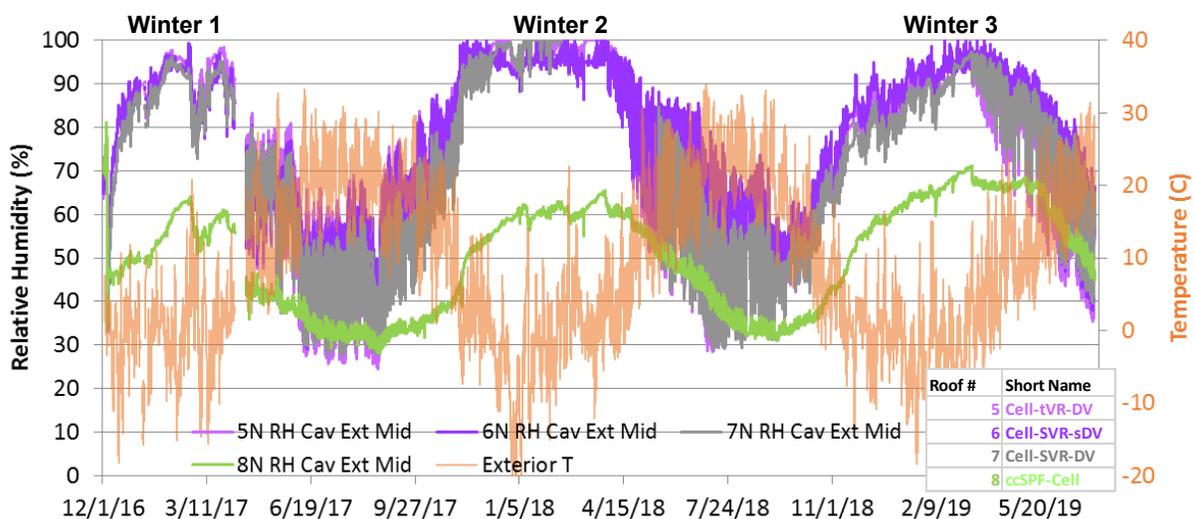
Figure 75. Cellulose roofs’ (5–8) mid-bay RH north conditions

In Winter 1, the north-facing cellulose roof RHs (Figure 75) follows patterns similar to the fiberglass roofs, with RHs rising over the course of the winter to 90%–100% RH. However, the winter rise is more gradual in the cellulose roofs (compared to fiberglass), due to the moisture storage of the cellulose insulation. Consistent 90%+ RH levels only occur by mid-January in the cellulose roofs, compared to early December in the fiberglass roofs. In addition, the north-facing cellulose roofs do not reach 100% RH, unlike the fiberglass roofs.

Winter 3 north sheathing RHs (Figure 75) are much lower than Winter 2, with a much briefer period in the 95%–100% range. This is consistent with repacking of insulation improving hygrothermal performance. Roof 6 (small diffusion vent) is the high outlier, consistent with reduced drying through a smaller diffusion vent. Roof 8 (ccSPF-cellulose) is consistently much drier than the experimental cellulose roofs, well in the safe range.

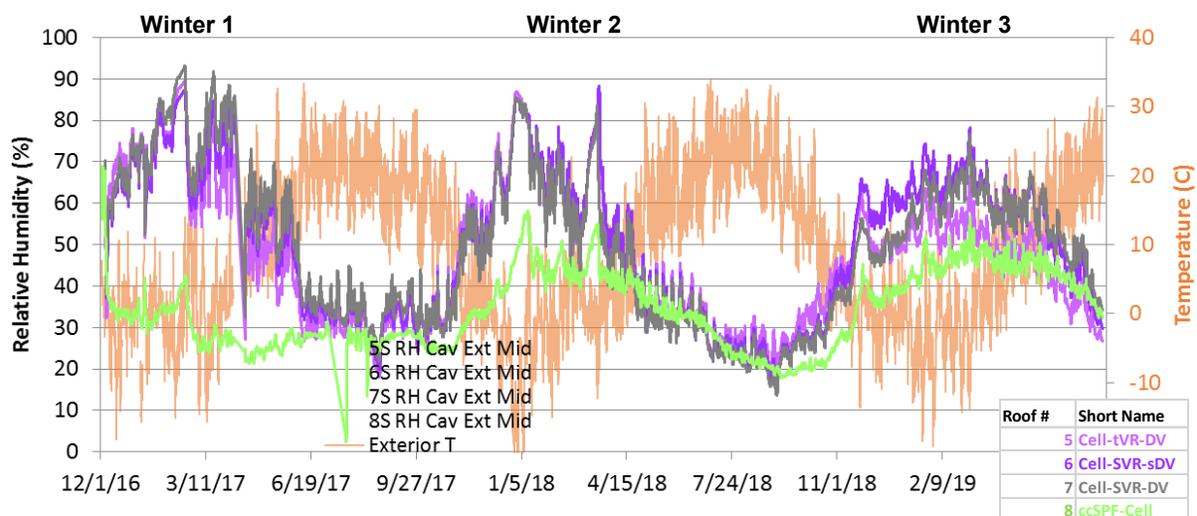
Figure 76. Cellulose roofs' (5–8) mid-bay RH south conditions, 24-hour moving average

The 24-hour moving average of south sheathing interface RH data (Figure 76) show expected trends, including drier conditions than the north side, Winter 2 (humidification) being wetter than Winter 1, and drier conditions in Winter 3 compared to Winter 2. Sheathing-insulation interface RHs remain below risk levels.

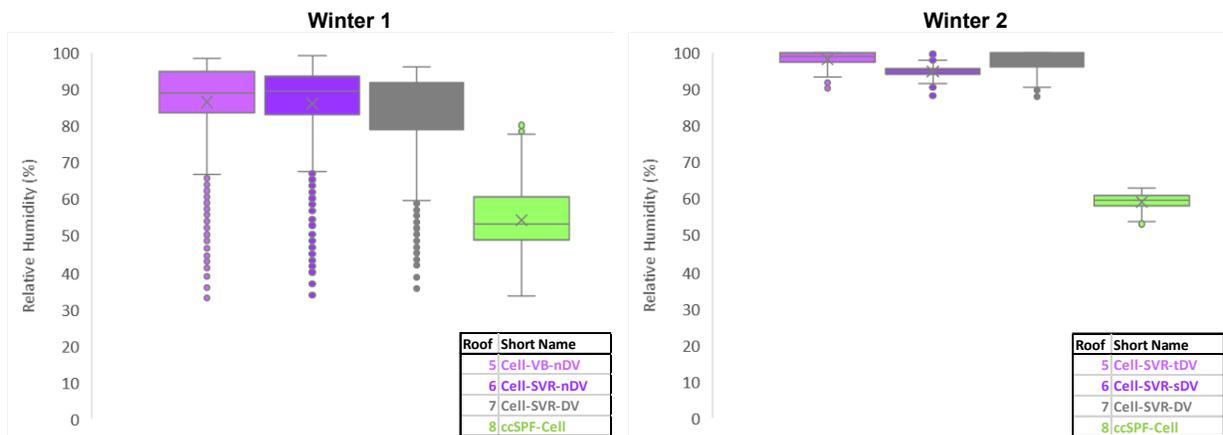
Figure 77. Cellulose roofs’ (5–8) mid-height north RH box-whisker plots, Winter 1 vs. Winter 2

The Winter 1 vs. Winter 2 plots (Figure 77) show the severity of Winter 2’s humidified load, pushing interface RHs near 100% for much of the winter, with no low-RH outliers as seen in Winter 1. There is no clear differentiation between the experimental cellulose roofs, although Roof 7 (full-size diffusion vent) is the driest in Winter 1, consistent with its greater outward drying. Roof 8 (hybrid ccSPF-cellulose) runs at much lower (drier) RHs throughout both winters.

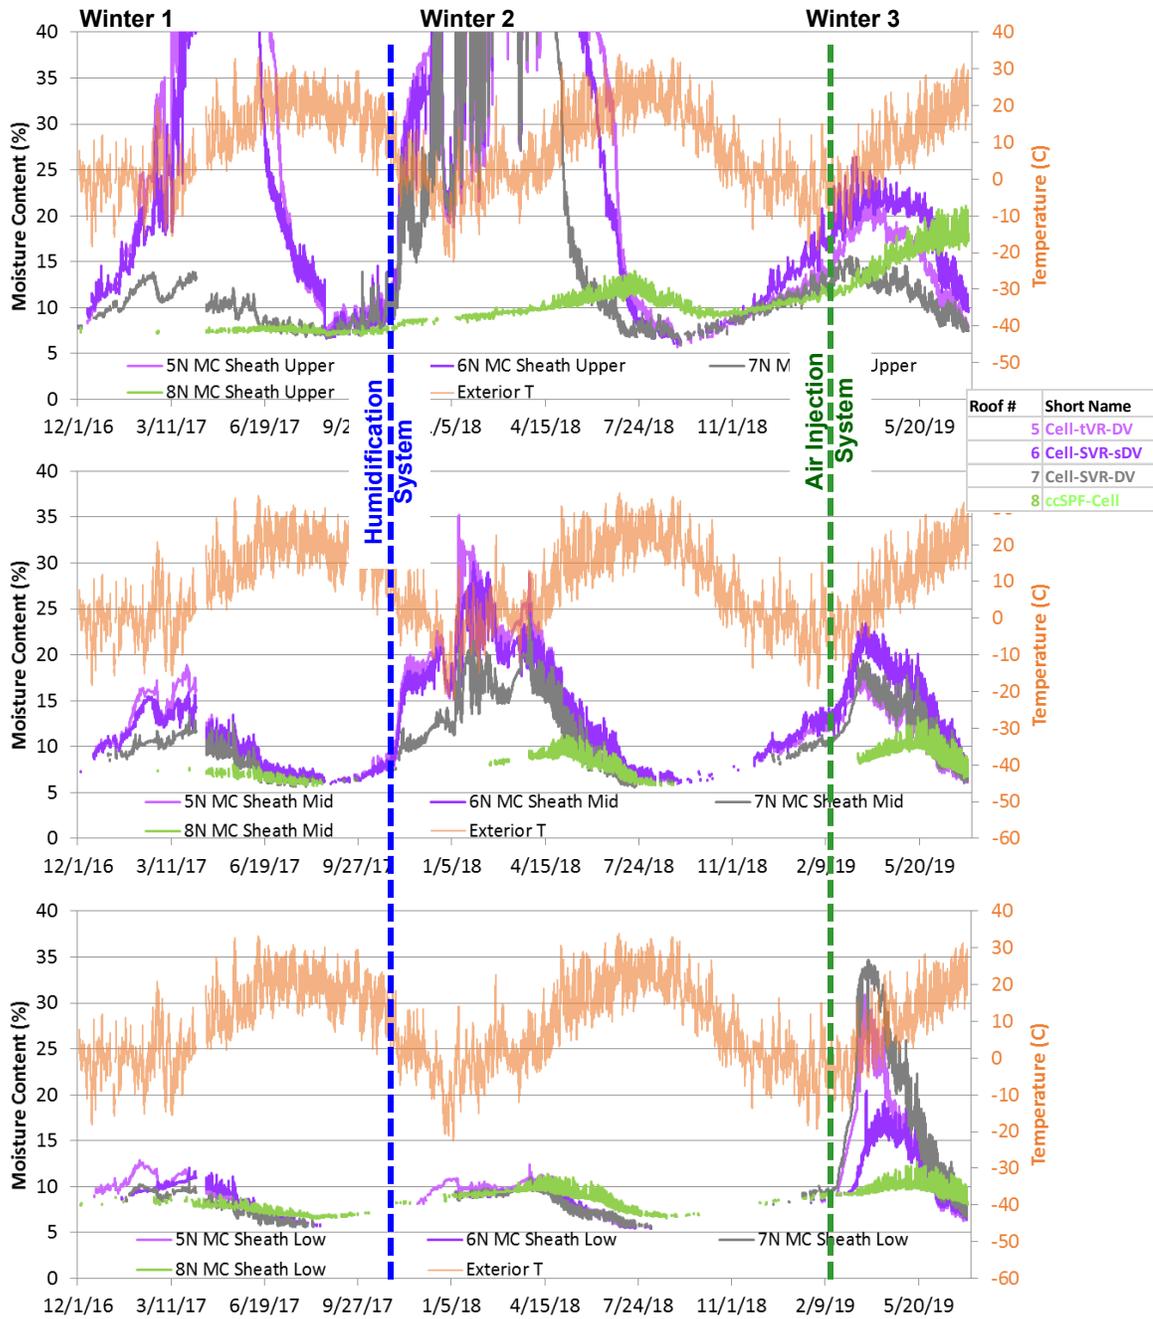
Figure 80. Cellulose roofs' (5–8) sheathing MC north measurements

On the north side in Winter 1, Roof 5 and Roof 6 (no diffusion vent) have a substantial rise in MC, above 40%; reported values peaked in the 45%–50% MC range. Like the wafer sensor results (Figure 72), these results appear to be spurious values due to borate salt migration from the cellulose into the wood sheathing caused by liquid water condensation. However, it does indicate that these roofs are experiencing severe moisture loading at the roof ridge, with likely condensation. The plotted values should not be taken as valid wood MC measurements, though.

In contrast, Roof 7 (diffusion vent) and Roof 8 (ccSPF-cellulose) both had safe conditions at the north upper location. Roof 7 had peak MCs under 15%, and Roof 8 below 10%. The middle and lower wood north-side MCs all remained below 20%.

Winter 2 has much higher MCs than Winter 1; operation of the humidification system is highlighted in BLUE. For instance, in Winter 1, Roof 7 (full-sized diffusion vent) remained at dry (under 15% MC) conditions, while in Winter 2, it rose to wet (over 40% MC) conditions. A similar contrast can be shown at the mid-height sensors: all sheathing MCs remained in the safe range in Winter 1, but maximums exceeded 25% in Winter 2.

In summer 2018, Roof 7 (full-sized diffusion vent) showed safer behavior than Roof 5 (tight diffusion vent) and Roof 6 (small diffusion vent). For instance, at the upper location, it was the fastest-drying roof in spring. Roof 7 was also the driest in winter at the mid-height sheathing, again indicating that the greater drying of the diffusion vent is not limited to localized ridge conditions.

Winter 3's performance before air injection is much drier than Winter 2, consistent with all other measurements. After air injection in late February 2019 (**GREEN** vertical dotted line), sheathing MCs rapidly increase at the low location (to 30%–35% MC), and to a lesser degree at the middle sheathing location. The upper sheathing measurements do not show a response. In addition, the maximum MCs are lower than in the fiberglass roofs, likely due to cellulose moisture storage.

After the conclusion of air injection (mid-April), sheathing MCs declined to safe levels.

Roof 8 (ccSPF/cellulose) shows a cycling rise in MC at the upper sheathing location, which appears to peak in late spring/early summer; this seasonal response is different than the cellulose roofs, and could indicate slow moisture accumulation in the assembly. However, peak MCs are within the safe range. These trends are further examined below.

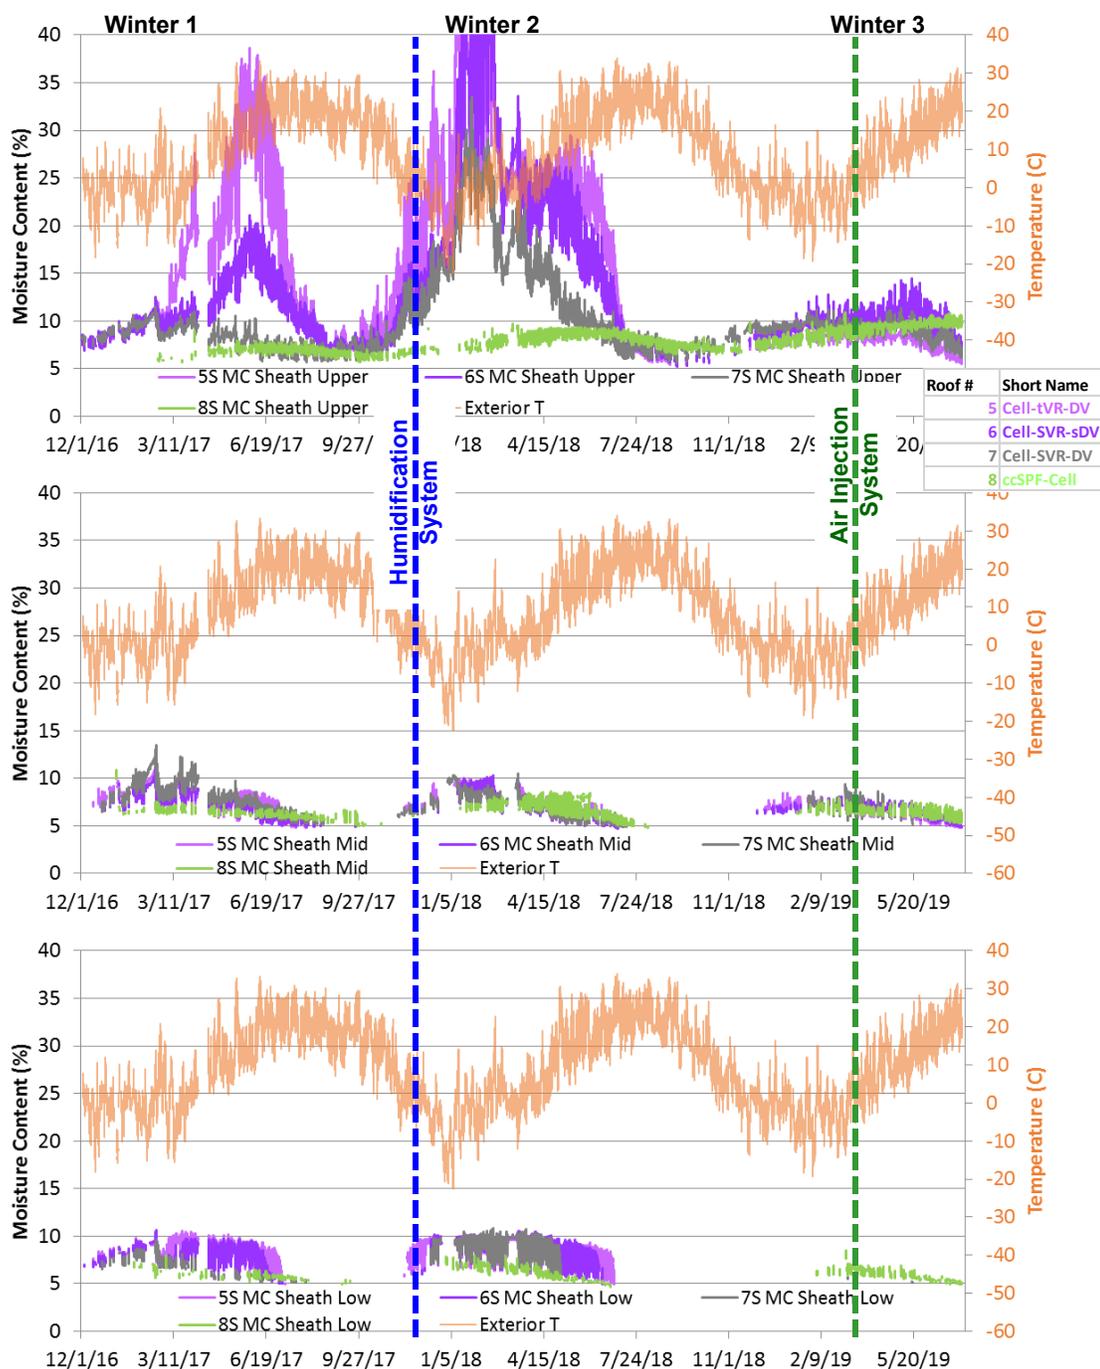
Figure 81. Cellulose roofs' (5–8) sheathing MC south measurements

The south-side roof sheathing MCs are plotted in Figure 81. Again, south-side measurements are much drier than the north side, and the expected spatial pattern (wettest at upper location) is observed.

On the south side, in Winter 1, the same pattern was seen of Roof 5 and Roof 6 (no diffusion vent) showing greater moisture accumulation near the ridge than Roof 7 (diffusion vent). However, unlike the north side, this rise began during warmer spring conditions (March–April 2017). MCs rose to 20% (Roof 6) and over 35% (Roof 5); again, these results are suspect due to condensation and possible migration of borate salts into the sheathing. Roof 8 (ccSPF-cellulose)

both had safe conditions at the south upper location (under 10% MC). The middle wood south-side MCs all remained below 15%, and the lower MCs below 10%.

In Winter 2, the south side shows similar issues of much higher MCs than Winter 1 due to interior humidification. Roof 7 (full-sized diffusion vent) appears drier than Roof 5 (tight diffusion vent) and Roof 6 (small diffusion vent) at the upper location, consistent with greater wintertime drying. Roof 5 and Roof 6 show peak MCs over 40%, which is likely a combination of high moisture levels and borate migration. As expected, Roof 8 (hybrid ccSPF-cellulose) shows low sheathing MCs throughout, including the humidified Winter 2.
