Monitoring of Unvented Roofs with Fibrous Insulation, Diffusion Vents, and Interior Vapor Control in a Cold Climate

Building America Report - 2001

September 2020

K. Ueno and J.W. Lstiburek

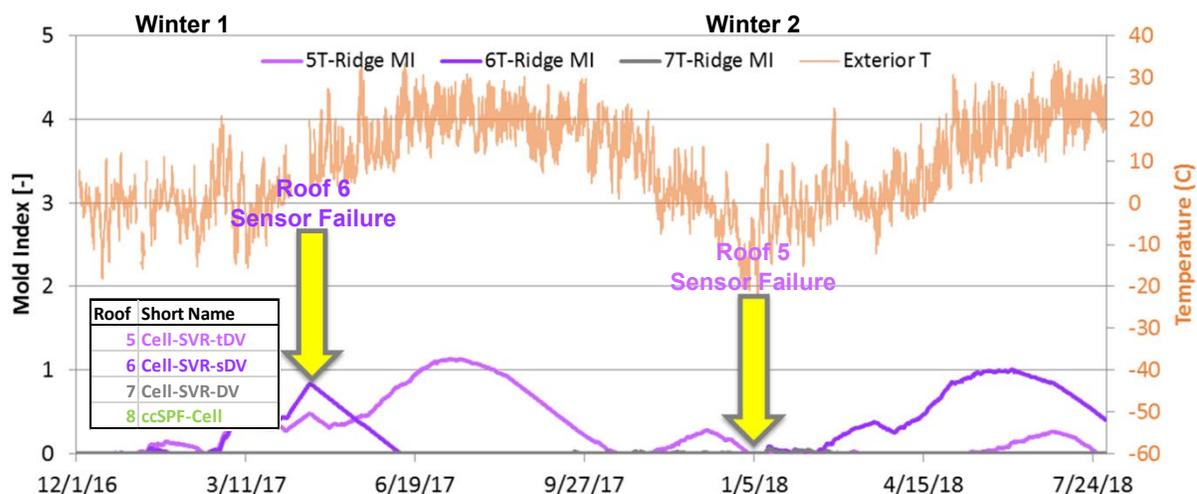
Figure 87. Cellulose roofs' (5–8) ridge mold index calculation results

In Winter 1, Roof 5 and Roof 6 reached 95%–100% RH early in the winter, while Roof 7 remained drier (Figure 70). In Winter 2, all three cellulose roof ridges rose to 95%–100% RH

early in the winter, and remained there until RH sensors failed. Sensor failures included **Roof 6** in Winter 1 (mid-April 2017) and **Roof 5** in Winter 2 (January 2018), as noted by yellow arrows. As a result, these mold index results are suspect; based on the raw data, all mold indices remain below 2.0. Unfortunately, the wafer sensors cannot be used as surrogates for RH, due to the borate salt migration issues.

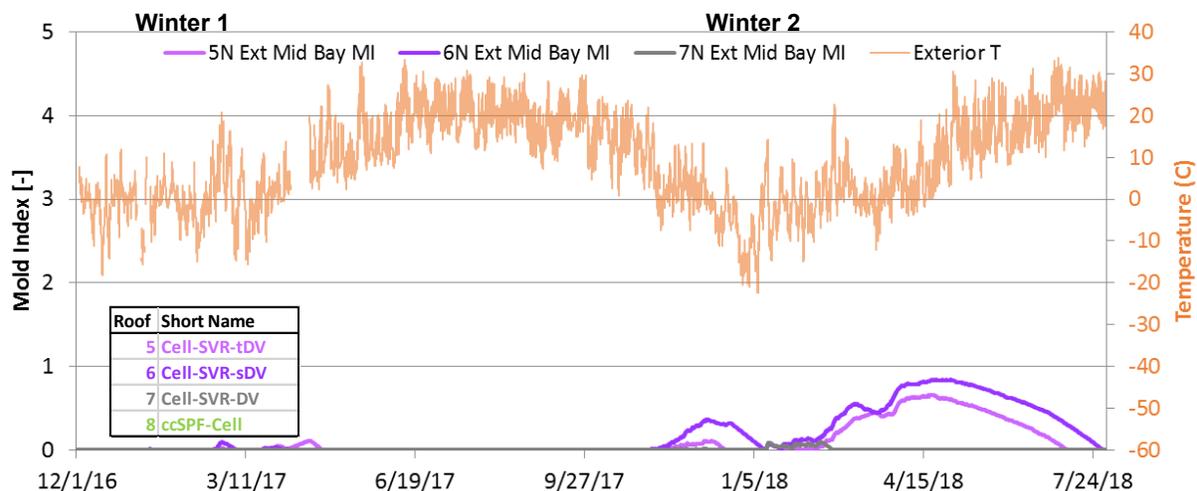
Figure 88. Cellulose roofs' (5–8) north mid-bay interface mold index calculation results

The north mid-bay insulation-sheathing interface mold index results are plotted in Figure 88. RHs were higher in Winter 2 compared to Winter 1, with 90%–100% RH conditions for most of the winter. This results in higher mold index values for **Roof 5** and **Roof 6**; however, mold index values did not exceed 1.0. The south orientation had even lower RH levels, so mold index values were not plotted.

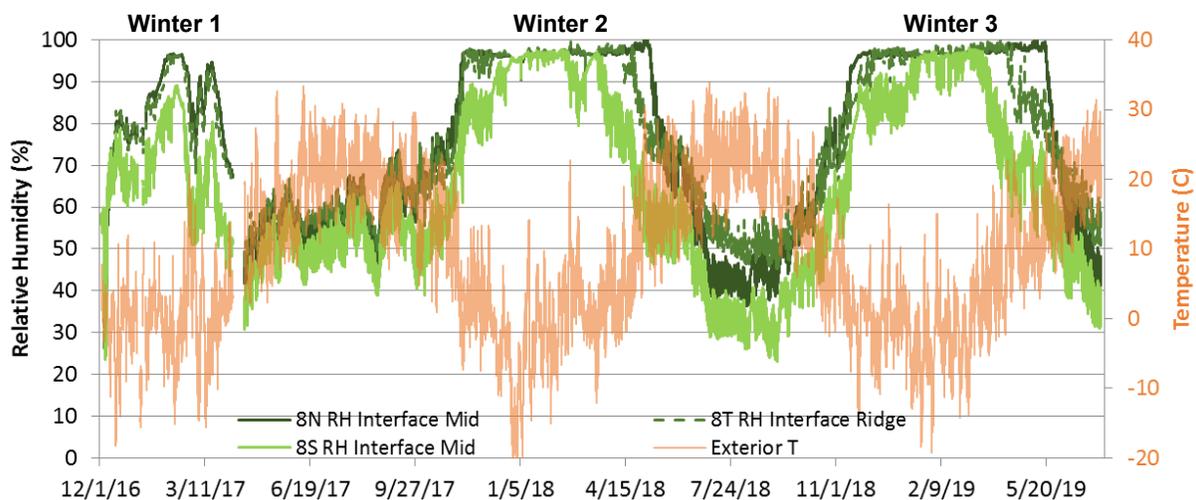
Figure 91. Hybrid ccSPF-cellulose interface RH measurements, with exterior T

The interface RH measurements for the north, south, and ridge are shown in Figure 91. In Winter 1, the north side and ridge have the highest RHs (with short peaks ~95% RH), and the south side has lower peaks. This matches previous measurements of moisture stratification and cooler temperatures on the north-side roof assembly. The RH levels track roughly inversely to the exterior temperature, as exterior temperature will affect interface temperature (assuming a constant interior temperature).

However, Winters 2 and 3 (humidified 50% RH interior) resulted in higher moisture risks at the interface; RH levels rose to 95%–100% for most of the winter. RHs were highest at the ridge/peak and on the north side.

For reference, visual inspection from the interior after Winter 2 did not reveal any moisture issues from the interior (dripping or staining). Disassembly of a guard bay after Winter 2 revealed no caking or visible moisture issues at the interface (see Section 8.6: Interface Surface Examination). Interface RH levels fell rapidly (to 30%–60%) each spring as exterior temperatures warmed.

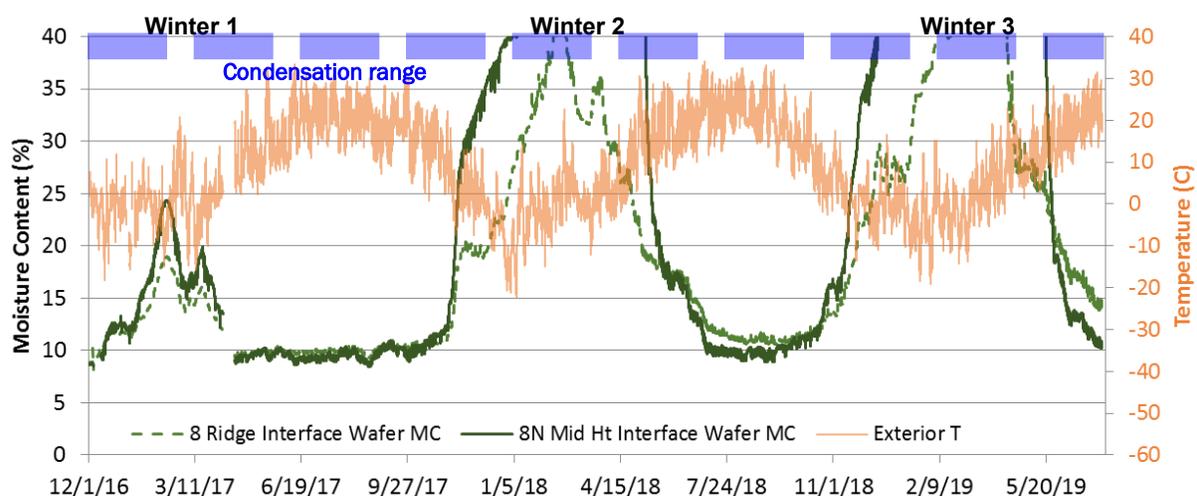
Figure 92. Hybrid ccSPF-cellulose interface wafer measurements, with exterior T

The wafer sensors at the interface (Figure 92) run roughly parallel to the RH measurements. Winter 1's maximum MCs are under 25%—far below the 100% RH or condensation range. However, in Winters 2 and 3, wafers rose over 40% MC, into the condensation risk range (**BLUE**). Liquid water condensation and borate contamination of the wafers likely plays a part in these high MCs.

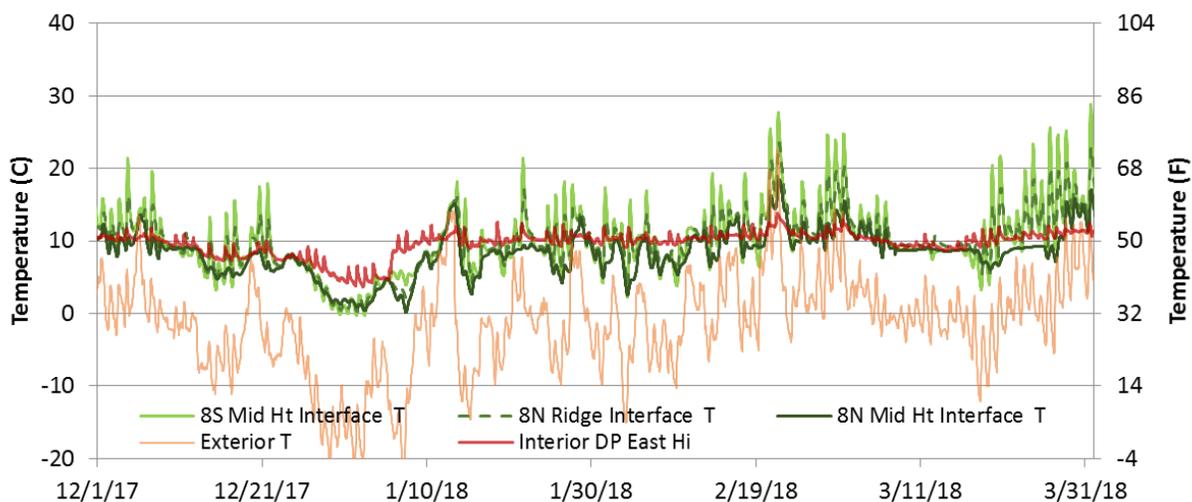
Figure 94. Hybrid ccSPF-cellulose interface Winter 2 temperature, with interior dewpoint

In contrast, in Winter 2 (Figure 94), interior dewpoint (**RED**) was higher than the interface temperatures (**GREEN**) for much of the winter, resulting in the measurements of high RH and possible condensation.

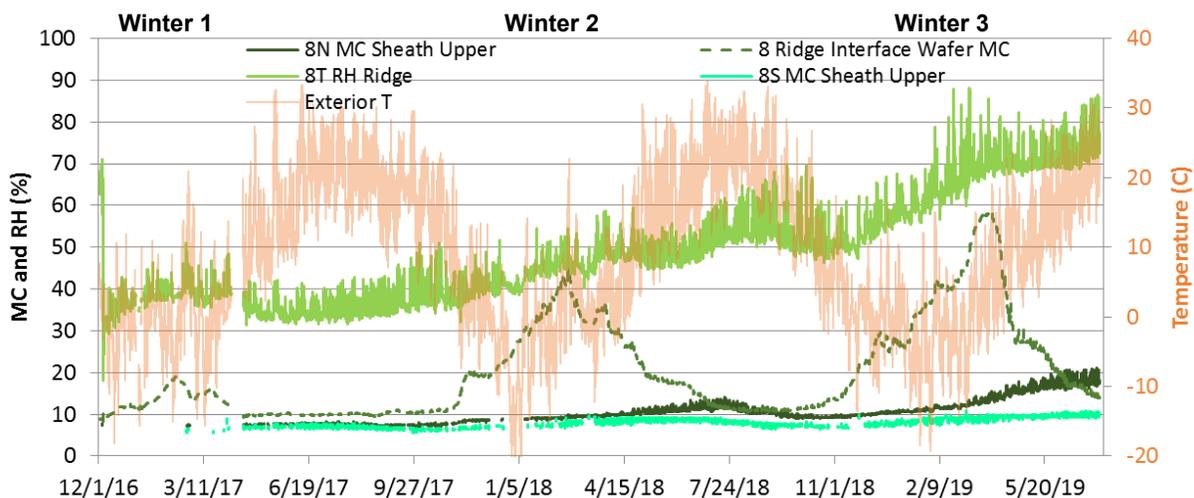
Figure 97. Hybrid ccSPF-cellulose interface RH measurements, with exterior T

The §R806.5 code-compliant hybrid ccSPF-cellulose roof (Roof 8) showed a concerning trend at one sensor over the three-year experiment: the ridge RH sensor showed a constantly increasing accumulation of moisture (Figure 70). It was unclear if this was due to sensor drift or an

The ridge RH and upper sheathing MC (north and south) are plotted together in Figure 97; these reflect moisture conditions at the ccSPF-to-sheathing interface near the roof ridge. Ridge wafer MC (cellulose-to-ccSPF conditions) is also plotted; outdoor temperature is also plotted for reference.

The continuous increase in RH (from 30% to 80%) would result in MCs rising from roughly 6% to 16%, assuming a typical sorption isotherm; this is roughly comparable to the north sheathing upper MC patterns. However, sheathing MCs indicate generally dry conditions and low risk. Wafer and sheathing MCs are not directly comparable; the wafer has a small form factor and is not subject to the same temperature gradients as roof sheathing, and is a different wood species than those composing OSB.

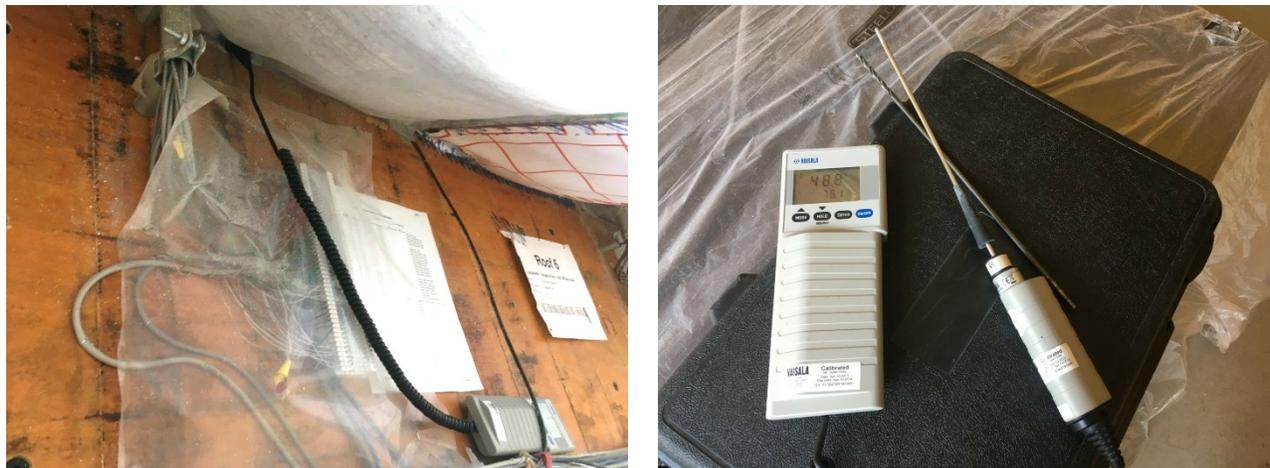
Figure 98. Measurement of T/RH at ridge using Vaisala probe

Given the uncertainty of the RH sensor measurements, conditions were also measured on a “spot” basis in mid-July 2019 using a handheld temperature/RH meter (Vaisala HMI41 indicator

and HMP42 probe). Measurements were taken at multiple points at the guard bay between Roofs 6 and 7, and in Roof 8 (ccSPF/cellulose). The probe was inserted through the cellulose and into the ccSPF until hitting the roof sheathing at the ridge (Figure 98).

The Vaisala measurements showed temperatures consistent with instrumentation results, but RHs roughly 10% lower than logger data. This is consistent with the ridge RH sensor drifting upward over time. The roof ridge hits temperatures over 120°F/50°C during summertime conditions, which is a likely cause of long-term damage to sensors, especially capacitive polymer RH sensors.

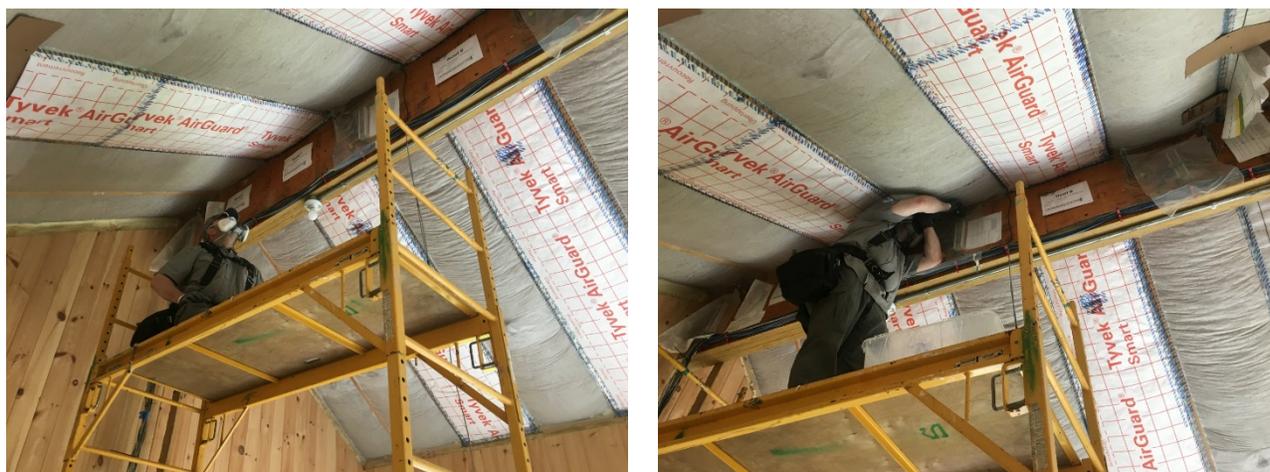
Figure 99. Cellulose insulation removal at guard bay between Roofs 6 and 7

Given the high ccSPF-cellulose interface moisture levels, conditions were visually examined at the conclusion of the experiment. The guard bay between Roofs 6 and 7 was opened and the cellulose at the ridge removed (Figure 99).

The cellulose was not “caked” or “packy” at the ccSPF-to-cellulose interface, as would be expected after liquid water wetting. The cellulose fell away freely when removed from the netting, leaving the ccSPF exposed. There was no visual indication of mold damage or staining on the ccSPF surface. Overall, this indicates that whatever wetting occurred safely dried without creating moisture issues. No insulation voids were noted between the ccSPF and cellulose in this disassembly.

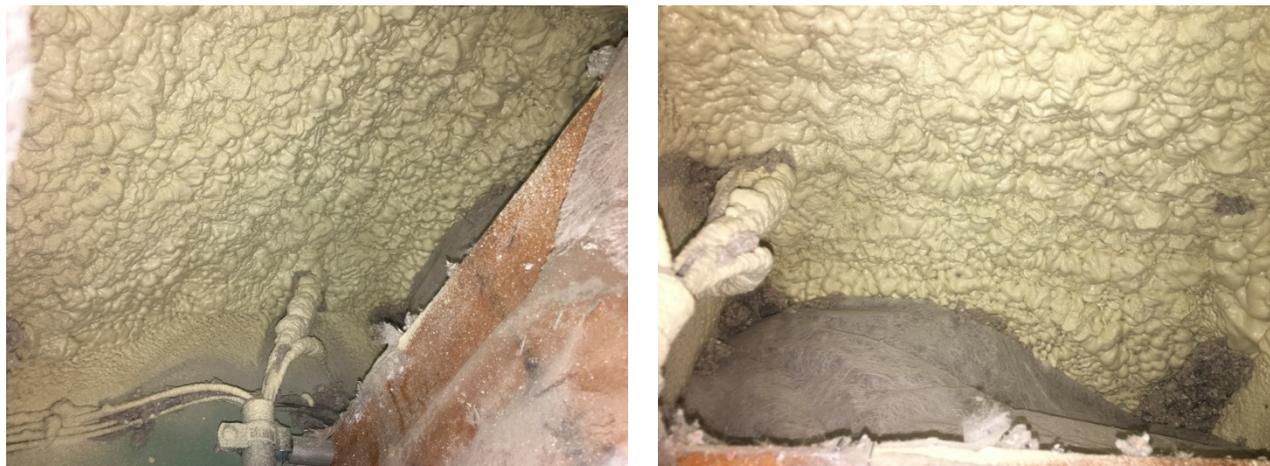
Figure 100. ccSPF surface conditions after removal of cellulose insulation

However, direct observation of the interface (Figure 99 and Figure 100) showed no indication of mold growth. Note that in cellulose insulation assemblies, the combination of hygric storage and borate preservatives have been noted to reduce incidence of mold; the safety of this interface with other insulation materials is unknown.

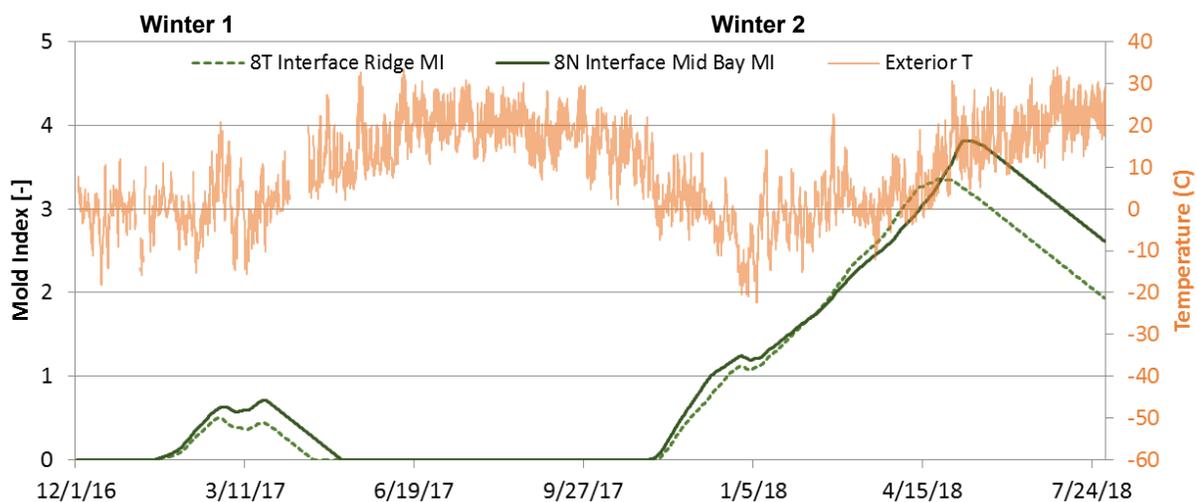
Figure 101. Hybrid ccSPF-cellulose interface mold index, with exterior T

Mold index values were calculated for the ccSPF-cellulose interface (Figure 101); one potential risk is that warmer wintertime temperatures at this interface would be more amenable to mold growth. In Winter 1, the mold index at the north and ridge conditions remains low (well below 0.5). However, Winter 2 and the following spring showed mold index values over 3.0, in the risk range.

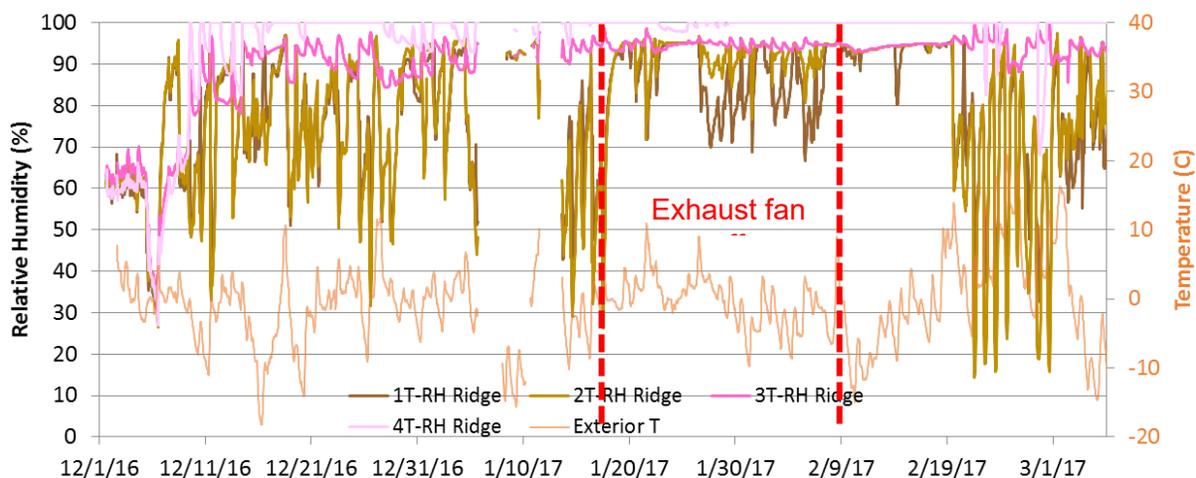
Figure 112. Fiberglass roof ridge RH measurements, showing exhaust fan on/off

RH at the roof ridge is plotted in Figure 112, and the period with the exhaust fan turned off is noted in red. During this fan-off period, the RH levels in Roofs 1 and 2 (diffusion vent/fiberglass) rise markedly and remain high. The likely explanation is that during exhaust fan-on periods, induced infiltration (small amounts of inward air leakage around or through the diffusion vent) protects the ridge from interior moisture. Turning off the fan removes this effect, as shown by the sharp rise in ridge RH. After the exhaust fan is turned off, RHs remain high for several weeks (possibly storage of accumulated moisture), but then drop.

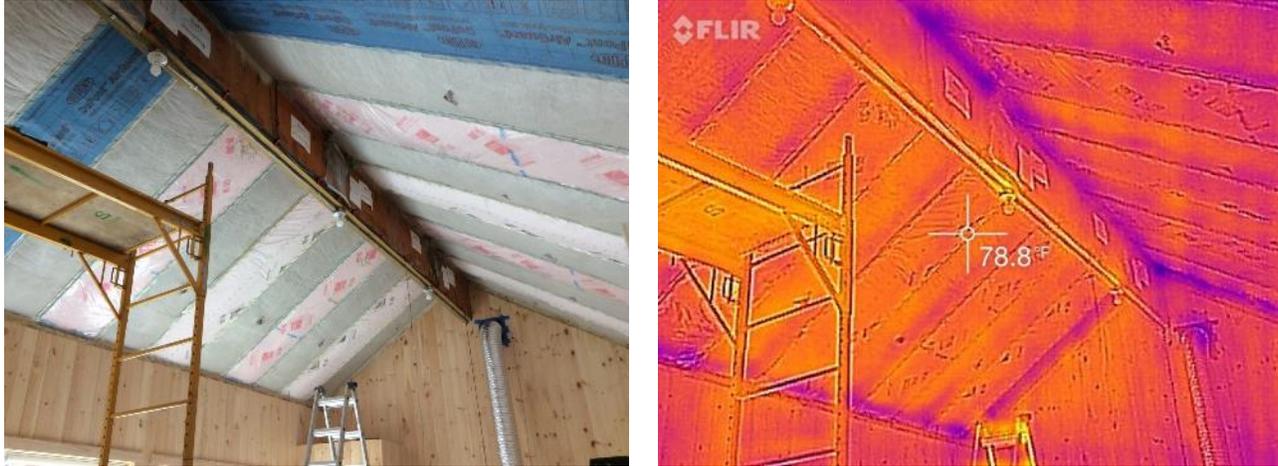
Figure 114. Visual and infrared image of interior of roof, no depressurization

Key findings include some thermal bridging at the ridge, rafters, and gable end/rake walls (Figure 114), as well as thermal bridging at the slab perimeter (Figure 115).

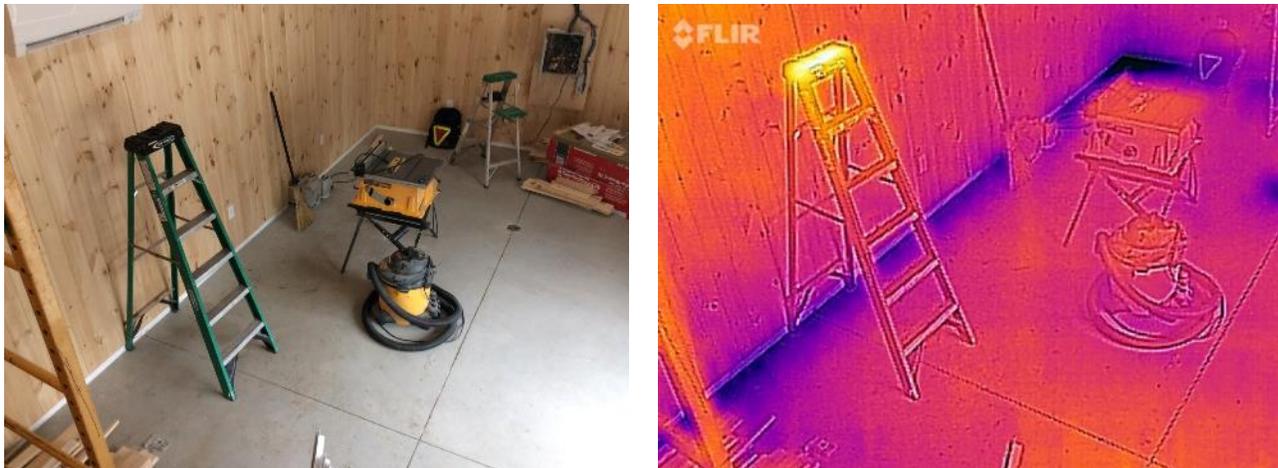
Figure 115. Visual and infrared image of floor-to-slab joint, no depressurization

The slab edge is insulated (with 4-in. semi-rigid mineral fiber); however, the wall is an even higher R-value (4-in. mineral fiber and 5-in. ccSPF), potentially causing this thermal anomaly. There are no noticeable thermal anomalies between roof bays (interior surface temperatures); concerns of uneven heat distribution from the wall-mounted minisplit head appear to be unfounded.

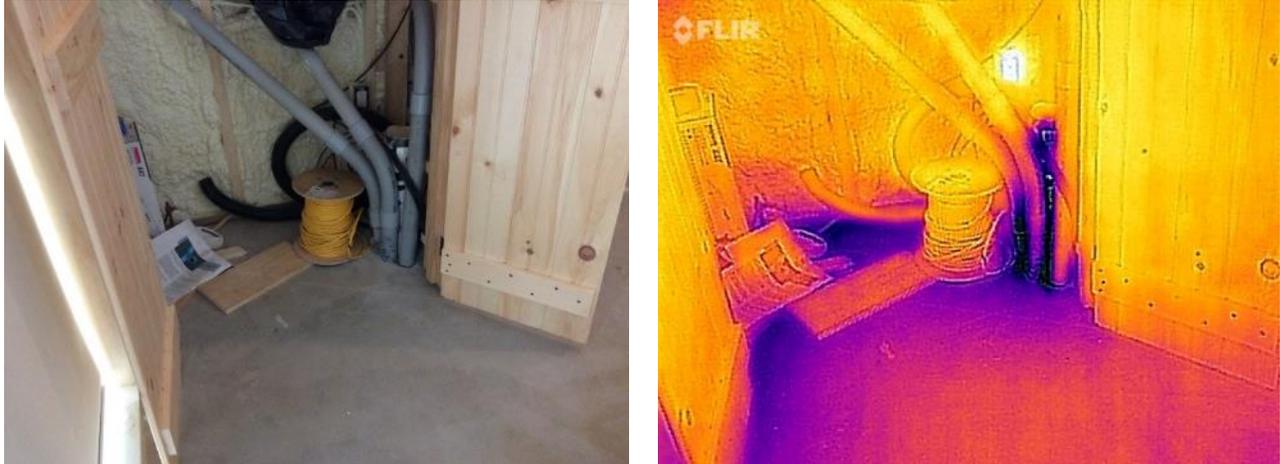
Figure 116. Visual and infrared image of conduit penetration at slab, depressurization test

The most significant air leakage was associated with electrical conduit penetrations through the slab (Figure 116); leakage occurred both through the conduit and at the opening between conduits. Exterior-to-interior airflow was confirmed with air velocity and temperature measurements via a Fieldpiece STA2 In Duct Hot-wire Anemometer (Figure 118, left), at 650 ft per minute/FPM and 58°F.

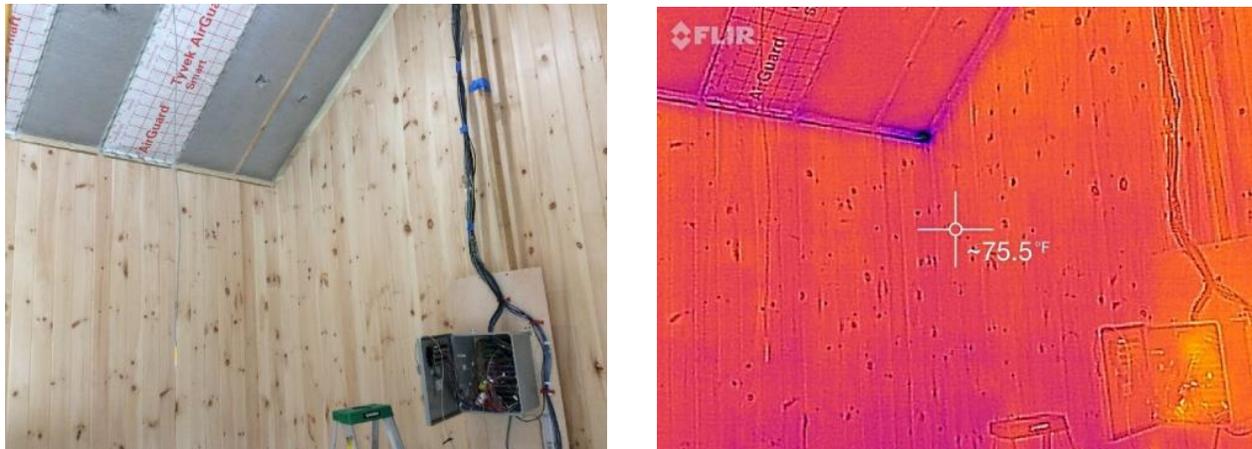
Figure 117. Visual and infrared image of roof corner, depressurization test

Another set of thermal anomalies was seen at the roof corners at the three-way intersection between the walls and roof (Figure 117). They were also examined with the anemometer (Figure 118); some corners showed airflow (99 FPM/66°F), but others had no measurable airflow despite the thermal anomaly.

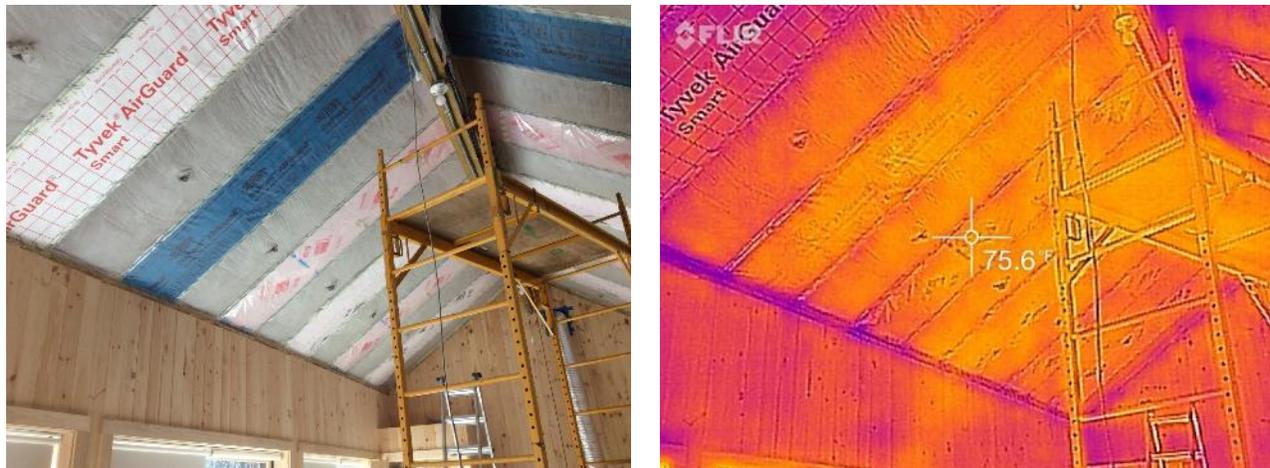
Figure 119. Visual and infrared image of overall roof, depressurization test

An infrared overview of the roof under depressurization testing is shown in Figure 119; no clear difference between the unpressurized and depressurized test was evident. Although there might be air leakage hidden behind the fibrous insulation, if rates are low, they would be difficult to detect from the interior.

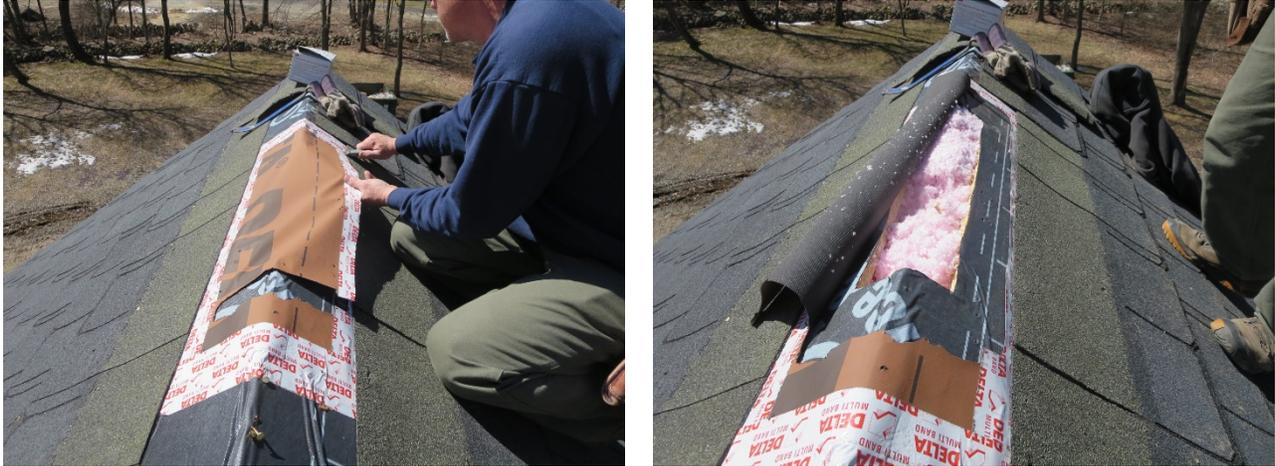
Figure 121. Cutting open existing diffusion vent ridge membrane, after vent removal

The ridge vent was removed and the diffusion vent material was opened to expose cavity conditions (Figure 121). The only notable anomaly was that the diffusion vent material was cut much larger than the sheathing opening. No empty nail holes penetrated the diffusion vent.

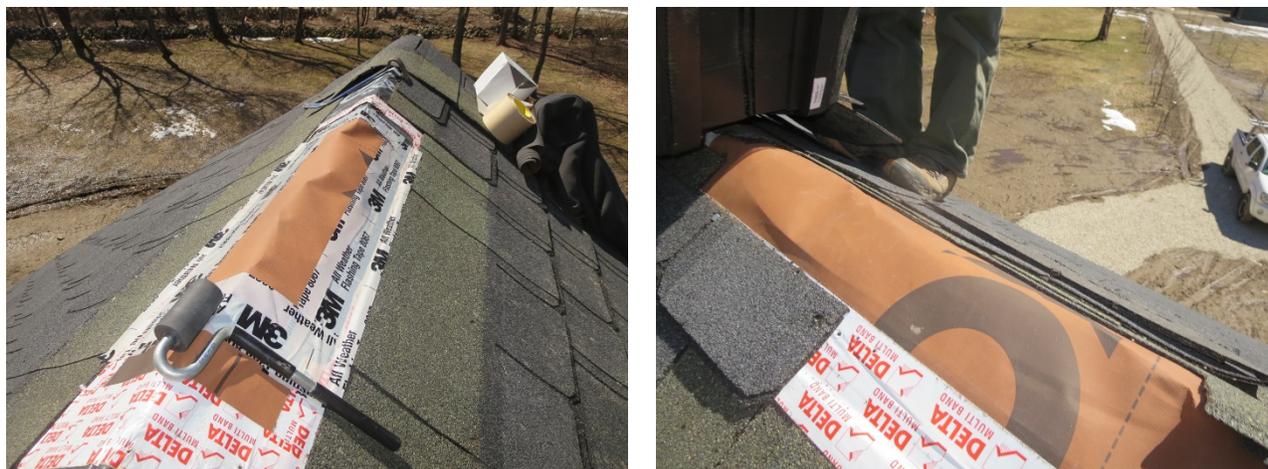
Figure 123. Reassembled Roof 1 diffusion vent (left) and Roof 2 examination (right)

The ridge was then reassembled, with taped edges closer to the sheathing opening (Figure 123, left), and Roof 2’s ridge was also visually examined after removing the vent cap (Figure 123, right); no anomalies were seen.

Interior cavity differential pressures were remeasured after the retrofit to determine whether this retrofit addressed the air leakage anomaly seen at Roof 1. The results with the building at -75 Pa are shown in Table 15; Roof 1 still has anomalously high air leakage. Almost all other ΔP measurements were 1 Pa or less, but all Roof 1 measurements were still anomalous—over 1 Pa.

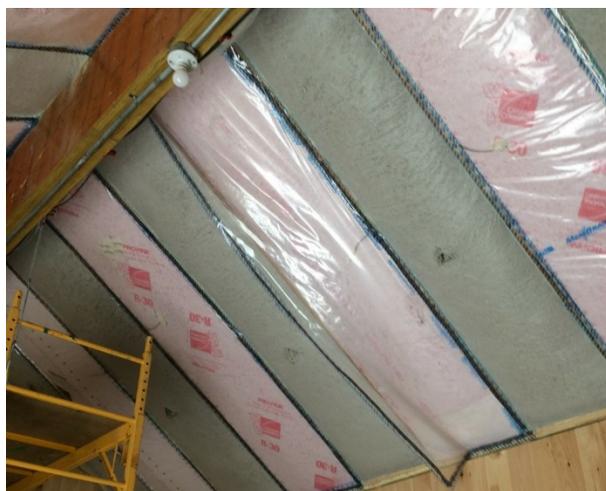
Figure 129. Roof 3 north vapor retarder failure (October)

However, even after this retrofit, several roofs had vapor retarder seal failures, including Roof 3 North (October 2017/Figure 129, then January 2018/Figure 130) and Roof 2 (December 2017).

Each was repaired using mechanical fasteners (staples) in addition to the sealing materials listed previously. These seal failures occurred at fiberglass roofs where there was noticeable “bellying” of the insulation, which resulted in a tensile load on the interior air/vapor retarder seal.

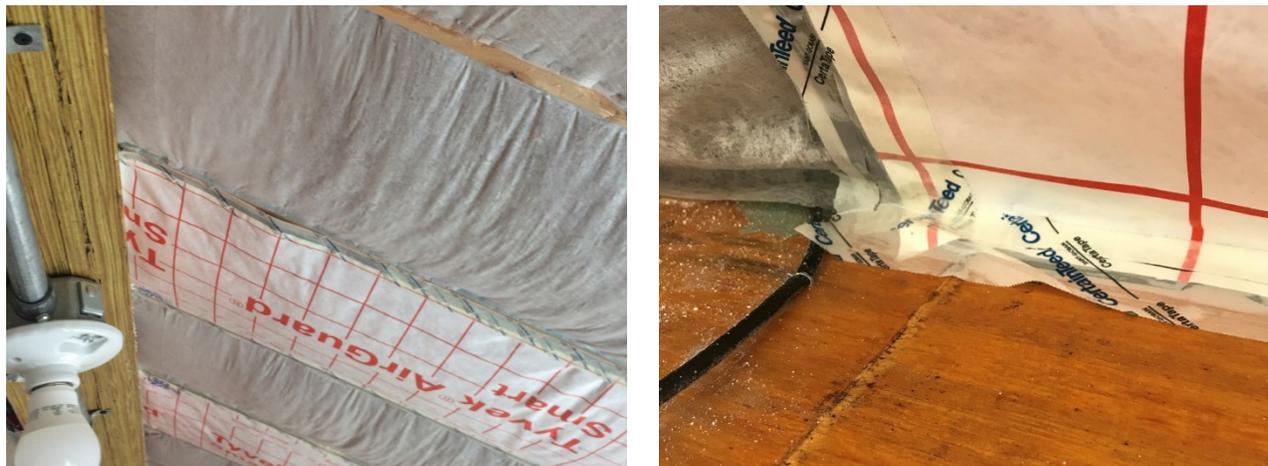
Figure 131. Tape adhesion loss at Roof 6 along rafter and at ridge

Some of the other roofs showed minor tape adhesion issues (Figure 131). This was addressed by retrofitting the tape seals in place, by cutting away the failed housewrap tape (leaving the double-

sided tape in place), applying high-performance construction tape, and rolling to improve adhesion (Figure 132). This was done at all bays that had the older housewrap tape.

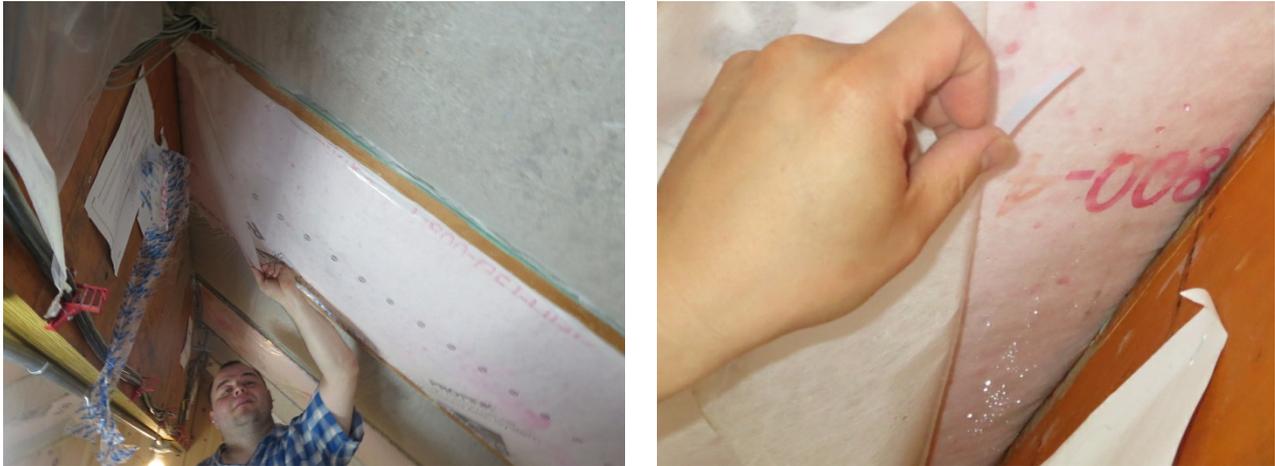
The interior fixed-perm vapor retarders on Roofs 3 and 5 were removed from the ridge beam downward (Figure 133, left); this revealed the accumulation of liquid water condensation at the vapor retarder-insulation netting interface, as demonstrated by visible droplets and water indicator paper (Figure 133, right). Further demonstrations of this wetting are shown in Figure

The pattern of wetness was worst at the ridge and decreased down the slope of the roof. The most noticeable patterns of wetness extended roughly 3 ft from the ridge. Wetness appeared to be roughly similar on north and south slopes.

Figure 133. Roof 3 vapor retarder removal (left), condensation accumulation (right)

This condensation might not fully reflect normal operating conditions: due to a controls issues, the interior temperature was set at roughly 60°F for a period before these observations. However, even if the interior temperature is non-representative, the spatial accumulation patterns are useful information.

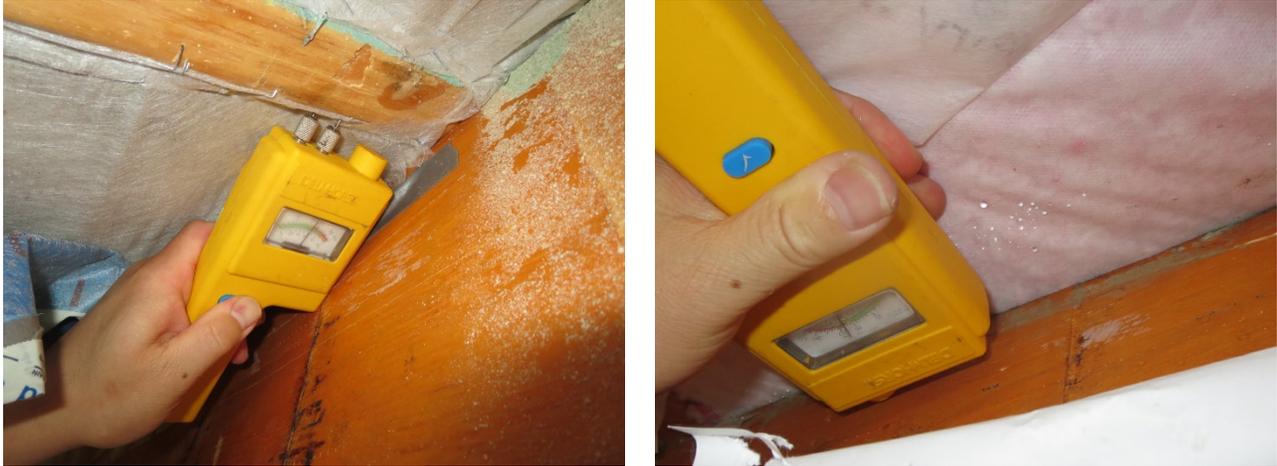
Wood MCs were measured at the framing with a handheld Delmhorst BD-10 meter (Figure 136). Consistent patterns were not seen, but MCs ranged from roughly 15% to 25%, with the highest MCs at the edges of the rafters near the ridge (per Figure 136, left).

Figure 136. Wood MC measurements at framing

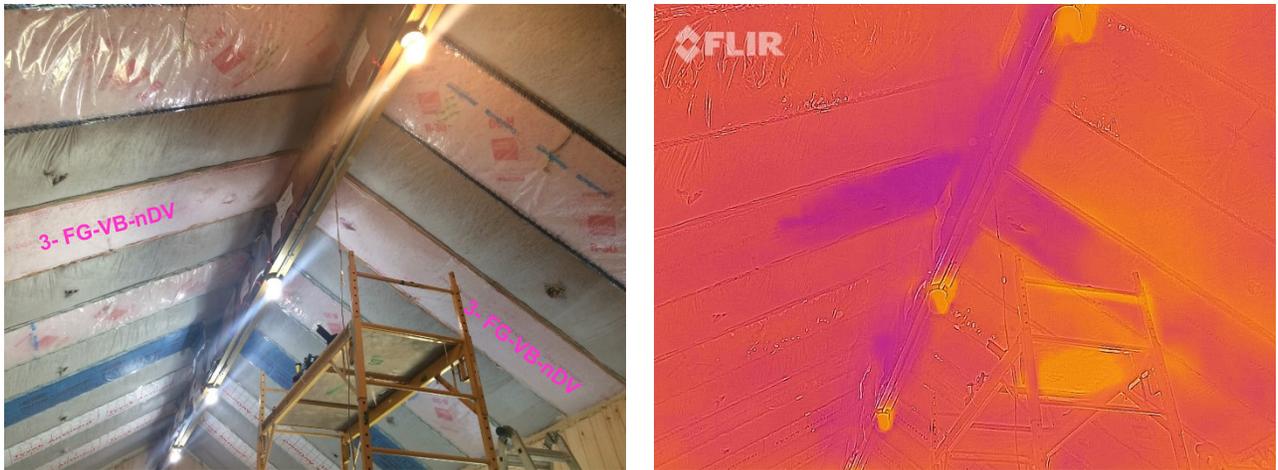
Roof conditions were also examined with an infrared camera (FLIR ONE Pro, -20°C to 400°C / -4°F to 752°F , accuracy $\pm 3^{\circ}\text{C}/5.4^{\circ}\text{F}$ or $\pm 5\%$, typical). With the interior vapor retarders removed, a pattern of cooler temperatures was observed at the ridge (Figure 114 and Figure 138), matching the wetted areas. This is ascribed to evaporative cooling of water from the exposed surfaces to the interior.

Figure 137. Visual and infrared image of Roof 3 (fiberglass) after fixed-perm vapor retarder removal

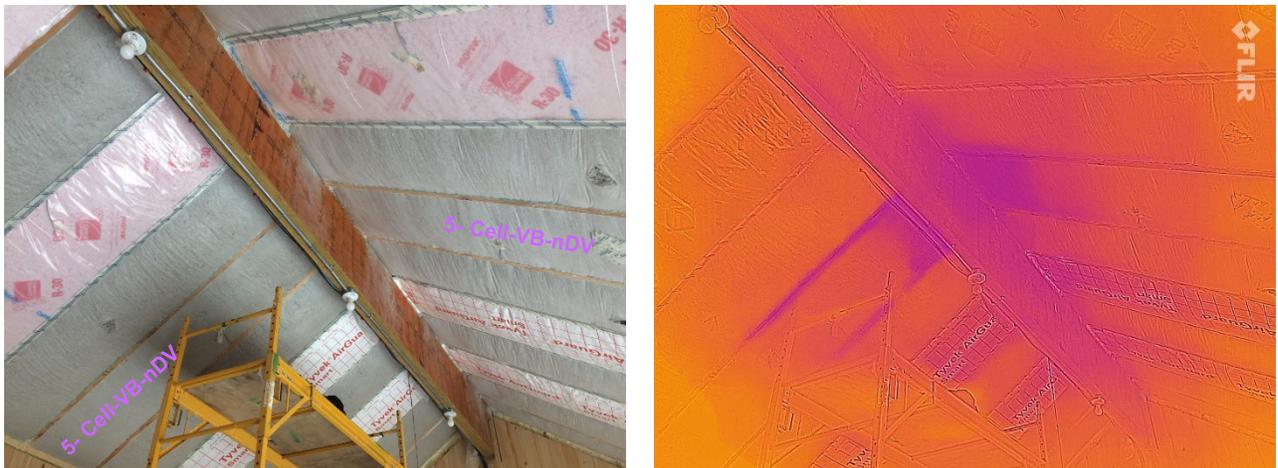
At Roof 5 (cellulose, Figure 138), the rafter framing was also cooler than adjacent bays, suggesting moisture accumulation at the wood. In addition, cooler surfaces were seen at the ridges of Roofs 6 and 7, suggesting possible ridge moisture accumulation in these variable-perm roof bays.

Figure 138. Visual and infrared image of Roof 5 (cellulose) after fixed-perm vapor retarder removal

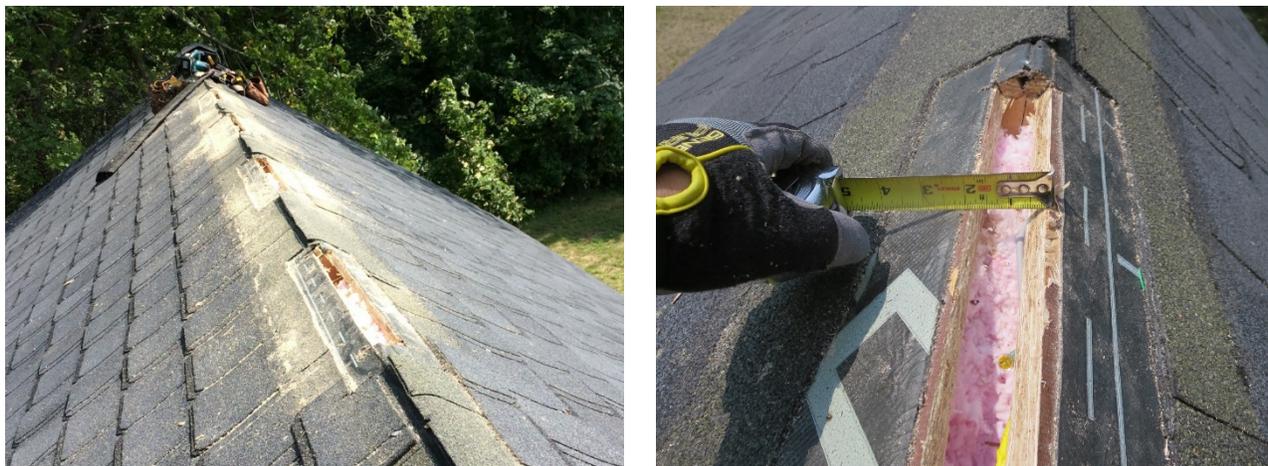
The non-diffusion-vent roofs (Roofs 3, 4, 5, and 6) were retrofitted with 2-in. wide diffusion vents (as detailed in Table 3) in late August 2017. The self-adhered membrane and sheathing were cut back to create a roughly 2-in. wide opening (Figure 140). The openings are roughly 22 in. wide (full width of the rafter bay).

Figure 140. Retrofit of 2-in. wide diffusion vents at Roofs 4, 5, 6, and 7

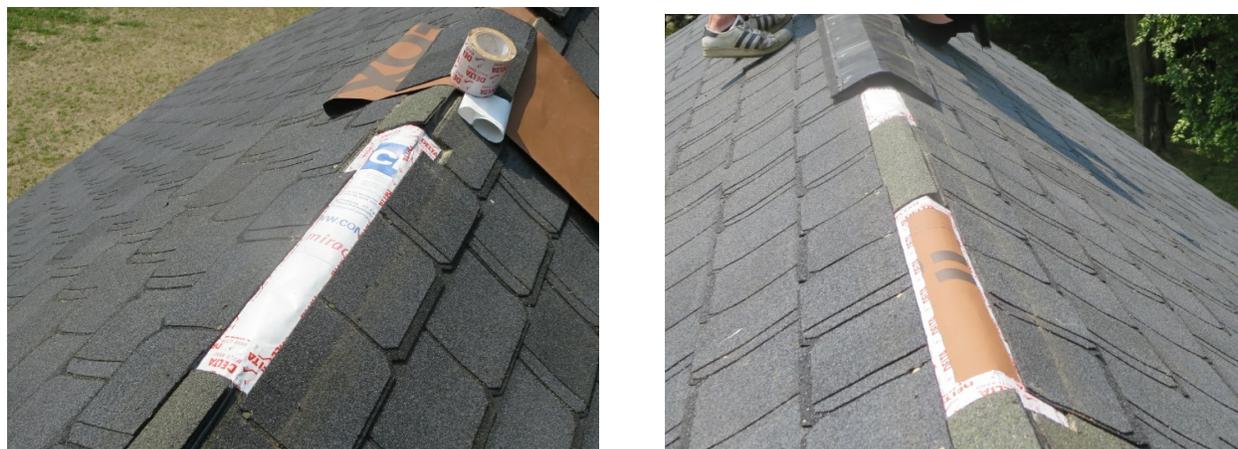
The remaining diffusion vent details were per the existing diffusion vent roofs (1, 2, and 7), with the vapor-open membrane adhered to the roof self-adhered membrane with flashing tape, and the ridge cap covering the diffusion vent (Figure 141).

Figure 141. Diffusion vent material installation and ridge cap coverage

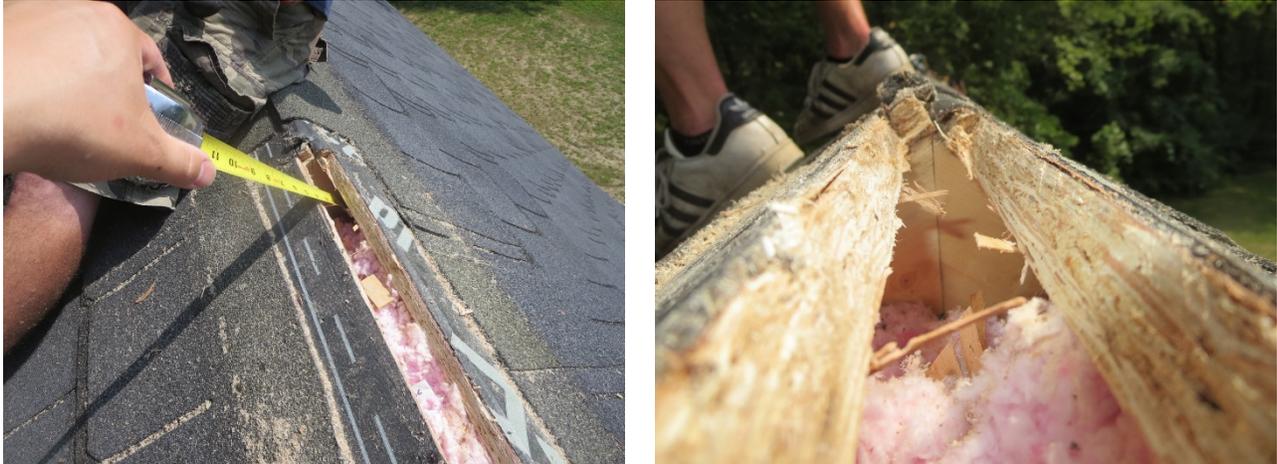
The ridge opening allowed for observation of insulation and sheathing conditions. The fiberglass insulation showed varied amounts of settling at the ridge, ranging from 1 to 2 in. to more than 3 in. (exposing most of the 2x4 nailer), per Figure 142. This settling resulted in an open-air cavity near the ridge.

Figure 142. Settling of fiberglass insulation at ridge, Roof 4

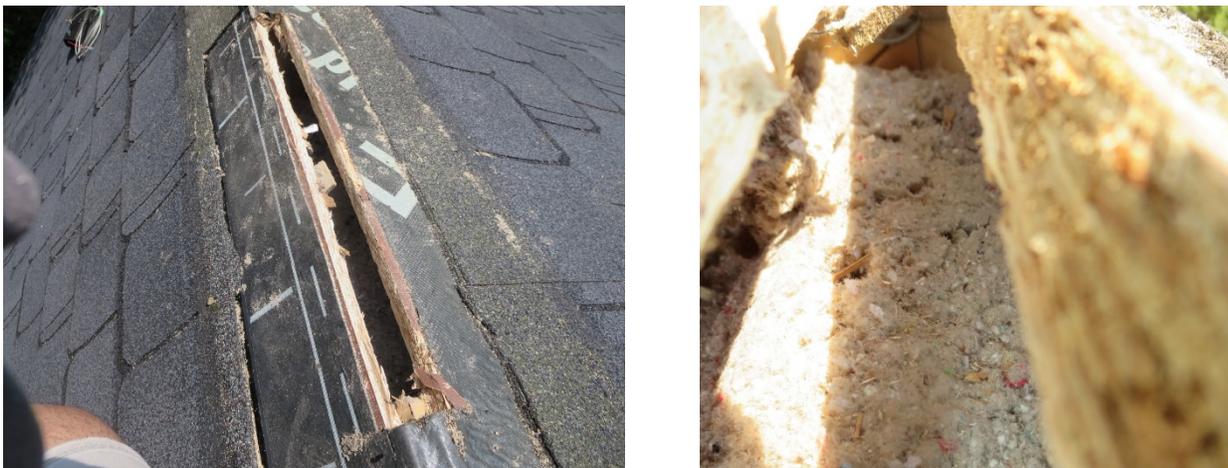
Insulation settling was also seen at the cellulose roofs (Figure 143). This settling at the ridge was in the range of 4 to 8 in., typically (Figure 144).

Figure 143. Settling of cellulose insulation at ridge, Roof 5

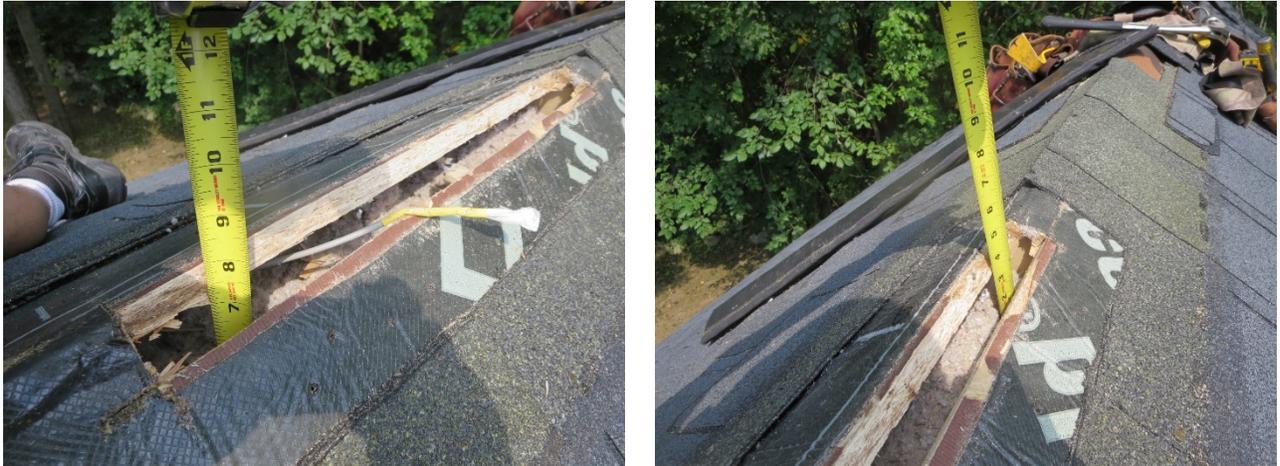
Figure 144. Settling of cellulose insulation at ridge, Roof 6

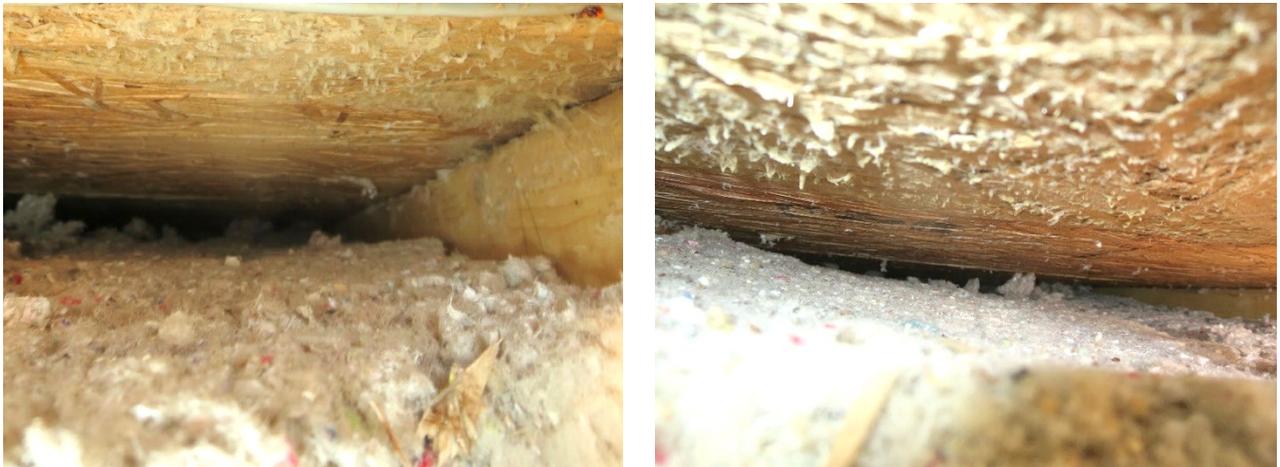
However, a surprising finding was that there was significant settling on the north-facing slope in both Roofs 5 and 6, varying from minimal to roughly 1 in. (Figure 145, showing view down slope).

Figure 145. Settling of cellulose insulation on north-facing slope, Roof 5

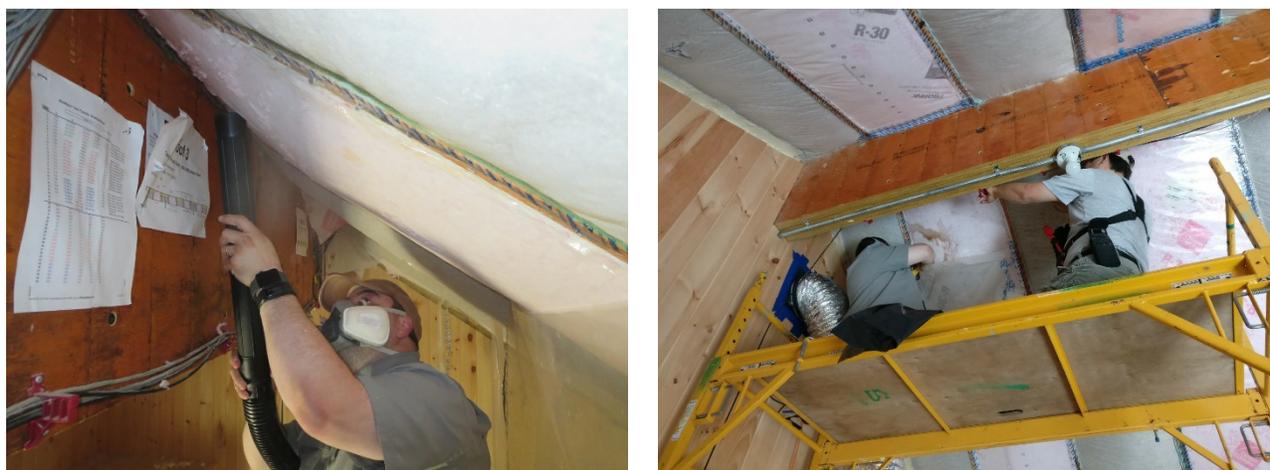
The interior vapor control and netting at the roof ridges were opened, roughly 2 to 3 ft from the ridge, on the north side. Insulation was carefully removed via vacuum cleaner (Figure 148).

Figure 148. Removal of fiberglass insulation at ridge of Roof 1
