Monitoring of Unvented Roofs with Fibrous Insulation, Diffusion Vents, and Interior Vapor Control in a Cold Climate

Building America Report - 2001

September 2020

K. Ueno and J.W. Lstiburek

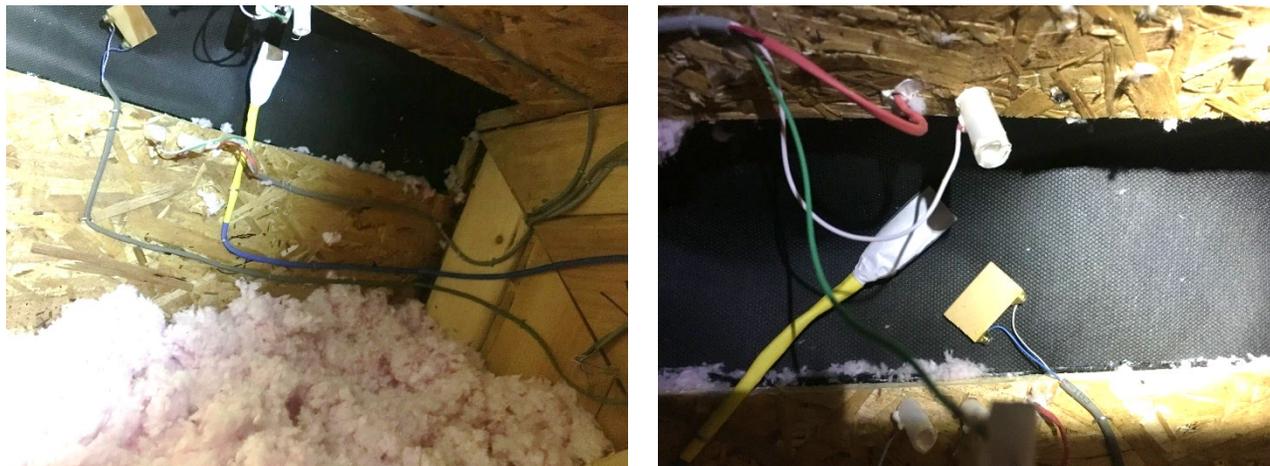
One MC pin had been knocked out of place from the sheathing; it was replaced and redriven (Figure 149, right).

Figure 149. Sensor replacement (left) and repair of failed MC pin (right)

The interior conditions of the roof framing and sheathing were inspected (covered in later sections), and the ridge RH and wafer MC sensors were replaced in all seven experimental fibrous insulation roofs (Figure 149, left). The repair splices were made with snap-on silicone-filled insulation displacement connectors (3M Scotchlok IDC Butt Connector UY); the splices were kept away from ridge conditions.

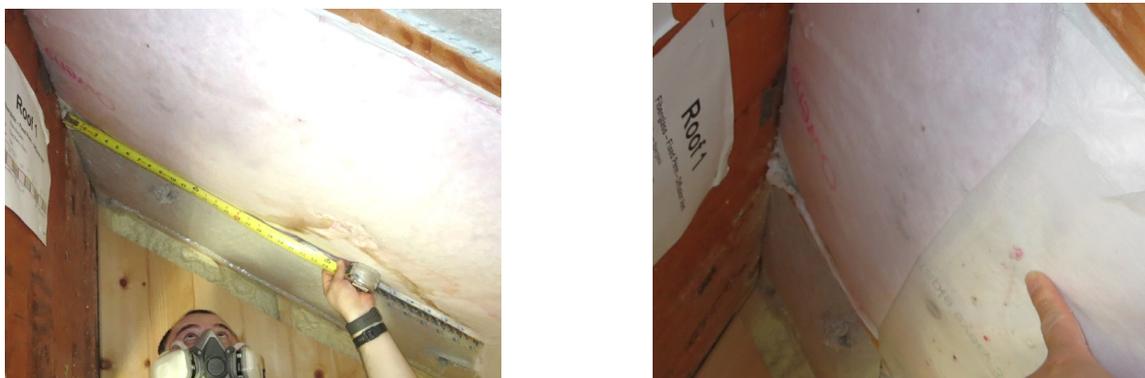
Roof 1 (Winter 1 and 2-full-size diffusion vent; fixed-perm interior vapor barrier) disassembly showed noticeable water staining on the vapor retarder and netting, on the north side (Figure 150, left).

Figure 150. Roof 1 water staining on netting (left) and pink spotting on fixed-perm vapor barrier (right)

In addition, dried pink spotting was found on the exterior side of the interior vapor barrier (Figure 150, right), consistent with summertime inward drive condensation on the fixed-perm vapor retarder at the ridge (like Roof 3, Figure 133 and Figure 134).

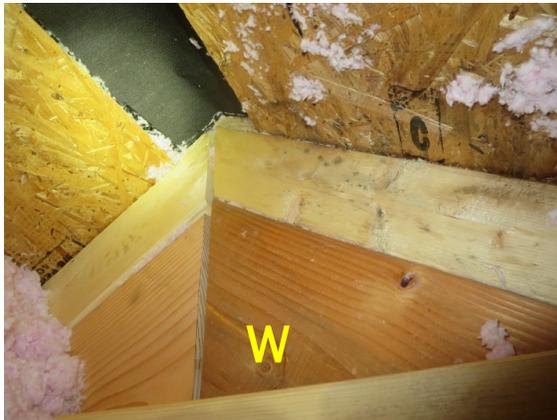
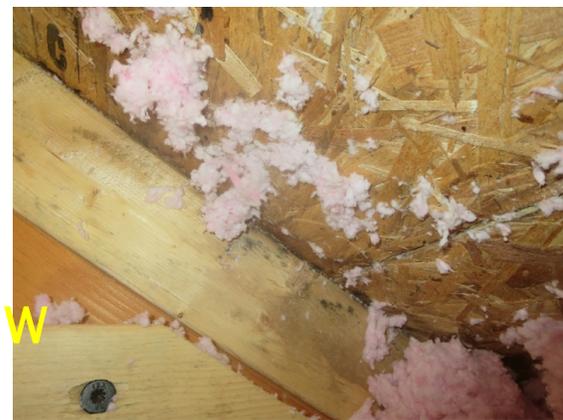
Further disassembly revealed minor mold spotting on the framing. The rafters are framed with a “stacked” 2x12 and 2x4 assembly to achieve a ~14.75-in. cavity depth. The visible mold occurred in the north bay, on the west-side rafter, on the 2x4 (lighter colored wood, Figure 151, left). There was minor staining on the roof sheathing near the west-side rafter (Figure 151, left, and Figure 152, left). In comparison, the east-side rafter was mostly clean, but with some minor mold spotting on the 2x4 (Figure 152, right). Some minor spotting was also seen on the horizontal collar tie (similar light-colored lumber to “stacked” 2x4).

The west-side rafter showed a noticeable bulk water stain on the 2x4, originating at the sheathing joint (Figure 151, right). The most likely explanation based on the visible patterns was condensation and rundown from the roof ridge along the sheathing; at the sheathing joint, surface tension resulted in a “drip,” causing the visible staining on the interior vapor control shown in Figure 150 (left).

Figure 151. Roof 1 mold spotting on sheathing/framing (left) and bulk water stain on 2x4 (right)

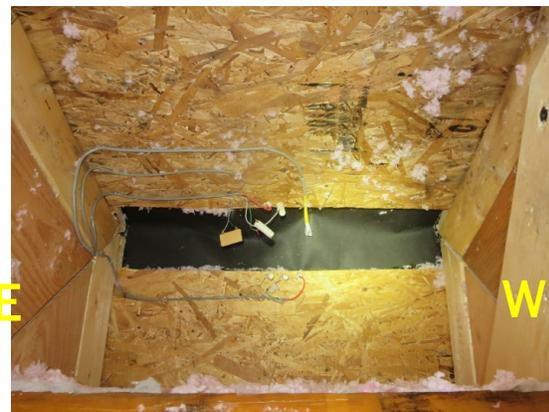
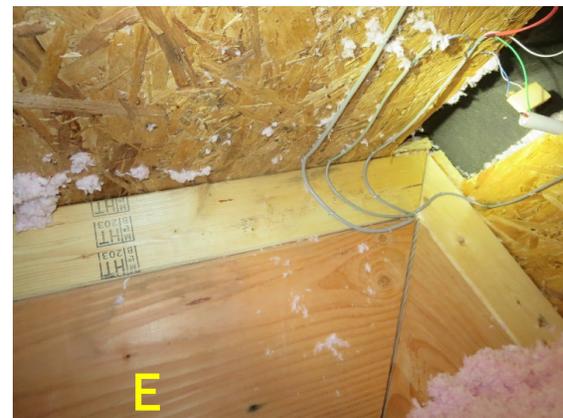
Figure 152. Roof 1 ridge sheathing conditions (left) and east-side rafter (right)

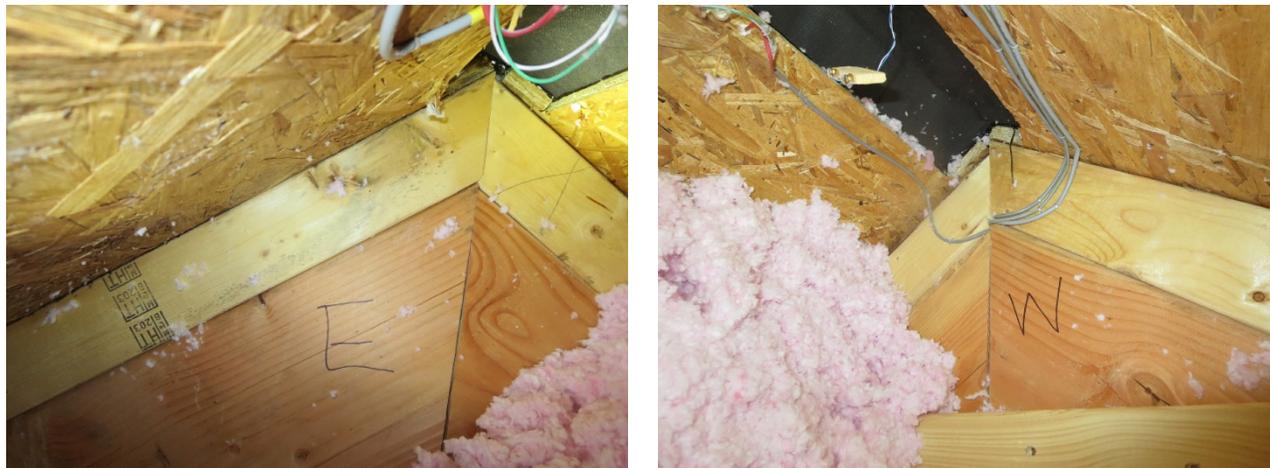
Roof 2 (Winter 1 and 2 full-size diffusion vent; variable-perm interior SVR) showed minor mold spotting on the east-side rafter (Figure 153, left) and no visible issues on the west side (Figure 153, right). This roof generally showed the least moisture accumulation, given the large ridge diffusion vent and variable-perm interior vapor control.

Figure 153. Roof 2 minor mold spotting on east rafter (left) clean conditions on west rafter (right)

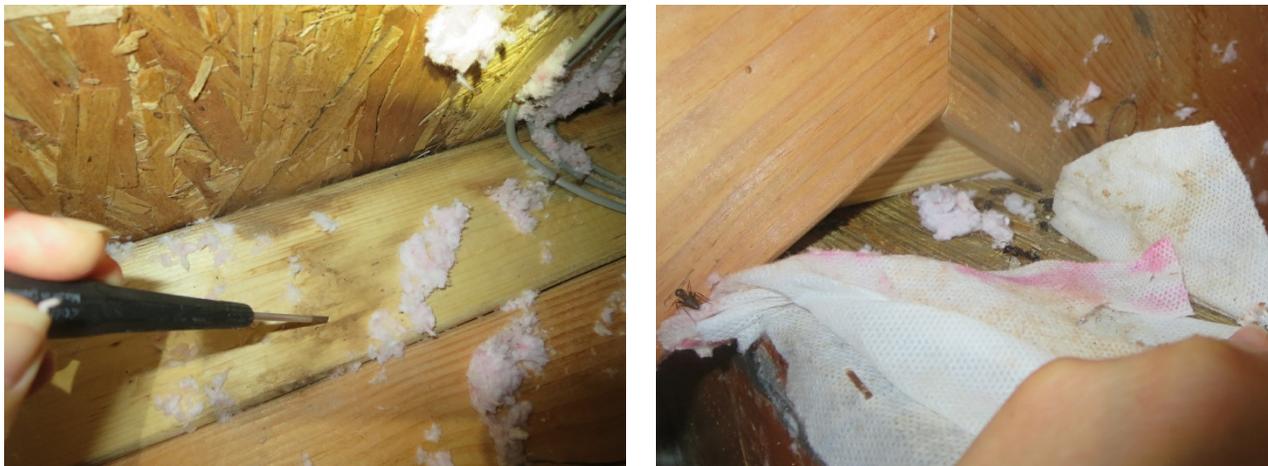
A close-up of Roof 3's east-side water staining is shown in Figure 155 (left). Although the water rundown stain is noticeable, mold staining appears minor.

A final notable item is that there was significant ant infestation/nesting, per Figure 155 (right). The ants left to the adjacent guard roof bay when disturbed; however, the location of the nest was not determined via disassembly. Ant infestation is a common indicator of moist wood products.

Figure 155. Roof 3 close-up of water staining on east rafter (left) ant infestation from adjacent bay (right)

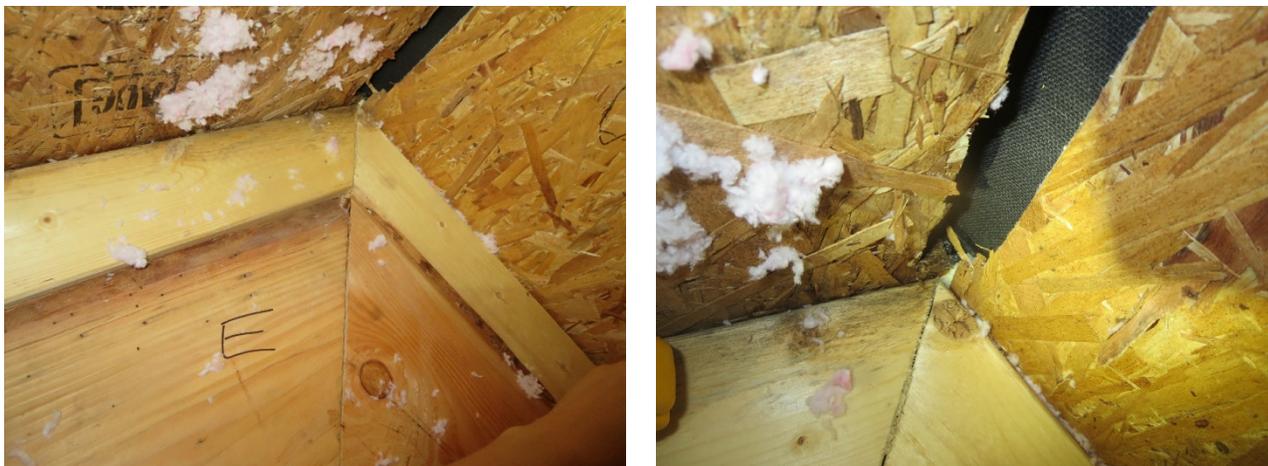
Roof 4 (Winter 1 no diffusion vent, SVR; Winter 2 small diffusion vent, SVR) showed minor staining on the 2x4 near the ridge on the east side (Figure 156, left and right) and minor damage to the sheathing on the north side.

Figure 156. Roof 4 mold and staining on east rafter (left) close-up of east rafter and sheathing stains (right)

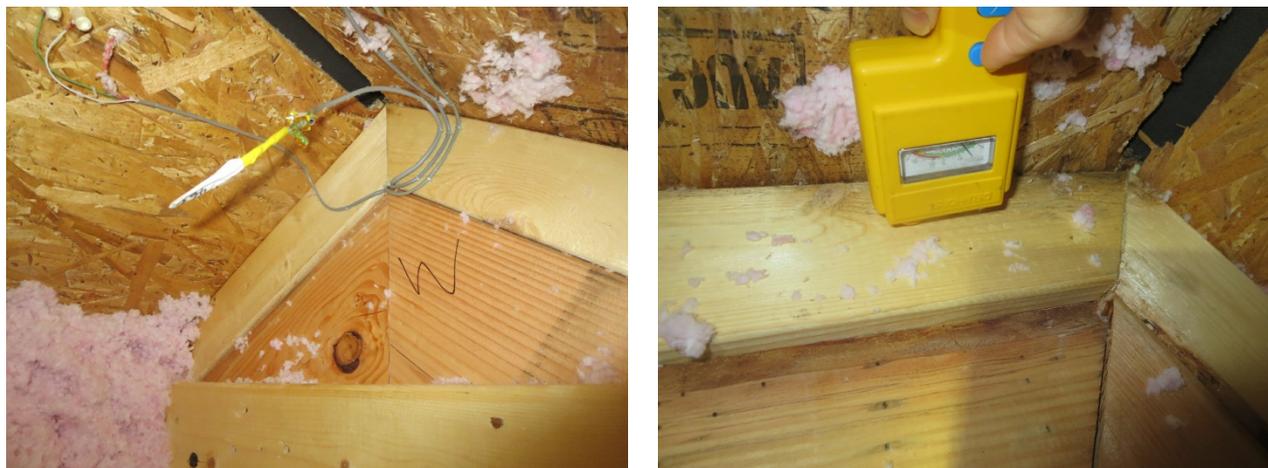
The west rafter appeared to be mostly intact and unstained (Figure 157, left).

In addition to visual inspections, wood MC measurements were taken at all stained areas, using a handheld Delmhorst BD-10 meter (Figure 157, right); all conditions were dry, as would be expected for summertime measurements.

Figure 157. Roof 4 mostly clean conditions on west rafter (left) wood MC measurements (right)

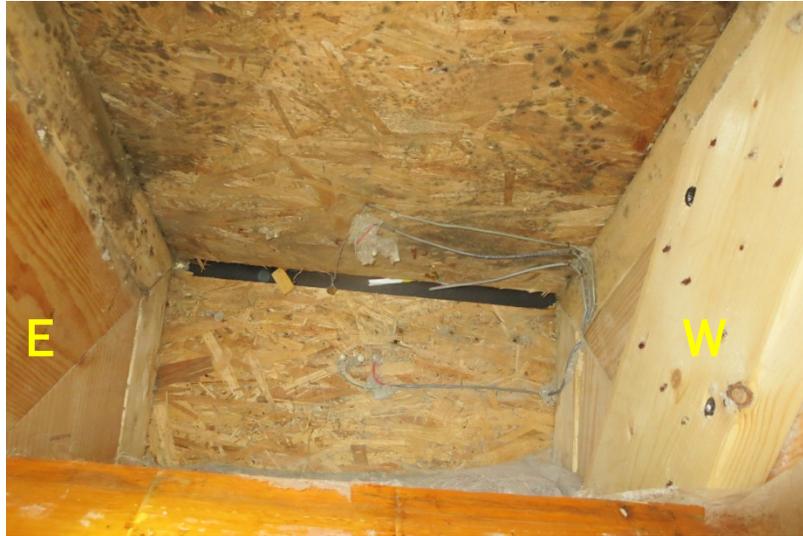
Roof 6 (Winter 1 no diffusion vent, SVR; Winter 2 small diffusion vent, SVR) also showed extensive staining to the framing (east-side rafter) and north roof bay sheathing, per Figure 162. The sheathing showed discoloration, grain raise, mold spotting, and extensively corroded fasteners.

Figure 162. Roof 6 peak overview; extensive mold on east rafter and north sheathing

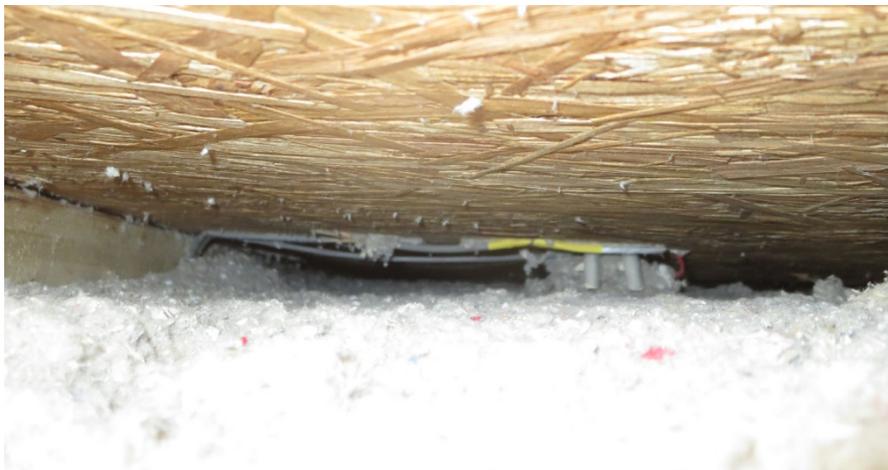
Roof 6 showed the same cellulose settling seen on Roof 5; a shot down the north rafter bay (Figure 164) shows cellulose stuck between the sheathing instruments. This indicates that settling occurred after insulation installation.

Figure 164. Roof 6 cellulose settling and gap at north rafter bay; note cellulose stuck in instruments

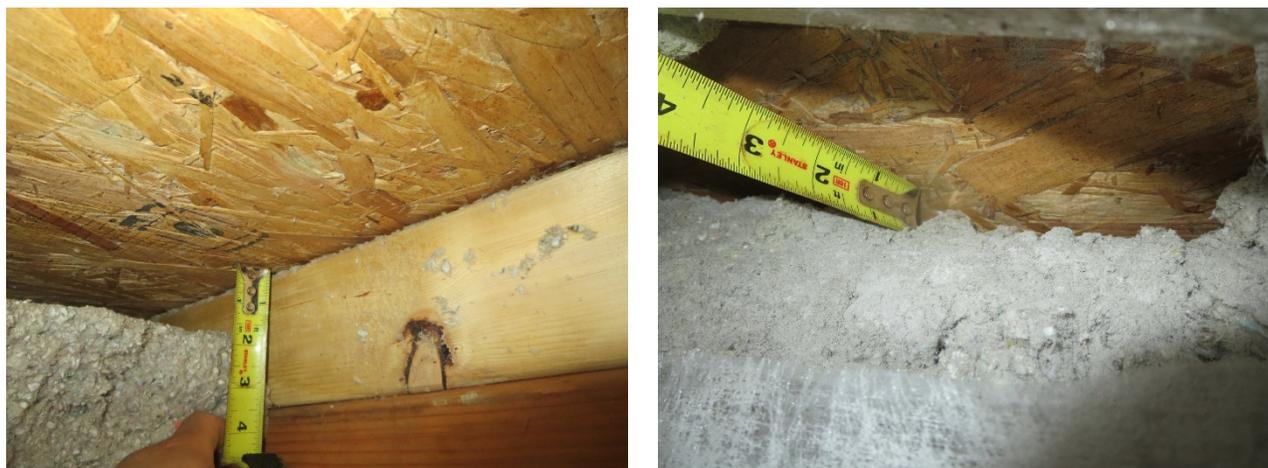
Roof 7 suffered from the same cellulose settling issues seen in Roofs 5 and 6; the gap was roughly 2 to 2.5 in. on the north side (Figure 166, left). Settling was less severe on the south side (roughly 1 in., Figure 166, right), which is consistent with drier conditions at the sheathing-insulation interface due to greater solar exposure.

Figure 166. Roof 7 cellulose settling at north rafter bay (left) and south rafter bay (right)

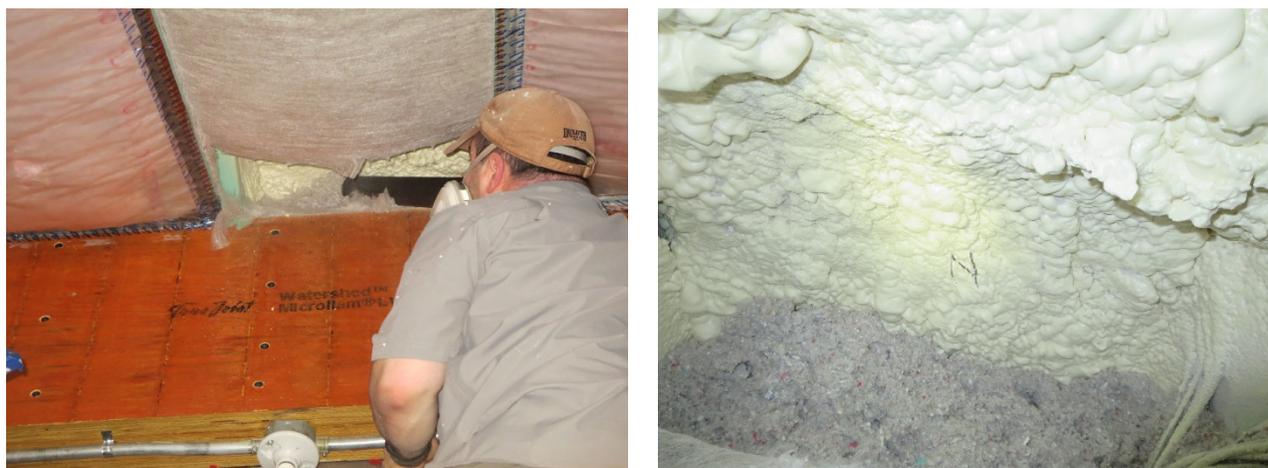
Therefore, the guard bay between Roofs 3 and 4 was disassembled, exposing the interface (Figure 167, left). No evidence was found of significant wetting, which would include “packy” or caked cellulose insulation, visible staining, or odors.

No indication was found of the ant infestation; it is possible that the tunnels are inside the closed-cell spray foam, which was not cut open.

Figure 167. Disassembly of guard bay (hybrid ccSPF-cellulose) ridge and examination

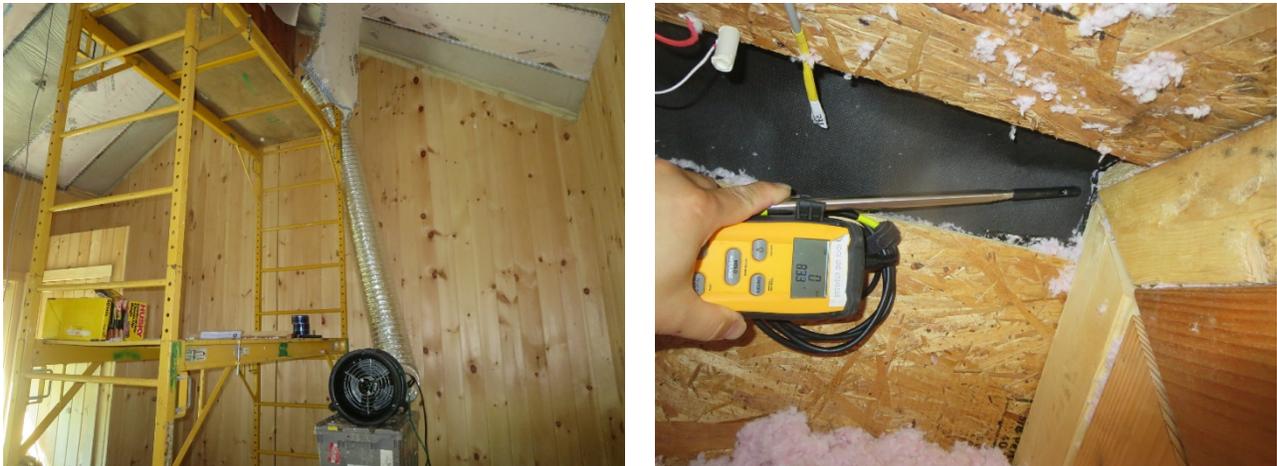
Therefore, the test hut was depressurized to -75 Pa (Figure 168, left), and airflow at the diffusion vent was measured with a Fieldpiece STA2 In Duct Hot-wire Anemometer (Figure 168, right). No airflow was measured. However, later calculations demonstrate that an airflow of $0.69 \text{ l}/(\text{s}\cdot\text{m}^2) @ 75 \text{ Pa}$ is equal to a velocity of $0.13 \text{ ft per minute/FPM}$, which is far below the equipment's measurement range of 40 FPM . However, this testing showed no "bypass" air leakage, due to imperfect tape sealing of the diffusion vent.

Figure 168. Test hut depressurization (left) and airflow measurement at diffusion vent (right)

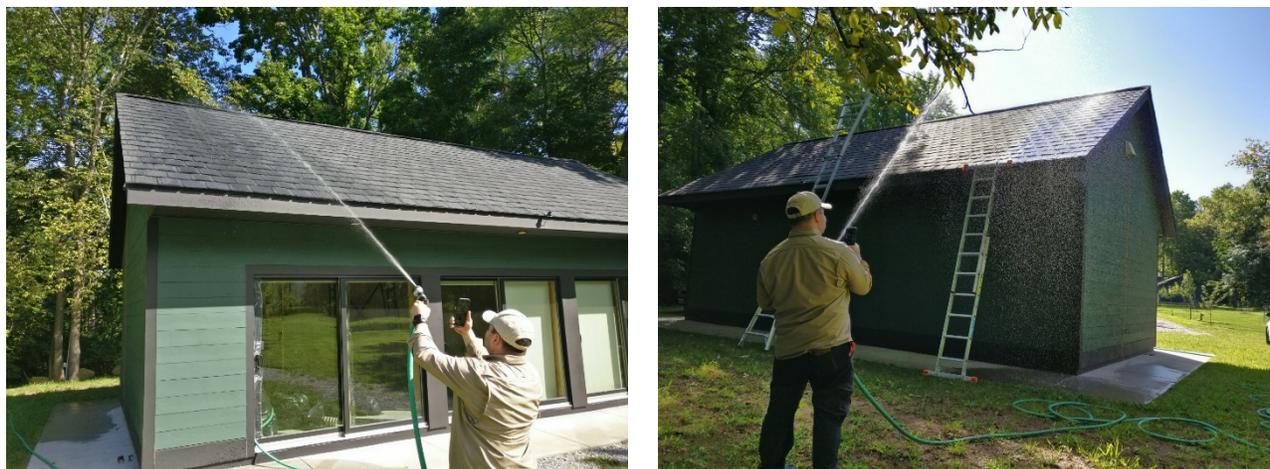
Figure 169. Hose spray testing of roof ridges with interior observation

Another possible issue was that the visible bulk water staining was due to precipitation leakage rather than condensation rundown. Therefore, the test hut was depressurized to -75 Pa , and water was sprayed, aiming at the ridge detail (Figure 169), to simulate the effect of wind-driven rain.

This test was conducted for 10 minutes of water spraying from each side, with no detectable water leakage visible from the interior. Infrared observation during this testing distinctly showed cooling of the diffusion vent and ridge from water spraying, but no water penetration.

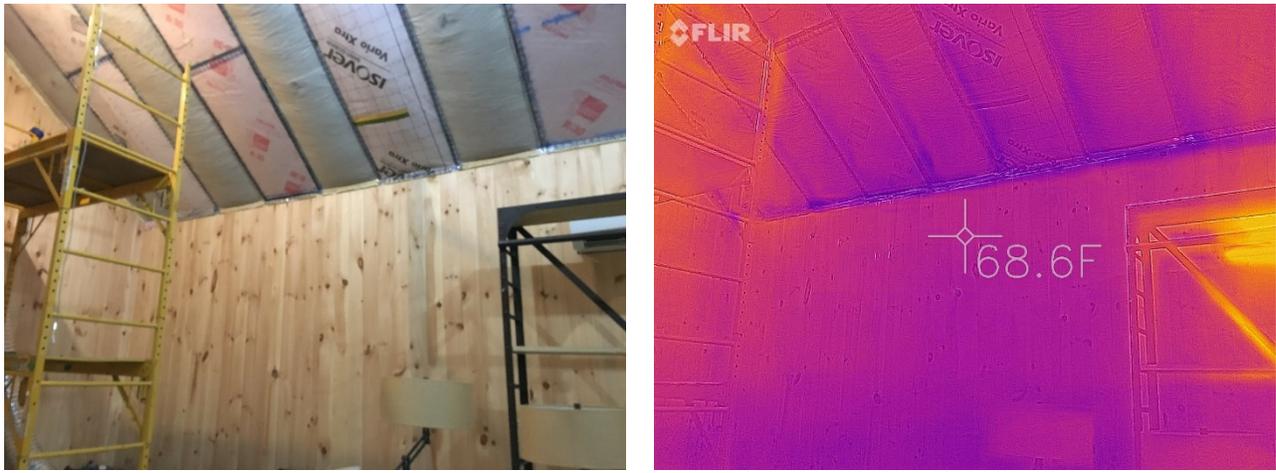
Figure 173. Visual and infrared image of interior of roof, depressurization testing

A baseline infrared observation of the building was done prior to depressurization to identify existing thermal bridges or other anomalies and to avoid ascribing them to depressurization air leakage. Findings included thermal bridging at the roof framing (Figure 173), thermal stratification of the interior (consistent with interior temperature measurements), and thermal bridging at the slab perimeter (per previous observations).

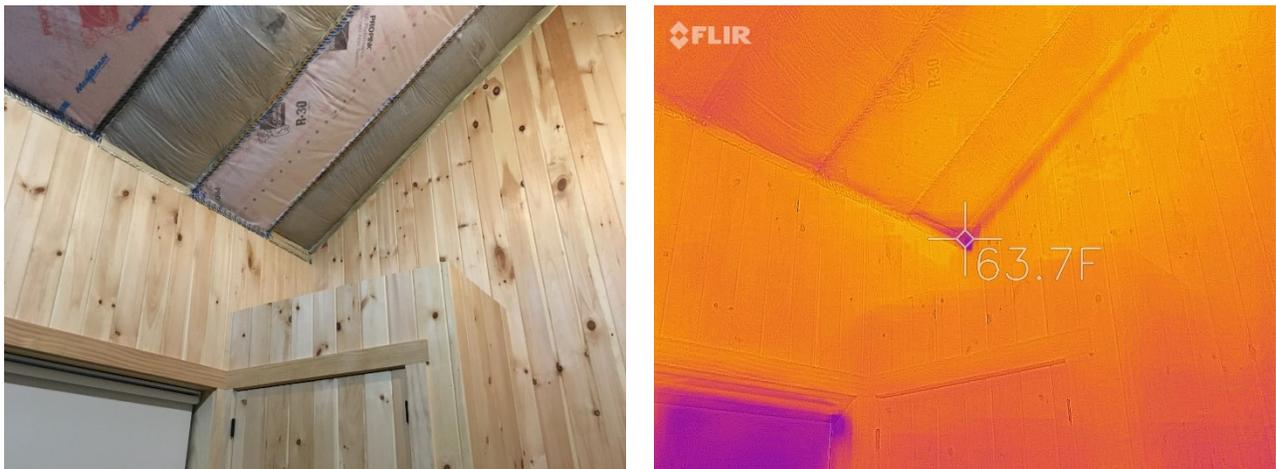
Figure 174. Visual and infrared image of interior of roof, depressurization testing

Then, infrared observation was combined with depressurization to search for air leakage. Figure 174 shows a point air leak at the corner of the building (triple point connection of walls to roof). However, this air leak is in a guard bay, not a test bay, so it does not affect the research. Similarly, a point air leak was found at an upper corner of a sliding glass door (Figure 175, Figure 116); again, this does not affect the test roofs.

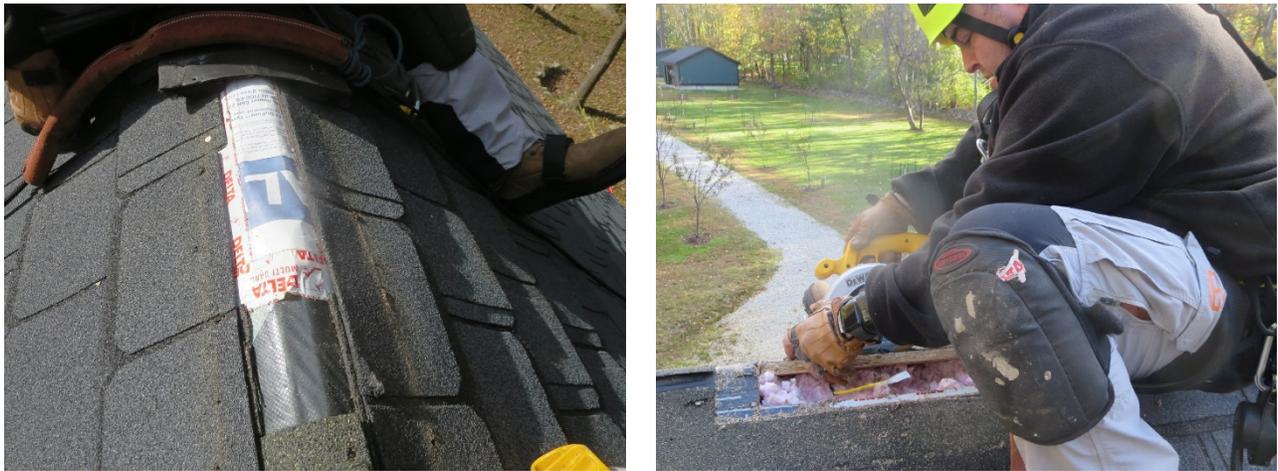
Figure 177. Removal of tight (~25-perm) diffusion vent (left) and cutting new diffusion vent opening (right)

The tight diffusion vent roofs (Roofs 3 and 5) showed limited drying, moisture accumulation, and poor performance in Winter 2. Therefore, as shown in Table 3, these roofs were retrofitted with full-size (~6-in.) ridge vapor diffusion openings. This work is documented in Figure 178: the existing tight diffusion vent was removed, the opening enlarged by cutting the sheathing, and the new diffusion vent (Dörken Delta Foxx) installed and sealed with tape.

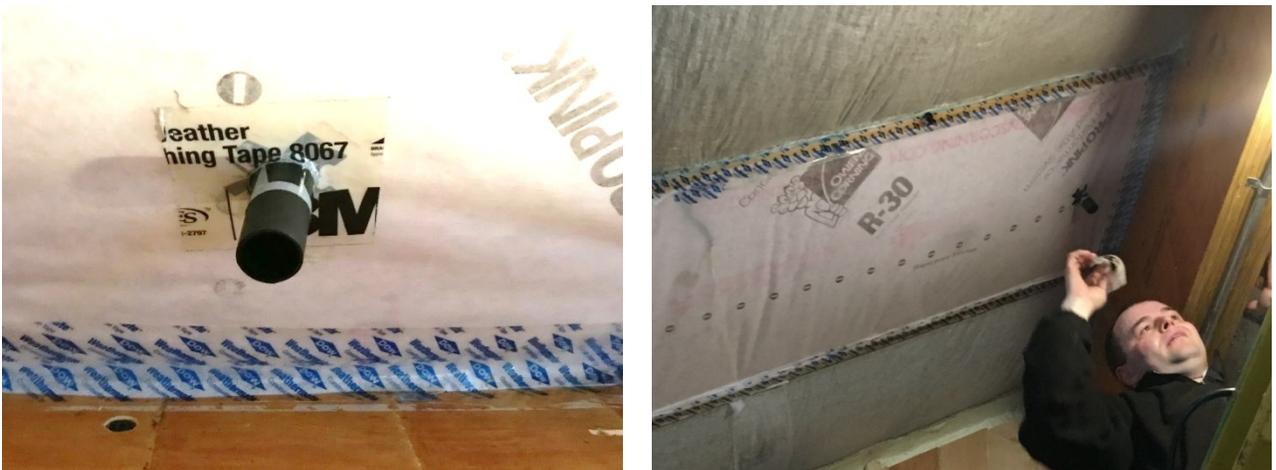
Figure 189. Roof ridge relief port close up (left); roof ridge relief port overview (right)

Pressure relief at the rafter bays is provided by a relief port made of 1-in. nominal polyethylene tubing, attached to the interior air-vapor control membrane with flashing tape (Figure 189).

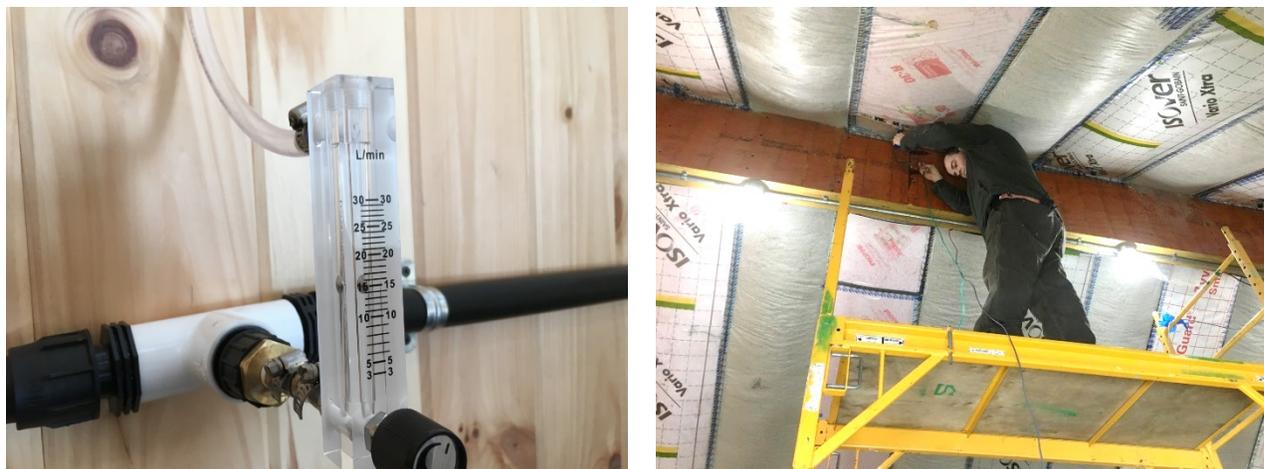
Figure 190. 15 liters/minute airflow rate (left), measuring pressure difference at relief opening (right)

When the air injection system was run, the maximum airflow that could be applied consistently to all rafter bays was 15 liters/minute, or 0.53 CFM, in each rafter bay (Figure 190, left).

A commissioning test was performed to seal the relief port and measure the developed pressure (Figure 190, right). The results are shown in Table 21.

These results suggest that Roof 4 (fiberglass, SVR, small diffusion vent) is either more airtight or receives more airflow than other bays. However, previous air leakage testing of pressure drop across the air-vapor control membrane with the hut depressurized to -75 Pa did not identify this roof bay as anomalous (Table 19). Differences in airflow are unlikely given the metering through rotameters. Another possibility is that the airflow pathways and/or airflow resistance through the insulation affect the pressure drop at the relief port.

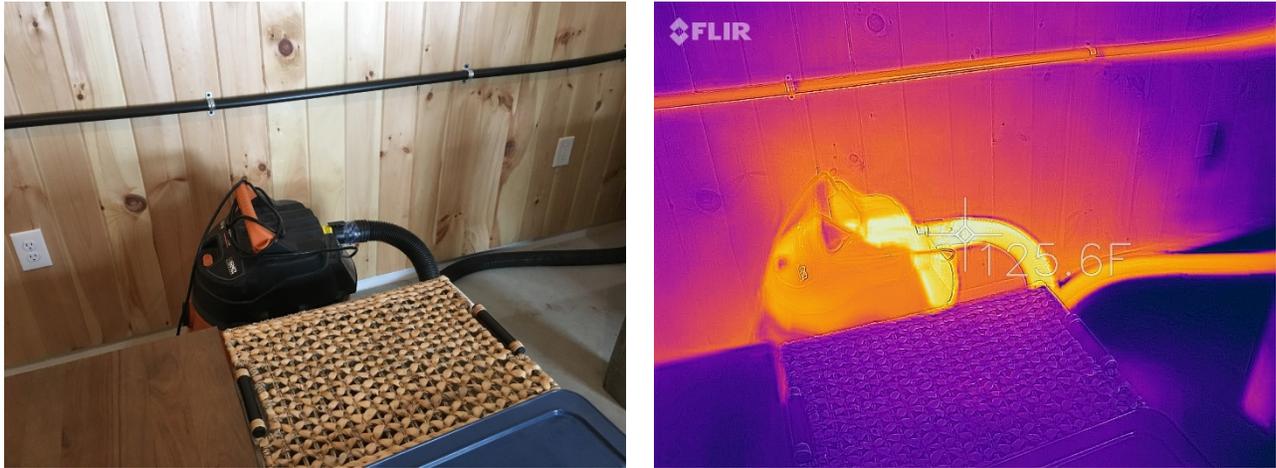
Figure 191. Visual and infrared image of show vacuum; heat generation visible

The air injection system and roof bays were inspected with an infrared camera while in operation. The shop vacuum was noticeably hot in operation (maximum temperature 113°F, Figure 173); this is consistent with the unit operating with constricted flow and in continuous operation. This was concerning, as injecting high-temperature air into the rafter bays is not representative of in-service air leakage in the field.

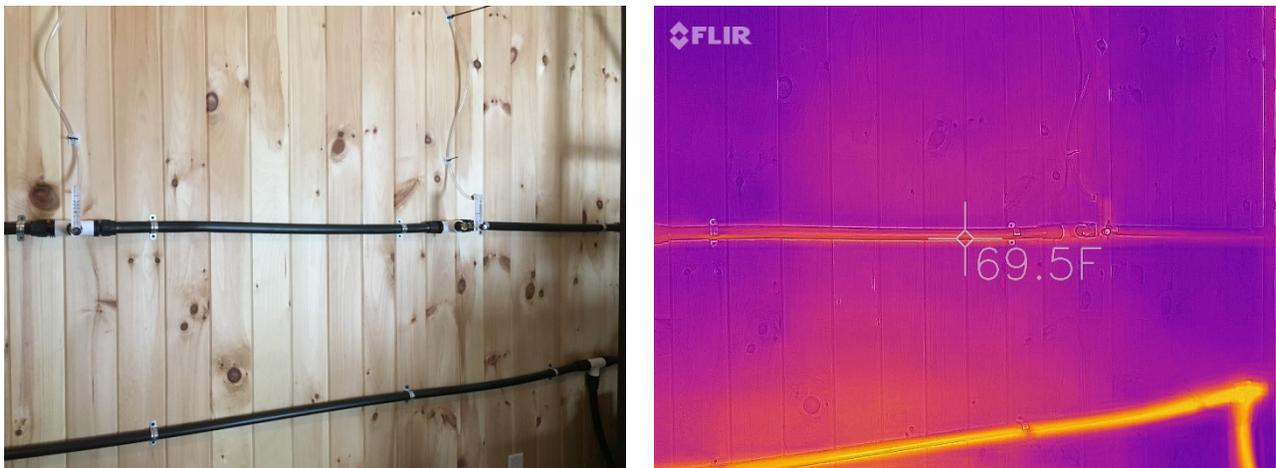
Figure 192. Visual and infrared image of manifold and tubing; PVC tubing at ambient temperature

However, examining the upper manifold tube and the small-diameter PVC tubing (Figure 192), the air had cooled to ambient test hut conditions. This is consistent with the small airflow (0.5 CFM per rafter bay) and exposed surface area of the tubing.

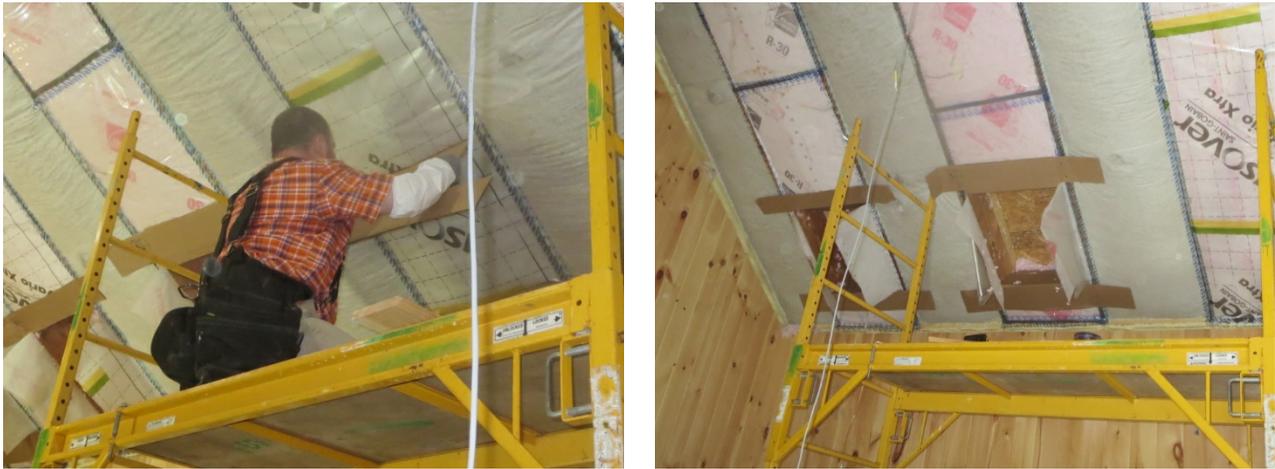
Figure 193. Installation of cardboard baffles for north roof sheathing examination

Given the high sheathing MCs measured at the north lower roofs after running the air injection system (Figure 57 and Figure 81), the assembly was visually inspected to examine indications of moisture damage and/or mold. The interior vapor control and netting were opened directly above the air injection port, low on the north roof, 1 or 2 ft up. Cardboard baffles were inserted to hold back the insulation, fastened in place, and the insulation removed, per Figure 193 and Figure 194.

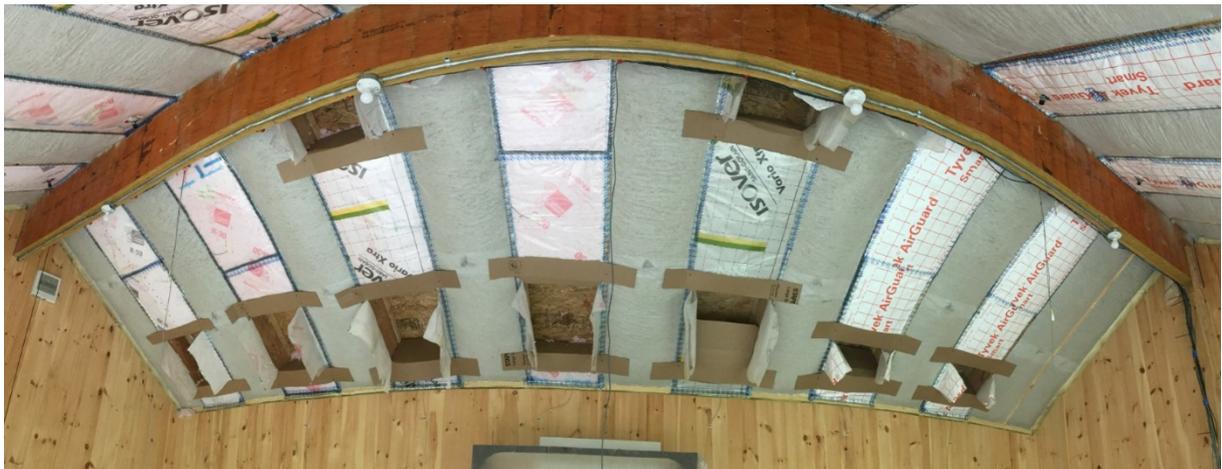
Figure 194. Overview of north-side roof openings

Given the lack of visual indications of problems, Roofs 6 and 7 were only opened for a 1-ft distance along the roof, rather than 2 ft (Figure 194).

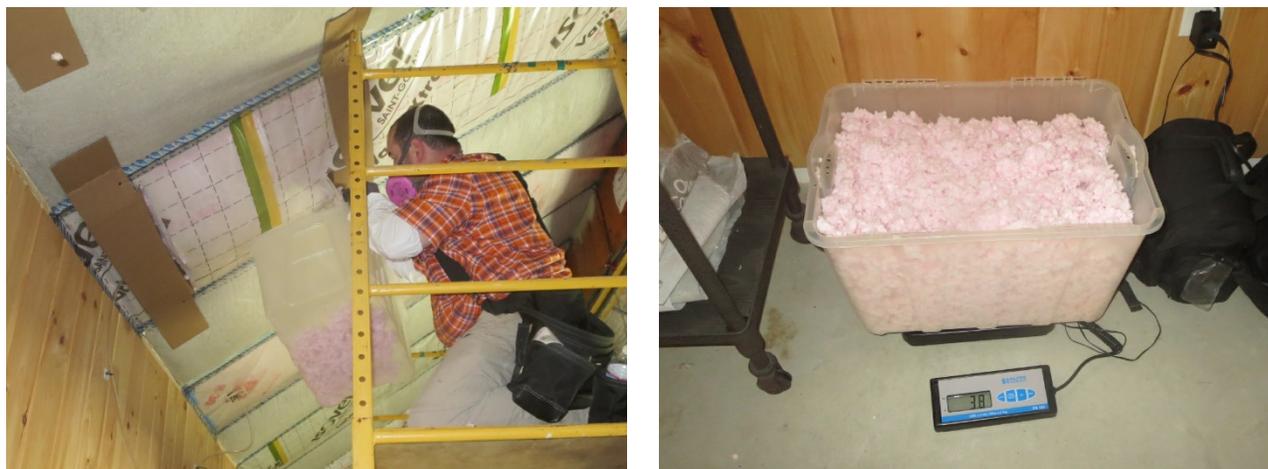
Figure 197. Removal of fiberglass for density measurement and weighing

These north roof openings were also used to take insulation density measurements. Insulation was carefully removed in multiple bins and the weights summed (Figure 197); the dimensions of the opening were measured and/or estimated (based on the belly of the insulation netting).
