Field Testing Unvented Roofs with Asphalt Shingles in Cold and Hot-Humid Climates

Building America Report - 1409

Kohta Ueno and Joseph Lstiburek

K. Ueno, J.W. Lstiburek
Building Science Corporation

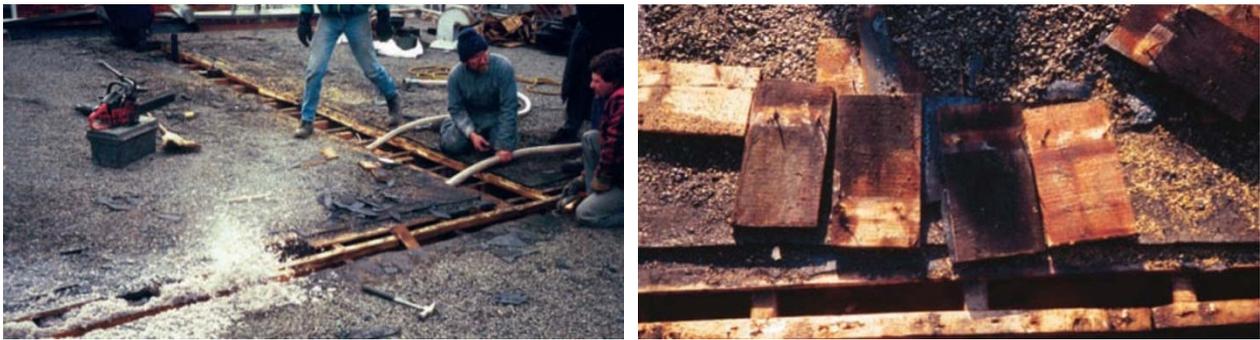
However, a dense-packed compact roof assembly has high moisture and durability risks (due to wintertime interior-sourced condensation), as discussed by Lstiburek (2010b), and Schumacher and LePage (2012) (Figure 1).

Figure 1: Dense pack insulation of roof (L) and resulting moisture issues (R) Lstiburek (2010b)

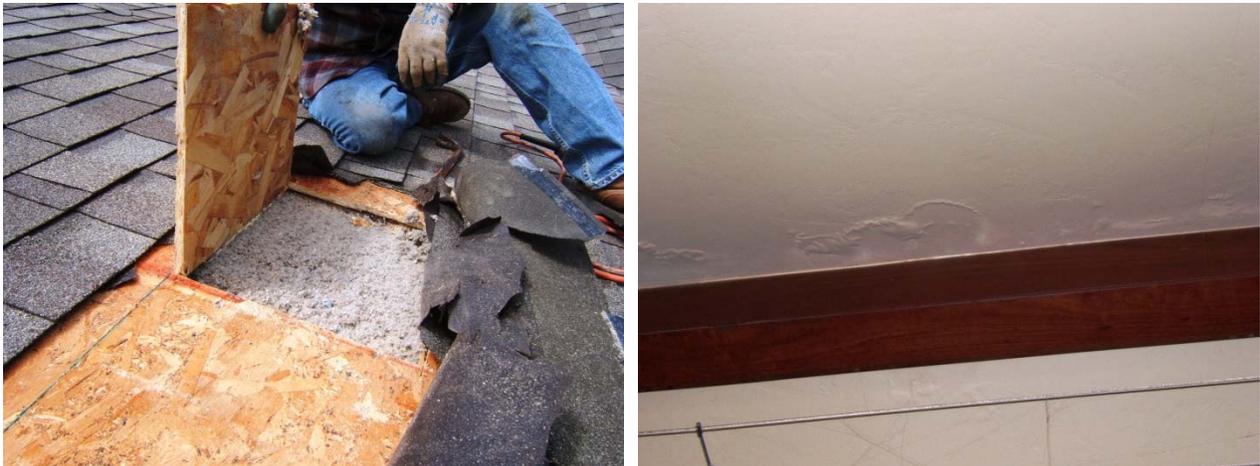
These issues occurred soon after construction (first winter); the problems were manifested as paint blistering at the interior gypsum board near the roof (Figure 10, right), due to dripping of accumulated condensation. The issue was definitely localized at the ridge of the roof; disassembly at lower portion of the roof showed dry sheathing conditions (Figure 10, left). Air barrier imperfections at the interior gypsum board (in particular, at the ridge board interruption) were a contributing factor.

Figure 10: Dry sheathing lower at roof (L), and interior ridge conditions (R)

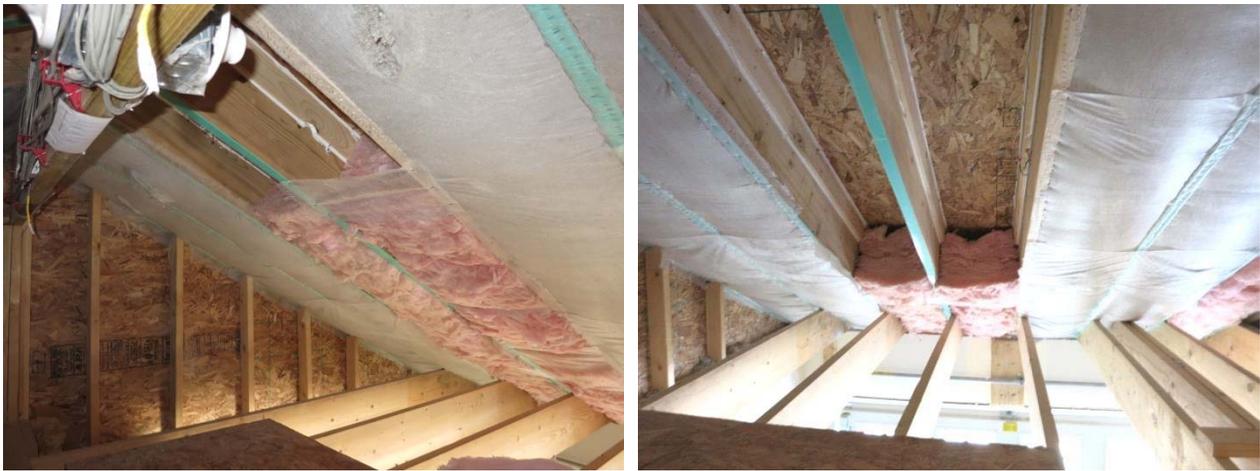
This assembly is identical to Roof 2 (Top vent cathedral-cellulose/gypsum board), but with fiberglass batt replacing the dense pack cellulose. Installation of the R-38 batt in these roofs is shown in Figure 21; note that even with careful installation, there is some “buckling” of the batts away from the roof sheathing (not Grade I installation).

Figure 21: Top vent fiberglass roofs (roofs 4 and 5)

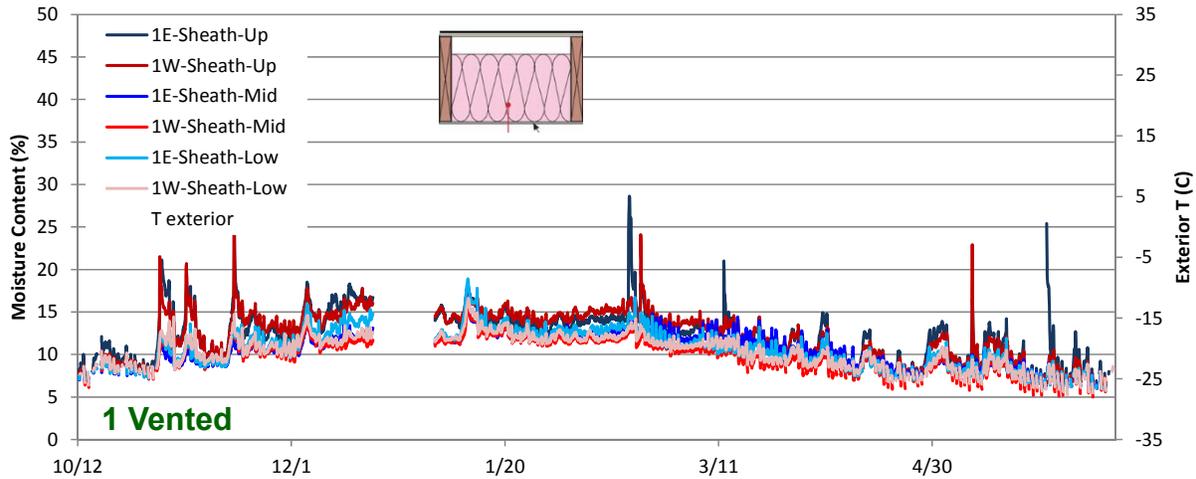
Figure 44: Roof 1 (vented) sheathing moisture contents

The results for Roof 1 (compact vented) assembly are shown in Figure 44. For the majority of the winter, moisture contents are well below 20%, which is in the safe range for mold growth. The occasional spikes to over 20% appear to be associated with precipitation events; it is plausible the spikes seen at the upper sheathing sensors are associated with wind-driven rain, blowing rain into the ridge vent. However, these wetting events quickly dried. The “safe” behavior of this roof is consistent with Smegal and Straube’s (2014) monitoring results.

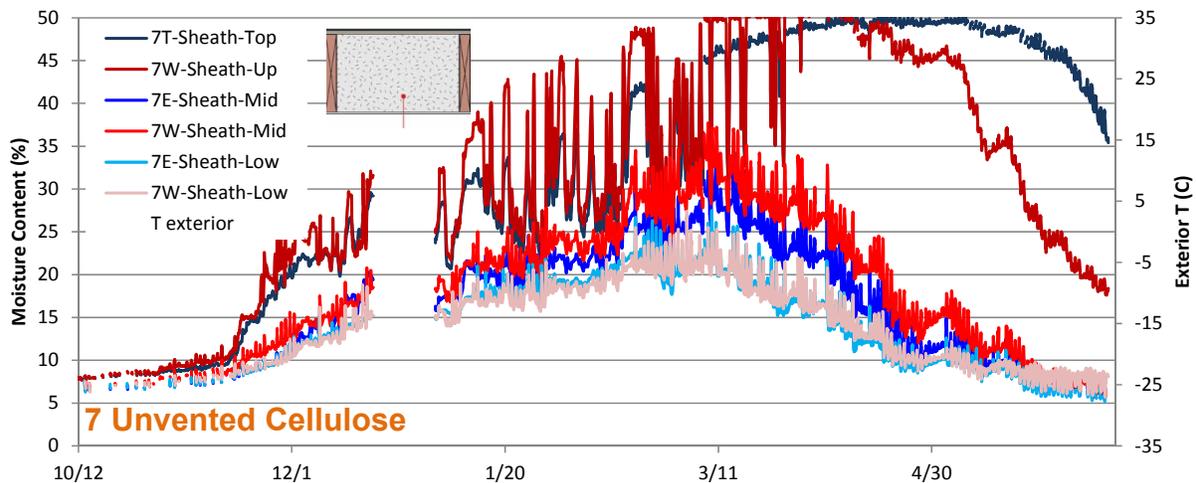
Figure 45: Roof 7 (unvented cellulose) sheathing moisture contents (unfiltered data)

The results for unvented cellulose (Roof 7) and diffusion vent cellulose (Roof 6) are shown in Figure 45 and Figure 46, respectively. Moisture contents are much higher, with much of the winter well over 20% MC. In addition, both roofs show the expected spatial pattern: moisture levels are greater at the higher portion of the roof, with roof ridge moisture contents well over 40% (risk of rot and decay).

The upper moisture content measurements are difficult to read, due to the sudden shifts at high MCs. These MC anomalies coincide with freezing temperatures; it is likely that freezing of water in the sheathing results in inconsistent electrical resistance (and thus measured MC). The MC trends during non-freezing temperatures are more representative of actual conditions. Therefore, the previous data were filtered (only MC measurements above 32°F/0°C plotted) to make the graphs more readable; all remaining graphs are shown with filtered data. The filtered data for unvented cellulose (Roof 7) and diffusion vent cellulose (Roof 6) are shown in Figure 47 and Figure 48.

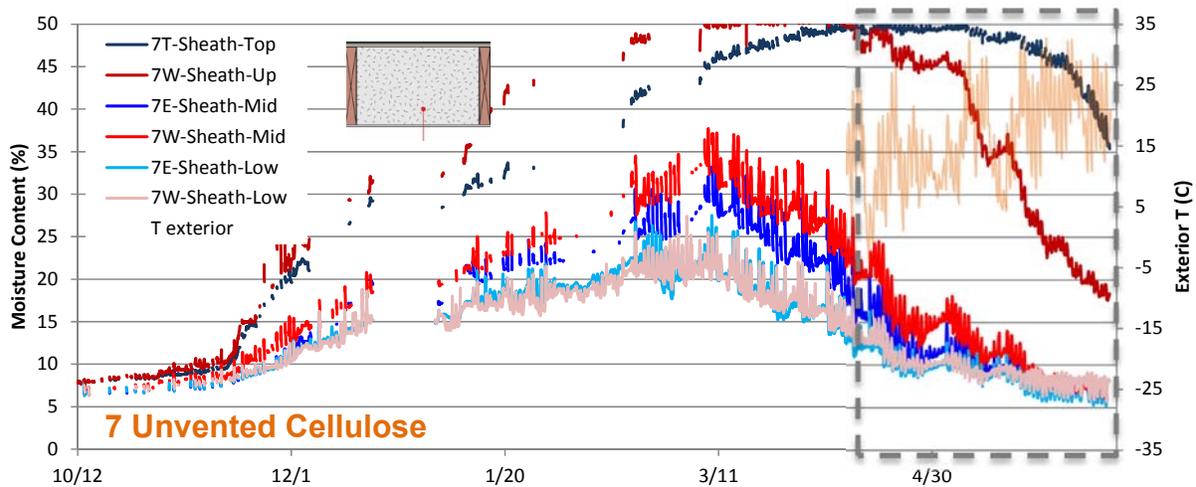
Figure 47: Roof 7 (unvented cellulose) sheathing moisture contents (filtered data)

One marked difference between these two roofs is their dry-down period in the spring, highlighted in dashed grey rectangles. The moisture content in the diffusion vent (Roof 6) roof falls much faster, and to a lower level (12% MC) than the unvented roof (Roof 7) (17% and 35% MC). This is likely an indication of the greater drying available by diffusion in Roof 6.

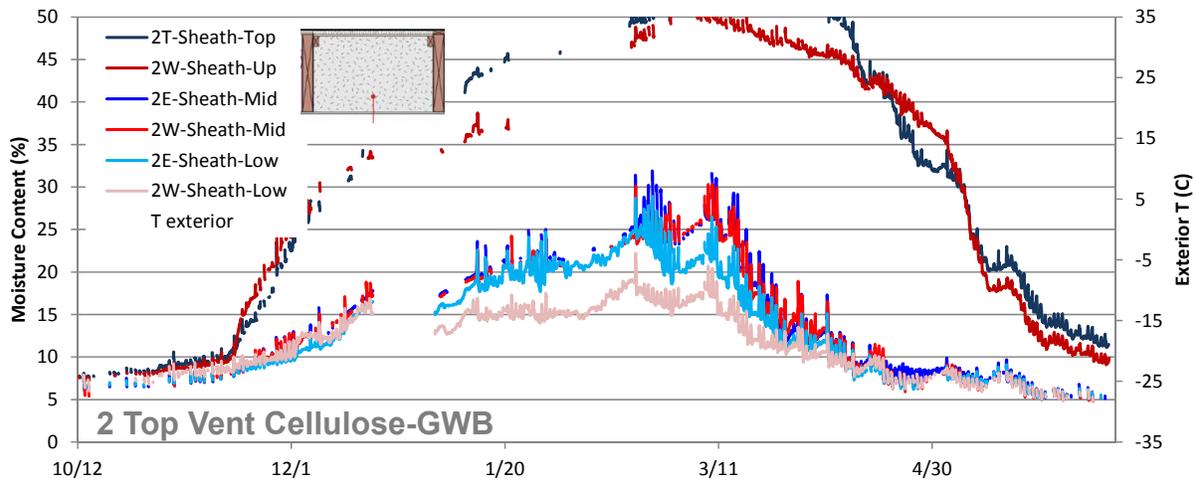
Figure 49: Roof 2 (top vent cellulose with gypsum board) sheathing moisture contents

The results for the cellulose “top vent” (“breather” mesh netting under shingles) roofs are shown in Figure 49 (top vent cellulose with gypsum board) and Figure 50 (top vent cellulose, no gypsum board). The same high moisture contents and spatial patterns were seen (greatest moisture at roof peak). The gypsum board assembly (Roof 2) has drier moisture levels at the lower portions of the roof than the assembly without gypsum board (Roof 3). This is reasonable, given that the painted gypsum board provides some level of air leakage and vapor flow control. These roofs had springtime drying rates similar to the diffusion vent roof, possibly due to upward drying into the mesh air space.

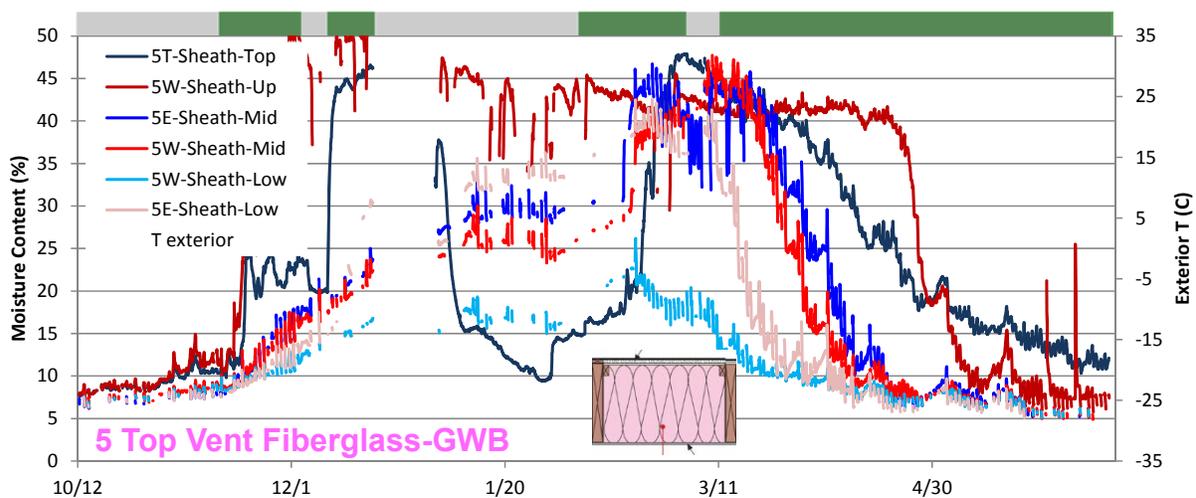
Figure 51: Roof 5 (top vent fiberglass with gypsum board) sheathing moisture contents

The results for the fiberglass “top vent” (“breather” mesh netting under shingles) roofs are shown in Figure 51 (top vent fiberglass with gypsum board) and Figure 52 (top vent fiberglass, no gypsum board). These measurements showed much greater variation in moisture levels over the winter, with sudden drops in moisture content. Therefore, these graphs were plotted with the constant dewpoint graphic; there is some correlation between periods of sudden drying and periods when humidification was not running.

The two assemblies show different responses: the gypsum board assembly (Roof 5) has some degree of stratification (higher MCs at upper parts of roof), while the no gypsum board assembly (Roof 4) showed high moisture contents at almost all locations.

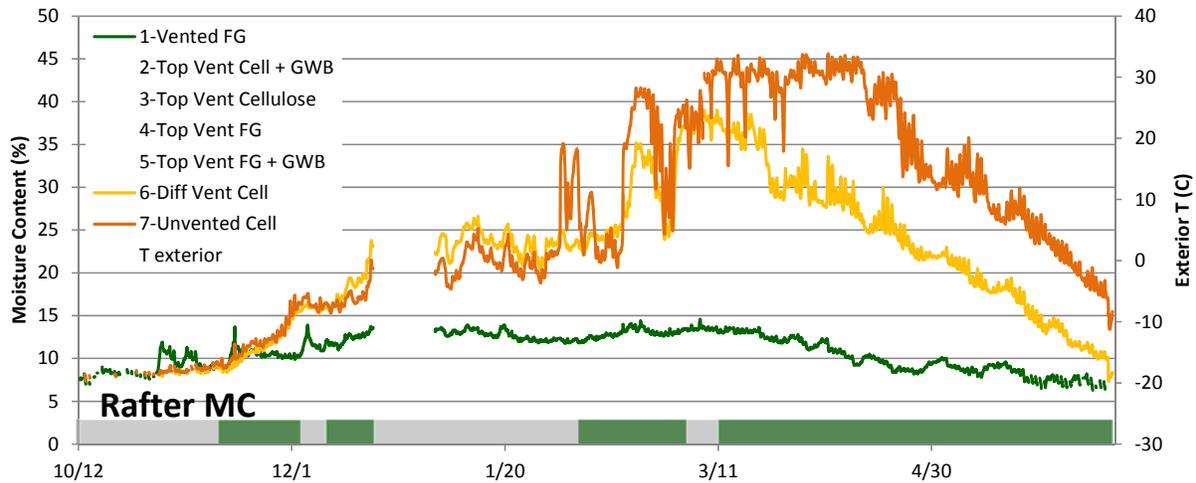
Figure 55: Rafter framing moisture content, vented (1), diffusion vent (6), and unvented (7)

The vented roof (1) shows consistently dry performance (all MCs below 15%), while roofs 6 and 7 MCs rise in winter, to peaks in the 40-45% MC range. However, the diffusion vent (6) roof dries more rapidly than the unvented (7) roof, and to a lower ending MC (8% vs. 15%).

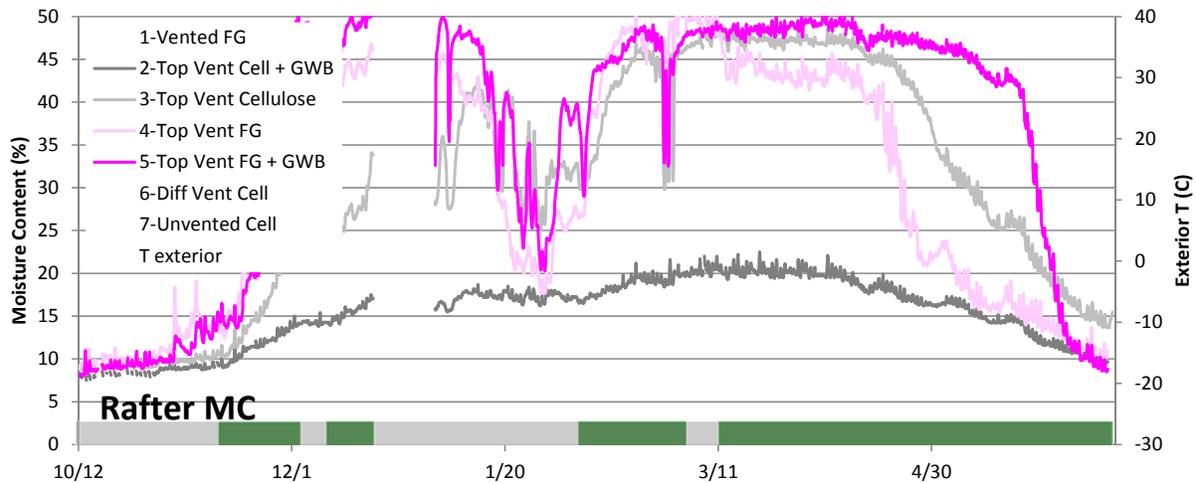
Figure 56: Rafter framing moisture content, top vent cellulose (2, 3) and fiberglass (4, 5)

The top vent roofs (Figure 56) show greater MC variations over the course of the winter, but three of the four roofs move roughly in parallel. The top vent cellulose with gypsum board (2) assembly stays much drier (peak ~21% MC) than the remaining roofs (45-50% MC). The MC rise and fall patterns can be roughly correlated with humidification system operation (green/grey bar). All top vent roofs dry in the spring to the 10-15% MC range. The top vent fiberglass with gypsum board (5) roof shows the slowest drying, but no clear reason is seen for this behavior.

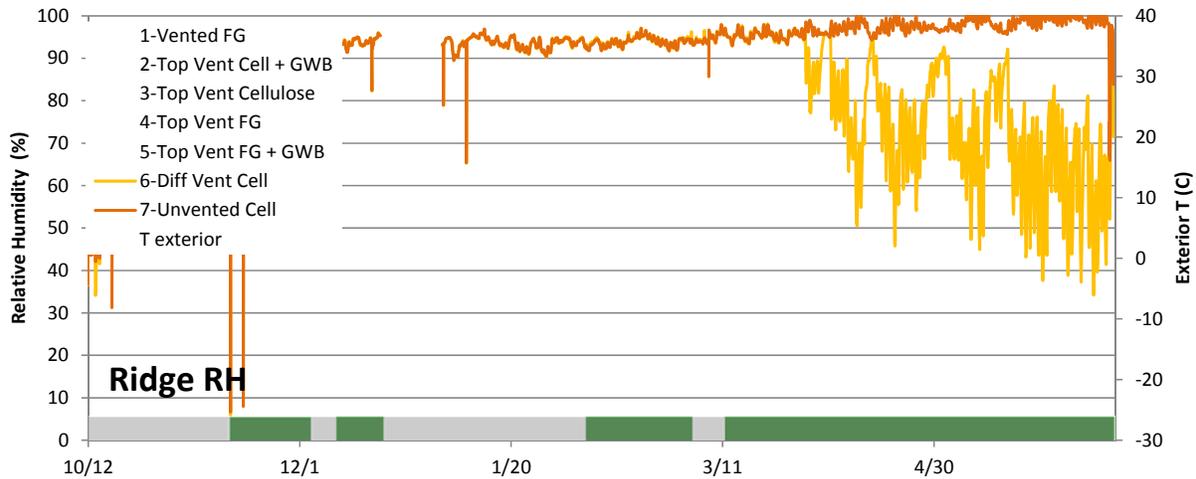
Figure 57: Roof ridge peak RH, diffusion vent (6) and unvented (7)

The unvented and diffusion vent roofs both spike in RH after the installation of humidification, and remain at high RH (90-100%) through most of the winter. In the spring, the diffusion vent roof dries to safer levels, while the unvented assembly remains at high RH levels.

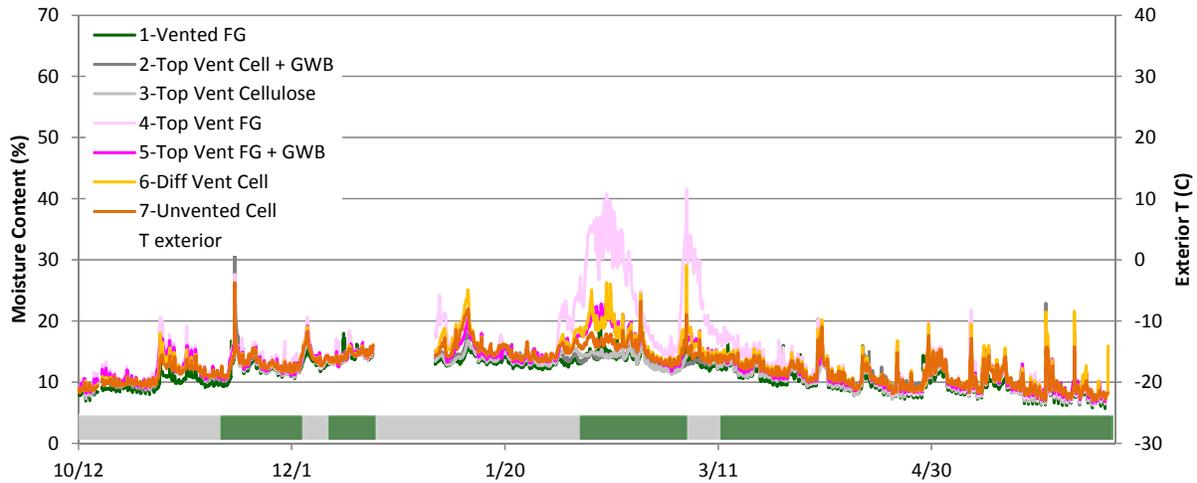
Figure 63: Roof “doghouse” sheathing moisture content measurements

The measured doghouse MCs are shown in Figure 63, with outdoor temperature for reference. MCs remain mostly below 20%, with some brief excursions above that range that dry quickly. However, the top vent fiberglass roof without gypsum board (Roof 4) showed much higher MCs, with peaks in the 40% range. Combined with the anomalies seen in rafter bay peak RH (and

matching wafer sensor), they suggest air leakage may be occurring at this test bay. Leakage of high humidity indoor air could result in the doghouse sheathing wetting seen here.

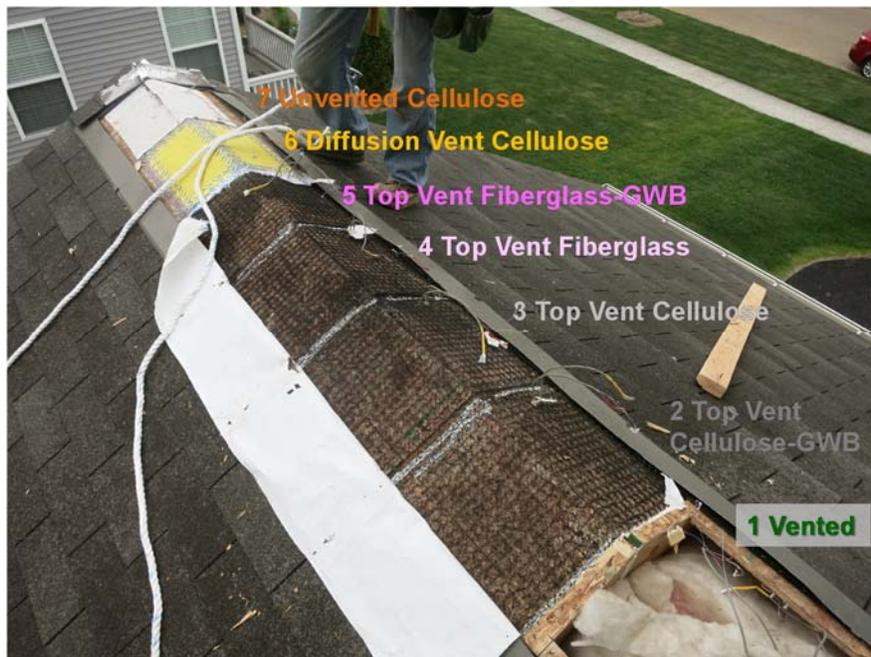
Figure 65: Ridge conditions, before removal of breather mesh

Given the concentration of moisture at the roof ridge, the exterior disassembly proceeded from the ridge downward. Conditions after removing the “doghouse” sheathing, 2x4 standoffs, and housewrap ridge wrap are shown in Figure 65.

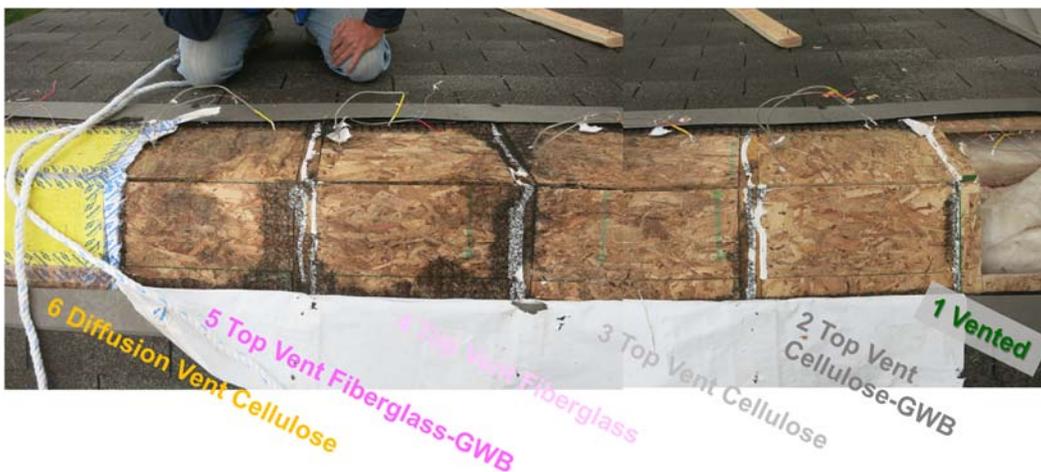
Figure 66: Ridge conditions, after removal of breather mesh

Conditions after removal of the “breather” mesh are shown in Figure 66 and Figure 67. The breather mesh was run continuously across all four “top vent” assemblies, so unintentional cross flow could occur here. The roof sheathing is not continuous across the four bays, due to the “dropped” sheathing detail.

There was apparent exterior moisture damage (stained, likely mold growth on sheathing), with the greatest damage concentration at the fiberglass bays.

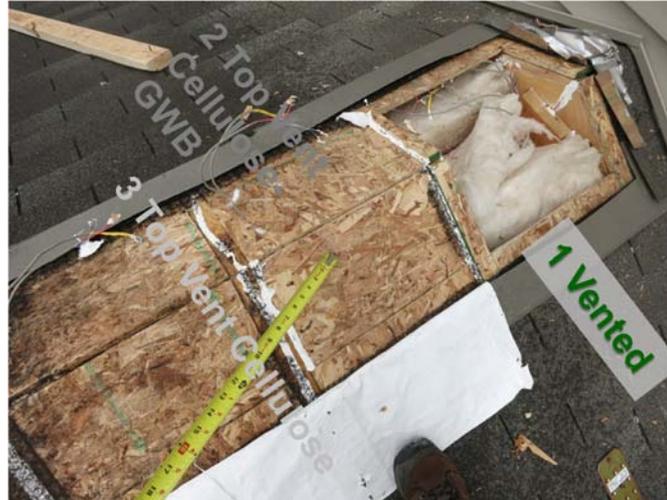
Figure 69: Ridge sheathing conditions, Roofs 1, 2, and 3

There is damage to the sheathing at the top vent cellulose roof (3), shown previously in Figure 68. However, based on the damage pattern (adjacent to bay 4, top vent fiberglass), and the complete lack of top surface damage in the adjacent cellulose bay (top vent cellulose with gypsum board; Figure 69), it is likely that the staining on roof 3 is due to cross-airflow leakage coming from the adjacent fiberglass assembly.

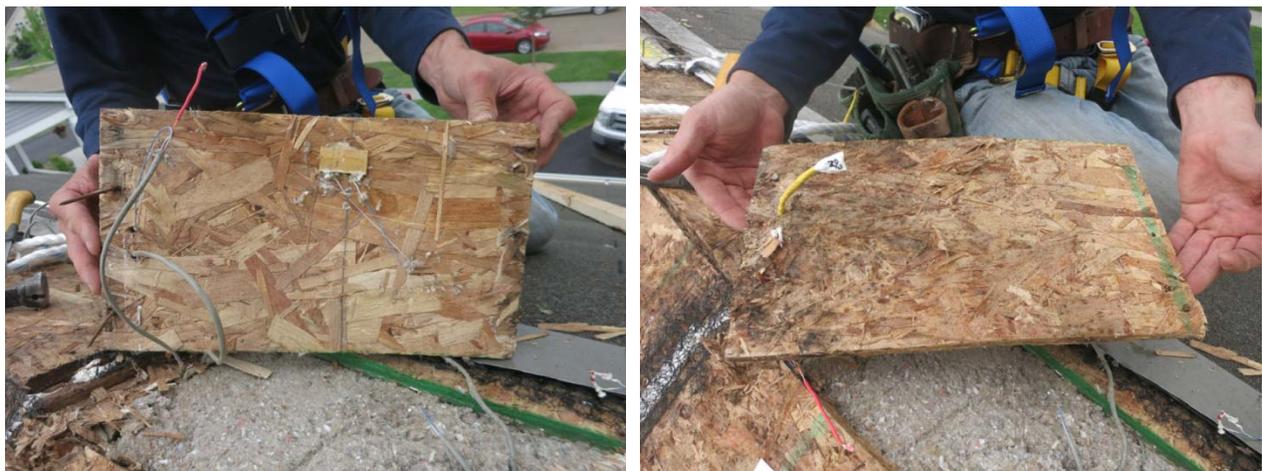
Figure 70: Ridge sheathing bottom (L) and top (R) conditions, Roof 3

The top and bottom of the sheathing in Roof 3 (top vent cellulose with gypsum board) is shown in Figure 70. The interior surface showed rusted fasteners, some discoloration, and grain raise/thickness swelling of the OSB, but no visual indication of mold growth. The top side, in contrast, showed the mold growth that is suspected to have originated from an air leak from the adjacent (fiberglass) bay.

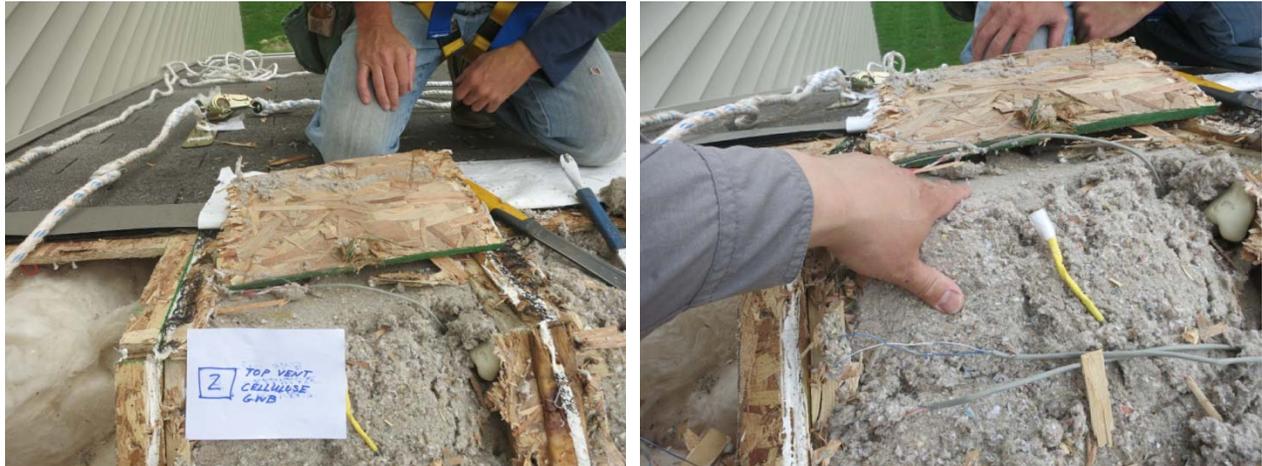
Figure 71: Ridge sheathing top conditions, Roof 2 (L); cellulose conditions (R)

Conditions at Roof 2 (top vent cellulose, no gypsum board) are shown in Figure 71; interior sheathing had similar conditions to Roof 3 (no visible mold growth, rusted fasteners, grain raise of OSB).

The cellulose insulation had not settled over the course of a winter, and was not visibly damaged. There was some “caking” of the cellulose (adhesions to the roof sheathing), which is regarded as an indication of dried moisture accumulation (Rose and McCaa 1998, Derome 2005).

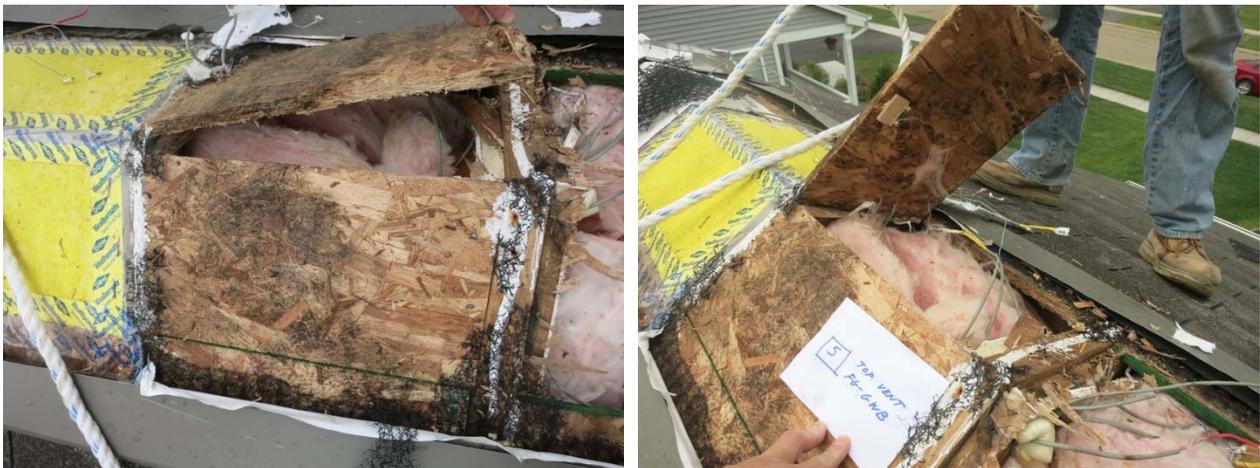
Figure 74: Ridge sheathing conditions, Roof 5

Similar images are shown for Roof 5 (top vent fiberglass with gypsum board); both exterior and interior sides showed extensive damage and staining (wetter on the inside).

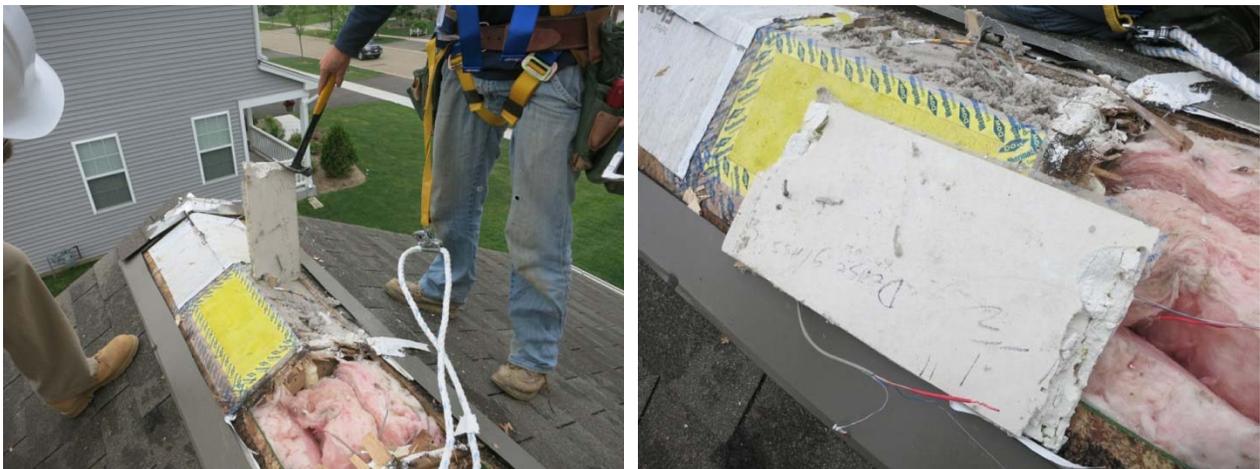
Figure 77: Ridge sheathing top and bottom conditions, Roof 6

The gypsum sheathing at the diffusion vent roof (6) had no evidence of damage from the exterior. When disassembled, the gypsum sheathing appeared to be basically intact, with no evidence of staining or mold growth (Figure 77).

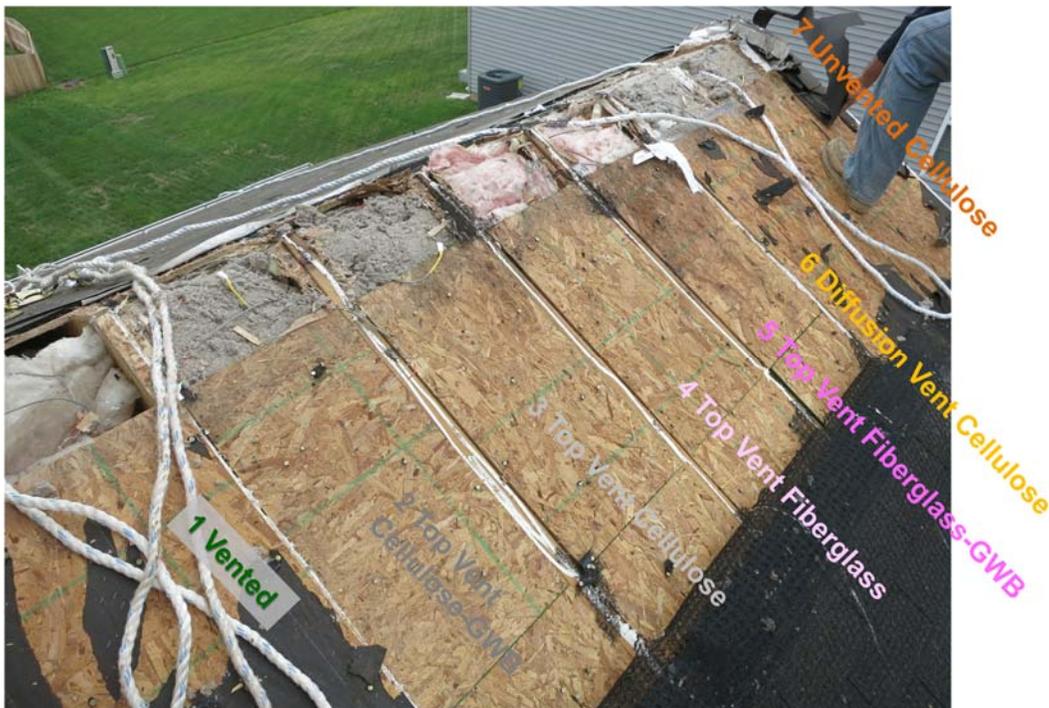
Figure 79: Sheathing away from ridge, west (front) face of roof

Following disassembly of the ridge, the roof cladding materials were stripped near the ridge; the front (west) face is shown in Figure 79. There is some degree of exterior staining at all of the top vent roofs, but it is more severe at the fiberglass batt roofs.

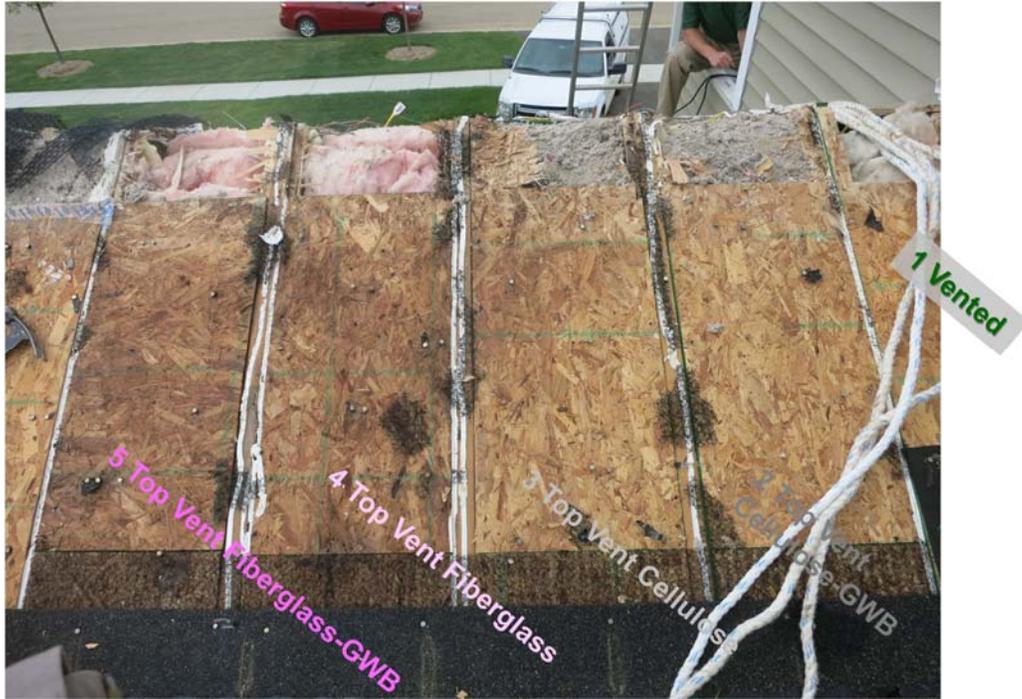
Figure 80: Sheathing away from ridge, east (rear) face of roof

The same condition on the east (rear)-facing roof is shown in Figure 80, showing similar patterns (worse conditions at fiberglass batt roofs).

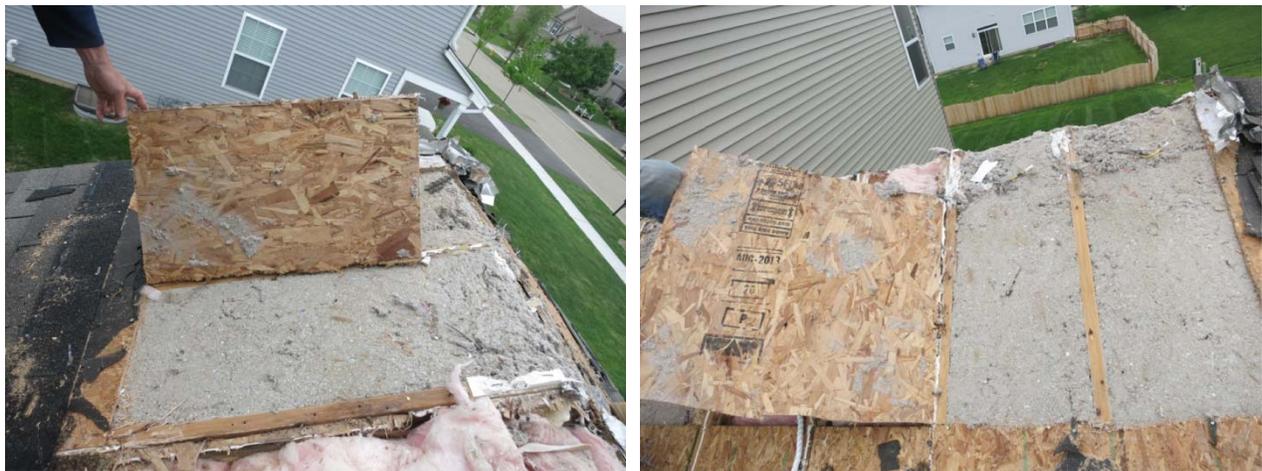
Figure 81: Sheathing away from ridge, Roofs 4 and 5 (L), Roofs 6 and 7 (R)

At the top vent cellulose roofs (4 and 5) and dense pack cellulose roofs (6 and 7), the sheathing was largely intact (minor damage seen, of grain raise, “caking,” and fastener corrosion), as shown in Figure 81.

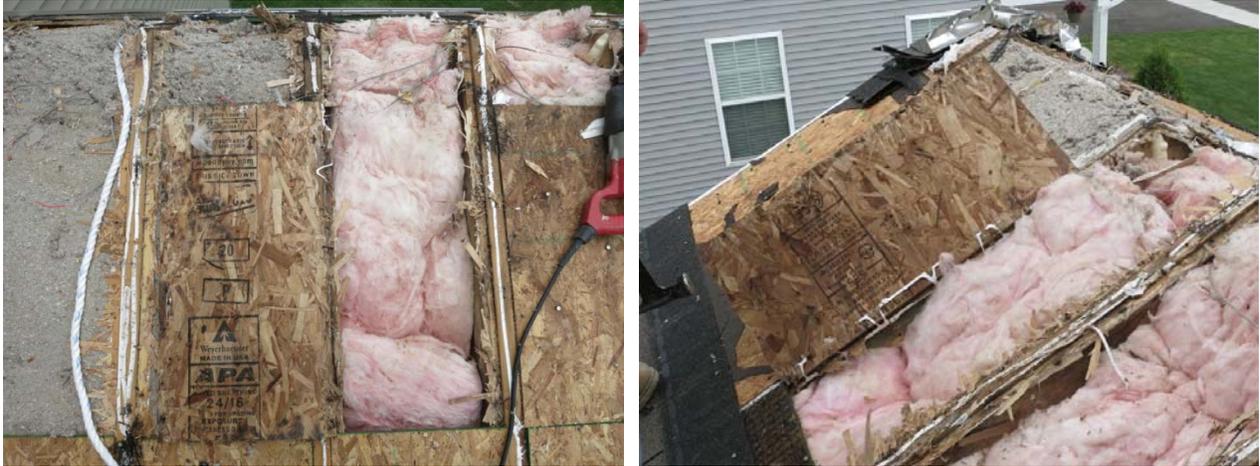
Figure 82: Sheathing away from ridge, Roofs 4 (left) and 5 (right)

Similar to the ridge, the fiberglass batt roofs showed worse conditions than the cellulose bays, away from the ridge (Figure 82). The sheathing condition at Roof 4 (top vent fiberglass, no gypsum board) was worse than Roof 5 (top vent fiberglass with gypsum board).

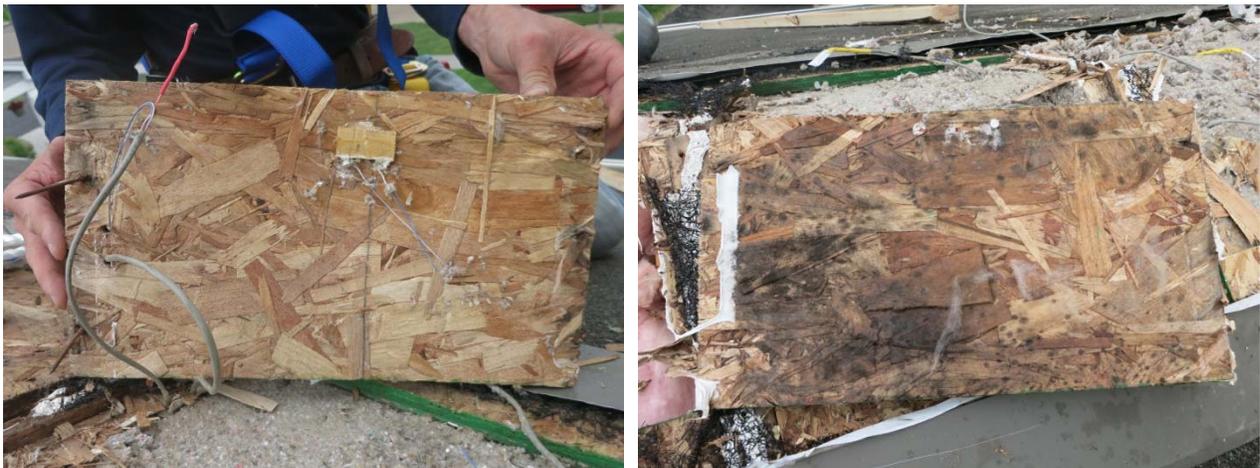
Figure 87: Top vent roofs, no interior GWB, East/front face; cellulose (L) and fiberglass (R)

The top vent roofs gave a comparison of cavity insulations: dense pack cellulose vs. fiberglass batt. An ideal comparison would have compared dense pack cellulose with blown-in fiberglass, eliminating the installation variable. The batt installation was imperfect, with air leakage paths and voids, allowing for air bypass of the insulation (and thus greater damage).

In general, the moisture measurements were comparable, or in some cases, the instrumentation in the fiberglass bays showed lower moisture levels. However, during disassembly, it was clear that the roof sheathing and framing in the fiberglass batt roofs suffered much more moisture-related damage, including staining, mold, and mold growth, relative to the cellulose roofs (Figure 87).

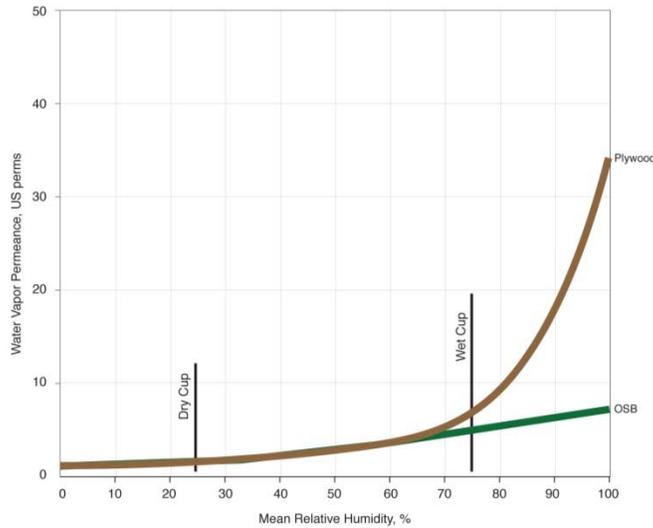
However, the results indicated no significant drying or durability benefit for the top vent cellulose roofs (2 and 3), when compared with the unvented roof (7). One reason why these roofs had disappointing performance was the permeance of the sheathing. The moisture vapor permeance of OSB and plywood sheathing as a function of relative humidity is shown in Figure 88. At higher moisture levels, such as the wet wintertime conditions seen in the test assemblies, plywood is much more vapor permeable (20-35 perms) than OSB (5-8 perms).

Figure 88: Vapor permeance of plywood and OSB sheathing as a function of RH

OSB sheathing was chosen for the experiment because it is the commodity material used by production builders. Keeping the sheathing material constant across all roof bays eliminated an experimental variable, simplifying analysis. If this experiment had demonstrated adequate performance with OSB, plywood would clearly also perform well. If additional research work is conducted on top vent roofs, a more permeable sheathing material than OSB is recommended.

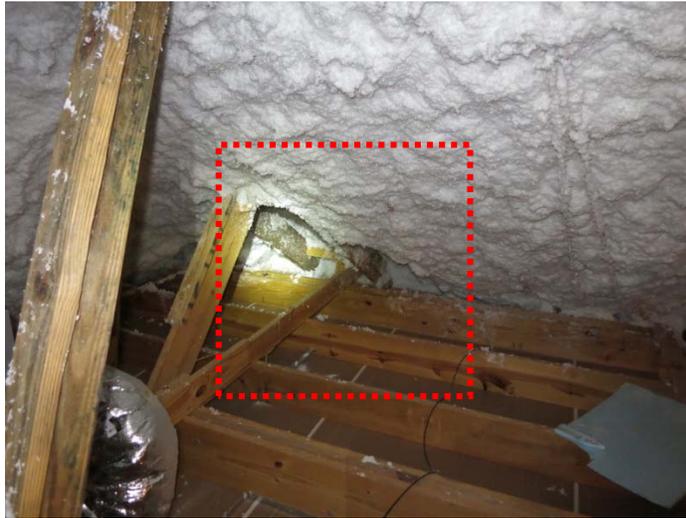
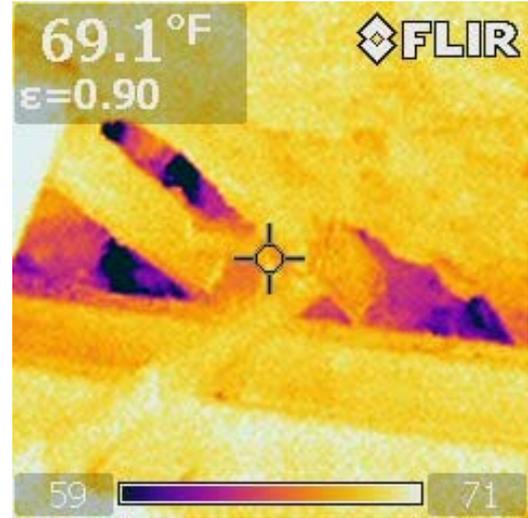
The roof peaks were examined for any sign of air leakage at the diffusion vent details; no evidence was found. However, leakage often occurred at transitions and connections between roofs and walls, especially at complicated details with multiple intersecting planes. For instance, leakage was evident at dormer and gable end intersecting planes at the front of the house (Figure 108 and Figure 109), and roof-wall connections at the rear of the house (Figure 111). These and the following leaks are keyed to Figure 110.

Figure 108: Air leakage at roof-to-wall details at dormer/intersecting roofs (Location A)

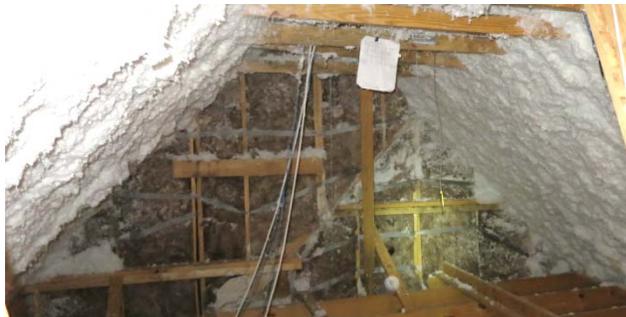
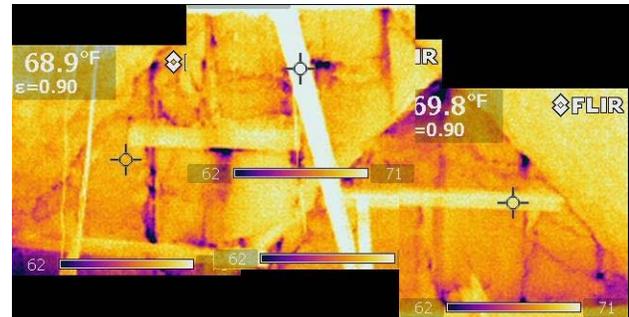
Figure 109: Air leakage at front attic gable end (Location B)

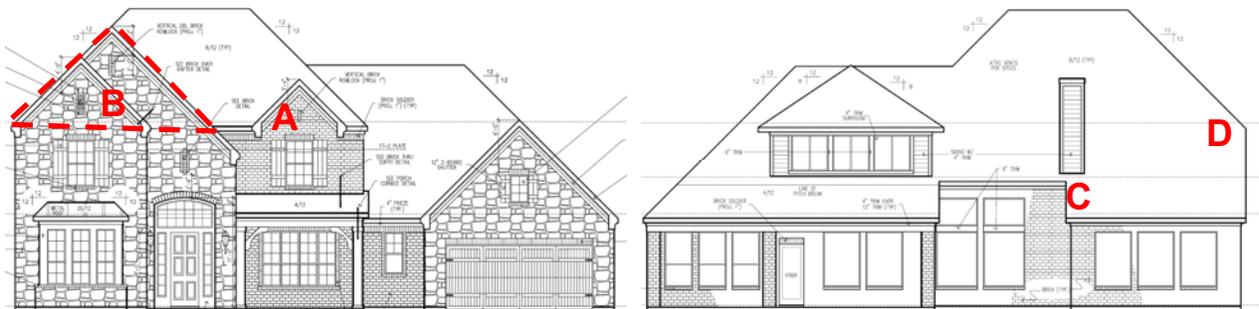
Figure 110: Front and rear elevations, showing air barrier failure locations

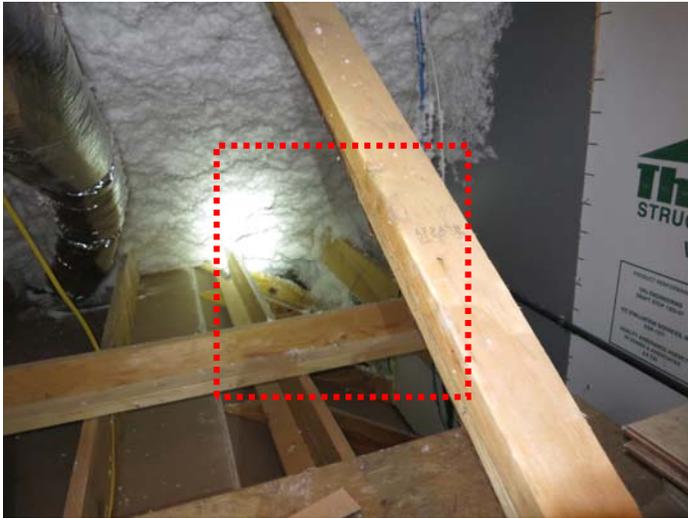
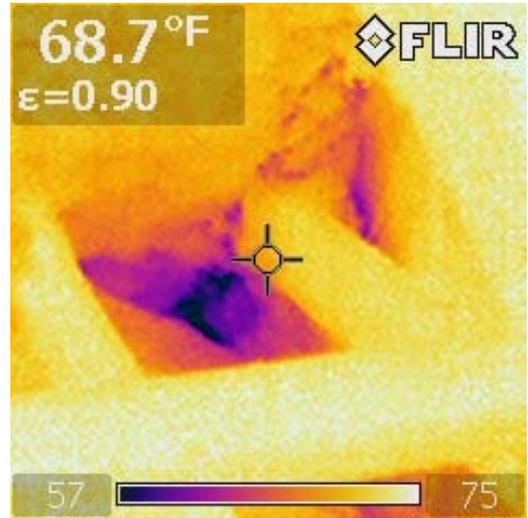
Figure 111: Air leakage at roof-to-wall details at roof-wall intersection (Location C)

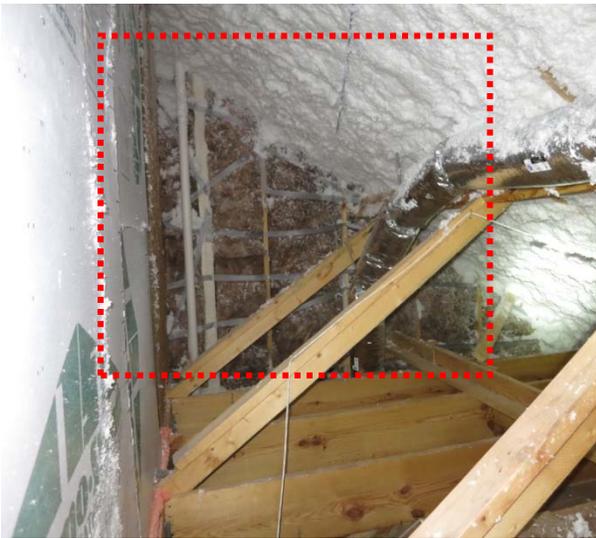
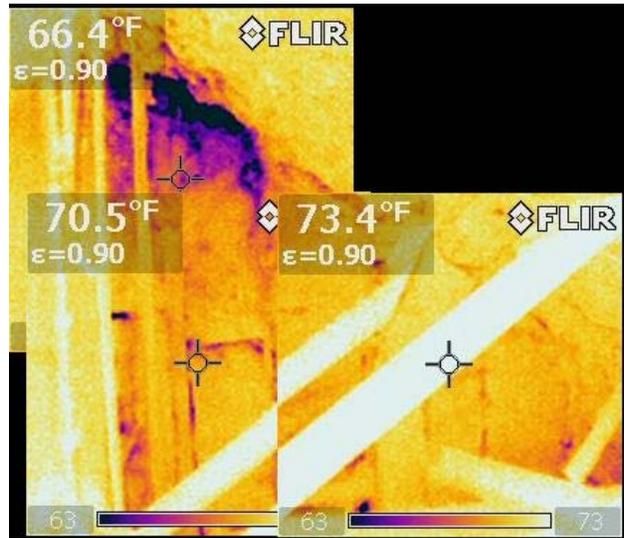
Noticeable leakage was found at top of roof-wall intersection at small rear attic over master bedroom, at an interior-to-attic wall (Figure 112). This occurred despite the use of closed cell spray foam to seal these connections; apparently, not all key areas were sealed.

Figure 112: Air leakage at rear attic over master bedroom (Location D)

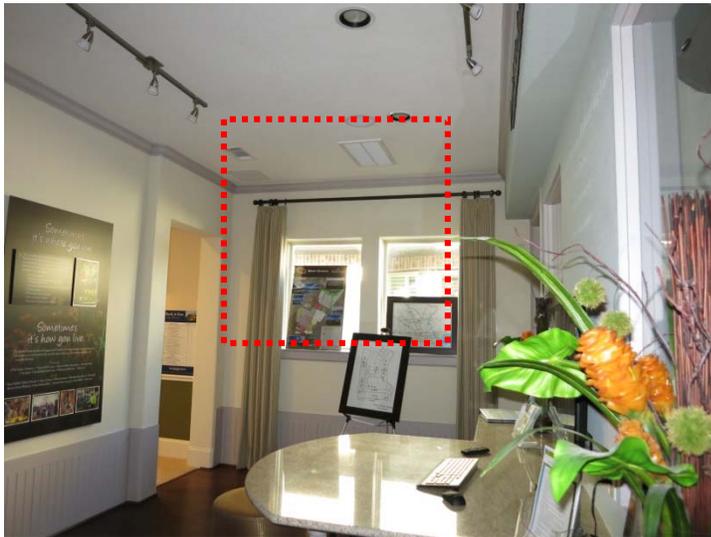
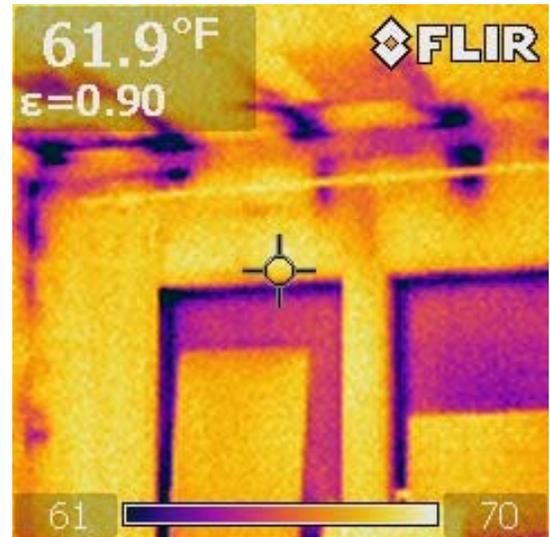
Observations from below corroborated that air leakage was occurring at roof framing connections/penetrations, at the roof-to-wall connection (Figure 113 and Figure 114).

Figure 113: Air leakage at roof-to-wall connections, from interior space (first floor)

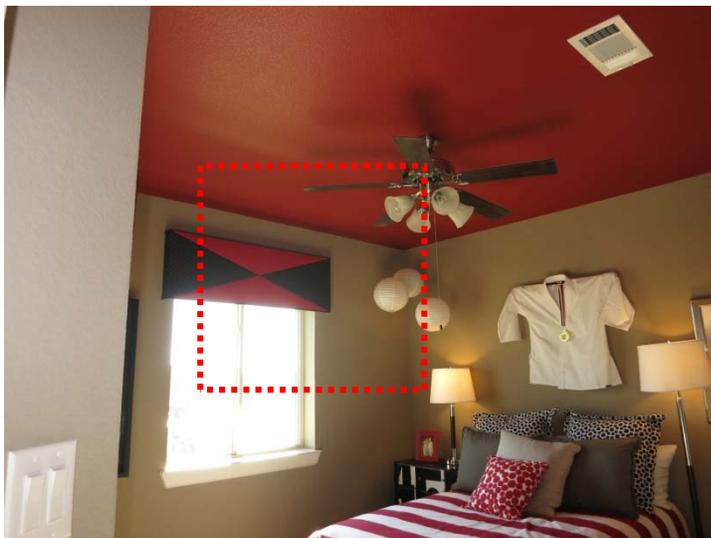
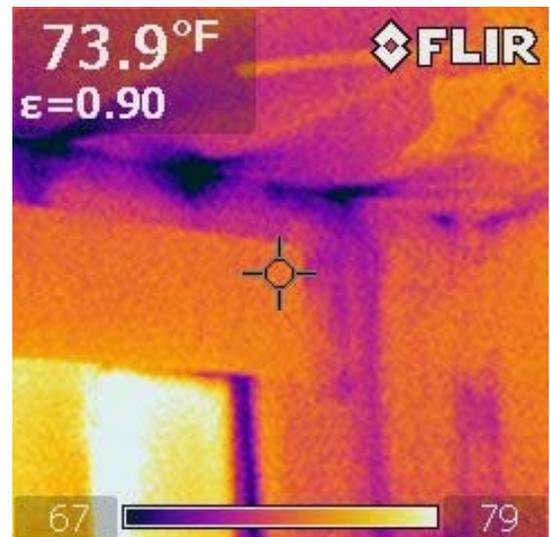
Figure 114: Air leakage at roof-to-wall connections, from interior space (second floor)

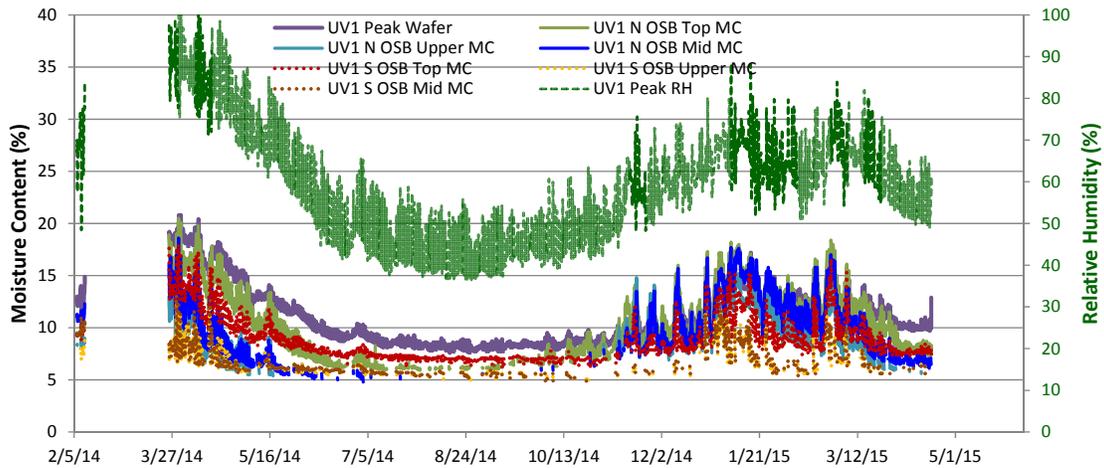
Figure 123: Unvented roof (UV1) roof MC and RH measurements

During the first winter (early 2014), the roof ridges/peaks clearly have high MCs and RHs, with RHs in the 80-100% range, and some MCs near or over 20%. Only the “falling” side of the peak MC/RH period was captured in data collection; the “rising” side occurring during the data gap from February-March). However, the trend in the gap is clear. The highest MC measurements were typically near the top of the roof assembly.
