Field Testing Unvented Roofs with Asphalt Shingles in Cold and Hot-Humid Climates

Building America Report - 1409

Kohta Ueno and Joseph Lstiburek

K. Ueno, J.W. Lstiburek
Building Science Corporation

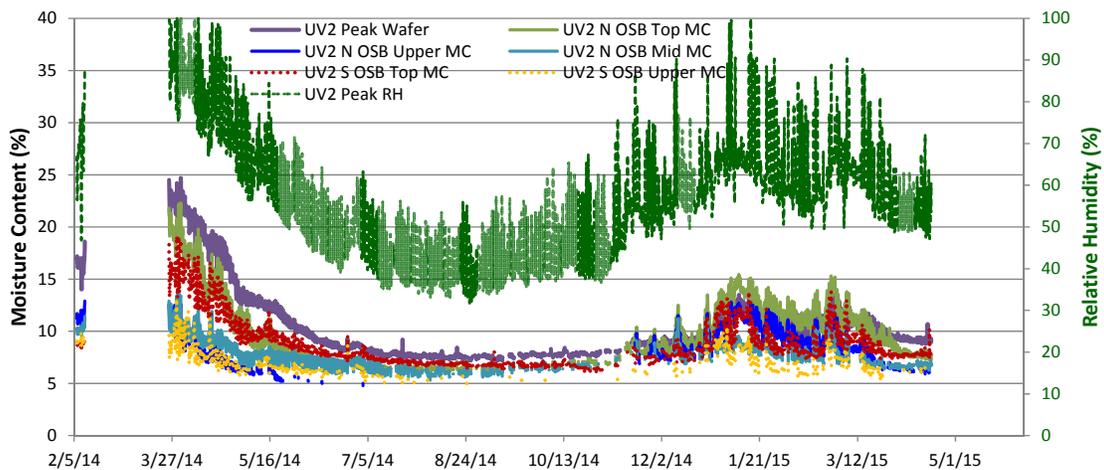
Figure 124: Unvented roof (UV2) roof MC and RH measurements

During the first winter (early 2014), the roof ridges/peaks clearly have high MCs and RHs, with RHs in the 80-100% range, and some MCs near or over 20%. Only the “falling” side of the peak MC/RH period was captured in data collection; the “rising” side occurring during the data gap from February-March). However, the trend in the gap is clear. The highest MC measurements were typically near the top of the roof assembly.

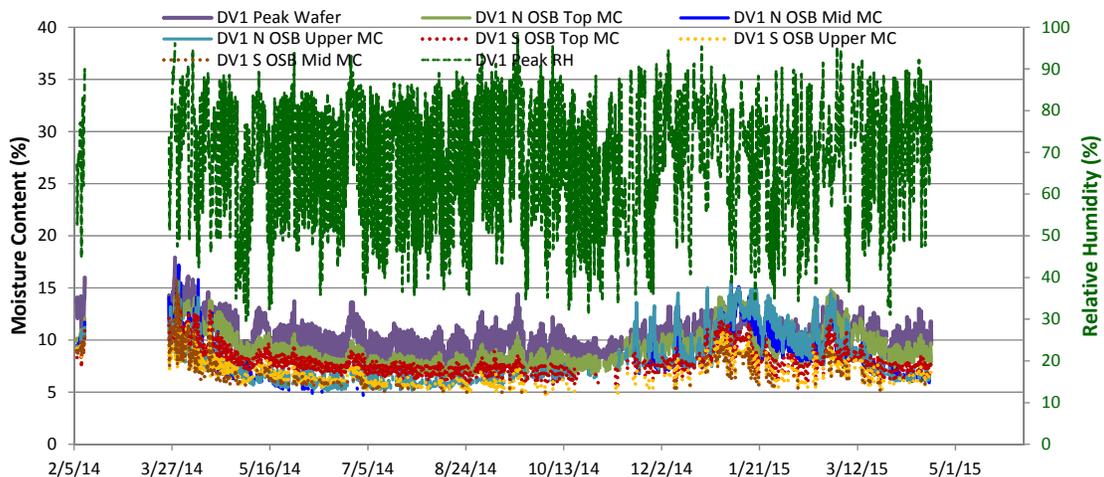
Figure 125: Diffusion vent (DV1) roof MC and RH measurements

The diffusion vent roofs were plotted in a similar manner, in Figure 125 (DV1), Figure 126 (DV2), Figure 127 (DV3), and Figure 128 (DV6). These roofs had a markedly different pattern than the unvented roofs: instead of a seasonal swing, the RH and MC measurements are relatively stable over the measurement period.

In the diffusion vent roofs, initial winter MCs and RHs are much drier (“safer”) than the unvented roof. Peak MCs remain well below 20%. However, summertime MCs are higher than in the unvented roofs. In winter 2014-2015, wood MC rose, but again well within the safe range (below 15%, typically). The highest MCs are typically towards the peak of the roof. Roof peak RH measurements cycle on a diurnal basis, with the majority of the readings in the 50-80% range. The diurnal RH cycling in the diffusion vent roofs is a greater range than that seen in the unvented roofs.

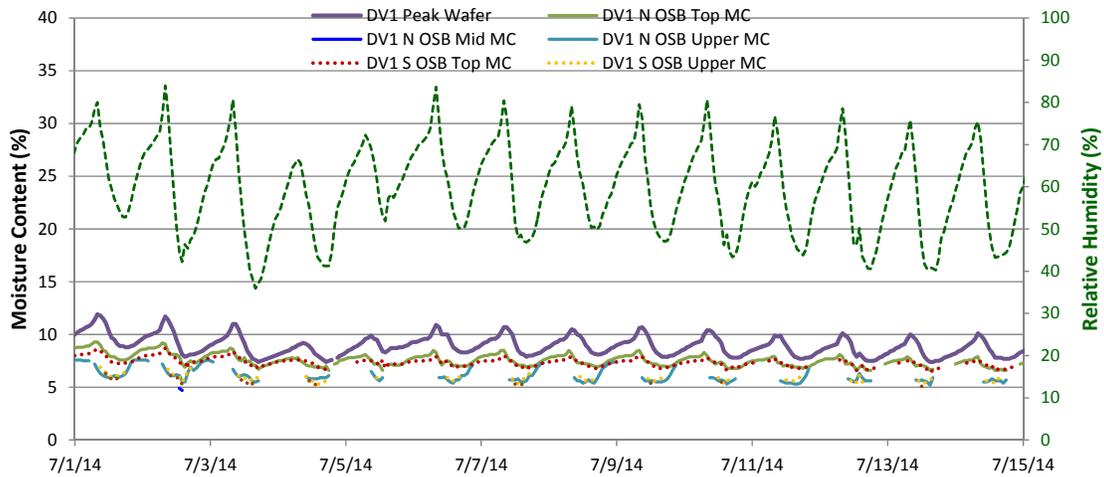
Figure 129: Diffusion vent (DV1) roof MC and RH measurements, summer (July 2014) detail

The summertime diurnal pattern is shown in more detail in Figure 129, which plots two weeks from July 2014. The roof peak RH shows a consistent sawtooth pattern, with a slow rise, and a sharp fall on a daily basis. The drop in RH consistently occurs at 7 AM, which is consistent with morning solar warming of the roof. In the late afternoon (4-5 PM typical), RH starts to rise again, continuing to overnight until the morning.

The MCs have a similar type of sawtooth behavior, albeit over a much smaller range.

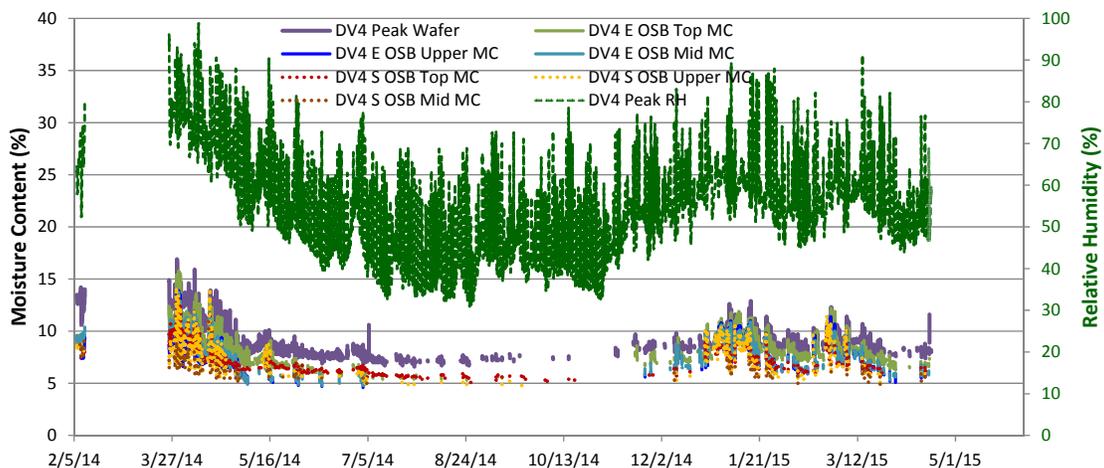
Figure 130: Diffusion vent at hip (DV4) roof MC and RH measurements

These roofs exhibit behavior partway between the unvented and diffusion vent roofs. There is a noticeable seasonal swing in RH and MC, with the peaks in the winters. Similar to the unvented roofs, winter 2014-2015 peak RHs and MCs were much drier than the first winter.

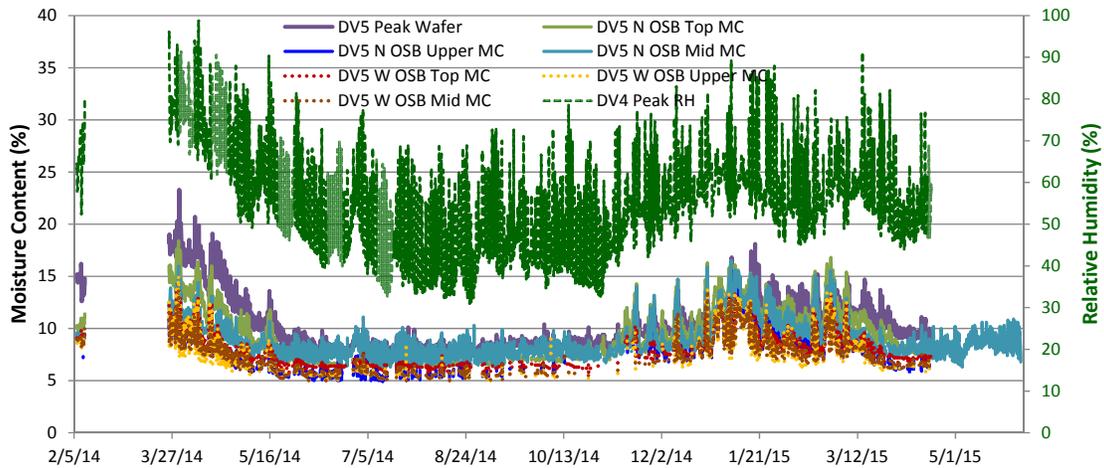
Figure 131: Diffusion vent at hip (DV5) roof MC and RH measurements

However, in the summer, RHs have a diurnal variation similar to the diffusion vent roofs, albeit a slightly lower range (40-70% RH vs. 50-80%).

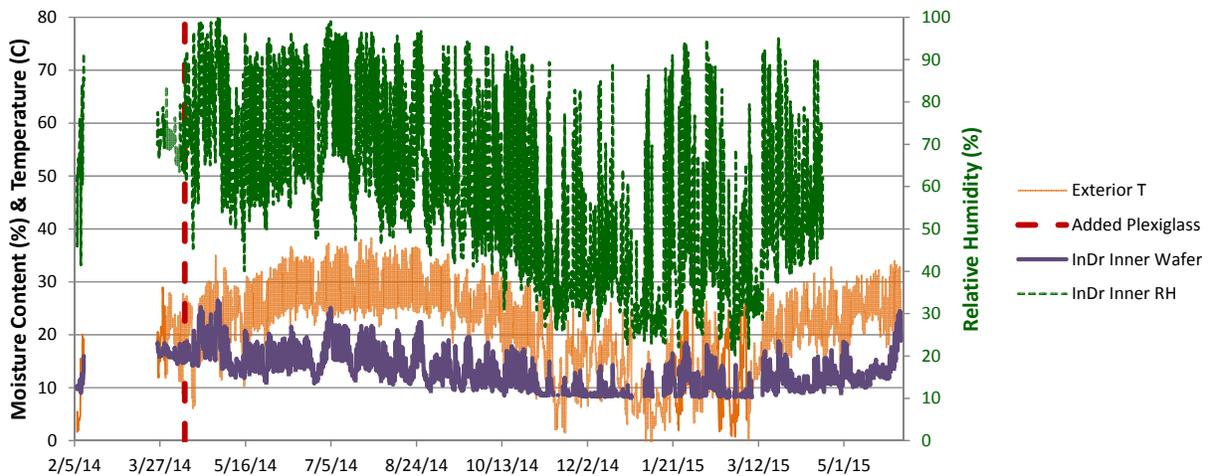
Figure 132: Inward drive interior-side RH and wafer sensor, with outdoor T

The interior side RH and wafer MC for the inward drive experiment are shown in Figure 132, with exterior temperature for reference. The experiment was only put into operation in mid-April 2014, when the clear acrylic plastic cover was installed and air sealed (red dotted line), thus resulting in potential moisture accumulation. The RH and wafer MC rise after the installation of the clear plastic cover. Interior side RHs have peaks over 90% in the summer, but fall in the early winter when outdoor temperatures drop.

The interior side RH and wafer MC measurements move in parallel, as expected. In previous calibration (Ueno and Straube 2008), the “wafer” sensors come to equilibrium with 100% RH

conditions (air in closed container over water) at 28%–30% MC; immersing the sensors in liquid water increases MCs to the 40%–45% range. The wafer MCs remain below 28-30%, which indicates no condensation or 100% RH conditions (consistent with RH results).

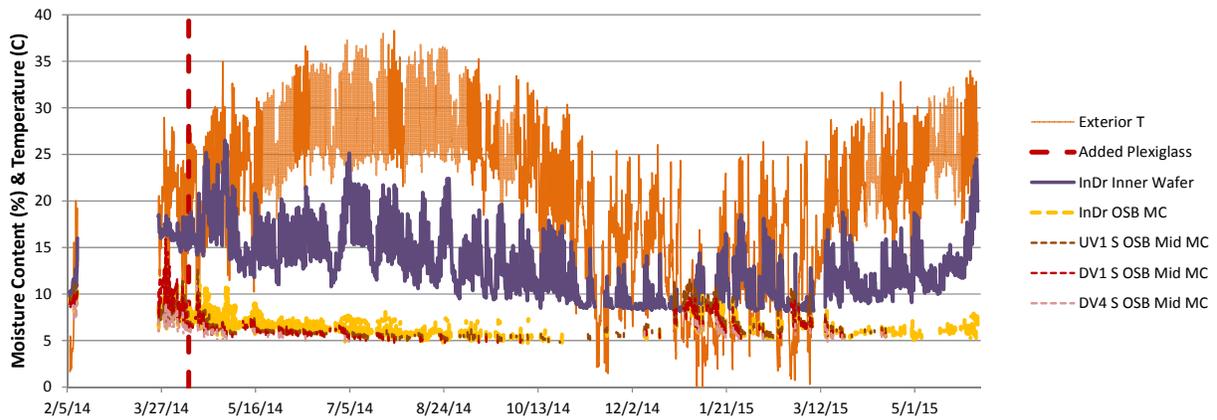
Figure 133: Inward drive wafer sensor MC and sheathing MCs, with outdoor T

The inward drive roof sheathing MC is plotted with other lower sheathing MCs (same south orientation, both unvented and diffusion vent) in Figure 133. The wafer MC and outdoor temperature are also plotted for reference. The sheathing MC in the inward drive experiment is consistent with the other sheathing MCs, which points away from accumulation of moisture within the sealed box.

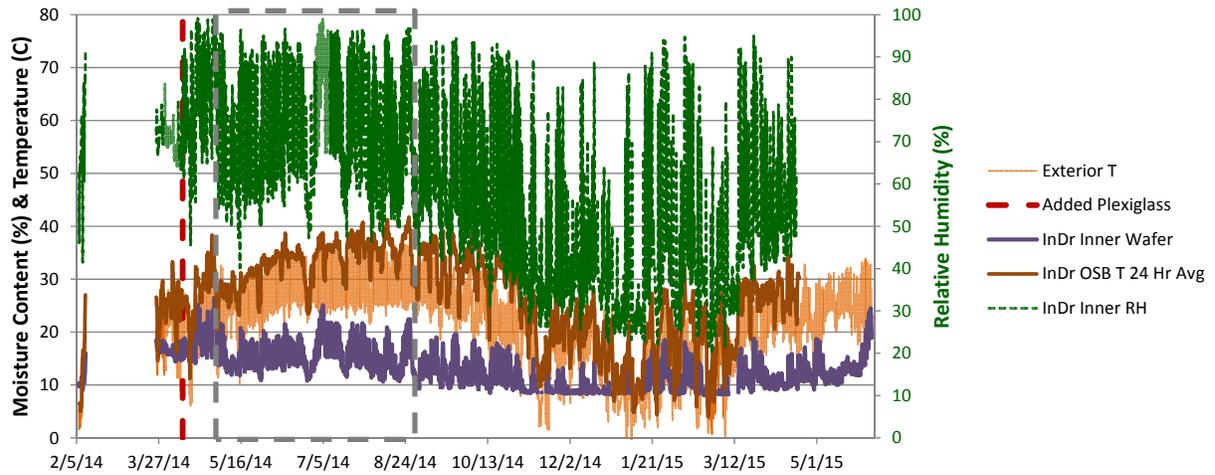
Figure 135: Inward drive interior-side RH, wafer MC and sheathing temperature 24 hour average

The most direct correlation to the wafer data was found by plotting the exterior sheathing temperature (24-hour rolling average), per Figure 135; this is consistent with adsorbed moisture being driven from warm/hot sheathing to the cool (interior) side of the assembly, or “ping-pong” water within the closed system. The correlation is very clear during summer conditions (May-August 2014 plotted in Figure 136).

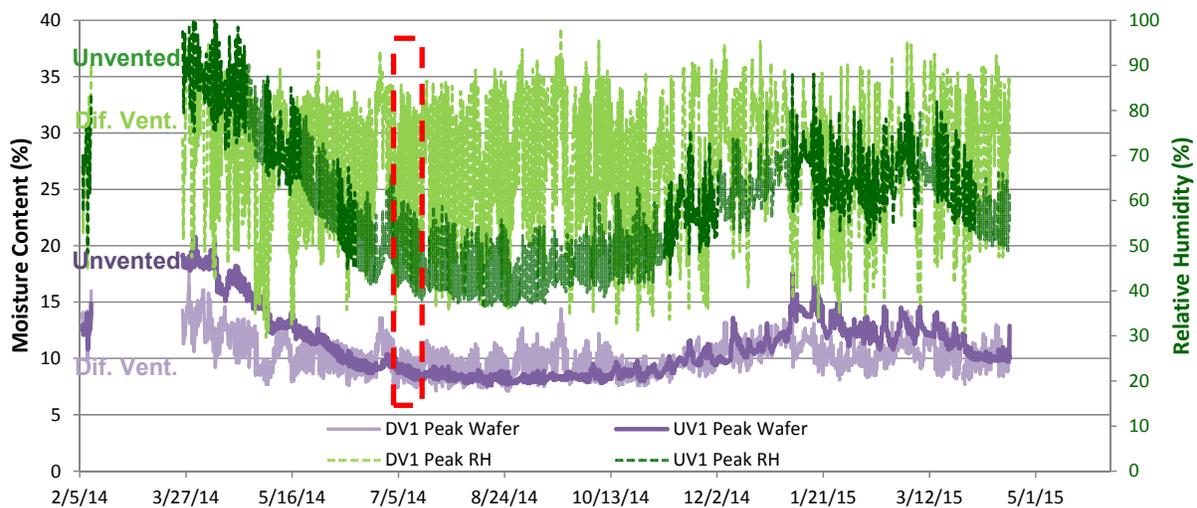
Figure 137: Diffusion vent (DV1) and unvented (UV1) comparison (ridge RH and wafer MC)

A representative example of the relative behavior of the unvented and diffusion vent roof is shown in Figure 137, which plots roof ridge RH and wafer MC, for diffusion vent (DV1) and unvented (UV1) roofs.

The unvented roof shows the seasonal rise and fall (wetter in winter), and dry conditions in the summer. In the winter, interior moisture accumulates at the ridge under the vapor impermeable membrane. In the summer, the thermal gradient drives moisture downward, out of the assembly; the vapor impermeable membrane prevents the entry of any exterior moisture.

In comparison, the diffusion vent roof is drier in the winter, due to the vapor permeability of the diffusion vent material. In the summer, RHs are higher than the unvented roof, possibly due to connection to exterior moisture conditions, via the vapor-open ridge. This connection could also explain the diurnal cycling of RH levels.

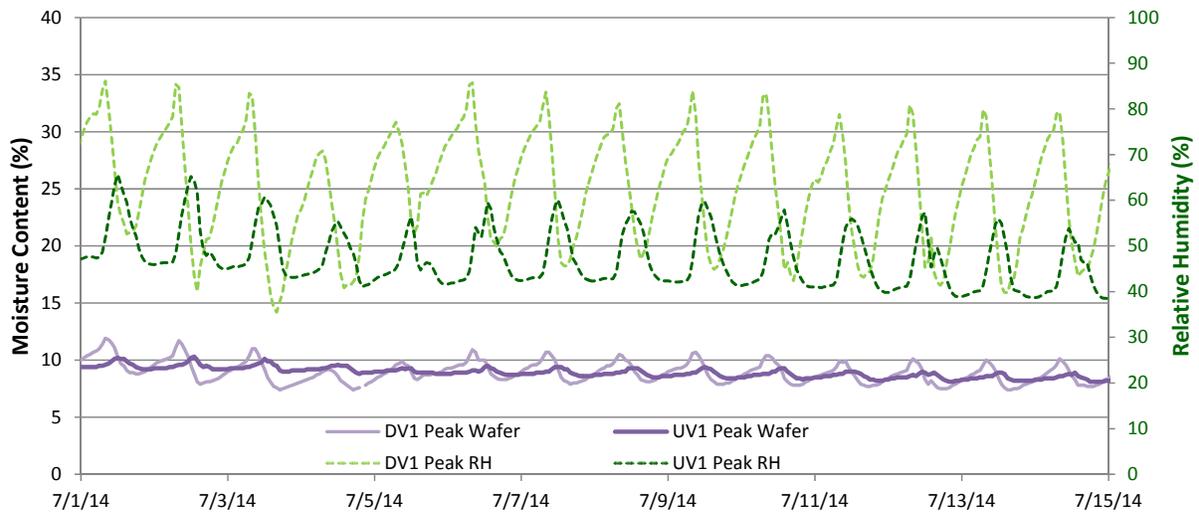
Figure 138: DV1 and UV1 comparison (ridge RH and wafer), summertime detail

The diurnal cycling of RH levels is examined more closely for a summer period (July 2014) in Figure 138, which zooms in on the area highlighted by the red box in Figure 137. As mentioned earlier, the diffusion vent ridge RH has a sawtooth pattern, with a sharp drop in RH in the morning (6-8 AM range). In contrast, the unvented roof’s diurnal cycles are offset by several hours, with the peak/drop off occurring in the late morning (10 AM-12 noon range). These two ridge locations are on the same roofline, and should see identical exterior conditions (solar exposure).

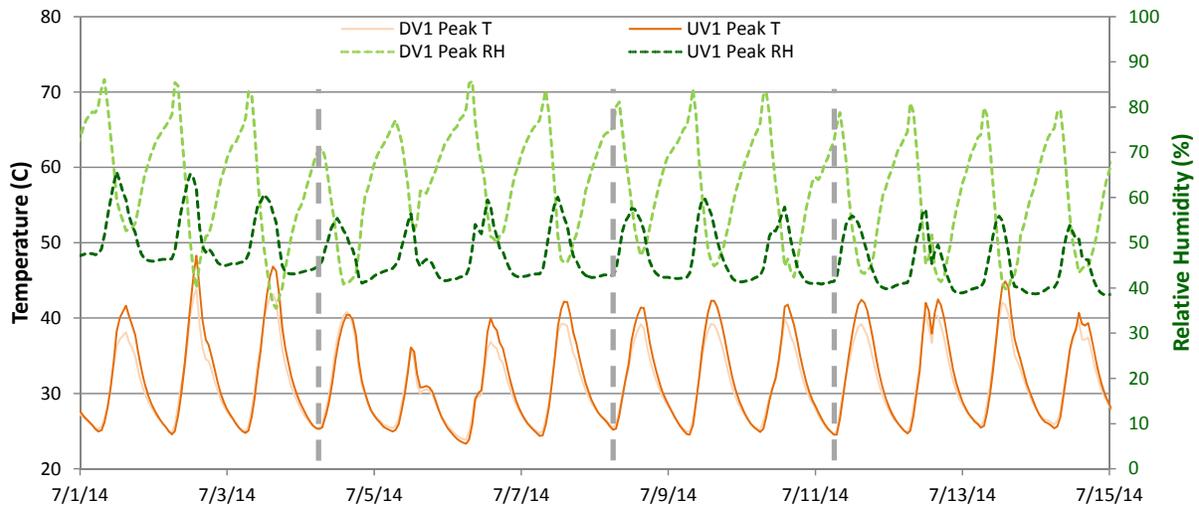
Figure 139: DV1 and UV1 comparison (ridge RH and wafer), summertime detail

Ridge RHs were plotted with ridge temperatures (Figure 139), to determine if temperature anomalies cause the “offset” behavior. Ridge temperatures track identically between the two roofs. Rising temperatures correlate with (a) a drop in DV1 RH, and (b) a rise in UV1 RH (grey lines). The diffusion vent roof has slightly lower peak temperatures than the unvented roof (typically by 5.5°F/3°C). It is plausible that the difference reflects evaporative cooling from the diffusion vent roof.

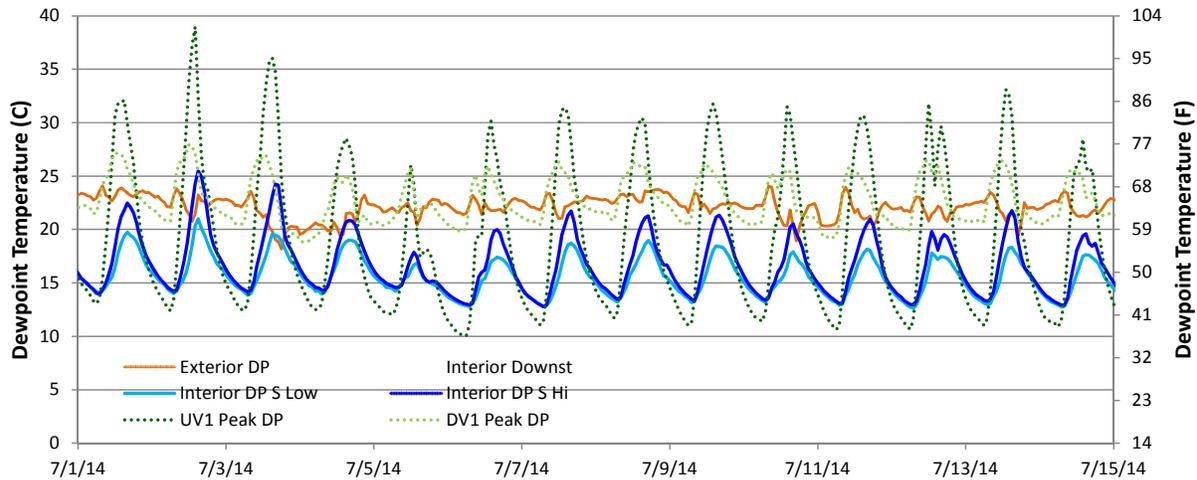
Figure 140: Summertime dewpoint comparison: interior, attic, exterior, and UV1/DV1

As another reference, the roof T/RH sensors are plotted in terms of dewpoint temperature (absolute air moisture content), with interior (attic) and exterior dewpoints shown for reference (Figure 140). The dewpoint at the ridge rises above both attic conditions (blue lines) and exterior conditions (orange). More importantly, in terms of absolute moisture content, the unvented roof has higher (wetter) peaks than the diffusion vent roof, reversing the order seen in Figure 138.

In general, dewpoint “spikes” at the ridge is likely caused by the heating of roof sheathing, when in turn releases (desorbs) adsorbed moisture. This could easily drive dewpoints above interior conditions in the main attic space, given moisture stratification.

In the afternoons/evenings, as ridge dewpoints drop, the unvented roof drops far below ambient conditions, while the diffusion vent roof tracks closer to ambient dewpoints. This reflects the vapor-open ridge material, which couples exterior and interior moisture conditions.

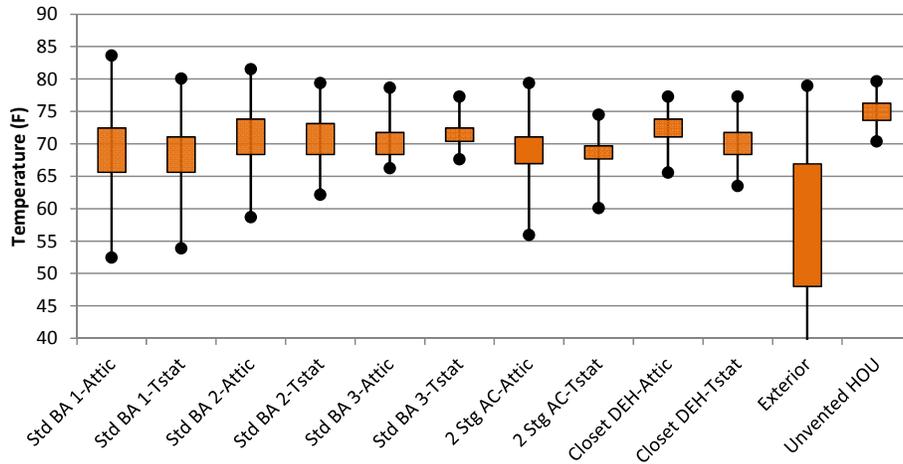
Figure 142: Rudd and Henderson (2007) interior temperature data and Houston unvented data

Figure 142 shows that the diffusion vent roof test house was operated at a higher temperature than the circa 2001 Building America houses, and with a smaller setpoint variation range.

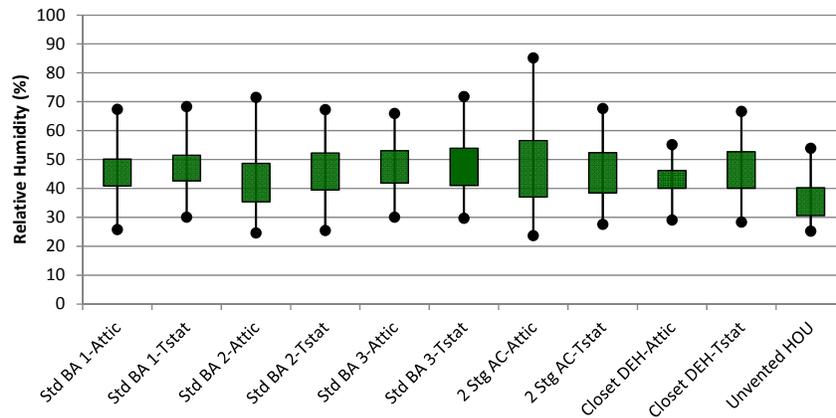
Figure 143: Rudd and Henderson (2007) interior RH data and Houston unvented data

Figure 143 shows that wintertime RH levels were lower in the diffusion vent roof house. When results are plotted as dewpoint (Figure 144), interior conditions are closer to (albeit still lower than) the circa 2001 Building America houses.

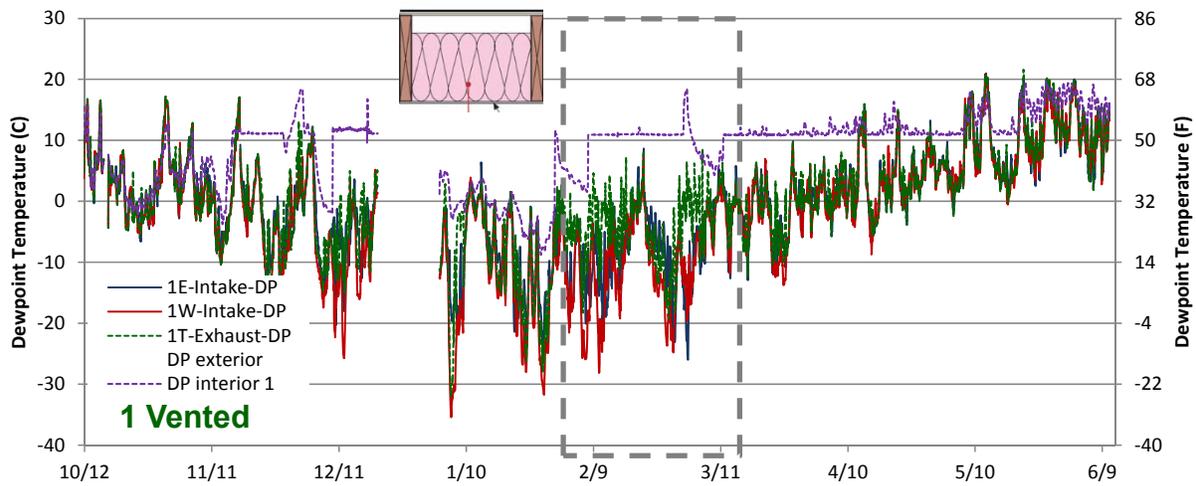
Figure 145: Intake and exhaust dewpoints, w. interior & exterior (Roof 1-Vented)

The intake (soffit/eave), exhaust (ridge), interior, and exterior dewpoint for the vented roof (1) are plotted in Figure 145. The general trend is that the ventilation space dewpoints mostly match exterior conditions. However, there is one period (highlighted in the grey rectangle) when the exhaust dewpoint is noticeably higher; this data is expanded in Figure 146.

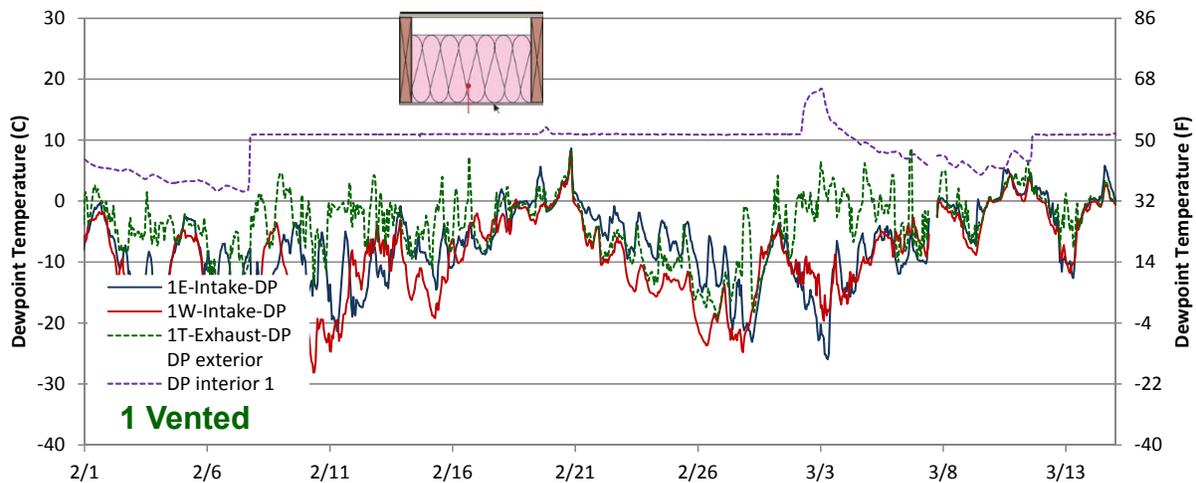
Figure 146: Intake and exhaust dewpoints, w. interior & exterior (Roof 1-Vented)-Detail

This expanded period appears to match when the humidification system was running during colder weather. This might indicate some level of moisture removal at low exterior dewpoints.

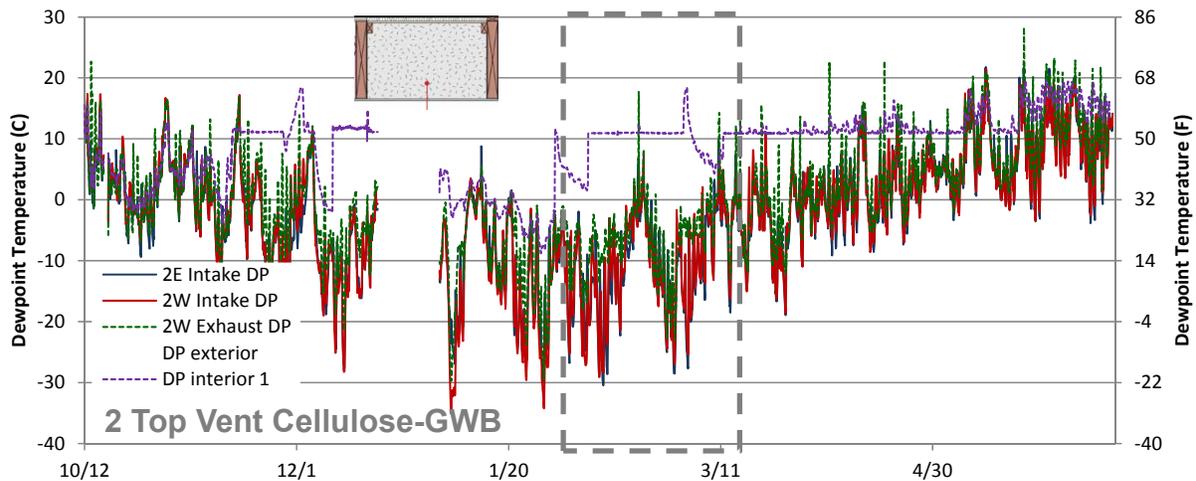
Figure 148: Intake and exhaust dewpoints, w. interior & exterior (Roof 2-Top Vent Cell.-GWB)

The data for the top vent cellulose roof with gypsum board (2) is shown in Figure 148; the highlighted period from Roof 1 is shown here, but in this roof, the dewpoints are all close to exterior conditions. A close up of that period (Figure 149) seems to indicate that the exhaust dewpoint is slightly higher during this period, but not by the same degree as the vented assembly. This would indicate that more moisture is removed from the vented roof than the top vent roof.

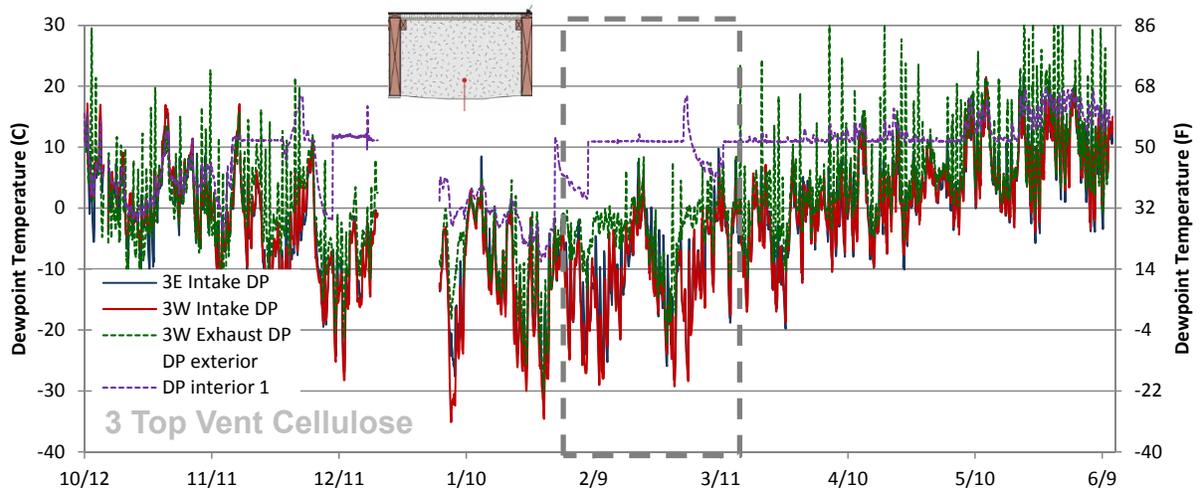
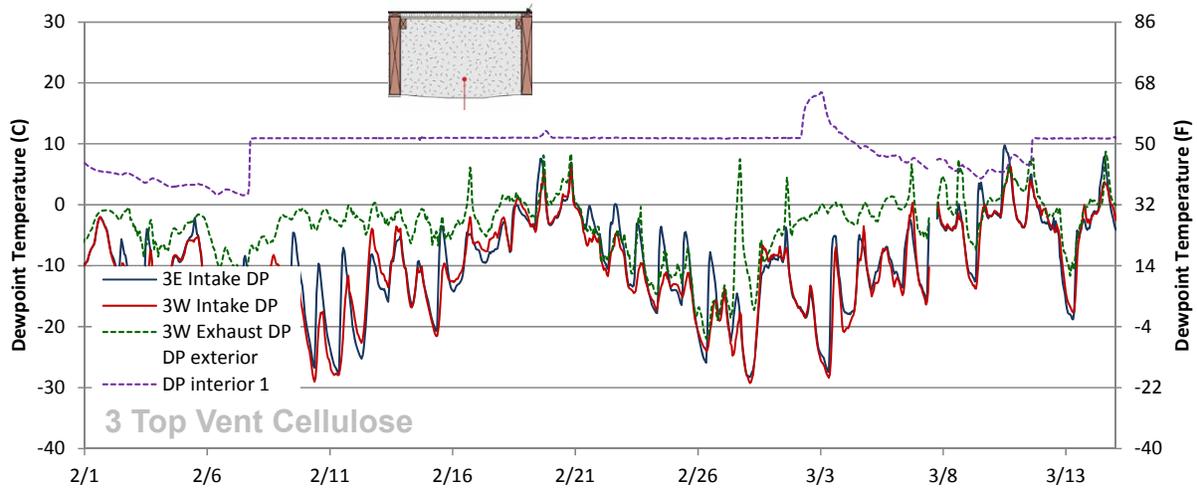
Similar plots are shown for the top vent cellulose roof, no gypsum board (3), in Figure 150 and Figure 151, with mostly similar patterns.

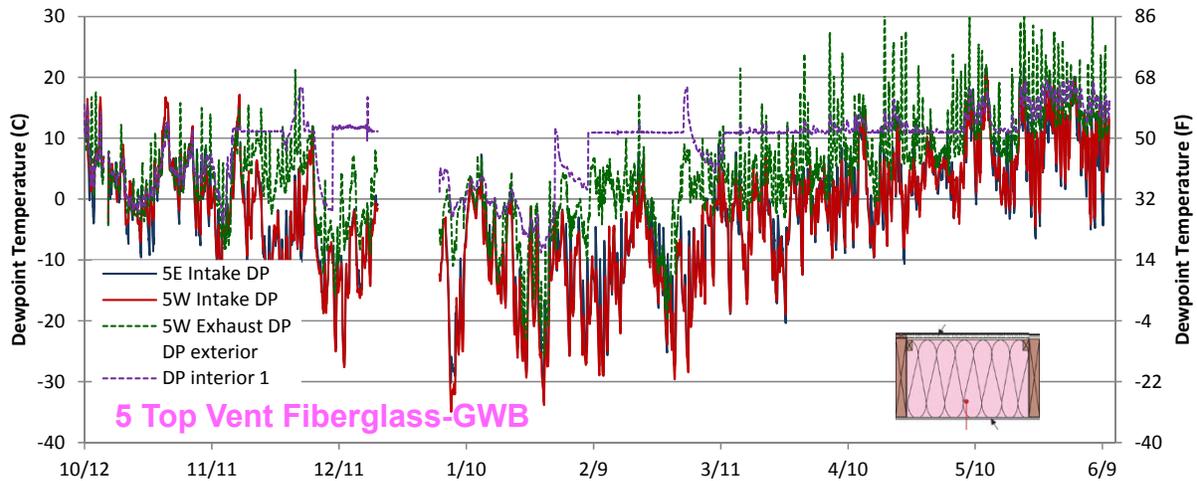
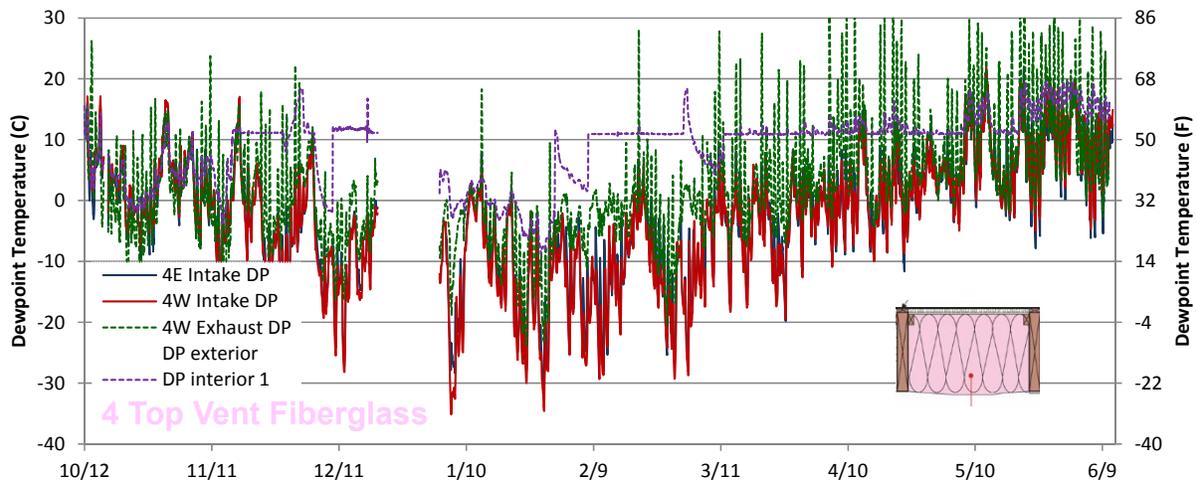
Dewpoints are plotted for the top vent fiberglass roofs with gypsum board (5) and without gypsum board (4) in Figure 152 and Figure 153, respectively. Roof 5 shows elevated exhaust dewpoints (compared to exterior/intake), while Roof 4 shows smaller differences, but greater variations.

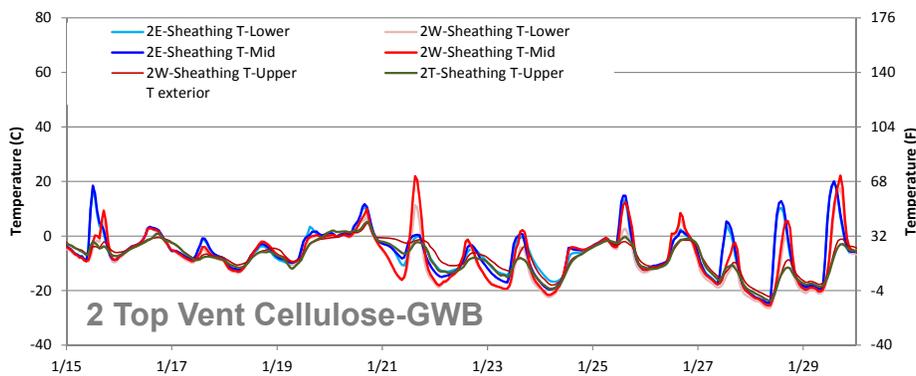
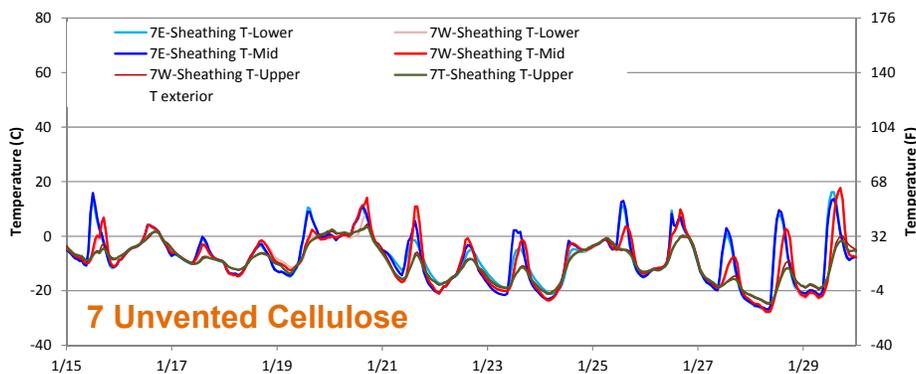
Temperatures plots from two weeks in winter are shown in Figure 154 and Figure 155. As a general behavior, both roofs show temperatures peaks for east side several hours before the west side, which is consistent with the sun path and geometry.

One significant difference was seen on 1/21; the top vent (2) cellulose west-facing sensors spike higher than the unvented cellulose (7) roofs. However, the presence or absence of snow on the roof (Figure 156) is likely causing this difference rather than ventilation effects. The snow melt pattern might be influenced by heat loss through the roof assemblies, but it is probably mostly caused by wind-blown snow deposition and other geometry effects.

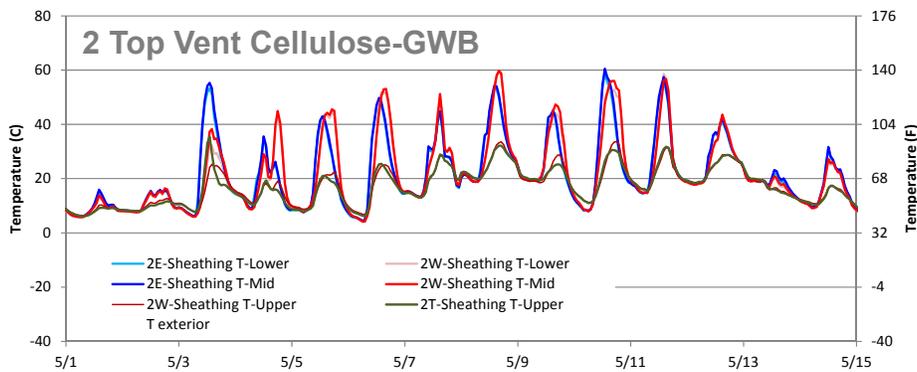
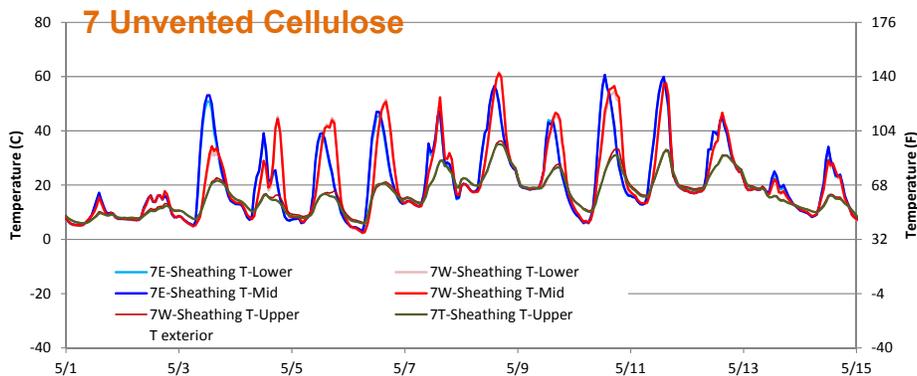
Similar plots for summertime (May) conditions are shown in Figure 157 and Figure 158. The roof sheathing temperatures are close enough to be basically indistinguishable, between the two roofs. The east-west peaking patterns are similar to wintertime behavior.

The one striking pattern is the lower temperatures seen at the “upper” sheathing areas; it is seen on both orientations in both roofs. The reason is likely the shading effect of the “doghouse”

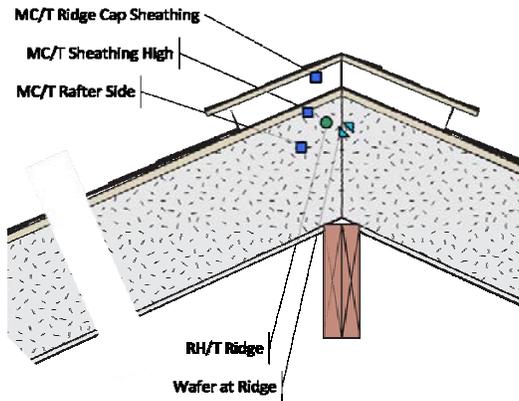
Figure 159: Ridge and “doghouse” monitoring detail, unvented cellulose roof

detail; the upper/top sheathing temperatures are shaded/shielded from direct solar gain by this ventilated roof area (Figure 159). Overall, the temperature measurements show little indication of the “top vent” detail having an effect on sheathing temperatures.

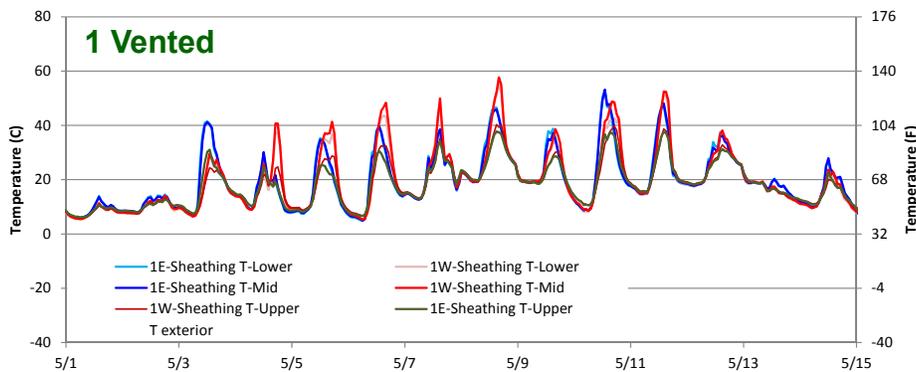
Figure 160: Summertime sheathing temperatures for Roof 1 (vented fiberglass)

As another comparison, sheathing temperatures for the vented fiberglass roof (1) are plotted in Figure 160, given that it is known to have good ventilation, with its open geometry (~4 in. air space between sheathing and fiberglass batt). The summertime roof sheathing temperatures in the vented fiberglass (1) roof are noticeably lower than the top vent (2) cellulose and unvented cellulose (7) roofs.
