### **Rainwater Management Performance of Newly Constructed Residential Building Enclosures During August and September 2004**

Prepared for the Home Builders Association of Metro Orlando and the Florida Home Builders Association By:

Joseph William Lstiburek, Ph.D., P.Eng. Building Science Corporation 70 Main Street Westford, MA 01886

January 11, 2005

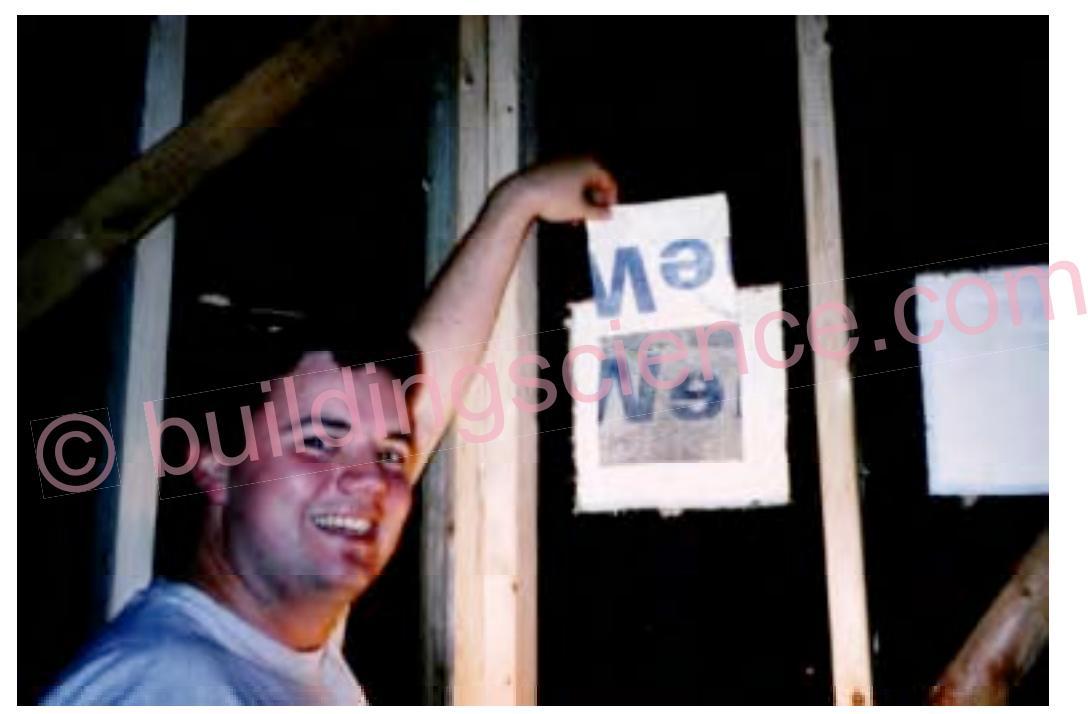
There appear to be significant performance issues with WRB's relating to manufacture, testing and approval. All plastic housewraps and some building papers tend to bond to stucco renderings thereby negating drainage (Photograph 3). Additionally, many plastic housewraps loose their water repellency (Figure 9) when in contact with sheathing and stucco renderings (Photograph 4).

Photograph 4: Stucco Rendering Bonding to Plastic Housewrap

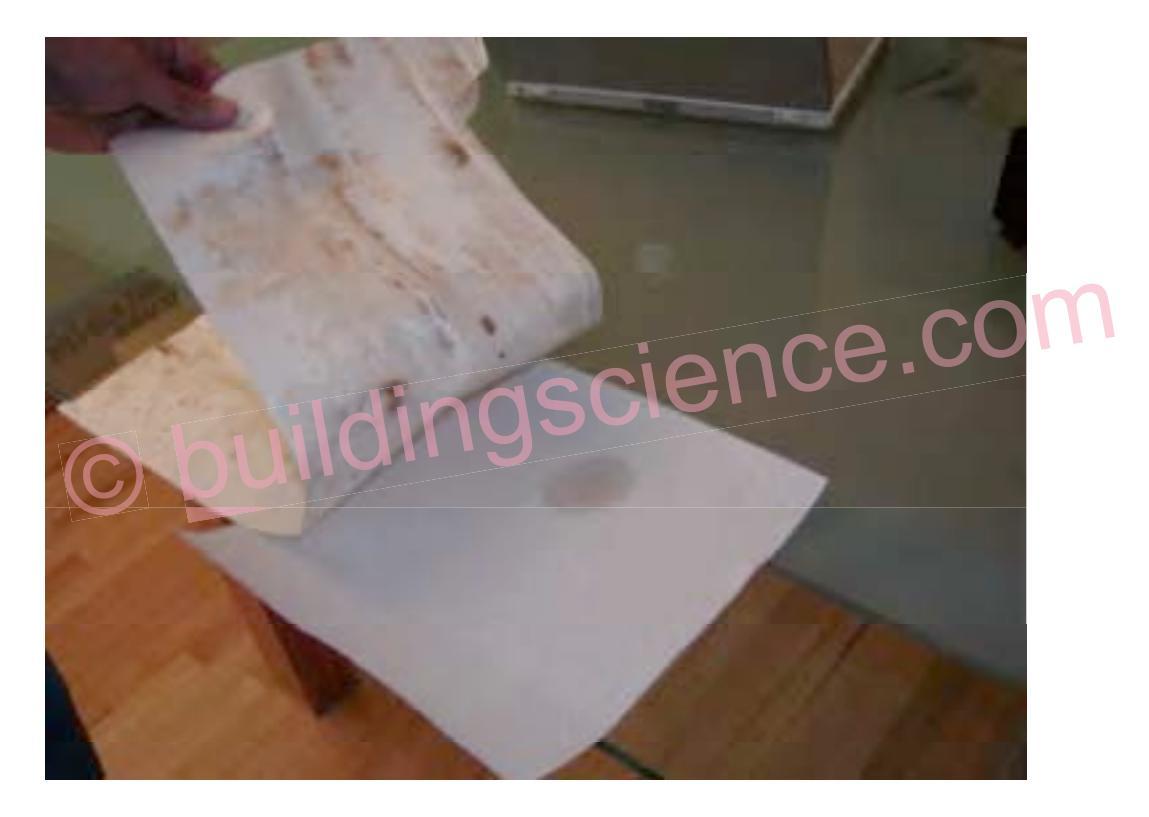
All perforated plastic housewraps fail a simple test for water repellency and water holdout (Photograph 5 and Photograph 6). Many non perforated housewraps fail a similar test when exposed to surfactants (Photograph 7, Photograph 8 and Photograph 9).

Photograph 6: Plastic Housewrap Failing Water Drop Test

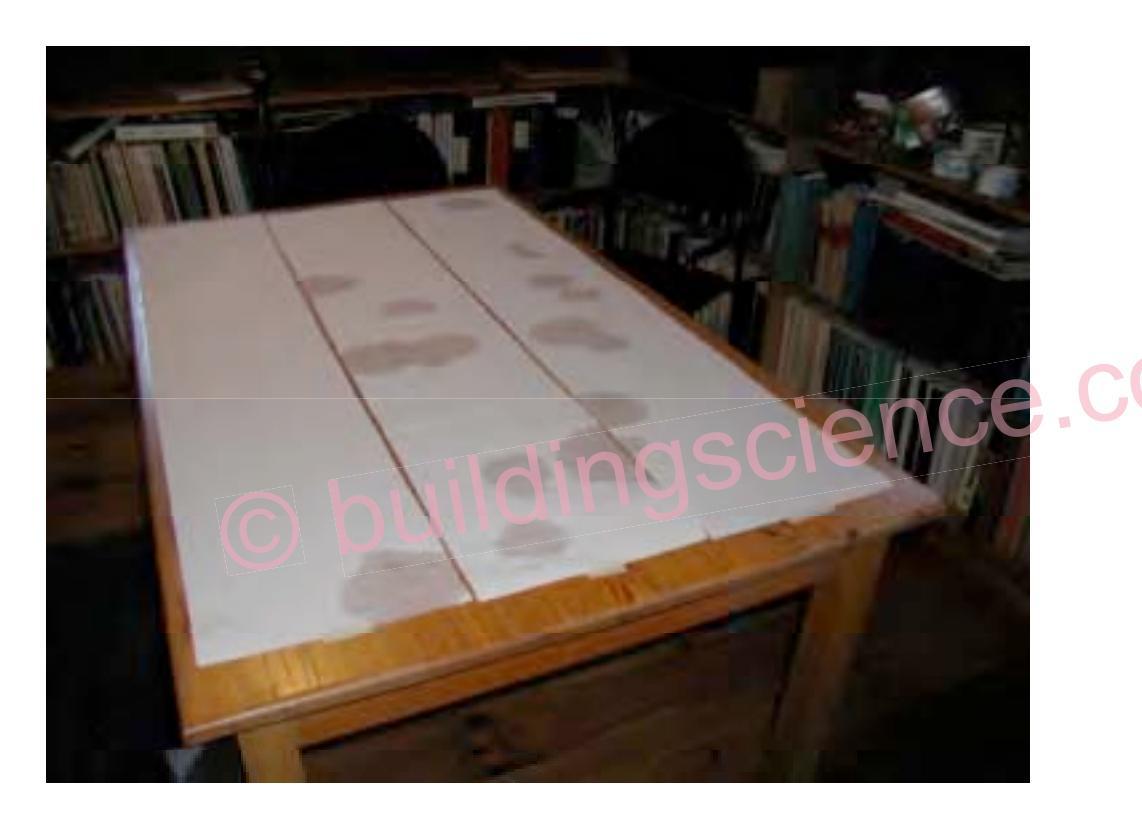
Photograph 9: Extensive Failure of Plastic Housewrap During Water Drop Test

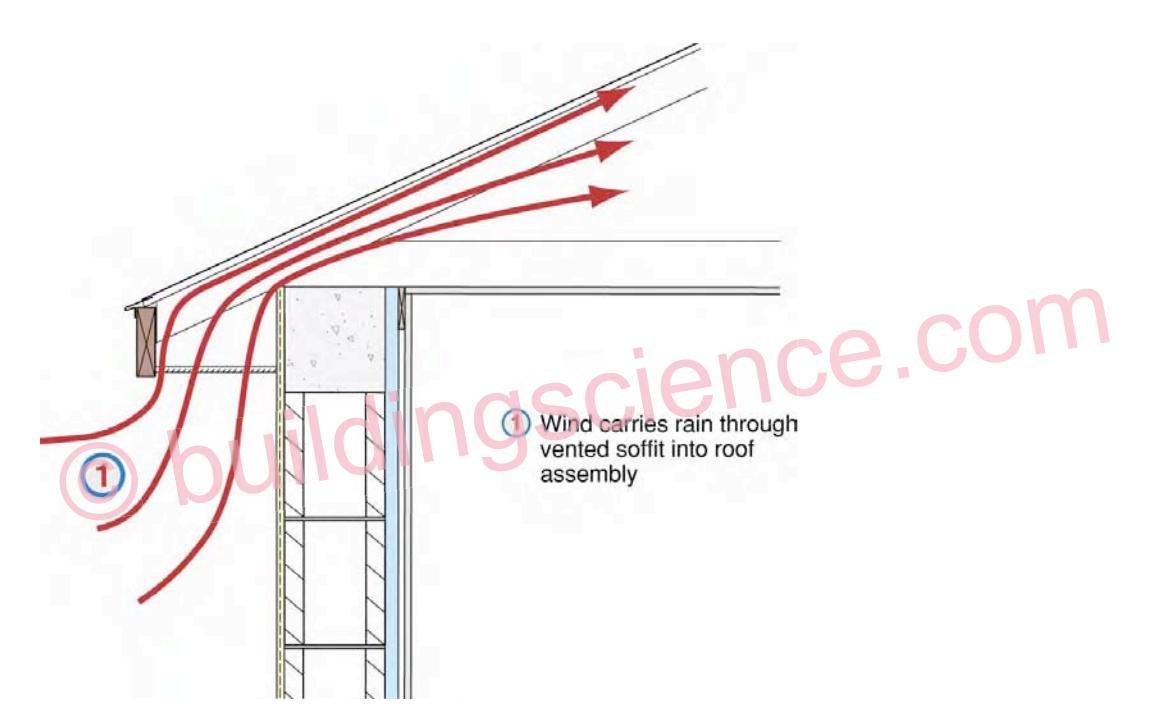
Anecdotal evidence indicates that a significant amount of rainwater entered soffit vent assemblies. This is consistent with the physics of the applied wind loads and the geometry of the soffit assemblies. Soffit geometries are currently not designed to address extreme wind driven rain exposures. Additionally, unvented roof designs which can address this mode of rainwater entry are currently not explicitly allowed in the Florida Building Code – although they are allowed in the International Residential Code.

Figure 15 illustrates rainwater entry during wind driven rain events. Figure 16 illustrates the use of baffles to reduce air pressure driving forces and facilitate the use of air pressure changes to deposit rain in soffit assemblies rather than in attic spaces.

Figure 15: Wind Driven Rain Entry In Vented Soffit Assembly

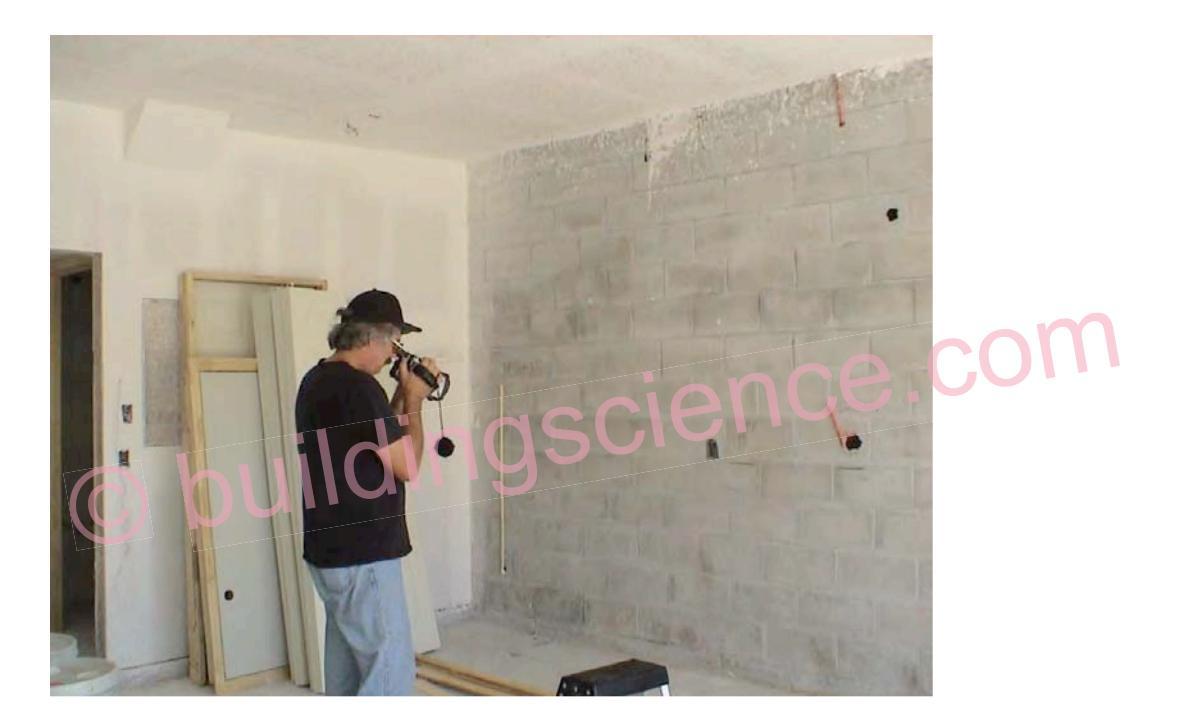
Photograph 45: Camera Probe Leak Detection

Water leakage testing of stucco renderings was conducted using numerous methods. These methods are memorialized in Photograph 42, Photograph 43, Photograph 44, Photograph 45, Photograph 46, Photograph 47, Photograph 48 and Photograph 49.
