Mold Control in **Publicly Funded** Housing Developments

Building Science Corporation/Peregrine Group/Bugs, Mold, and Rot III

Case Studies Mold Complaints in Public Housing 1989-1999

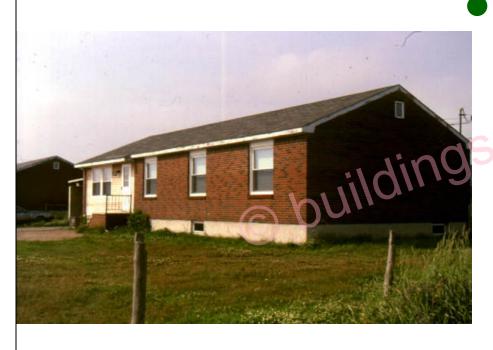
EXISTING CONDITIONS

- Built in 1973
- Single story, full basement
- 1100 square feet
- 3, 4, or 5 bedrooms and 1 or 2 bathrooms
- High occupant loading

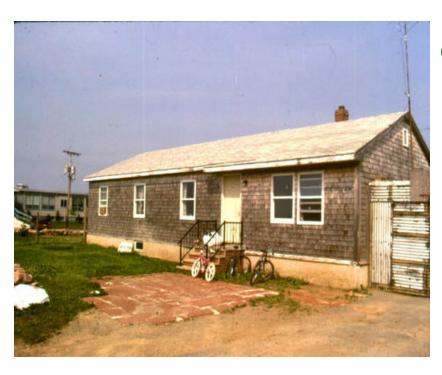
Test Results

- 5 to 9 airchanges per hour at a depressurization pressure of 50 Pascals
- typical leakage or tightness for houses of this type, age, and location

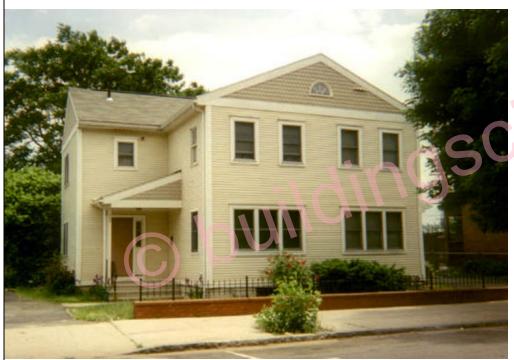
Existing Conditions

- 1990 duplex units -two story wood frame structures constructed over cast concrete basement foundations and basement floor slabs.
- Space conditioning systems are gas fired, high efficiency aerodynamically uncoupled.
- Exhaust fan systems in the kitchen and bathroom were installed, however they did not extract noticeable quantities of air

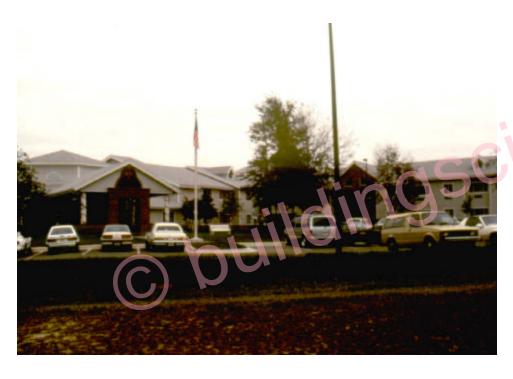
- ExistingConditions
 - Units range from 800 to 1,200 sq. ft.
 - 2 story, vented crawlspace
 - 8 units per building

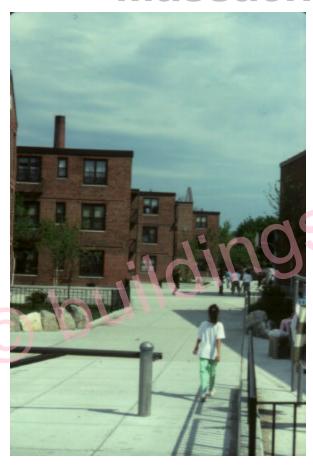
- Existing Conditions
 - 1940's three story walk-up units
 - Units range from 500 to 800 sq. ft.
 - Renovations included new windows and high-efficiency heating

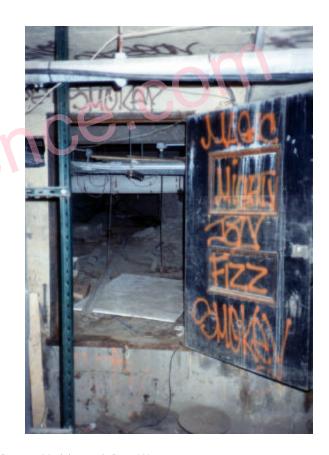
- Test Results
 - Measured rh in excess of 65% @ 70• F during winter months
 - 1 to 2 air changes per hour at a depressurization pressure of 50 Pascals

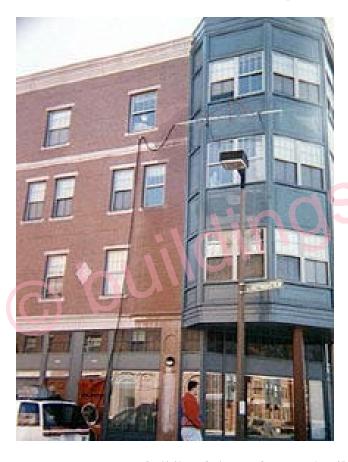
- ExistingConditions
 - Individual units ranged from 950 to 1,300 ft2 in floor area over two levels.
 - Steel framed, four story, multi-unit project
 - The space conditioning systems consisted of perimeter hydronic radiators coupled to a gas boiler system

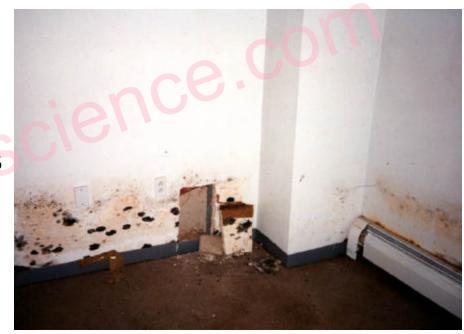
- Test Results
 - 5 to 6 airchanges per hour at a depressurization pressure of 50 Pascals
 - Extremely leaky for multifamily apartment construction of this type, age and location

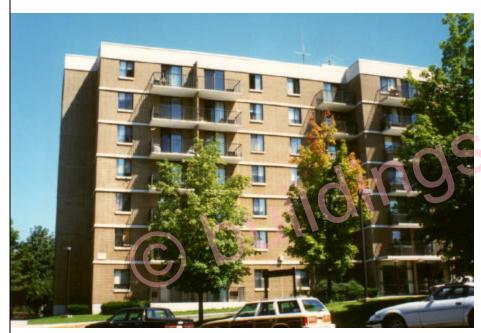
- Existing Conditions
 - 1980 7 story apartments
 - Concrete frame structure with block infill walls with stud back-up with gypsum on both sides
 - Space conditioning systems are gas fired centrally located boilers with individual vertical fan coil units

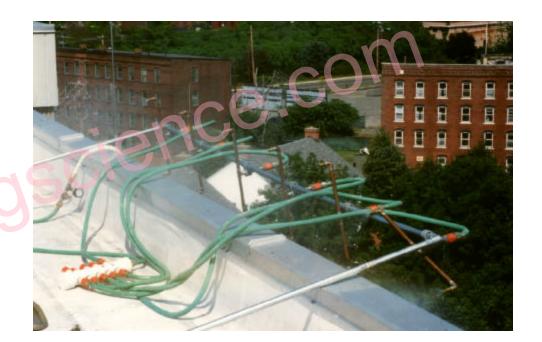
- Test Results
 - Water leakage through facade

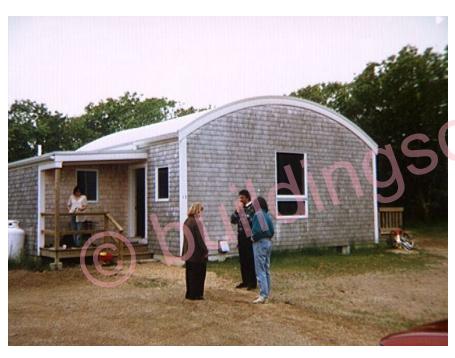
Existing Conditions

- 2 years old single family residences
- One story wood frame structures constructed predominantly over basement foundations. Portions of some units are constructed over elevated pier foundations.
- Wall assemblies are 2x6 with plywood sheathing, housewrap and cedar shingles.
- Roof assemblies are curved, rigid foam insulated stress skin panels with a roofing membrane.

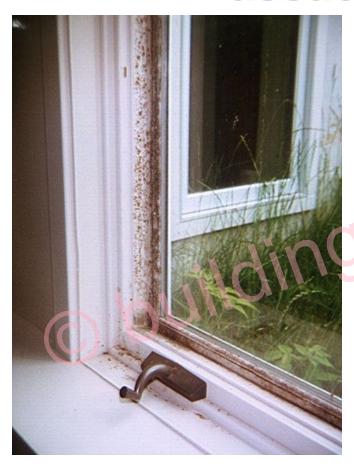
- Existing Conditions (con't)
 - Windows are double glazed, low E wood frame windows
 - Space conditioning systems are propane fired boilers with hot water radiation.
 - Exhaust fan systems in the kitchen and bathrooms are installed.
 - 2, 3 and 4 bedroom -floor areas -1,200 and 1,500 square feet

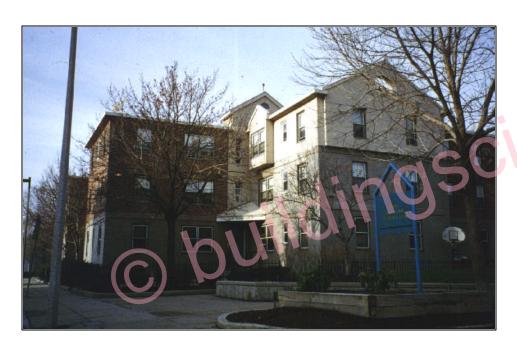
Existing Conditions

- Two story uninsulated masonry structures constructed just after the Second World War.
- Space conditioning systems are hydronic radiators connected to a central heating system not located within units.
- No controlled mechanical ventilation such as exhaust fan systems in the kitchens or bathrooms were installed.
- The units had recently (within the past few years) undergone window replacement.

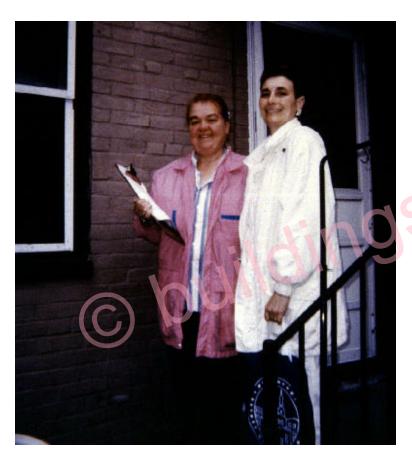
Existing Conditions

- State funded development
- Completed in 1939
- Renovated in 1987-1990 at cost of \$100,000/unit
- 540 apartments
- 1,510 Residents
- 16 City Blocks
