Tough Act to Follow

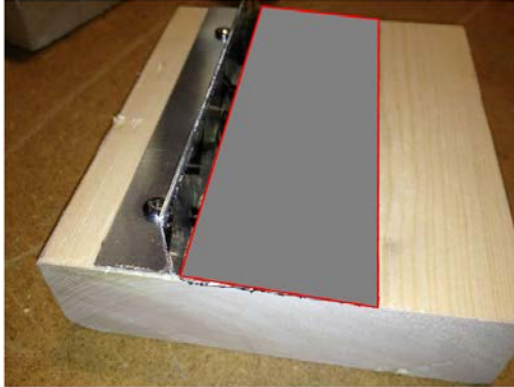
Photo #1
Metal "L" angle sill dam requires secure attachment to opening sill

Flashing tape applied onto sill dam leg and on opening sill

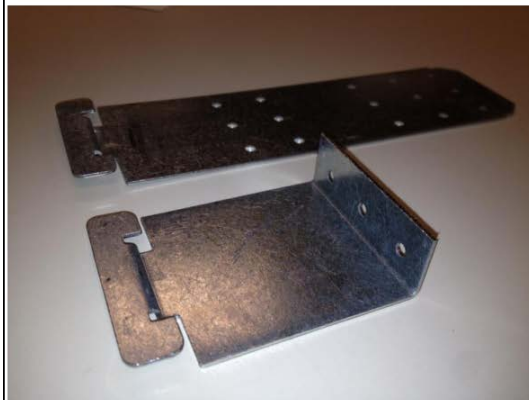
Photo #2
Standard Installation Clip is cut to length and then bent 90°. The clip length will need to be determined per job as it is based on the width of the joint between the sill dam and the window plus the leg height of the sill dam.

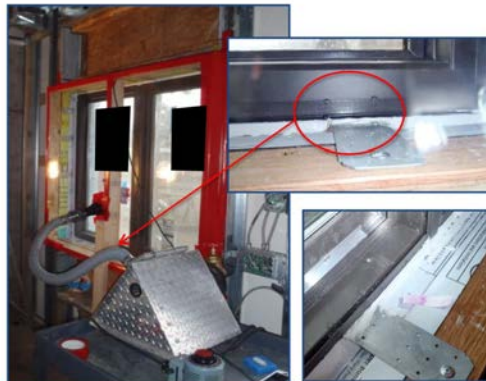
Leak #	Cycle #	Time	Description of Leak Behavior and Origin or Failure Mechanism if Known:
1	4	5:21	Technicians observed water intrusion at the sill, to the left of the center mullion.

Comments/Observations: Master Test 3 is the initial assessment of Specimen 3. A [redacted] casement "C" window measuring 56" x 48". Prior to testing, a purge was run to remove debris and/or moisture from the test area. Master Test 3 tested Specimen 3 at 4.5 Psf. Technicians observed water intrusion at the sill, to the left of the center mullion. Due to water intrusion, Specimen 3 received a Fail.

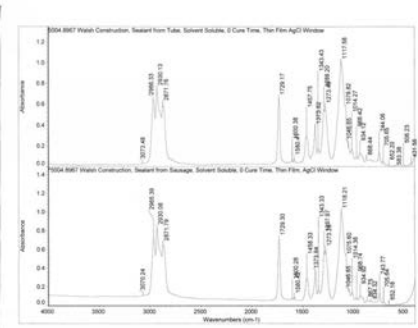
Figure 1: The FTIR Spectra Obtained on the Acetone: Toluene Soluble Portions of the Tube and Sausage Sealant Samples after 0 Hours Cure Time.

FTIR:
 Solvent Deposition:
 The FTIR spectra obtained on the of the acetone:toluene soluble portions of the tube and sausage sealant samples after 0 hours cure time were similar and were indicative of phthalate plasticizer and polypropylene glycol.
 The FTIR spectra are presented in Figure 1.

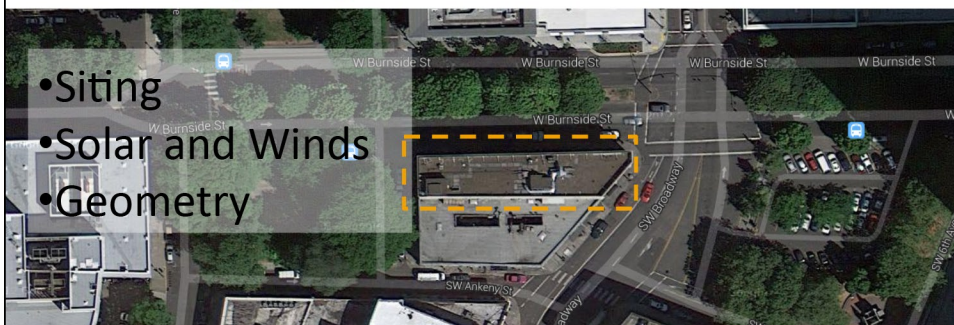
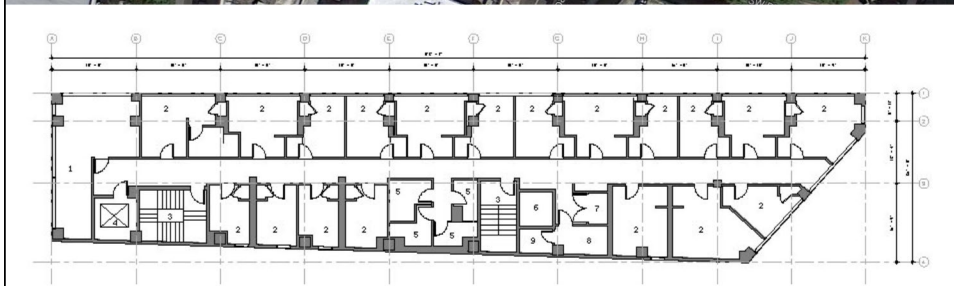
MARK O. HATFIELD BUILDING

Basic Building Design

- Structural Frame
- Windows
- Heating System

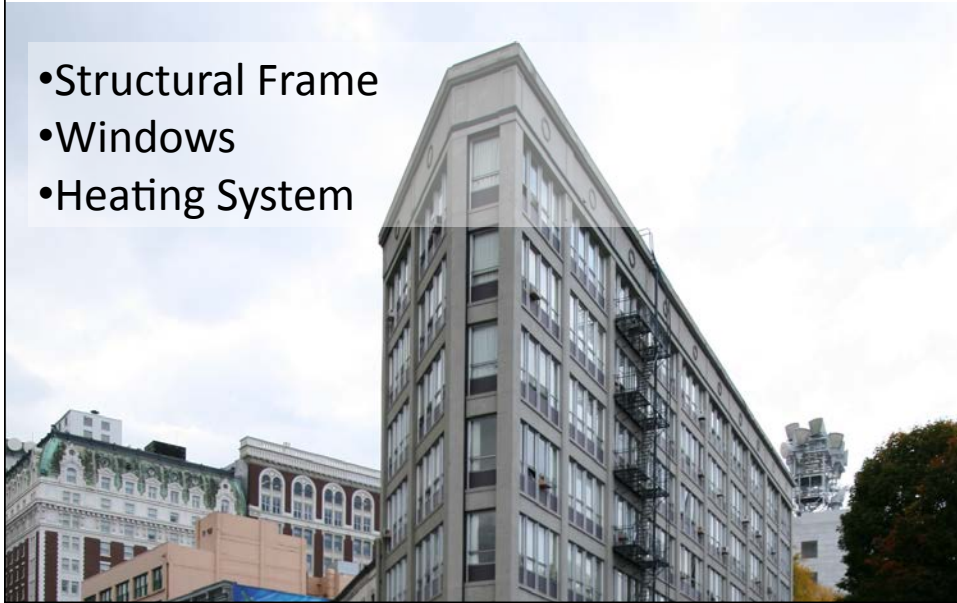
MARK O. HATFIELD BUILDING

Envelope

- Window to Wall Ratio
- Thermal Bridging
- Frame
- Windows

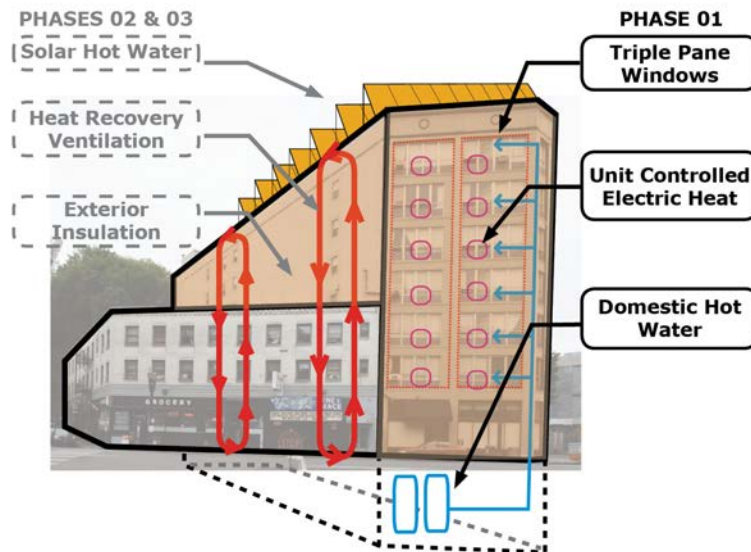
ASSEMBLY OPTIONS

Existing Building	Good Rehab	Better Rehab	Best Rehab Passive House
Basement Slab Insulation	none	none	none	none
First Floor Insulation	none	none	none	none
Wall Insulation	none	none	2" EPS Exterior Insulation	6" EPS Exterior Insulation
Roof Insulation	Existing 4" Polyiso Board	Existing 4" Polyiso Board w/limited repair	Existing 4" Polyiso Board w/limited repair	Existing 4" Polyiso Board w/limited repair
Window Frame	Aluminum (not thermally broken)	Fiberglass (Cascadia 300 tilt/turn)	Fiberglass (Cascadia 300 tilt/turn)	Fiberglass/Vinyl (Rehau Geneo Euroline 4700)
Frame U-Value	unknown	0.289	0.289	0.14
Window Glazing	Single Pane	2-pane/Cardinal LoE 366 Argon	3-pane/Cardinal LoE 366/180 Argon	3-pane Rehau Geneo PHZ
U Value IGU	1.02	0.20	0.12	0.11
Airtightness (ACH at 50 pa)	10	5.00	0.60	0.60
Airtightness (cfm/sf, 75a)			0.16	0.16

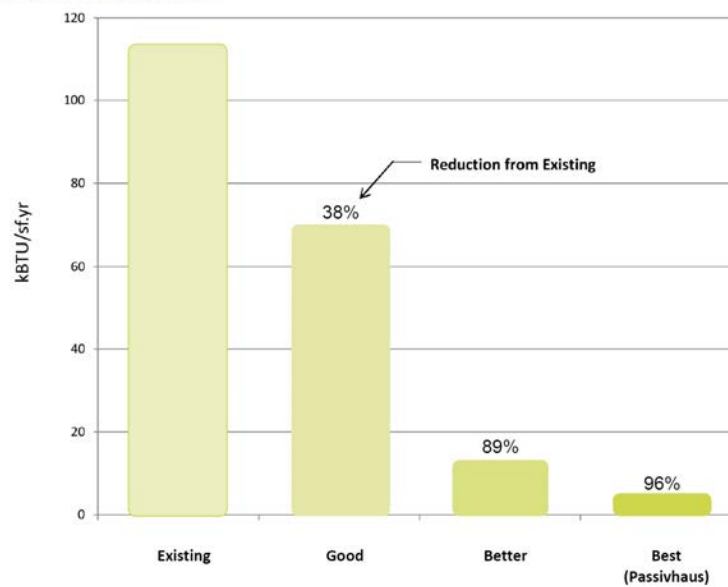
ENVELOPE PERFORMANCE STUDY

Annual Heating EUI (Source: Green Hammer)

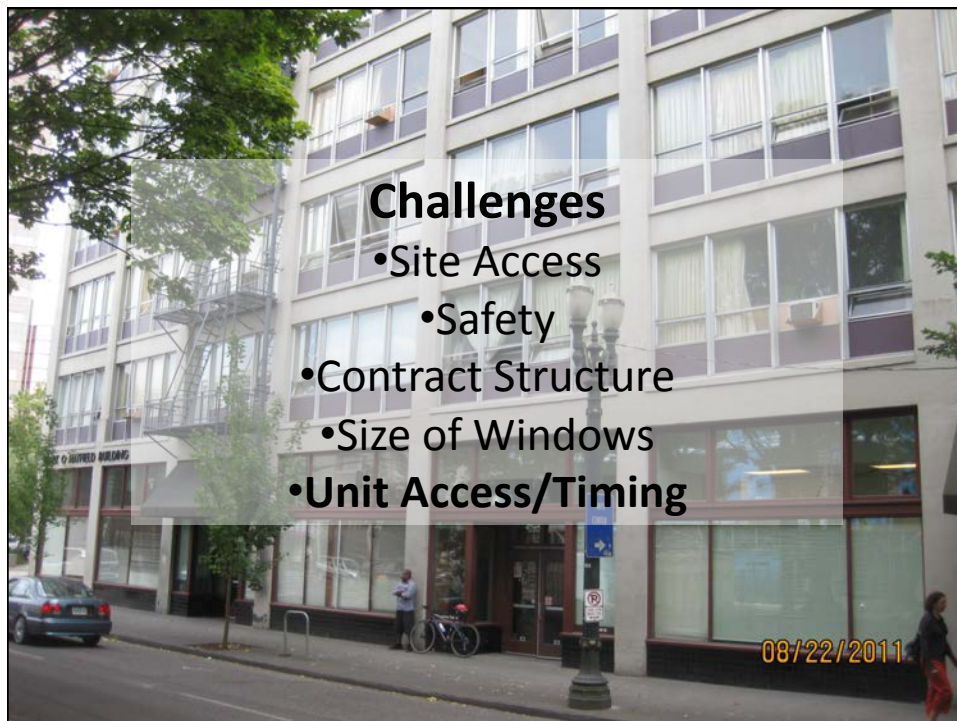
COMPLETED PROJECT SCOPE

Phase 01

- **Single pane windows replaced with Cascadia triple pane windows**
- **Windows and flashing designed to anticipate EIFS at a later date**
- **Mechanical ventilation designed to anticipate HRV at a later date**
- **Heating disconnected from oversized boiler and switched to unit electric heaters with connection to window watchers**
- **Installed new high efficiency DHW Heaters**
- **Concrete repair and air sealing**

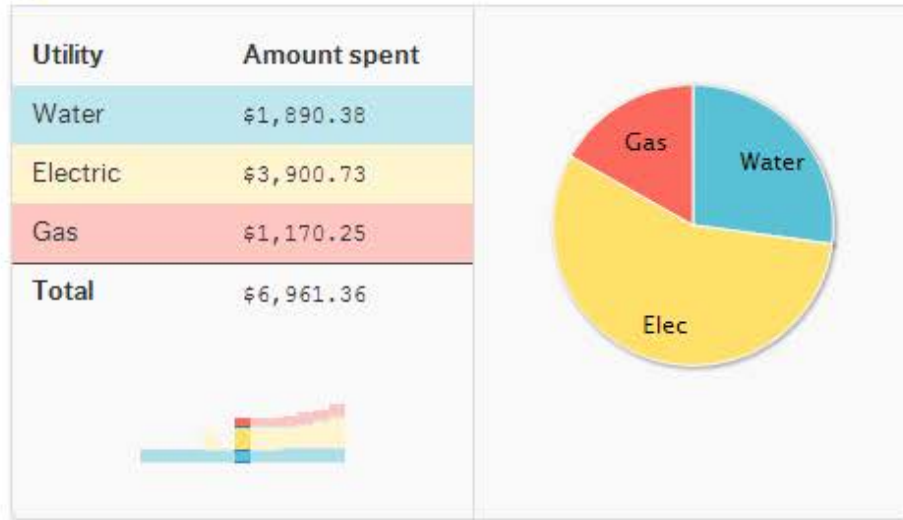
PERFORMANCE

July 2011

💰 Cost Breakdown

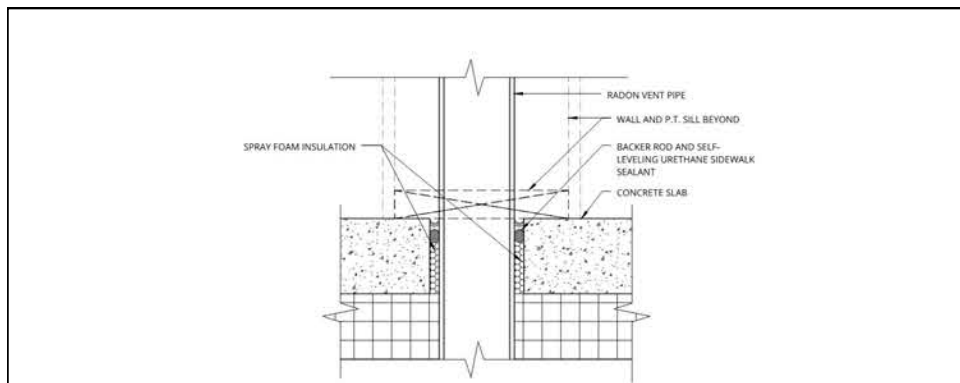
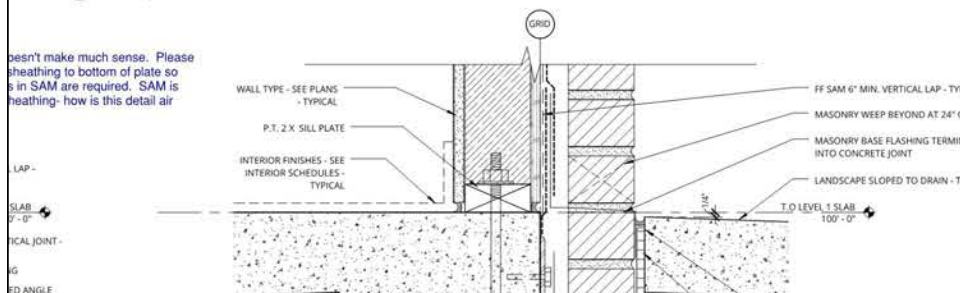
A4.21 | 3" = 1'-0"

5 RADON VENT AT SLAB

doesn't make much sense. Please consider extending sheathing to bottom of plate so that fewer transitions in SAM are required. SAM is not in contact with sheathing- how is this detail air tight?

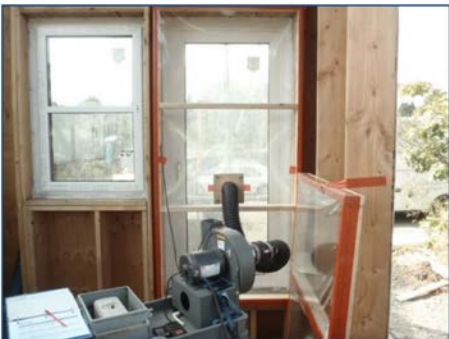
Comments/Observations: Master Test 1 is the initial assessment of Specimen 1, a Euroline brand door measuring 80" x 80 1/2". Prior to testing, a purge was run to remove debris and/or moisture from the test area. Master Test 1 tested Specimen 1 at 6.00 psf. Technicians did not observe any water intrusion during the test and Specimen 1 received a Pass.

Test Date	Location	Master Test	Daily Test	Specimen ID	Product Type	Test Pressure	Final Result	Observations
8/20/14	Mock up	1	1	1	Door	6.00 psf	PASS	Ø Leaks
8/20/14	Mock up	2	2	1	Door	12.00 psf	PASS	Ø Leaks
8/20/14	Mock up	3	3	2	TIR/Turn	6.00 psf	PASS	Ø Leaks
8/20/14	Mock up	4	4	2	TIR/Turn	15.00 psf	PASS	Ø Leaks

* Testing was performed at 6.00 PSF interior vacuum pressure in accordance with the project specification. Test pressures that exceed 6.00 PSF were conducted for exploratory purposes only for a 5-minute period.
