Operation Helping Hands Green Dream 2 Prototype

Case Study
New Orleans, Louisiana

The Green Dream 2 is a single-family home built on the site of a hurricane-damaged house that stood for 3 years before being demolished by the city of New Orleans. Staff and students from Portland Community College met the homeowner and his family on a trip to New Orleans and wanted to help them by building a new home; one that would be durable, healthy, comfortable, energy-efficient and affordable. Portland Community College connected the homeowner with Catholic Charities Operation Helping Hands who, in turn, asked BSC and the LSU AgCenter to be a part of the team.

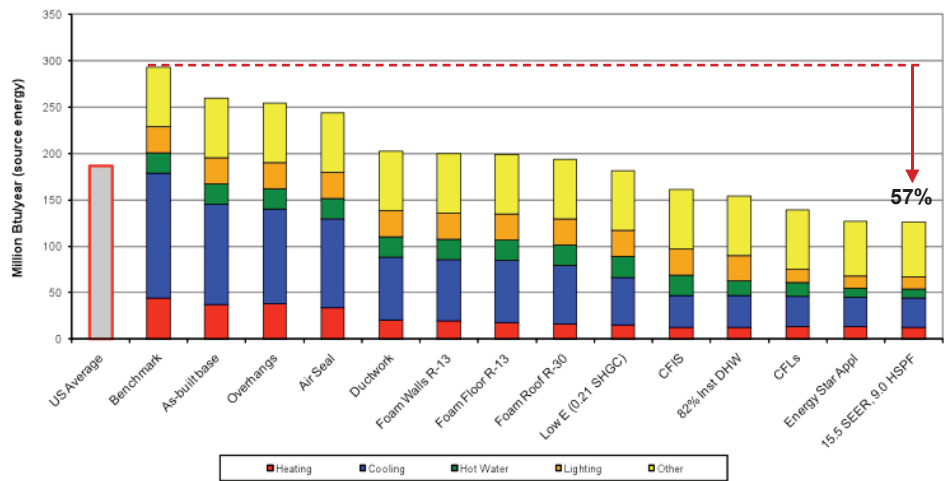
PARAMETRIC STUDY

The parametric chart above shows the energy use reduction when compared to the Building America Benchmark house. In order for the house to be flood-recoverable, another important goal of the project, insulation materials were chosen that would not be damaged in a flood and would be able to be cleaned in place after a flooding event; both spray foam insulation and polyisocyanurate insulating sheathing have these characteristics. The windows installed in the house have both a low solar heat gain coefficient (SHGC) to reduce the amount of solar heat gain into the house, and an impact rating which

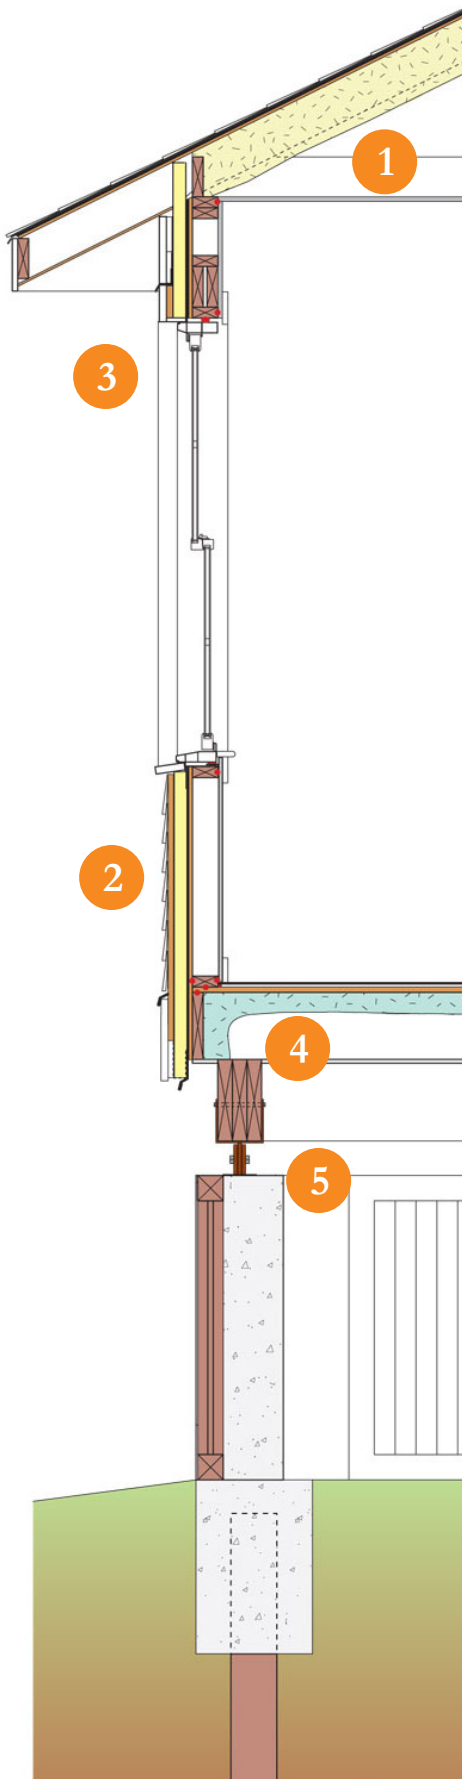
ENCLOSURE DESIGN

1 Roof Assembly: Truss-framed unvented attic with R-30 roof insulation: 7" medium-density (0.8 pcf) open cell spray foam below roof sheathing, 5/8" treated plywood roof sheathing, fully-adhered roof membrane, high wind-rated asphalt shingles installed over the trusses, 1/2" paperless drywall installed below trusses.

2 Wall Assembly: 2x4 treated walls at 16" o.c. with R-13 wall insulation: stud bays left open, 1/2" treated plywood, housewrap, 2" foil-faced polyisocyanurate insulating sheathing, 3/4" treated furring strips and fiber cement siding installed on outside face of studs, 1/2" paperless drywall installed on inside face of studs.

3 Window Specifications: Showcase Custom Vinyl Windows and Doors single-hung, double pane, spectrally selective, impact rated Low-E: U=0.40, SHGC=0.21.

4 Air Sealing: Maximum 2.5 in² leakage area per 100 ft² of enclosure area. Critical seal air sealing approach with spray foam in both roof and floor assemblies and airtight drywall approach used in wall assembly. Adhesives and sealants used between framing members, around windows and doors, and at all mechanical and electrical penetrations through the enclosure.

5 Foundation and Floor Assembly: Wood pile, concrete grade beam and adjustable pier foundation, treated joist-framed floor on treated sill beam with R-15 floor insulation: 2.5" high-density (2.0 pcf) closed cell spray foam between floor joists, 1/2" fiber cement protection board installed below floor joists.

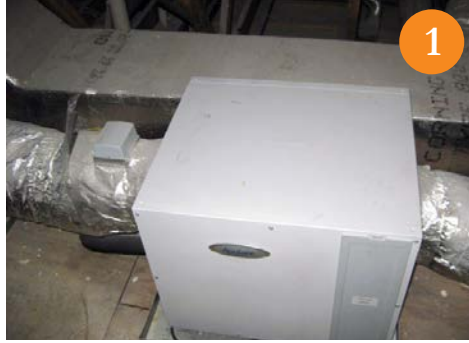
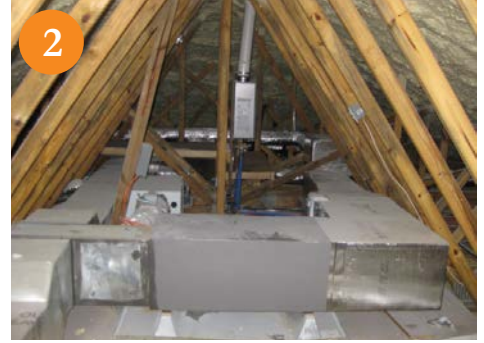
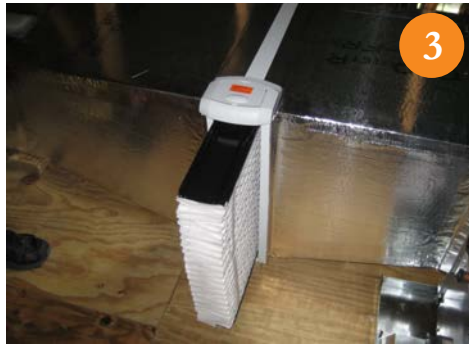
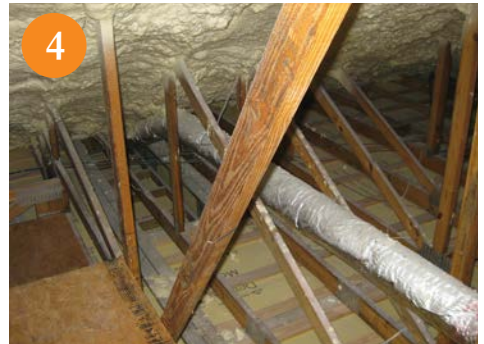
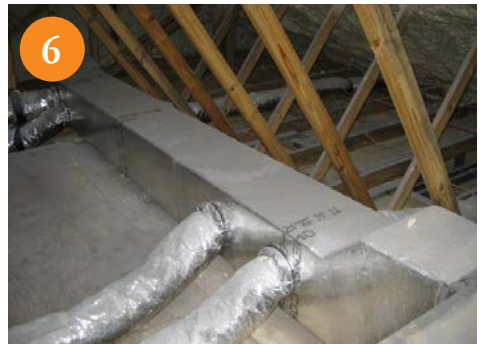
MECHANICAL DESIGN

Heating, Cooling and Dehumidification: 9.0 HSPF/15.5 SEER air source heat pump split system with ① supplemental whole house dehumidification. ② Interior unit installed in conditioned attic with ③ MERV 13 filter.

Ventilation: Central fan-integrated with supply only ventilation system controlled with built-in controls in dehumidifier. ④ Outside air ducted to the return side of the air handler including both motorized and manual dampers.

Local Exhaust Ventilation: Intermittent spot exhaust provided in bathrooms and ⑤ kitchen.

Space Conditioning Distribution: Air handler with sheet metal plenums and ⑥ R-6 duct board supply trunk and R-6 flex duct run-outs installed in conditioned space. Ducted central return, dehumidifier return and transfer grilles above bedroom doors.

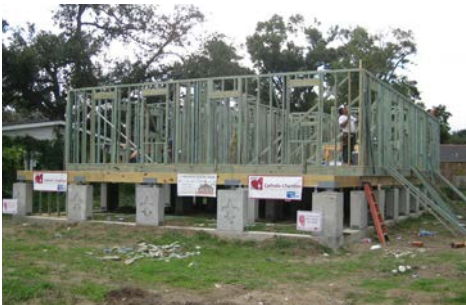
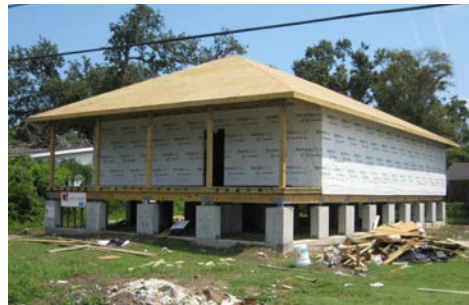
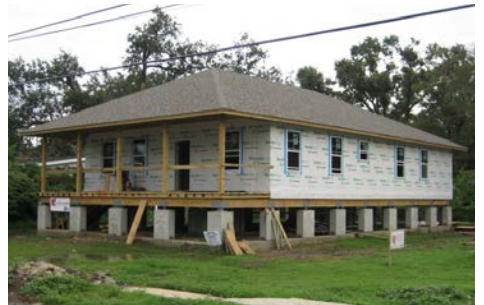
Construction began in June 2009 with the driving of the wood piles for the foundation. Concrete grade beams were poured over the piles and telescoping concrete piers were set on the grade beams. On top of this foundation, both borate pressure treated and ACQ pressure treated wood was used to frame the house and porches. Throughout the construction, a Catholic Charities

Once the housewrap was in place on the treated plywood, the project team held a window installation demonstration for volunteers and industry professionals.

The window installation sequence from the drawing set was followed step by step as project team members assisted volunteers in installing Green Dream 2's sixteen windows.

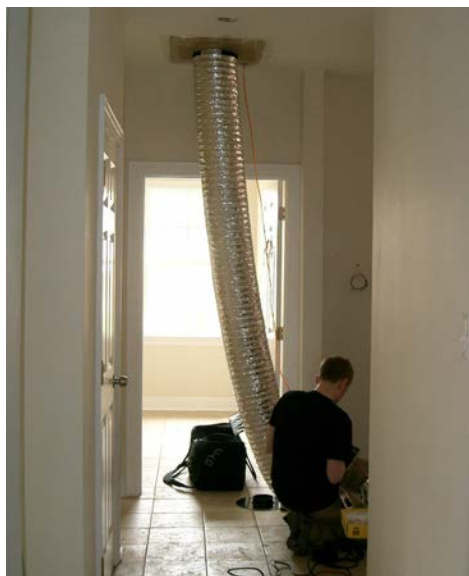
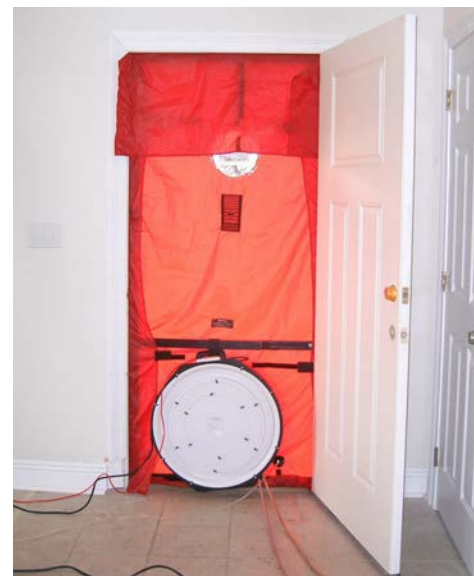
During the design phase of the project, performance goals for overall house airtightness and duct leakage were set for Green Dream 2. While construction was wrapping up, BSC performed both a blower door test and a Duct Blaster® test to find out if the goals were met.

BSC's maximum air leakage target is 2.5 in² per 100 ft² of enclosure area. For Green Dream 2, this is equal to 1590 CFM 50. When tested, the air leakage was 1123 CFM 50, well below the maximum CFM 50, meeting our set goal. BSC's performance target for total duct leakage is 10% of total system CFM while the performance target for duct leakage to outside is 5% of total system CFM. Green Dream 2 has a 2-ton system installed, equal to 800 total system CFM (400 CFM per ton). Results from the Duct Blaster® showed no measurable duct leakage to outside and only 50 CFM total duct leakage.

Both results greatly surpass the targets of 40 CFM duct leakage to outside and 80 CFM total duct leakage. In addition to the Duct Blaster® and blower door tests, room by room air flows were tested using a flow hood and all found to be as designed.

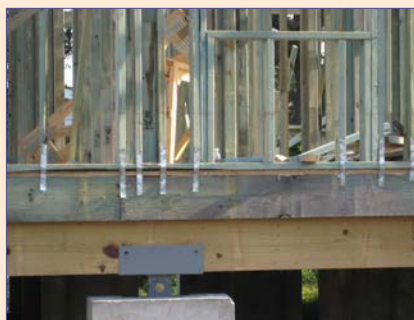
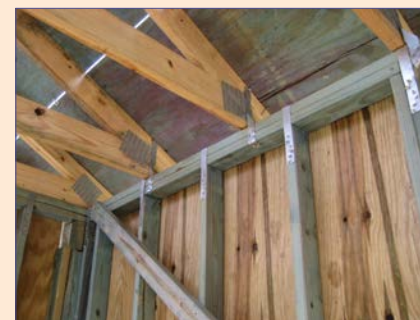
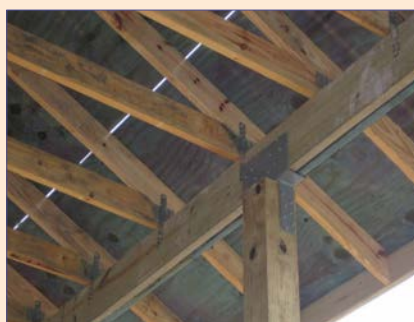
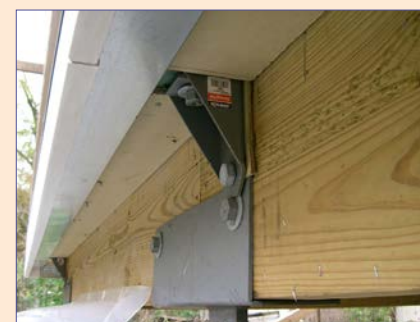
DESIGN HIGHLIGHT: HIGH-WIND CONNECTORS, THE PRESCRIPTIVE PATH

Upon opening the International Residential Code, you will quickly find that the IRC does not cover framing for houses in high-wind zones. Rather, it suggests you design your structure using any of the given references. Green Dream 2 was designed using the Wood Frame Construction Manual, 130 mph, Exposure B. The prescriptive path in the manual was followed, and along with catalogs of high-wind connectors, a schedule of types, quantities and locations was created. Installed correctly, the combination of high-wind connectors ensures the home will resist loads present during a high-wind event.
