1. 18 WILLIAMS AVE, WESTFORD, MA & 130 NORTH ROAD, BEDFORD, MA

1.1 Introduction

1.1.1. Project Overview

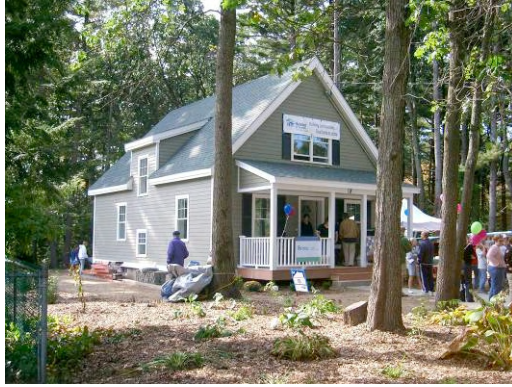
Figure 1.2: Southeast view

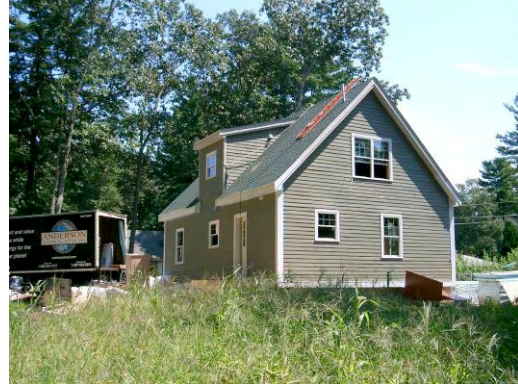
Figure 1.3: Northwest view

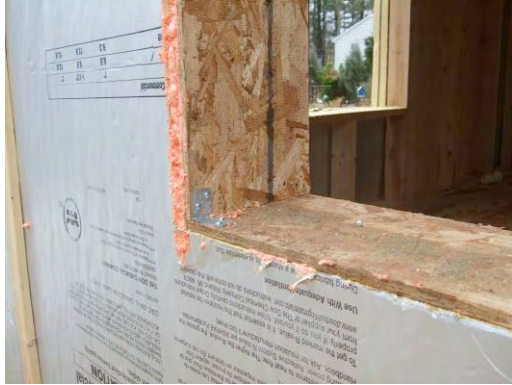
Figure 1.7: Exterior view of plywood “box” detail used at windows

The goal of this project was to create a home with a high R-value enclosure, a right-sized mechanical system, energy efficient lighting, appliances, windows and doors, and also have the possibility of adding site-generated power at some point in the future. To ensure that solar-generated power could be successfully installed, the house was sited with a large south facing sloped roof. The high R-value enclosure was achieved through 4" of rigid foam insulation on the interior of the basement walls, the exterior of the stud walls and on top of the roof rafters. Many details (in particular, window and door installation) needed to be developed in order to ensure Habitat's volunteer labor could successfully implement the critical water management and air barrier details. See the figures below for construction photos showing the window installation with 4" of rigid foam.

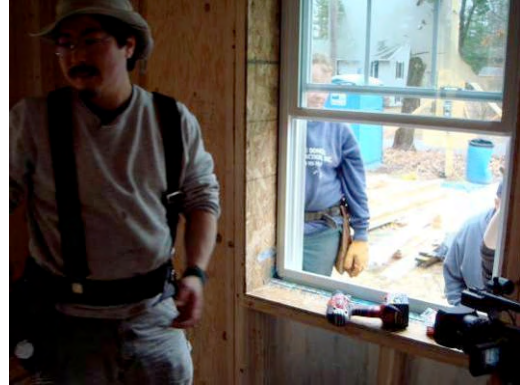
Figure 1.8: Interior view of plywood “box” details used at windows

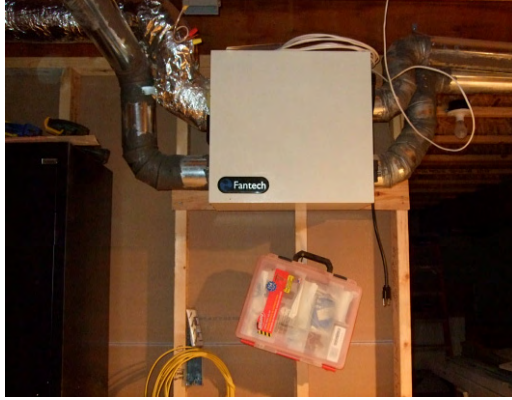
Figure 1.11: Installed energy recovery ventilator

- **Ventilation:** An energy recovery ventilator was donated to this project; it was a small (70 CFM nominal) unit with no control capability (i.e., on/off). Installing an ERV (not HRV) without a defrost cycle was considered somewhat risky. Discussions between company principals and the manufacturer determined that at the specified operating conditions (interior humidity limited by exhaust ventilation, 33% duty cycle) that frost-up was a relatively low risk. This duty cycle was achieved using a hard-wired 110 V electromechanical timer switch (Intermatic/Grasslin KM2ST-1G). In addition to timer operation, this switch has the ability to be turned completely off or completely on. These modes dovetail well into “vacation mode,” and a mode to be used when higher ventilation rates than normal are needed.

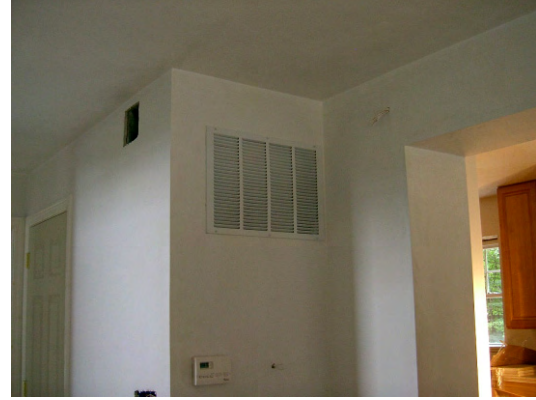
Figure 1.12: Central return, with ERV supply "soft connected" near return

The system was installed as a “semi distributed” setup, with a single point drawn (from the second floor), and a single point supply, located next to the central air handler return (see Figure 1.21). A fan cycling controller is installed on the air handler, set to run at 16% duty cycle (5 minutes on/25 minutes off). Therefore, the ventilation air provided by the ERV will have some distribution throughout the house, due to this fan cycling operation.

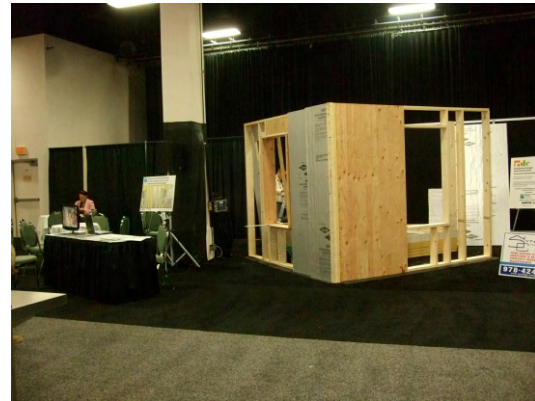
Figure 1.15: Mockup demonstration at Build Boston 2008/Residential Design 2008

Previous work included the construction of a mockup for test and demonstration purposes at the company's Westford site in August 2007 (see Figure 1.22), as well as a mockup demonstration at the Build Boston 2008/Residential Design 2008 conference in April 2008 (see Figure 1.23). The former was particularly instructive, by providing concrete examples of the issues that need to be addressed when building these assemblies in the field. For instance, sequencing issues proved to be important: installing vertical strapping on the entire wall eliminates the clearances required to install all window flashing elements. Therefore, details were developed showing omission of the strapping near the window, until after window installation.

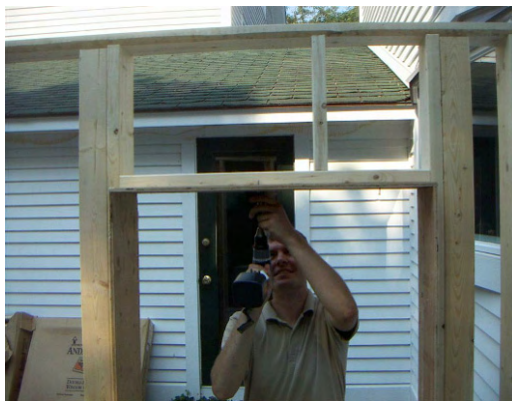
Figure 1.16: Window rough opening, showing "wing" studs as nailers for trim

Another issue was the placement of framing members required as a nail base; for instance, the furring that supports the exterior window casing requires the "wing" studs shown in Figure 1.14 and A-13.4 in the plans. Similarly, attaching the siding cornerboards required some pre-planning, to ensure that there was a bearing surface and nail penetration for the boards (see Figure 1.17).

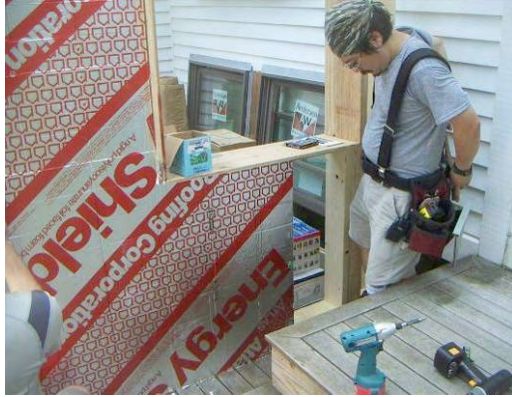
Figure 1.18: Plywood “box” liner at window rough opening for 4” foam wall

Window: With 4" of foam exterior to the frame wall, window attachment quickly becomes an issue, as there would be inadequate structural support for the window. The solution was to build a plywood "box" (with metal reinforced corners) inside the rough opening, which is sized for this reduced dimension (see Figure 1.7, Figure 1.8, Figure 1.18 and A-13.4). The window is placed at the outside edge of the wall, which simplifies integration into the drainage plane (exterior face of the foam, in this case).

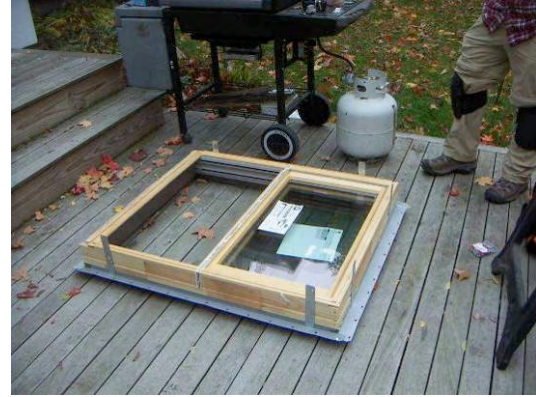
Figure 1.19: Metal strap attachment for window-to-frame connection

During the mockup installation, one issue was the fastening of the window: using 6" screws at the manufacturer's spacing (every other flange hole) was quickly deemed to be expensive, slow, and questionably effective. After some deliberation, an alternate detail was developed, as shown in Figure 1.19: metal straps are attached to the side of the window, and screws are driven laterally through the straps into the framing. This installation is essentially identical to window installation into a masonry opening.

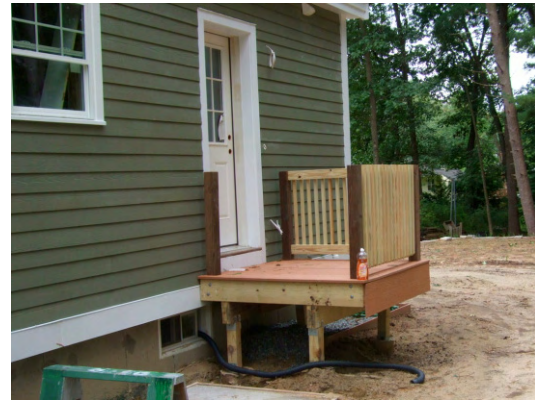
Figure 1.23: Constructed detail for deck support (exterior foundation pier)

Deck/porch attachment: Again, the use of very thick foam insulating sheathing results in difficulties when attaching a porch or deck to the rim joist. Several options were developed and drawn up, including a wood spacer, casting of “pilasters” to the exterior of the concrete foundation wall (see Figure 1.22), and using pier foundations exterior to the foundation wall. This final option was what was implemented by the Habitat for Humanity crew, as shown in Figure 1.23.

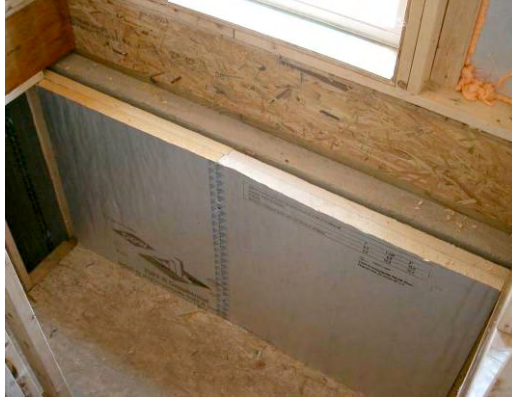
Figure 1.24: Basement foam at stairwell (pre air sealing)

Both of these problems were solved with the final design of the assembly: pressure treated 1x2 furring strips were directly attached to the concrete wall, creating a drainage space which was directed into the sub-slab gravel field. The two layers of 2” foam were then attached to the furring strips using conventional wood fasteners (see Figure 1.24 and Figure 1.25), and metal roofing washer plates (see Figure 1.39). These washers also provided a layer to which the gypsum board fire protection board could be attached. Of course, it was vital to ensure that the drainage cavity was air sealed from the interior to prevent indoor air quality problems. This was accomplished with spray foam.

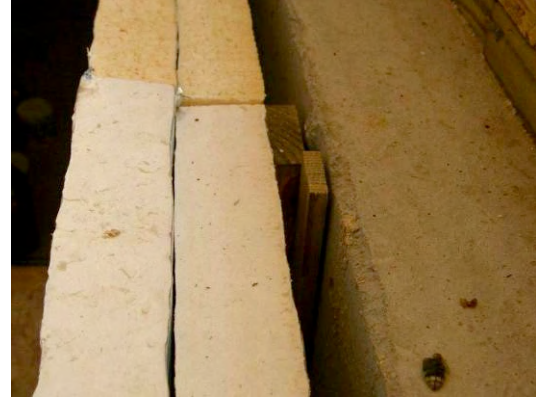
Figure 1.25: Close-up of basement foam detail (pre air sealing)

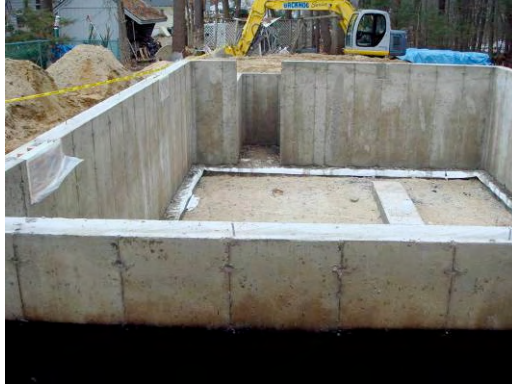
Figure 1.26: Foundation walls

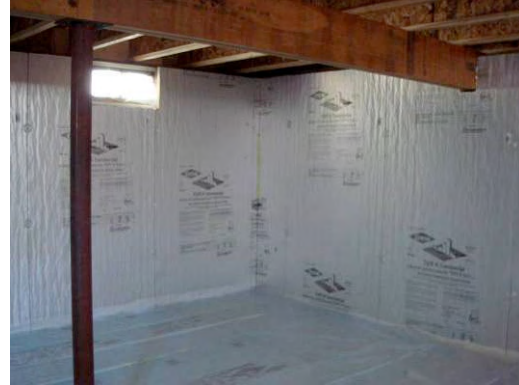
Figure 1.27: Basement insulation

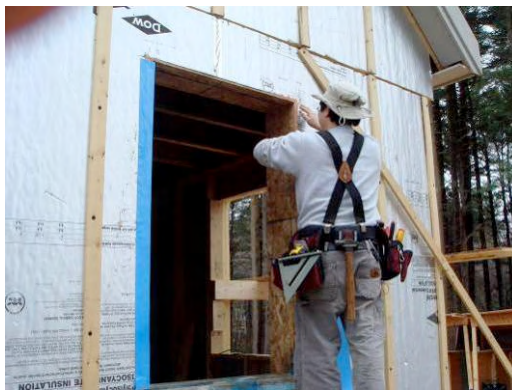
Figure 1.38: Kohta Ueno from BSC flashing a window opening

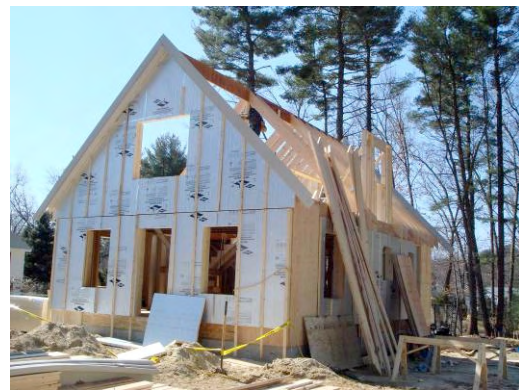
Figure 1.29: Framing, foam and furring strips

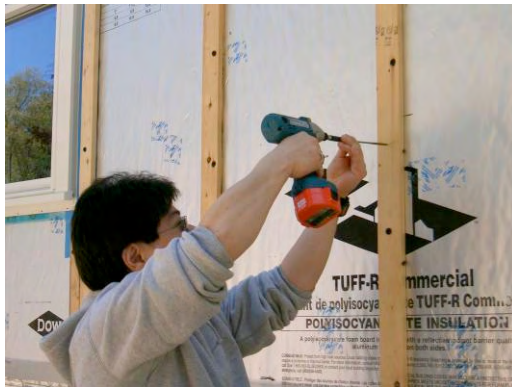
Figure 1.30: Kohta Ueno from BSC testing a furring strip fastener

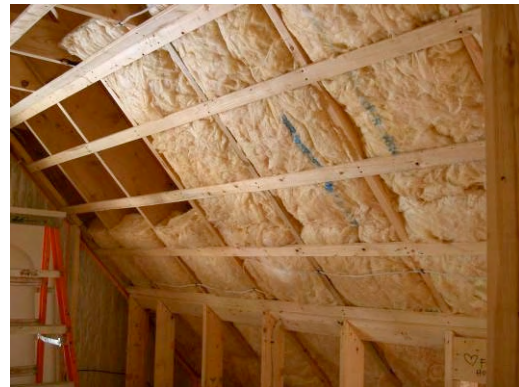
Figure 1.31: Roof insulation

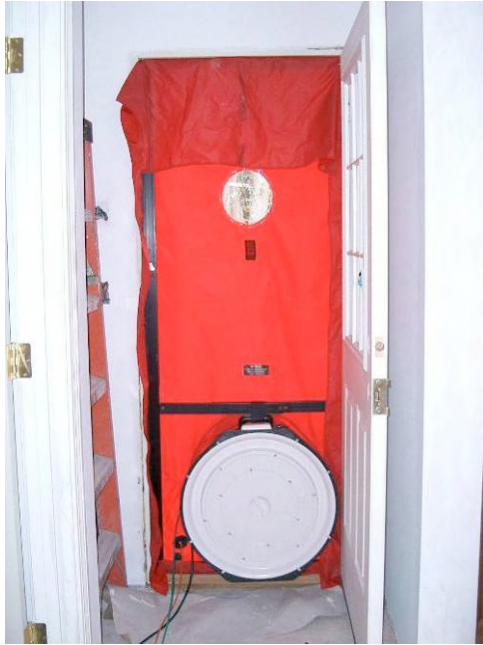
Figure 1.32: Blower door testing

The team has performed the standard battery of performance testing, including overall air infiltration (blower door), duct leakage (total and to exterior), HVAC system static pressure and overall flow, HVAC register flows, room pressurization, and ventilation system flows. See Performance Test in Table 1.3: Enclosure Specifications and Table 1.4: Mechanical system

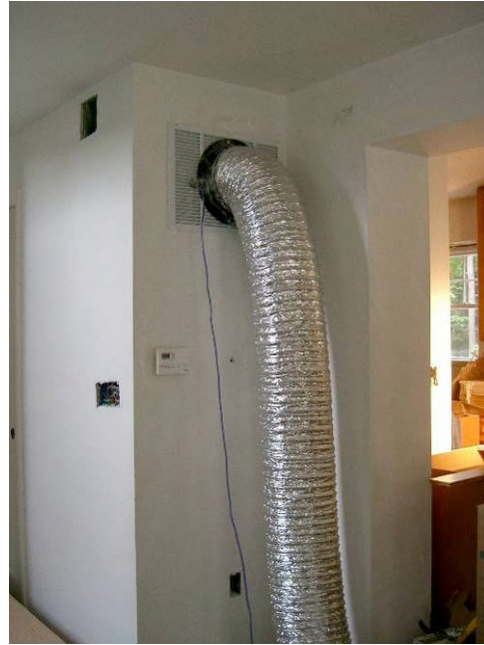
Figure 1.33: Duct Blaster® testing

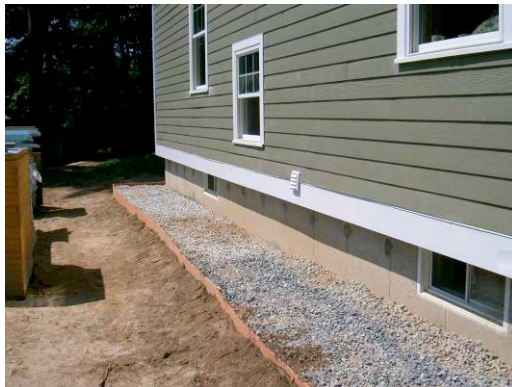
Figure 1.34: Gravel drainage and “no-planting zone” perimeter

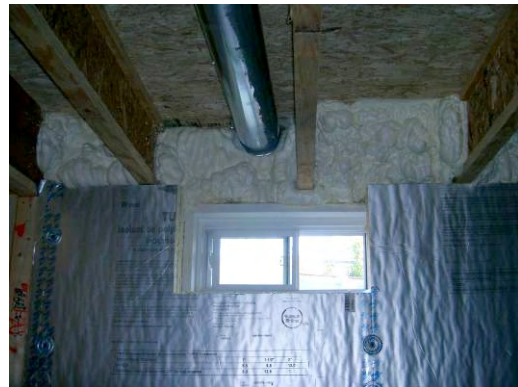
Figure 1.35: High density spray foam air seal around enclosure penetration

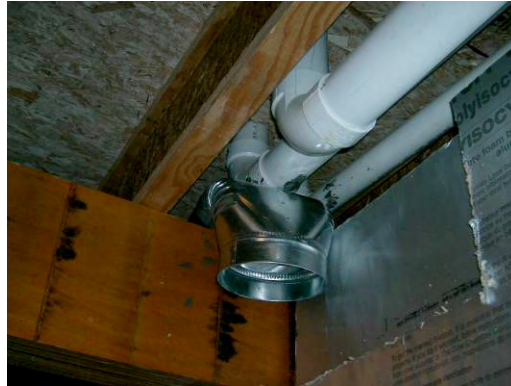
1. **Ductwork and Plumbing:** The plumbing and the ductwork competed for space at the ends of the home since there is 4" of foam on the inside face of the concrete foundation wall. The next house drawings should show both the plumbing locations in addition to the ductwork locations that we already show on the plans. See Figure 1.36 below.

Figure 1.36: Plumbing, ductwork and foam in joist bay

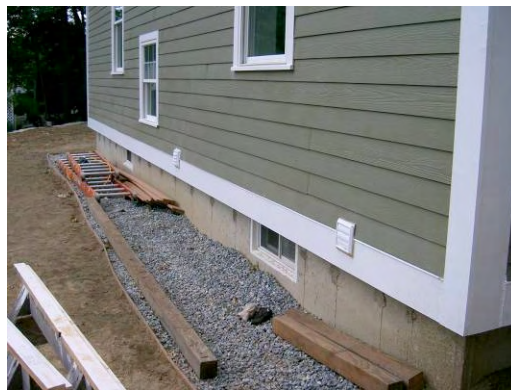
2. **Intake and Exhaust Locations:** Since the home has a small footprint and vents were required for the hot water, furnace and ERV intakes and exhausts as well as the dryer out through the rim joist area, special attention needed to be paid to the vent locations in relation to walkways, windows, doors and utilities in order to meet code. For future houses, it would be necessary to have an accurate site plan from the builder locating proposed driveways and walkways to ensure venting locations would not interfere with these site items. And while the plan may meet the building code, the local building inspector may have additional requirements and changes. In the case of the Westford House, the inspector asked to have 4' between the gas main and the dryer vent; while the code deferred to the dryer manufacturer's instructions that indicated 2' would be sufficient. See Figure 1.37 below and SK-02 located in the Appendices section of this report.

Figure 1.37: ERV intake and exhaust

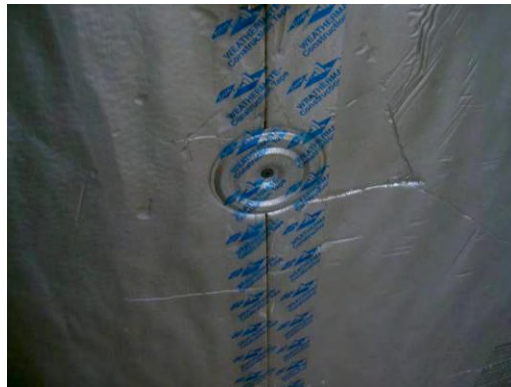
- Basement Foil-Faced Foam Installation:** The 4" of foil-faced foam was difficult to attach to the concrete foundation wall. Therefore, wood furring strips were fastened to the foundation wall and the foam was then attached to the furring strips using roofing washers. This worked out reasonably well and the team would likely use this same detail in future projects. See Figure 1.39 below.

Figure 1.39: Roofing washers fastening foil-faced foam to furring strips

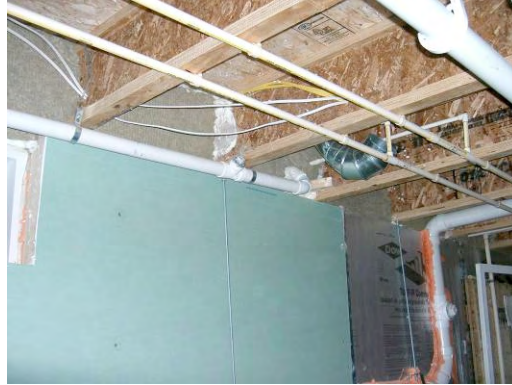
- Basement Foil-Faced Foam Thermal Barrier:** The foil-faced polyisocyanurate installed in the basement could not be left exposed to the interior without a thermal barrier. It should be noted, however, that a different type of foil-faced polyisocyanurate (Dow Thermax) is rated to be left exposed (ICC-ES NER-681). To solve this problem, the team suggested installing 1/2" gypsum board over the foam to serve as the thermal barrier, using drywall screws driven into the metal roofing washers mentioned previously. A paper-faced mold-resistant gypsum board was used. See Figure 1.40 below.

Figure 1.40: Gypsum board over foil-faced foam

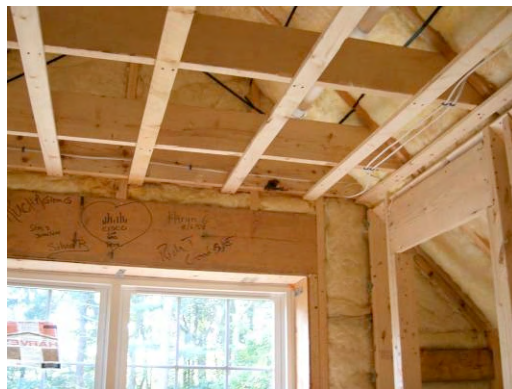
- Air-Barrier Above Second Floor Ceiling:** The original design of the air barrier at the second floor ceiling was to run the drywall (air drywall approach) on the underside of the rafters. However the collar ties and strapping for the second floor ceiling were installed before this drywall was installed, as seen in Figure 1.41 below. With the strapping installed, it would have been very difficult to install the drywall. Even without the strapping installed, the drywall would have to have been cut and notched around the collar ties to serve as an effective air barrier. The air barrier plane was transitioned from the interior gypsum (on the first floor) to the roof sheathing, with foam sealant at the soffit.

However, during testing of the house, we saw a significant amount of air leakage in the attic coming in through the soffit at the second floor dormer (as discussed in Appendix E1. In the future, details are required for a more effective air-barrier without using drywall above the collar ties. See Figure 1.41 below.

Figure 1.41: Second floor strapping and collar ties

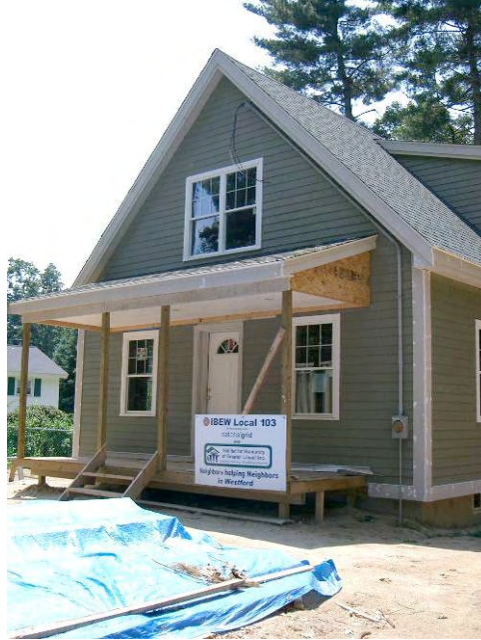
- Electrical Service Entrance:** The main electrical box and wires are located on the front of the house and run up the side of the house and along the front gable wall. Aesthetically, the team would have preferred not to have the wires on the front of the house. For future houses, it would be necessary to have an accurate utility plan from the builder locating utility connections to the house to ensure utility connections would be in our preferred locations (if the site allows). See Figure 1.42 below.

Figure 1.42: Electrical service on front of house

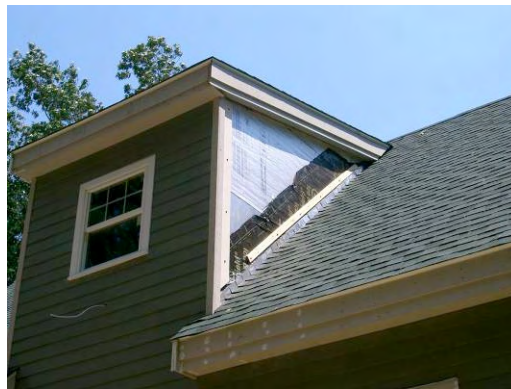
9. **12:12 Roof Pitch:** The 12:12 roof pitch and the dormers were difficult for the volunteer crew to build. Not many volunteers wanted to go up on the steeply pitched roof to work on the roofing and dormers, see Figure 1.43 below. The next house plans to be built in Bedford will have lower sloped roofs and not have any dormers, to accommodate Habitat's volunteer labor force.

Figure 1.43: Dormer

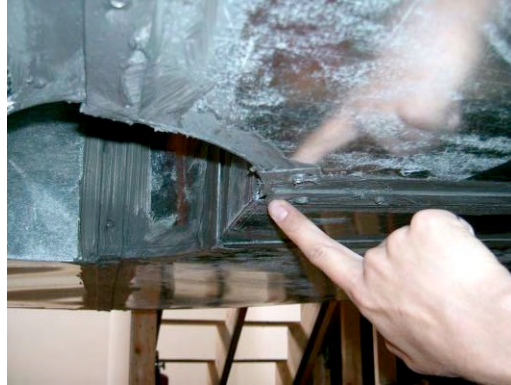
perimeter of the window with a caulking gun. There were gaps in the seal that would affect the air-tightness of the home. Other volunteers were using mastic to seal the sheet metal ducts and left holes that required a second application of mastic, see Figure 1.44 below. For future houses, it would be necessary to have more demonstrations with the volunteers being sure to explain how their work affects the home's performance. It is time consuming to have to repeat tasks and there is always the possibility that the builder may forget to go back. It is also necessary to continue to have good communication between the team and the builder to ensure we are on site at critical times.

Figure 1.44: Air leakage location in sheet metal duct

During testing, the leakage to exterior was small enough to be immeasurable. However, total duct leakage was still high (145 CFM, or 20% of nominal flow), which is typical for sheet metal systems. Despite multiple attempts at air sealing with mastic, these results were not reduced during this project; yet register flows were still within specified ranges.
