Building Smaller, Building Better: Getting to Net Zero Ready by Design

Betsy Pettit, FAIA
Building Science Corporation
www.buildingscience.com

BETTER BUILDINGS BY DESIGN CONFERENCE
Burlington, VT February 12, 2009

Retrofit of Existing Farmhouse into a 2 Story Single Family Home with 3 Bedrooms and 2.5 Baths

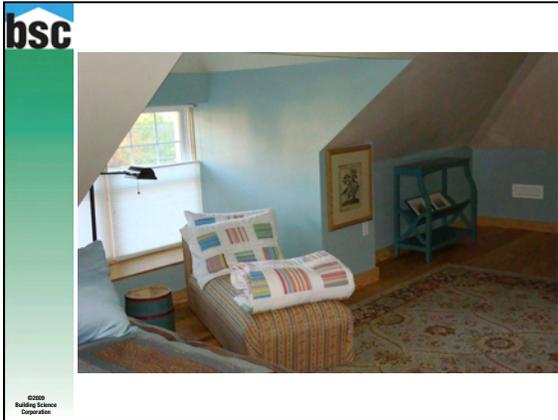
Existing Farmhouse

The Farmhouse is located in a Cold Climate, Climate Zone 5A (5596 HDD, 5358 CDH)
