Building Smaller, Building Better: Getting to Net Zero Ready by Design

Betsy Pettit, FAIA
Building Science Corporation
www.buildingscience.com

bsc Westford House Westford, MA

Project Overview

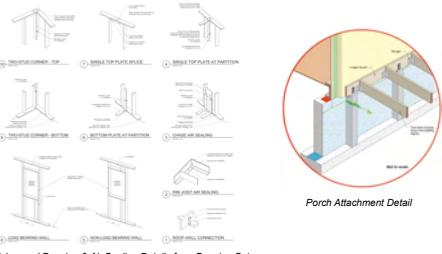
Advanced Framing & Air Sealing Details from Drawing Set

4.5 Air Sealing of Interior Cavities	Fire stopping and caulk are used to seal connections between interior partitions, floor joists and ceiling joists, where walls and floors to prevent air leakage

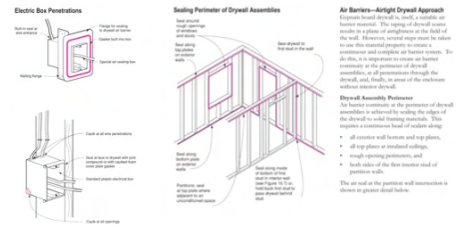
Details from BSC Information Sheet on Airtight Drywall Approach – Reviewed with Drywall Installers
