Deep Energy Retrofit of a Sears Roebuck House: A Home for the Next 100 Years*..... 13 Years Later

Betsy Pettit, FAIA Buildingscience.com betsy@buildingscience.com

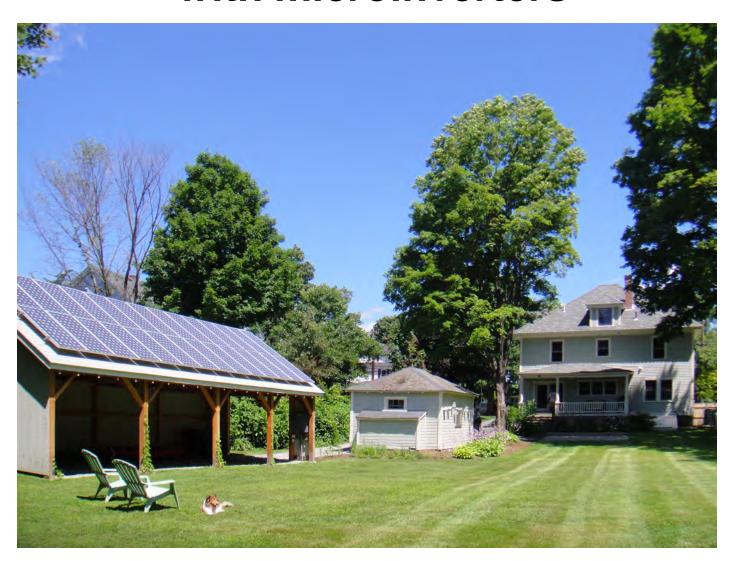
2010 - 4.9 kW PV System – 28 @ 175w panels with microinverters
