SIPs...it's about the joints and more

By: Henri Fennell, CSI/CDT

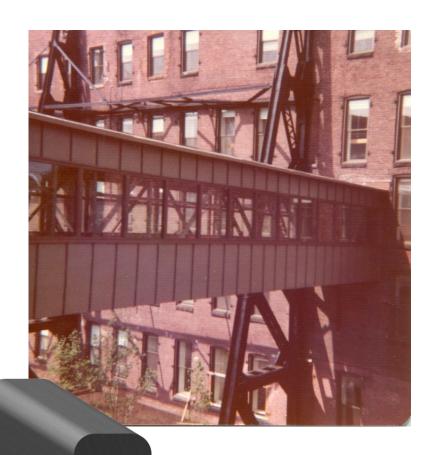
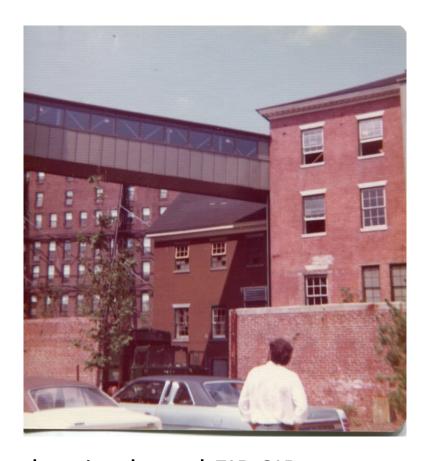
Roll-formed galvanized steel FIP SIPs on new pedestrian bridges in Boston - 1975

Glued rubber cap seals at the standing-rib panel joints

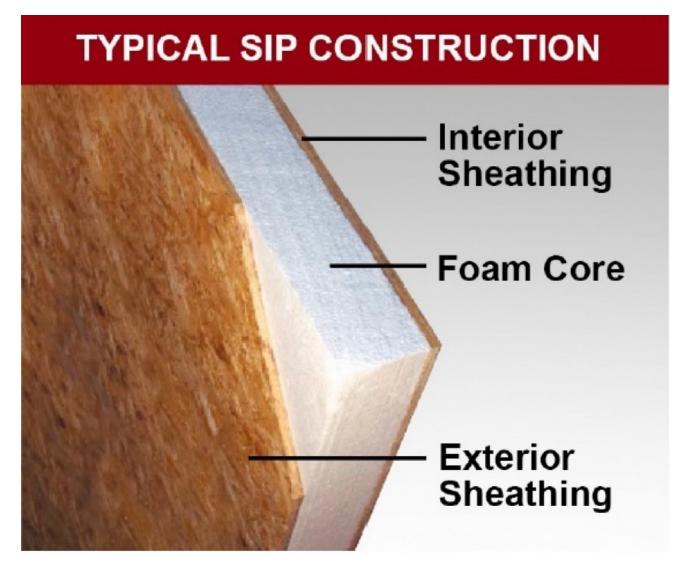
What are SIPs?

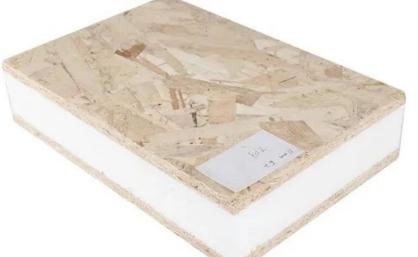
Nailbase products have no tension side; therefore, they are nonstructural and must be supported continuously.

Drywall as the tensionside skin does not provide spans as long as OSB or metal skins.

Double-sided EPS SIPs can span from 8 to 24 feet.

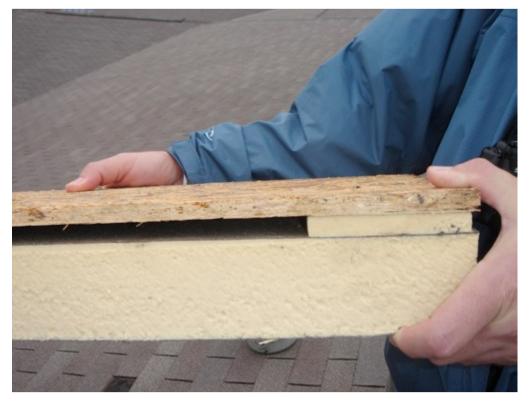
Photograph 8: Vented Foam Panel—The upper panel surface is OSB that acts as a nail base for shingle and other roofing systems.

Vented Laminated Nailbase Panel

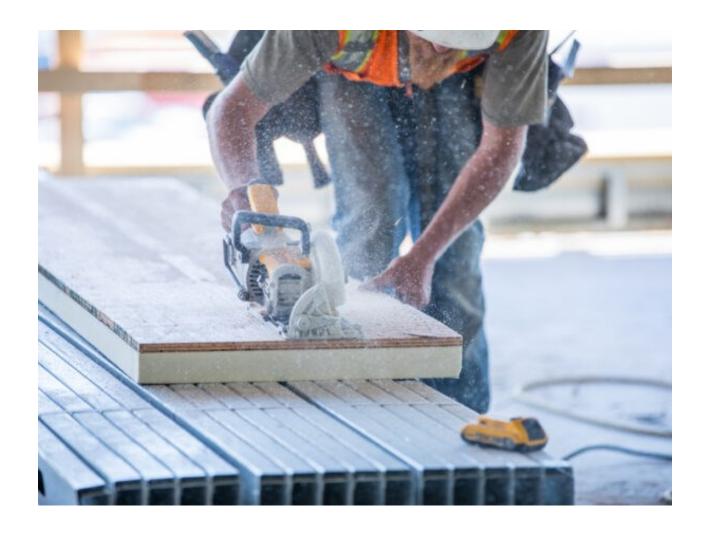
Cutting SIPs to size

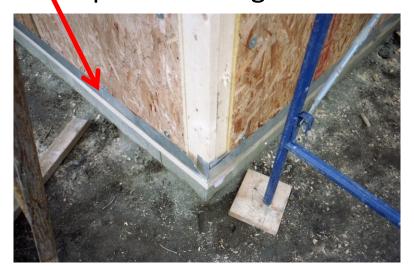
Winter panels spaced approx. ¾"apart

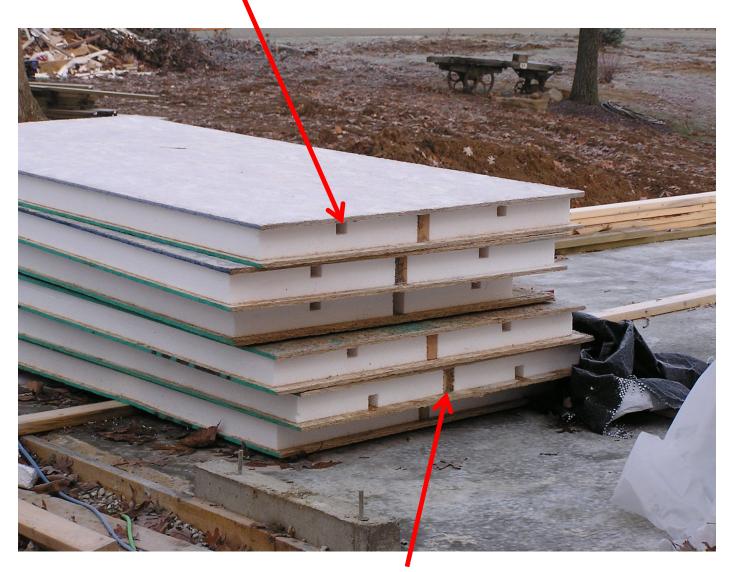
Wiring chases in laminated SIPs

These 4' wide SIPs have 2'-0" O. C. studs

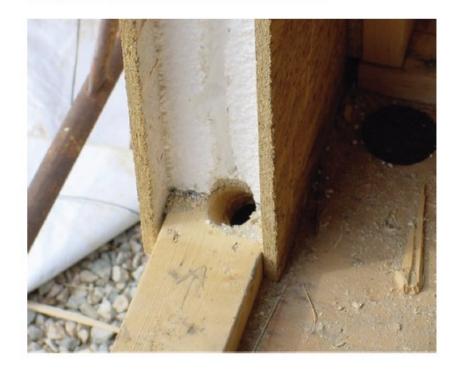
IMAGE 9.2
FLOOR SILL PLATE CHASE CUT OUT TO PASS
FROM SIP WALL TO BELOW FLOOR.

Wiring SIPs

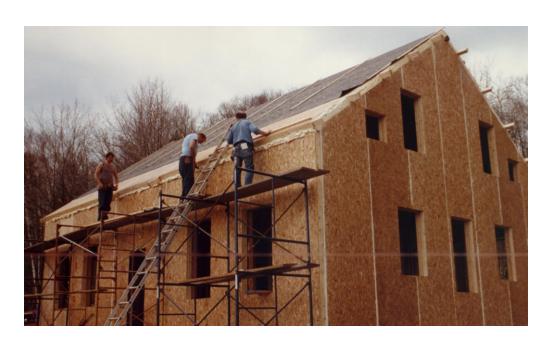
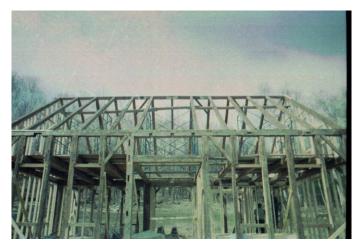
Two days from open frame to enclosed

Pre-manufactured 4' wide
Winter panels – Panels were
ordered in various lengths to
reduce waste – cut more
precisely on site

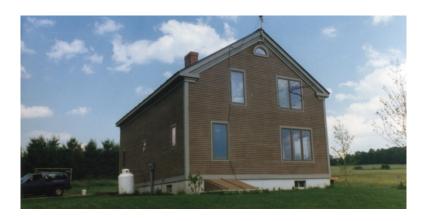
Lyme, NH, 1988

Two days from open frame to enclosed

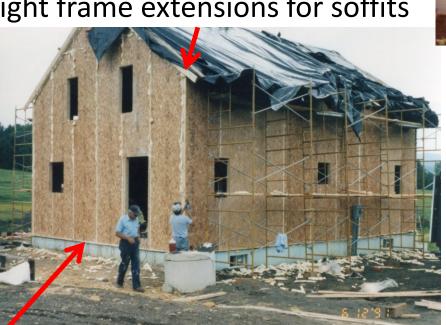
Light frame extensions for soffits

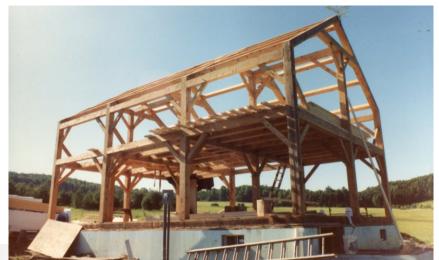
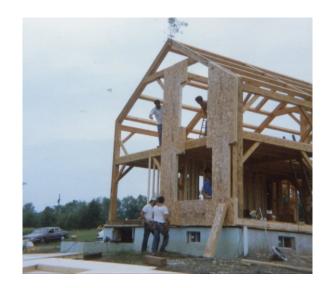
These wall panels cover the rim joists

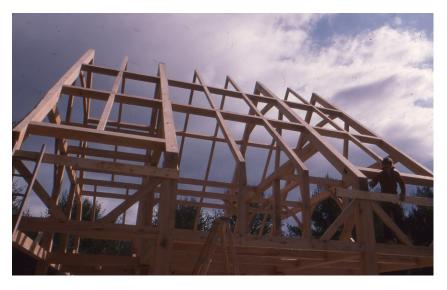
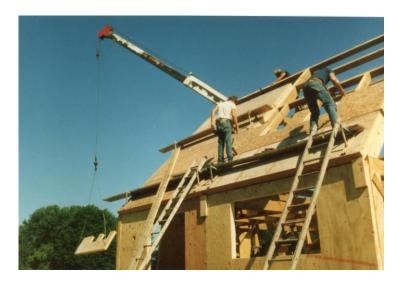
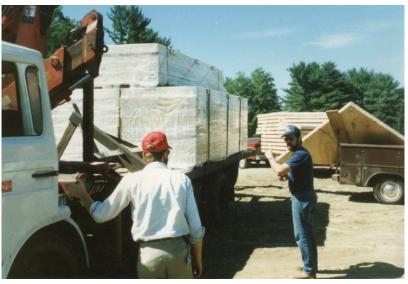
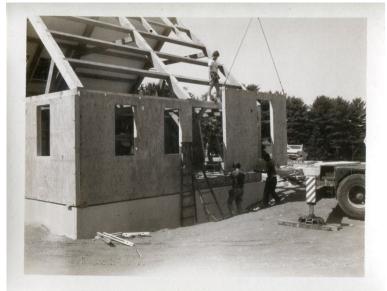
Randolph, VT, 1991

Custom SIPs, Prewired

Shop drawings and electric plans make this work

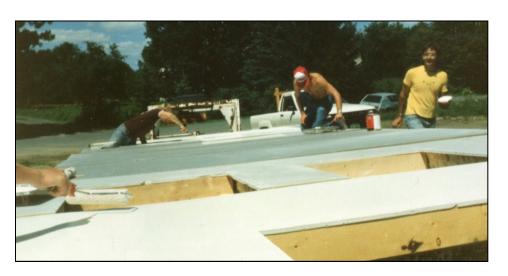
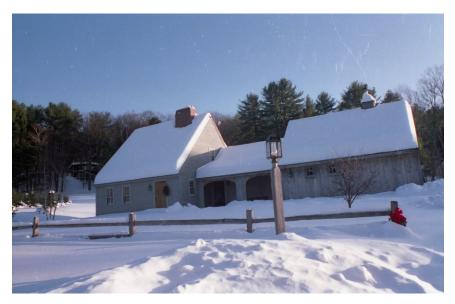
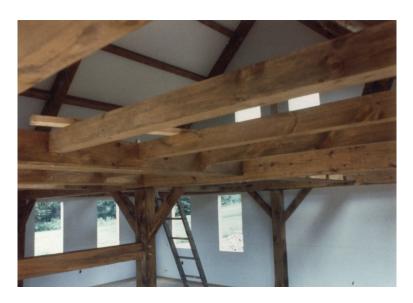
Custom SIPs, Prewired

Pre-painting to avoid cutting in around the posts and beam frame

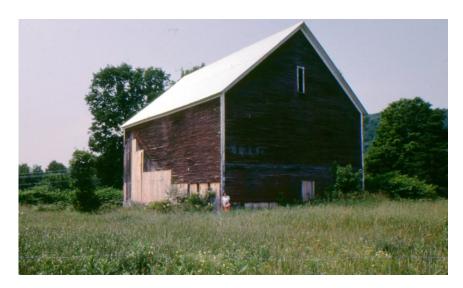
Adaptive reuse – SIPs on an 1800s barn

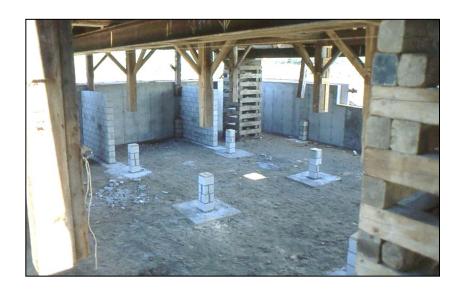
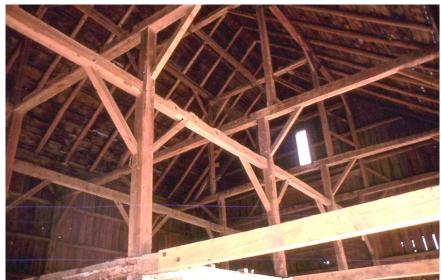
The SIPs were ordered and manufactured during this part of the project schedule

New foundation and guano removal

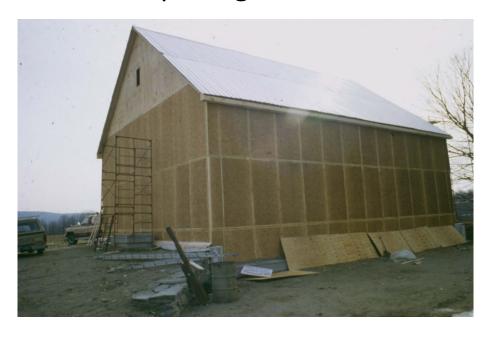
Window openings come next

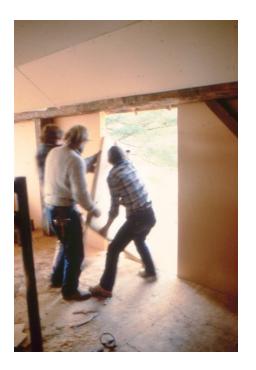
SIPs can be installed without a crane in some cases

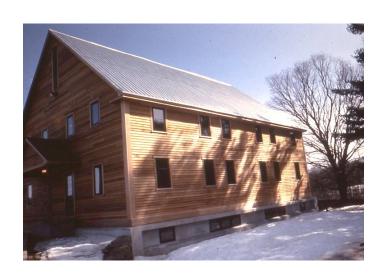
Blower door test result = .06 CFM50/sf

Nearly 100% of space heat is provided by computers, solar gain, and lights (Energysmiths)

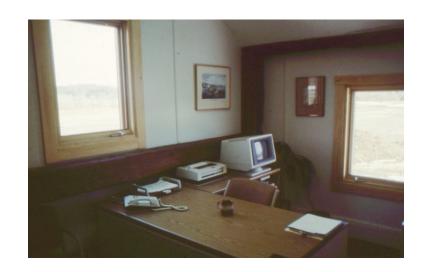
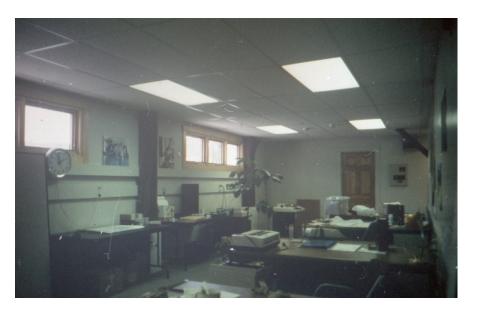
Exterior Nailtab SIP Wall System

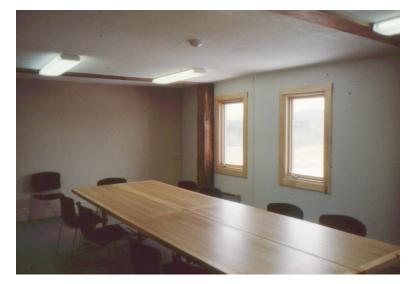
SIPs C-C PUF (6" = R-40)

ACH nat. <.03 (1984) KWH/SM/Yr. <100

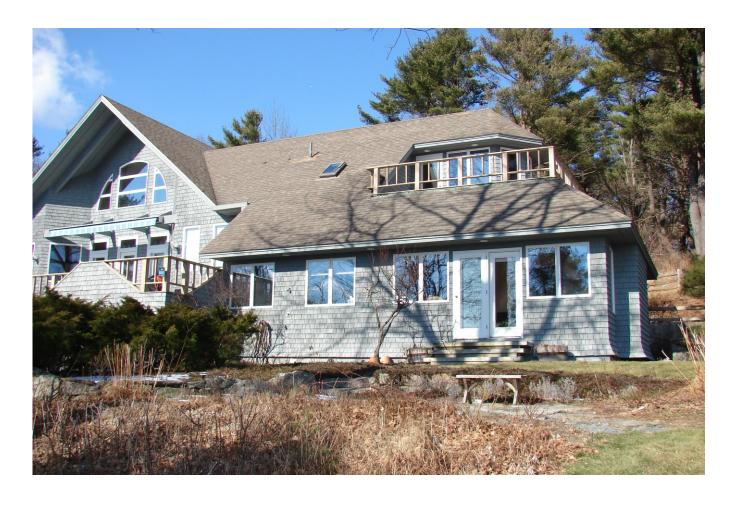
Custom panels for long roof long spans

Structural SIPs with full-thickness panel joint sealants

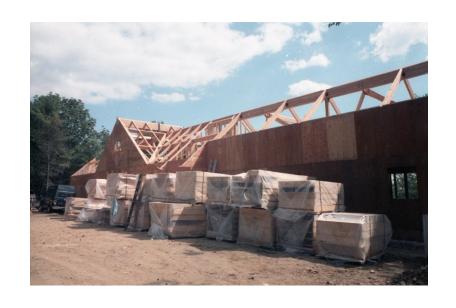
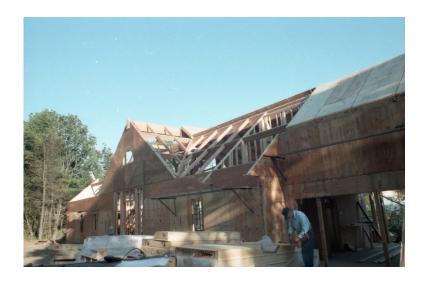
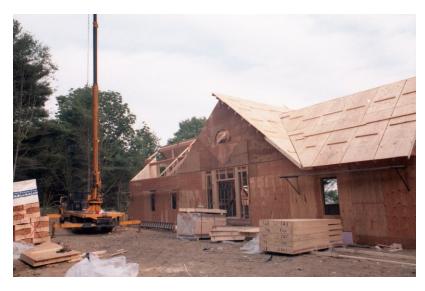
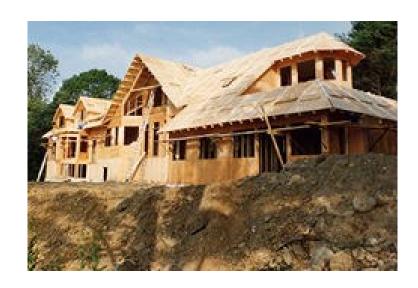
Custom panels for long roof spans

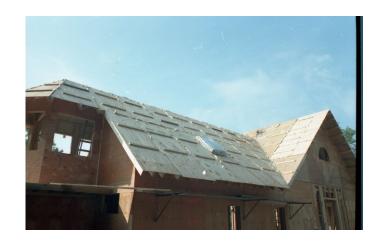
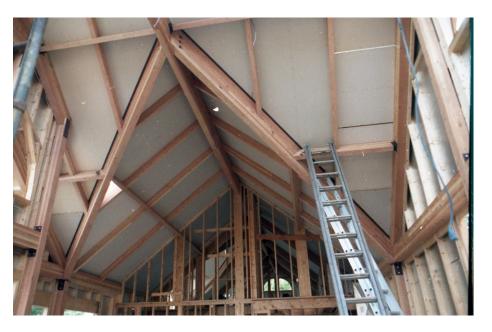
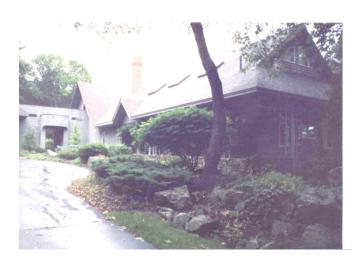
Custom panels for long roof spans

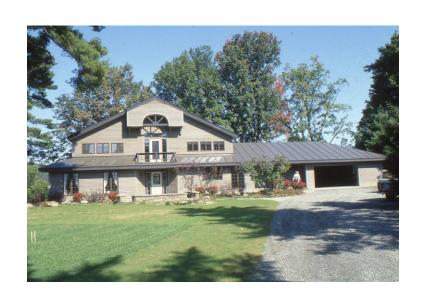
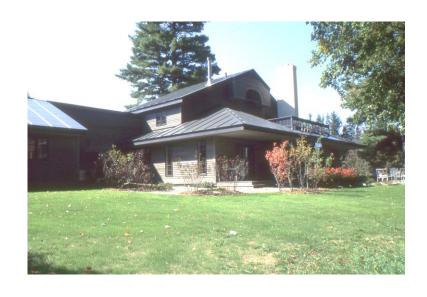
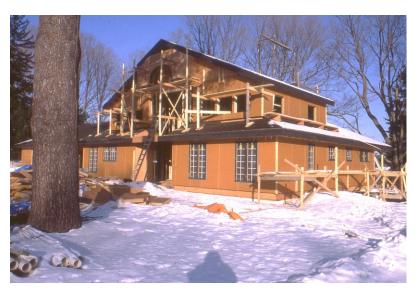
SIPs on stick-framed construction

SIPs attached on the outside of stick framing allows complete flexibility with the utilities in the wall framing space.

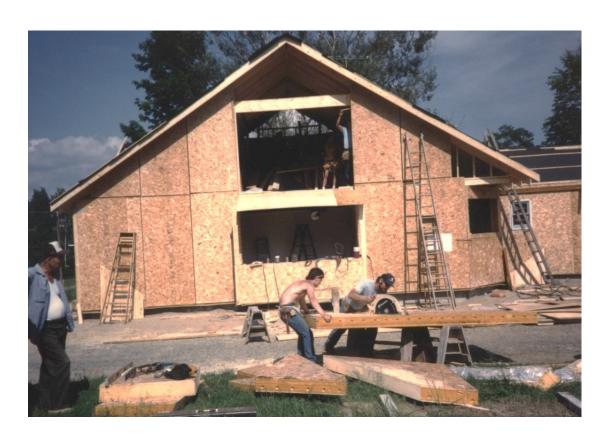
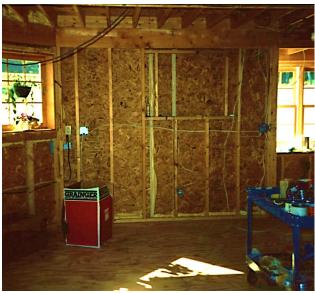
SIPs retrofit of stick-framed residence

SIPs attached to the rim joists and the studs

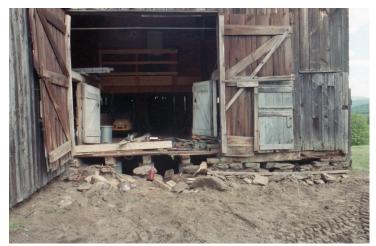
Adaptive reuse – SIPs inside an 1800s barn

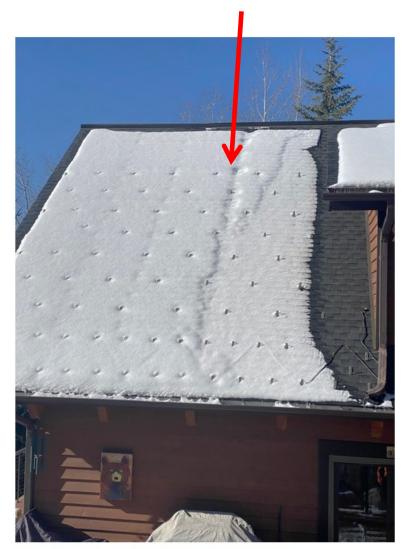
Photograph 1: The vertical snow melt lines correspond with the SIP assembly joints

- First, the lack of air sealing at the lower joint panel connections of the SIP assembly...
- Second, the use of dark shingles over an unvented SIP assembly manufactured with an EPS core.
 EPS experiences dimensional and physical property changes at temperatures above 150 degrees
 F. Dark asphalt shingles regularly exceed 150 degrees F...

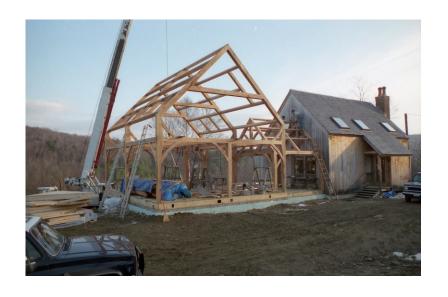
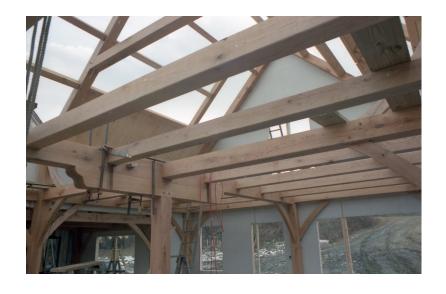
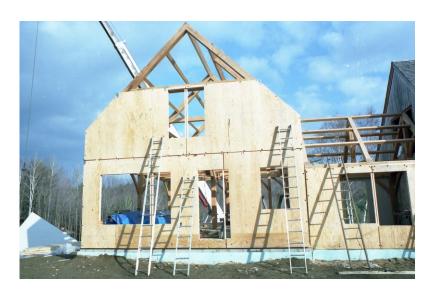
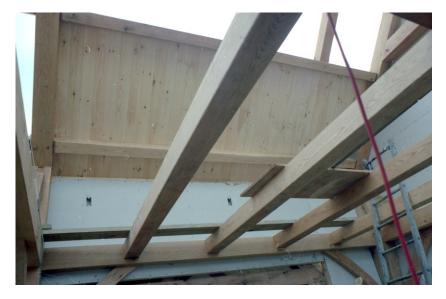
Roof SIPs require a crane

Randolph, VT, 1991

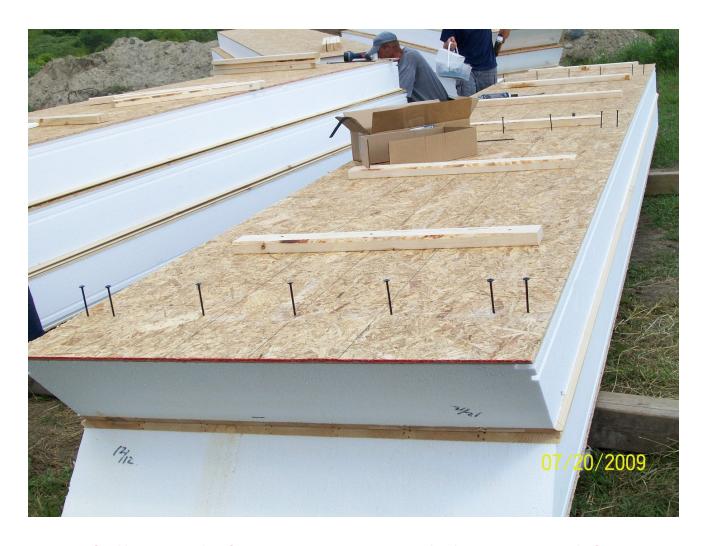
Seven full-depth fasteners at each horizontal framing member, perhaps more along the long edges after installed

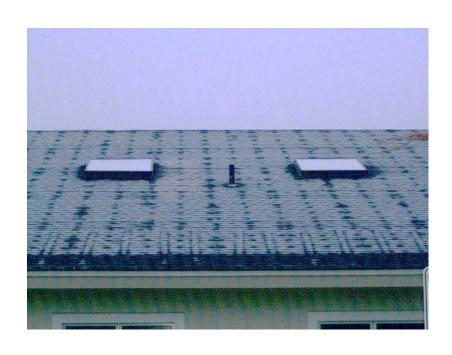
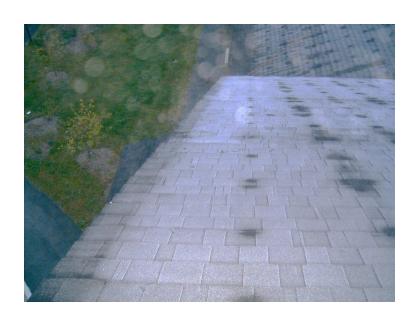
Thermal bridging through full-depth fasteners is seen in the frost melt pattern

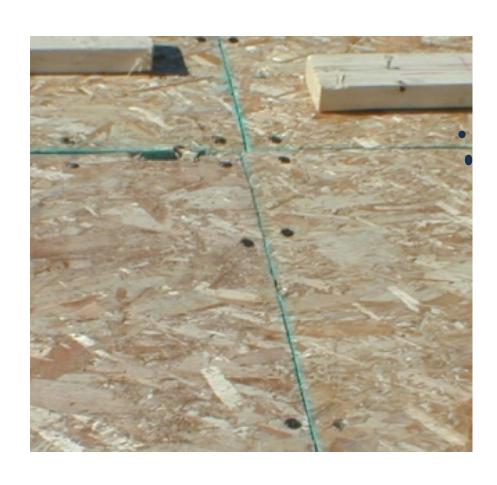
Fourteen full-depth fasteners

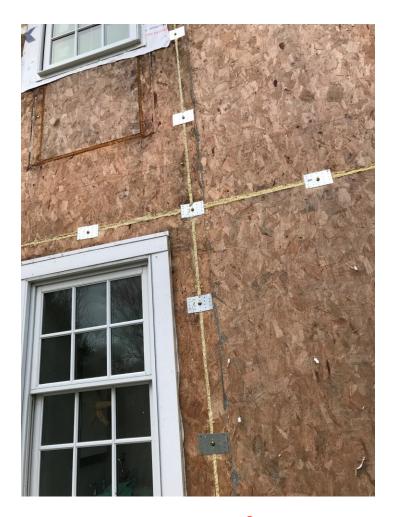
Seven full-depth fasteners

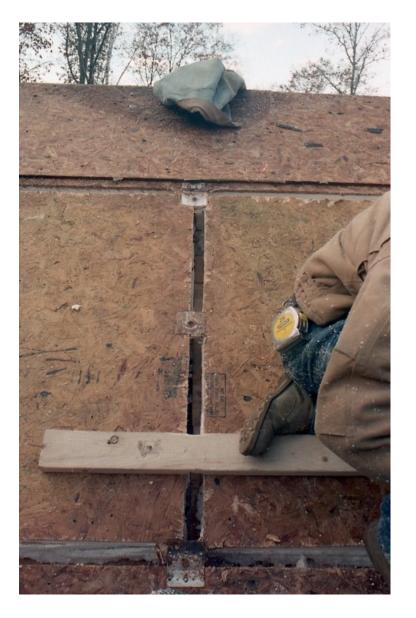
Using truss plates to attach multiple panels with one screw reduces the number of thermal bridges for SIP installations.

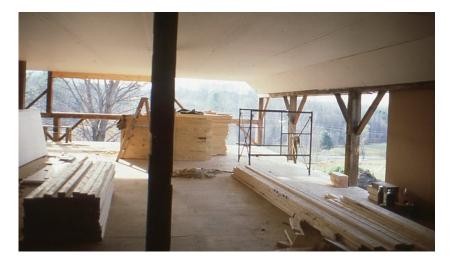
Fewer full-depth fasteners with truss plates

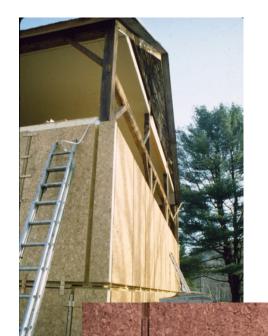
The Nailtab fastening system

Fastening only the inside skin to the frame eliminates thermal bridging.

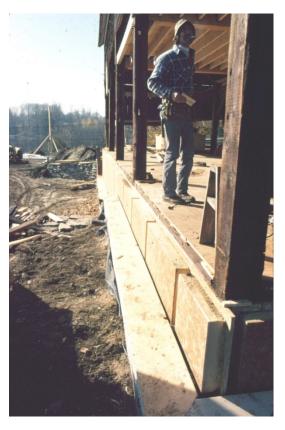
Zero full-depth fasteners

SIPs C-C PUF (6" = R-40)

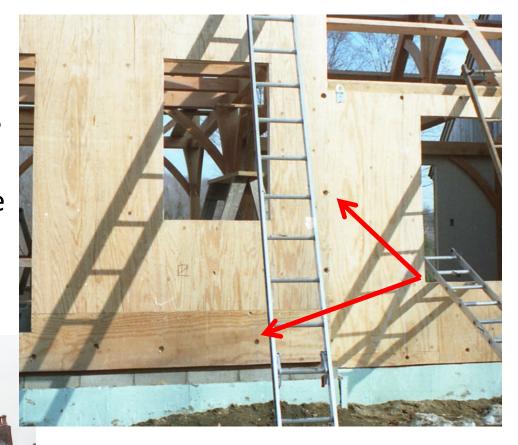
Only the inside skin was attached to the timber frame in this project. The plug fill foam was installed at the same time as the joint seal foam.

1.25" holes drilled through the outside skin and the foam core provides access for attachment.

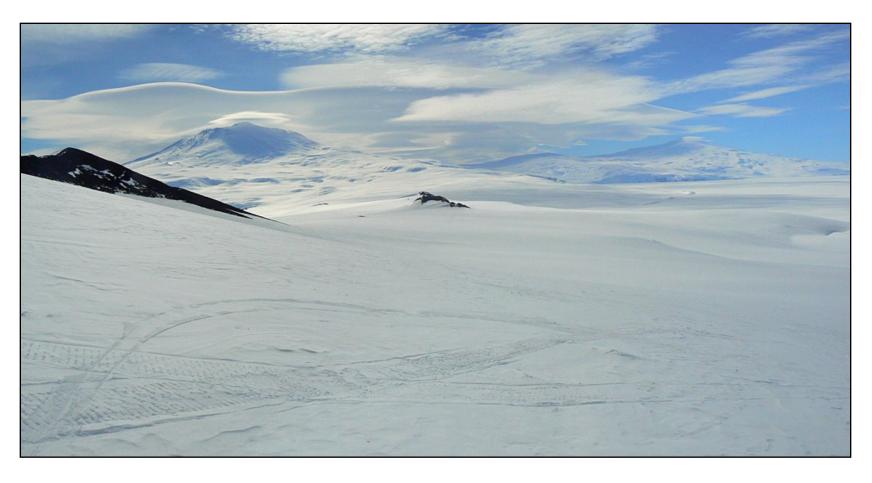
The Summer Environment for the ARRO in Antarctica

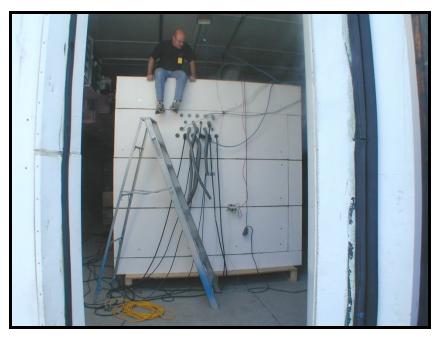
The first ARRO Project being tested at the U.S. Cold Regions Research Environmental Laboratory

~200 watts total energy for –70F outside, 70F inside.

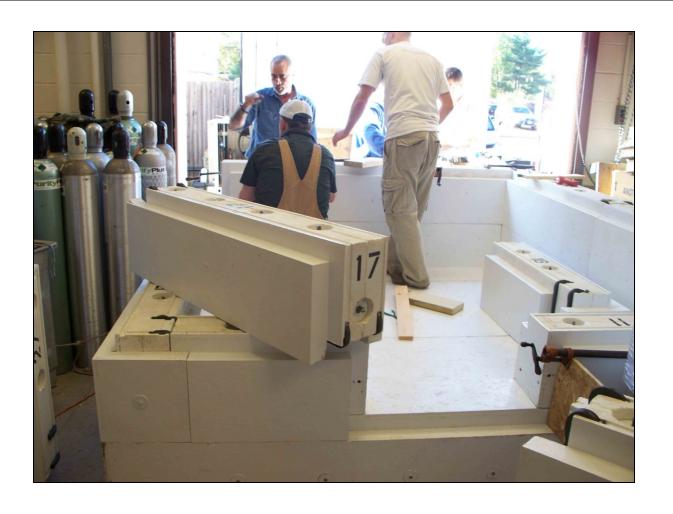
ARRO II has no full-depth thermal bridges

Pre-assembly at the University of New Hampshire Aerospace Department prior to shipping them to Antarctica

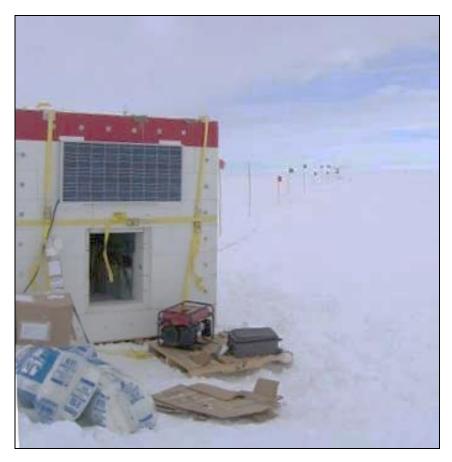
ARRO II has no full-depth thermal bridges

On site at McMurdo in Antarctica 2005

No snow inside in the spring!!!!!

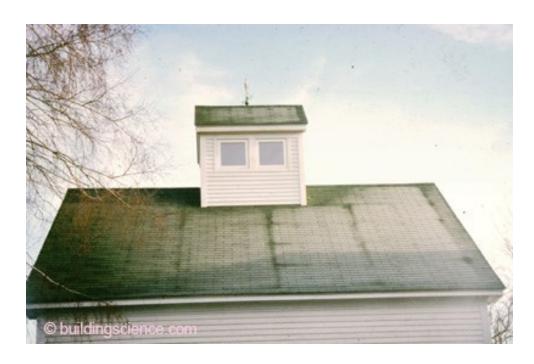
Building Science on Panel joints

Convection – internal

Note melt pattern diagnostic method

Convection – in to out

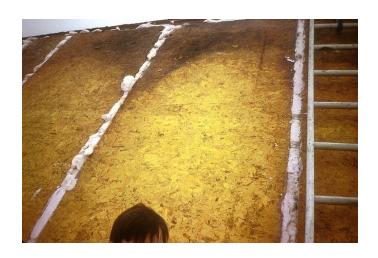
SIP problems are almost always related to sealant issues at the panel joints. Here you can see the concentration of damage along and at the top of the unsealed panel joints.

This pattern of damage is distinctive and can be found in many cold climate SIP roof failures. It can easily be avoided by sealing the panel joints by filling them full depth.

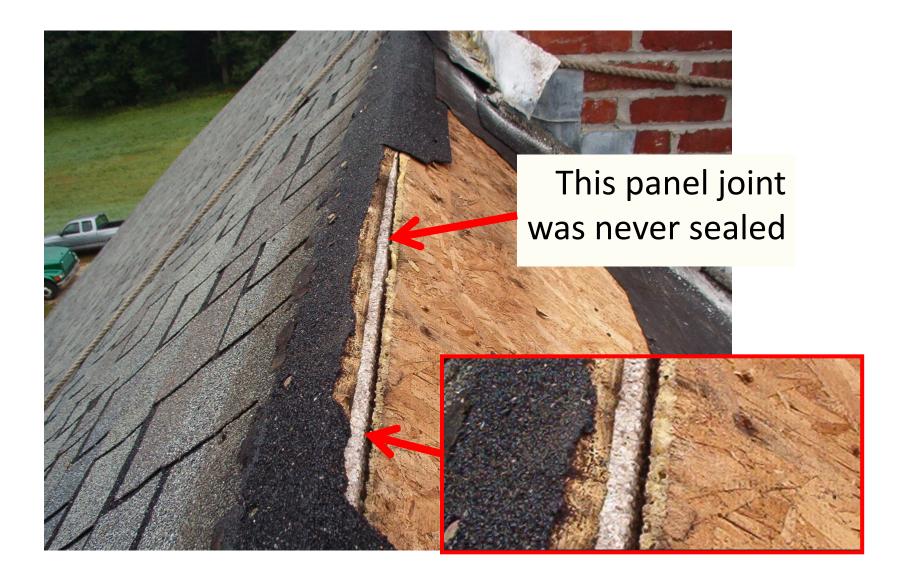
Ridge rot due to open panel joint

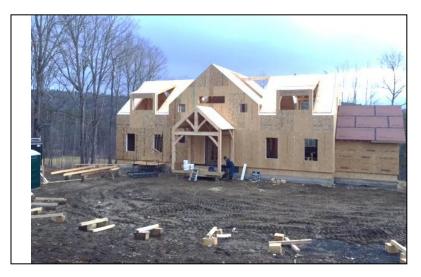
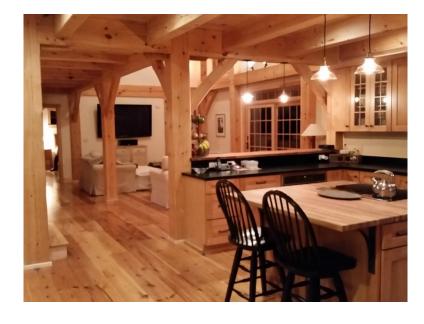
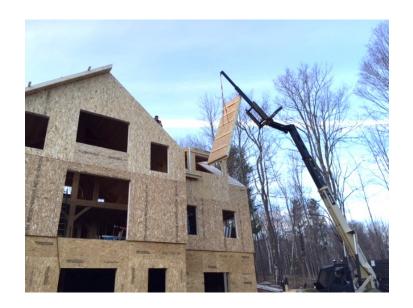
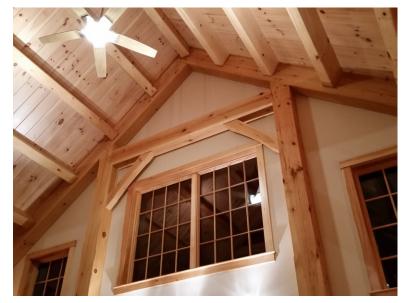
SIP failure due to misapplied foam sealant

Lyme, NH 2017

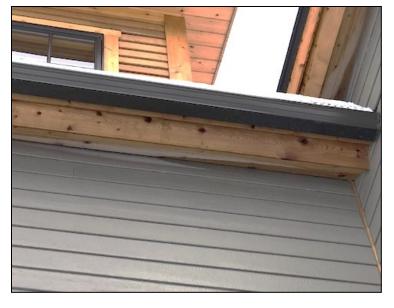
Frost diagnosis

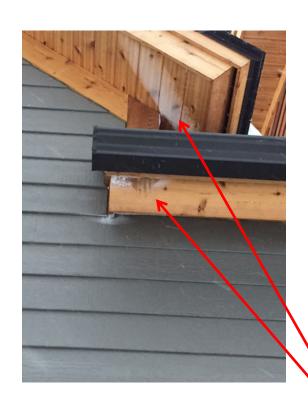
Cold chemicals without moisture don't perform

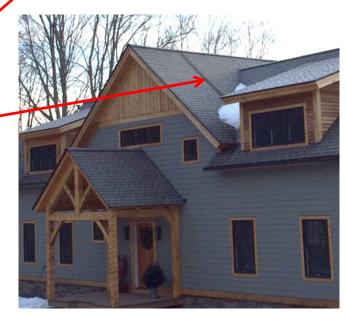
Infrared and daylight frost patterns – failed panel joint air sealing

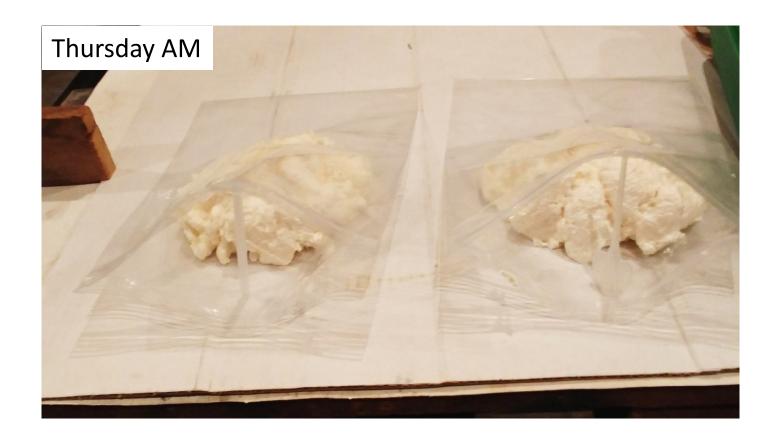
One-component foam sealant

Shot two Ziploc bags from the same gun at the same time on Thursday, then closed the bag on the left.

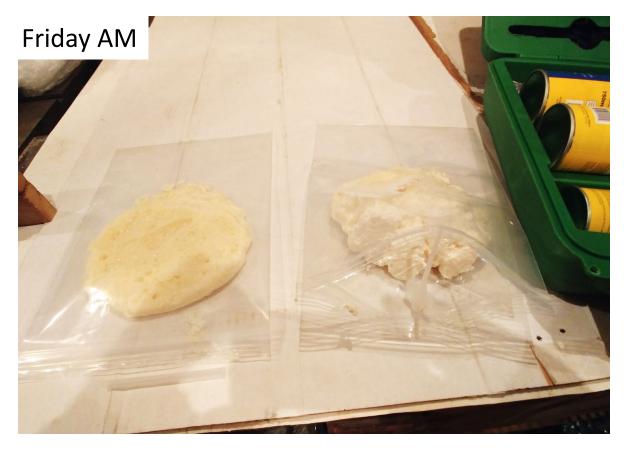
One-component foam sealant

Without moisture

With moisture

By Monday, the bag on the left was just liquid!

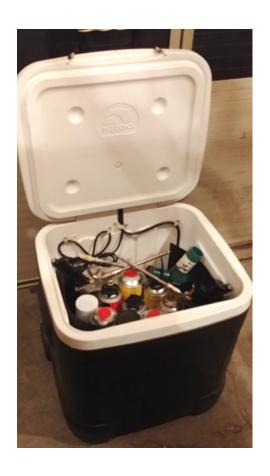
Kits and Cans – Pre-conditioning Cans

Foam conditioning "hot box" for 200 board-foot kits (less than \$100.00)

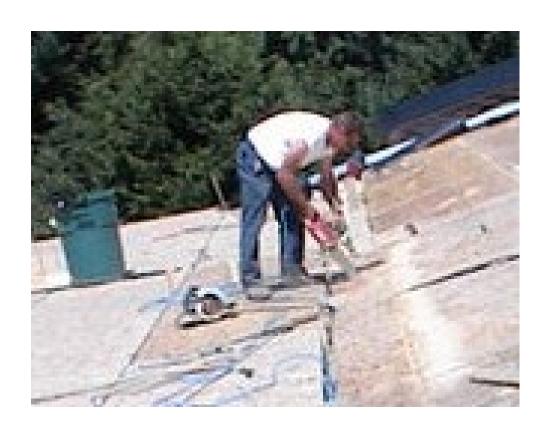
Remediation methods for saving the SIPs

- 1. Create a full-depth panel joint space
- 2. Fill the panel joint to make the seal and eliminate the convection space

Circular saw for the OSB and an electric chain saw typically with a bolt through the bar to prevent the saw from going through to the inside.

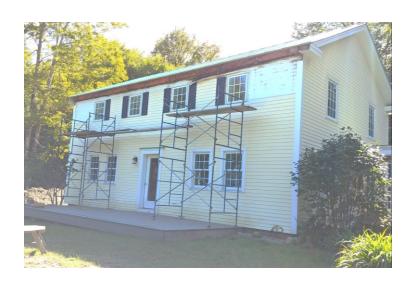
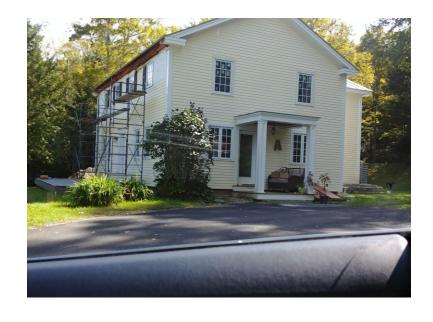
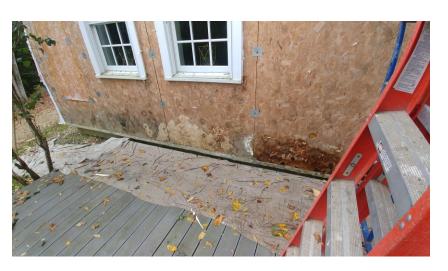
Failing paint, siding, and rotted soffits indicated that there were moisture problems

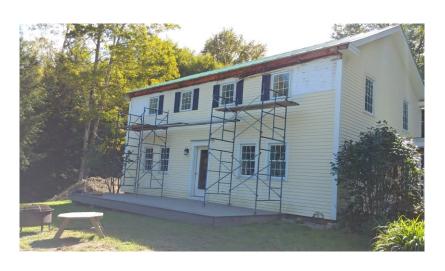
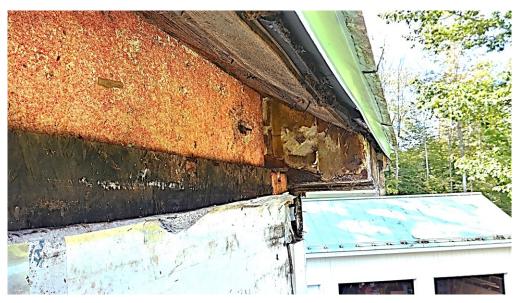
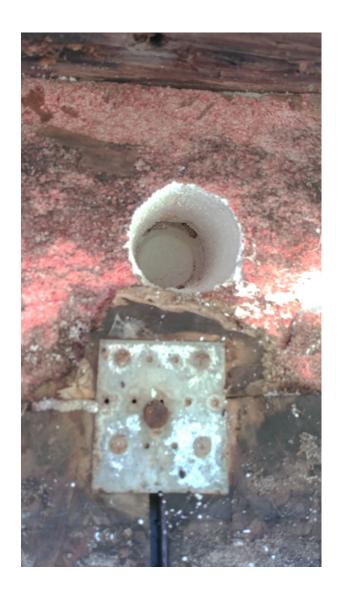
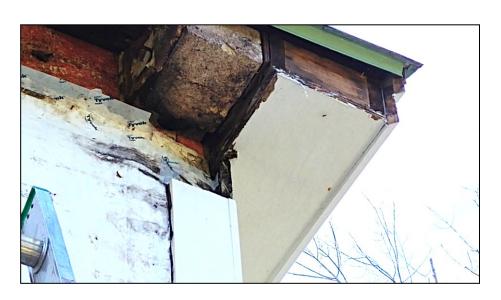
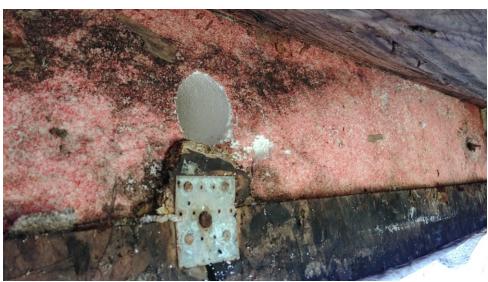
Glue-laminated EPS SIPs

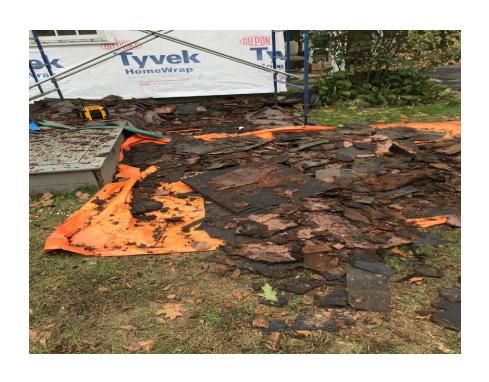
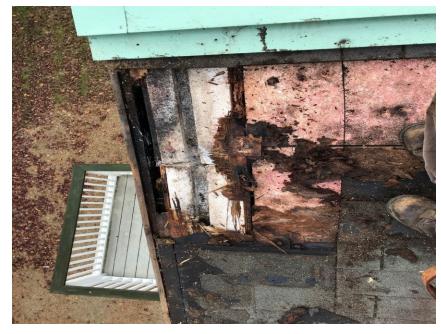
Warm air rises to the top behind the WRB

Fan penetration leaking into the joint gallery and traveling to the unsealed location

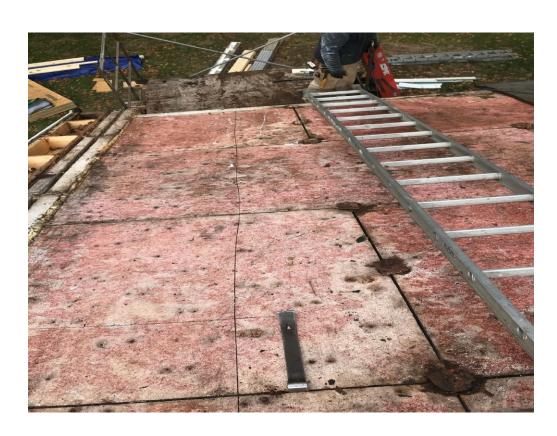
Joints after they are cleaned out

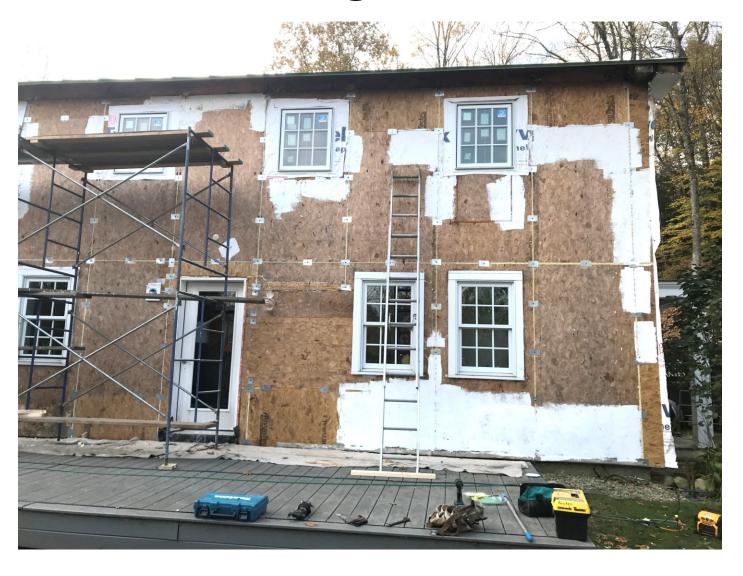
Mold killer coating used in areas with marginal damage

Sealing the joints prior to gluing on the new sheathing

OSB and soffit applique are removed prior to gluing on the new sheathing and the new soffit framing

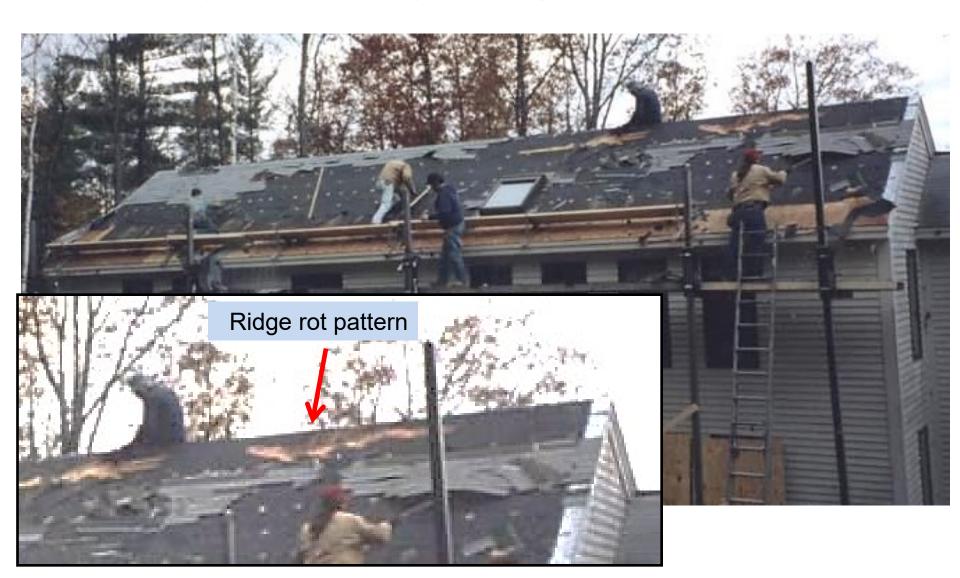
Ridge rot in SIPs

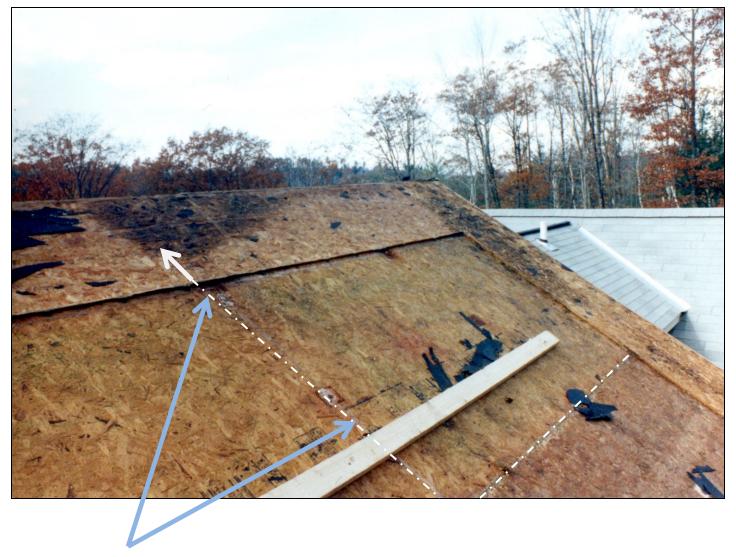
The sealant is not full depth at the vertical joints on this SIP

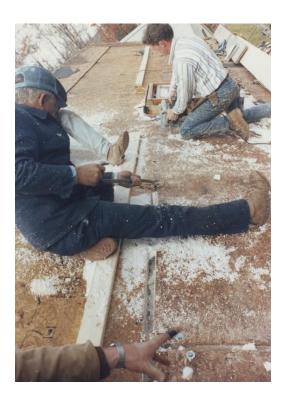
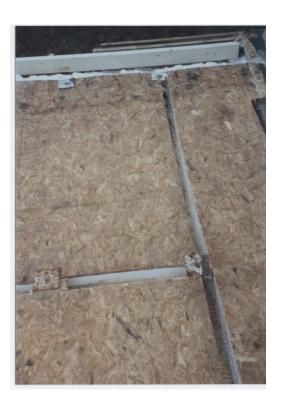
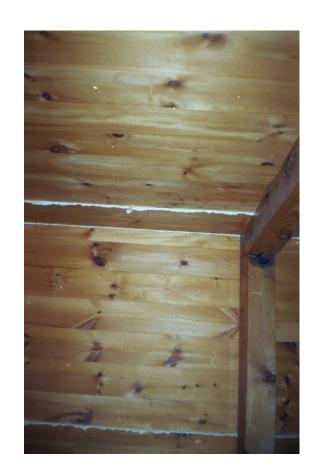
SIP Problems

Here the panel joints are being enlarged and cleaned out to allow full-depth air sealing. The foam beads at the interior seams verify that the panel joints were the air leakage paths that caused the moisture damage.

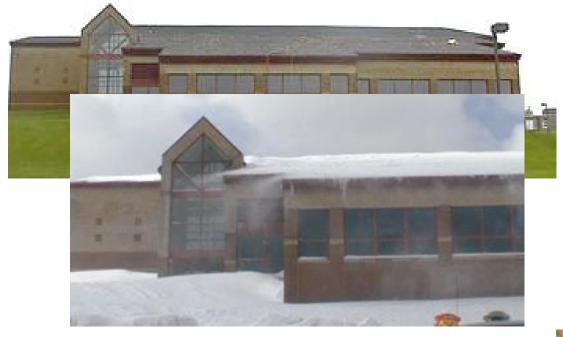
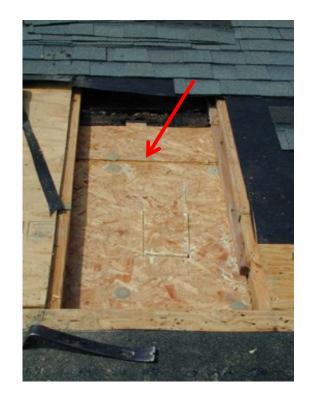
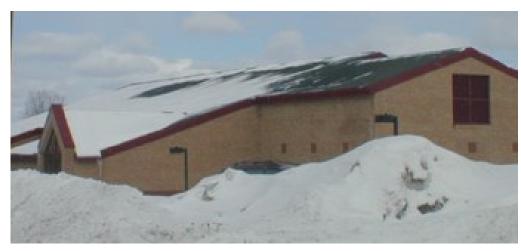
OSB sheathing wrinkles, heat loss, and icing over vented nailbase SIPs

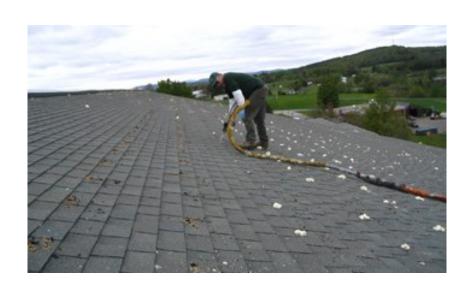
Filling the vent spaces with C-C foam solves the problem

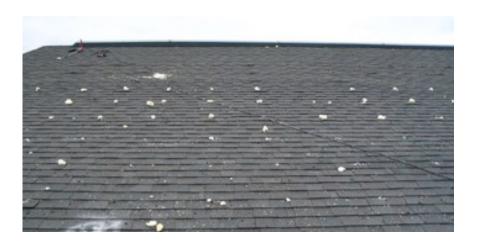
Fill the vent spaces – adds R-value and seals the panel joint air leaks

Filling the vent spaces adds Rvalue and seals the air leaks

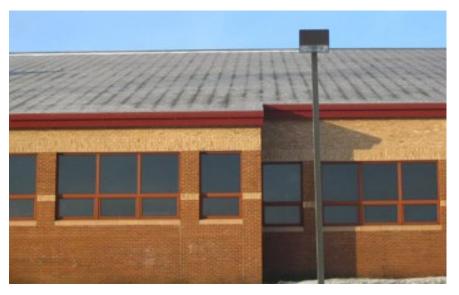
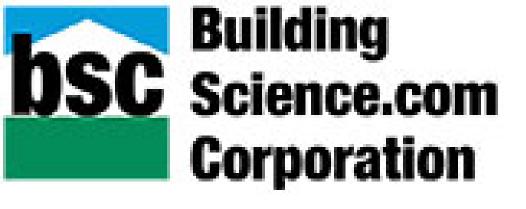
Frost-melt QA after repairs

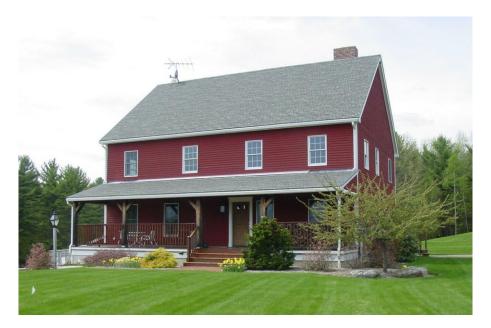
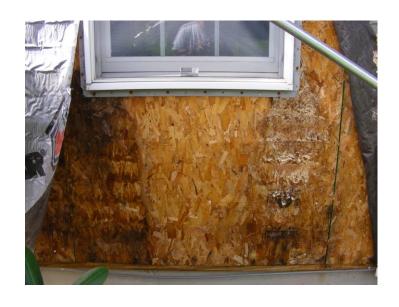
Poor air sealing can cause this damage

It is hard to tell how much of this OSB damage is from open panel joints and how much is from a flashing issue.

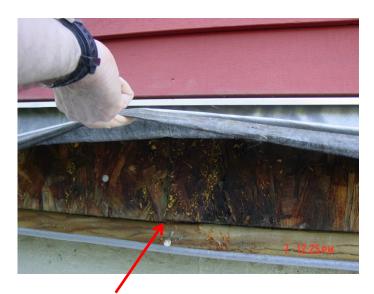
Poor air sealing can cause this damage

No sealant at the sill

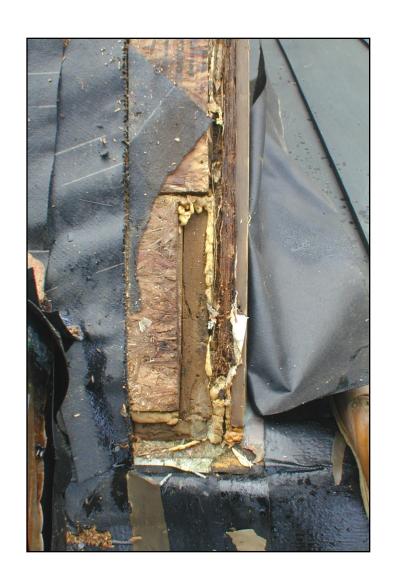
Panel joint galleries

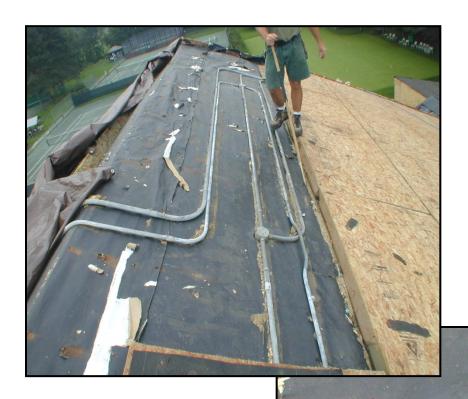
Air/moisture from one penetration can travel throughout panel joint galleries if they are not sealed full depth

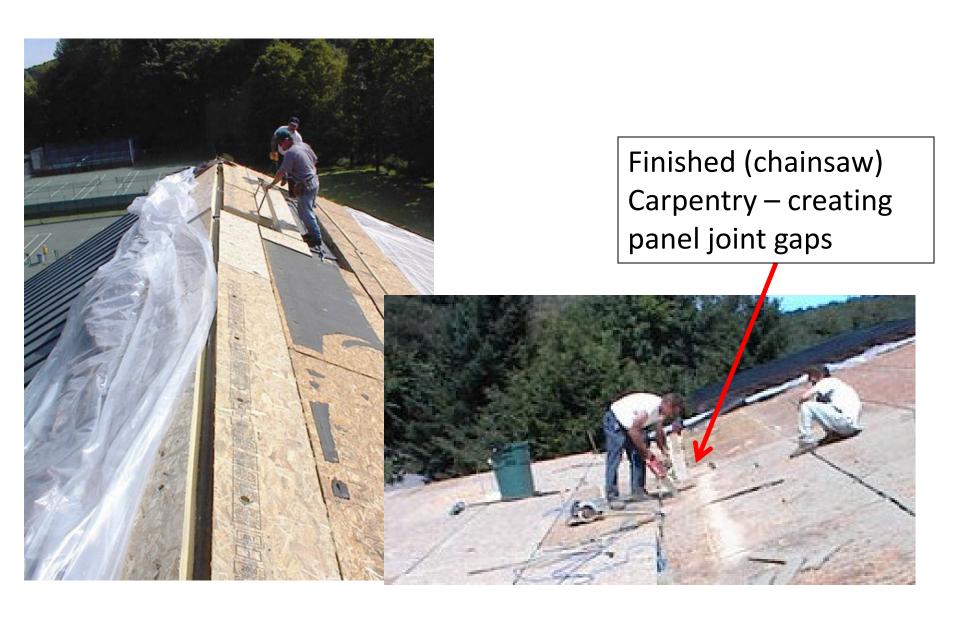
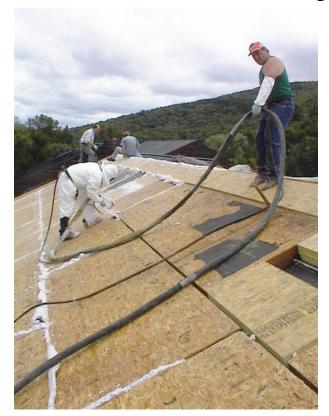
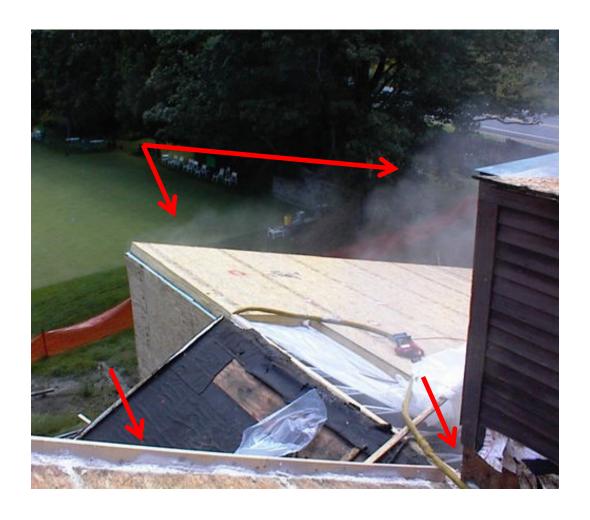
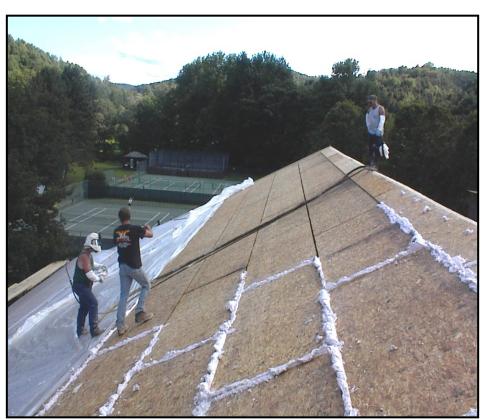
Air leaks at the wall-to-roof location are open to some of the panel joint galleries.
