SIPs...it's about the joints and more

By: Henri Fennell, CSI/CDT

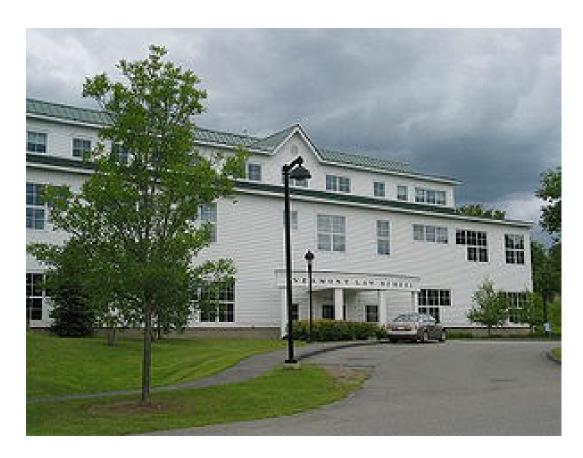
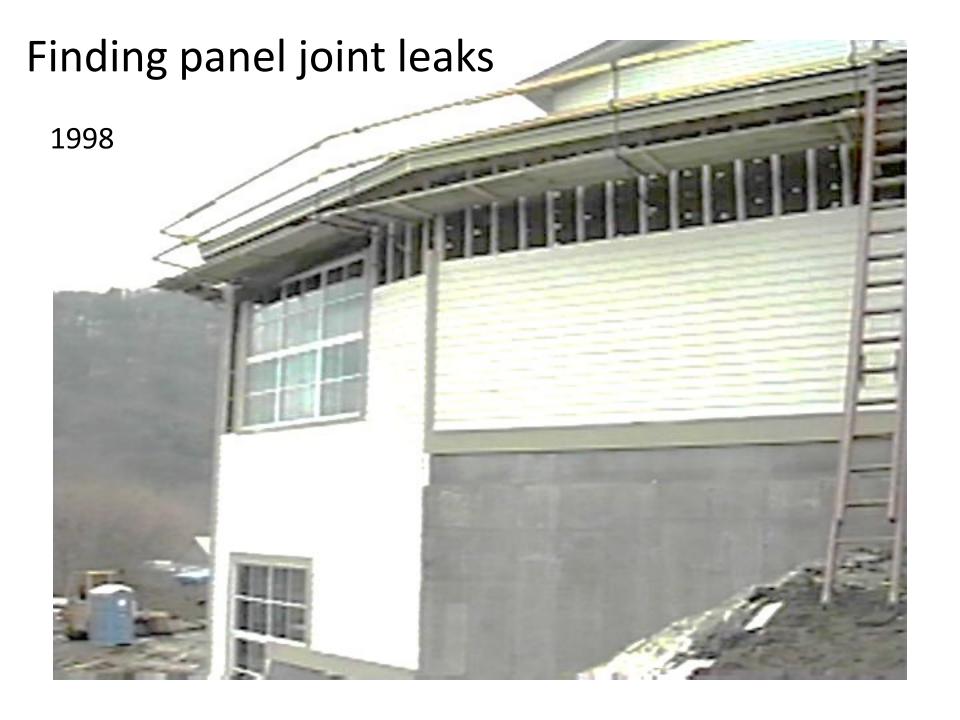
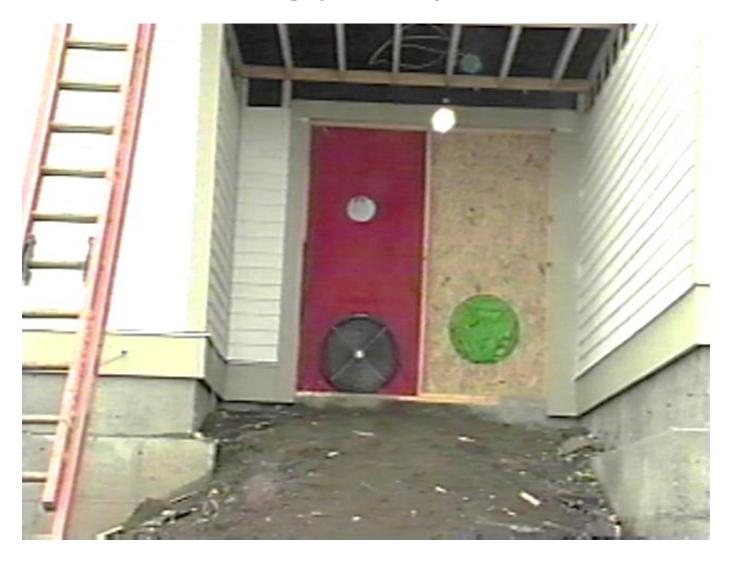
IR and Fog QA methods

Sealants applied during SIP installations don't always work

Expanded polystyrene and OSB SIPs installed on a steel frame in cold weather with foam sealant applied to the panel edges during the crane installation work

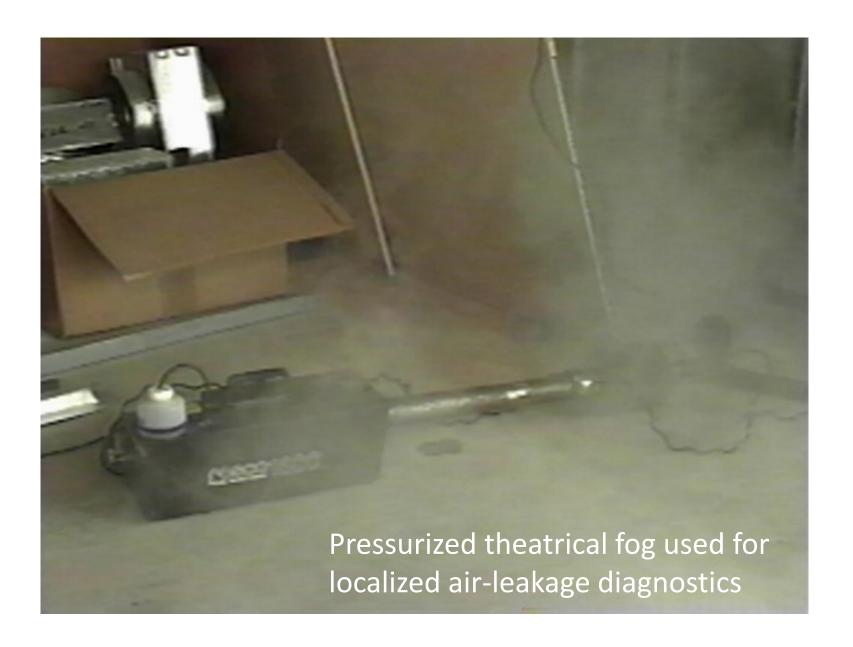
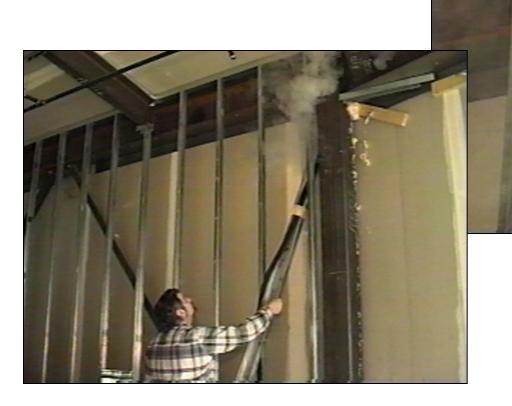
Blower door setup for pressurized theatrical fog (daylight) and depressurized infrared imaging (nightime)

Note: A 10' length of 1-1/2"
PVC schedule 40 would work
nicely here to support shop vac
tubes and hose

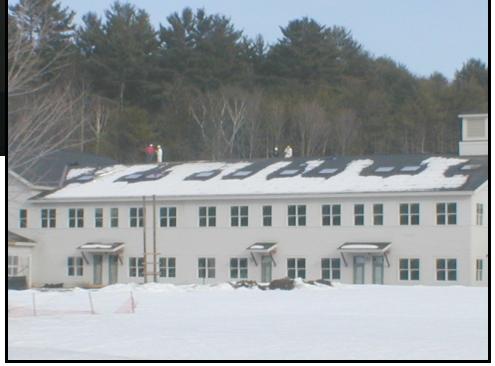
Nailbase panels on an acoustic metal deck

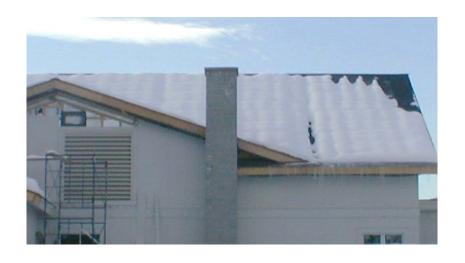
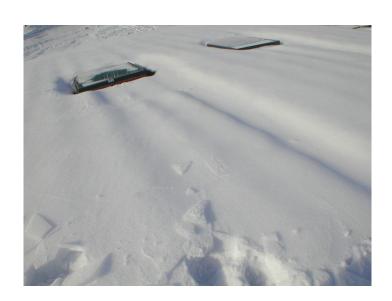
This project didn't have time to cause ridge rot, but the melt patterns show where the leakage is

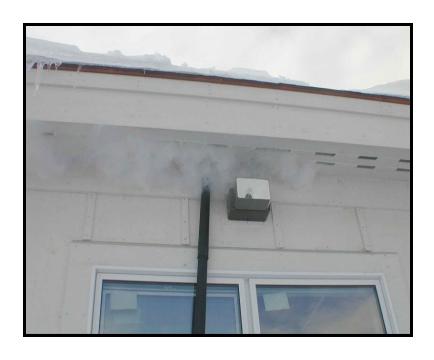
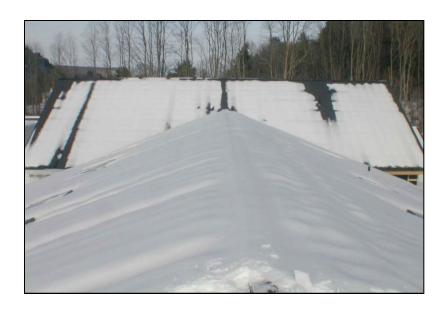
Timing roof vents to verify and calculate the flow rate

No roof ventilation was observed until the ridge vents were uncovered

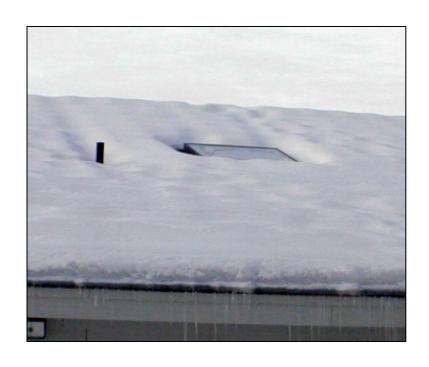
Fog leaking out at penetrations was visible at the ridge cap only after the snow was removed

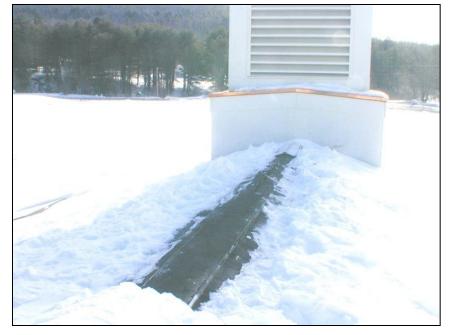
Melt patterns indicated air leakage at the penetrations and around the skylights, as well at the sofits

But no fog leakage was observed until the ridge vents were uncovered

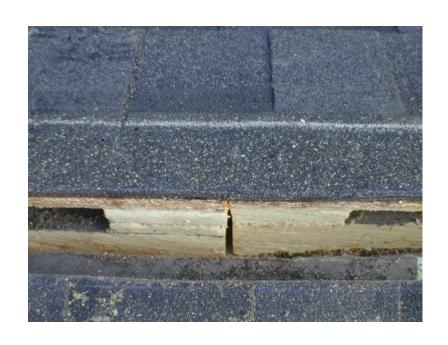
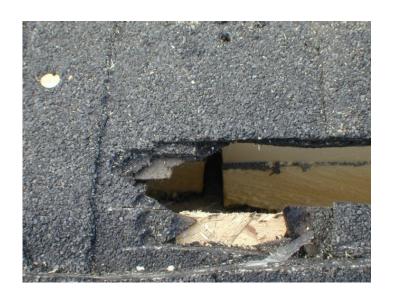
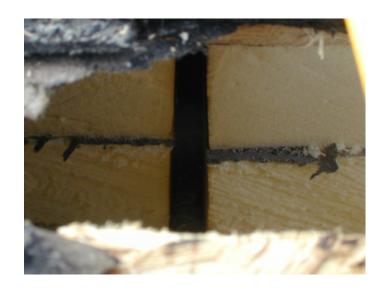
The panel joints are not sealed

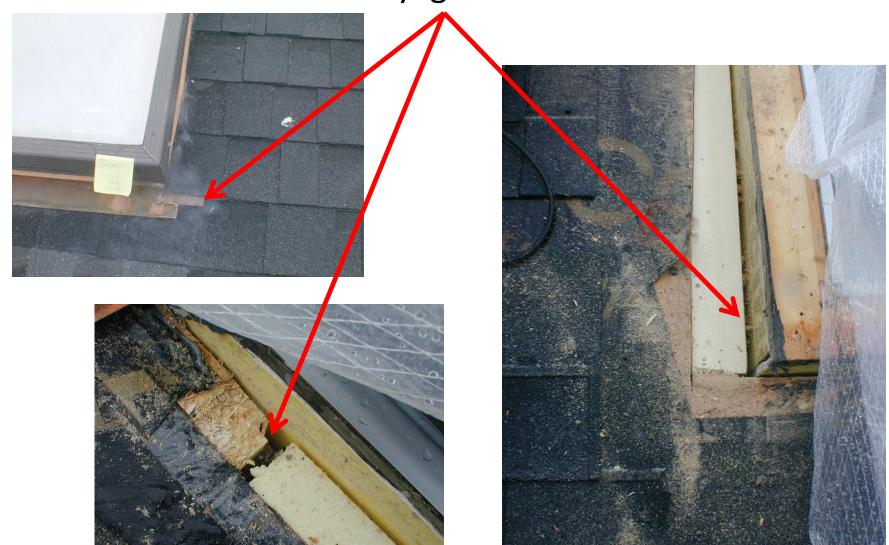
Fog test shows where the panels are not sealed to the skylight curbs

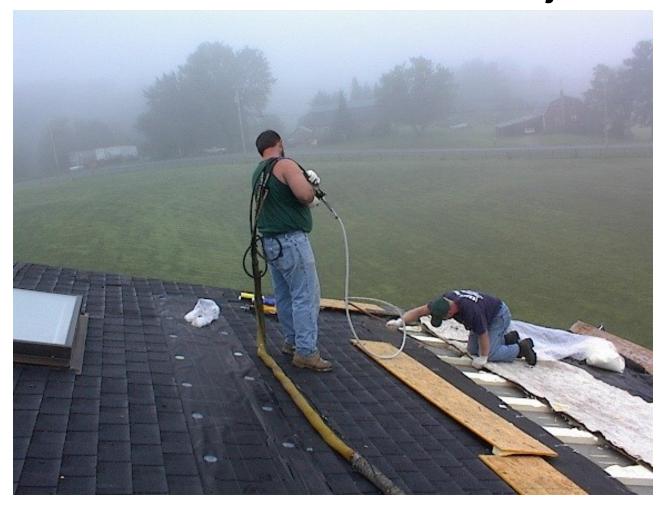
The panel joints were sealed and R-13 added to the roof insulation with closed-cell injected polyurethane foam

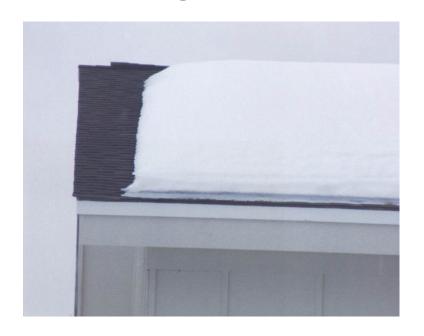
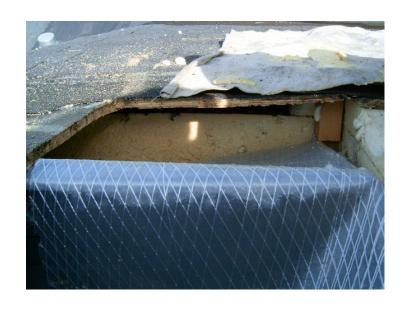
Overhangs – thermal bridging and solar gain

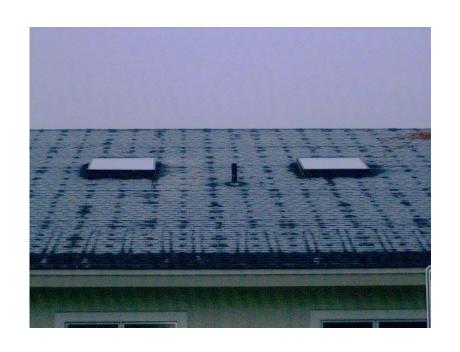
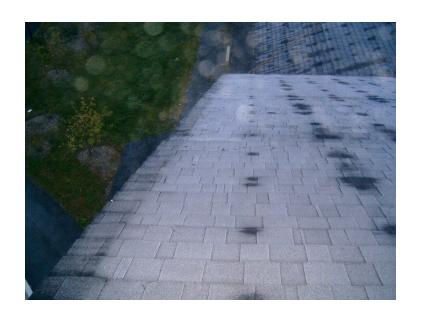
Ice Dam Remediation – Panel joint failures

Thermal bridging through the fasteners is the only melt pattern after the repairs

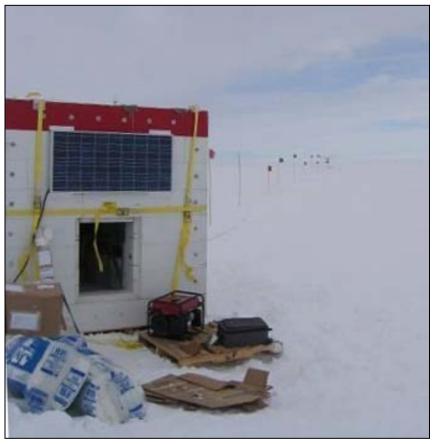
On site at McMurdo in Antarctica

No snow inside in the spring!!!!!

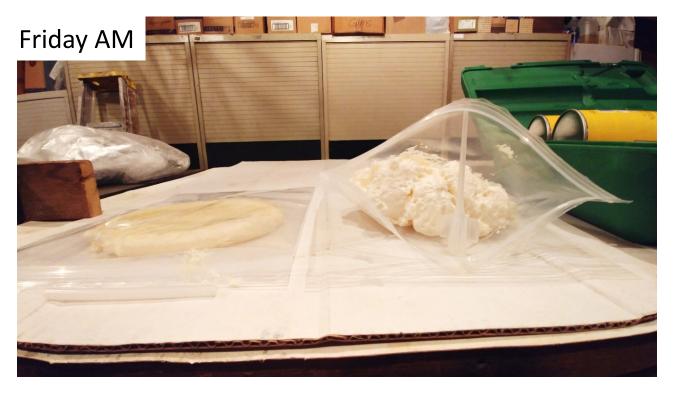
One-component foam sealant

Without moisture

With moisture

- This is our most misunderstood instruction.
- You only need an ounce of water to properly cure an entire can of foam.
- When foaming a deep void with a large cross section of foam, mist with water every two inches.
- A relative humidity rating above 55% is adequate to assure product curing."

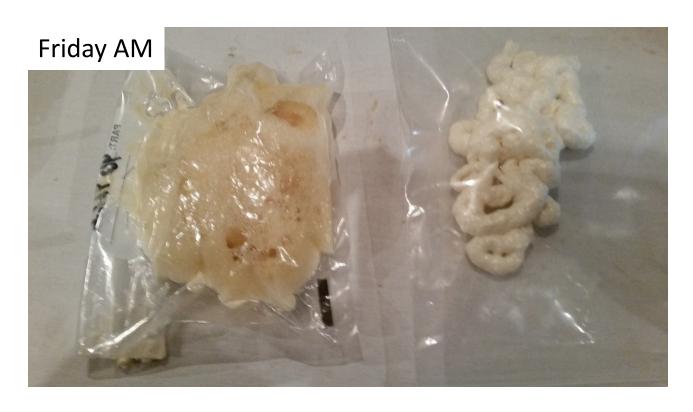
One-component foam sealant

Without moisture

With moisture

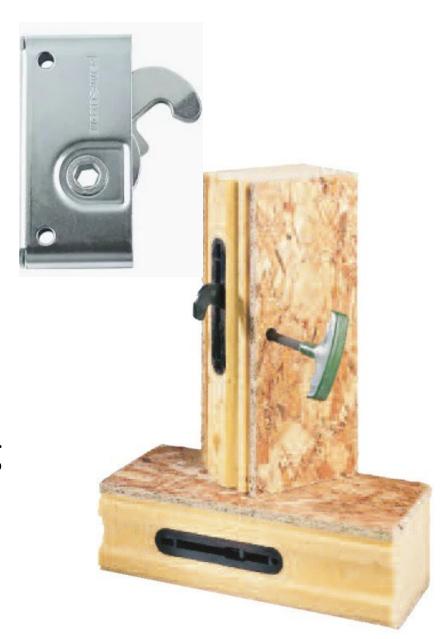
Panel joint details

- The Cam Lock detail compresses the gaskets
- Often used in most cooler/freezer panels
- It doesn't work in both directions or in a changeof-plane condition
- Minimal thermal bridging
- More costly

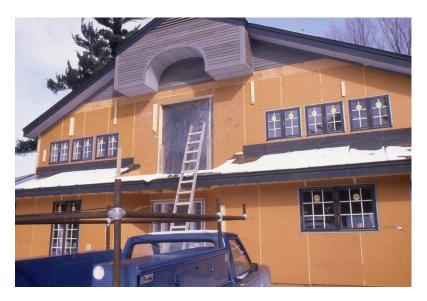
SIPs on stick-built frame – Roof is IPF

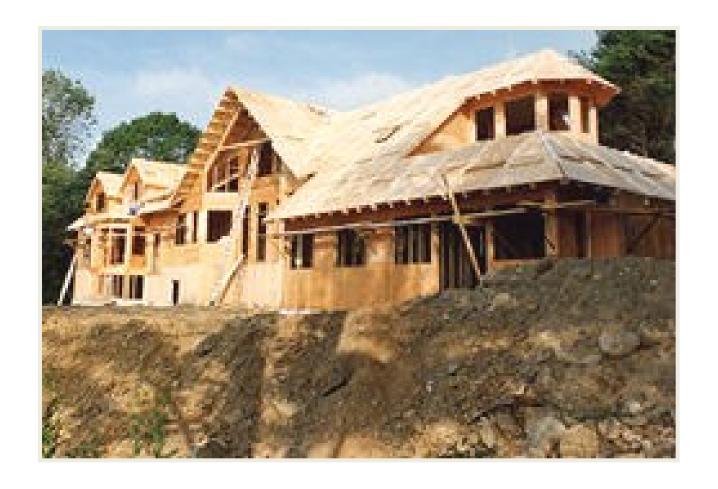
Custom panels for long roof spans

Long-span structural SIPs with full-thickness panel joints
