Insight

Stress Relief

By Joseph W. Lstiburek, Ph.D., P.Eng., Fellow ASHRAE

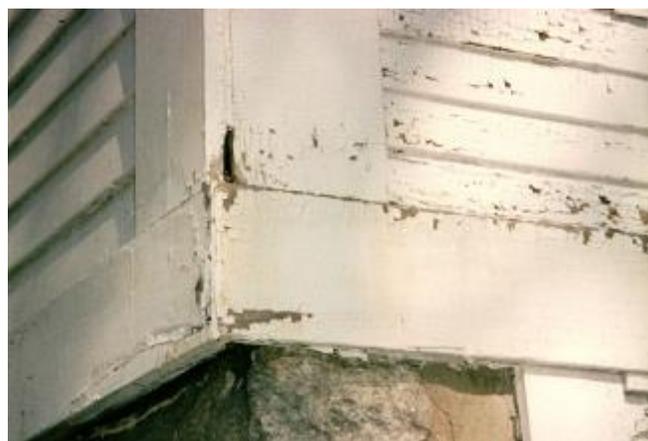
Photograph 1: Bad Paint - The paint looks bad, real bad, but there is no decay. This is an old uninsulated wood frame building. Board sheathing, asphalt impregnated felt building paper. Wood clapboard siding and wood trim. Oil based primer and oil based paint. Water is getting behind the wood siding and trim via capillarity. The water can't evaporate outward through the impermeable paint film.

Let's start the story by looking at **Photograph 1**. A couple of things you need to know with this image. The paint looks bad, real bad, but there is no decay. This is an old uninsulated wood frame building. Board sheathing, asphalt impregnated felt building paper. Wood clapboard siding and wood trim. Oil based primer and oil based paint. Water is getting behind the wood siding and trim via capillarity (**Figure 1**). The water can't evaporate outward through the impermeable paint film. The only drying is inward. The moisture content in the wood siding and trim cycles due to incident solar radiation and heat loss from the

building. The moisture content cycling causes expansion and contraction in the wood causing the paint film to be stressed leading it to fail. If the paint had been a modern vapor open (permeable) and flexible acrylic latex none of this would have happened. The amount of wetting could have been handled by the paint characteristics alone. Lots of available energy to dry both inwards and outwards. The felt building paper and the wood board sheathing allow inward redistribution of moisture. So, the easy fix for this problem is to scrape the paint down to bare wood, prime with an oil based primer and topcoat with an acrylic latex paint.

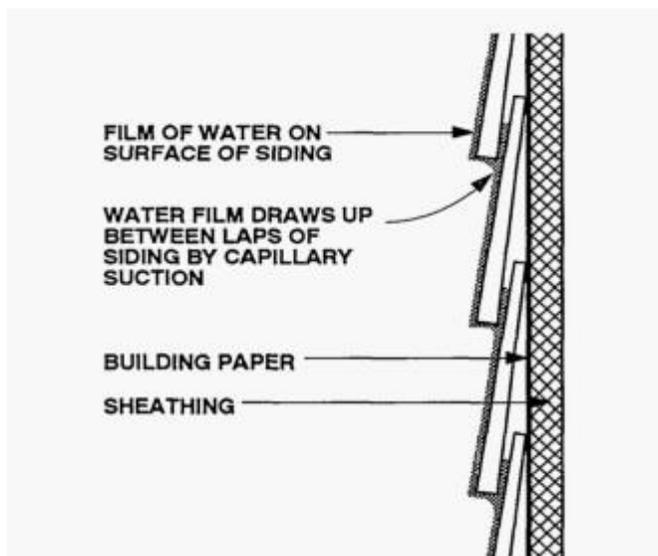
Figure 1: Capillary Rise In Siding – This image comes from the DOE Moisture Control Handbook, circa 1989, not much has changed.

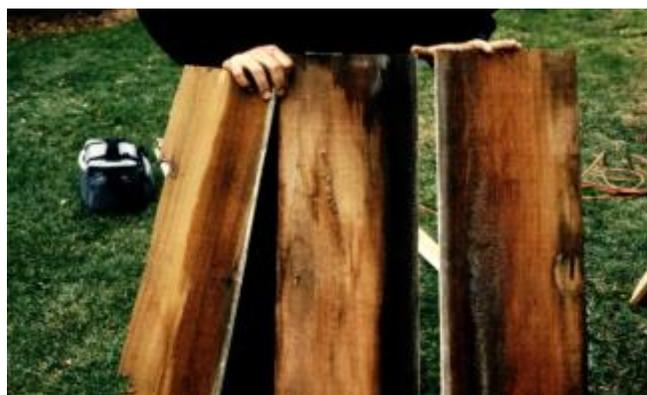
Photograph 2: Capillary Wetting - The effect of increasing the dwell time for moisture at the overlaps of siding. The “classic” means of addressing this issue is to reduce the capillary absorption at the overlaps and joints by “back priming” or “back coating” the back surfaces of the siding.

Photograph 2 and **Photograph 3** shows the effect of increasing the dwell time for moisture at the overlaps of siding. The “classic” means of addressing this issue is to reduce the capillary absorption at the overlaps and joints by “back priming” or “back coating” the back surfaces of the siding.

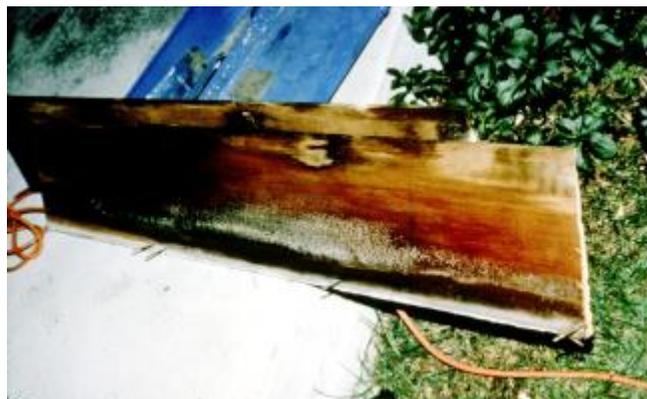
Photograph 3: More Capillary Wetting – This is more of a cold climate issue than a warm climate issue. Inward drive in warm climates increases the drying of the cladding. Of course this assumes that the inwardly driven moisture can go

somewhere...like into absorptive building papers and sheathings.

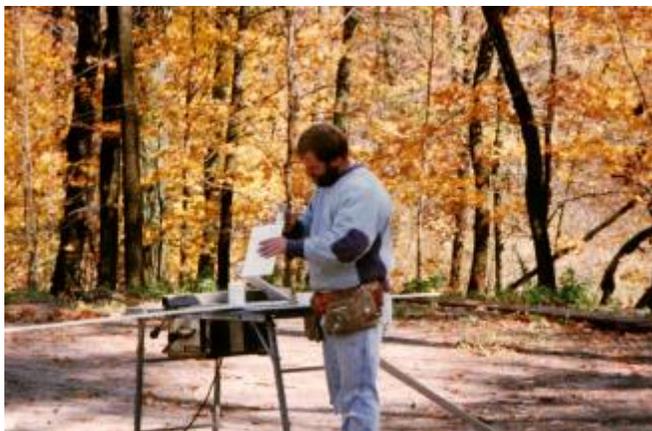
Photograph 4: Sealing End Cuts - Over time coating of the back surfaces of siding was extended to the cut ends of siding and trim. Wood is anisotropic...it absorbs water differently based on the grain/fiber direction. Cut ends absorb way more water than the face of siding and trim. Painting of cut ends became necessary to control decay of wood and wood based claddings as it reduced water absorption.

Over time coating of the back surfaces of siding was extended to the cut ends of siding and trim. Wood is anisotropic...it absorbs water differently based on the grain/fiber direction. Cut ends absorb way more water than the face of siding and trim. Painting of cut ends became necessary to control decay of wood and wood based claddings as it reduced water absorption (Photograph 4).

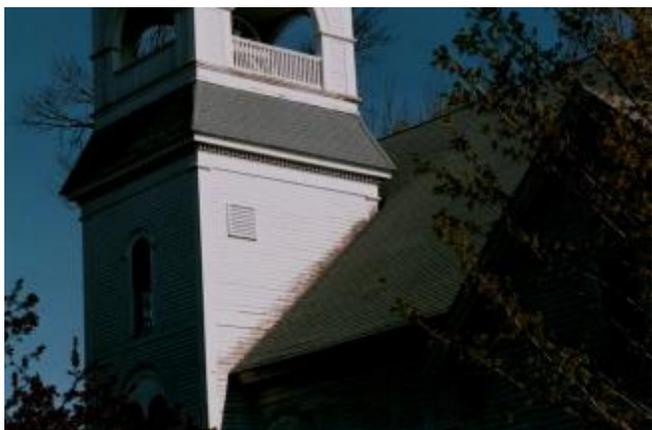
Photograph 5: Faith Based Water Control – Sloping end cuts not sealed where the cladding intersects the sloping roof.

Worse, no air gap between the end cuts and the sloping roof. A minimum 2 inch gap is necessary.

Cut ends proved to be particularly sensitive to water absorption particularly at wall-to-roof interfaces (Photograph 5). Sealing cut ends coupled with an air gap became the norm.

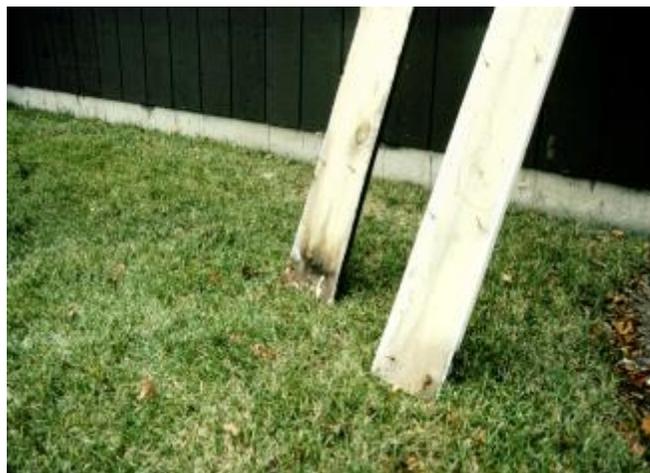
Photograph 6: Trim Issues - Trim elements tended to be the “weak link” as they tended to be adjacent to the most joints hence the most cut ends and exposed fibers. Where they butted into other elements or components or other trim pieces capillary absorption tended to be enhanced.

Trim elements tended to be the “weak link” as they tended to be adjacent to the most joints hence the most cut ends and exposed fibers. Where they butted into other elements or components or other trim pieces capillary absorption tended to be enhanced (Photograph 6). Sealing/painting cut ends, back coating and adding an air gap to act as a capillary break became necessary (Photograph 7). The approach evolved into coating “all six surfaces” (Figure 2) coupled with air gaps between intersecting components such as decks and roofs.

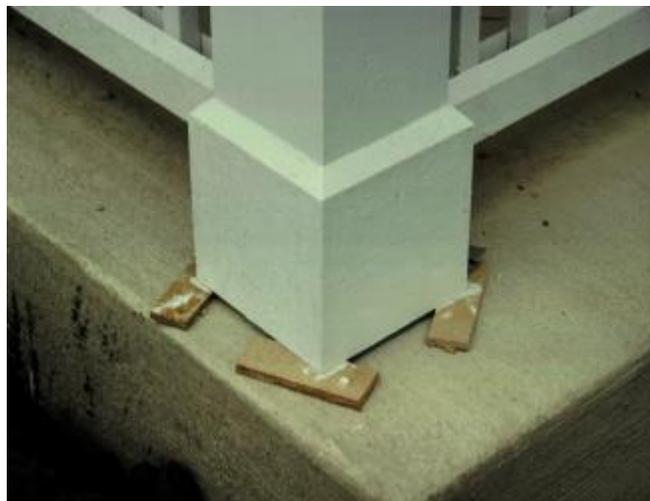
Photograph 7: Trim Gap - Sealing/painting cut ends, back coating and adding an air gap to act as a capillary break became necessary.

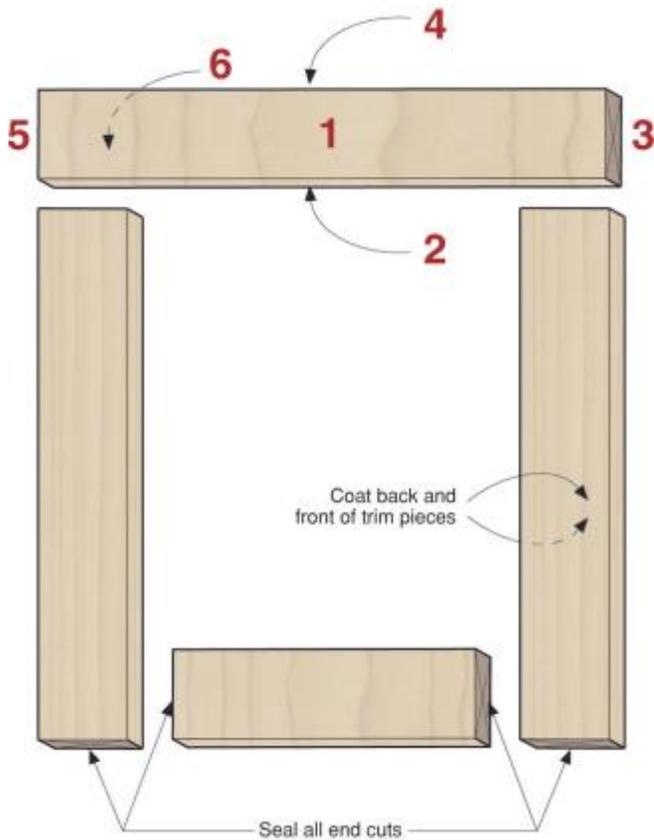
Figure 2: Trim Details - Seal or coat all six surfaces of materials to limit water absorption. Back ventilate trim materials so that absorbed water can evaporate and be vented to the exterior.

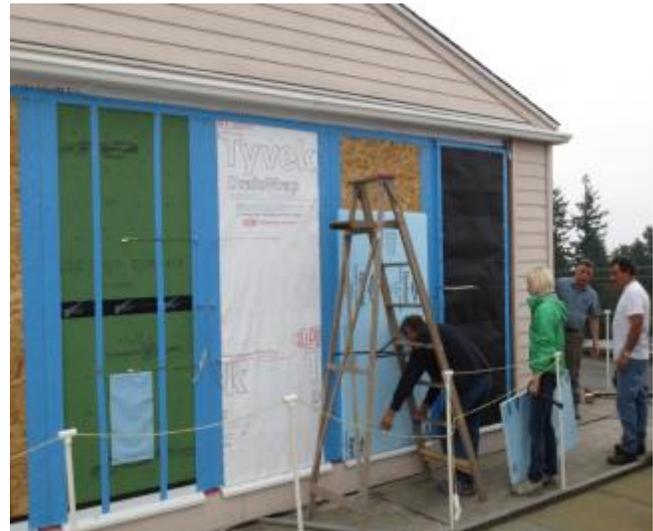
Photograph 8: Test Hut Stress – You can't calculate this. Being an old school engineer the approach to figure this out was obvious – guess – and test to failure.

Being an old school engineer the approach to figure this out was obvious – guess – and test to failure (Photograph 8 and Photograph 9). Apparently, somewhere between 1/4 inch and 3/8 inch works well with wood and engineered wood based claddings and trim along with fiber cement cladding and trim components.

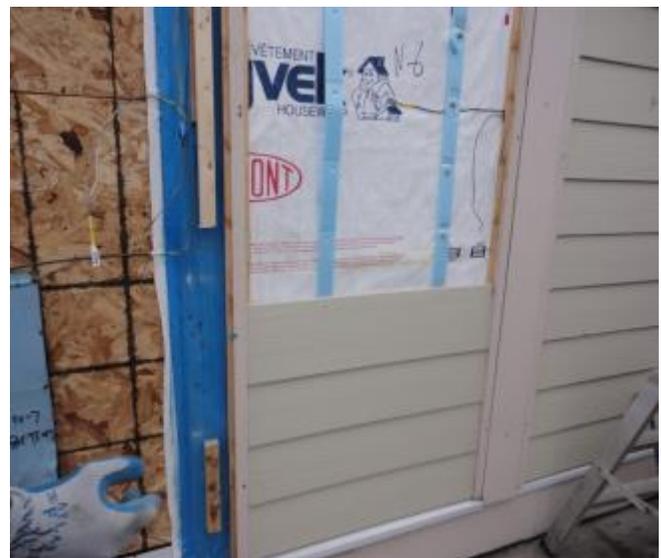
Photograph 9: More Test Hut Stress - Apparently, somewhere between 1/4 inch and 3/8 inch works well with wood and engineered wood based claddings and trim along with fiber cement cladding and trim components.

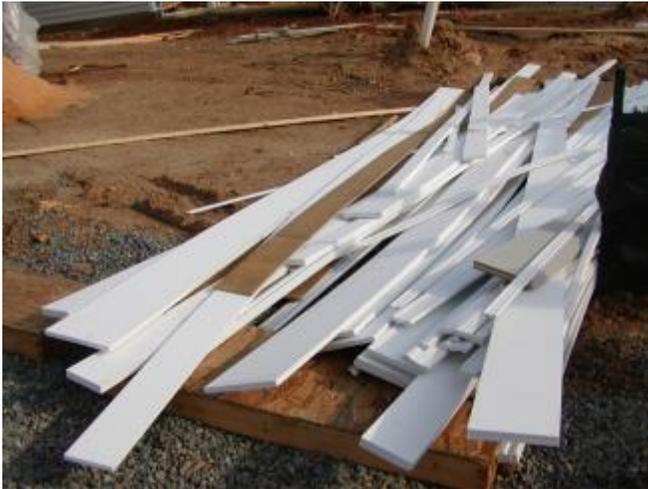
Photograph 10: Modern Trim - Today virtually all wood trim and engineered wood claddings, fiber cement and composites come coated on all six sides or protected on all six sides.

Today virtually all wood trim and engineered wood claddings, fiber cement and composites come coated on all six sides or protected on all six sides (**Photograph 10**). But not all trim and claddings are installed over air gaps. As previously stressed the gap is necessary in high performance assemblies. So how to do this?

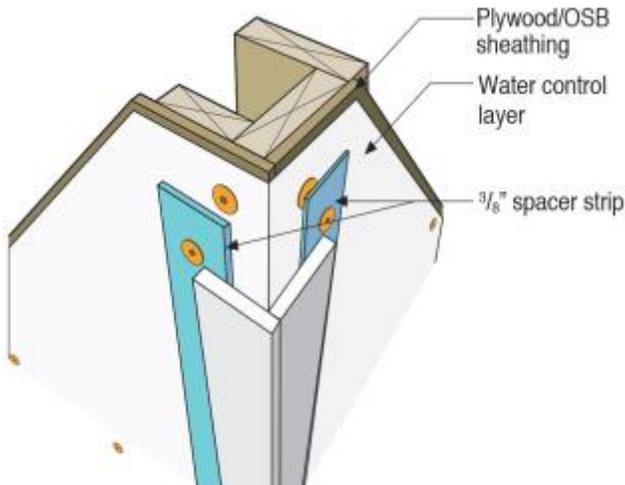
Figure 3: Air Gap – OSB and plastic housewrap. The spacer strips are 1/4 inch to 3/8 inch strips of foam or sill gasket material.

Figure 3 and **Photograph 11** show how to do it with OSB and with continuous insulation less than 1 1/2 inches thick. The spacer strips are 1/4 inch to 3/8 inch strips of foam or sill gasket material. No issues. Easy.

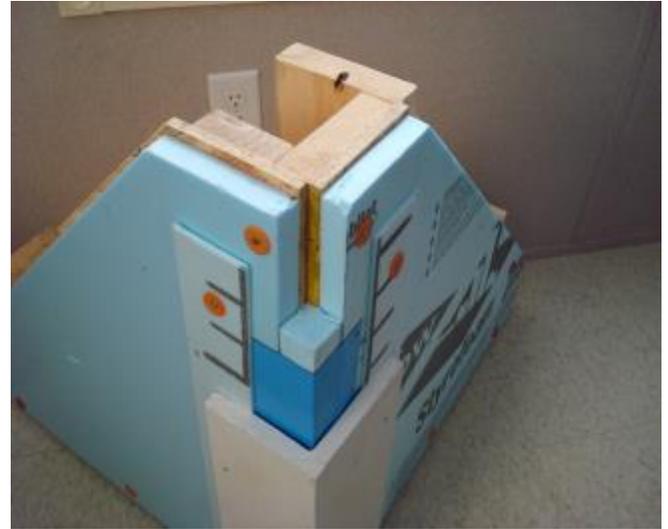
Photograph 11: Air Gap – Not complicated with continuous insulation less than 1 1/2 inches thick. The spacer strips are 1/4 inch to 3/8 inch strips of foam or sill gasket material. No issues. Easy.

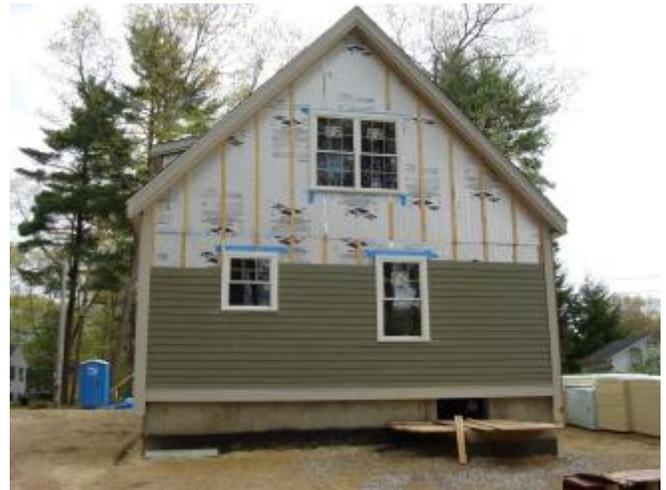
Photograph 12: Wood Furring - When you get to thicker layers of continuous insulation things get more complicated. You are pretty much limited to furring strips of 1x4 wood and long wood screws. Epoxy coated steel works well.

When you get to thicker layers of continuous insulation things get more complicated. You are pretty much limited to furring strips of 1x4 wood and long wood screws. Epoxy coated steel works well (**Photograph 12**). Thinner wood furring and the furring splits....ask me how I know? **Figure 4** lays out the steps to install back vented trim and siding on a high performance wall with multiple layers of continuous insulation.

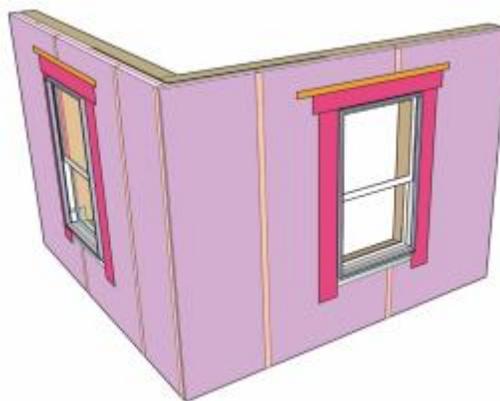
Figure 4a: Continuous Exterior Insulation – Water control layer is the exterior face of the insulation. Note the taped joints.

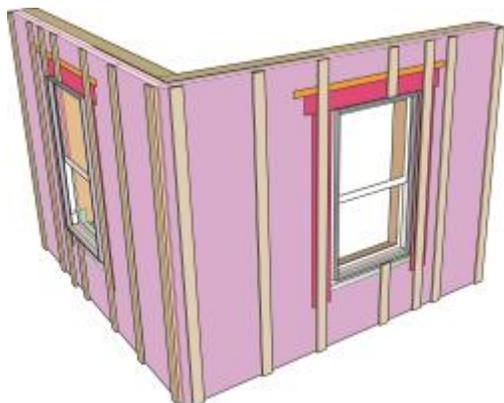
Figure 4b: Furring Strip Spacers – Note the corner geometry of the wood furring. The furring is gapped laterally at the corner.

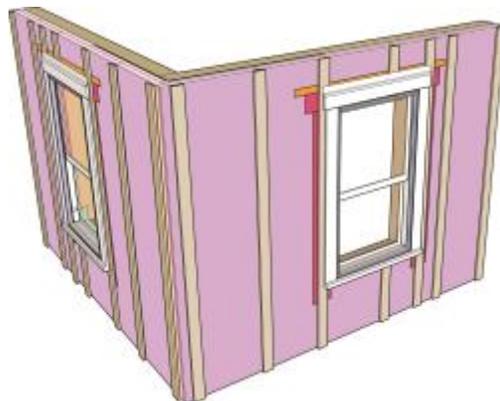
Figure 4c: Window Trim Installed – Note that the flashing above the horizontal trim at the top of the window is installed to protect the trim not to protect the window unit.

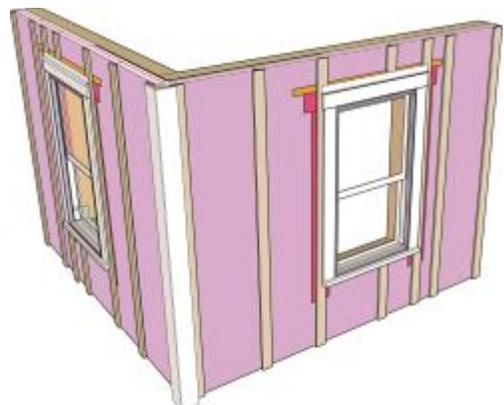
Figure 4d: Corner Trim Installed – The two corner trim pieces are attached “to themselves” and then the “L-shaped” trim assembly is attached to the gapped wood furring at the corner.

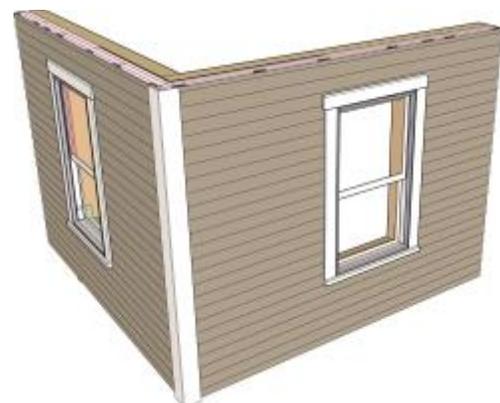
Figure 4e: Cladding Installed – Sealed on all six sides over an air gap. Awesome.
