How to Look at a House like a Building Scientist (Part 2: Heat)

This article is the second in a series on various building diagnostic tools to sleuth out problems in buildings.

By Kohta Ueno, Senior Associate, Building Science Corporation

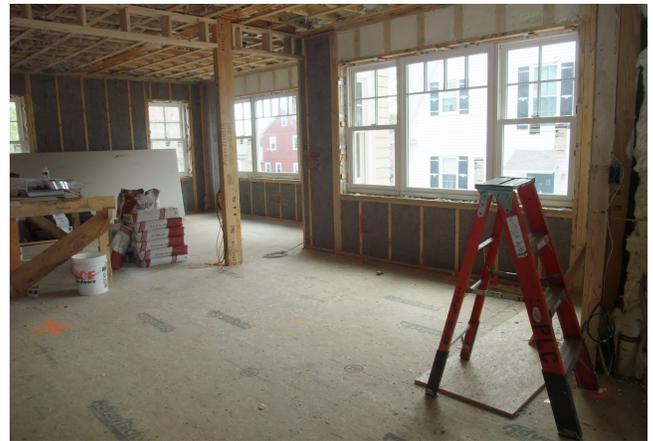
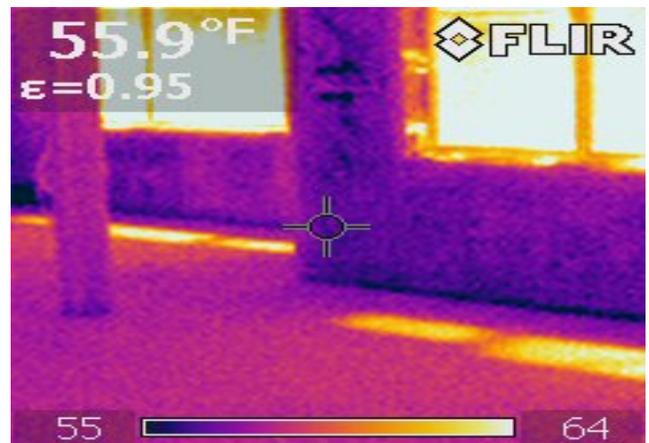
As a first warning: there are plenty of times when my first glance at the infrared image resulted in the wrong answer. For instance, I walked into this house in rough frame, and was startled by the big warm thermal anomalies across the floor (Error! Reference source not found.). Was heat running already, resulting in duct conduction through the floor? Nope... those are just the sunlit spots on the floor from the windows, and it wasn't obvious at first because the sun had gone behind a cloud.

Figure 1: Rough construction with mystery thermal anomalies on the floor

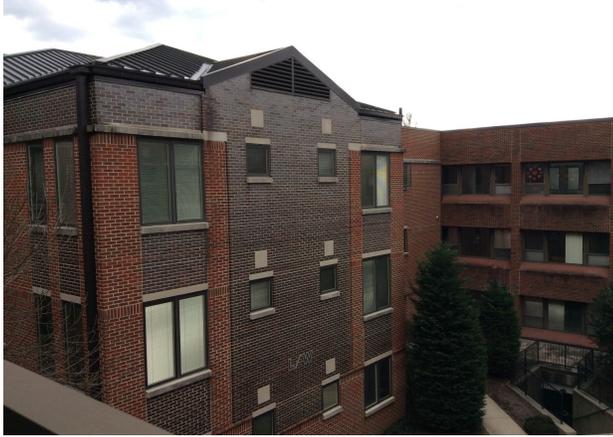
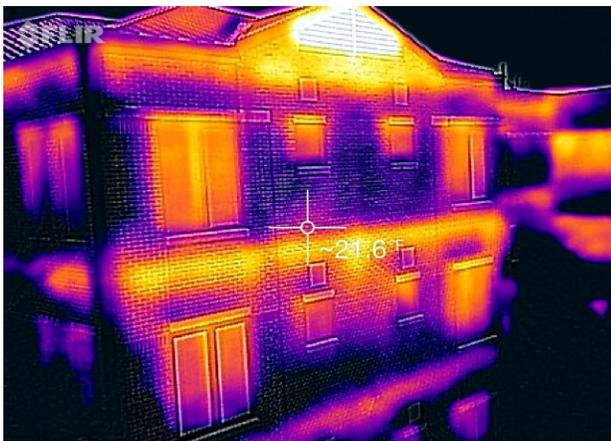
A really shocking example of air leakage is shown in Error! Reference source not found.: why are there bands of warm brick surfaces in this wintertime shot of this multifamily building? Thermal conduction through steel structure, perhaps?

Figure 2: Gross air leakage visible on exterior building enclosure/shell

The warm air leaks in Error! Reference source not found. were worst towards the top of the building, consistent with stack effect, or warm air rising. But the problems were worse than just energy use. During the summer, stack effect reverses, and the lower levels tend to "suck" on the brick cavity. They were pulling in enough outside moist air that they were having condensation and mold problems on their chilled water piping, above the suspended ceiling.

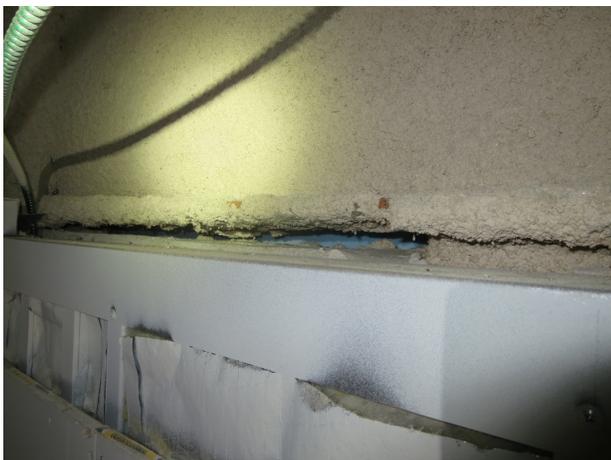
A look above the suspended ceiling showed a fireproofed steel perimeter beam above the concrete block/CMU and steel stud wall (Error! Reference source not found.). If you look carefully, you can see a little bit of blue in the gap between the two... yep, that's blue Dow Styrofoam.

Figure 3: Beam-to-wall interface (above ceiling)

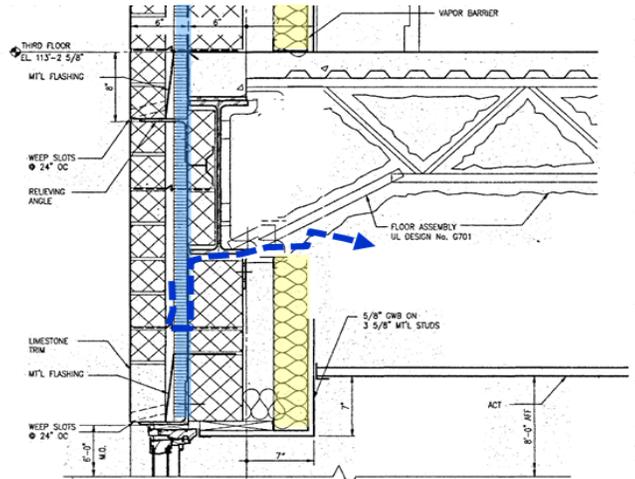
The problem is clearer in the building section (Error! Reference source not found.): the building has a structural steel frame with infill CMU block and steel stud framing, that stops short of the steel. And there's no exterior air barrier "wrap" (e.g., adhered membrane) on this building: so outside air (from the brick cavity) is free to get through the foam joints and come in through this half-inch gap around the entire building's perimeter.

Figure 4: Air leak at gap between beam and wall

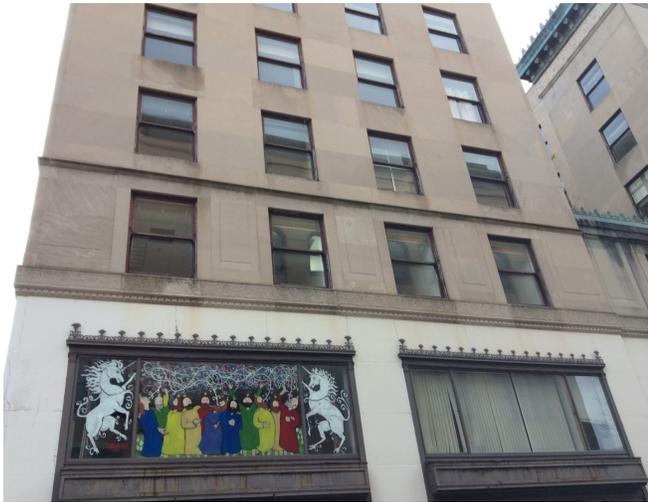
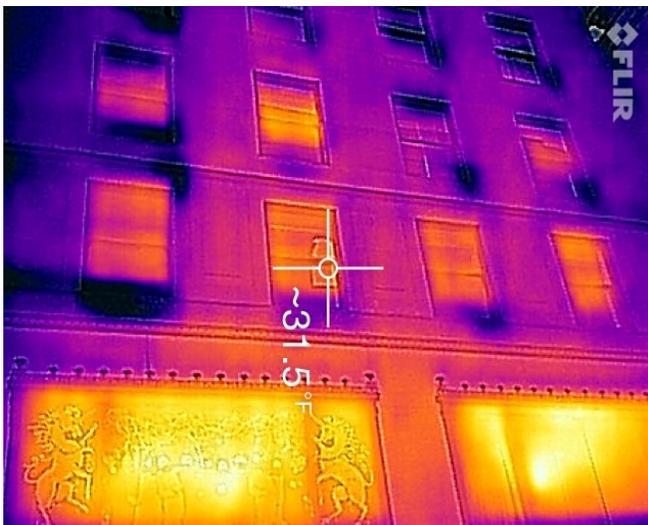
This is shown at window sills of a masonry building in Error! Reference source not found.. Windows or glass, unlike most wall claddings, shed almost all of the wind-blown rain that hits them onto the wall below. As a result, window sills are critical for draining this concentrated water away via drip edges, or else you end up with "drool patterns" below the windows, as shown.

Figure 5: Exterior of masonry building, showing sill water runoff

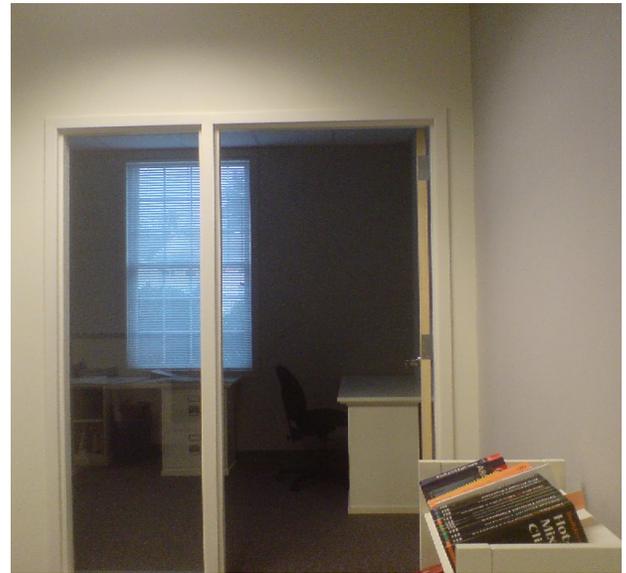
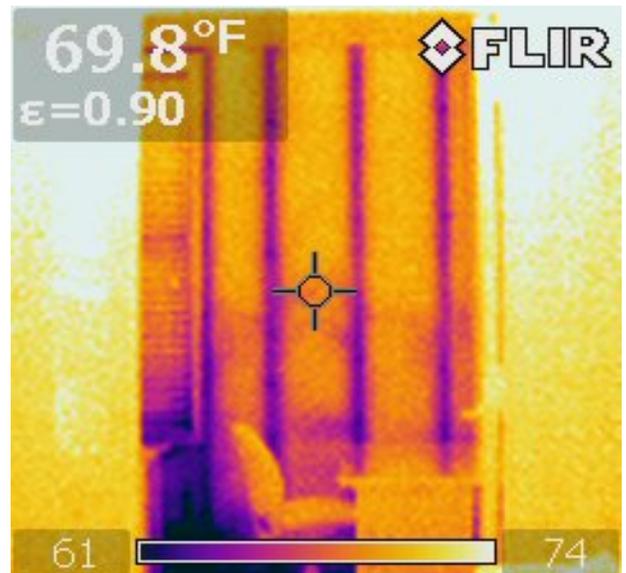
Thermal bridging through framing can be pretty obvious with an infrared camera if there’s an indoor-outdoor temperature difference. Error! Reference source not found. is a wintertime shot of steel studs, which are far more thermally conductive than wood studs. Thermal bridges such as uninsulated slab edges or structural steel embedded in insulated walls would show up in a similar way.

Figure 6: Thermal bridging through steel stud wall construction

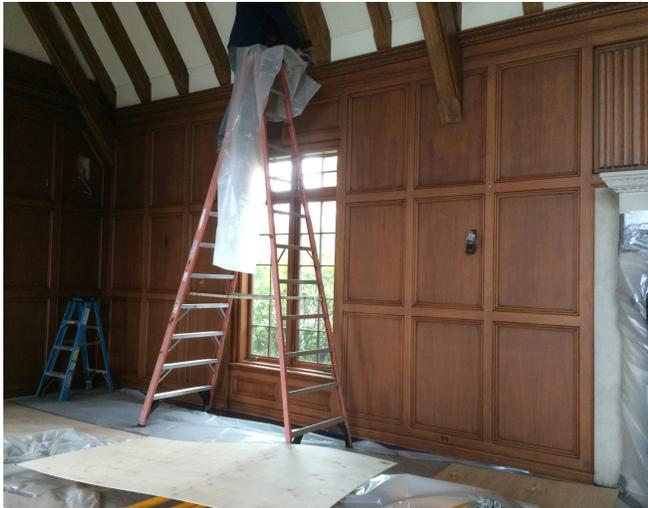
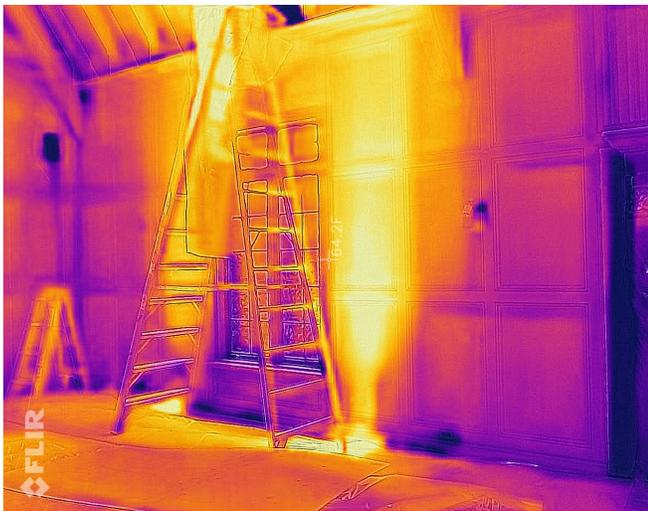
For instance, these floor-mounted heating registers “throw” air up onto the wall very well in Error! Reference source not found.. As a bonus: this demonstrates the Coandă effect, which is air (or other fluid) following an adjacent flat or curved surface, thus resulting in increased “throw” (check out ACCA Manual T for more).

Figure 7: Hot “plumes” from floor registers in heating operation

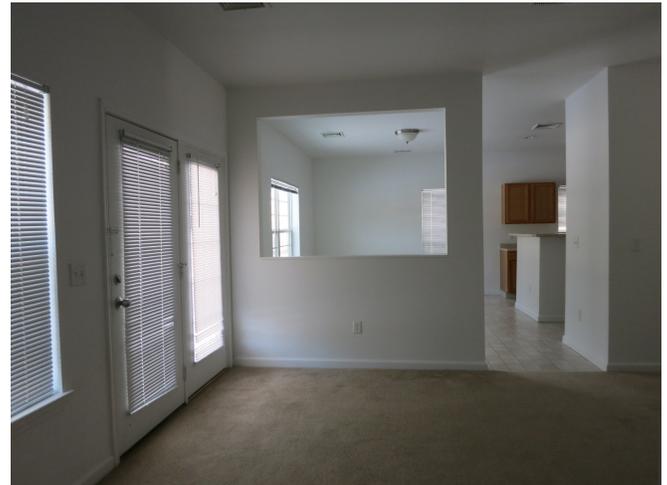
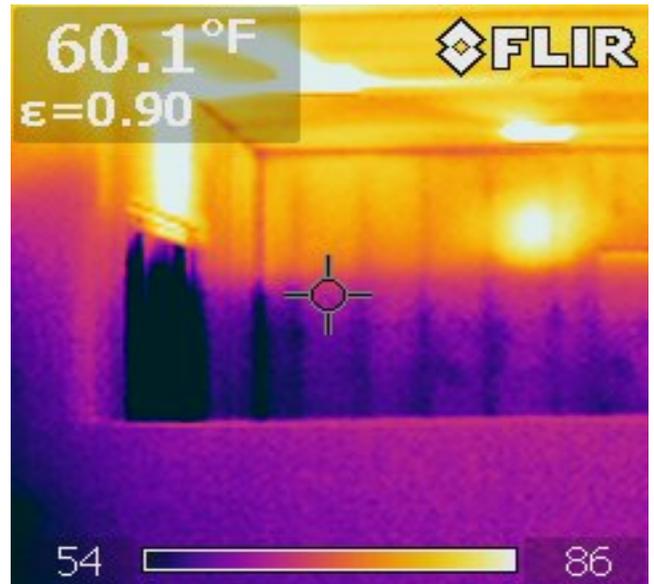
A problem-solving infrared observation was this wintertime shot inside a house in Error! Reference source not found.: why is the top of the room glowing? One clue is the ceiling-mounted registers in these first-floor rooms, which are the visible “hot spots” that are also blowing onto the tops of the walls. The problem was that these registers were built for horizontal throw, not vertical, so they ended up “layering” the hot air into the top of the room’s “air sandwich,” resulting in pretty spectacular thermal stratification. There was nothing that “broke up” the hot air at the top of the room, so it stayed there, and left the bottom half cold.

The problem at this house was even worse than discomfort: with this stratification, the thermostat was typically below the hot-cold boundary line. So the heating system ran for hours until the hot layer got deep enough to affect the thermostat... the system would shut off... then the cycle would repeat. But of course, the second floor was sweltering the entire time.

Figure 8: Thermal stratification from poor ceiling register distribution

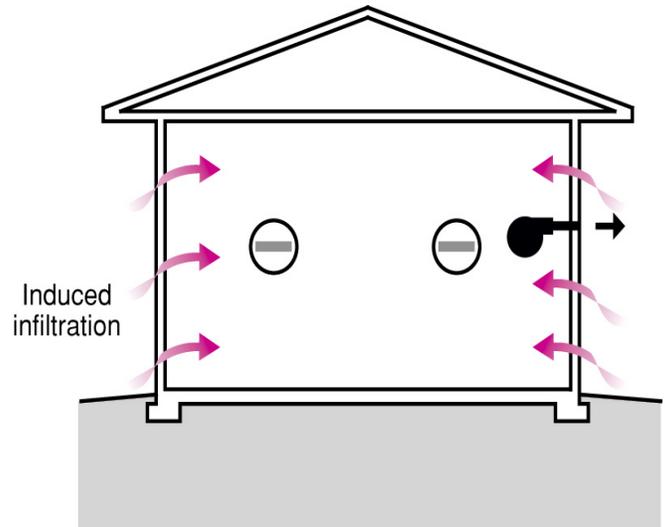
Figure 10: Building depressurization (causes induced infiltration of exterior air)

Depressurization (pulling air out of the building, **Figure 10**) results in “induced infiltration” or inward leakage of exterior air; the leak would be visible on the inside of the building. This is my typical go-to technique. I recommend walking around the building with an infrared camera first, to find any existing thermal anomalies (such as thermal bridges). Then, I would depressurize (turn on the blower door fan), and do another walk of the building, to see what has changed.

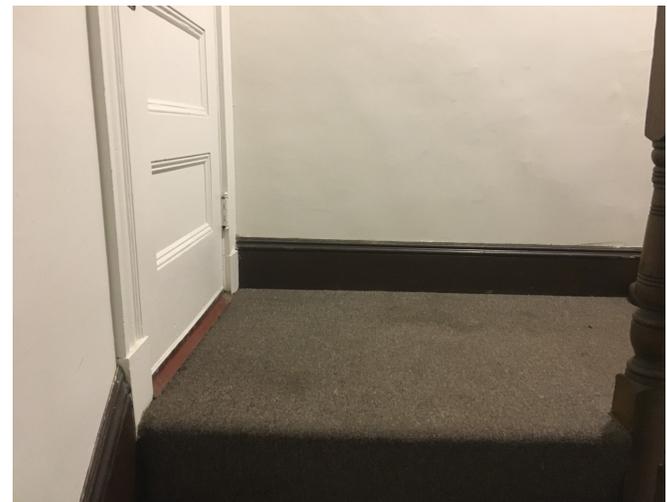
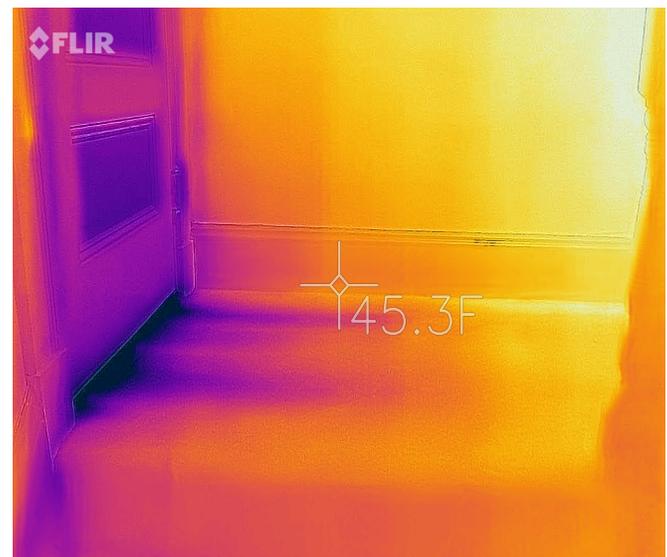
Figure 11: Induced infiltration air leakage “plumes” at a door sill gasket (winter)

One characteristic of air leaks is they often appear as “plumes” or “jets” of air, as shown at a leaky door threshold weatherstrip in **Figure 11**. Once again, this shows up on the surfaces being hit by that cold outside air (induced infiltration).

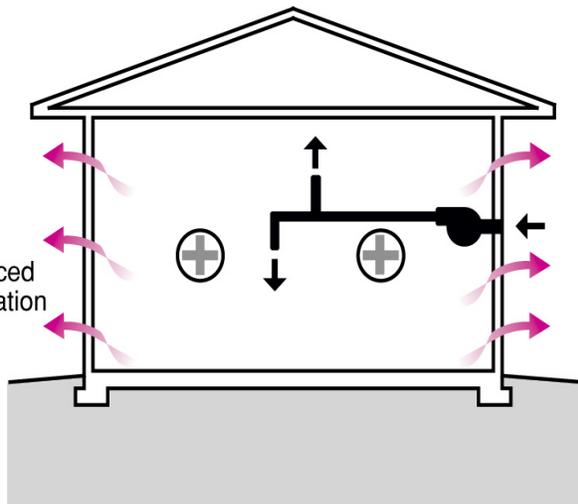
Figure 9: Building pressurization (causes induced exfiltration of interior air)

Pressurization (forcing air into the building, **Figure 9**) results in “induced exfiltration” or outward leakage of interior air; the leak would be visible on the outside of the building. However, these air leakage thermal anomalies are often overwhelmed by outdoor surface temperatures, especially during the day, when the building is sunlit.

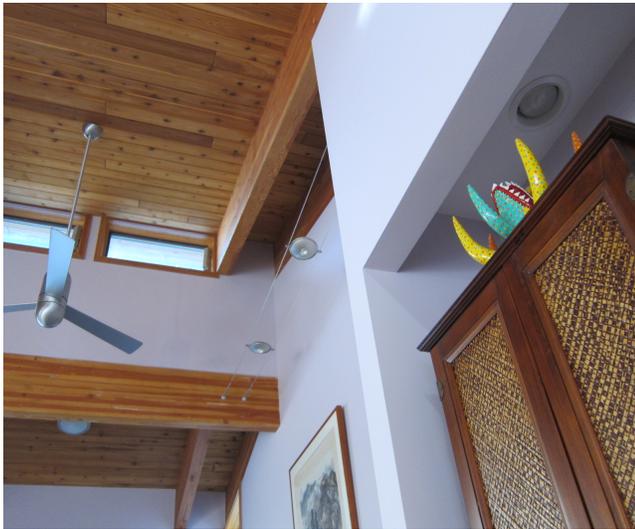
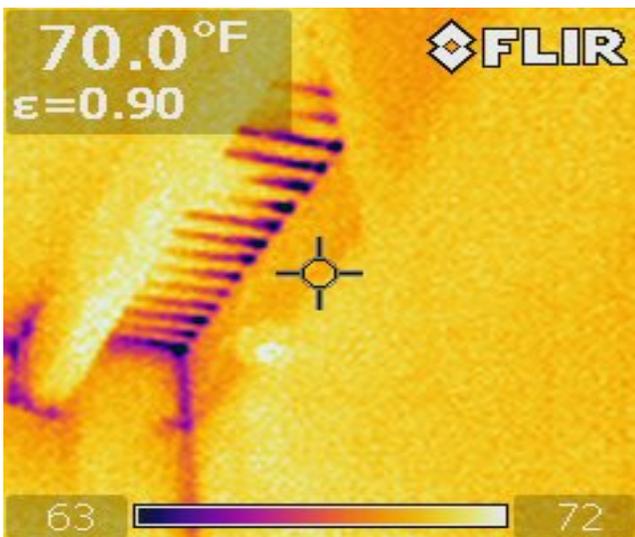
Figure 12: Air leakage at tongue and groove roof/ceiling that extends indoors/outdoors (winter)

Tongue and groove ceilings are a classic problem when they run from indoors to outdoors at the gable end or roof rake: depressurization in wintertime shows air jetting in at every board joint (**Figure 12**).

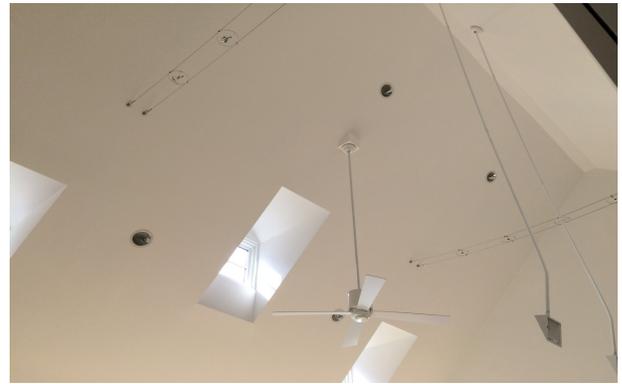
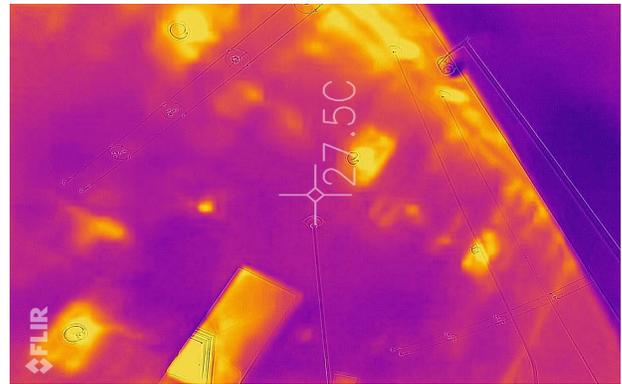
Figure 13: Induced infiltration at cathedral ceiling; note ridge and recessed lights (summer)

This technique can also be used to find air leakage hidden behind interior finishes. **Figure 13** shows a vented cathedral ceiling during summertime depressurization: hot outside air is leaking in at the roof ridge vents, through fiberglass insulation, and is getting pulled inside via the recessed lights and other ceiling plane air leaks.

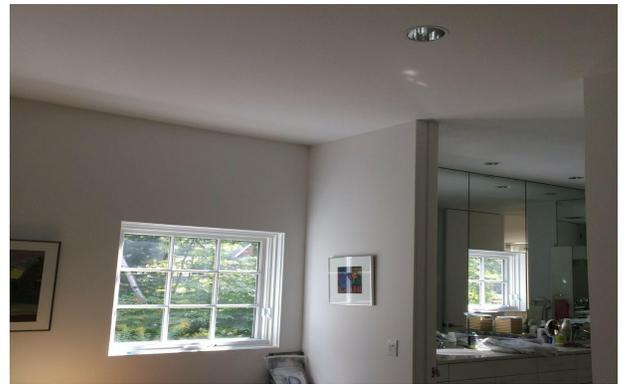
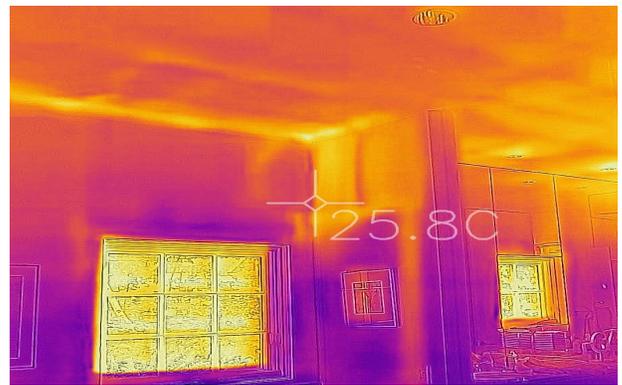
Figure 14: Induced infiltration at vented attic into interior wall and at exterior top plate (summer)

Similarly, **Figure 14** shows outside air being pulled from the hot vented attic above the ceiling, down into the interior wall (“wing” wall at the bathroom) and the top plate of the outside wall.

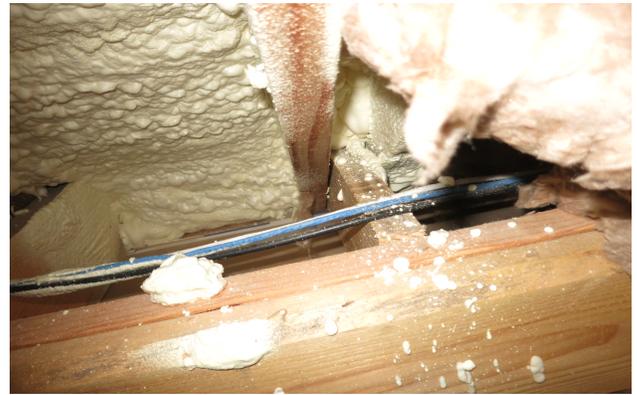
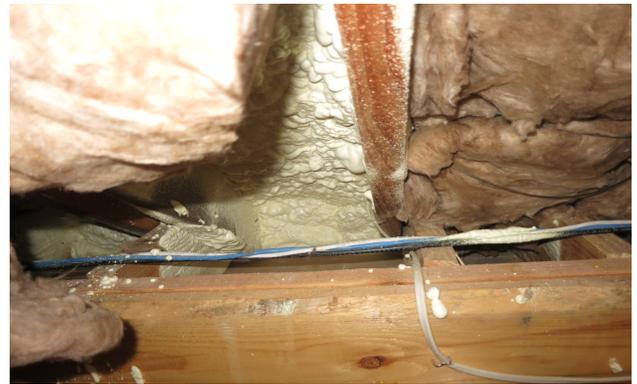
Figure 16: Spray foam imperfections at wood-to-wood joints

An example of this is shown in Error! Reference source not found., which is a “flash and batt” (closed-cell spray foam and fiberglass batt) house being depressurized in wintertime. A huge fan of cold outside air is getting pulled in at the roof-to-wall joint. Pulling back the fiberglass (Error! Reference source not found.) revealed a row of unsealed wood-to-wood joints at the rafter-to-ceiling joist connection.

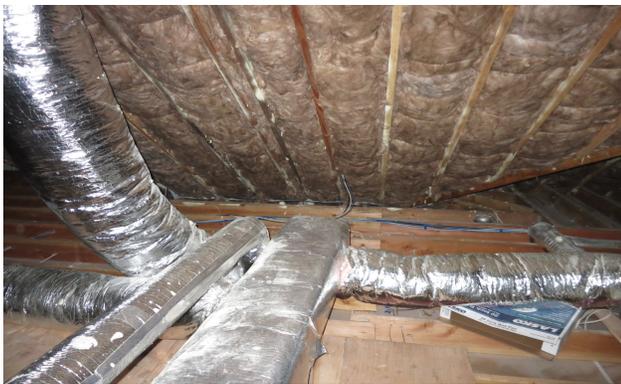
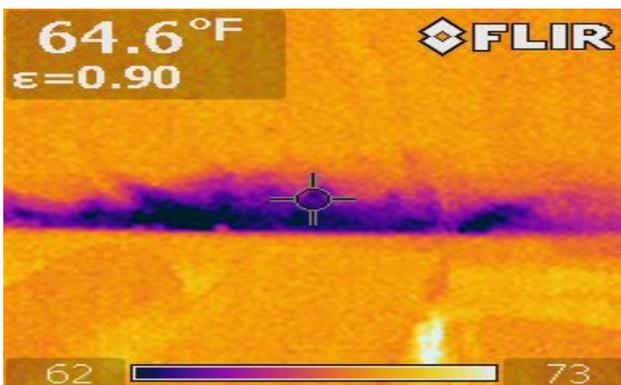
Figure 15: Induced infiltration at spray foam/fiberglass (flash and batt) attic roof-wall connection (winter)

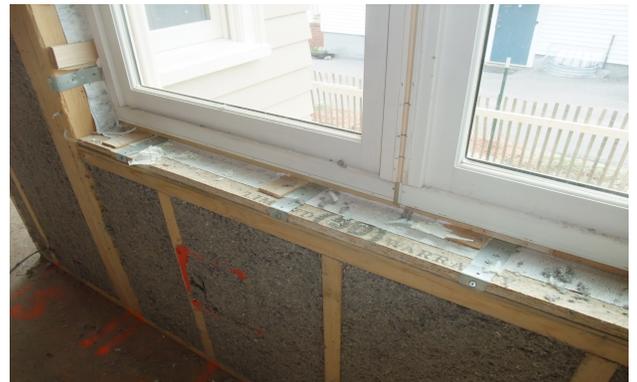
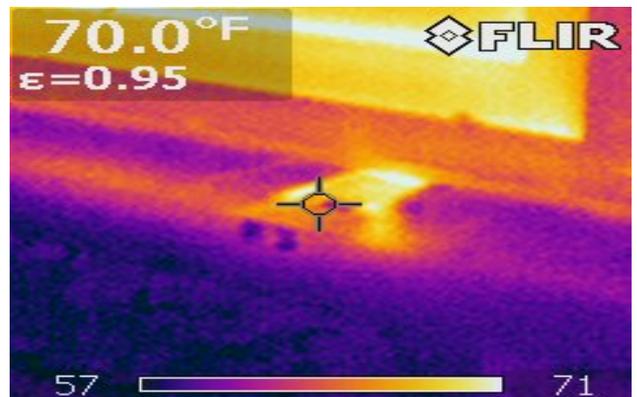
Figure 17: Air leakage around shims at window-to-wall rough opening (summer)

Another troublesome detail is windows that are installed using side clips (commonly called masonry straps) and/or window shims. Error! Reference source not found. shows a window that was well sealed around its perimeter, except where the shims penetrated through. The recommended detail is to cut the shims off flush, and to run the air sealing detail over the surface.

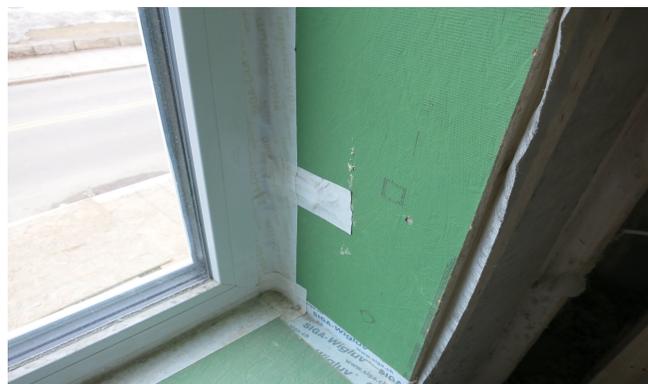
Figure 18: Air sealing window by covering installation clip with tape

Good solutions to window side clips include using a tape seal covering the entire clip/strap (Error! Reference source not found.) or embedding the entire clip in the same sealant used around the window perimeter (Error! Reference source not found.).

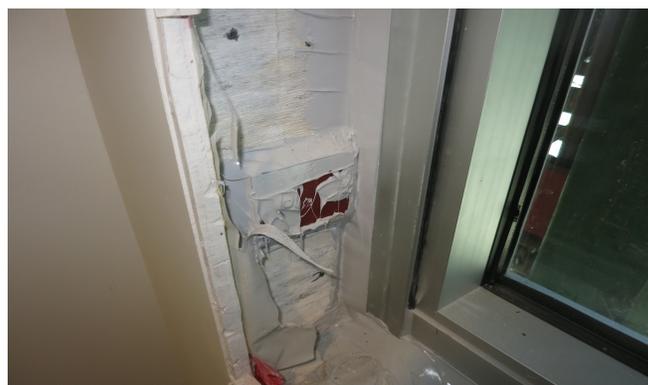
Figure 19: Air sealing window by embedding clip in sealant

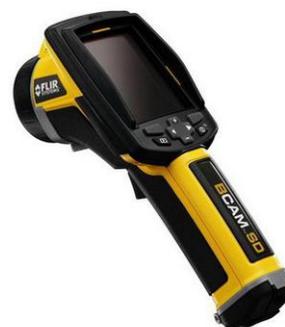
Figure 20: FLIR b40 infrared camera

I have been using infrared cameras since 2008, so I'm definitely not an old-timer from the days of liquid-nitrogen cannisters and cart-size cameras. I started out using a FLIR b40 (Error! Reference source not found.), which sold for about \$5000 when new, came in an armored Pelican case, and put out 240 x 240 pixel images ("IR resolution: 120 X 120 pixels"). Taking a \$5000 instrument to bang around in an attic was never a comfortable feeling. Also, the image was a narrow "soda straw" view: you had to step back to get a good view of the building, and at that point, the image was too blurry (pro tip: use a fixed temperature scale, snap multiple images in a panorama, and stitch them together in photo-editing software).

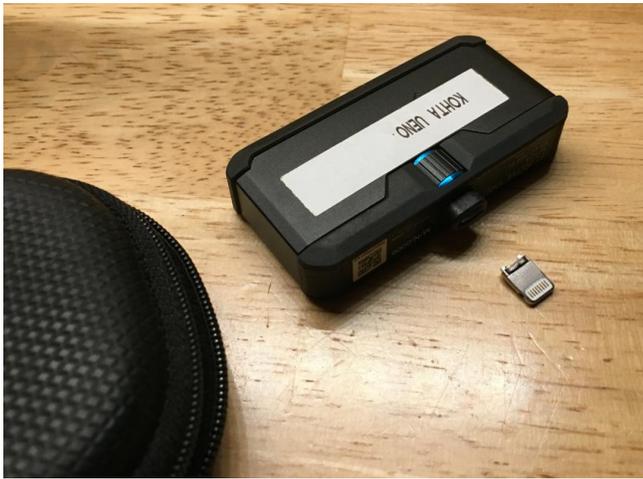
Figure 22: Breaking the connector off the FLIR ONE Pro

However, I have a few warnings and lessons learned from my IR camera. I've gotten some pretty strange numbers from the temperature readout, so I rely on it more for the image than surface absolute temperature measurements. It seems like the phone battery drains quickly while running the software. Using this setup outdoors in winter results in really quick battery drain, so I need to tuck it into my coat between shots. Pairing infrared shots with visual shots (like I've done above) makes it much clearer what is going on in reports and presentations. Lastly—be careful of the connector that plugs into the phone: if you knock it around, it can fall right off (Error! Reference source not found.). FLIR doesn't repair these units, but they offer a discount on a replacement when sending back the broken unit.

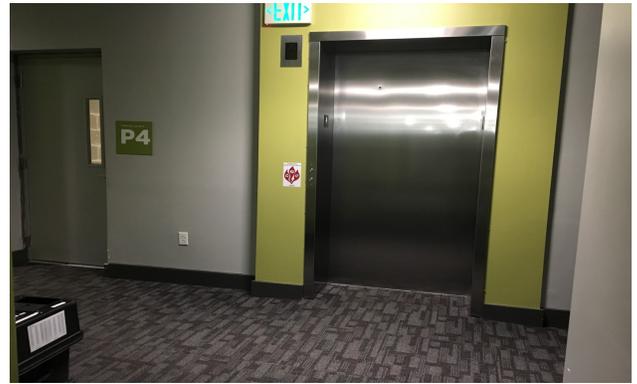
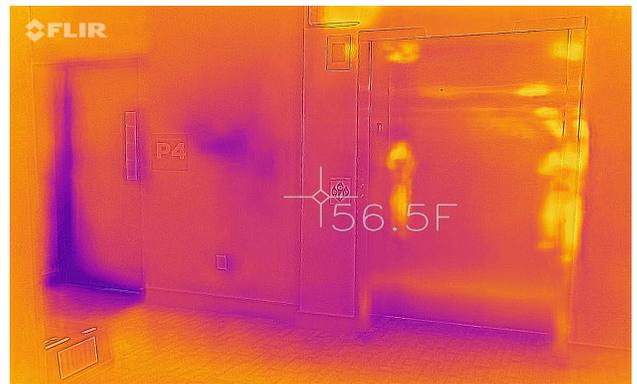
Figure 23: Infrared reflections on a shiny elevator door

I ran into this while scanning hallways in a building (Error! Reference source not found.): “Wow, some serious thermal anomalies at that elevator door... is there a massive summertime air leak?! Oh wait... that’s a reflection of me and a colleague, as well as the overhead lights...” Yes, I accidentally took an infrared selfie.

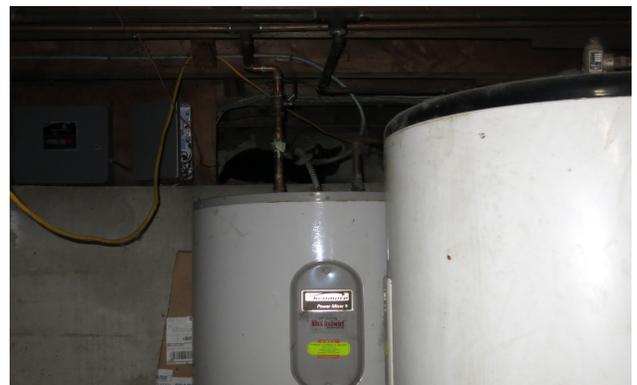
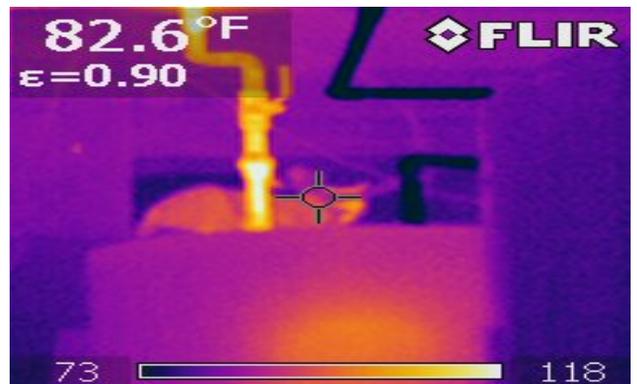
Figure 24: A furry basement thermal anomaly

Lastly, you sometimes run into surprises with an infrared camera as shown in **Figure 24**. I was scanning a client’s basement... “Yep... cool basement walls, warm water heater, hot pipe, WHAT THE WHAT IS THAT?!” If you turn on a flashlight (or turn up the brightness in the visual shot), you’d see that the homeowner’s black cat likes to perch on the basement wall.
