Case Study National Grid Deep Energy Retrofit Pilot Program Three-Story Victorian Partial Retrofit

Brookline, Massachusetts

OVERVIEW

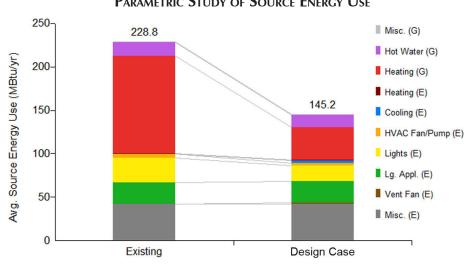
PARAMETRIC STUDY OF SOURCE ENERGY USE

Image from BSC generated by NREL's BEOpt 1.1 for retrofits

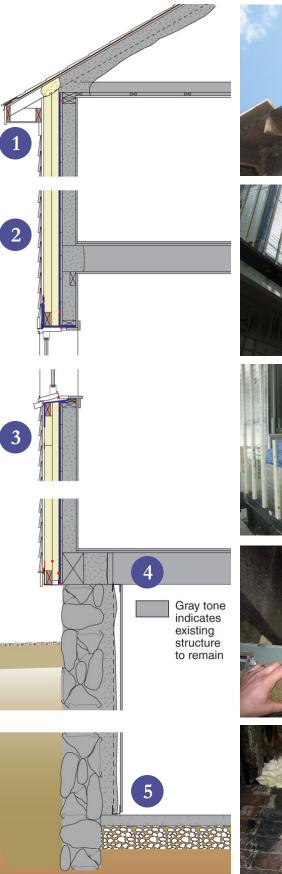
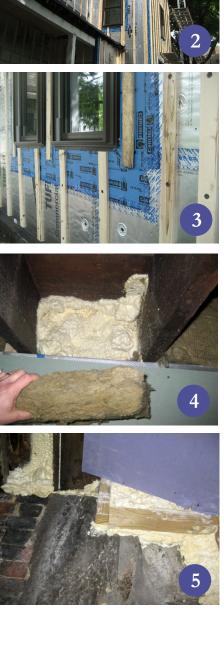
ENCLOSURE DESIGN

1 Roof Assembly: Retrofit measures completed in the previous enclosure retrofit; R-48 (nominal): Unvented roof assembly with 8" of closed-cell spray foam between the rafters; ½" plywood; fully-adhered membrane; asphalt shingles.

Wall Assembly: R-40 (nominal): Existing dense-packed cellulose insulation in wall framing cavities; housewrap over existing board sheathing, sealed at perimeter and all penetrations with seams taped; two layers of 2" foil-faced polyisocyanurate insulating sheathing; ¾" furring strips; wood siding.

Window Specifications: New Paradigm triple-glazed, krypton/ argon blend gas, low-E vinyl windows, U=0.20, SHGC=0.25; windows installed in alignment with drainage plane.

Infiltration: Sealant applied between housewrap and existing board sheathing at top and bottom of wall; sealant between successive layers at bottom of wall transitions airflow control to foundation airflow control of previous work; taped insulating sheathing with joints offset; two-part foam applied at the top of insulating sheathing to connect to closed-cell spray foam of previous work.

S Foundation Assembly: Retrofit measures completed in the previous enclosure retrofit; 3" closed-cell spray foam applied directly onto the existing field stone foundation walls; gypsum wall board thermal barrier on 1⁵/₈" metal studs partially embedded in closed-cell spray foam; 7" closed-cell spray foam at sill beam with a layer of rigid mineral wool insulation; slab remained uninsulated.

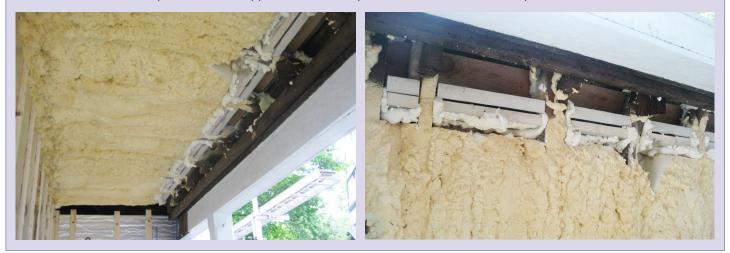
Design Challenge: Doubling Efforts

This project presented interesting challenges of connecting the control functions of an exterior wall retrofit system to previous retrofit work. At the front of the building is an overhanging floor where the previous retrofit had applied closed-cell SPF. The exterior insulating sheathing added as part of the current retrofit was applied to the face of the wall and continuous through the location where the porch roof had been cut away. As seen in the photo to the right, the use of two-part kit foam does not appear to have successfully connected the new work to the previous work at the first attempt. A second application of two-part foam was needed to provide robust connections.
