Impact Resistance of Advanced Framed Wall Systems with Insulating Sheathing as the Primary Sheathing

Research Report - 0603

Testing Results

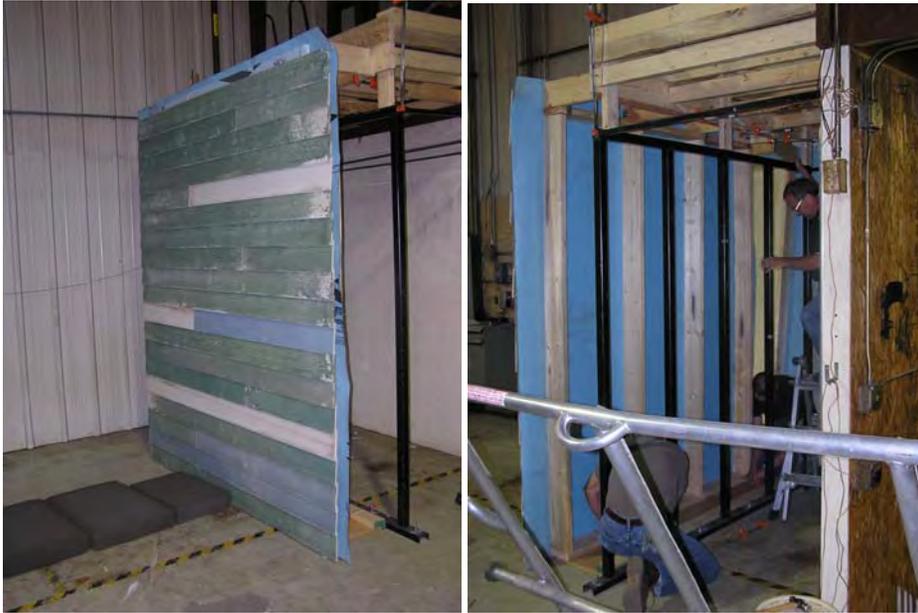
Each panel was clamped at the top and the bottom to a metal frame to provide the out of plane resistance for the panels.

Figure 2: Front and back of wall test set up

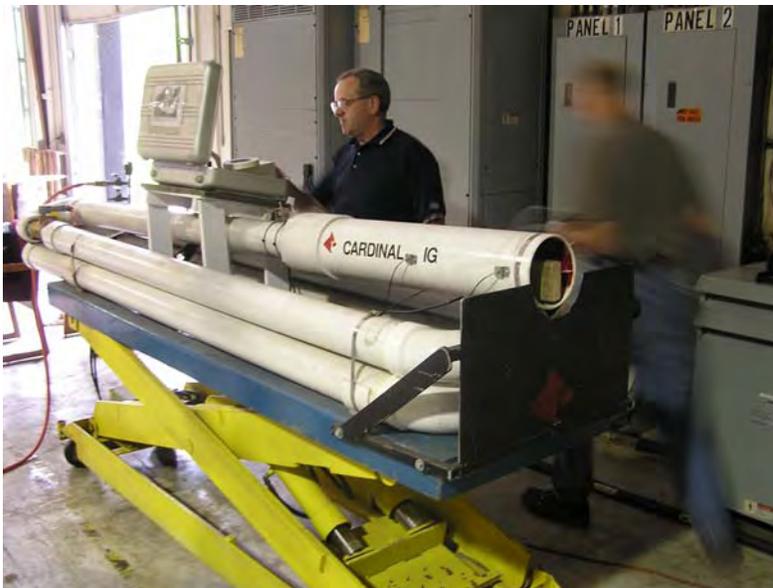
An air cannon was used to launch the 2x4 projectile at the test velocity¹.

Figure 3: Air Cannon

¹ The velocity of the studs cannot be directly controlled. The air cannon is pressurized to a certain air pressure before firing and the velocity of the stud is measured during each test. Due to this, slight variations to the stud velocity are common during the testing. In addition, the alternate velocities were determined by choosing alternate air pressure levels and measuring the corresponding velocities. This is why the velocity for the third tests ended up on an odd number.

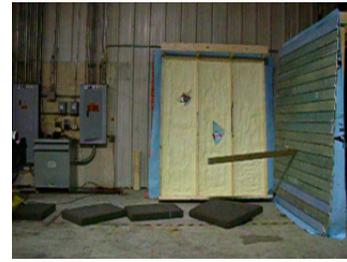
Stud impacting Wall 4

Figure 7: Wall 4 (Housewrap + ½ inch OSB Sheathing) fail at 50 fps

The baseline wall provided less resistance to impact than was expected. The failure at 50 fps was dramatic with the 2x4 projectile stud penetrating to half of its length through the assembly.

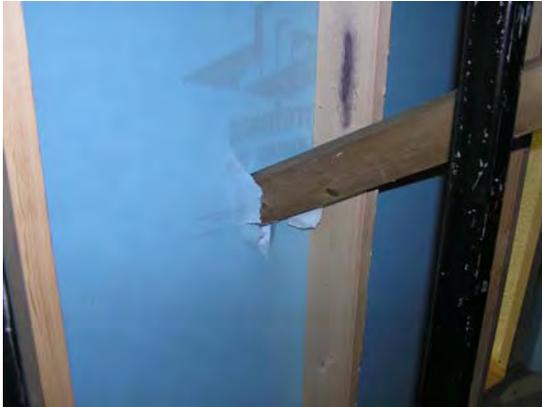
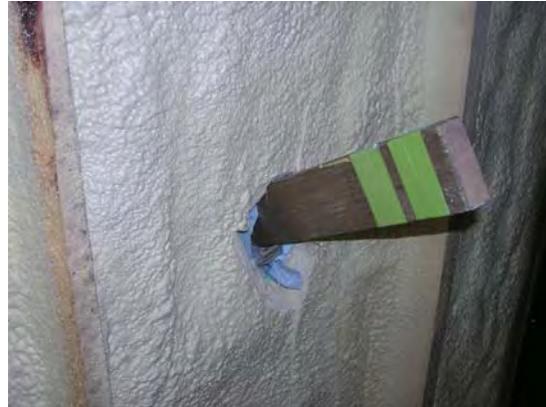
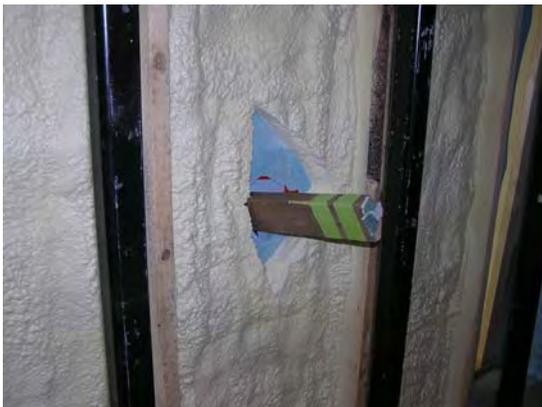
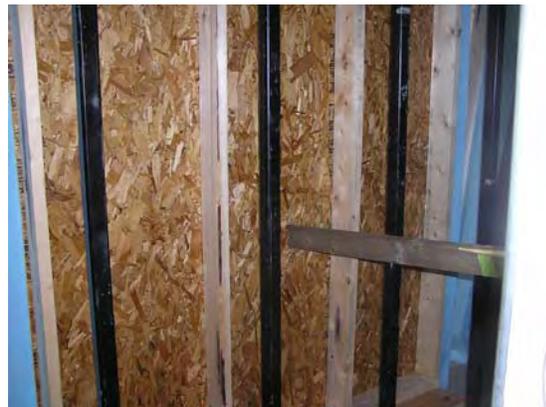
Figure 8: Stud penetration through all wall assemblies at 50 fps

Penetration failures were observed with all of the wall systems (including the OSB sheathed wall) at this stud velocity. These results were surprising as it was expected (based on information from other sources) that the OSB wall would be adequate to resist the impact.

Since all the wall designs (including the baseline wall) failed at this test velocity the test protocol was modified in order to determine the resistance threshold of the various assemblies. The velocity of the stud was reduced to approximately 40 fps from 50 fps.

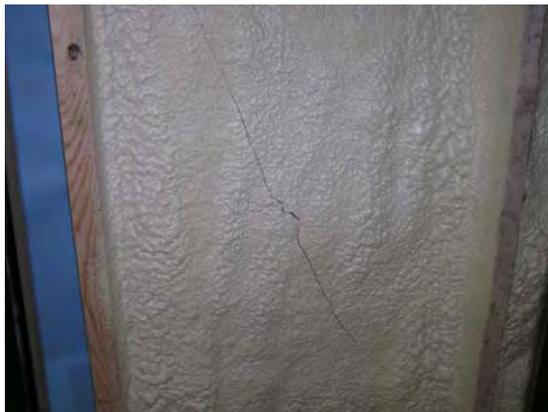
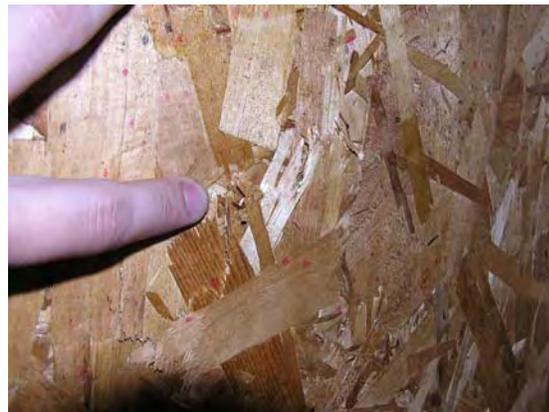
Figure 11: Cracking of both Closed Cell Foam and OSB Sheathing at 40 fps

At this new velocity, both Wall 2 (insulating sheathing and closed cell spray foam) and Wall 4 (OSB), were able to resist the force of impact of the stud, though damage to both systems was noted.

A more surprising result was that there was very little difference between the performance of Wall 2 (Insulating Sheathing + Housewrap + 2” Closed Cell Spray Foam) and Wall 4 (Housewrap + 1/2 inch OSB Sheathing). There appeared to be some composite action between the closed cell spray foam and the housewrap material. The bond between the two materials appeared to redistribute the impact force much better than the OSB sheathed wall alone. This could be seen by the size and distribution of the cracks in the closed cell foam. The failure location was more spread out and not limited to the immediate area of impact.

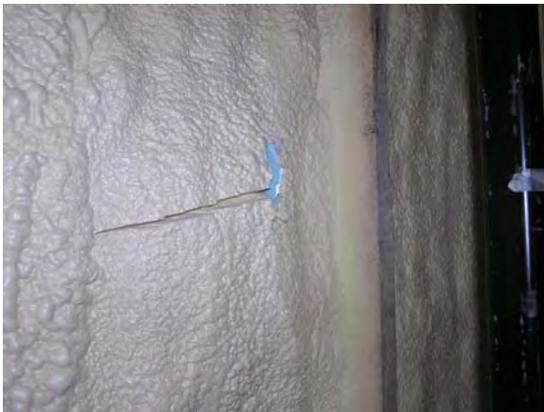
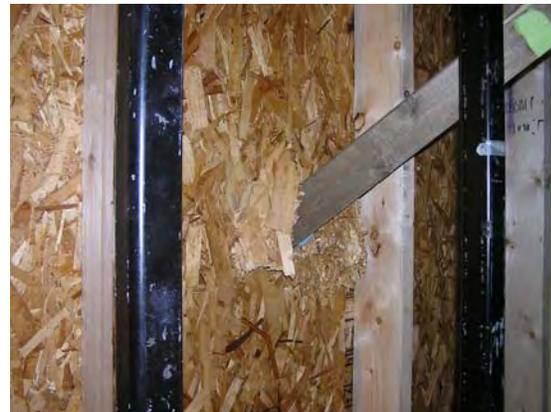
Figure 14: No penetration of Wall 2 and penetration of Wall 4 at 43 fps

At this velocity, the maximum threshold of Wall 2 was reached with two of the tests resisting the studs from penetrating through the wall assembly and one test allowing the stud to penetrate. At this same velocity, the OSB panel failed on all tests. This indicated that Wall 2 with insulating sheathing and 2 inches of closed cell spray foam was a slightly better performing wall than Wall 4 constructed with ½ inch OSB sheathing.

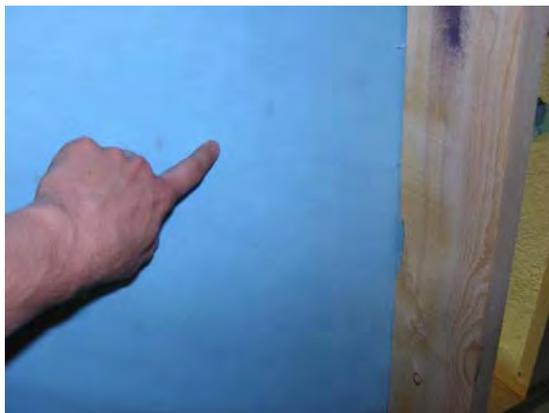
Figure 17: No penetration of Wall 1 at 30 fps

This result seemed to indicate that the addition of the closed cell spray foam to Wall 2 added an appreciable amount of impact resistance to the wall assembly.

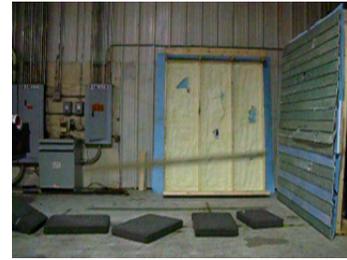
Stud impacting Wall 5

Figure 18: Wall 5 (Insulating Sheathing + Housewrap + 1/2 “ OSB Sheathing + 2” Closed Cell Spray Foam) pass at 50 fps

The site retrofit of a wall panel to create Wall 5 demonstrated how a wall could be constructed to resist puncture at 50 fps test velocity. The performance of this wall seemed to be less affected by the cladding performance than any of the other test walls. The stud penetrated through the fiber cement siding however did not penetrate through the remaining layers and bounced off the wall assembly. Damage to the remaining layers did occur though the stud was not able to penetrate in such a way as to remain lodged in the wall assembly as was seen in other wall panels.
