Peter Baker, P.Eng., Building Science Corporation

## Window Repair, Rehabilitation and Replacement

Building America Experts Meeting  
November 14, 2011, Minneapolis, MN

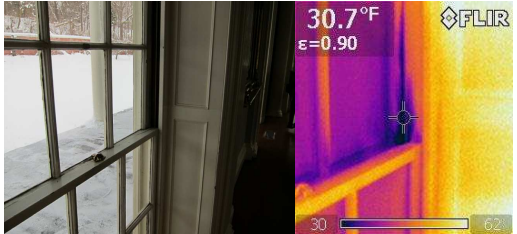
- Air Infiltration
  - Common pathways are at sash to frame interfaces

30.7°F  
ε=0.90

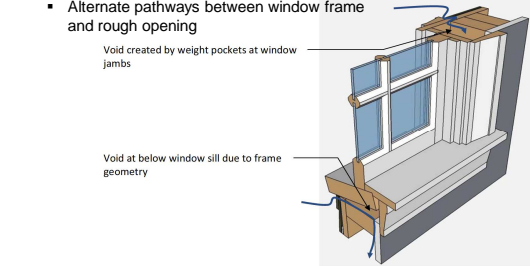
- Air Infiltration
  - Alternate pathways between window frame and rough opening

Void created by weight pockets at window jambs

Void at below window sill due to frame geometry

- Air Infiltration
  - Infiltration between the sashes and the window frame are address with all window retrofit measures
  - Infiltration between the frame and the rough opening are only addressed as part of a complete window replacement
  - Additional air sealing outside of the window retrofit is generally needed – typically through the use of spray foam insulation

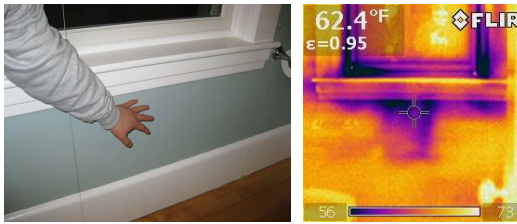
- Air Infiltration
  - Alternate pathways between window frame and rough opening

62.4°F  
ε=0.95

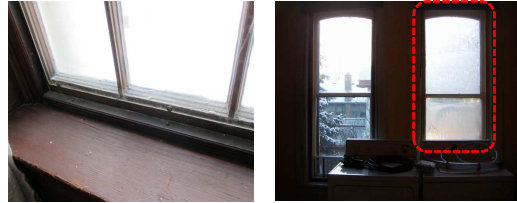
- Interstitial Condensation
  - Concern created by uncontrolled air leakage into space between original "prime" window and interior or exterior storm window

- Interstitial Condensation
  - For cold climates, the inner glazing element needs to be as air tight as possible (Drive is reversed for hot humid climates).
  - The exterior glazing element should be as air tight as possible to maximize performance.
  - If needed the exterior glazing element can be made incrementally more air leaky to help alleviate any condensation problems that may occur (increasing air leakage will reduce overall window energy performance).
  - Be aware of air by-pass through elements such as sash weight pulleys

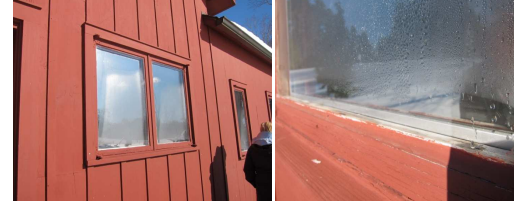
- Interstitial Condensation
  - Concern created by uncontrolled air leakage into space between original "prime" window and interior or exterior storm window

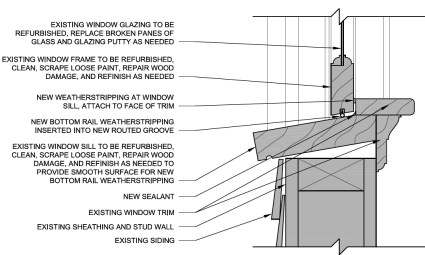
#### Window Rehabilitation
