Greening Affordable Housing

bsc Westford House Lowell HFH Lowell, MA

Project Overview

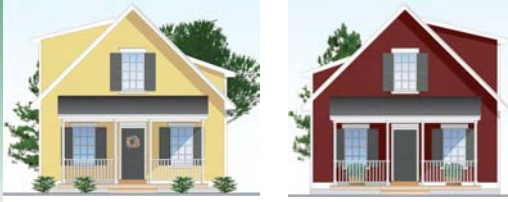
bsc Lowell Habitat for Humanity Westford, MA
 2,156 sq. ft. @ \$92/sq. ft. **HERS 49**

Gas (400 therms) = \$50/month @ \$1.50 /therm
 Electric (4200 kWh) = \$50/month @ \$.15/kWh
 = \$3.30 per day

With 3.5 kWp PV (350+- kWh/month)
 Electric = \$0

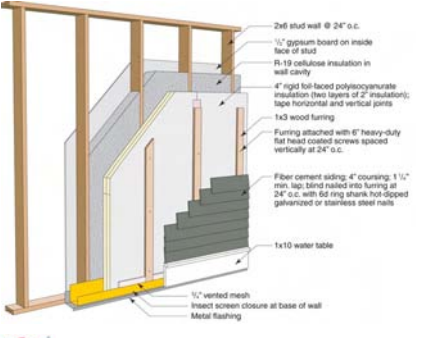
- 2x6 stud wall @ 24" o.c.
- 1/2" gypsum board on inside face of stud
- R-19 cellulose insulation in wall cavity
- 4" rigid foil-faced polyisocyanurate insulation (two layers of 2" insulation); tape horizontal and vertical joints
- 1x3 wood furring
- Furring attached with 6" heavy-duty flat head coated screws spaced vertically at 24" o.c.
- Fiber cement siding, 4" coursing, 1 1/2" min. lap; blind nailed into furring at 24" o.c. with 6d ring shank hot-dipped galvanized or stainless steel nails
- 1x10 water table
- 1/2" vented mesh
- Insect screen closure at base of wall
- Metal flashing
