Insight Blue Hawaii¹

By Joseph W. Lstiburek, Ph.D., P.Eng., Fellow ASHRAE

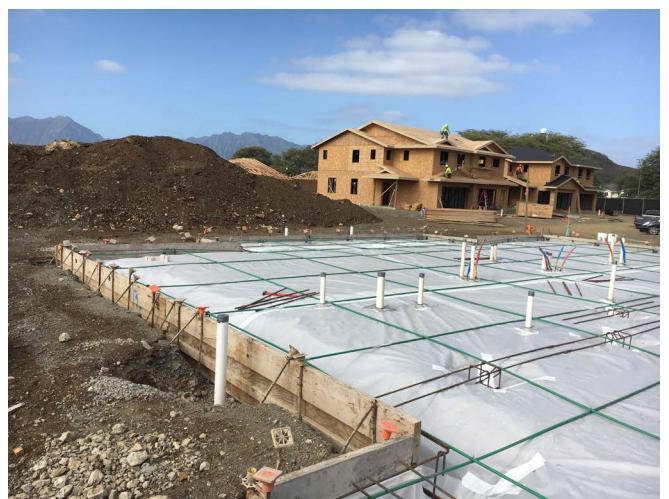
Photograph 2 – Slab Done Right: Note the complete polyethylene ground cover, taped joints, wrapped under the perimeter slab edge and tied into the perimeter slab forms with a polyethylene "hem". The ground is treated under the slab and at the slab perimeter with fipronil prior to the installation of the polyethylene ground cover.

You want to see some fabulous concrete slabs? Ask the Marines at Kaneohe Bay, O'ahu. Check out **Photograph 2** and **Photograph 3**. Note the complete polyethylene ground cover, taped joints, wrapped under the perimeter slab edge and tied into the perimeter slab forms with a polyethylene "hem". Even better, note the stainless steel mesh clamped to the pipe penetration that gets cast into the slab creating a physical termite barrier. The ground is treated under the slab and at the slab perimeter with fipronil prior to the installation of the polyethylene ground cover.

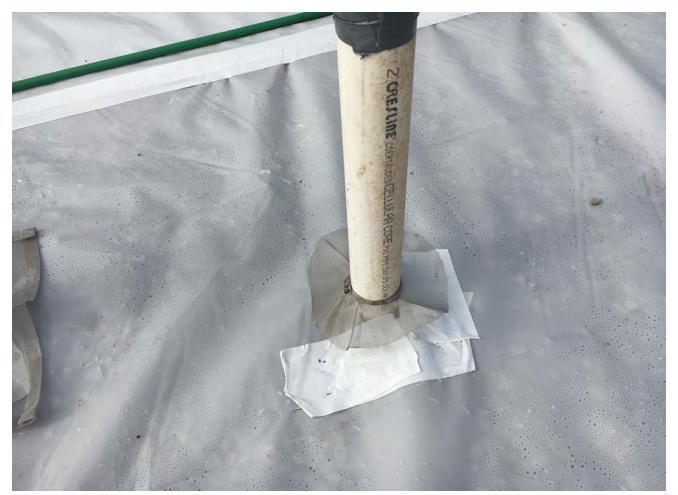
Photograph 3 – Physical Barrier: Even better, note the stainless steel mesh clamped to the pipe penetration that gets cast into the slab creating a physical termite barrier.

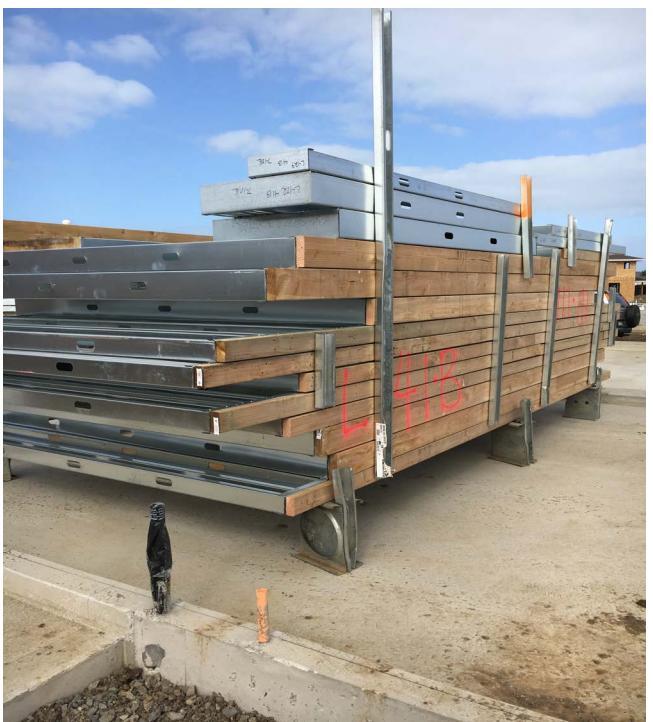
Photograph 4 – Steel Framing: Even with steel framing we typically have a wood top plate and wood framing around punched openings such as windows.

On to Hawaiian residential walls. They sure like their steel framing (**Photograph 4**). Termites don't eat steel. Not a lot of wood stud framing. But steel rusts. Where the steel framing is in contact with the concrete slab the bottom track of steel is wrapped with a peel and stick membrane to reduce the risk of corrosion (**Photograph 5**). But it is impractical to get rid of all wood. So you minimize it and move it up away from the ground and those miserable termites (**Photograph 6**).

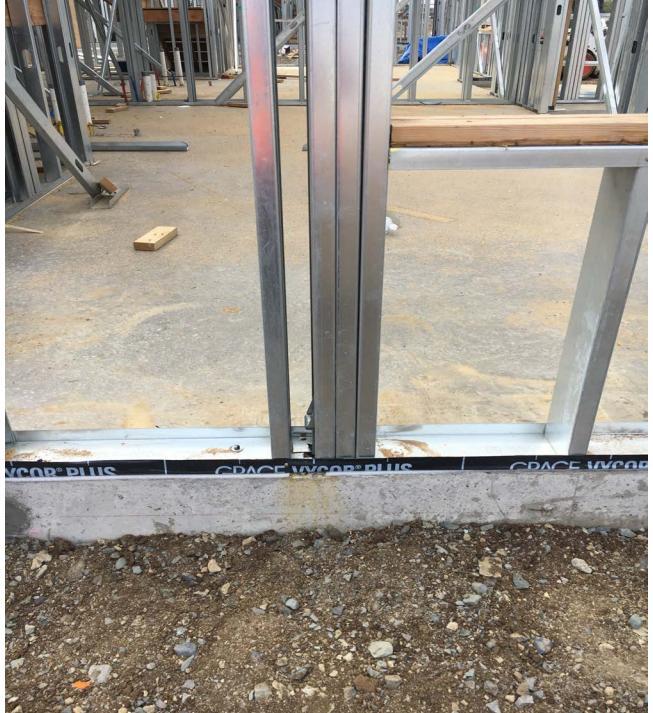
Photograph 5 – Steel Rusts: Termites don't eat steel. Not a lot of wood stud framing. But steel rusts. Where the steel framing is in contact with the concrete slab the bottom track of steel is wrapped with a peel and stick membrane to reduce the risk of corrosion.

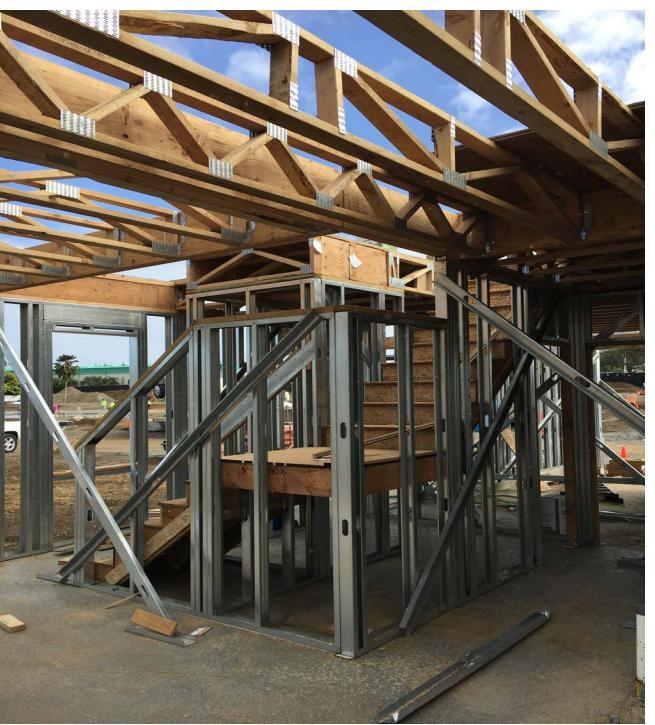
Photograph 6 – Minimize Wood: It is impractical to get rid of all wood. So you minimize it and move it up away from the ground and those miserable termites.

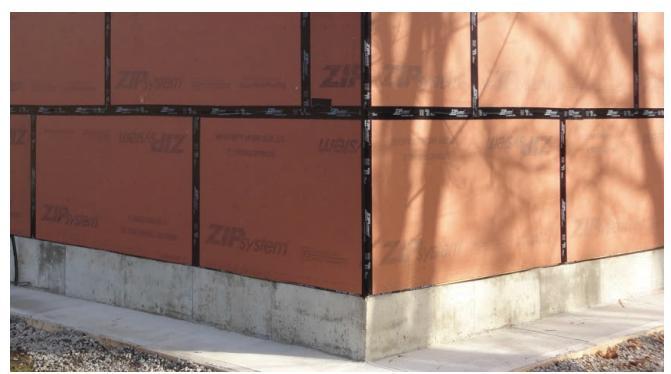
Photograph 7 – OSB Sheathing: Note the integral water control layer on the face of the OSB. The joints in the OSB are taped to provide water control layer continuity and air control layer continuity. The OSB also acts as a "vapor throttle" reducing inward vapor drive. Note in hot, humid climates the dominant vapor flow is from the outside to the inside. Also note the "concrete skirt" around the perimeter of the foundation to keep insects, vermin and plant growth away from "where the building touches the ground". More "physical barrier" stuff. Don't knock it, it works.

Photograph 7 shows an OSB sheathing with an integral water control layer on the face of the OSB. The joints in the OSB are taped to provide water control layer continuity and air control layer continuity. The OSB also acts as a "vapor throttle" reducing inward vapor drive. Note in hot, humid climates the dominant vapor flow is from the outside to the inside. Also note the "concrete skirt" around the perimeter of the foundation to keep insects, vermin and plant growth away from "where the building touches the ground". More "physical barrier" stuff. Don't knock it, it works.

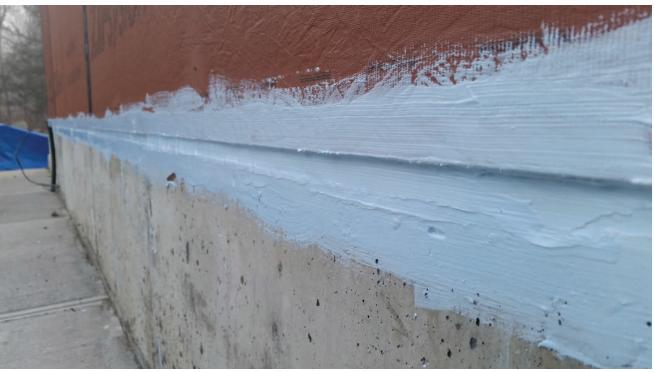
Photograph 8 – Continuous Seal: Note the "airtight" seal between the sheathing and the concrete foundation. We do not want "salty" air getting into the wall framing and causing havoc with our steel studs and connections.

Photograph 8 shows an "airtight" seal between the sheathing and the concrete foundation. We do not want "salty" air getting into the wall framing and causing havoc with our steel studs and connections.

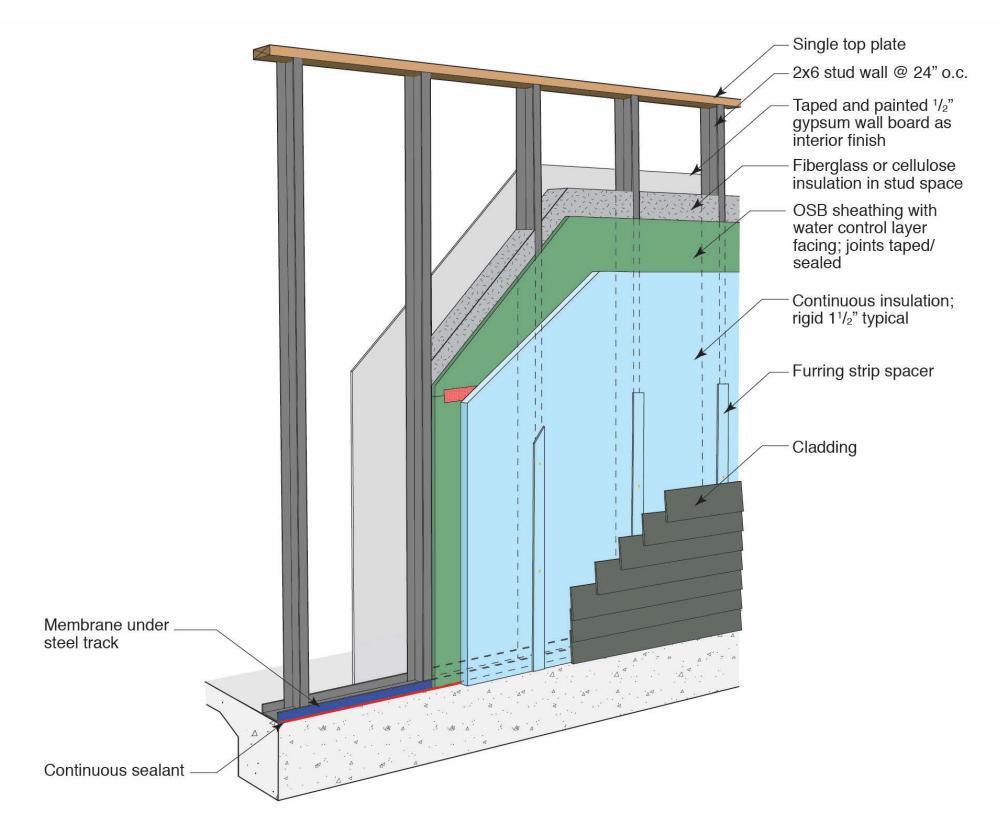
Figure 1 – Steel Framing: Everyone knows that steel framing has lousy thermal performance. We need continuous insulation over the exterior of the steel framing. Pick any continuous insulation you want. They all work in this configuration.

Now, everyone knows that steel framing has lousy thermal performance. We need continuous insulation over the exterior of the steel framing (**Figure 1**). Pick any continuous insulation you want. They all work in this configuration. The windows and punched openings are handled as shown in **Figure 2**. No need to "picture frame" or use a "ROESE" - a "rough opening extension support element" (see "<u>BSI-022</u>: <u>The Star-Crossed</u> <u>Lovers of Building Science</u>", November 2016).

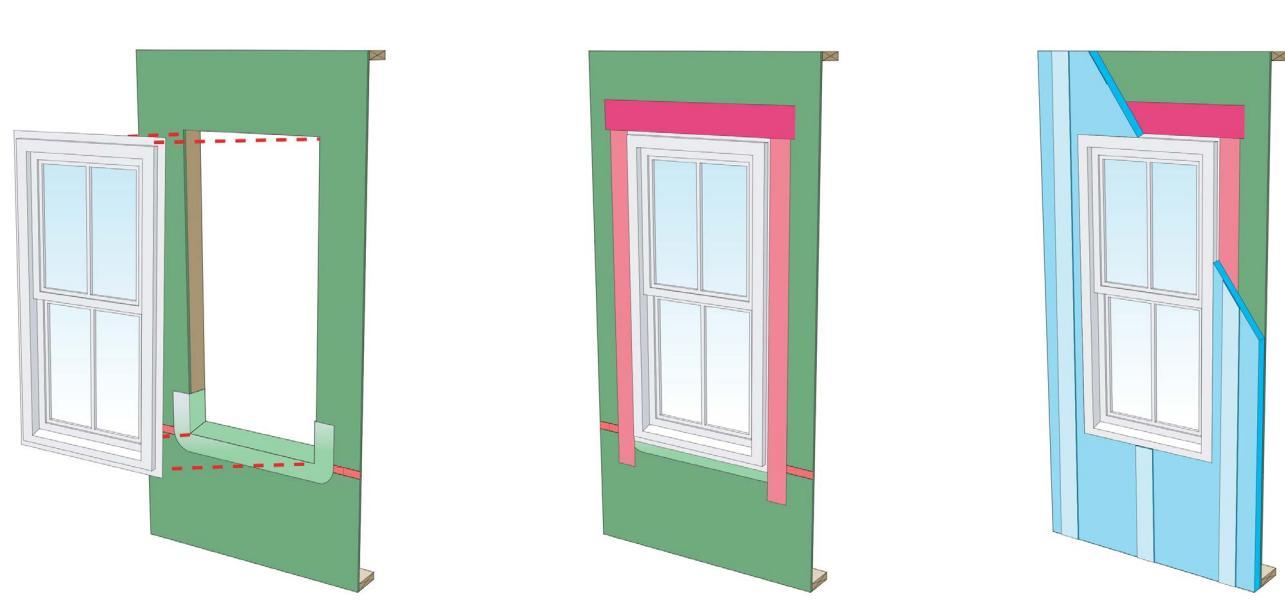
Figure 2a – Window Installation: Note the "pan flashing" at the bottom of the rough opening and note that the window flange is installed directly on the OSB sheathing. **Figure 2b – Window Installation:** Flashing tape is used to provide water control layer continuity and air control layer continuity. **Figure 2c – Window Installation:** Continuous insulation is installed over the OSB sheathing. Note that the water control layer is behind the continuous insulation.

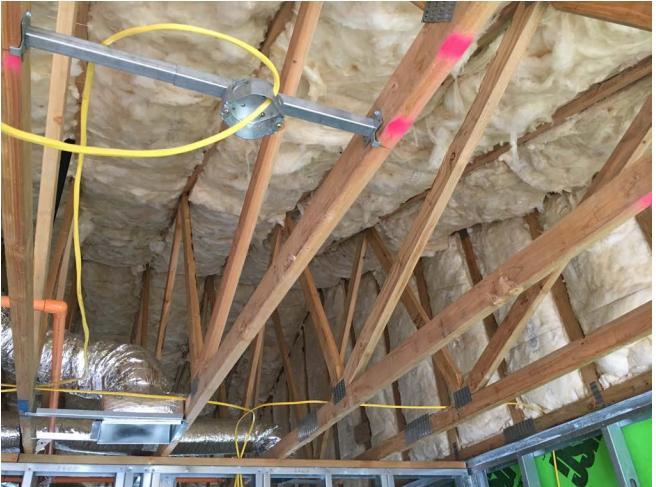
Photograph 9 – Hawaiian Roofs: Don't vent roofs in Hawaii. Move the insulation from the "flat" to the "slope" and install a vapor diffusion ridge vent to allow vapor to exit the assembly via vapor diffusion. No air change between the attic and the exterior occurs. This has three huge benefits. First, no salty air into the attic and no corrosion. Second no exterior humid air into the attic to cause ducts to sweat and a huge increase in airtightness of the entire assembly reducing part load humidity problems and providing a huge thermal benefit. Third, the ducts are now in conditioned space providing a huge thermal benefit.

On to Hawaiian residential roofs. Vented roofs in Hawaii lead to corrosion of roof truss connections. Easy solution. Don't vent roofs in Hawaii. Move the insulation from the "flat" to the "slope" (**Photograph 9**) and install a vapor diffusion ridge vent to allow vapor to exit the assembly via vapor diffusion (**Figure 3** and **Photograph 10**). No air change between the attic and the exterior occurs. This has three huge benefits. First, no salty air into the attic and no corrosion. Second no exterior humid air into the attic to cause ducts to sweat and a huge increase in airtightness of the entire assembly reducing part load humidity problems and providing a huge thermal benefit. Third, the ducts are now in conditioned space providing a huge thermal benefit. We were here before ("<u>BSI-088: Venting Vapor</u>", July 2015).

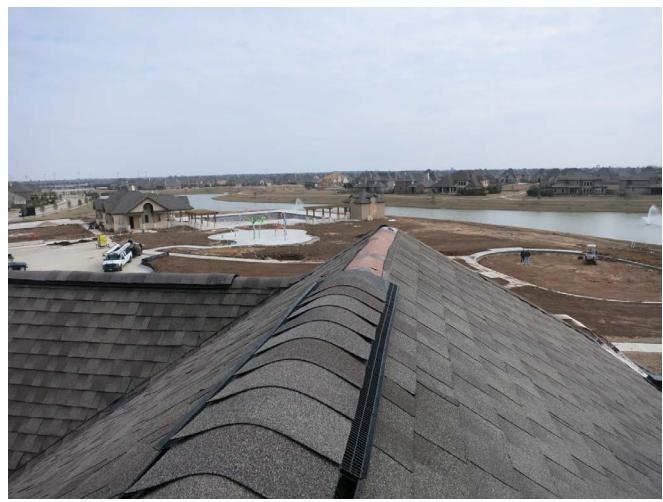
Photograph 10 – Vapor Diffusion Ridge Vent: Standard ridge vent coupled with a vapor open, air tight and water tight membrane covering the slot opening in the roof sheathing at the ridge.

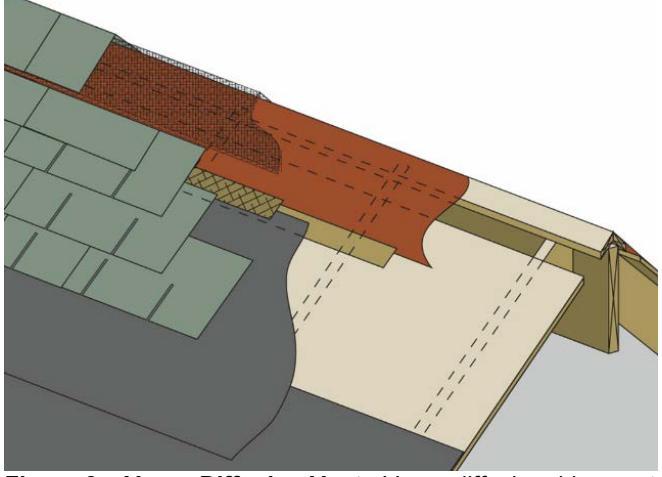
Figure 3 – Vapor Diffusion Vent: Vapor diffusion ridge vent allows vapor to exit the assembly via vapor diffusion. No air change between the attic and the exterior occurs.

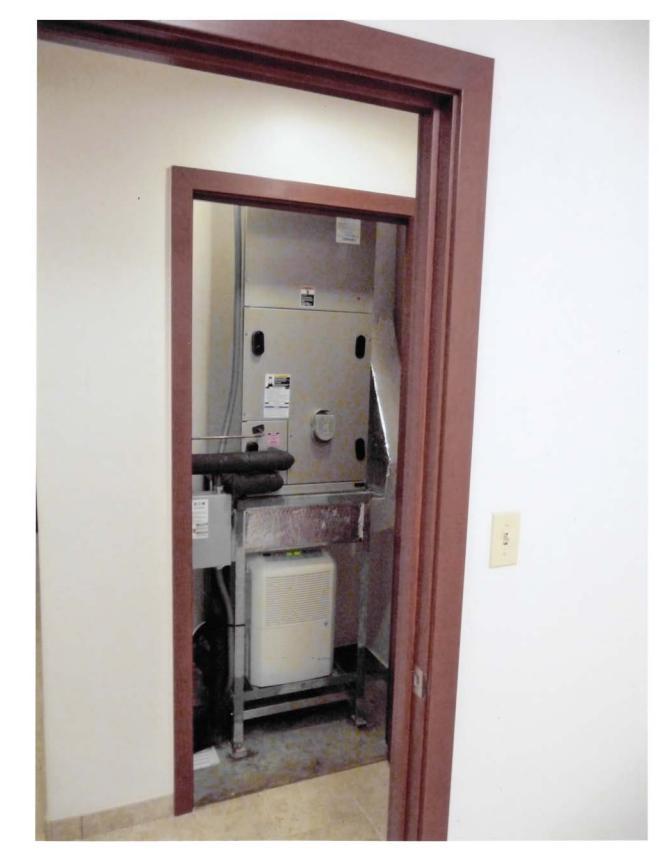
Photograph 11 – Dehumidifier: Still have a part load humidity problem to deal with. We have great windows, lots of thermal insulation, compact fluorescent and LED lights, and controlled ventilation. Not much of a sensible load. We do have a big latent load. We have to remove the humidity. Yup, we need a dehumidifier.

Not quite done. Still have a part load humidity problem to deal with. We have great windows, lots of thermal insulation, compact fluorescent and LED lights, and controlled ventilation. Not much of a sensible load. We do have a big latent load. We have to remove the humidity. Yup, we need a dehumidifier (**Photograph 11**). Now we are done.
