Thermal Metric Summary Report

(June 2015 Update)

Building Science Corporation

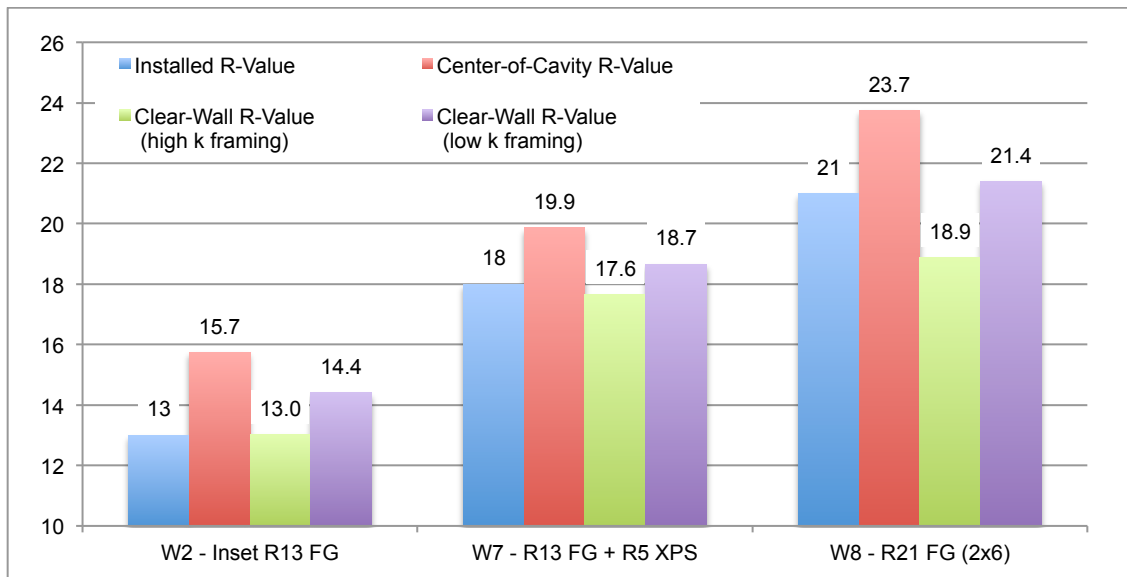
Figure ES-1 – Common Thermal Metrics for Reference Walls 2, 7, and 8

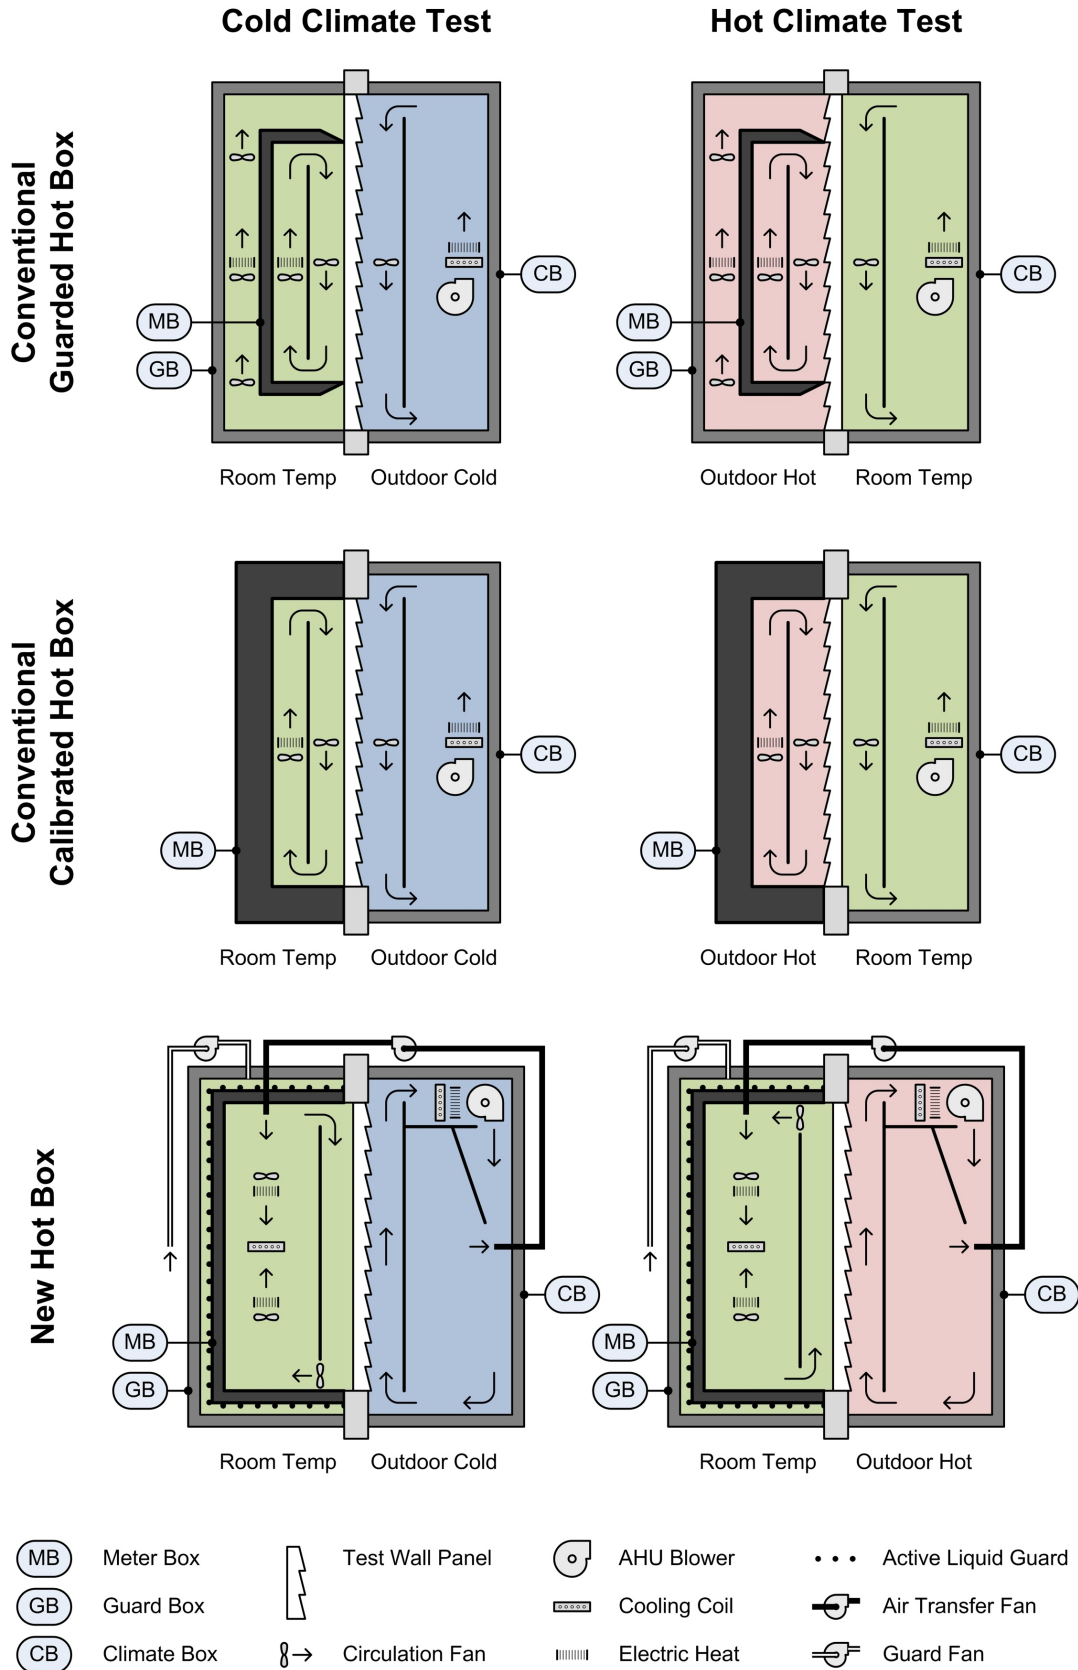
Figure 1 – Schematics of Conventional Guarded Hot Box (top), Conventional Calibrated Hot Box (middle) and Thermal Metric Research Hot Box (bottom)

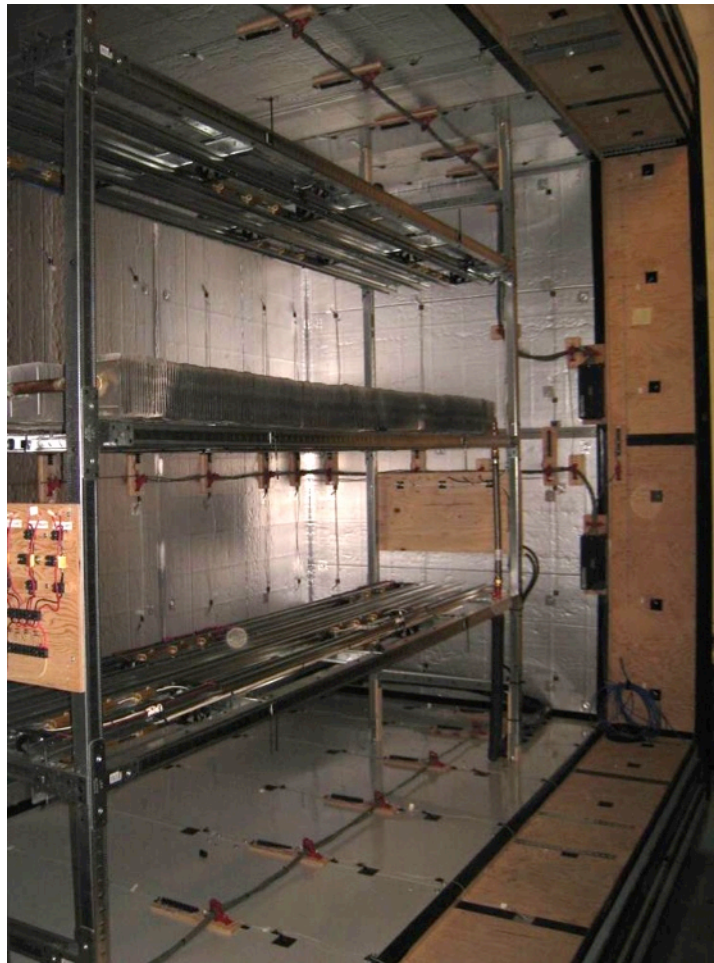
The temperature in the meter box is controlled by electric heat and hydronic cooling. Two heating arrays, each consisting of 16 heaters and 8 mixing fans, are installed in the upper and lower portions of the mixing part of the meter box as seen in Figure 2. The size, number and distribution of the heaters and fans ensure that the temperature is relatively uniform throughout the meter box. Again, voltage and current supplied to the heaters and mixing fans are measured across precision ($\pm 0.01\%$) resistors so that the power may be calculated.

Figure 2 – Upper and Lower Heating Arrays with Cooling Coil in Meter Box

Cooling is achieved by a large, finned convection coil mounted at mid-height in the mixing part of the meter box. The large heat transfer area permits the removal of significant amounts of heat with only modest (e.g. 1°C or 1.8°F) temperature increases across the coil. Distilled water is pumped from a chilled, constant temperature ($\pm 0.05^{\circ}\text{C}$) buffer tank, into the meter box, through the convection coil, and back out of the meter box. The flow rate is measured using a NIST traceable $\pm 0.2\%$ of reading flow meter and the supply and return temperatures are measured using a pair of precision thermistors ($\pm 0.1^{\circ}\text{C}$) and a pair of ultra-precision RTDs ($\pm 0.012\text{ohm}$). These measurements can then be used to calculate the power extracted by the cooling.

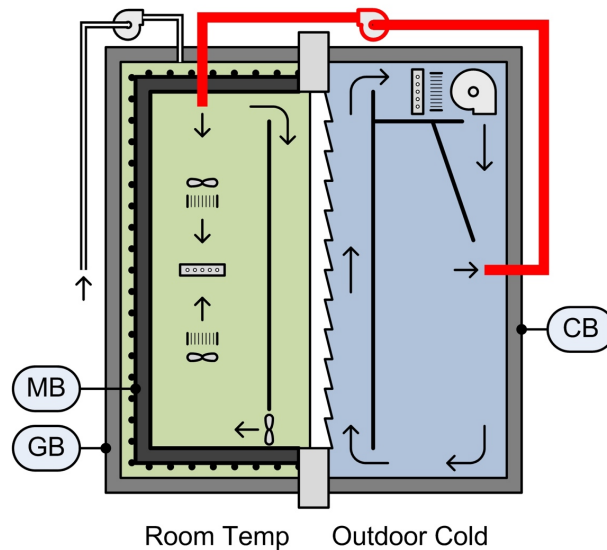
Figure 10 – TM Hot Box Schematic indicating Air Transfer System

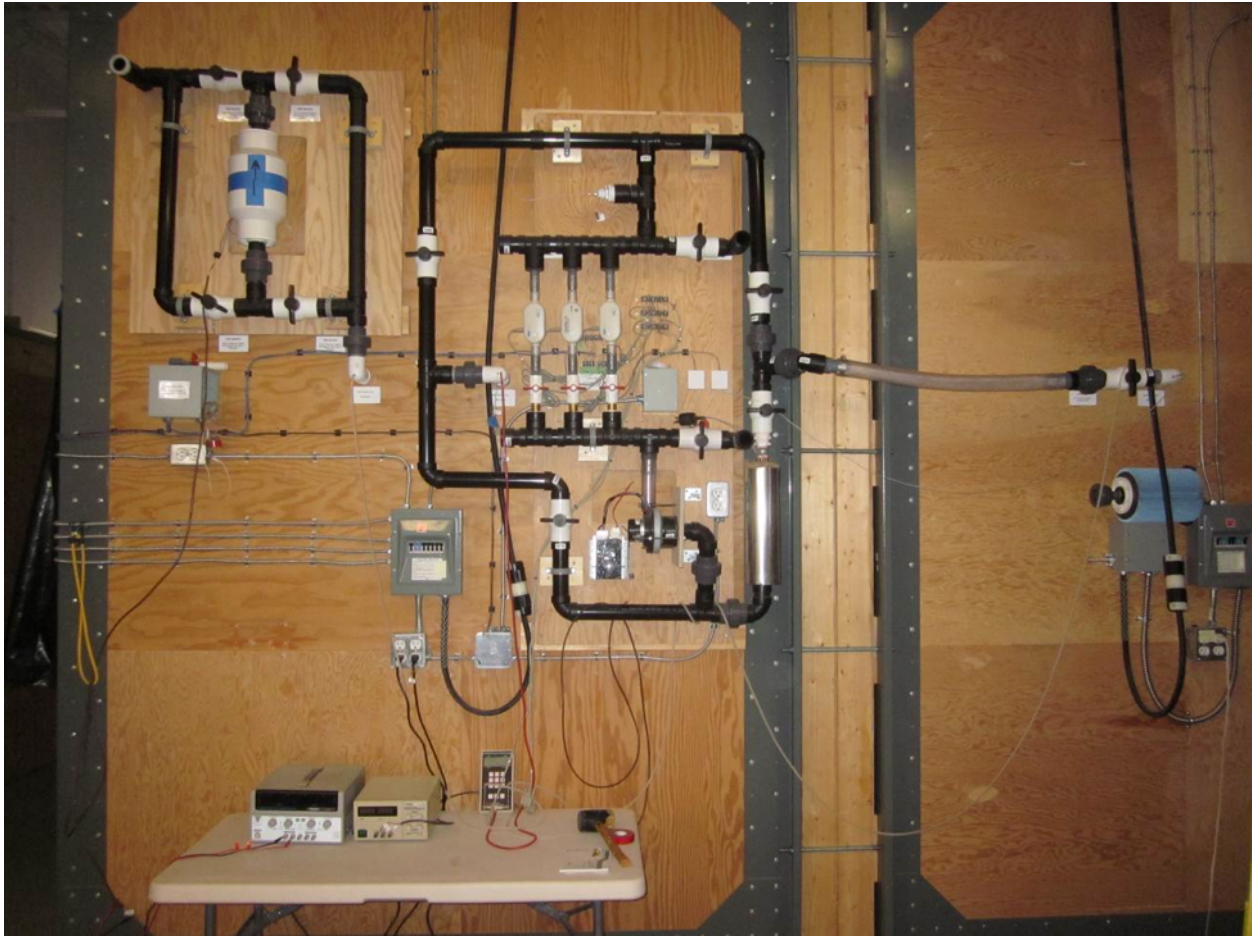
One of the novel aspects of the TM hot box is the air transfer system (ATS). The system, pictured in Figure 11, generates a pressure difference between the meter box and the climate box to drive airflow through available paths in the test wall specimen. The system comprises an inline variable-speed DC blower, an inline heater, three high-accuracy ($\pm 2\%$ of reading) mass flow sensors and piping and valves to allow researchers to negatively pressurize (i.e. induce infiltration) or positively pressurize (i.e. induce exfiltration) the meter box. A variable-speed DC guard fan with similar valves is used to minimize the pressure difference between meter and guard boxes so that airflow only occurs between the meter and the climate boxes.

Figure 11 – Guard Fan (Left) & Air Transfer System (Center)

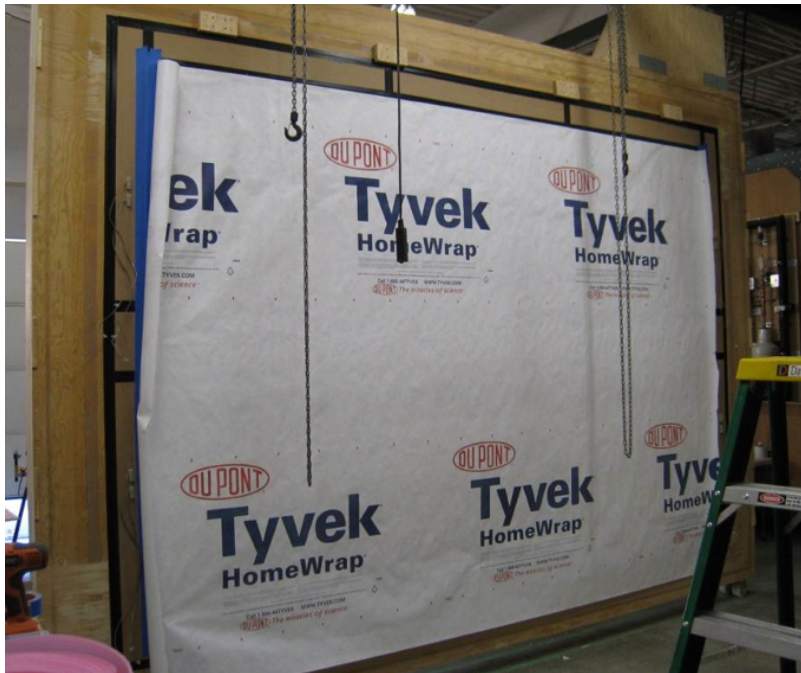
A single continuous sheet of spun-bonded polyolefin (SBPO) housewrap was stapled to the exterior of the wall and was taped on the sides only. Taping on the sides only ensures that air that exits at the mid-height of the sheathing at the imposed gap has a route to escape past the housewrap. This is an expected leakage path for air in an actual wall assembly.

Figure 17 – Tyvek Installed but Untaped

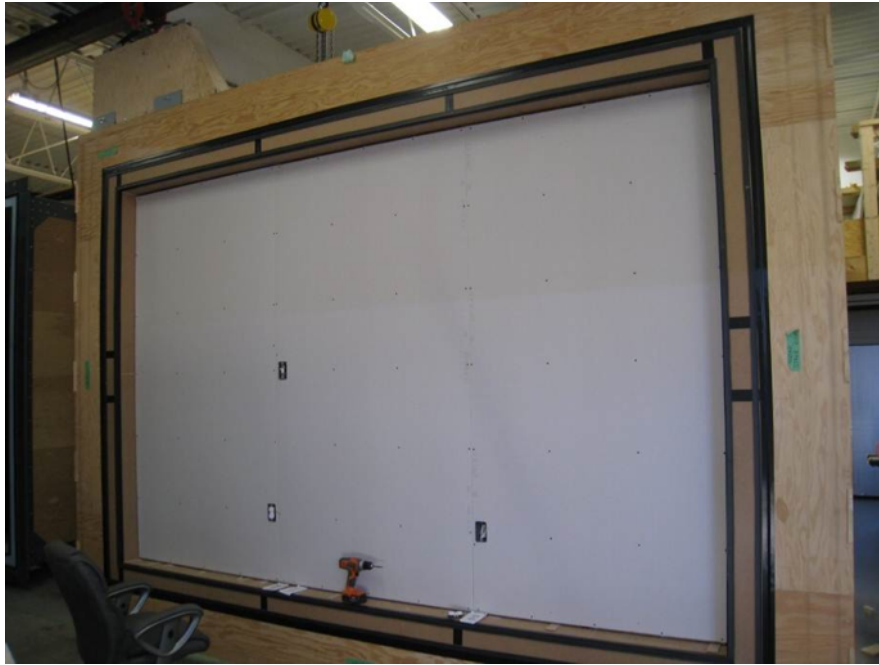
The drywall was installed with spacers on the top and bottom plates just as the OSB was installed. The last vertical stud on each end of the 8' x 12' assembly was sealed to the drywall with a gasket to ensure a leakage path was not provided at the ends of the wall. The vertical edges of the air barrier were sealed to simulate a continuous wall.

Figure 18 – Drywall Installed

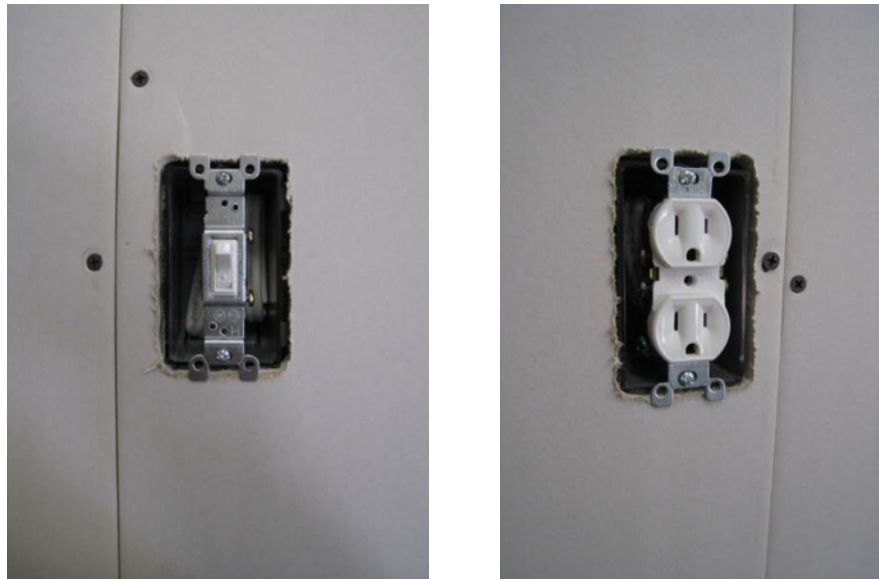
Figure 19 – Installed Switch and Plug

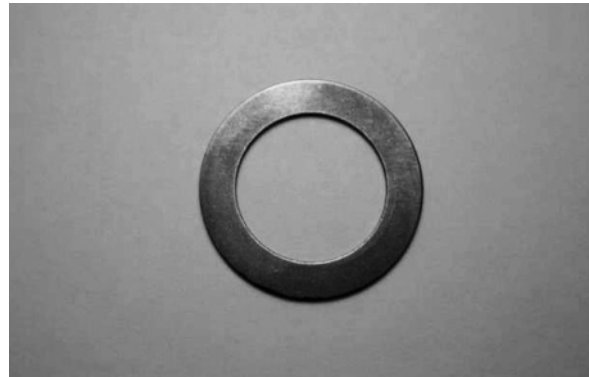
Upon air leakage testing the initial wall it was found that the leakage was too high compared to the data found in the literature review. The wall was disassembled and the 1/16" spacers were replaced on the drywall side with 1/32" spacers (Figure 20). The air leakage test was run again, and it was determined the leakage was still above the acceptable bounds. The OSB was removed and the 1/16" spacers were replaced with 1/32" spacers. The air test was run again and this provided acceptable air leakage rates.

Figure 20 – 1/32" Wall Spacers

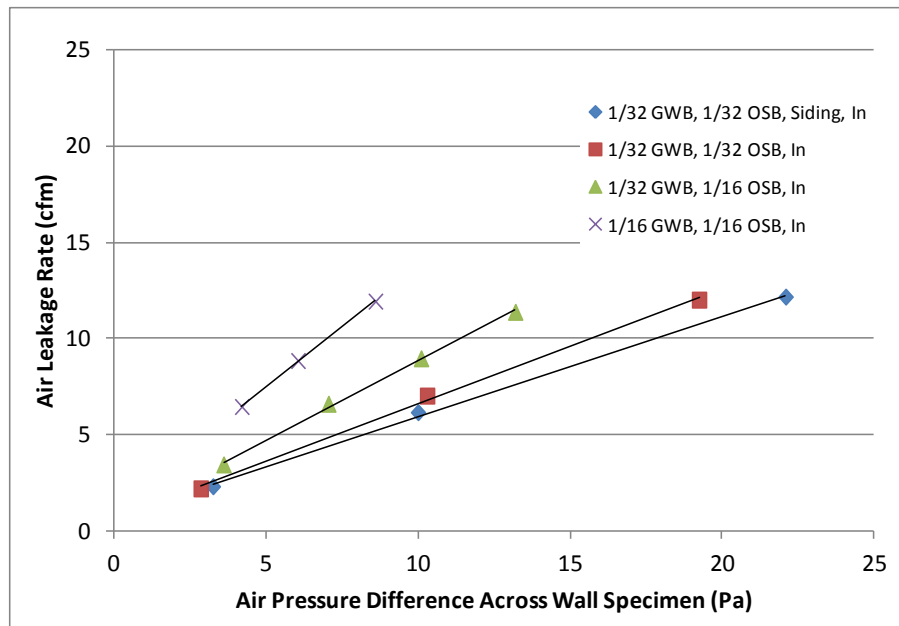
The results from the air leakage summary are shown in Figure 21. The analysis shows that with 1/32" spacers installed between both the drywall and the top and bottom plates as well as the OSB and the top and bottom plates an air leakage rate of approximately 0.25 CFM50/ft² is attained. This method of creating air leakage paths at the top and bottom plates was used for all of the walls discussed within this report.

Figure 21 – Imposed Gap Analysis

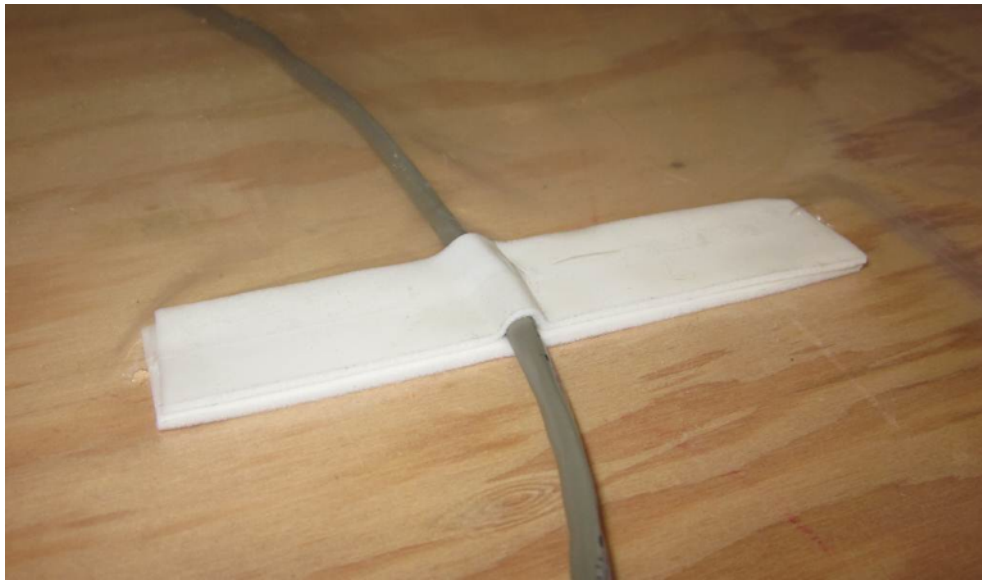
Sealing of the test wall requires the application and attachment of a continuous sheet of polyethylene on both sides of the wall. A clear polyethylene was chosen to limit changes to the wall surface from radiation. A mid-weight polyethylene was chosen because lightweight polyethylene was difficult to tape in place and heavyweight polyethylene is generally less translucent. The wires for the thermistor sensors had to penetrate the polyethylene, so a method was developed to air seal the penetration. Figure 22 and Figure 23 show the method of air sealing the thermistor sensor wires as they penetrate the polyethylene air seal. A conforming foam double-sided tape is applied to both sides of the slit in the polyethylene and then a double layer of heavy duty tape covers the whole assembly. Figure 24 and Figure 25 show the air sealing of the meter box side of the wall, while Figure 26 and Figure 27 show the air sealing of the climate box side. Thin double-sided tape is used on each sensor location, and slightly thicker double-sided tape is used to create a grid of adhesive locations between the sensors. A double-sided tape seal, seconded with heavy duty tape, creates the perimeter seal.

Figure 22 – Sealed Wall Wire Penetration

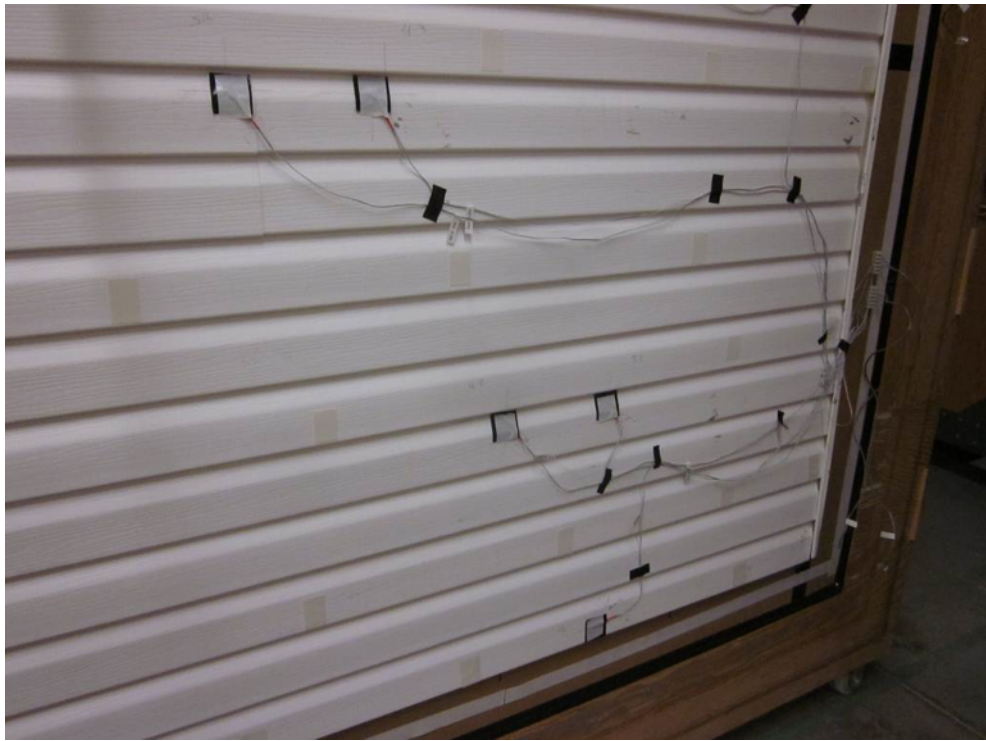
Figure 26 – Climate Box Side, Tape Grid

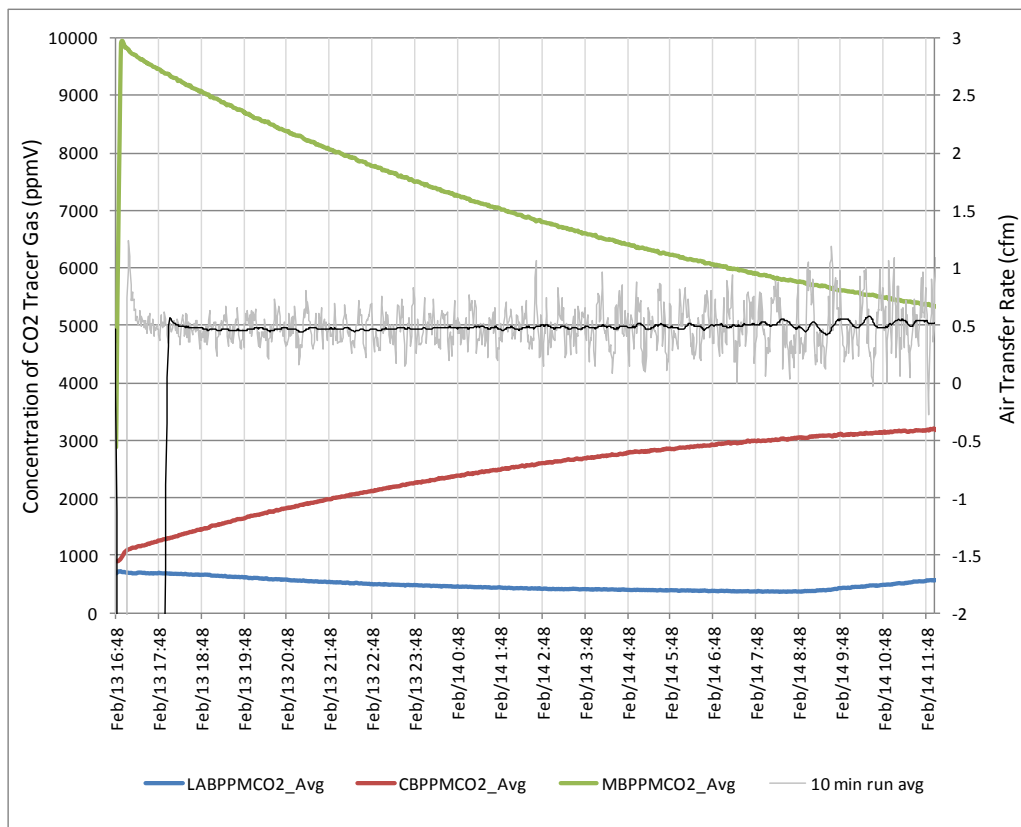
In order to quantify the heat flow due to air transfer through an assembly throughout the testing period a method of continuously monitoring the airflow through the assembly was required. A tracer gas system was assembled using CO₂ injection port in the meter box and monitors within the meter box and climate box. Atmospheric CO₂ is approximately 400 parts per million (ppm) and can be easily monitored with readily available components for building HVAC automation equipment. As a process, the meter box is first injected with CO₂ gas to a concentration approaching 10,000 ppm while the climate box begins closer to atmospheric levels. As the test progresses, depending on the leakiness of the assembly, the CO₂ transfers from the meter box to the climate box. The monitoring system takes a temperature-corrected reading every minute in both spaces. A data logger collects and stores the information. The data can then be downloaded and, using a mass balance equation comparing readings simultaneously in both spaces, the air transfer between the spaces can be calculated. A third CO₂ sensor monitors the laboratory space next to the box for comparison. Figure 28 shows the decay for a test wall showing the decay of the meter box CO₂, the climb of the climate box CO₂ and the correlating CFM of air leakage on a 10 minute average plotted on the right-hand axis. Using a 10 minute running average decay comparison (30 minute for sealed tests as the decay is much slower), the actual airflow is calculated. The 10 minute averages are averaged over a selected period to determine the air leakage for each set point.

Figure 28 – Tracer Gas Decay and Mass Flow

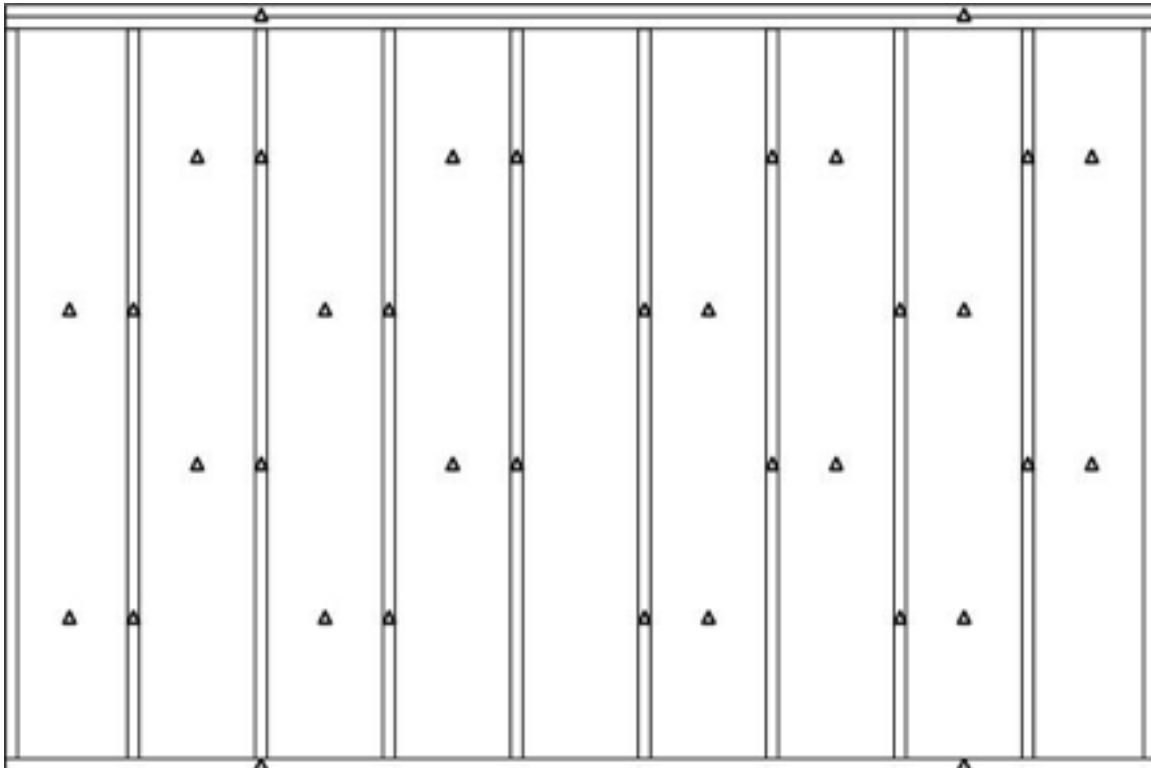
Paired temperature measurements are made on opposite sides of each specimen using calibrated thermistors. Each temperature measurement location on the meter box side correlates to a temperature measurement location on the climate box side. The thermistors are attached directly to the surface of the specimen using a three layer taping assembly including a black low emissivity top tape layer to limit interaction effects of neighboring surfaces. Figure 29 shows an instrumentation grid typical of the walls tested. Stud, stud bay, and top and bottom plate temperatures are measured and averaged.

Figure 29 – Temperature Measurement Locations

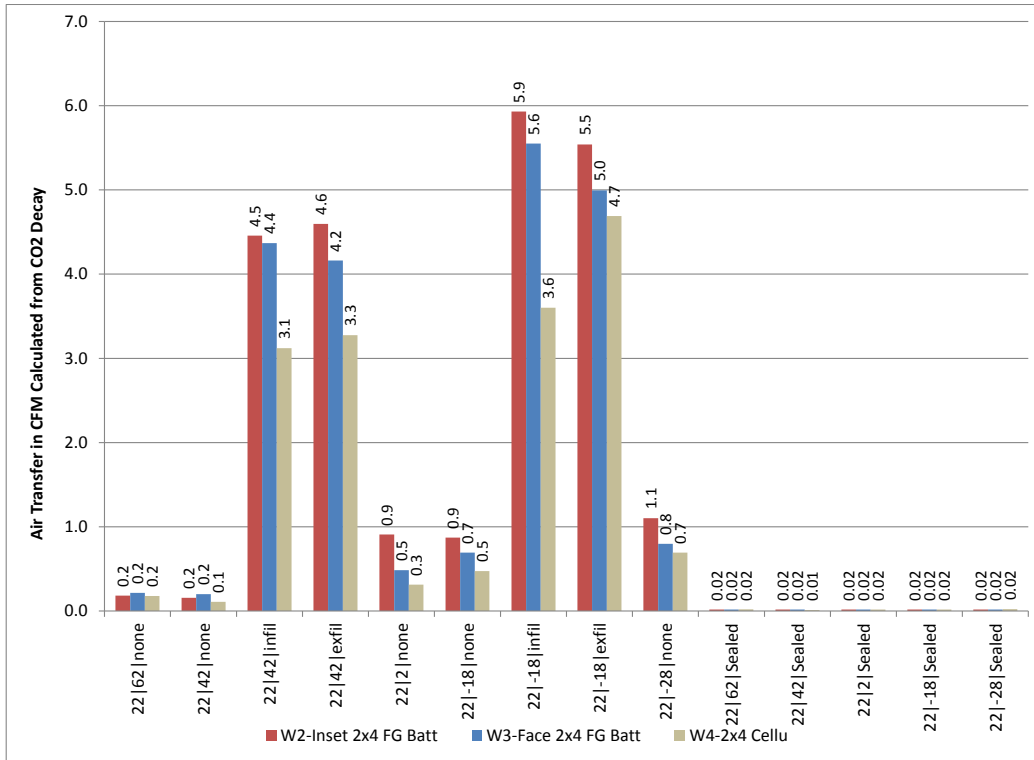
The infiltration (drawing air from the meter box) and exfiltration (supplying air to the meter box) tests were completed by imposing a 10Pa pressure differential over the wall specimen. Because each wall is different, the amount of air required to create a 10Pa differential varies. Wall 2 (Inset FG 2x4), Wall 3 (Face FG 2x4), and Wall 4 (Cellulose 2x4) have very similar constructions with the only difference being inset versus face-stapled batts versus damp sprayed cellulose. Figure 31 shows the air transfer rates in cubic feet per minute calculated on a mass basis from CO₂ decay. The figure shows that, under normal operating conditions, Wall 3 (face-stapled R13 FG batt) is slightly more resistant to airflow than Wall 2 (inset-stapled R13 FG batt). Wall 4 (damp-sprayed CFI) is more resistant to airflow than Walls 2 and 3. This order of airflow resistance is also visible under imposed 10Pa conditions at almost all temperatures. Note that the air leakage rates are higher at colder temperatures.

Figure 31 – Wall 2, Wall 3, and Wall 4 Air Transfer Rates in CFM

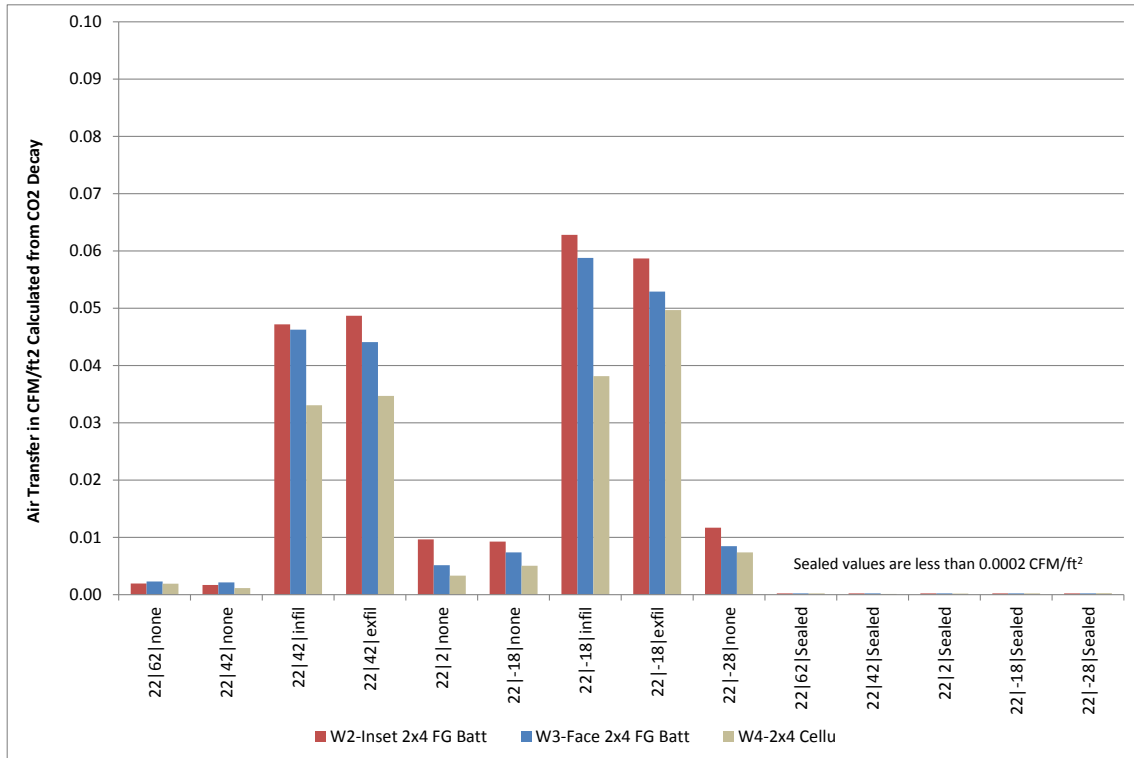
Figure 32 shows the information in Figure 31 divided by the area of the wall to show the leakage per square foot of wall surface. Figure 33 shows the energy flow in watts correlating to the information in Figure 31 for Wall 2, Wall 3, and Wall 4. These figures also show that very minimal airflow and heat flow were measured in the sealed wall tests.

Figure 32 – Wall 2, Wall 3, and Wall 4 Air Transfer Rates in CFM/ft²

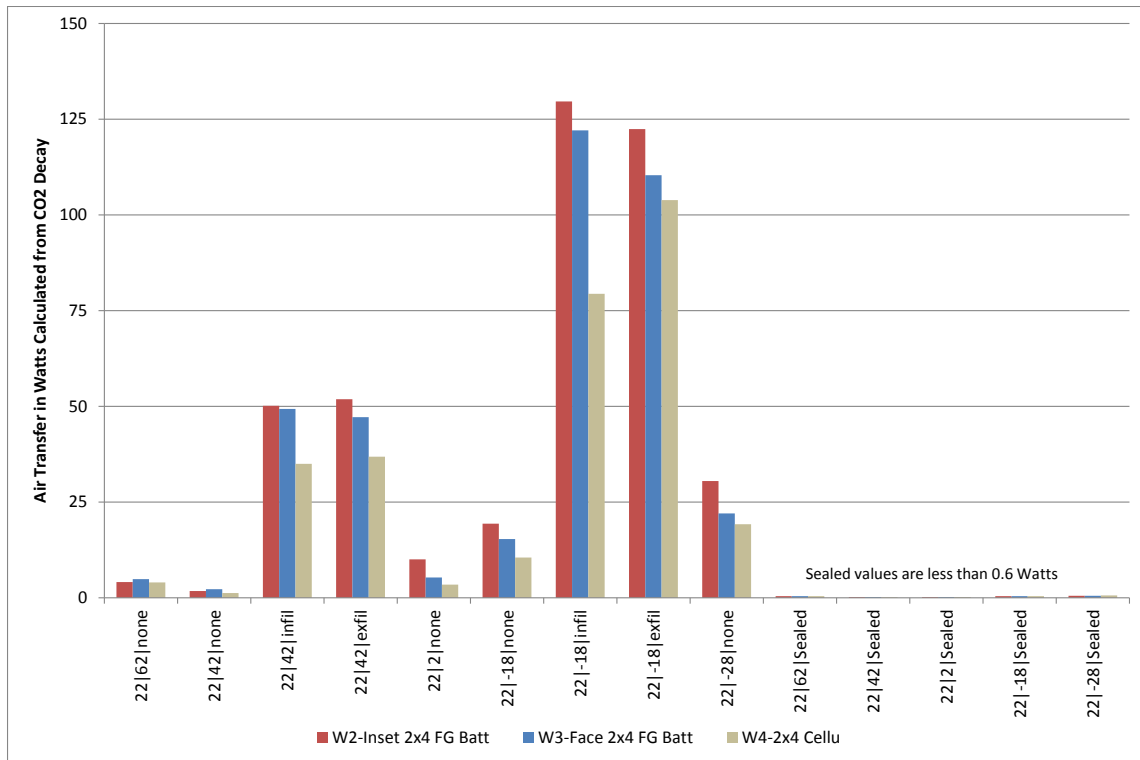
Figure 33 – Wall 2, Wall 3, and Wall 4 Air Transfer Rates in Watts

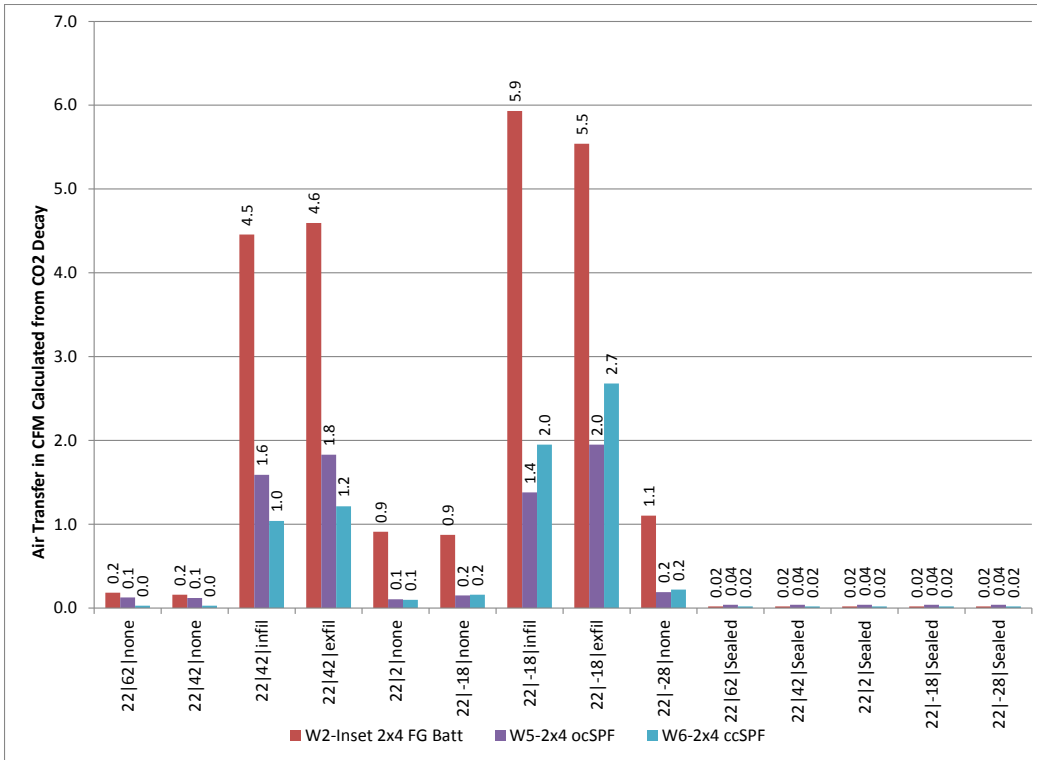
Figure 34 shows the air transfer rates in cubic feet per minute calculated on a mass basis from CO₂ decay. Figure 35 shows the information in Figure 34 divided by the area of the wall to show the leakage per square foot of wall surface. Figure 36 shows the energy flow in watts correlating to the information in Figure 34 for Wall 2, Wall 5, and Wall 6. These figures also show that very minimal airflow and heat flow were measured in the sealed wall tests.

Figure 34 – Wall 2, Wall 5, and Wall 6 Air Transfer Rates in CFM

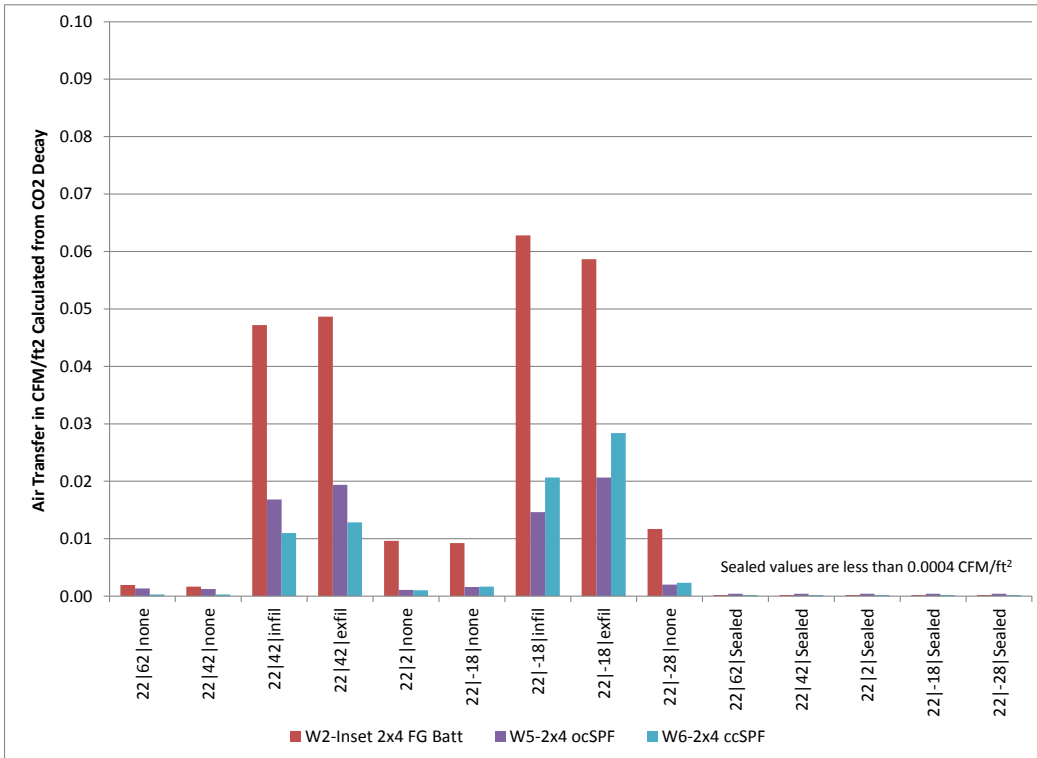
Figure 35 – Wall 2, Wall 5, and Wall 6 Air Transfer Rates in CFM/ft²

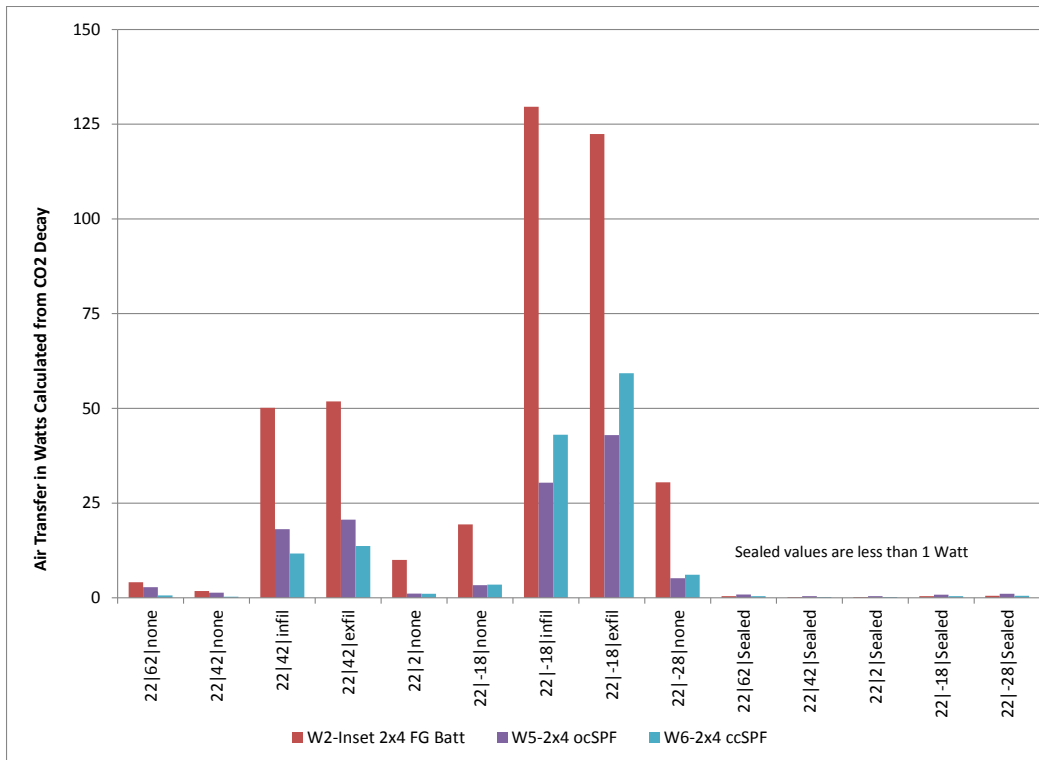
Figure 36 – Wall 2, Wall 5, and Wall 6 Air Transfer Rates in Watts

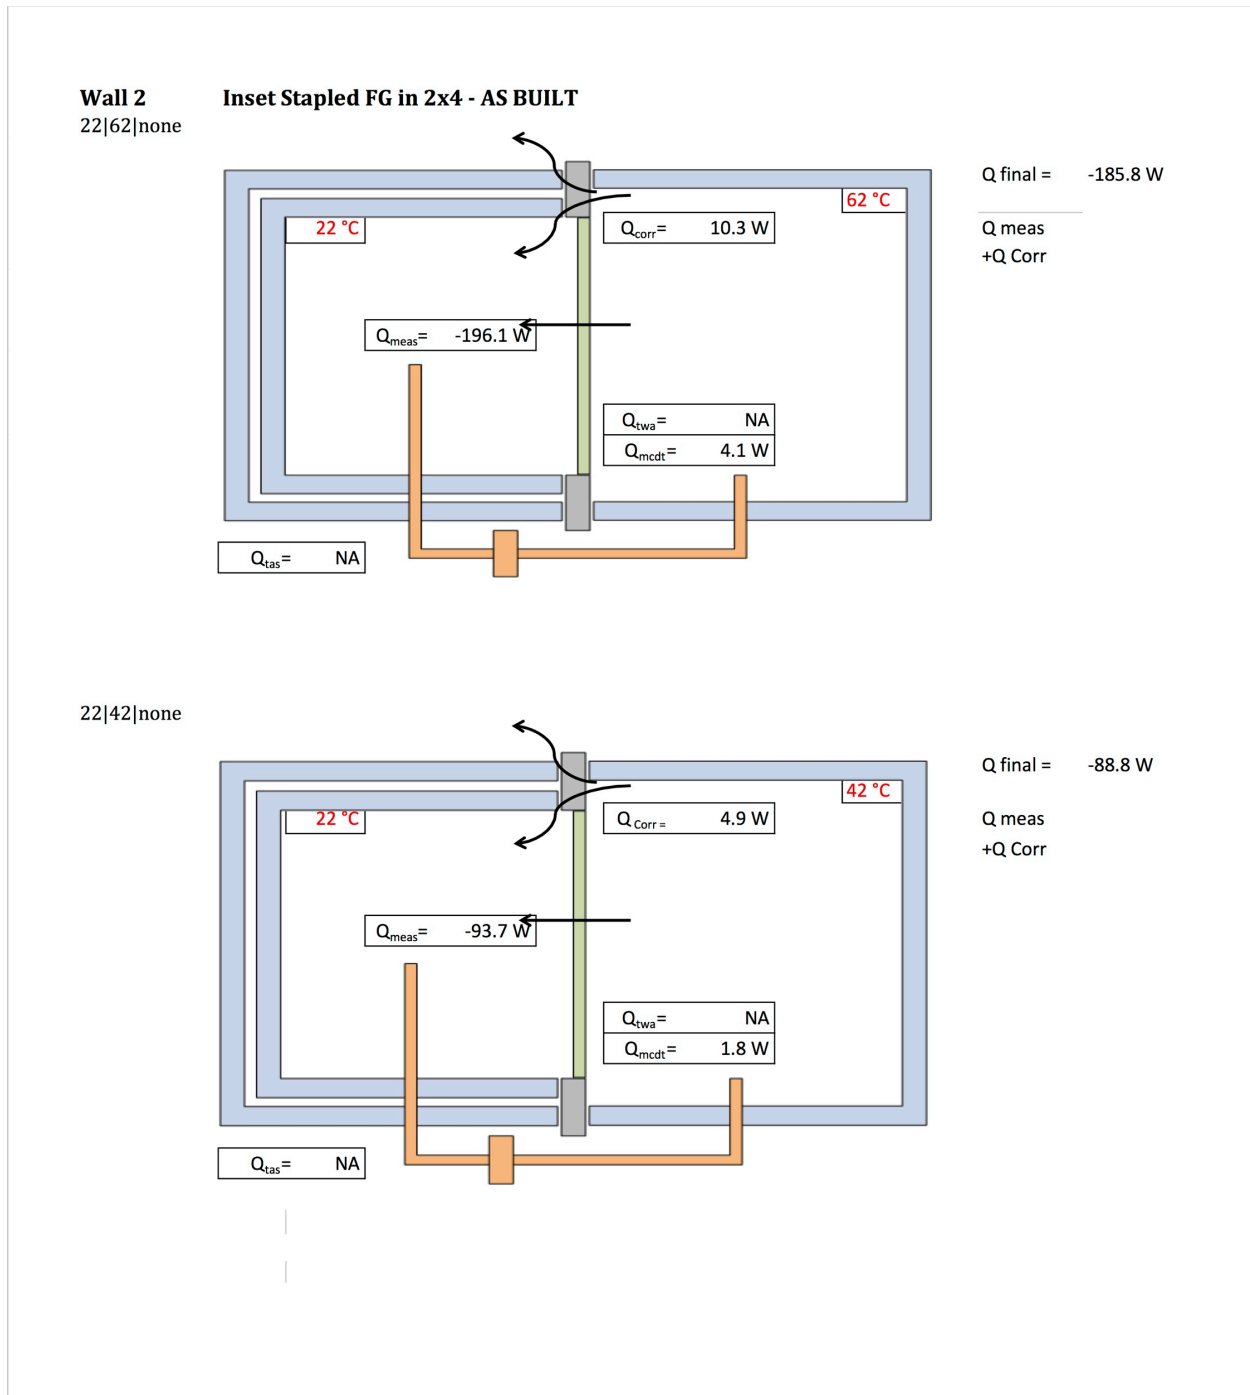
Figure 37 – Wall 2 As-Built 62°C and 42°C Data

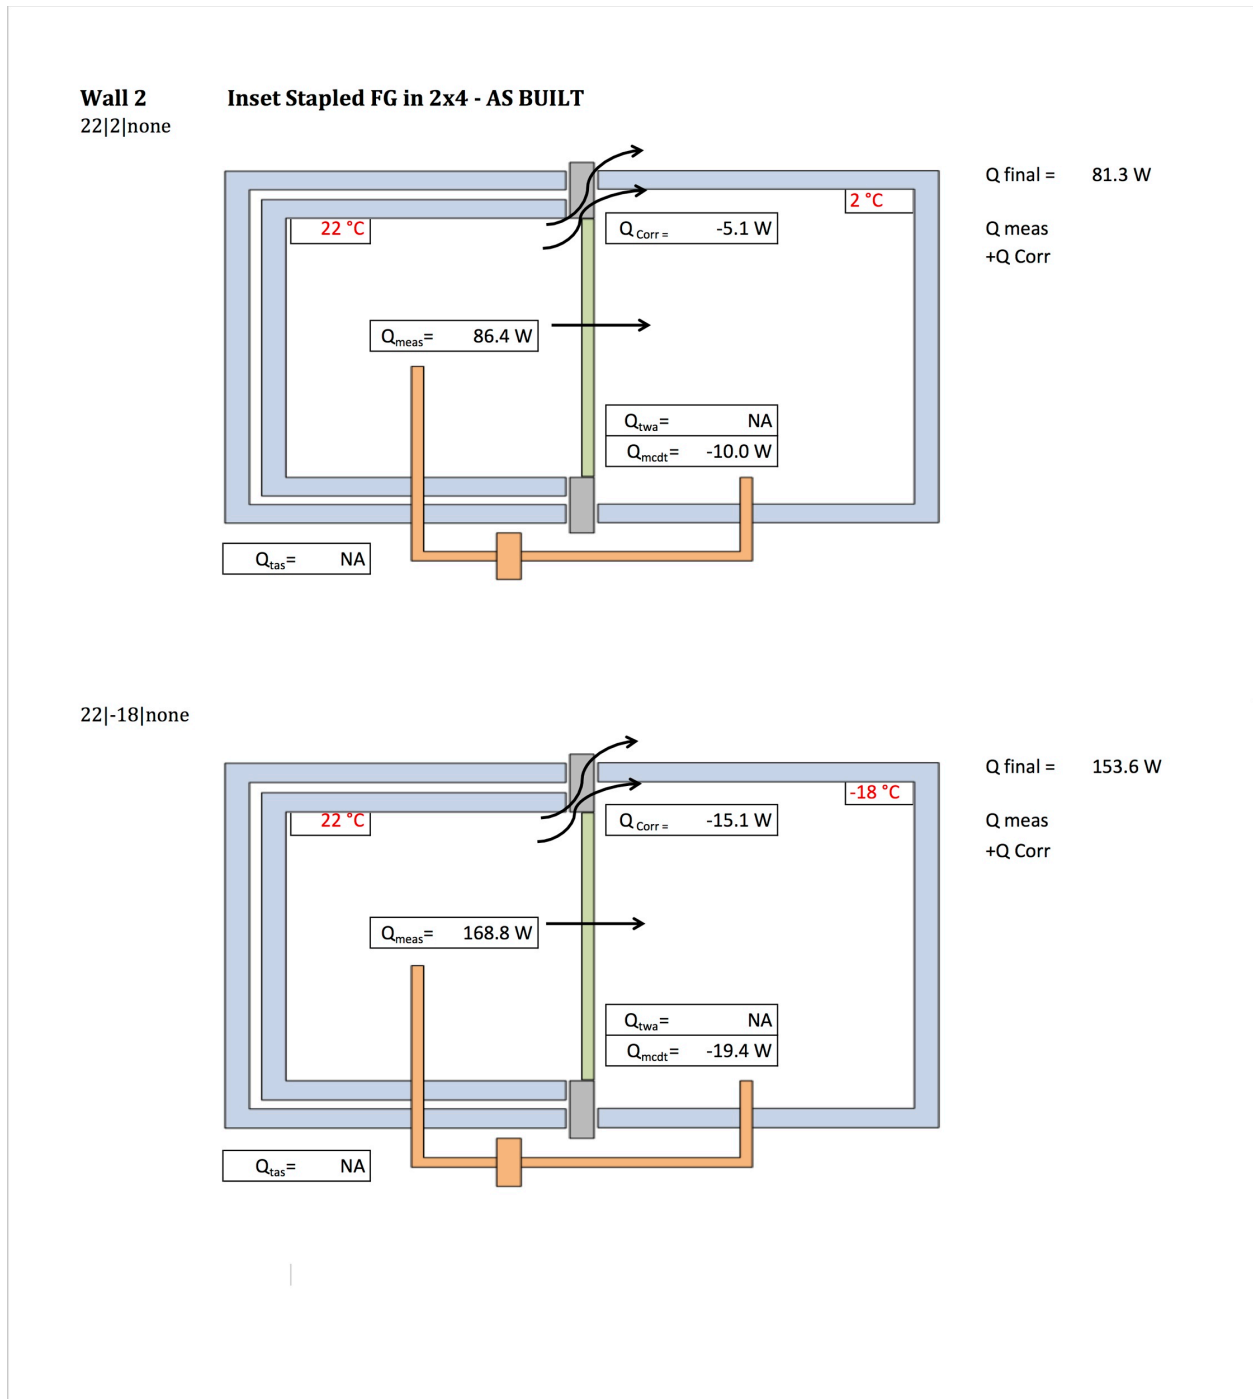
Figure 38 – Wall 2 As-Built 2°C and -18°C Data

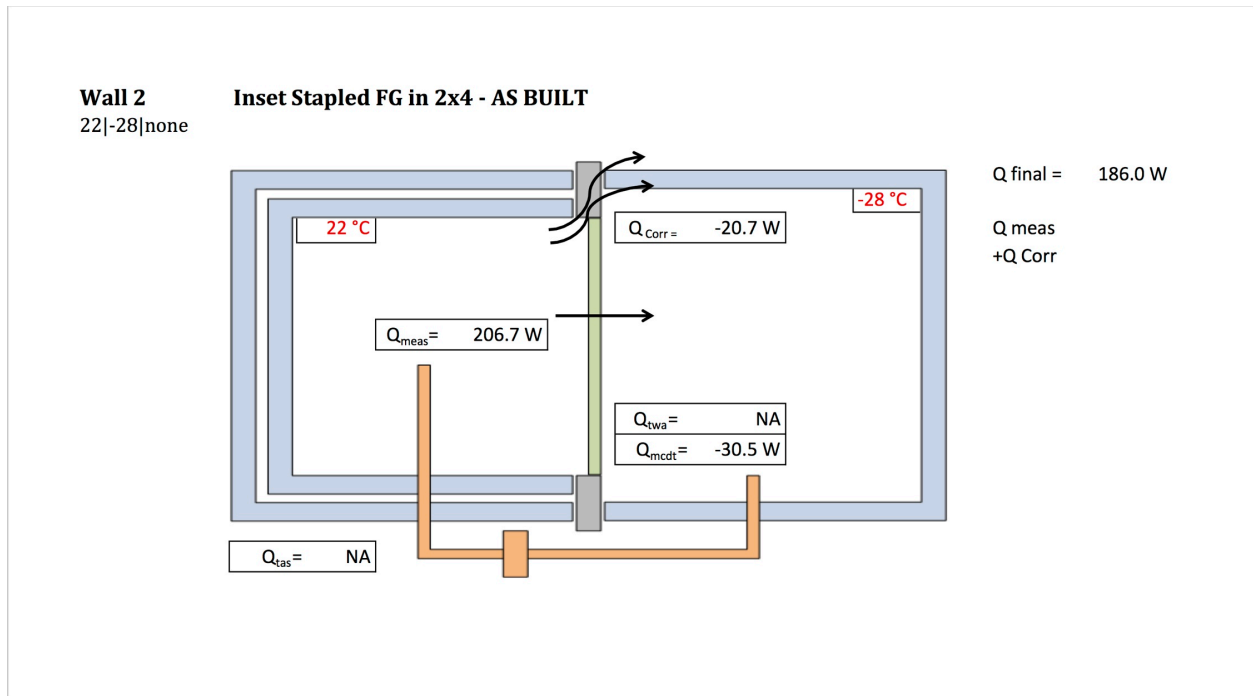
Figure 39 – Wall 2 As-Built -28°C Data
