Thermal Metric Summary Report

(June 2015 Update)

Building Science Corporation

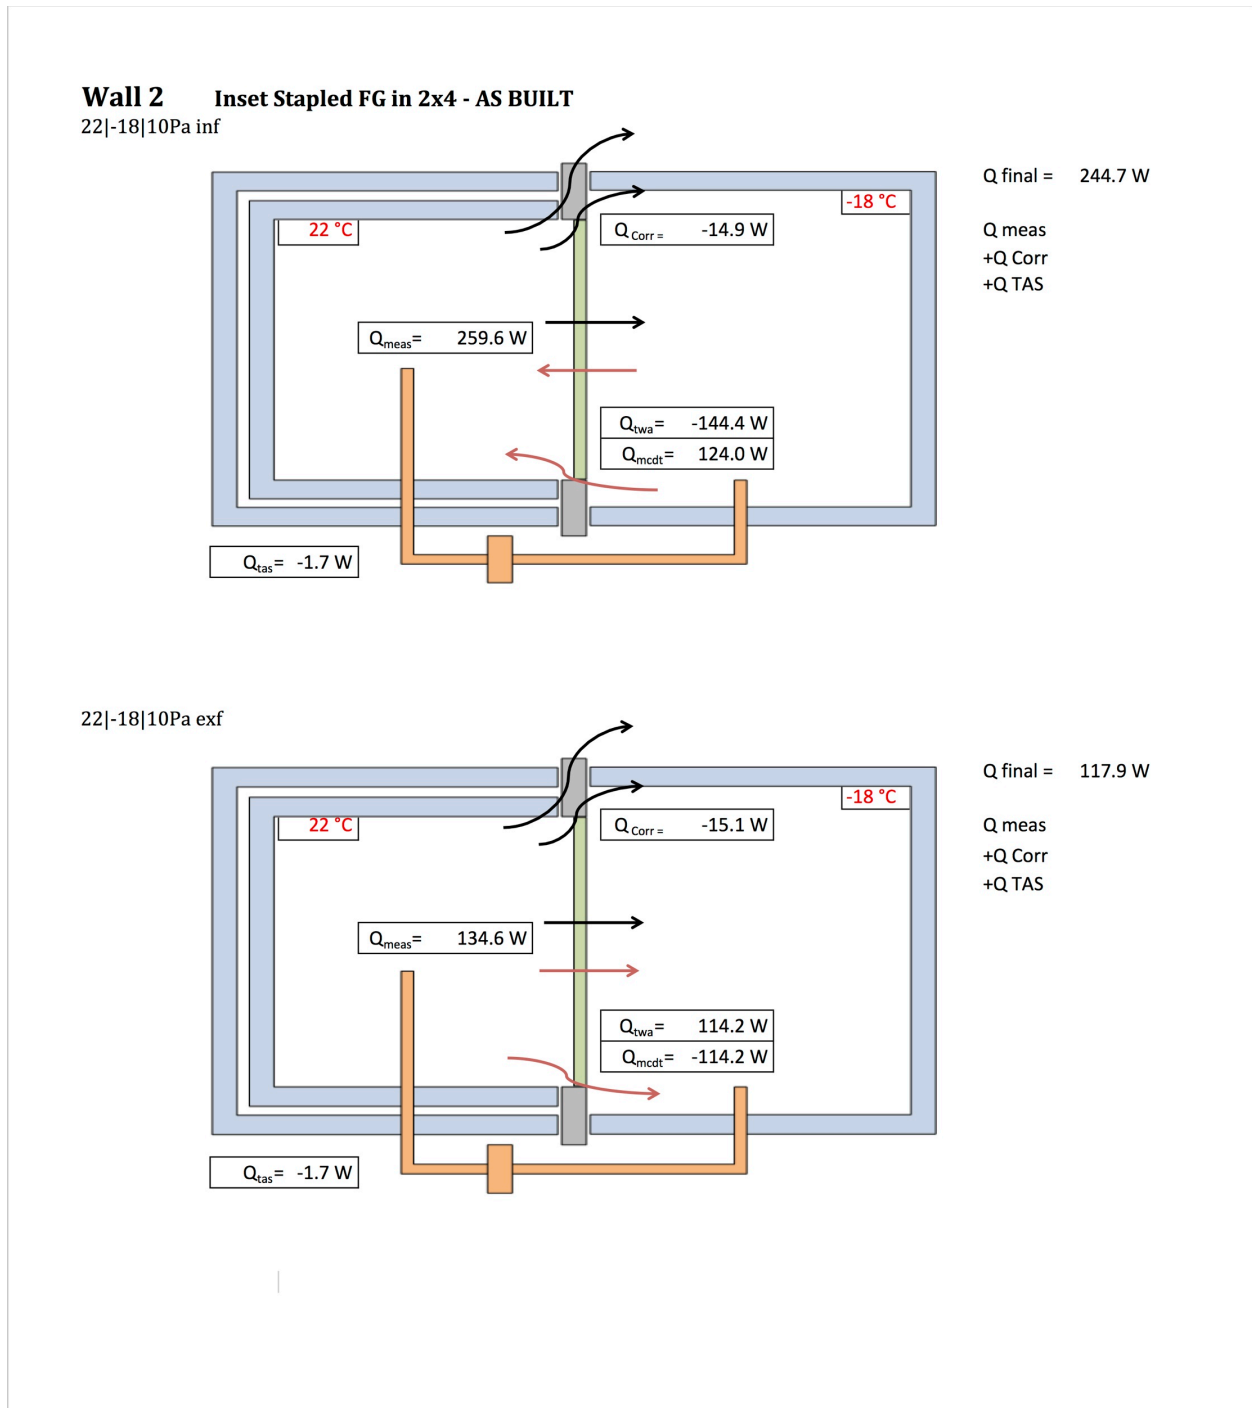
Figure 40 – Wall 2 As-Built -18°C Infiltration/Exfiltration Data

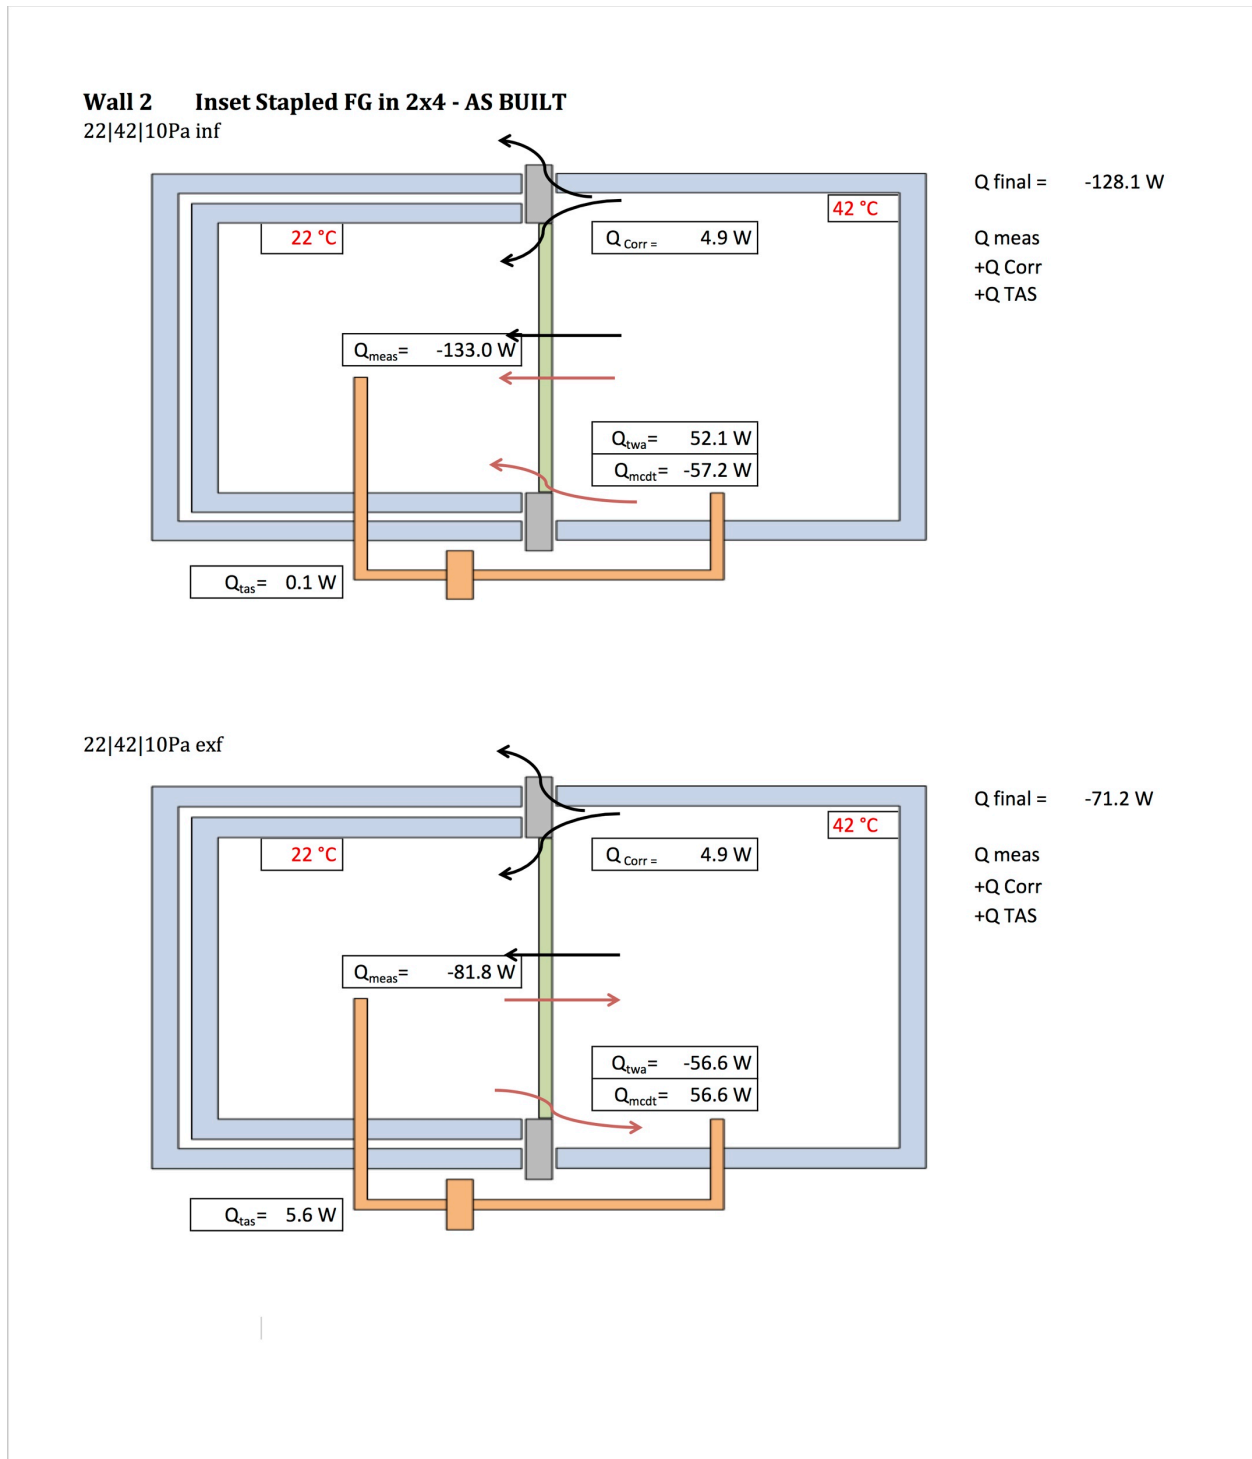
Figure 41 – Wall 2 As-Built 42°C Infiltration/Exfiltration Data

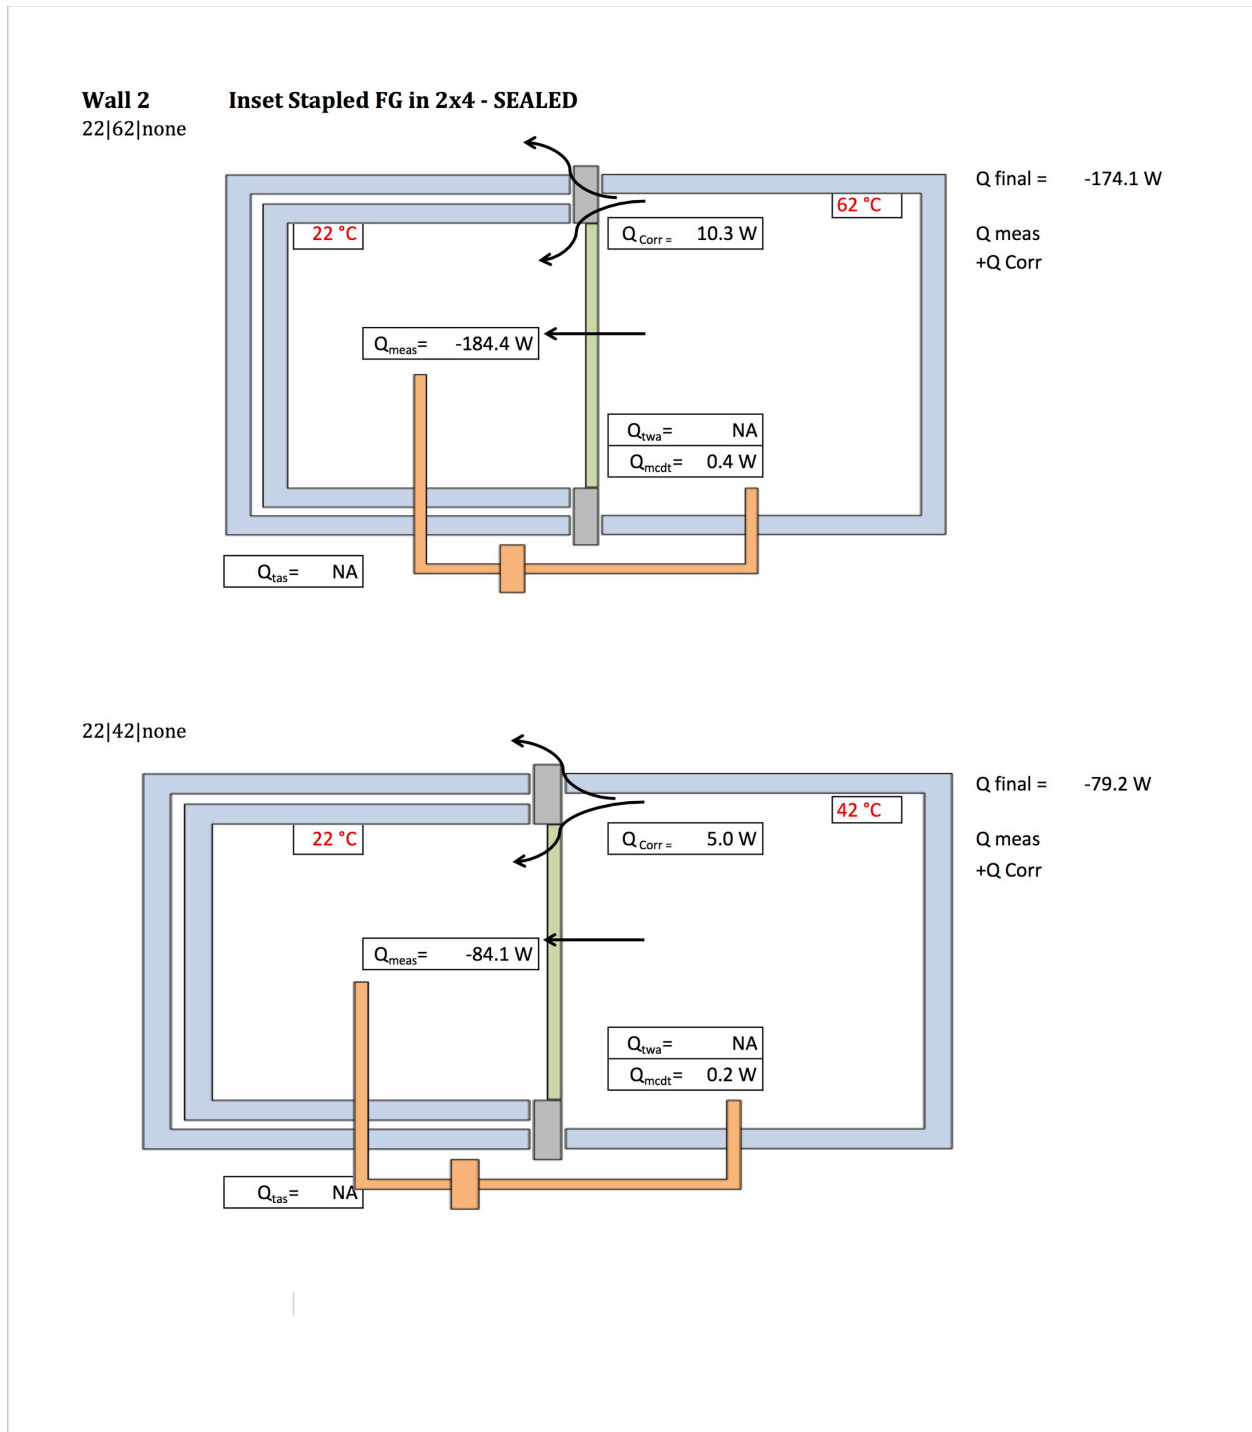
Figure 42 – Wall 2 Sealed 62°C and 42°C Data

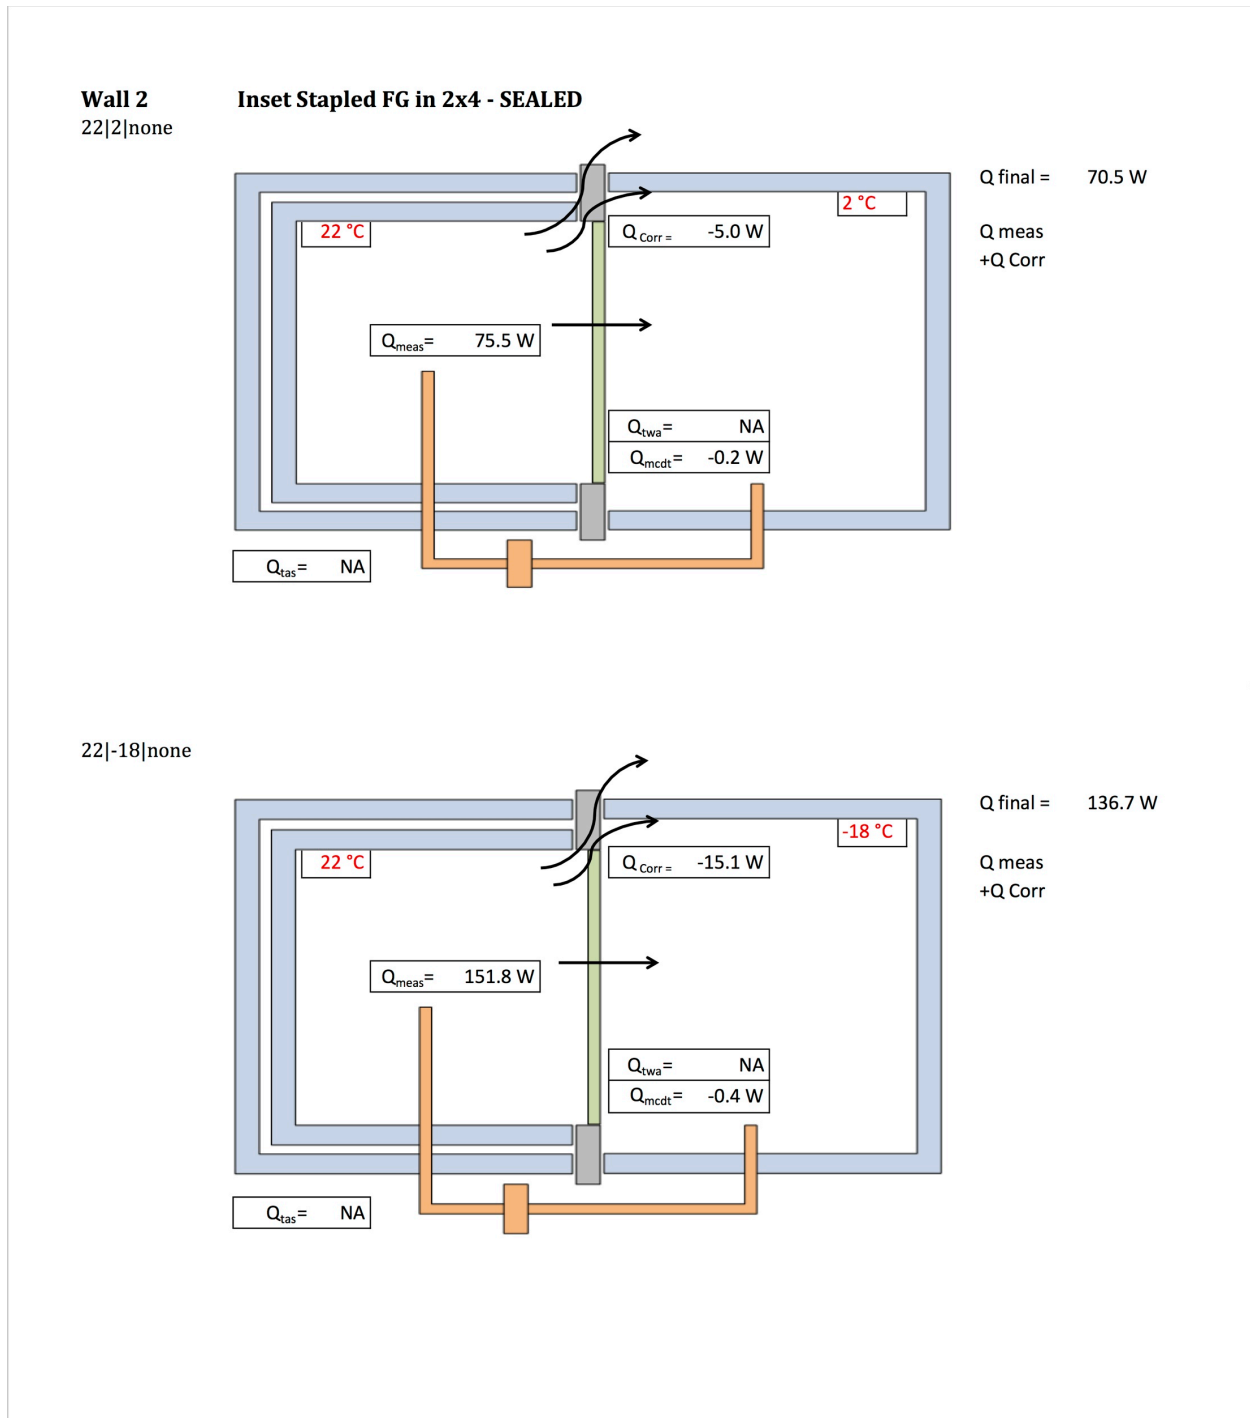
Figure 43 – Wall 2 Sealed 2°C and -18°C Data

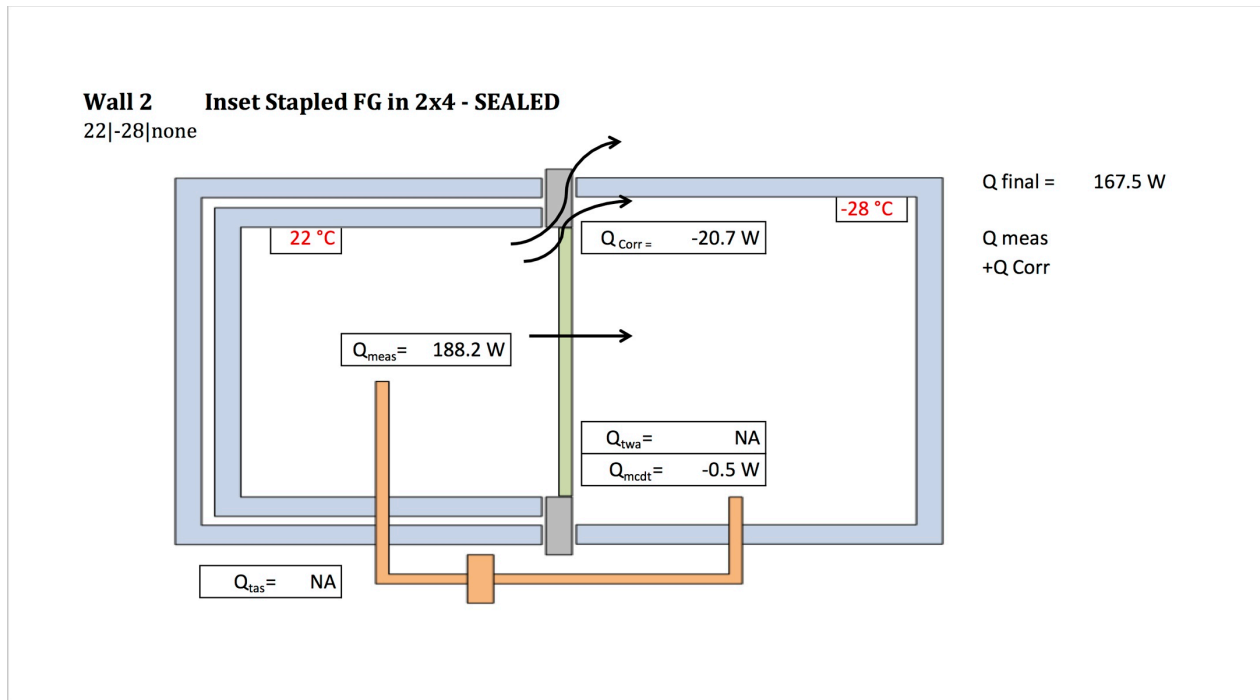
Figure 44 – Wall 2 Sealed -28°C Data

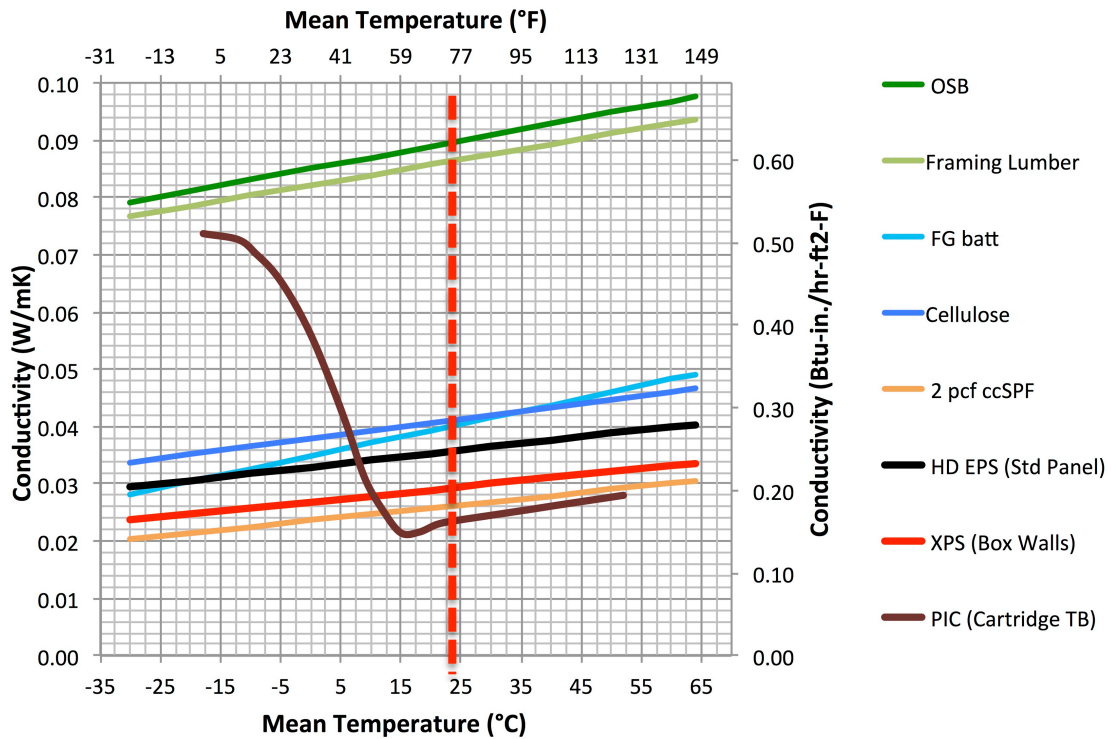
Figure 47 – Measured Temperature Dependency of Selected Materials from the TM Research Project

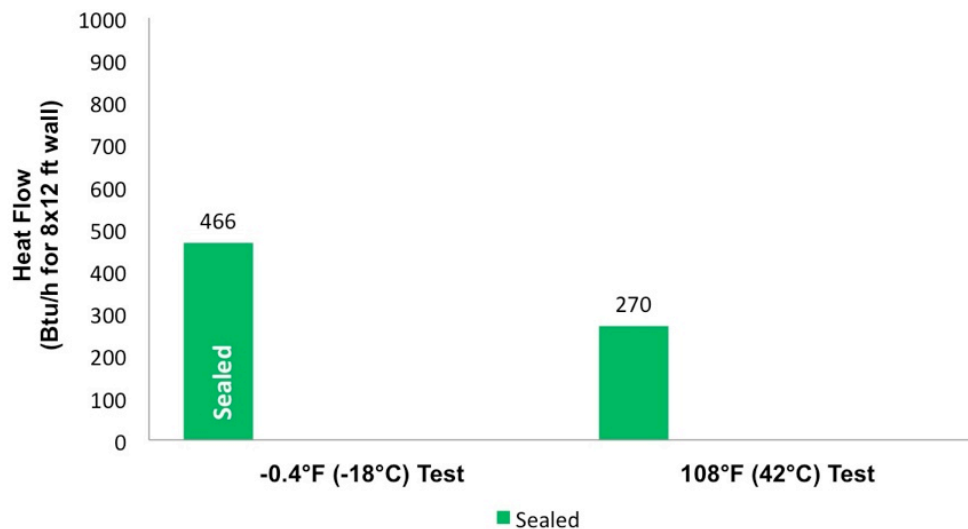
Figure 49 presents the measured heat flows for the “sealed” scenario of Wall 2. In these tests the wall was “sealed” on the exterior and interior sides using polyethylene sheets and tape, in order to eliminate air leakage through the assembly. In these tests mass flow across the assembly (i.e. from indoors to outdoors or vice versa) is assumed to be none existent. These tests represent the “ideal” or minimum heat flows represented by the simple conduction-only building enclosure heat loss model of Figure 50. These tests provide a baseline for comparing the induced airflow tests.

Figure 49 – Measured Heat flows for Wall 2 – Inset R13 FG batt, ‘Sealed’

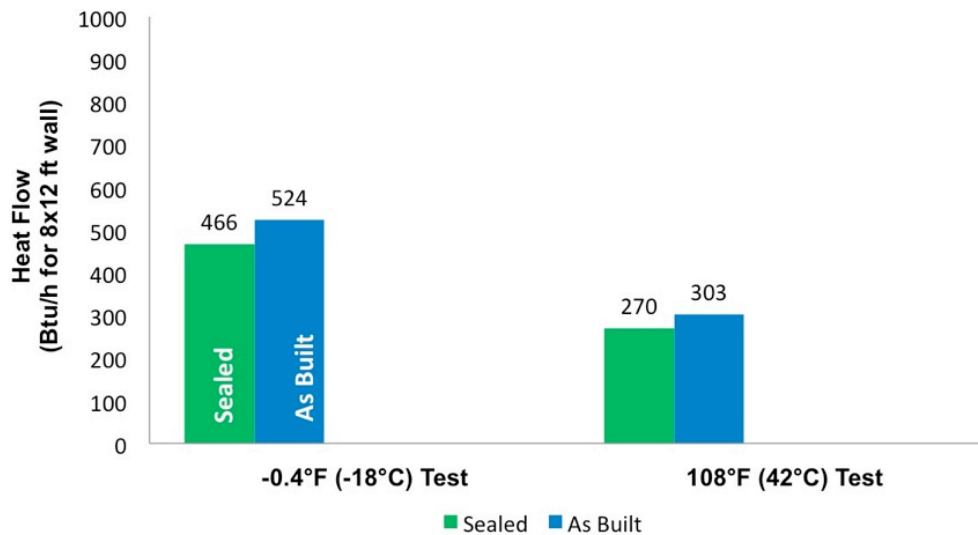
No intentional air pressure differentials were induced for the “as-built” wall tests, however temperature differences and circulation fans inevitably create small pressure differences (e.g. +/- 1 to 3 Pa) across the test wall assembly. Slightly higher heat flows were measured for the “as-built” tests. This may be evidence of small airflows driven by the unintentional pressure difference. In the TM Hot Box tests these small airflows are quantified using the CO₂ tracer gas system.

Figure 51 – Measured Heat flows for Wall 2 – Inset R13 FG batt, ‘Sealed’ vs ‘As-built’

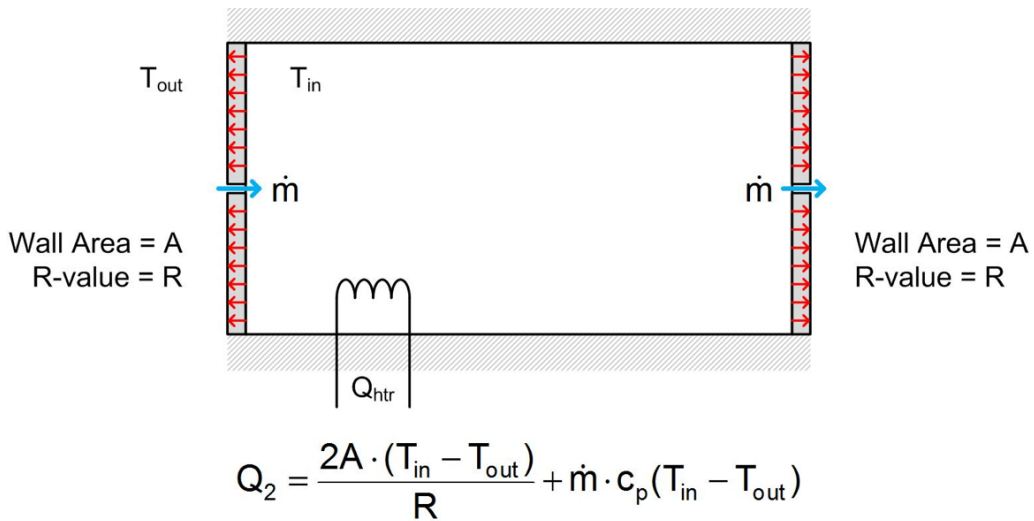
Typical building enclosure heat loss models, such as the one represented in Figure 52, treat air leakage as if it occurs through discrete holes and does not interact with conductive heat flow through the assembly. This approach can be used to predict the energy associated with the airflows and temperature differences measured in the TM induced infiltration and exfiltration tests. The air leakage energy flow can then be added to the "sealed" heat flow to predict the total heat flow associated with the temperature difference and air leakage. These totals are represented by the red bars in Figure 53.

Figure 52 – Simple Building Enclosure Heat Loss Model with Discrete Air Leakage

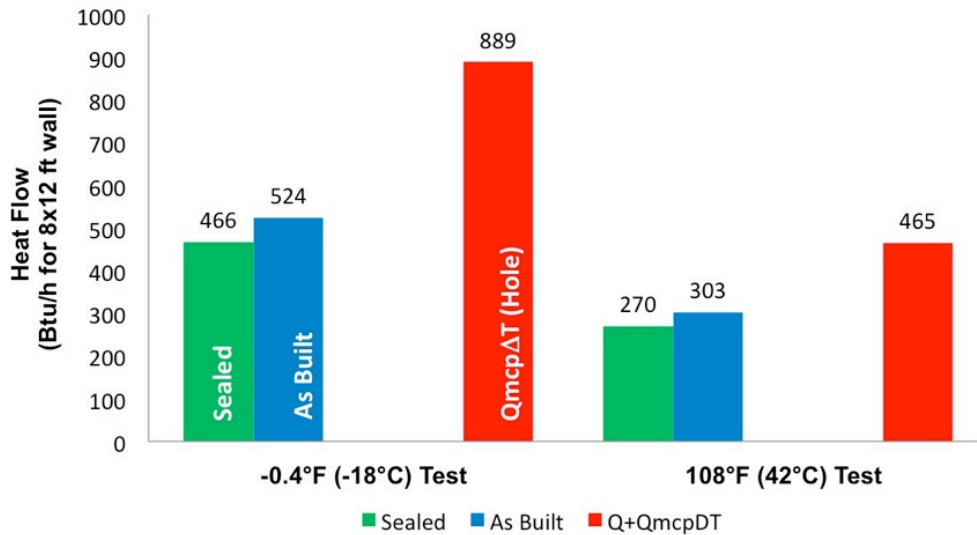
Figure 53 – Measured Heat Flows vs Predicted Airflow Impact for Wall 2 – Inset R13 FG batt

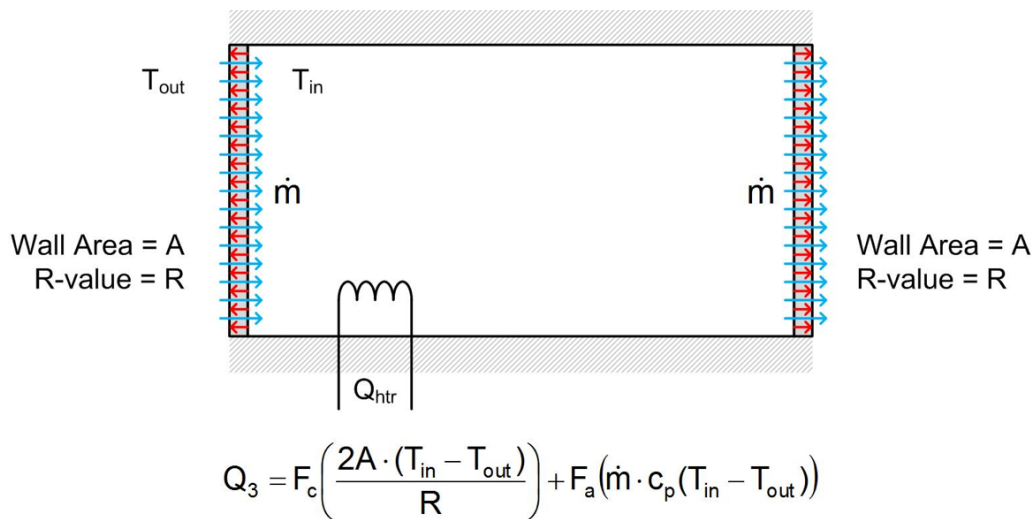
The TM reference wall test results show strong evidence of the interaction between conductive and convective heat flows. Figure 54 presents a simplified building model with equal areas of wall on the windward and leeward side of the building. The windward walls experience infiltration while the leeward walls experience exfiltration. Interaction results in heat exchange between the air and the materials inside the wall assembly and the total measured heat flow (represented by the brown bar in Figure 55) is less than predicted by the commonly used discrete air leakage model (represented by the red bar in Figure 55).

Figure 54 – Simplified Building Model for Interaction given Equal Infiltration & Exfiltration

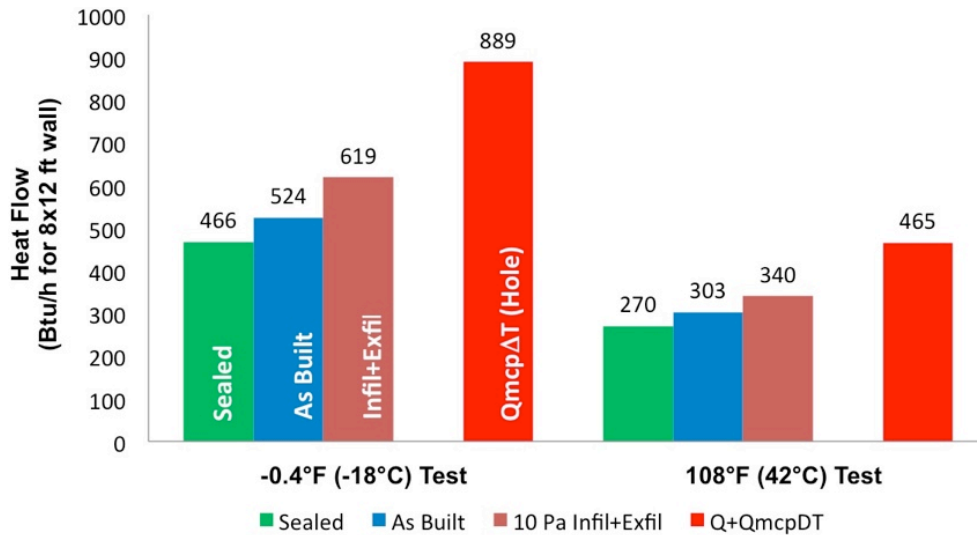
Figure 55 – Infiltration + Exfiltration Building Scenario for Wall 2 – Inset R13 FG batt

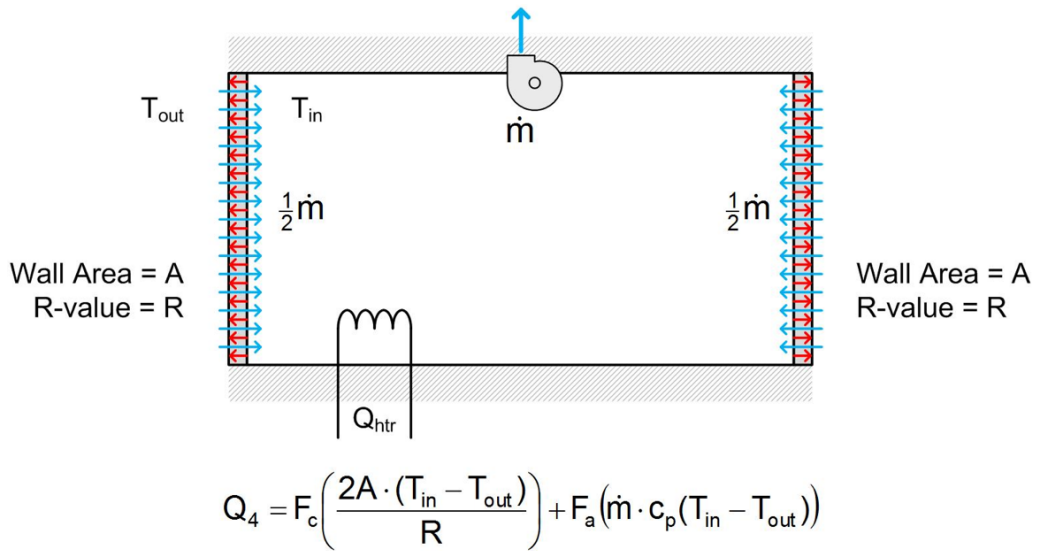
Figure 56 presents a simplified model for a different scenario. In this building a large mechanical exhaust removes air without any heat recovery (i.e. no interaction). As a result, the building is negatively pressurized and air infiltrates in both exterior walls. Again, interaction results in heat exchange between the air and the materials inside the wall and the total measured heat flow (represented by the purple bar in Figure 57) is less than predicted by the commonly used discrete air leakage model (represented by the red bar in Figure 57).

Figure 56 – Simplified Building Model for Interaction given Infiltration Only

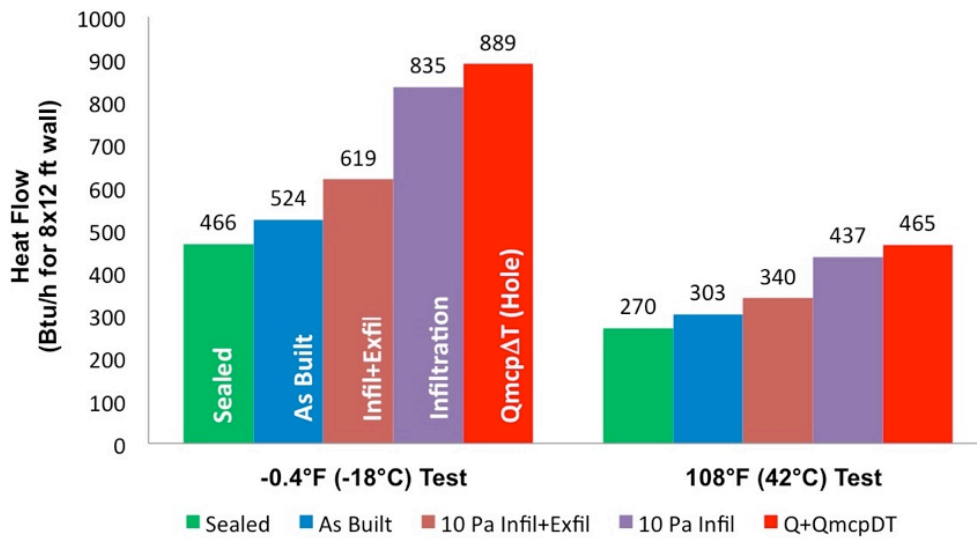
Figure 57 – Infiltration Only Building Scenario for Wall 2 – Inset R13 FG batt

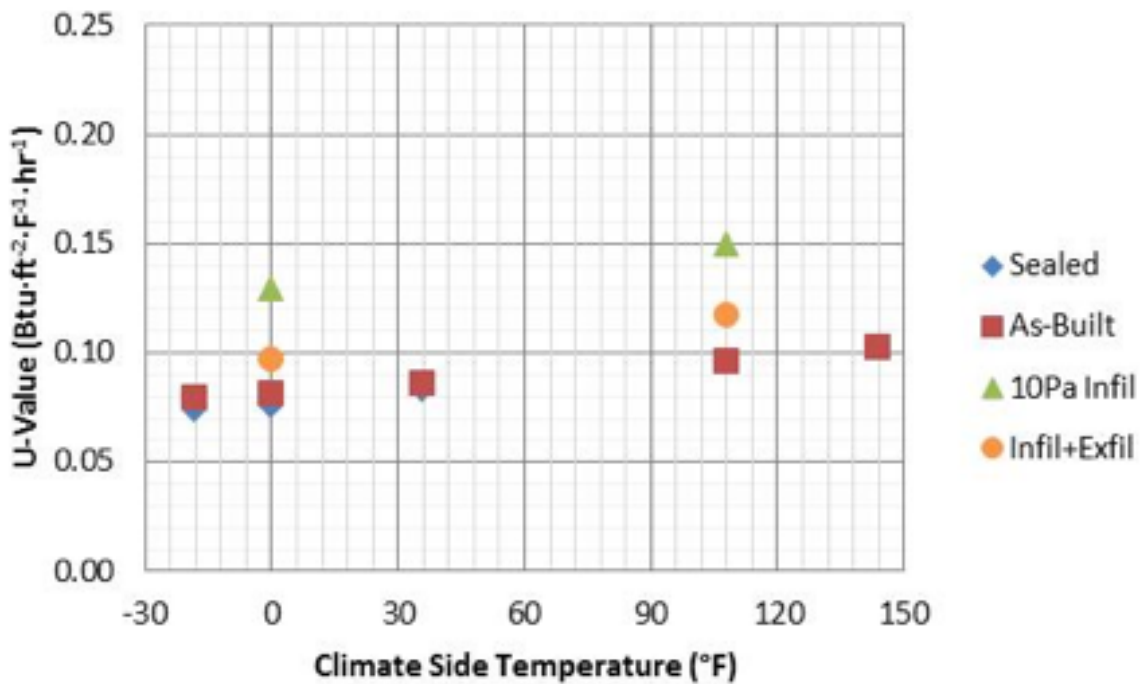
Wall 3: U-Value (Surface to Surface)

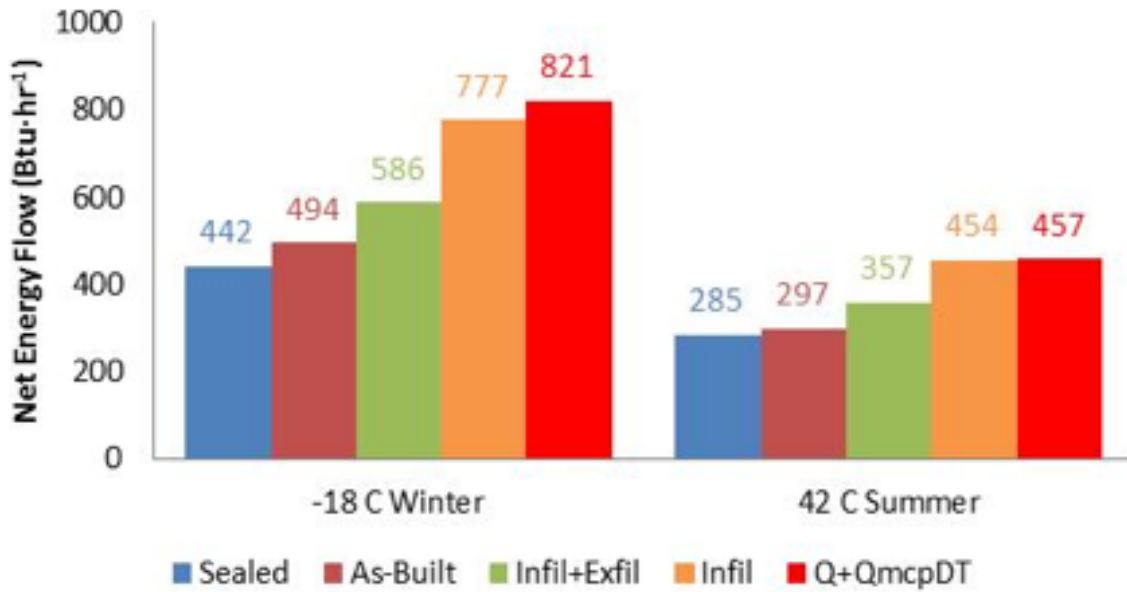
Wall 3: Building Energy Use per Wall

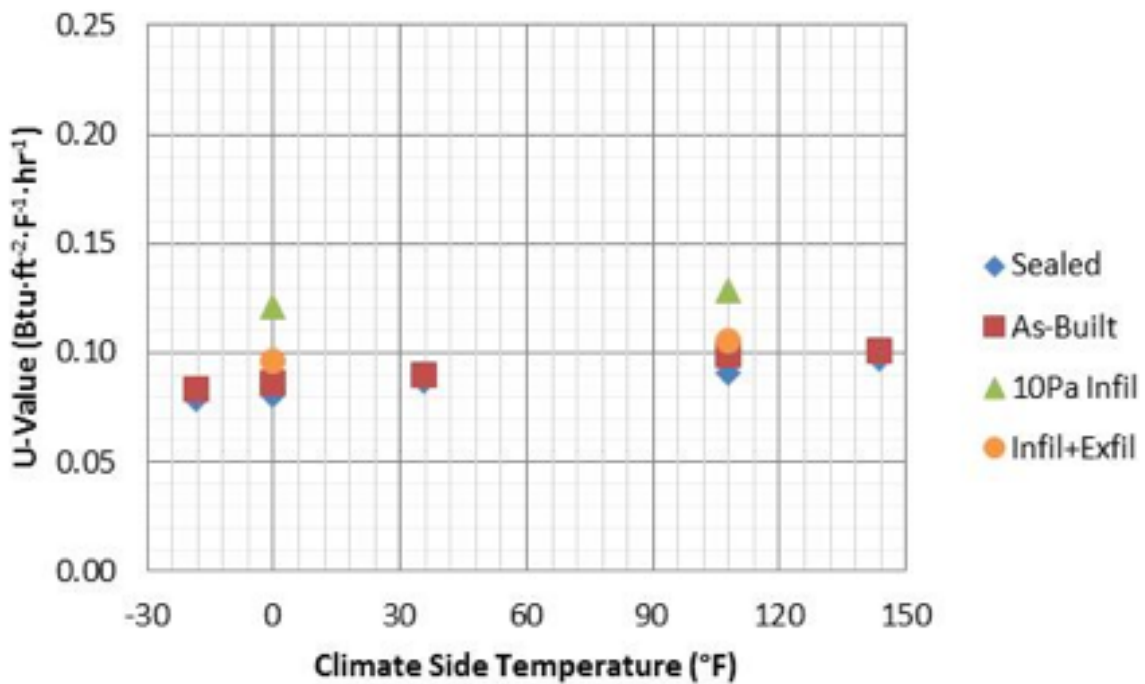
Wall 4: U-Value (Surface to Surface)

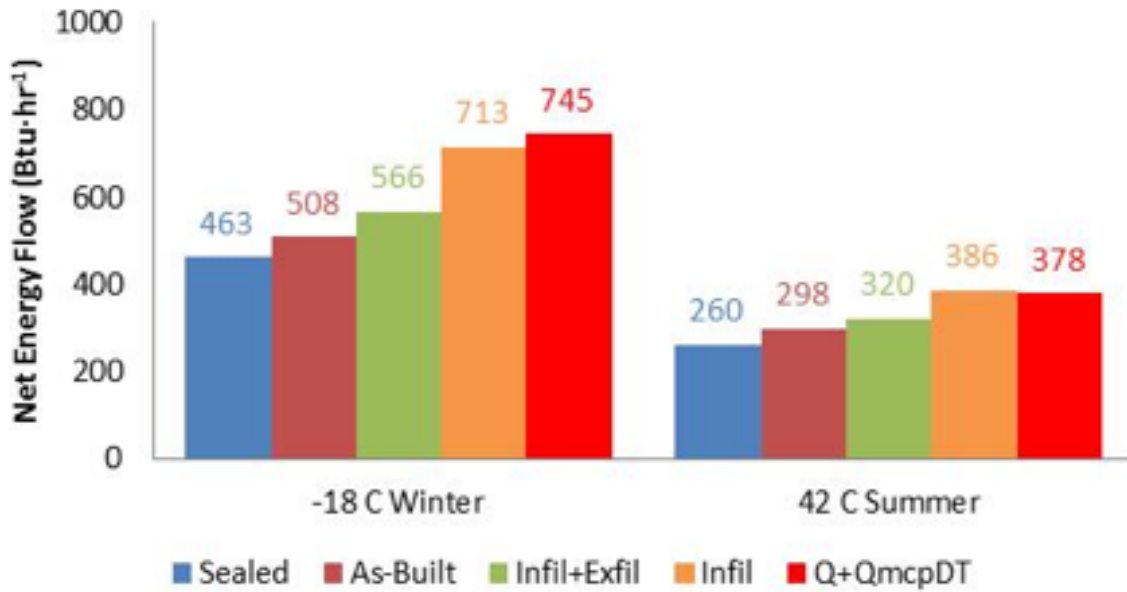
Wall 4: Building Energy Use per Wall

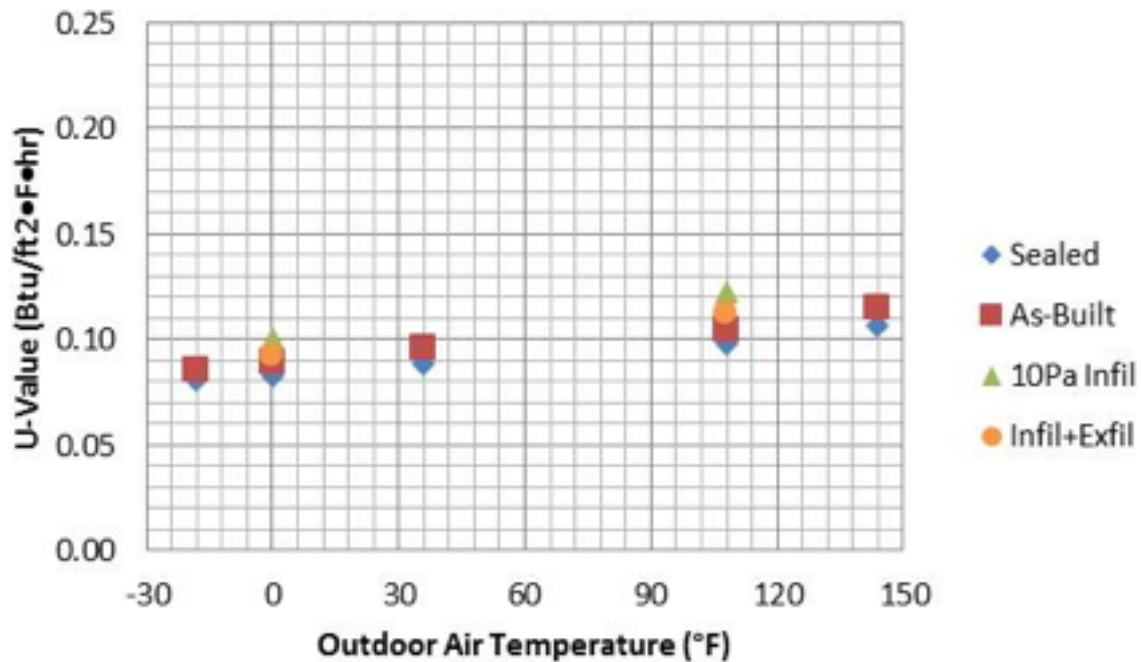
Wall 5: U-Value (Surface to Surface)

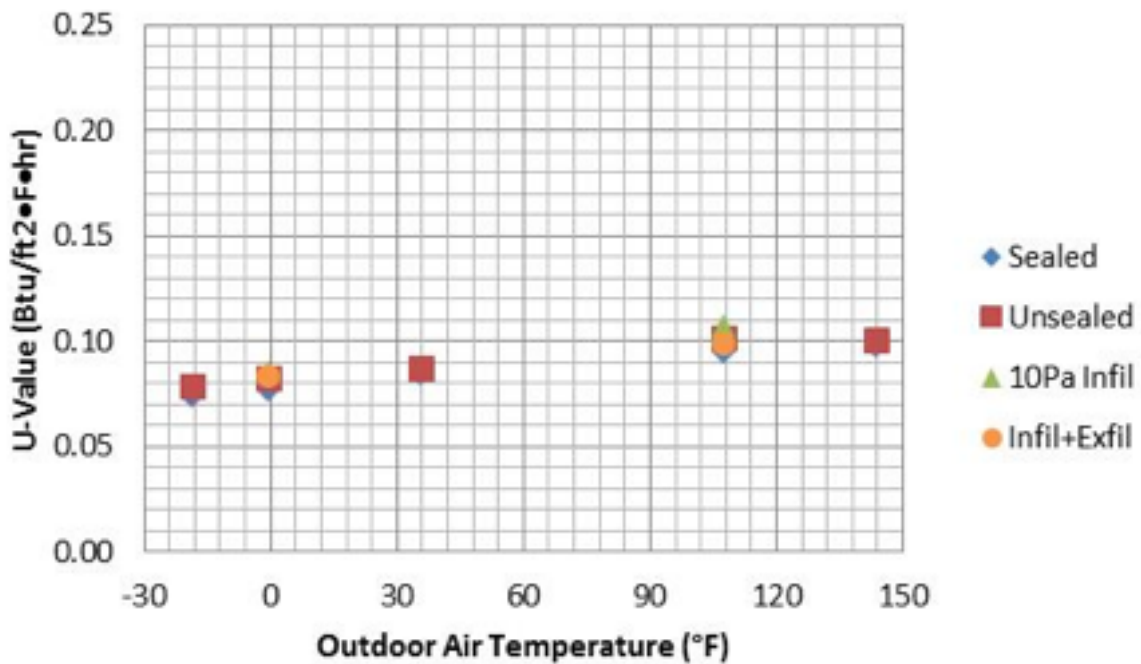
Wall 5 II: U-Value (Surface to Surface)

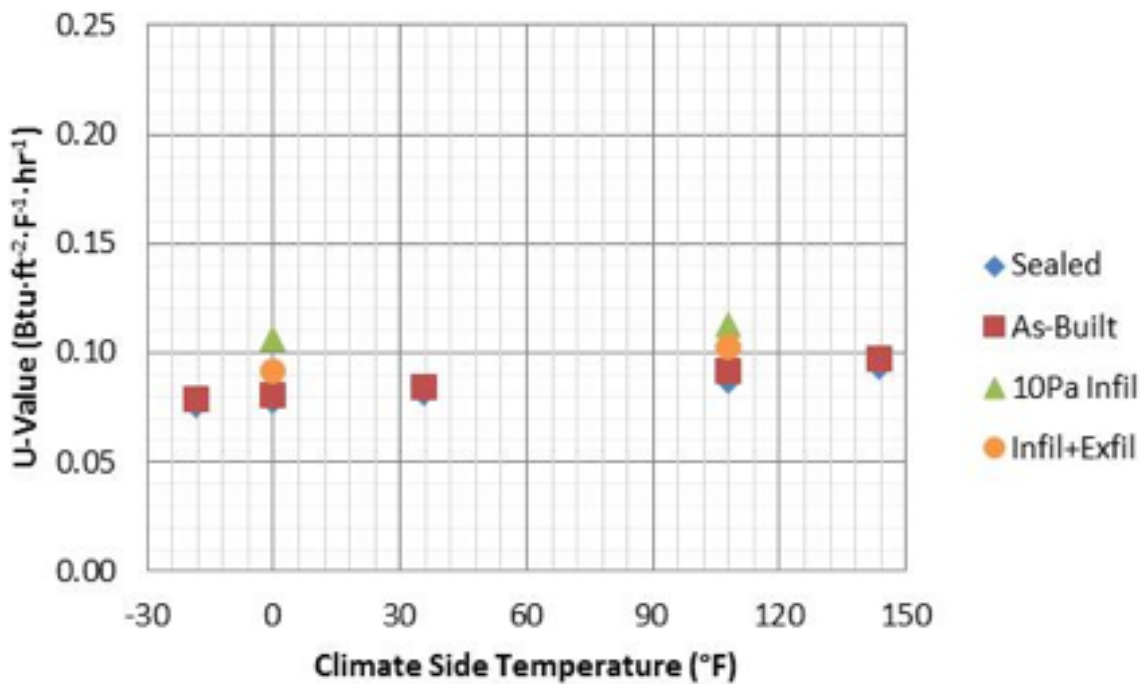
Wall 6: U-Value (Surface to Surface)

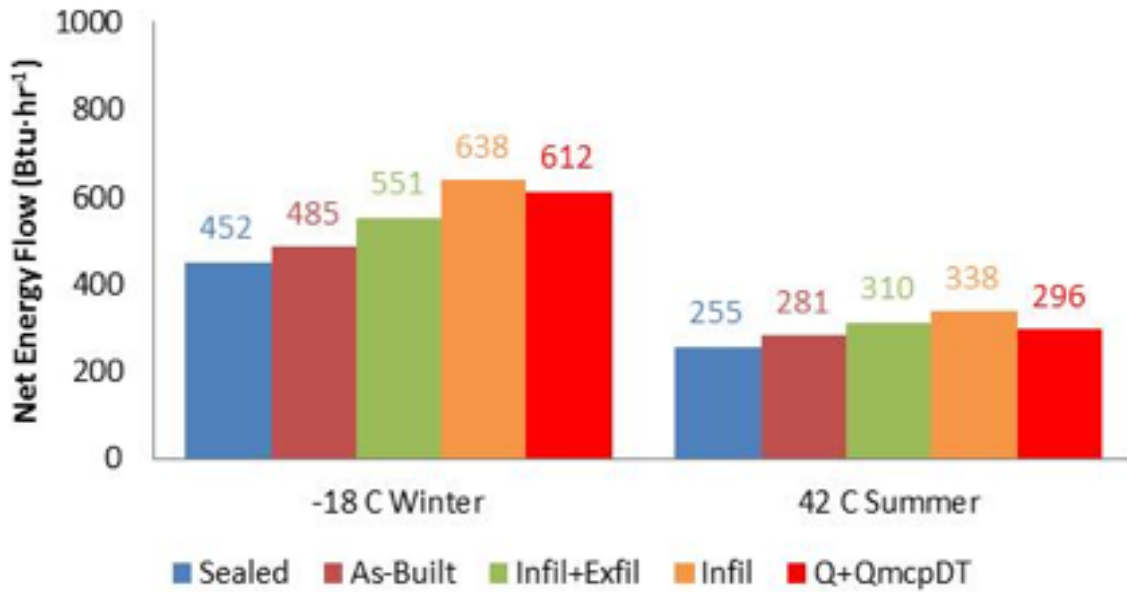
Wall 6: Building Energy Use per Wall

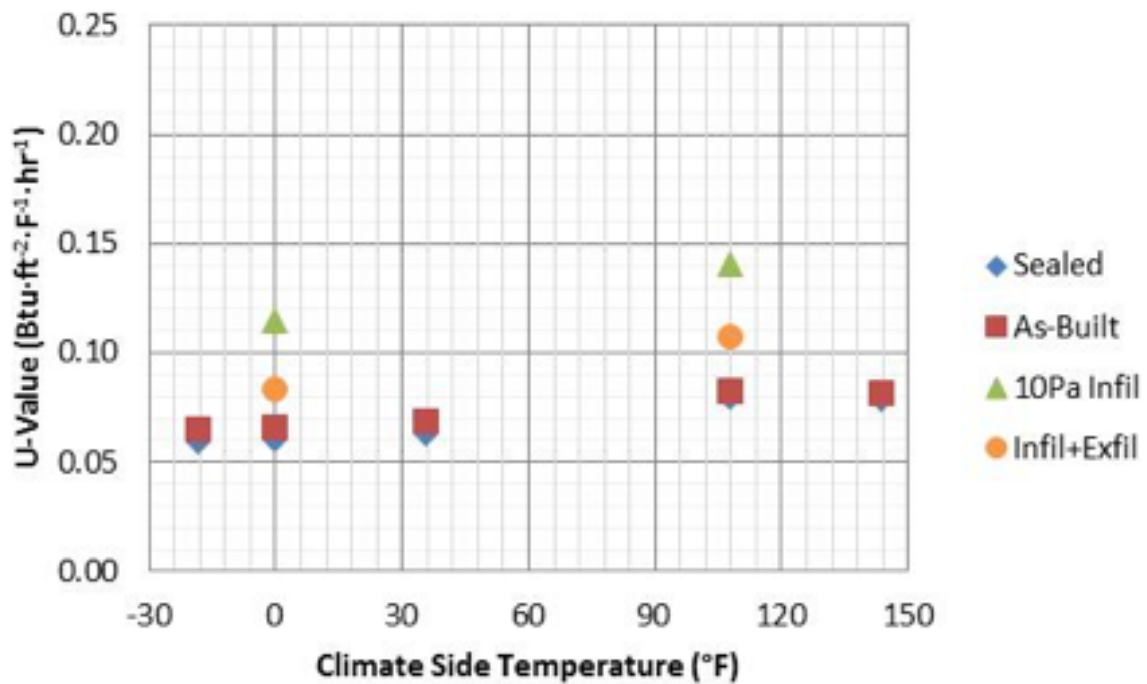
Wall 7: U-Value (Surface to Surface)

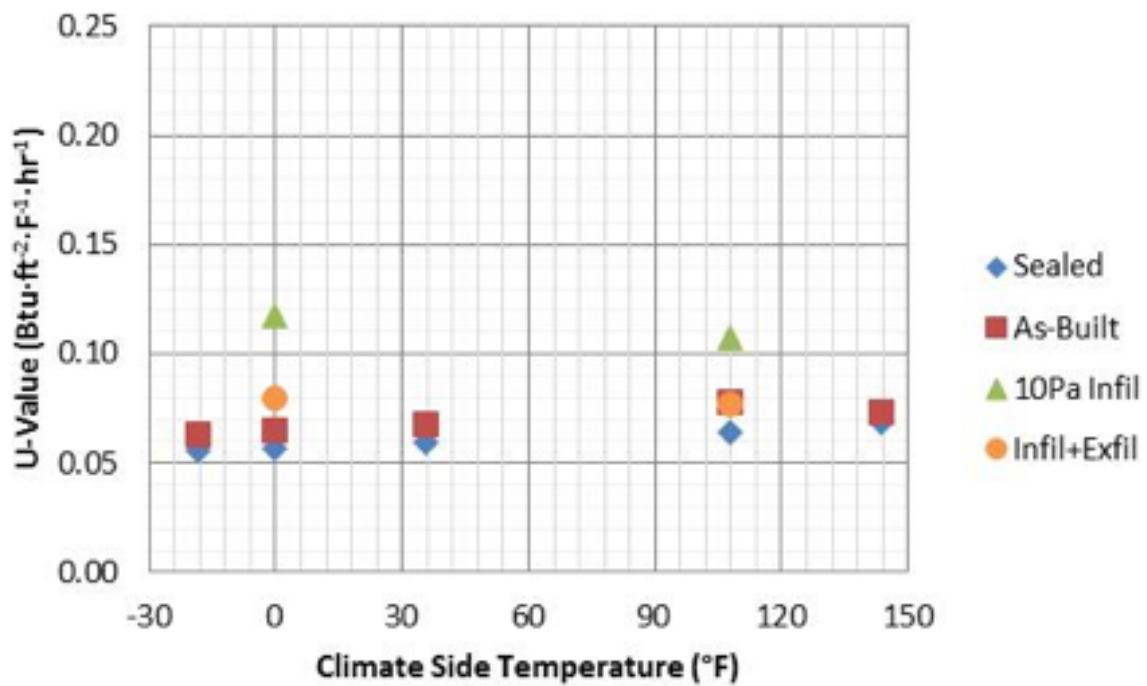
Wall 8: U-Value (Surface to Surface)

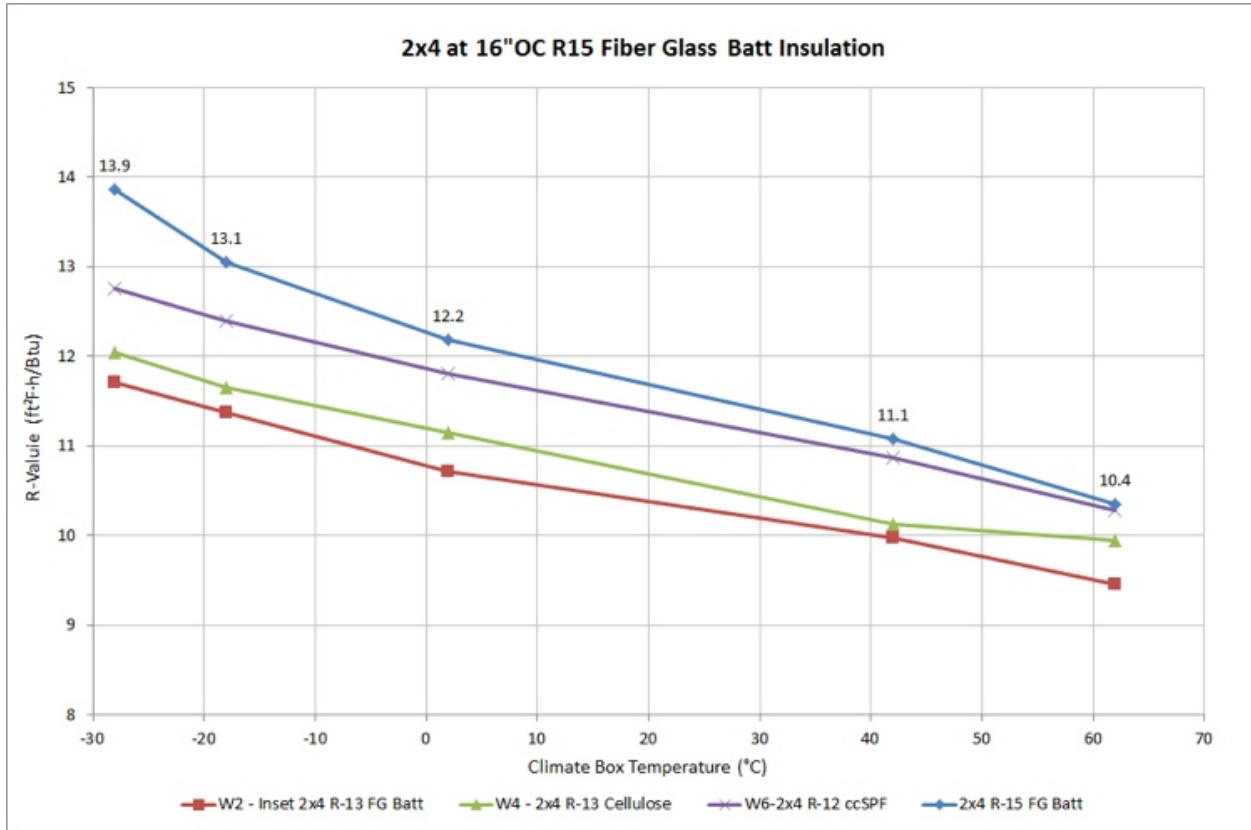
surface-to-surface (S-S) temperature difference by the inverse of the total heat flow. The R-values at each climate box setpoint, including the induced air flow R-values, are provided in the plot below.
