Thermal Metric Summary Report

(June 2015 Update)

Building Science Corporation

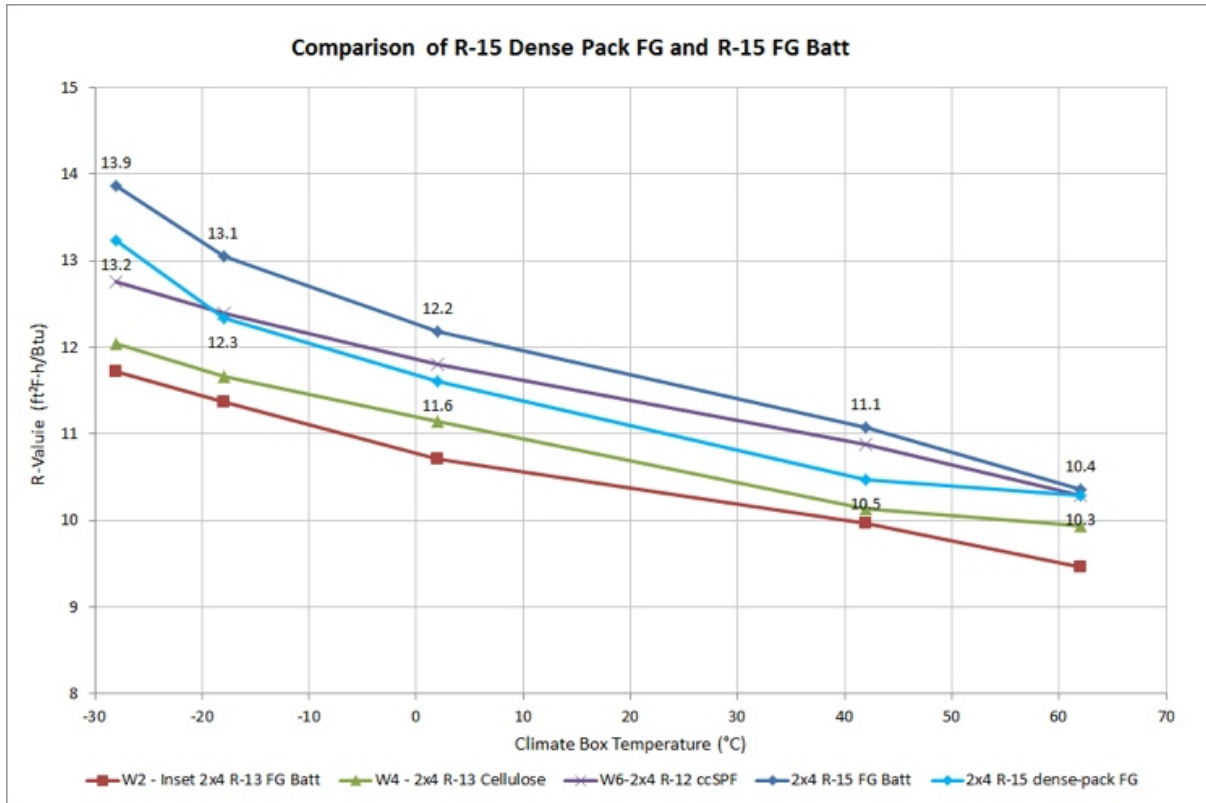
The R-15 batt wall is also included in the plot below.
